12.0 Mexican Hat, Utah, Disposal Site

12.1 Compliance Summary

The Mexican Hat, Utah, Uranium Mill Tailings Radiation Control Act (UMTRCA) Title I Disposal Site (site) was inspected on September 15, 2020.

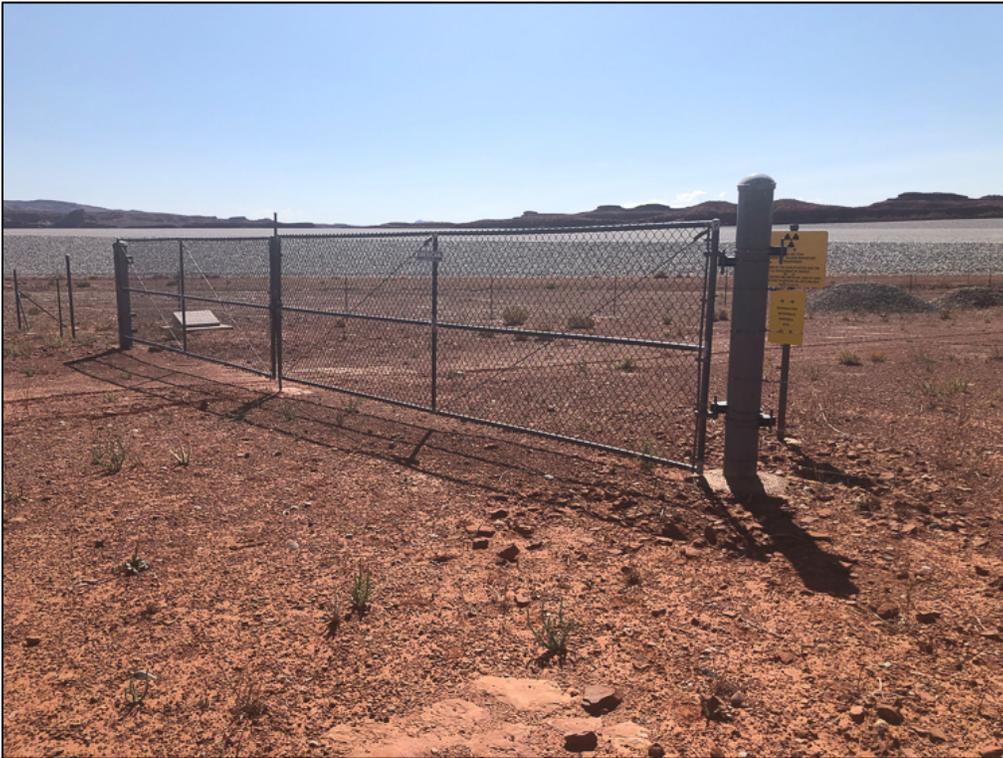
PL-1. Entrance Gate

Access to the site is from a short, unmarked dirt road off U.S. Highway 163 that ends at a graded parking area. Minor erosion continues to occur along the dirt access road, but the site remains accessible. Entrance to the site is through a locked steel entrance gate at the northwest corner of the site. The entrance gate was locked and functional. The entrance sign is affixed to a steel post immediately behind the entrance gate (PL-1). No maintenance needs were identified.

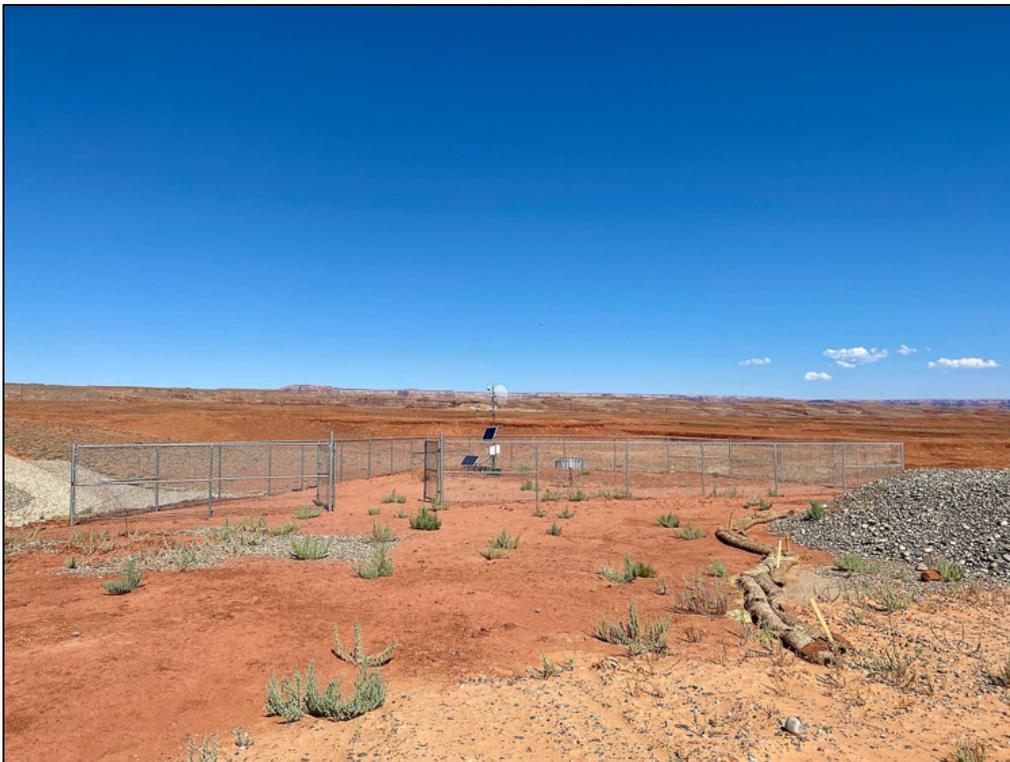
*PL-2. ICP Stockpiles with System Operation and Analysis at Remote Sites (SOARS)
Weather Monitoring Station in Background*

A perimeter chainlink fence was installed in 2019 around the existing System Operation and Analysis at Remote Sites (SOARS) weather monitoring station (PL-2). Approximately 260 linear feet of 6-foot-tall chainlink fence and a lockable double swing gate were installed on existing dirt and rock surfaces around the SOARS station.

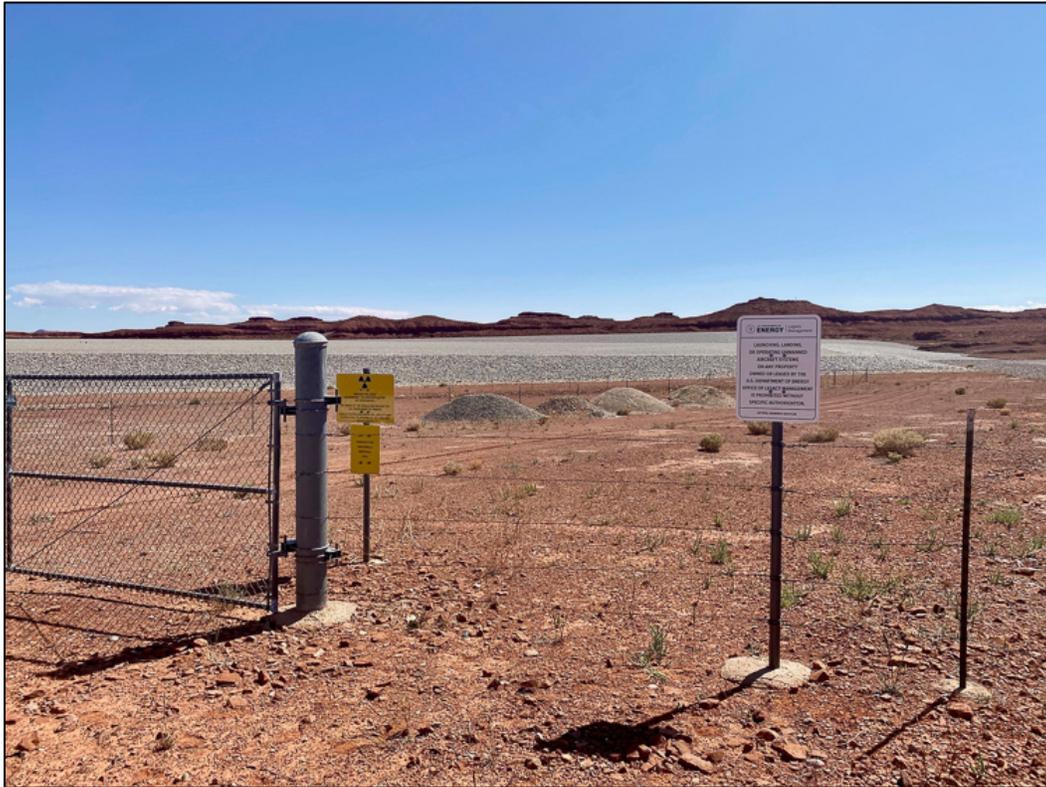
PL-3. UAS Warning Sign

Two new unmanned aircraft system (UAS) warning signs were installed during the 2020 inspection. One sign was installed by the entrance gate at the northwest corner of the site (PL-3), and one sign was installed on the southwest corner of the site between perimeter sign P31 and boundary monument BM-5 (PL-4). No immediate maintenance needs were identified.

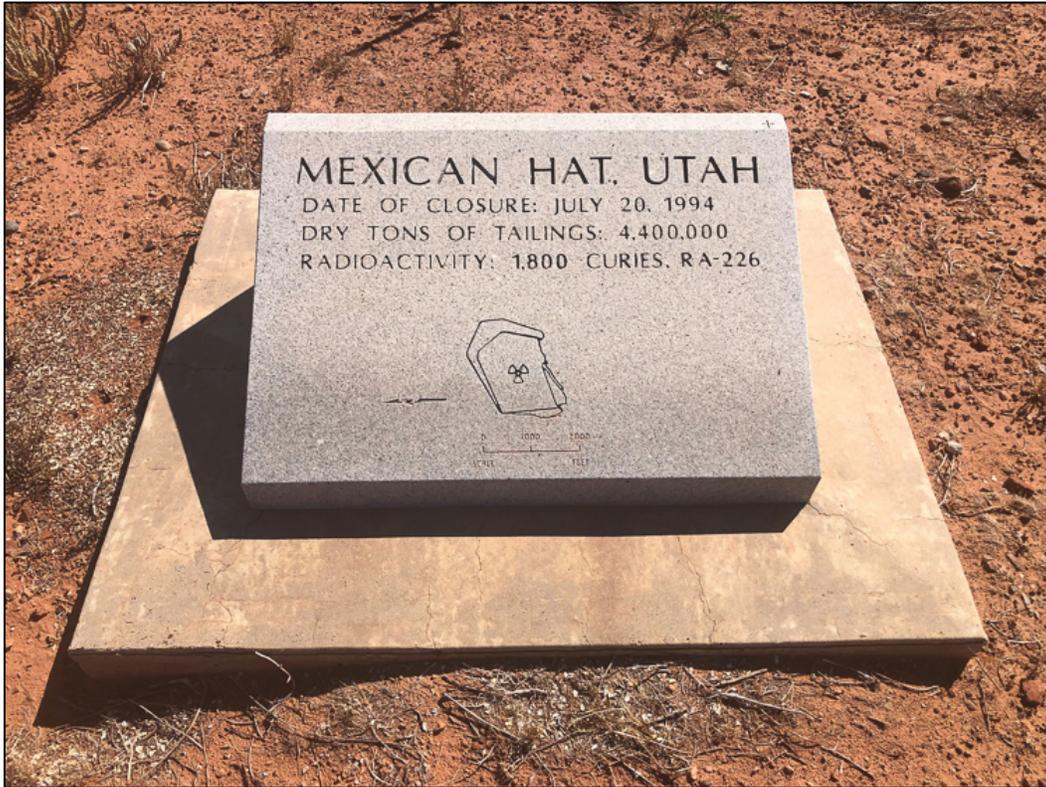
PL-5. Site Marker SMK-1

The site has two granite site markers. Site marker SMK-1 is just inside the fence near the entrance gate (PL-5); its concrete base has several minor cracks, but they do not compromise the integrity of the base, and repairs are not necessary at this time. Site marker SMK-2 is on the top slope of the disposal cell (PL-6). No immediate maintenance needs were identified.

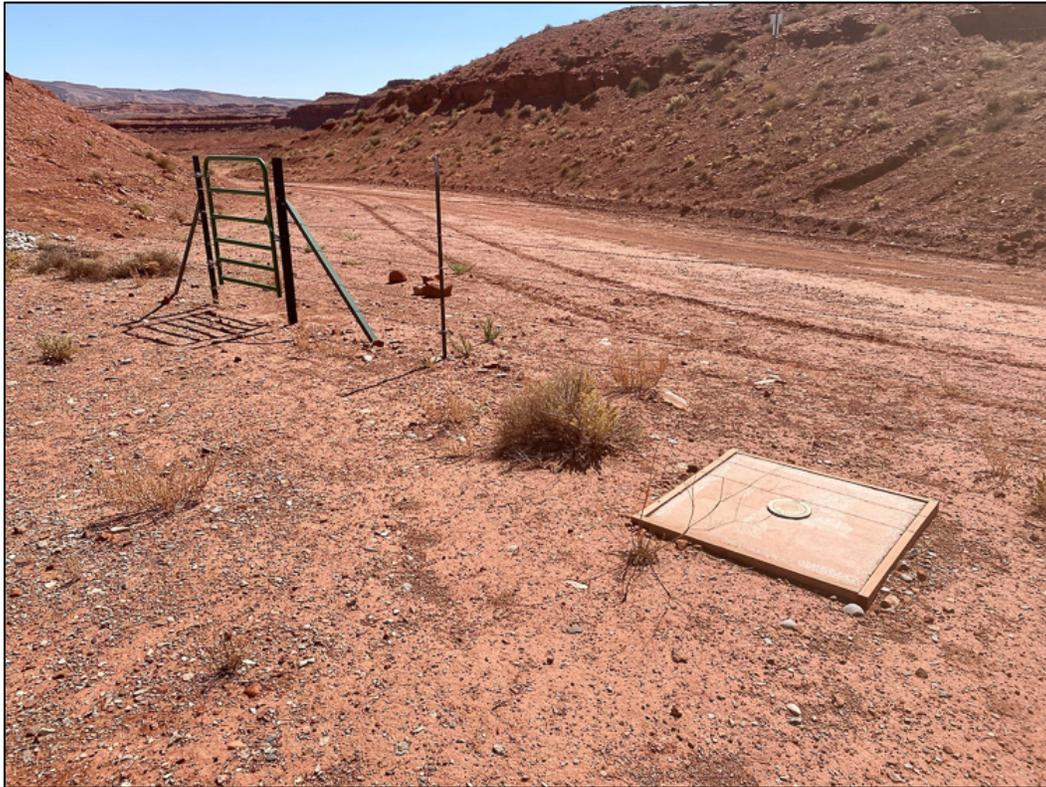
PL-7. Aerial Survey Quality Control Monument QC5

Five aerial survey quality control monuments, installed in 2018, were inspected during the 2020 annual inspection (PL-7). No maintenance needs were identified.

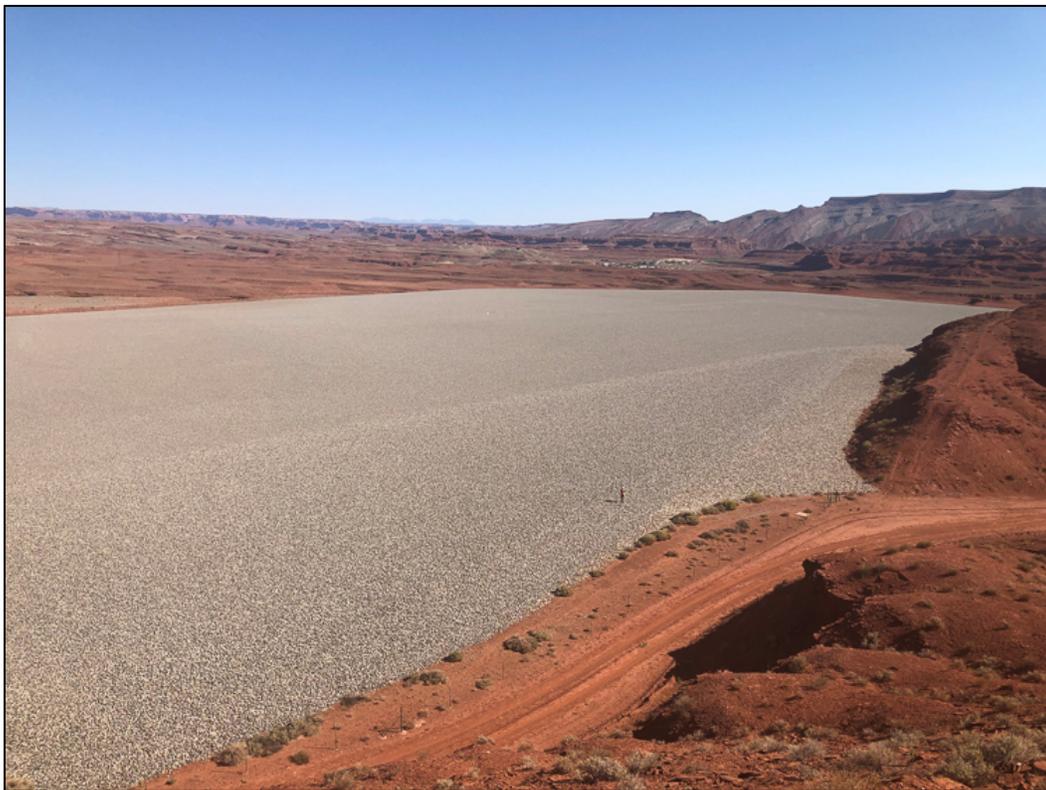
PL-8. Top of Cell – Looking Northeast

The disposal cell, completed in 1994, occupies 68 acres. The disposal cell is armored with riprap to control erosion. No erosion, settling, slumping, rock degradation, or other modifying processes that might affect the integrity of the disposal cell were evident on the top slope of the disposal cell (PL-8).

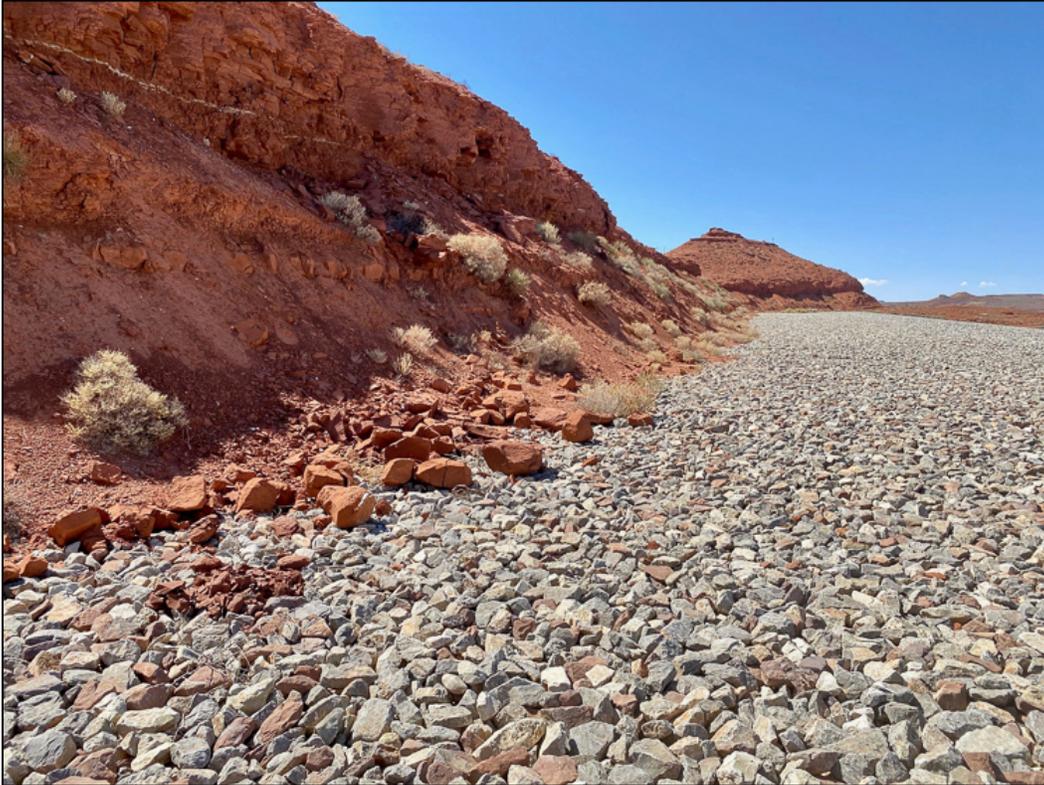
PL-9. Sloughed Rock Area on South Apron

There was no noticeable increase of sloughed red rock and soil along the south apron of the disposal cell (PL-9). Because the apron is adjacent to the base of a steep, rocky cliff, it is expected that sediment and rock from the cliff will continue to fall onto the apron. The accumulated material is not currently affecting the function of the apron, and this area will continue to be monitored.

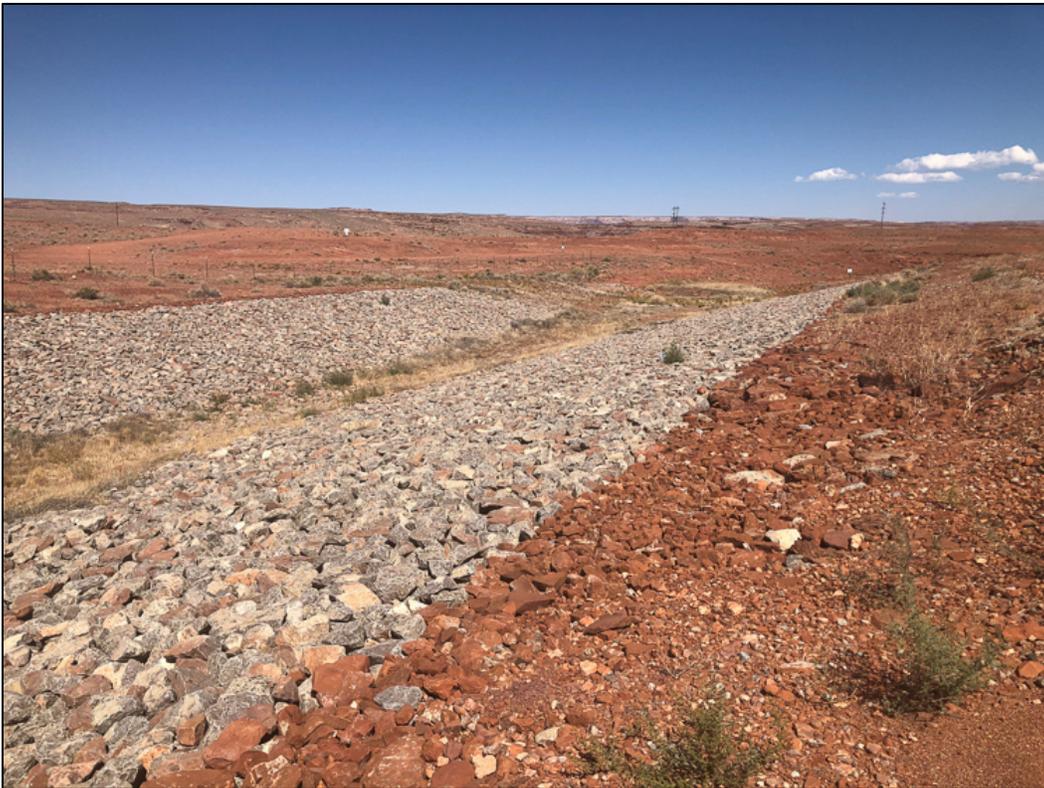
PL-10. West Diversion Channel

Upgradient offsite areas continue to erode, resulting in the transport of sediment onto the site and into the west diversion channel. Sediment accumulation has promoted the growth of vegetation, including perennial grasses and annual weeds, in the west diversion channel (PL-10). However, sediment accumulation and associated vegetation growth have not adversely affected the performance of the west diversion channel.

In accordance with the LTSP, vegetation conditions are observed during annual inspections to ensure that undesirable plant species, including deep-rooted plants on the disposal cell cover and noxious weeds, do not proliferate at the site. Except for deep-rooted vegetation, natural plant community succession is expected and will not adversely impact the performance of the disposal cell. Vegetation growth in the west diversion channel will continue to be monitored during annual inspections to ensure that it does not negatively affect the performance of this surface water diversion structure (PL-10). No maintenance needs were identified.

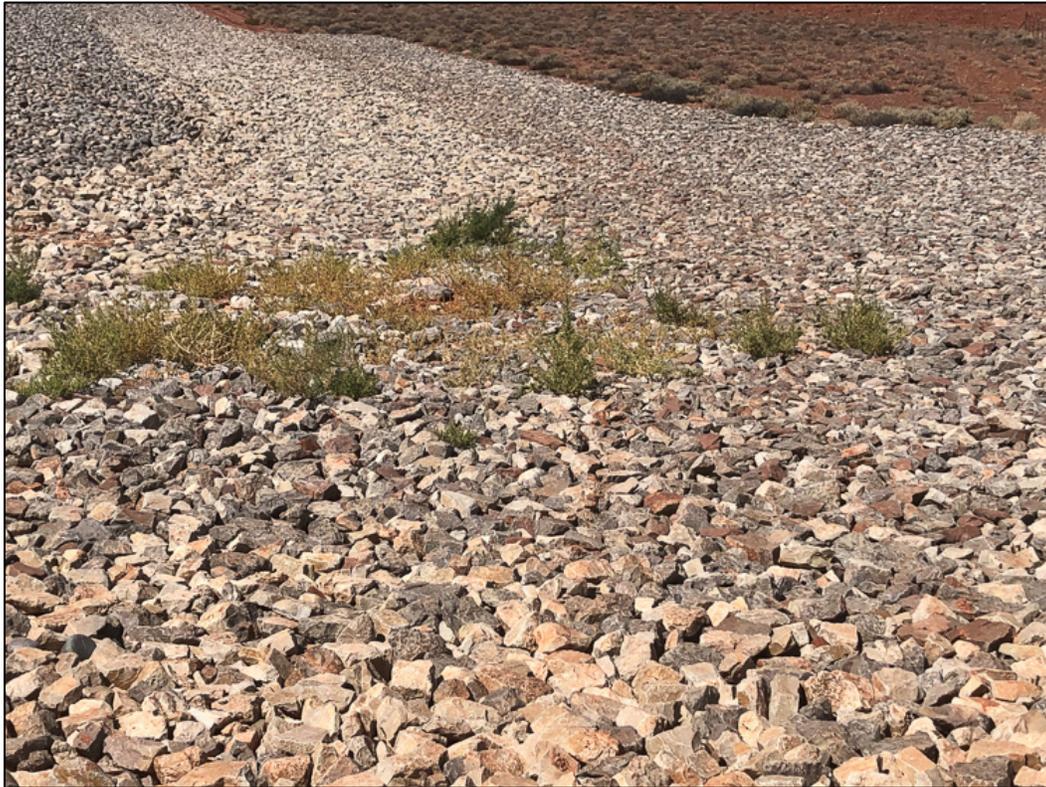
PL-11. Northeast Toe Drain

Sediment accumulation has also been observed along the transition zone from the apron to the northeast toe drain. The origin of this material is currently being evaluated and analyzed, but it may be a combination of windblown material and previously observed radon barrier erosion associated with the depression features. Visual observations during the inspection did not

identify any apparent increases in the sediment accumulation in this area compared to previous visual observations; however, increased vegetation growth was apparent in this drainage apron, at the toe of the northeast side slope (PL-11). Increased vegetation growth was most likely a result of the water used during the ICP project while moisture conditioning and compacting cover components. Inspectors will continue to monitor this area on the northeast side slope. Conversely, no sediment accumulation has been observed below the north side slope where one depression and radon barrier erosion have been identified. No immediate maintenance needs were identified.

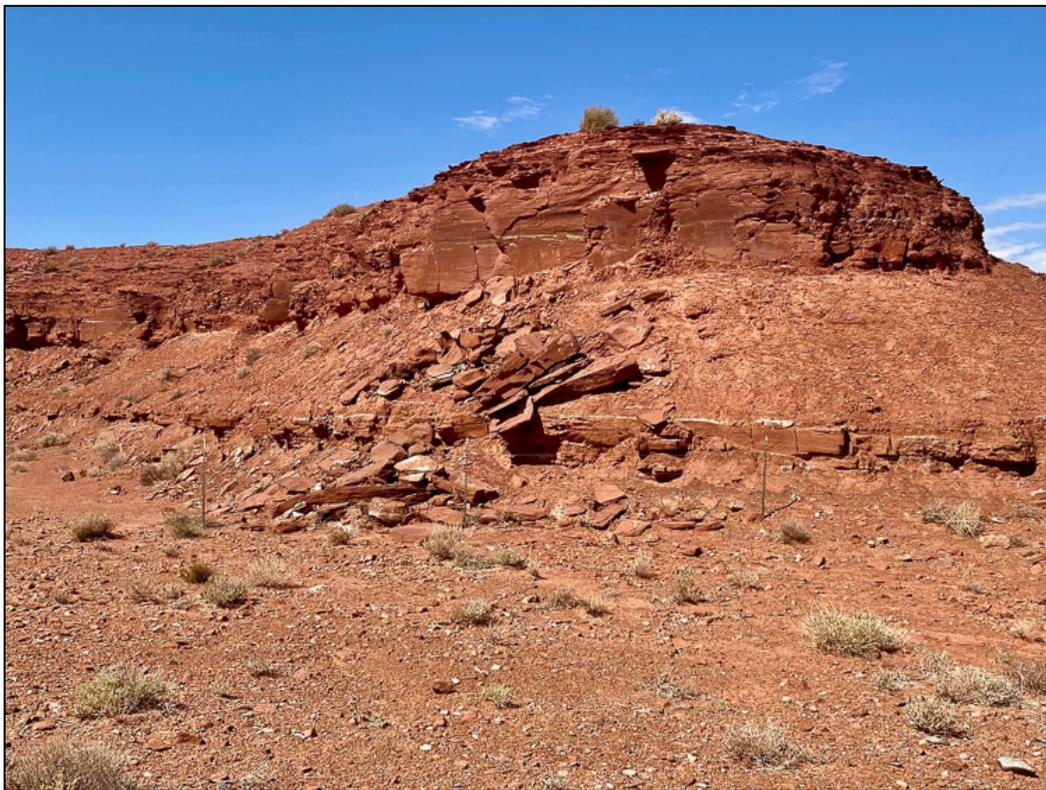
PL-12. Sloughed Rock Approaching Fence

Sloughed rock from an overhanging shelf continues to be observed along the southern perimeter of the site (PL-12). Although no visual changes were evident, and this material currently appears to be stable, this rock is approaching the barbed-wire fence between perimeter signs P22 and P23 and will likely need to be removed or secured in the future to protect the fence from damage or a potential breach.

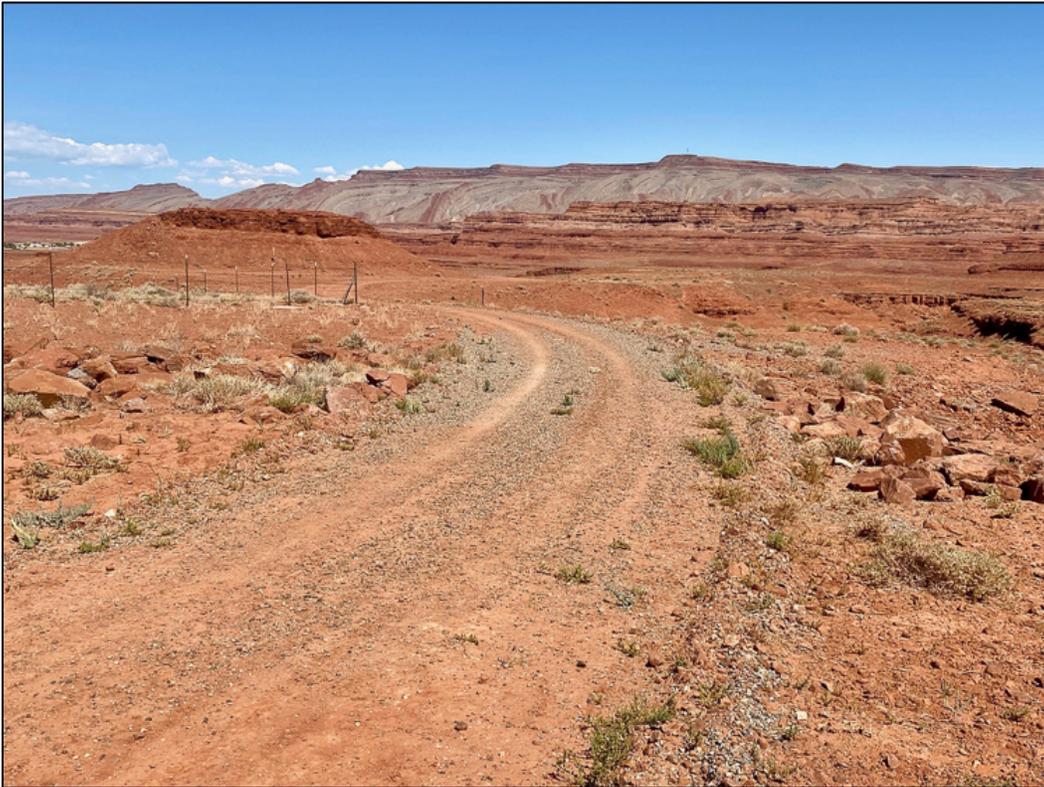
PL-13. Road Repair Area

As part of the ICP project, front-end road repairs were performed along the dirt access road to allow for safe transportation of haul trucks and delivery trucks. Road repairs included grading the entire access road. Two areas damaged from rain events were corrected by installing geocell with standard U.S. Department of Transportation-specific rock type to stabilize these areas, which will also allow for proper drainage from rain events. These repaired areas were examined during the inspection and appeared to be performing as designed (PL-13).

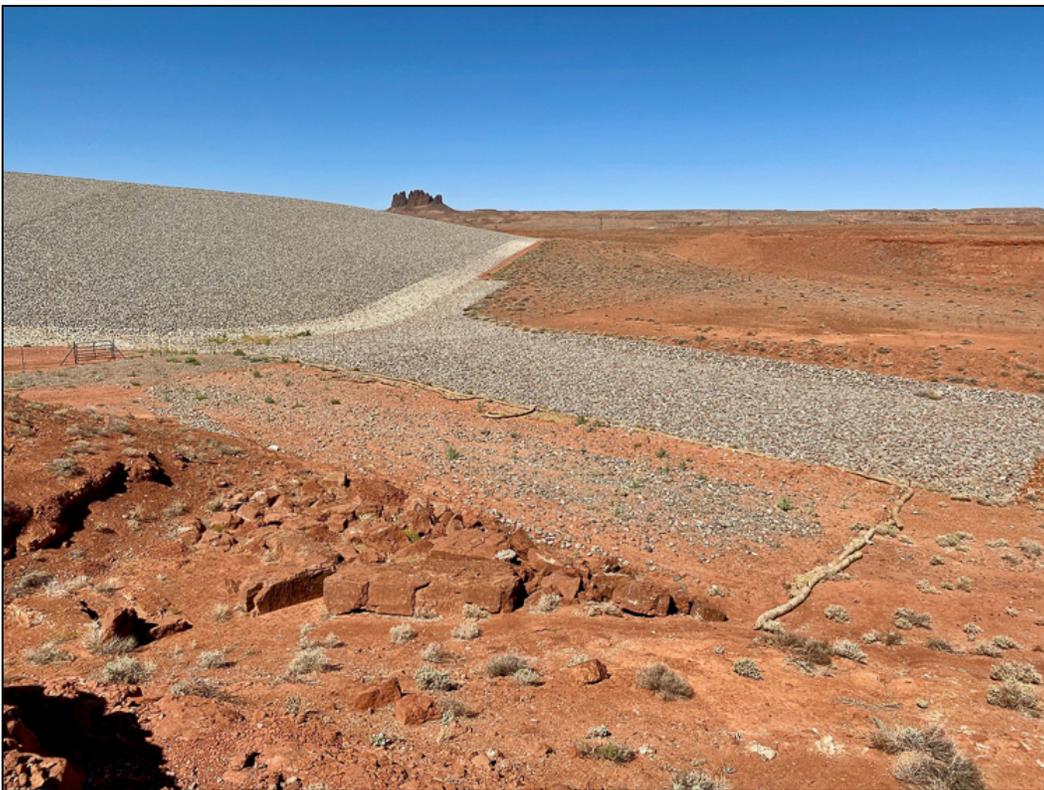
PL-14. ICP Storage Area

Material storage and equipment storage areas utilized during the ICP project were revegetated and had straw wattles installed to provide stormwater run-on and runoff protection (PL-14). These areas were also inspected, and new vegetation growth was observed in these areas. The straw wattles were still in place and performing as designed.

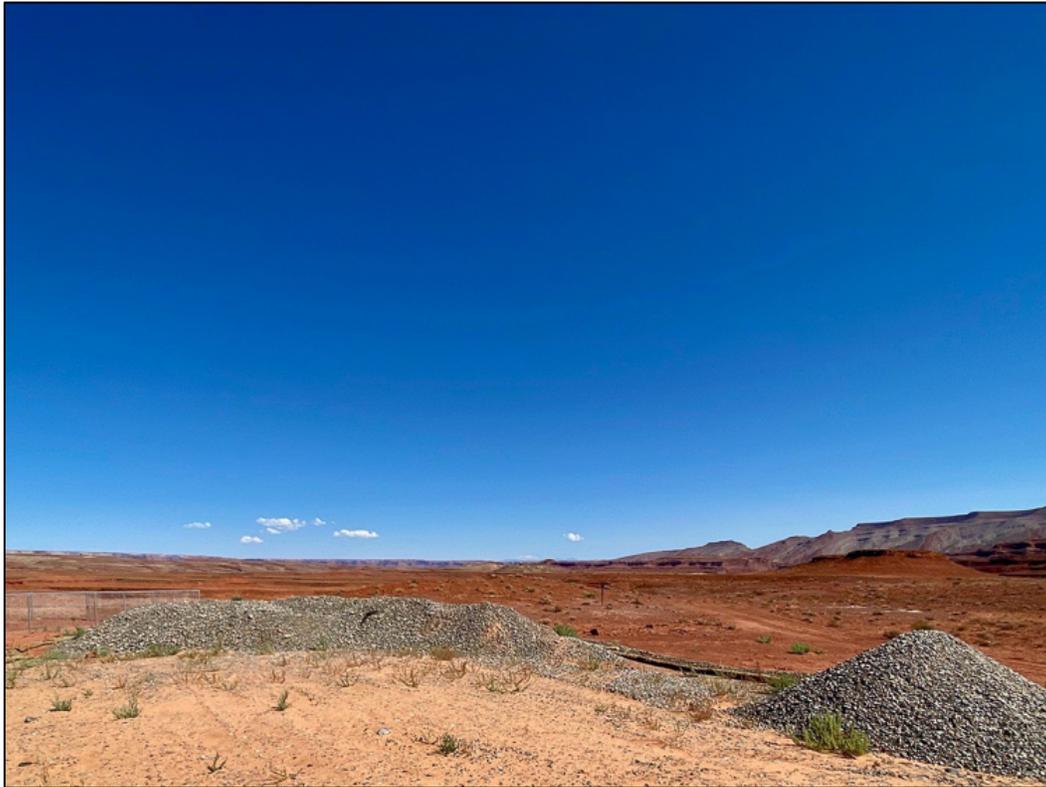
PL-15. ICP Stockpiles

The old bedding material removed during the ICP project and new excess bedding material were stockpiled near the SOARS perimeter chainlink fence (PL-15), and straw wattles were also installed around this material for stormwater runoff protection. The old bedding material was systematically screened for gamma radiation during the ICP project, and no elevated readings were observed. This area was evaluated during the inspection and is performing as designed. No immediate maintenance needs were identified with any of these site features.

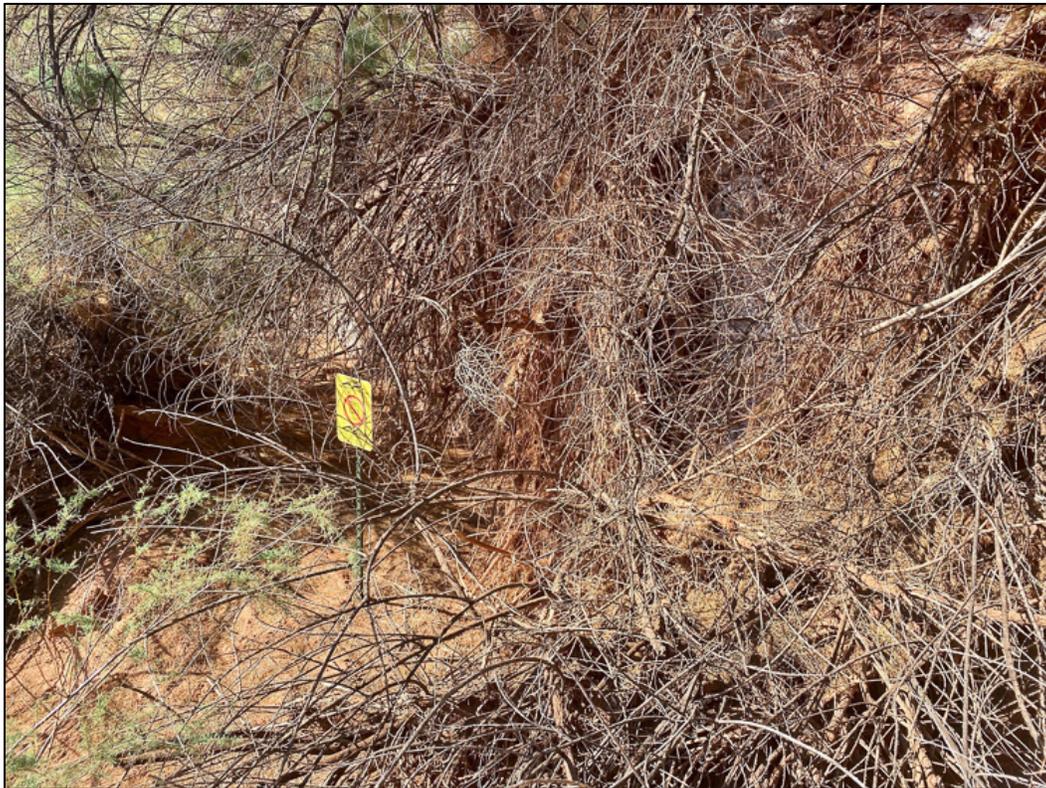
PL-16. Seep 0248

Since 2010, groundwater discharge from seeps had only been observed at cross-gradient Seep 0248, which typically exhibits dripping conditions. During the inspection, Seep 0248 (PL-16) was observed dripping; since the seep was only dripping and did not exhibit steady flow, an estimated flow rate was not evaluated. Additionally, upgradient (background) Seep 0261 (PL-19) was observed to be flowing during the inspection. Seep 0261 is approximately 0.50 mile upstream of Seep 0248 in Gypsum Creek.

Seep Location Number	Drainage	Location Relative to Disposal Cell	Photograph Location Number	Observed Seep Conditions
0248	Gypsum Creek	Cross gradient	PL-16	Seep was dripping at a much slower rate compared to previous visual observations (no flow rate measured).
0249	Gully No. 2	Downgradient	PL-17	Dry conditions (no evaporites present); seep area is covered with gray limestone that presumably is extra riprap apron material from disposal cell construction. Warning sign not posted at this location since this seep has never been documented to be discharging water.
0251	North Arroyo	Downgradient	PL-18	Dry conditions (no evaporites present).
0254	South Arroyo	Downgradient	N/A	Dry conditions (no evaporites present). Warning sign not posted at this location due to seasonal flash flood conditions in the ephemeral drainage.
0261	Gypsum Creek	Upgradient (background)	PL-19	Flowing conditions. This seep discharges directly into Gypsum Creek, which was dry outside of the immediate seep discharge area. Warning sign not posted at this location since this seep is a background location.

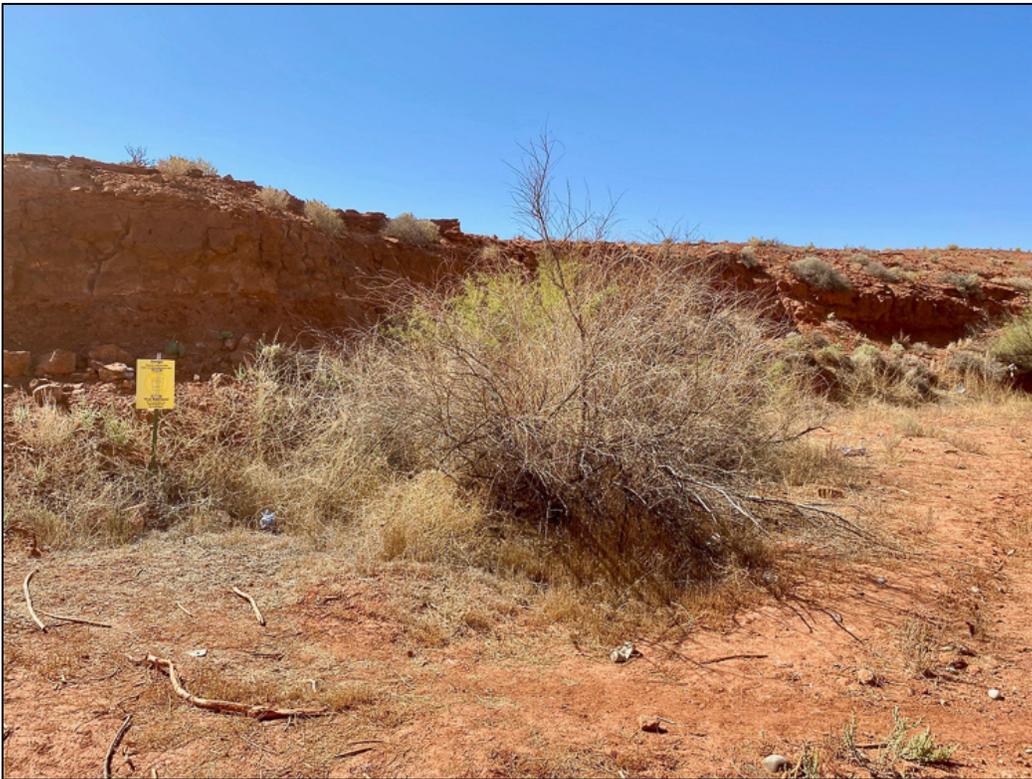
PL-20. Seep 0264

0264	North Arroyo	Downgradient	PL-20	Dry conditions (no evaporites present in immediate area). Ephemeral wash near seep location was dry with no evidence of evaporites in the areas observed during the inspection.
0922	Gypsum Creek	Downgradient	N/A	Dry conditions (no evaporites present in immediate area). Seep is along the south side of Gypsum Creek, and the seep location is still covered entirely by a sandbar that has formed along this section of Gypsum Creek.
