10.0 Lowman, Idaho, Disposal Site

10.1 Compliance Summary

Figure 10-1. 2020 Annual Inspection Drawing for the Lowman, Idaho, Disposal Site

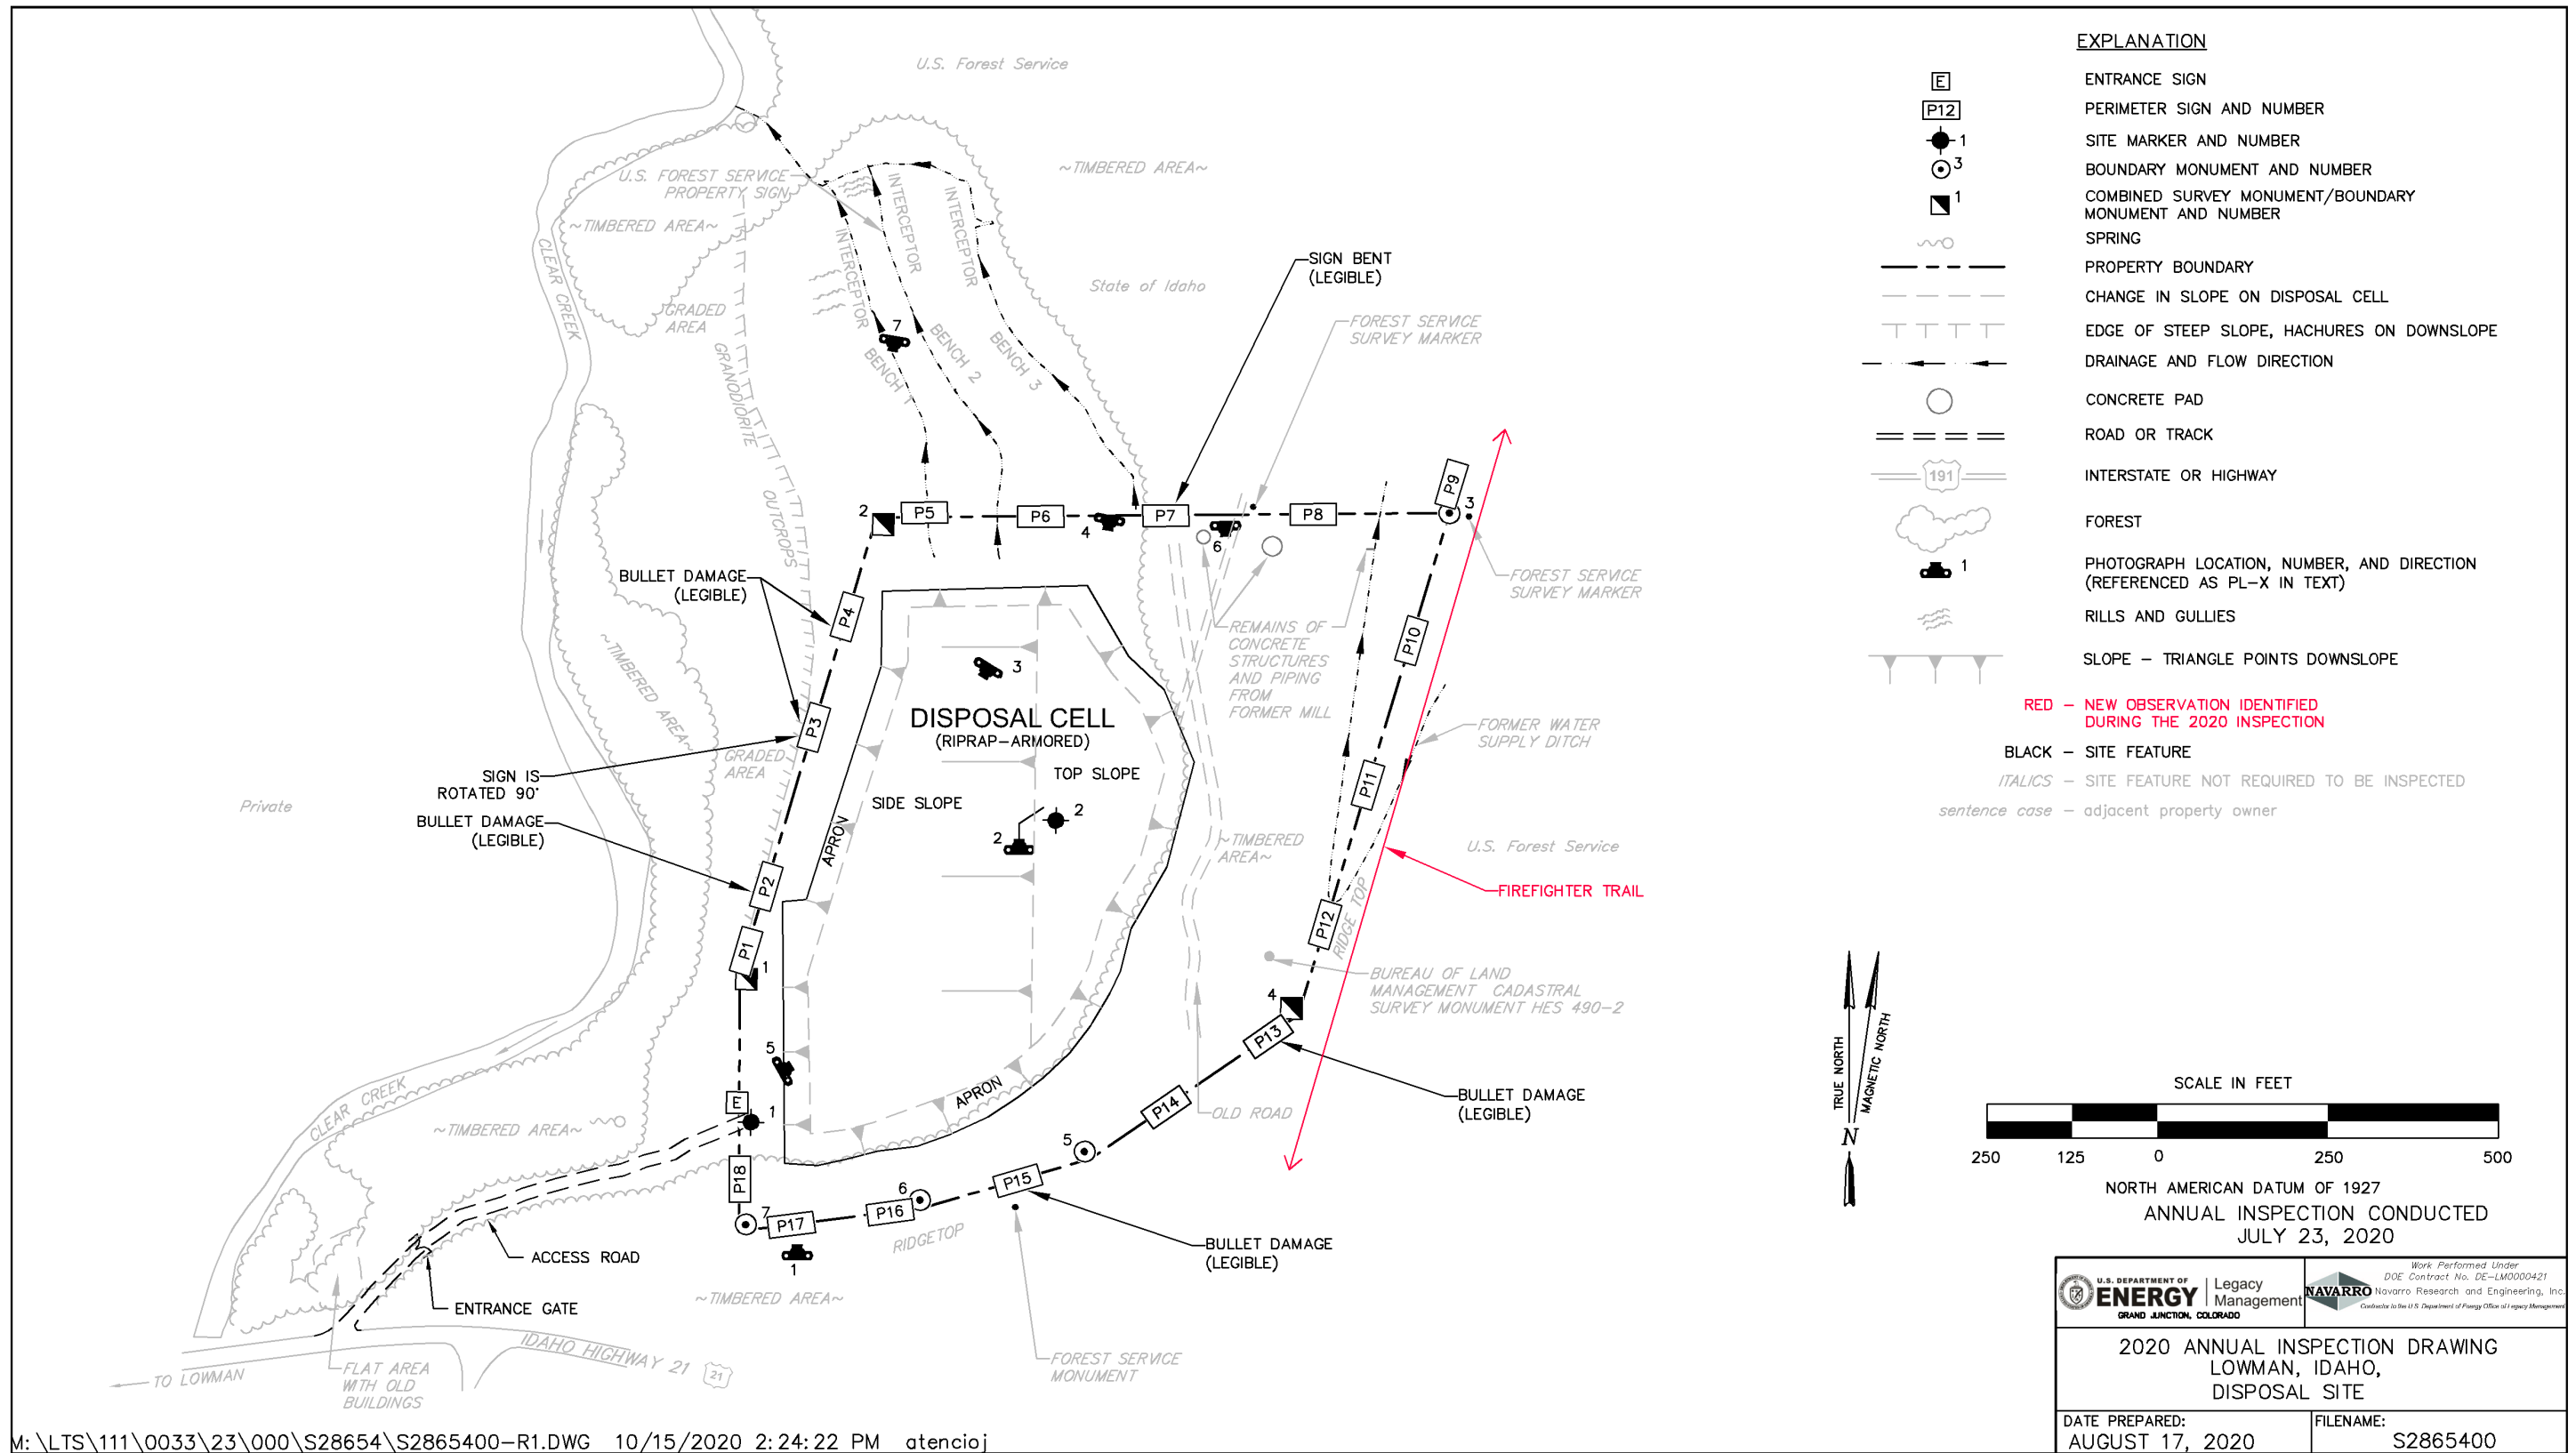
Figure 10-1 shows the locations of site features in black and gray font, including site surveillance features and inspection areas. Site features that are present but not required to be inspected are shown in italic font, and new observations identified during the 2020 annual inspection are shown in red. Inspection results are described in the following subsections. Photographs to support specific observations are identified in the text and in Figure 10-1 by photograph location (PL) numbers. The photographs and photo log are presented in Section 10.10.

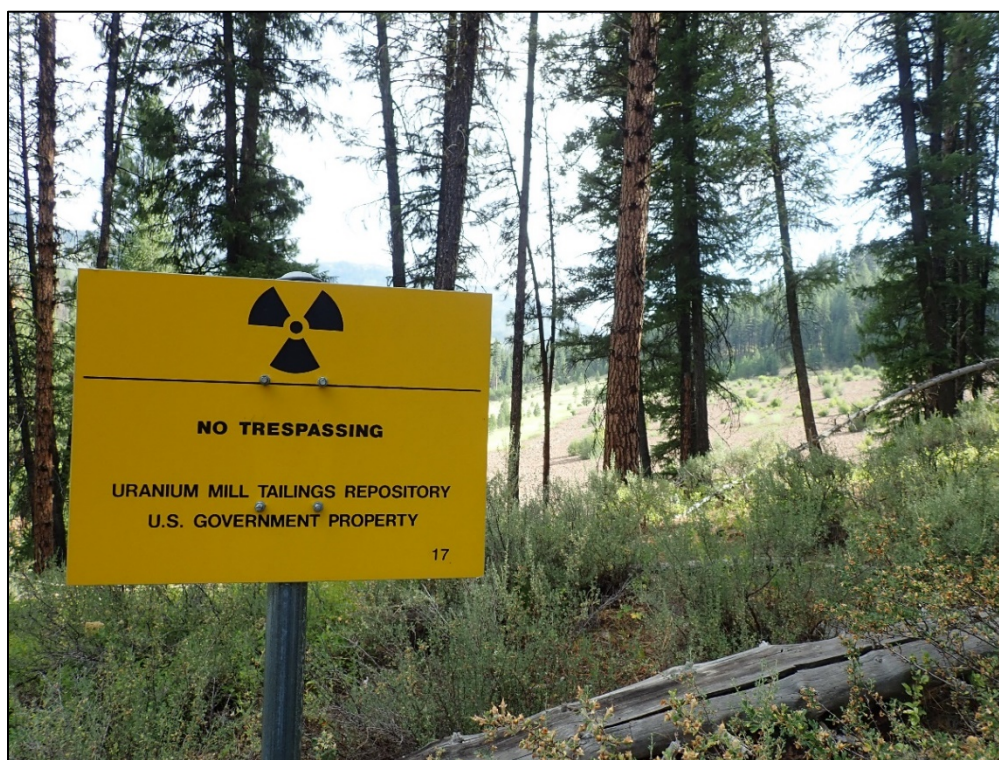
PL-1. Perimeter Sign P17

There are 18 perimeter signs, attached to steel posts set in concrete, positioned along the unfenced property boundary (PL-1). Several perimeter signs (P2, P3, P4, P13, and P15) have bullet damage but remain legible. Perimeter sign P3 is rotated about 90 degrees from its original position, but it continues to be legible and noticeable. Perimeter sign P7 is slightly bent from tree fall but remains legible. No maintenance needs were identified.

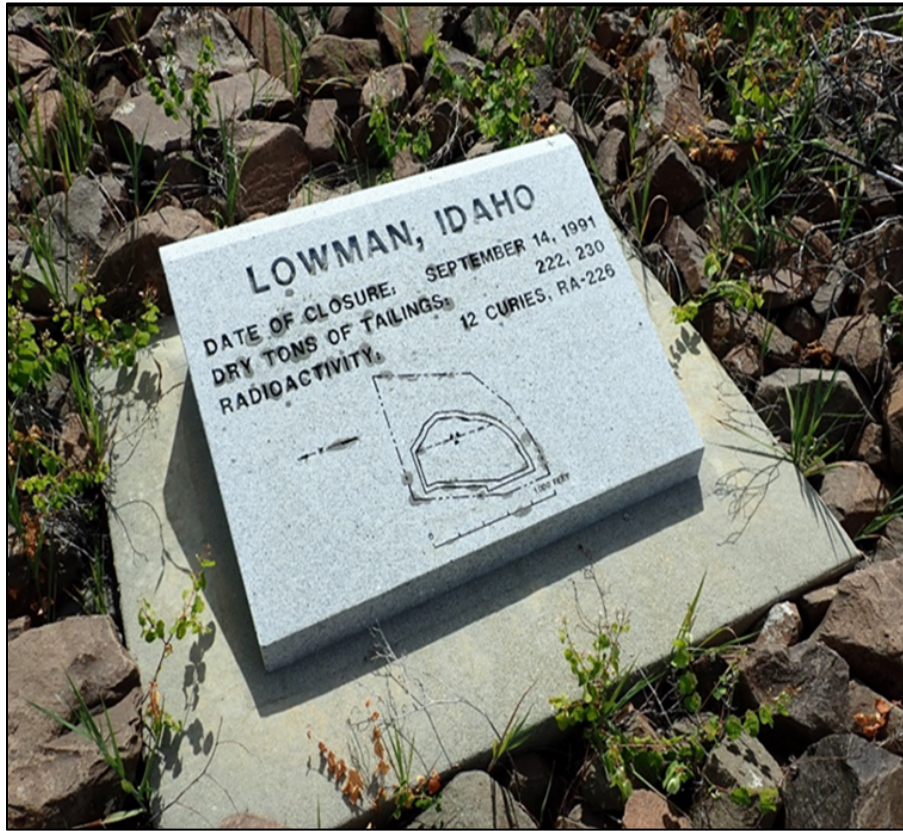
PL-2. Site Marker SMK-2

The site has two granite site markers. Site marker SMK-1 is just inside the southwest property boundary, and site marker SMK-2 (PL-2) is on the top slope of the disposal cell. Lichen is growing on the surface of both site markers, but it is easily removable by hand and does not detract from the legibility of the markers. No maintenance needs were identified.

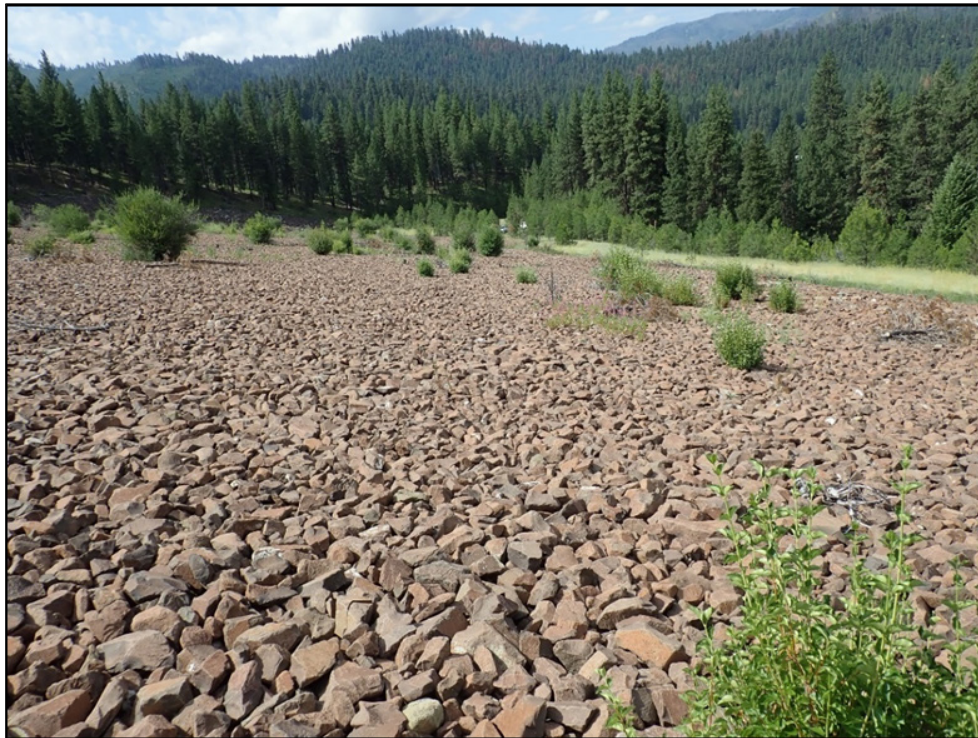
PL-3. Disposal Cell Cover

The disposal cell, completed in 1991, occupies 8.29 acres. The disposal cell top and side slopes are armored with basalt riprap to control erosion (PL-3). An apron of larger riprap surrounds the disposal cell on all sides (PL-4). There was no evidence of erosion, settling, slumping, rock degradation, or other modifying processes that might affect the integrity of the disposal cell.

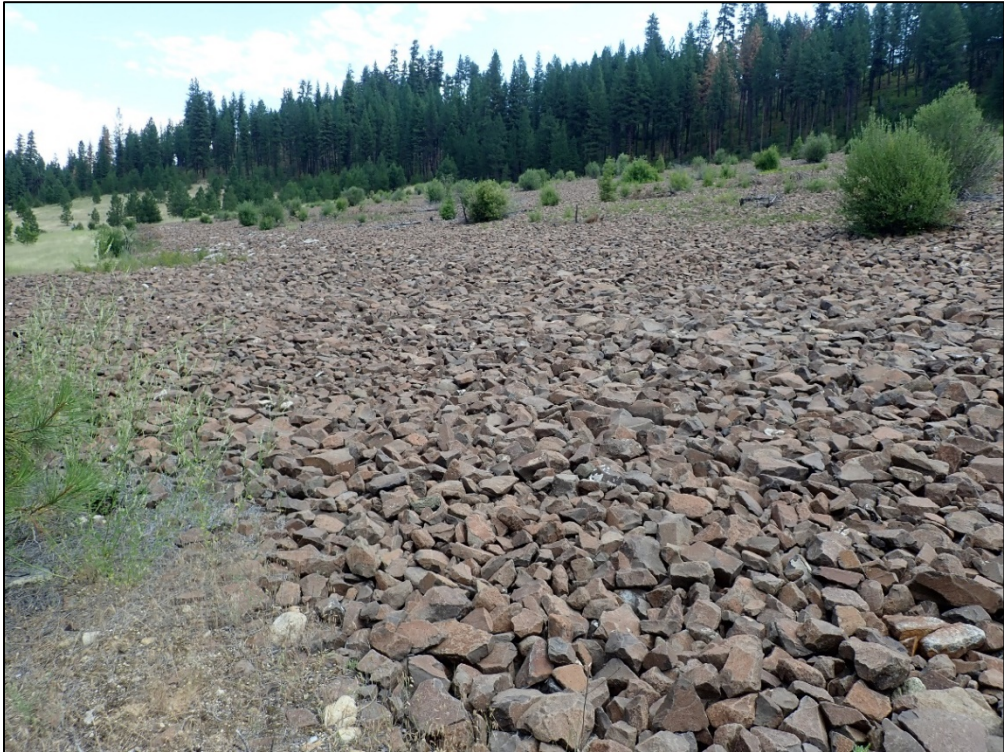
PL-5. Vegetation on Disposal Cell Cover

Natural vegetation continues to encroach on the top and side slopes of the disposal cell. Although the LTSP states that control of vegetation growth on the cell is not needed, LM concluded that controlling the growth of conifers—primarily ponderosa pine—would be a best management practice. Unlike the shrubs and other vegetation growing on the disposal cell, mature conifers could potentially become uprooted during windstorms and damage the surface of the disposal cell. Numerous ponderosa pine trees were observed on the disposal cell top and side slopes and were cut down and left in place in September 2018. Other plants growing on the disposal cell were not removed, as they do not present a physical threat to the integrity of the disposal cell (PL-5). No maintenance needs were identified.

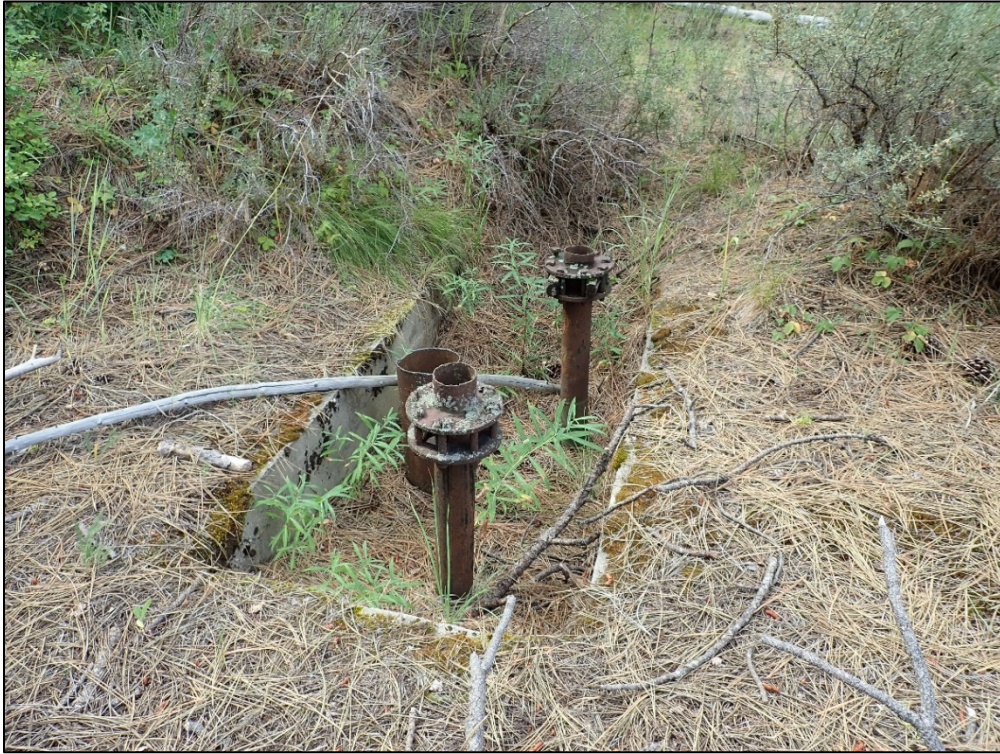
PL-6. Concrete Structure and Water Piping Remains

The steep slopes east and south of the disposal cell are stable and vegetated with well-established ponderosa pines, shrubs, and grasses. Several features from the historical mining operations remain on the steep hillside east of the disposal cell, including a water-supply ditch and the remains of a water piping system (PL-6). The slopes north and west of the disposal cell were highly disturbed during site remediation, but they are now stable and vegetated. No maintenance needs were identified.

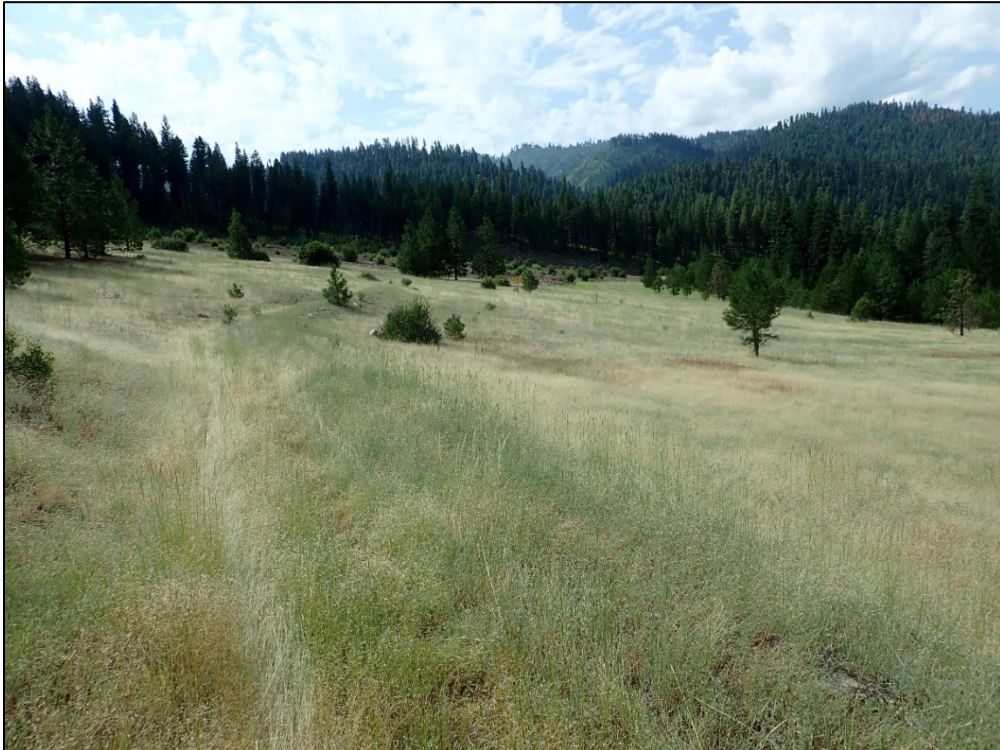
PL-7. Interceptor Bench 1

1998 to intercept stormwater runoff and route it offsite into Clear Creek. Over the years, minor erosion has breached the benches in several locations, and LM has conducted repairs on numerous occasions, most recently in October 2016. The three interceptor benches (PL-7) and a collection ditch are inspected annually to ensure that erosion in this area does not affect overall site stability. In 2020, inspection of the 2016 repairs showed they remain intact, and LM will continue to inspect as the vegetation continues to establish.
