4.0 Maybell West, Colorado, Disposal Site

4.1 Compliance Summary

Figure 4-1. 2020 Annual Inspection Drawing for the Maybell West, Colorado, Disposal Site

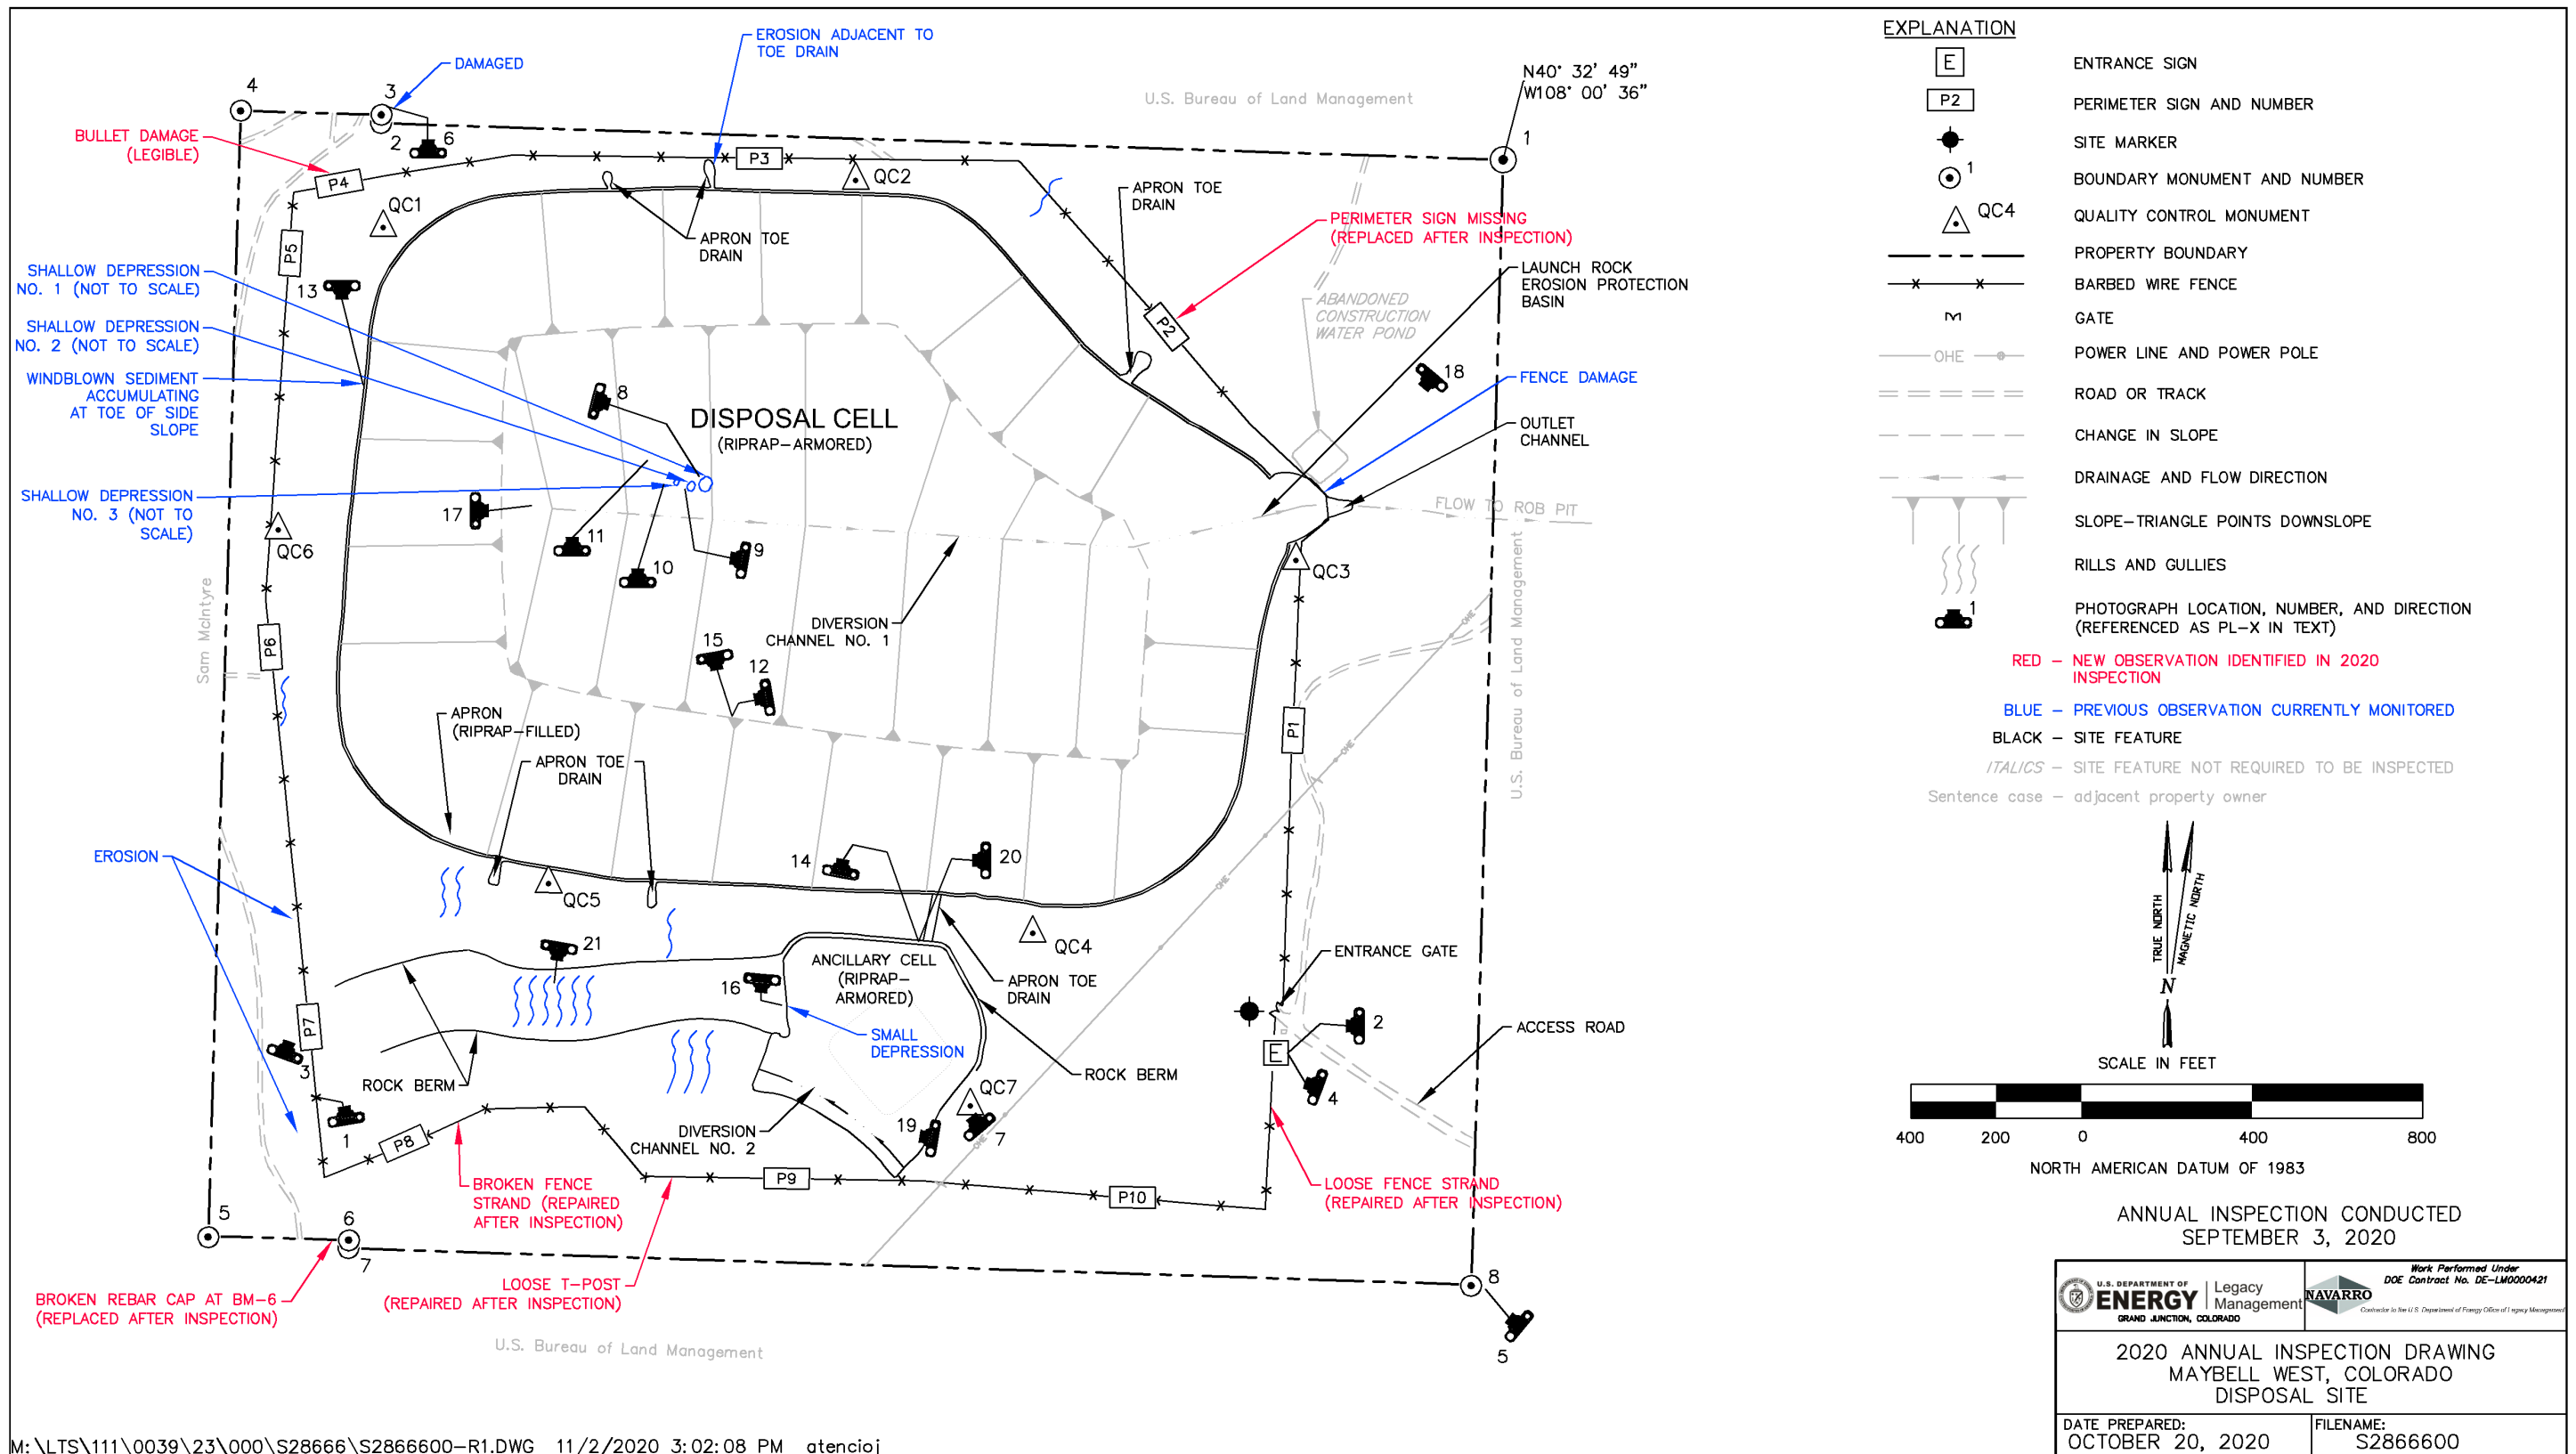
Figure 4-1 shows the locations of site features in black and gray font, including site surveillance features and inspection areas. Site features that are present but not required to be inspected are shown in italic font. Observations from previous inspections that are currently monitored are shown in blue text, and new observations identified in the 2020 annual inspection are shown in red. Inspection results and recommended maintenance activities associated with site surveillance features are included in the following subsections. Photographs to support specific observations are identified in the text and in Figure 4-1 by photograph location (PL) numbers. The photographs and photograph log are presented in Section 4.9.

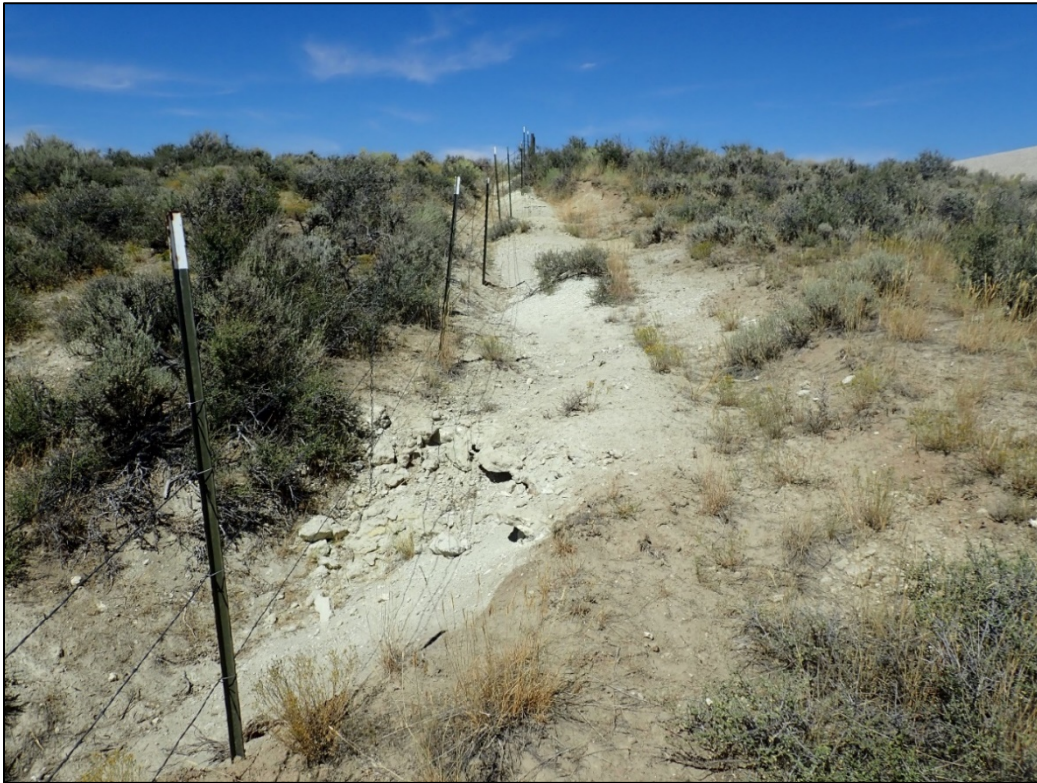
A four-strand barbed-wire fence encloses the disposal cell, the ancillary cell, the drainage structures, and much of the site. The fence primarily serves to prevent livestock trespass, because the site is surrounded by open rangeland used for cattle grazing. Minor damage to the perimeter fence occurs periodically because the site is in wintering grounds frequented by big game animals (primarily pronghorn, deer, and elk). Fence damage identified during the 2020 annual inspection consisted of one location where a strand was broken, one location where a strand was loose, and one location where a fence post was loose. Minor erosion continues to be observed between perimeter signs P6 and P8 (PL-1). The erosion will continue to be monitored and repairs to the fence will be made as needed. Repairs to the loose T-post, loose strand, and broken strand were completed on September 23, 2020.

PL-1. Erosion Along Western Perimeter Fence South of Perimeter Sign P7

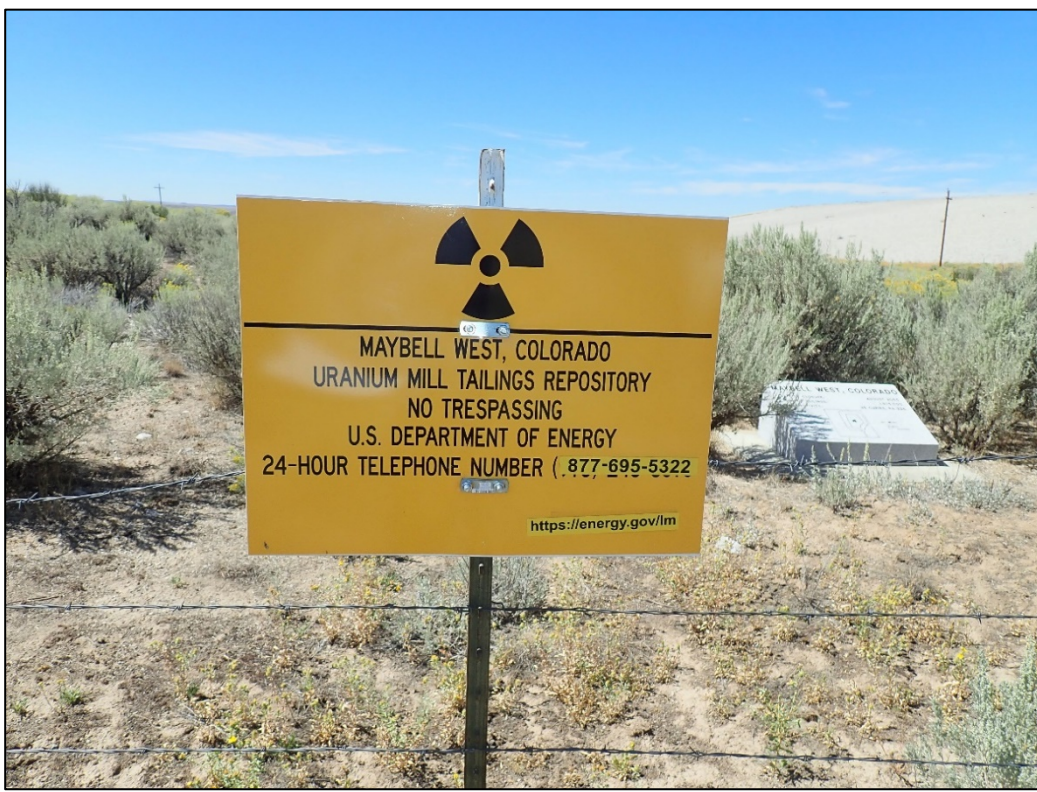
The entrance sign is mounted on a metal T-post directly south of the entrance gate (PL-2). Ten warning or perimeter signs are mounted on metal T-posts around the site (PL-3). Perimeter sign P2 was found to be missing at the time of the inspection and was replaced during a routine maintenance trip on September 23, 2020. No other maintenance needs were identified.

PL-2. Entrance Sign

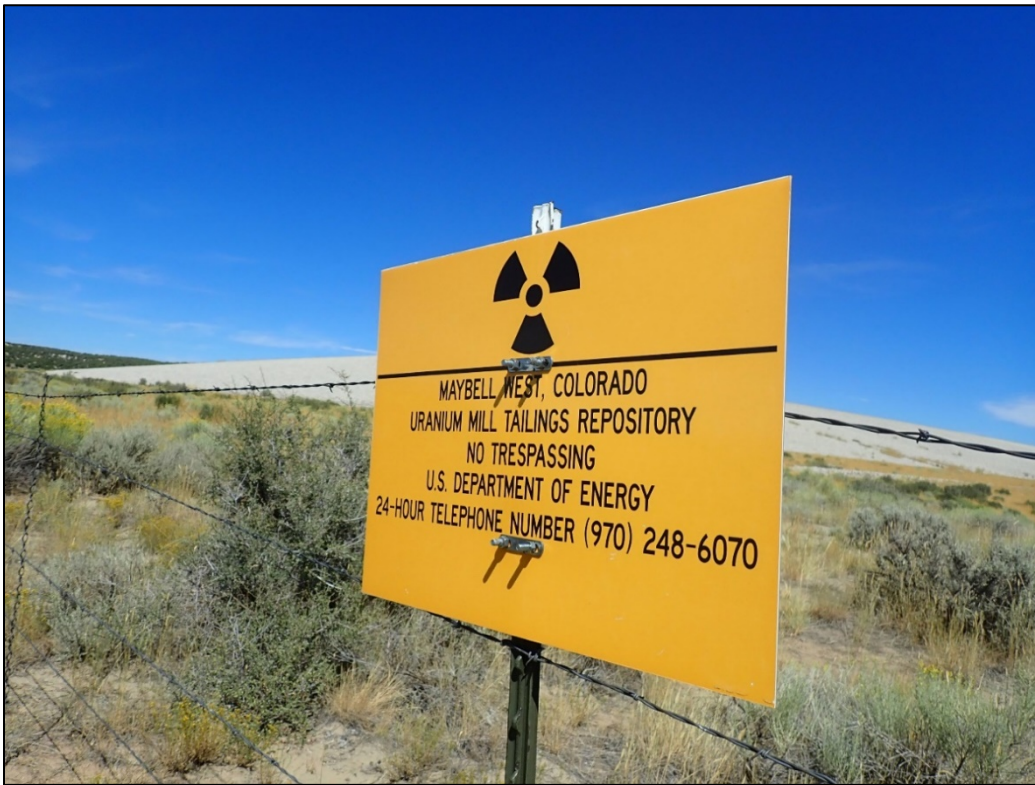
PL-3. Perimeter Sign P7

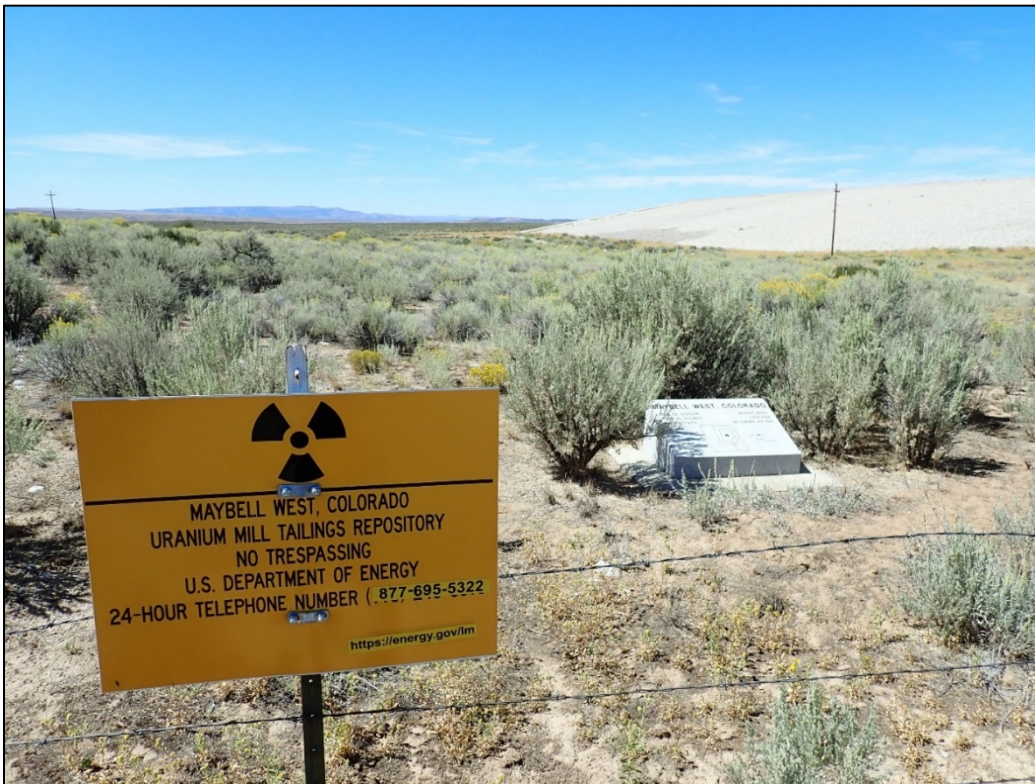
The site has one granite site marker near the entrance gate (PL-4). No maintenance needs were identified.

PL-4. Entrance Sign and Site Marker

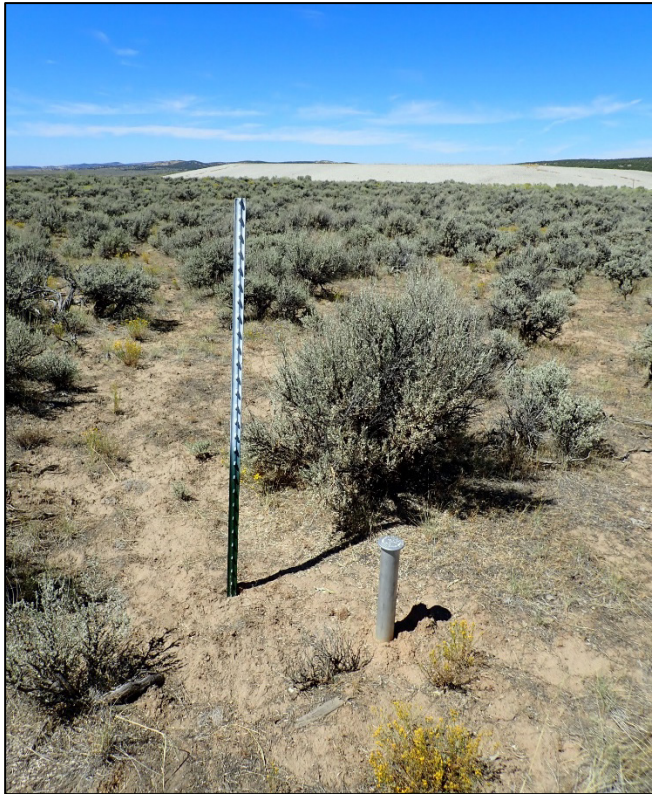
Eight boundary monuments are on the site boundary outside the fenced area (PL-5). Four of the monuments are at the property corners, and the other four define an approximate 20-foot offset along the north and south boundaries where the private land that LM acquired in fee adjoins the BLM withdrawal area on the western portion of the site. Boundary monuments BM-3 and BM-6 (capped pieces of rebar) define the two 20-foot offsets. Boundary monument BM-3 (PL-6) was first observed to be bent during the 2017 annual inspection; since then attempts to straighten the monument were not successful; however the monument is still in place. A plastic rebar cap covering boundary monument BM-6 was observed to be broken at the time of the inspection and replaced during the September 23, 2020, routine maintenance trip.

PL-5. Boundary Monument BM-8

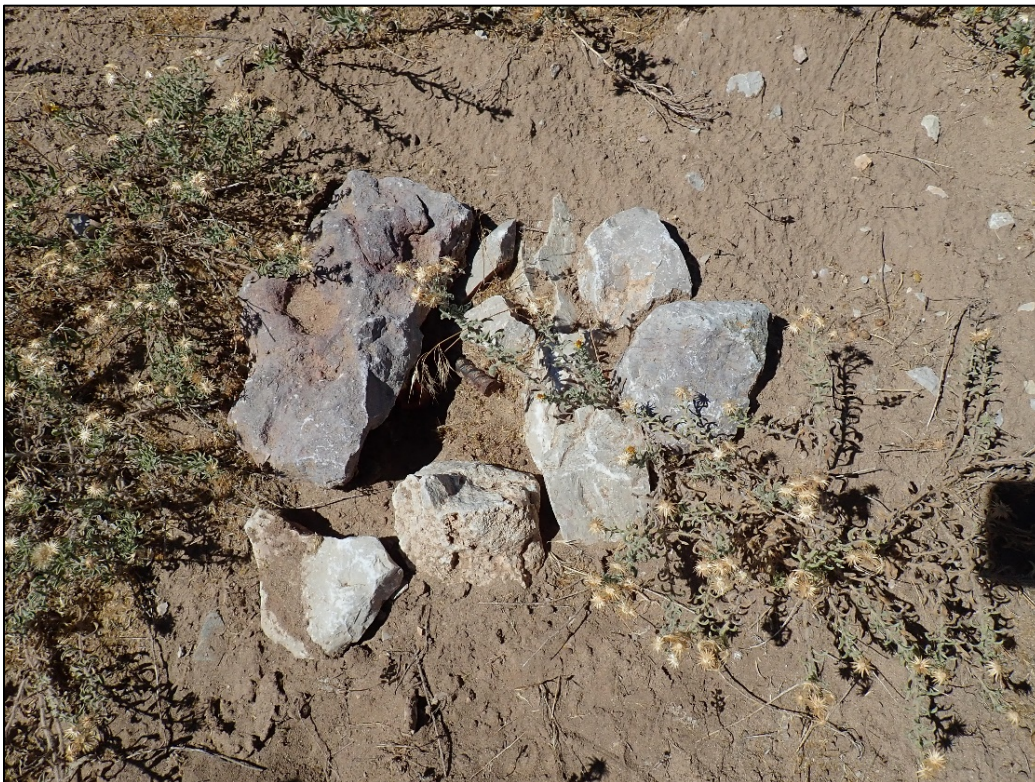
Boundary monument BM-3 is damaged and will need to be repaired or replaced but continues to delineate the property. No other maintenance needs were identified.

PL-6. Boundary Monument BM-3

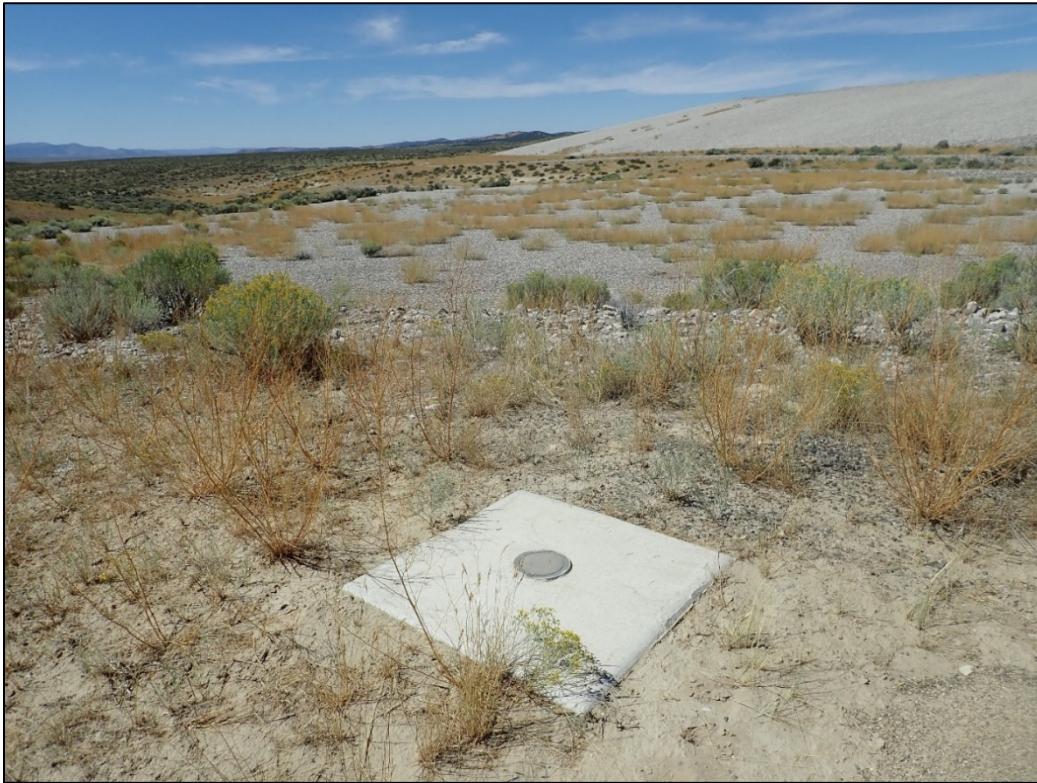
Seven aerial survey quality control (QC) monuments, installed in 2018, were inspected during the 2020 inspection (PL-7). No maintenance needs were identified.

PL-7. Quality Control Monument QC7 and Ancillary Cell Top Slope

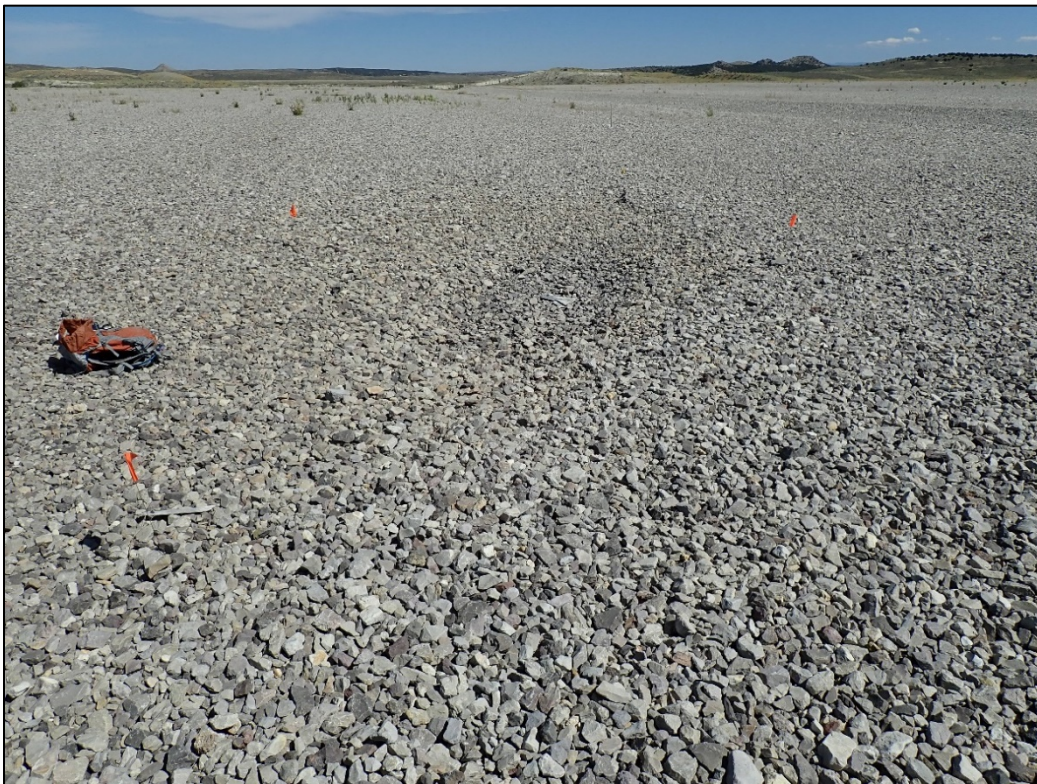
The disposal cell is on the reclaimed site of a former heap leach processing area. The top slope of the riprap-armored disposal cell occupies about 60 acres of the site. The top of the disposal cell showed no signs of significant erosion, settling, or other modifying processes that would affect the cell's integrity. However, three small shallow depressions have been observed (just north of Diversion Channel No. 1) since the site transitioned to DOE in 2010. These depressions appear to be the result of settlement of the underlying materials since completion of the disposal cell. Depression No. 1 was discovered during the initial annual inspection in 2010 (PL-8). A second smaller and shallower depression (Depression No. 2 [PL-9]) was first noted just west of the first depression during the 2016 annual inspection. A third, depression (Depression No. 3 [PL-10]) was first observed during the 2018 annual inspection. All three depressions appeared during the 2020 inspection to be approximately the same size as observed during the 2019 annual inspection. Measurements taken annually vary by the methodology employed (i.e., using a handheld tape measure), and the individual taking the measurements.

No standing water was observed in any of the depressions during the inspection. These depressions currently do not threaten the integrity or performance of the disposal cell. No maintenance needs were identified.

PL-8. Shallow Depression No. 1 on Disposal Cell Top Slope

All three depressions will continue to be measured during annual inspections to determine if additional, more significant settlement is occurring. The comparison of 2018 baseline survey data with data from future aerial surveys will help LM measure and monitor the depressions.

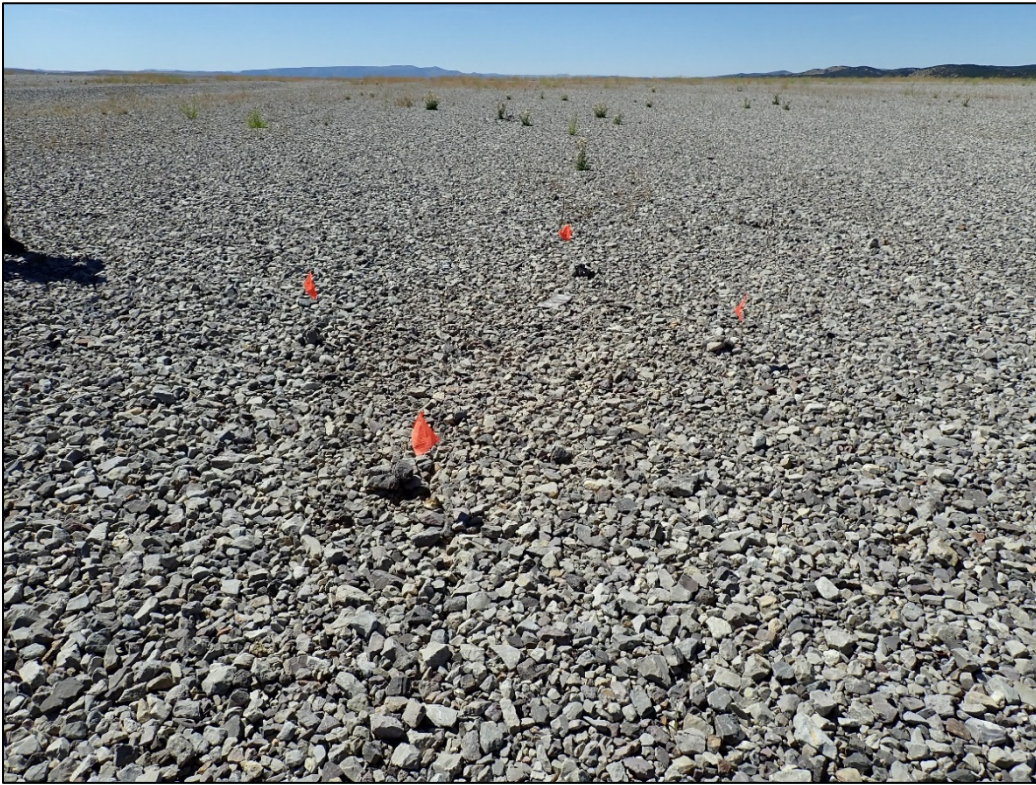
PL-9. Shallow Depression No. 2 on Disposal Cell Top Slope

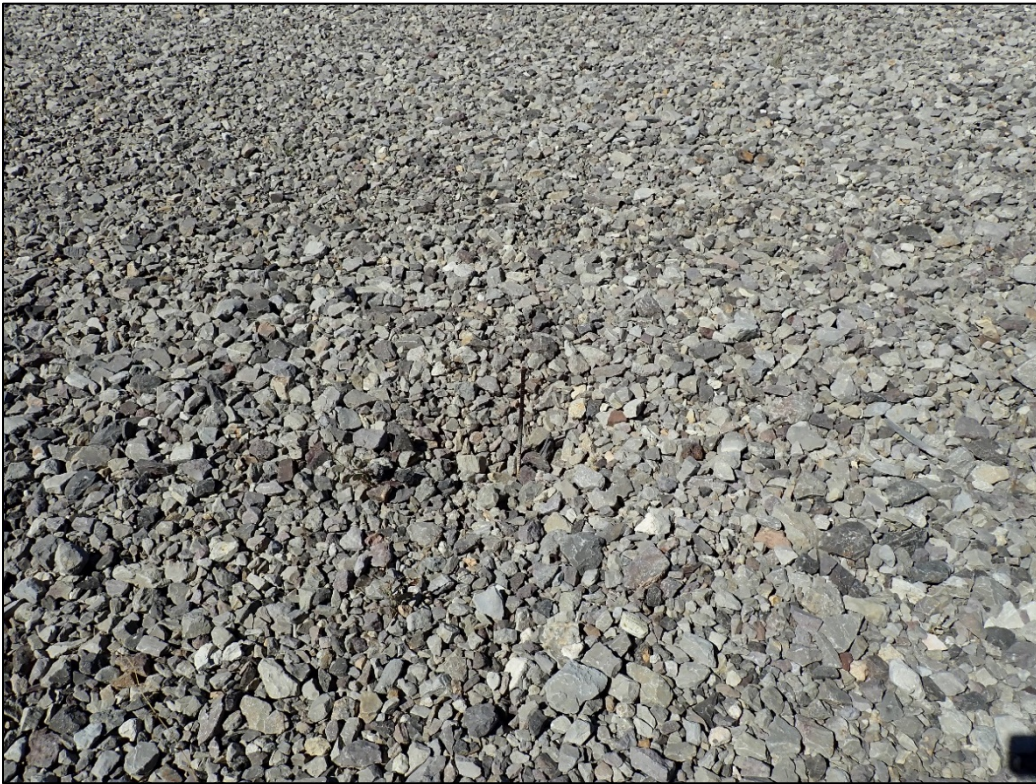
PL-10. Shallow Depression No. 3 on Disposal Cell Top Slope

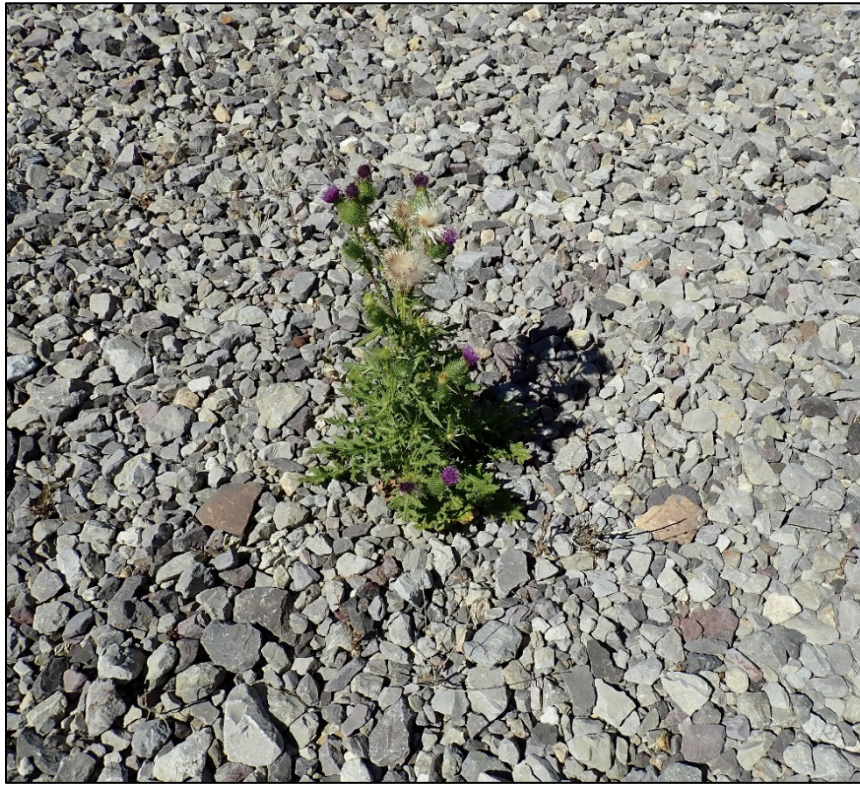
While various species of plants were present on the top slope of the disposal cell, no deep-rooted vegetation was observed. If encroachment of deep-rooted vegetation is observed, an evaluation will be conducted as required by the LTSP to determine if any action is necessary. Noxious weeds (PL-11) were identified and controlled (treated with herbicide) on the disposal cell top slope in accordance with the LTSP.

PL-11. Noxious Weed Growth on the Disposal Cell Surface

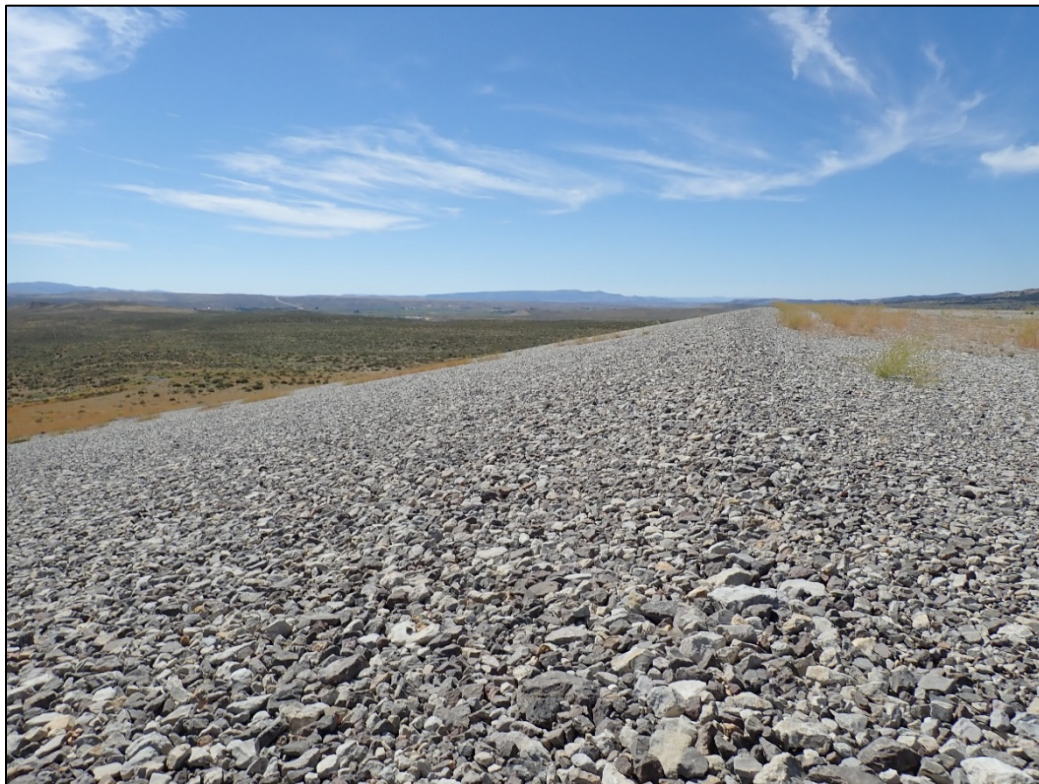
The disposal cell was designed to control surface water runoff resulting from a probable maximum flood event. The side slopes of the disposal cell were constructed with a 20% slope and are covered with a 1-foot-thick layer of riprap (PL-12). Minor sediment accumulation observed in the toe drain apron below the northwest side slope appears to be windblown (PL-13), and there was no evidence of side slope instability, erosion, or settlement. This area of sediment accumulation will continue to be monitored to ensure the toe drain and side slope are functioning properly.

PL-12. Disposal Cell South Side Slope

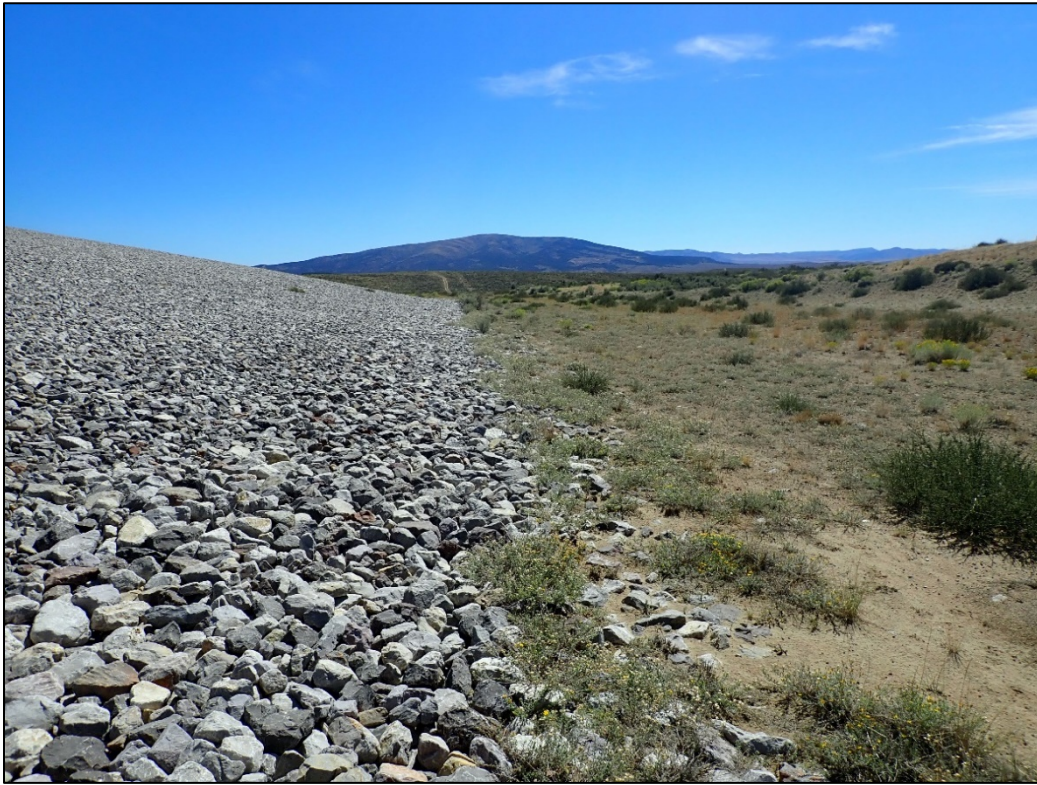
PL-13. Windblown Sediment Accumulating at Toe of Disposal Cell West Side Slope

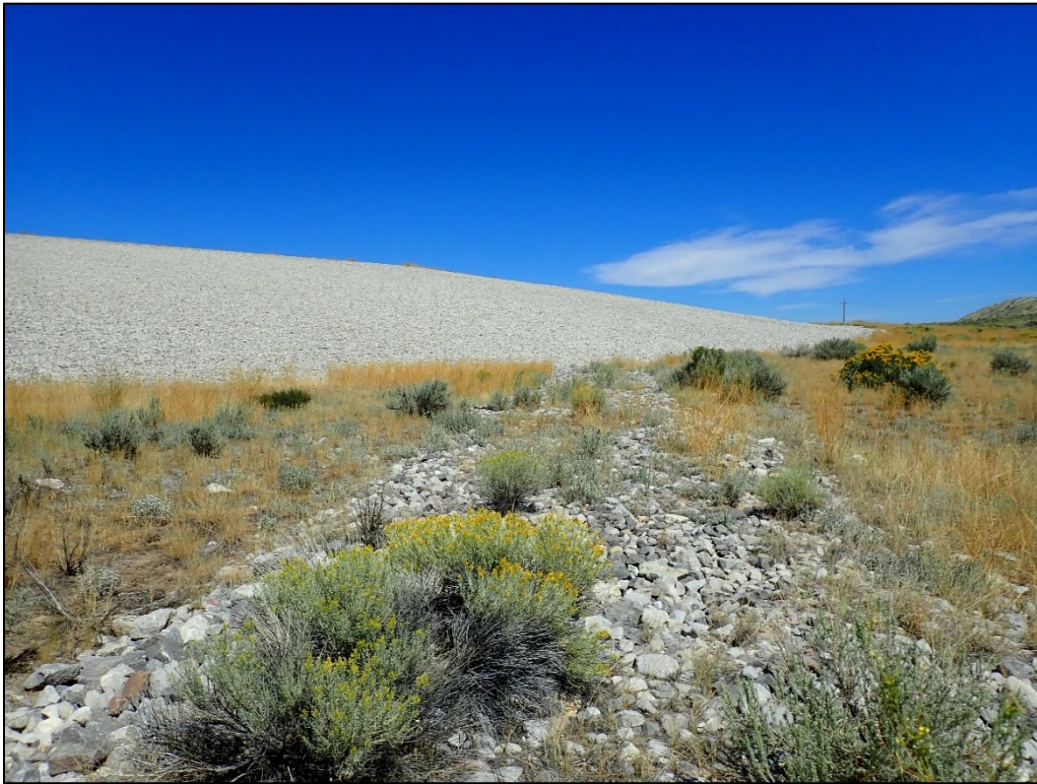
Surface water runoff from the side slopes is conveyed by an apron at the toe of the slope to six riprap-armored toe drains (PL-14) at low points in the apron. The apron and toe drains are constructed channels filled with riprap. Minor erosion has occurred adjacent to a toe drain along the north side of the disposal cell, but that has not impacted the performance of the toe drain. No maintenance needs were identified.

PL-14. Apron Toe Drain North of Ancillary Cell and Disposal Cell South Side Slope in Background

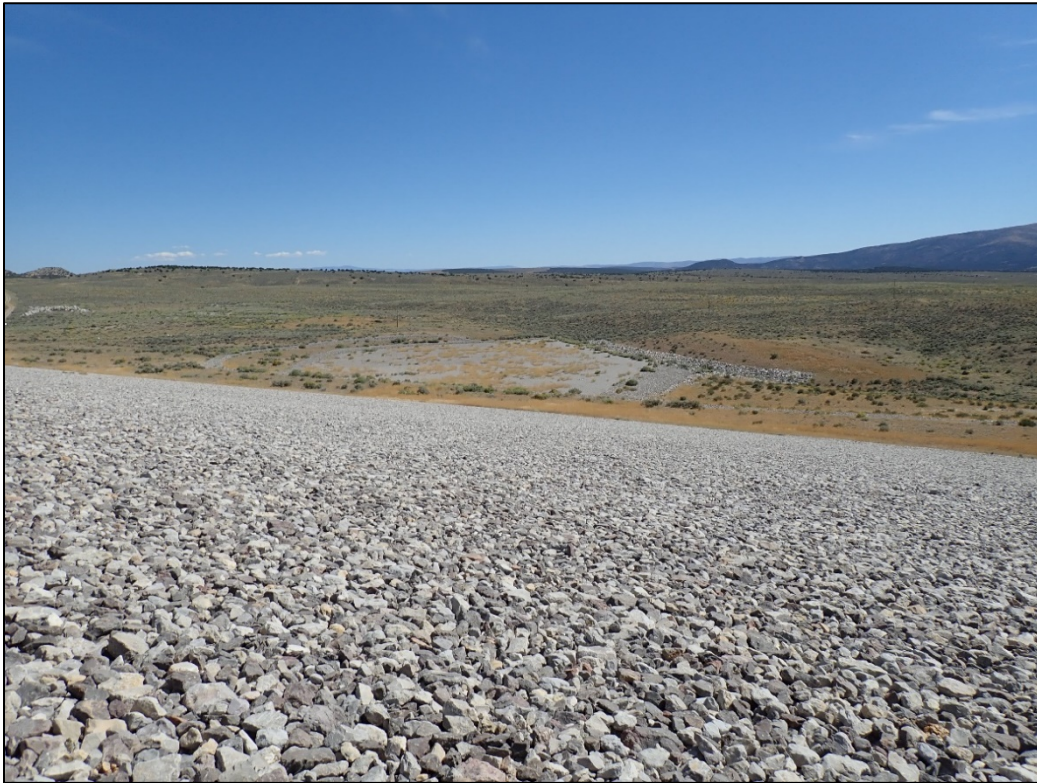
The ancillary cell (PL-15) was constructed to contain waste materials associated with the reclaimed evaporation pond area. It slopes gently toward the southwest. A rock berm wraps around its eastern and northern sides to protect it from surface water runoff. A small depression observed on the west end of the ancillary cell top slope is not impacting the performance of the cell, but it will continue to be monitored (PL-16). Various species of plants were present on the top slope of the ancillary cell. Noxious weeds were also observed on the ancillary cell at the time of the inspection and were treated during the September 23, 2020, routine maintenance trip.

PL-15. Disposal Cell South Side Slope with the Ancillary Cell in the Background

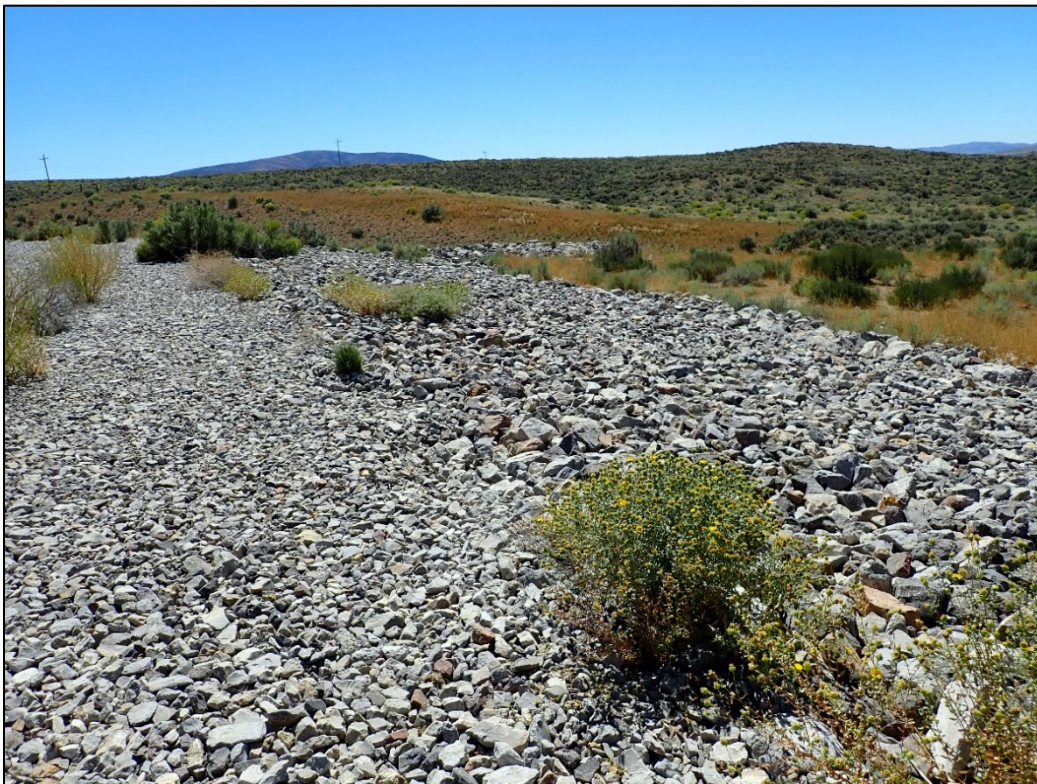
PL-16. Ancillary Cell West Side Slope with Small Depression on Cell Top Slope in Foreground

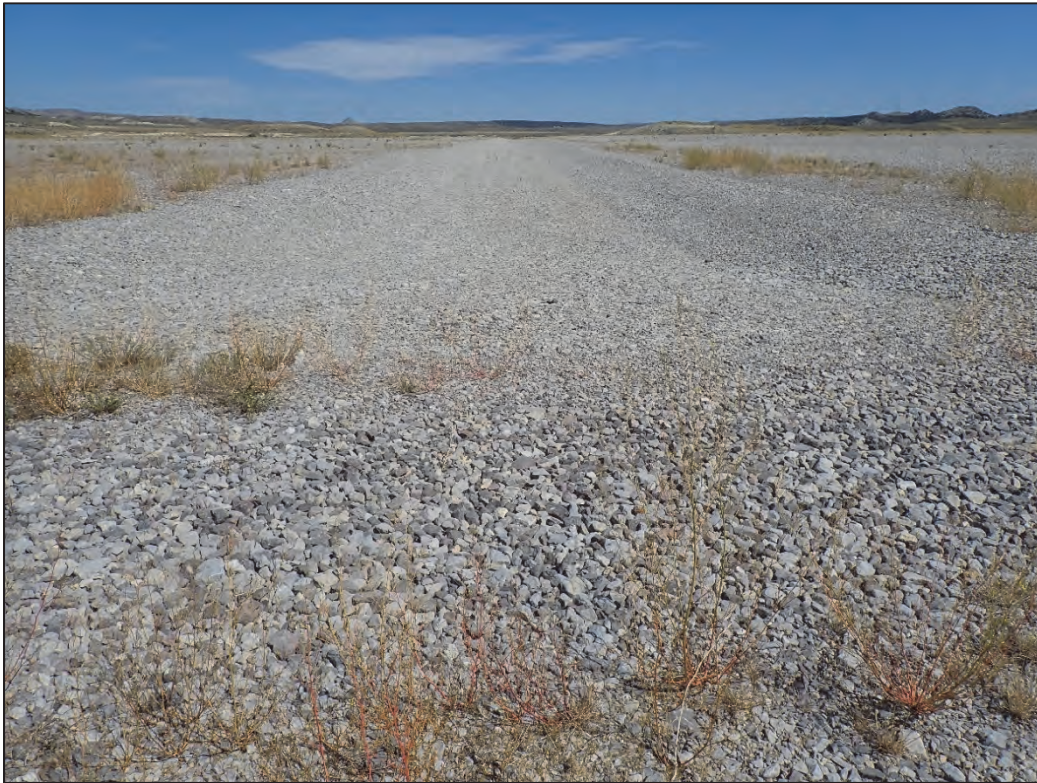
Final surface conditions at the site include a combination of rock armoring and contouring to achieve the surface water drainage control and erosion protection necessary to satisfy the design longevity requirements. The top slope of the disposal cell was designed to drain surface water runoff to the center and into riprap-armored Diversion Channel No. 1 (PL-17), which is graded toward and then down the east side slope of the disposal cell. Surface water runoff ultimately discharges into Rob Pit east of the site. An erosion protection structure, referred to as the Launch Rock Erosion Protection Basin (PL-18), was constructed at the outfall of Diversion Channel No. 1 to protect the disposal cell from headcutting that may occur from the deep channel that runs into Rob Pit. Diversion Channel No. 2 runs along the south side of the ancillary cell to convey surface water runoff away from the ancillary cell (PL-19). The diversion channels and outlet channel of the Launch Rock Erosion Protection Basin continue to function as designed.

PL-17. Diversion Channel No. 1

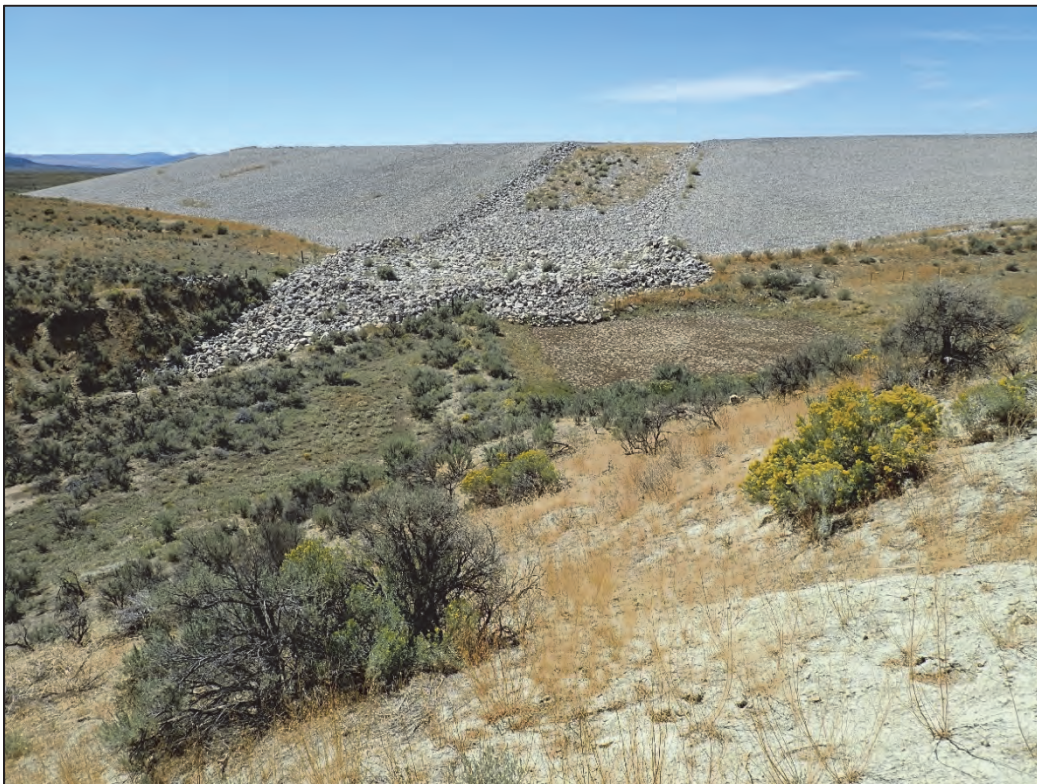
PL-18. Southwest View of Launch Rock Erosion Protection Basin

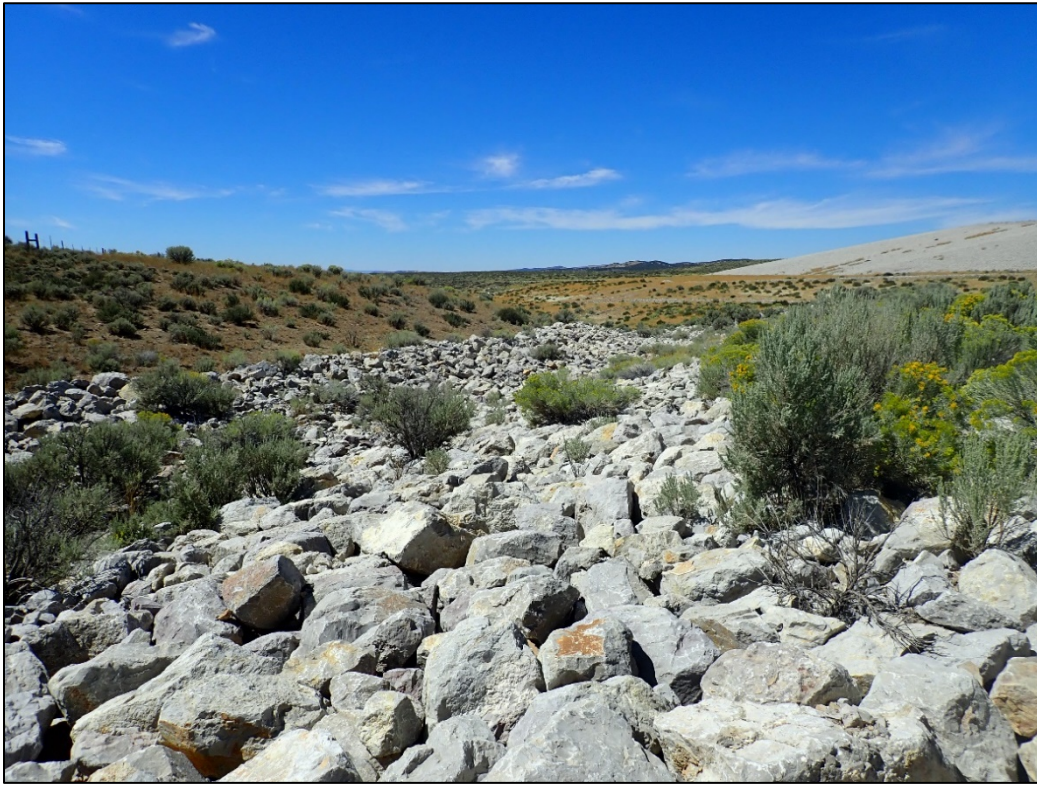
PL-19. Diversion Channel No. 2

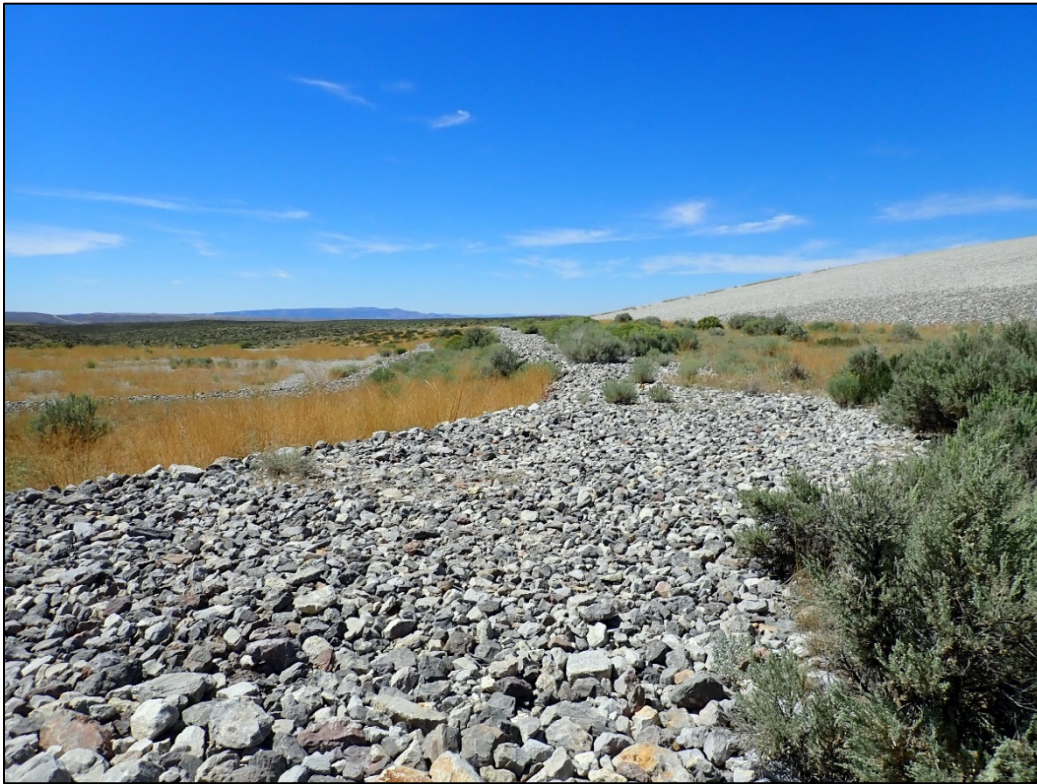
The rock berm that runs along the northern edge of the ancillary cell continues west across the slope south of the disposal cell to protect against erosion (PL-20). Several gullies and rills have developed on this south slope but do not threaten the integrity of the disposal cell (PL-21). The gullies will continue to be monitored and repaired as needed. The rock berm effectively controls headcutting from these gullies and protects the disposal cell. No maintenance needs were identified.

PL-20. Rock Berm North of Ancillary Cell
