4.0 Maybell West, Colorado, Disposal Site

4.1 Compliance Summary

Figure 4-1. 2020 Annual Inspection Drawing for the Maybell West, Colorado, Disposal Site

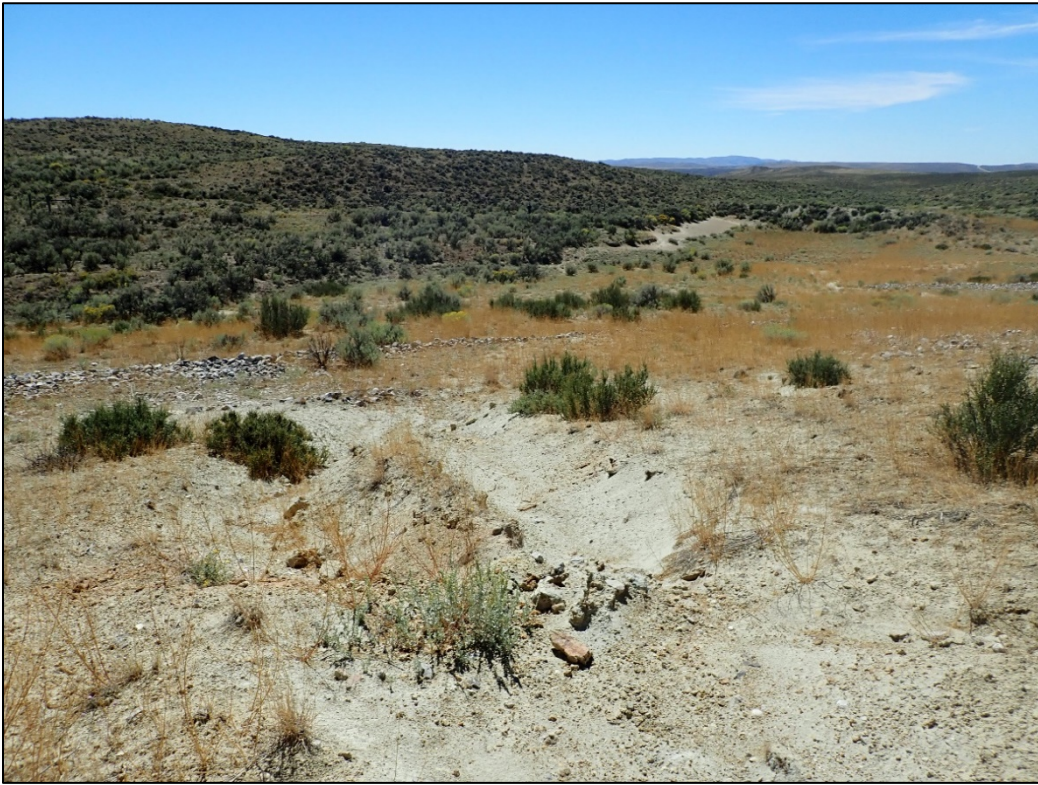
The rock berm that runs along the northern edge of the ancillary cell continues west across the slope south of the disposal cell to protect against erosion (PL-20). Several gullies and rills have developed on this south slope but do not threaten the integrity of the disposal cell (PL-21). The gullies will continue to be monitored and repaired as needed. The rock berm effectively controls headcutting from these gullies and protects the disposal cell. No maintenance needs were identified.

PL-21. Erosion Between Rock Berms West of Ancillary Cell
