11.0 Maybell, Colorado, Disposal Site

11.1 Compliance Summary

The Maybell, Colorado, Uranium Mill Tailings Radiation Control Act (UMTRCA) Title I Disposal Site (site) was inspected on September 3, 2020. No changes were observed on the disposal cell or in the associated drainage features. Inspectors identified several minor maintenance needs but found no cause for a follow-up inspection. Groundwater monitoring is not required.

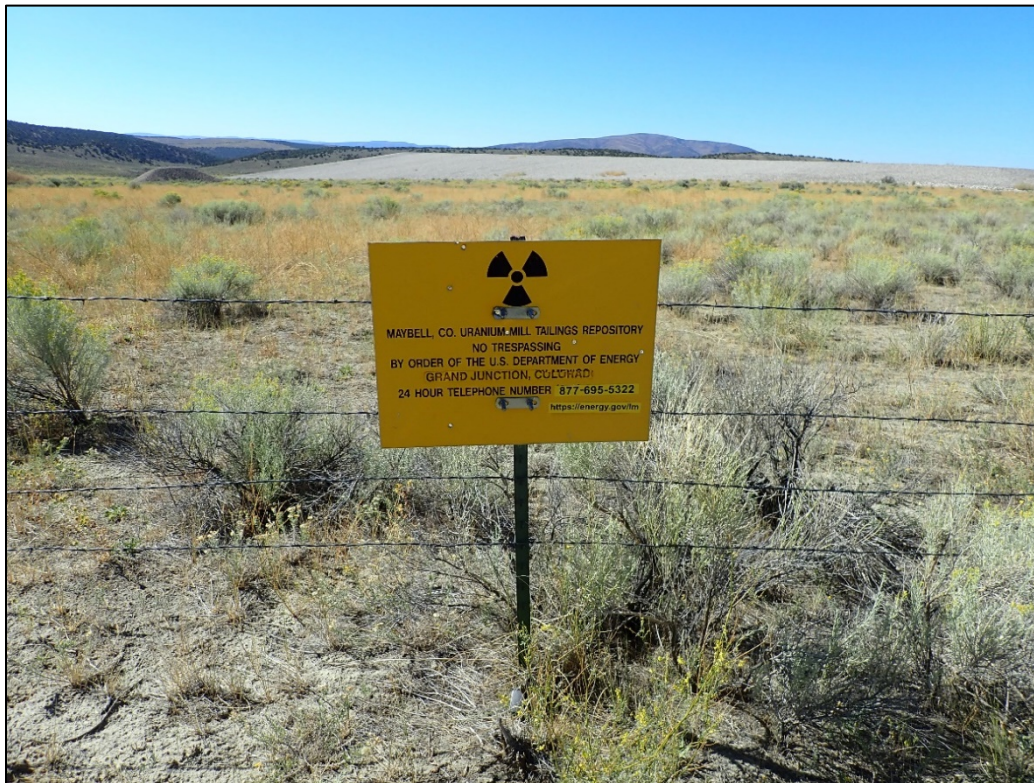
Access to the site is from the gravel-surfaced Moffat County Road 53, which runs north from U.S. Highway 40 approximately 8 miles east of Maybell, Colorado. County Road 53 ends at an unlocked gate near the northeast corner of the site (approximately 3 miles from the highway). The road continues west as a dirt two-track road directly north of the site. From the end of County Road 53 to the site entrance gate (and beyond, to the UMRCA Title II Maybell West, Colorado, Disposal Site), LM is responsible for road maintenance under a U.S. Bureau of Land Management right-of-way permit. Entrance to the site is through two locked, metal stock gates in the perimeter fence. One is the entrance gate, which is adjacent to the site marker and entrance sign (PL-1). The second gate is between perimeter signs P3 and P4 in the northwest corner of the property. Both gates were locked and functional. The entrance sign is near the entrance gate and is mounted on a T-post in the perimeter fence. The entrance sign has bullet damage but remains legible. No maintenance needs were identified.

PL-1. Entrance Sign

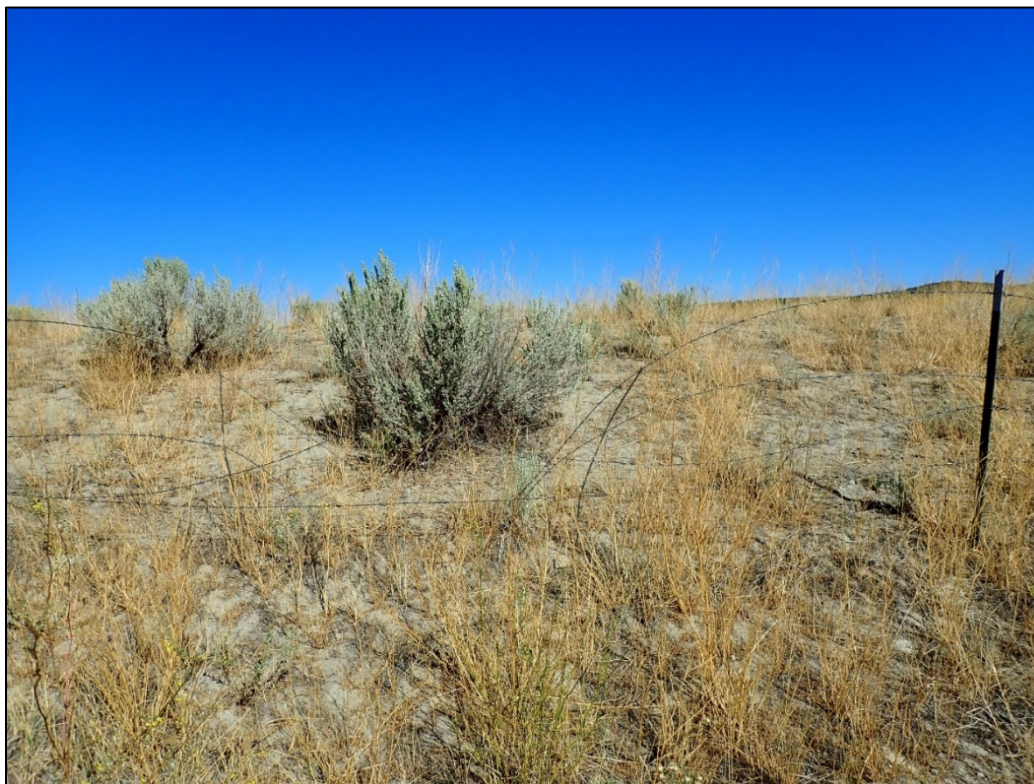
To facilitate land management by LM, a four-strand barbed-wire perimeter fence encloses the disposal cell, drainage structures, and much of the site. The site is in wintering grounds frequented by big-game animals (primarily pronghorn, deer, and elk) and is also surrounded by open range used to graze cattle. As a result, minor damage to the perimeter fence periodically occurs. Perimeter fence strands were broken in two locations (PL-2) near perimeter sign P1, and a loose T-post was observed along the perimeter fence near perimeter sign P7. Damage to the perimeter fence was repaired on September 21, 2020.

PL-2. Broken Fence Strands Along Northern Perimeter Fence

- Spraying noxious weeds and deep-rooted plants on the disposal cell
- Replacing perimeter sign P25
- Repairing loose T-post south of perimeter sign P7 along the western perimeter fence
- Repairing broken fence strands east of perimeter sign P1 along the northern perimeter fence

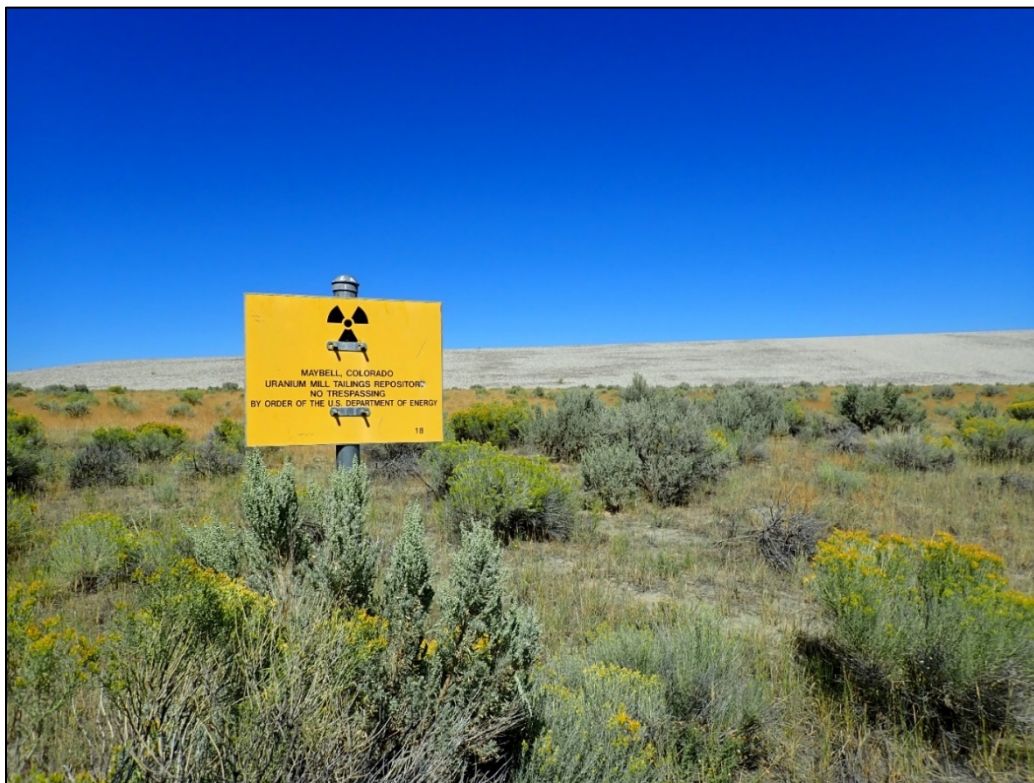
PL-3. Perimeter Sign P18

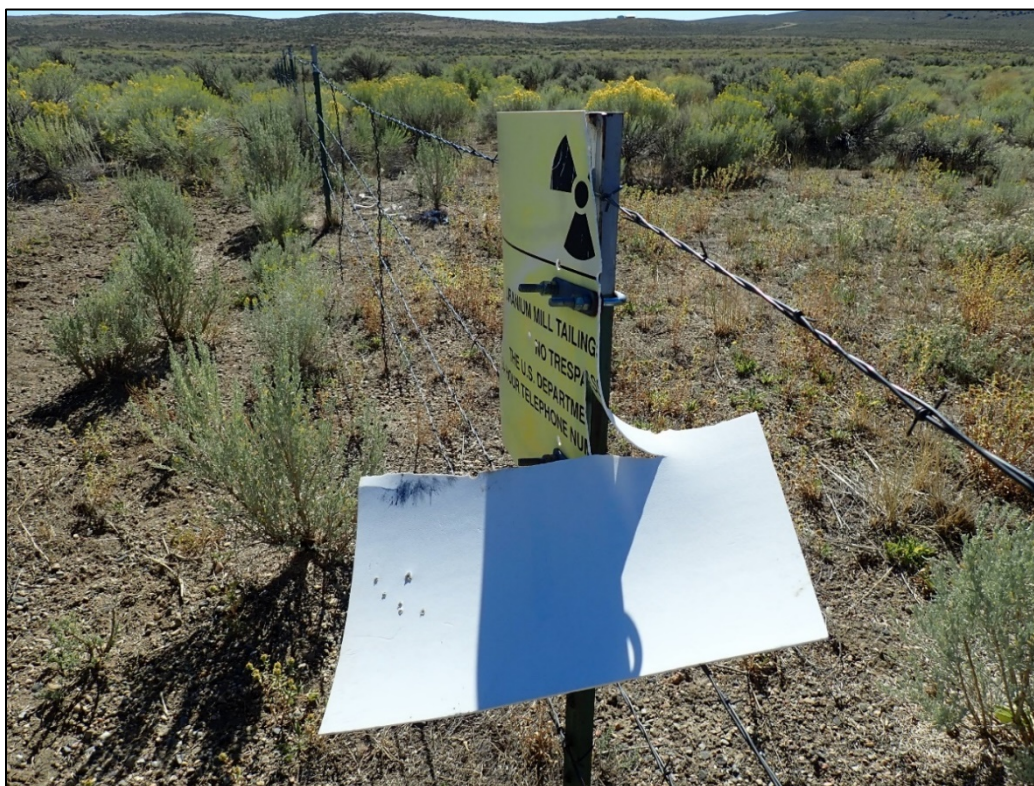
There are 26 perimeter signs. On the north, west, and south sides of the site, perimeter signs are attached to T-posts in the perimeter fence. On the east side of the site, perimeter signs are attached to steel posts set in concrete and are inside the property boundary approximately midway between the disposal cell and the perimeter fence (PL-3). Several of the perimeter signs along the dirt road north and west of the site (P5, P6, P8, P11, and P26) have bullet damage but remain legible. Perimeter sign P25 was observed to be damaged (PL-4) and was replaced on September 21, 2020. No other maintenance needs were identified.

PL-4. Damaged Perimeter Sign P25

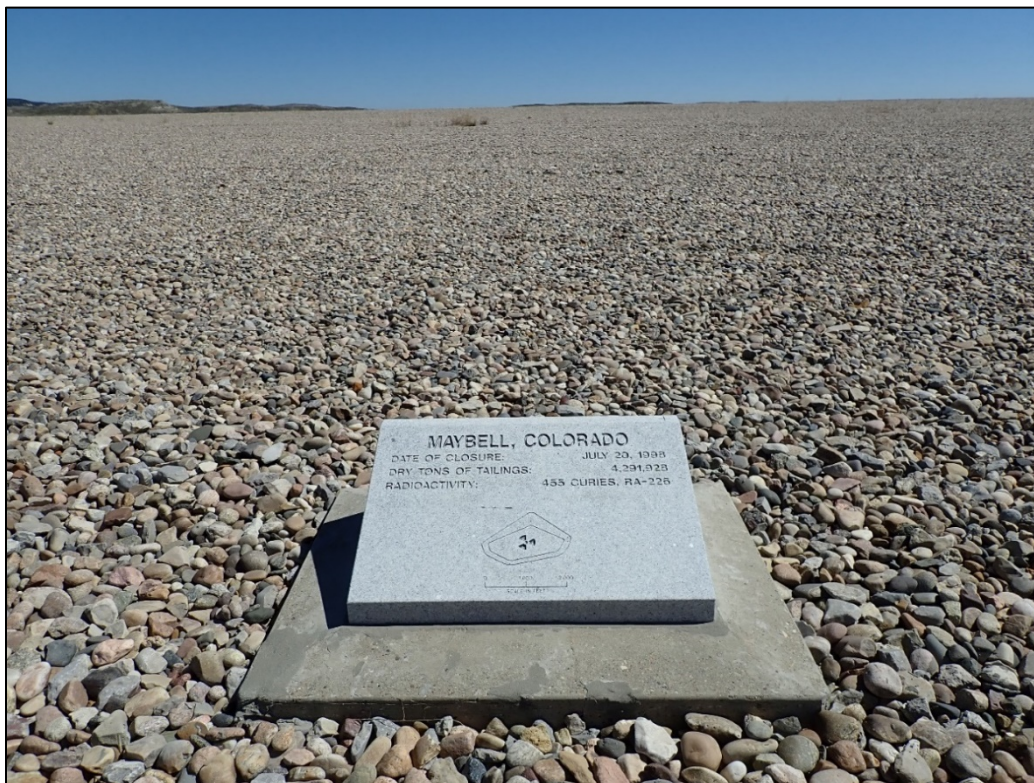
The site has two granite site markers. Site marker SMK-1 is just inside the entrance gate, and site marker SMK-2 is on the top slope of the disposal cell (PL-5). No maintenance needs were identified.

PL-5. Site Marker SMK-2

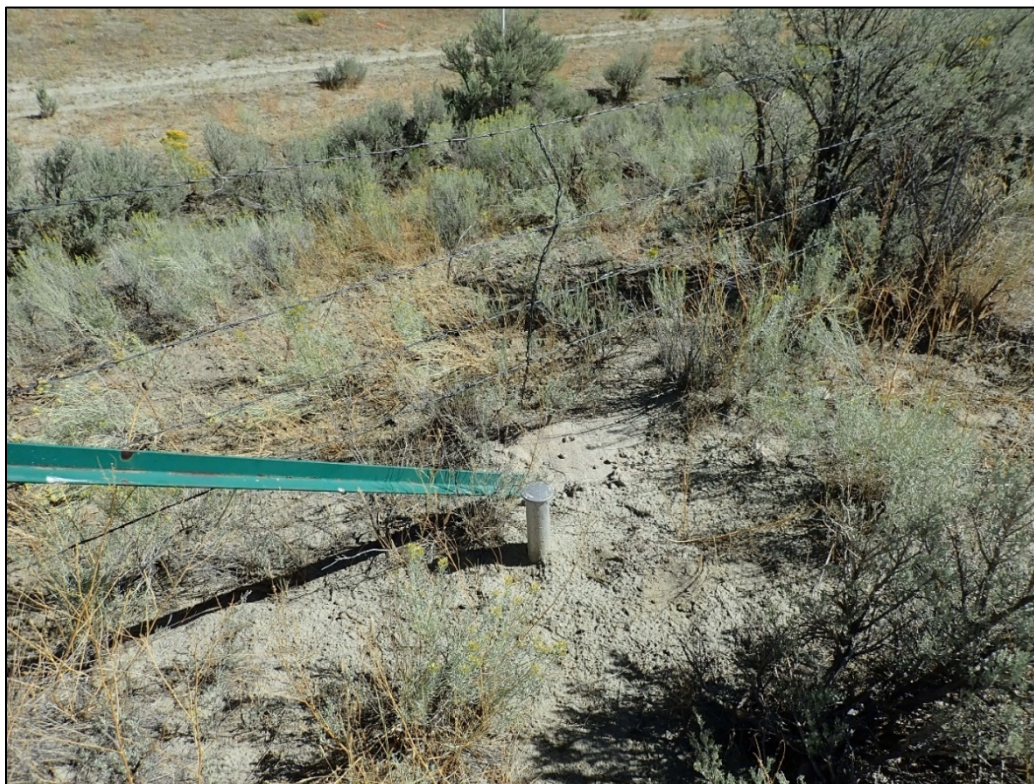
The site has two survey monuments. Survey monument SM-7 is on the bench above Johnson Wash just north of perimeter sign P21, and survey monument SM-8 is south of the disposal cell on the bench above Diversion Channel No. 2. The two survey monuments were not inspected during the inspection but were confirmed to be present and intact during a previous site visit. Seventeen boundary monuments delineate the property boundary (PL-6). No maintenance needs were identified.

PL-6. Original Boundary Monument BM-1A

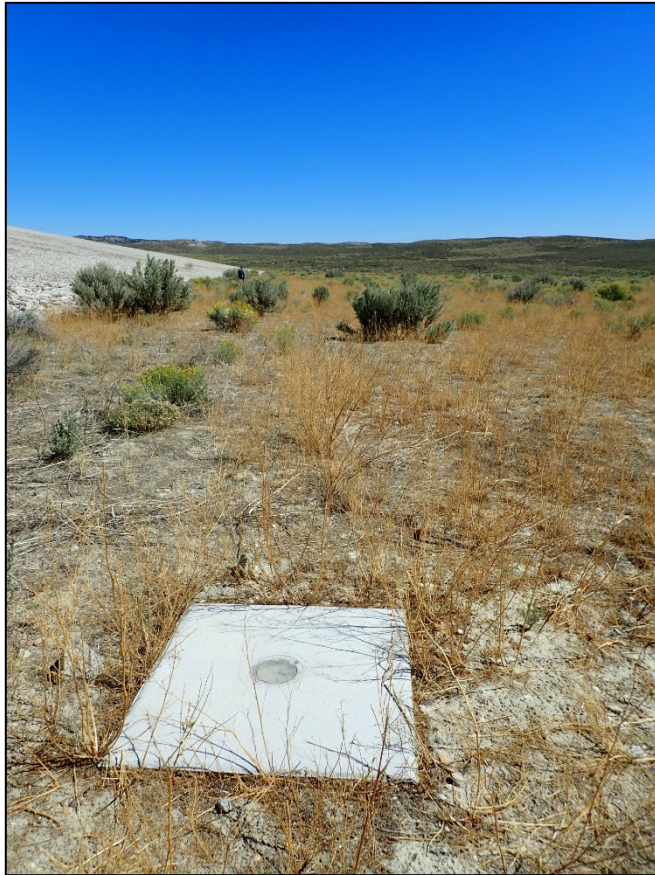
Five aerial survey quality control monuments, installed in 2018, were inspected during the 2020 inspection (PL-7). No maintenance needs were identified.

PL-7. Quality Control Monument QC5

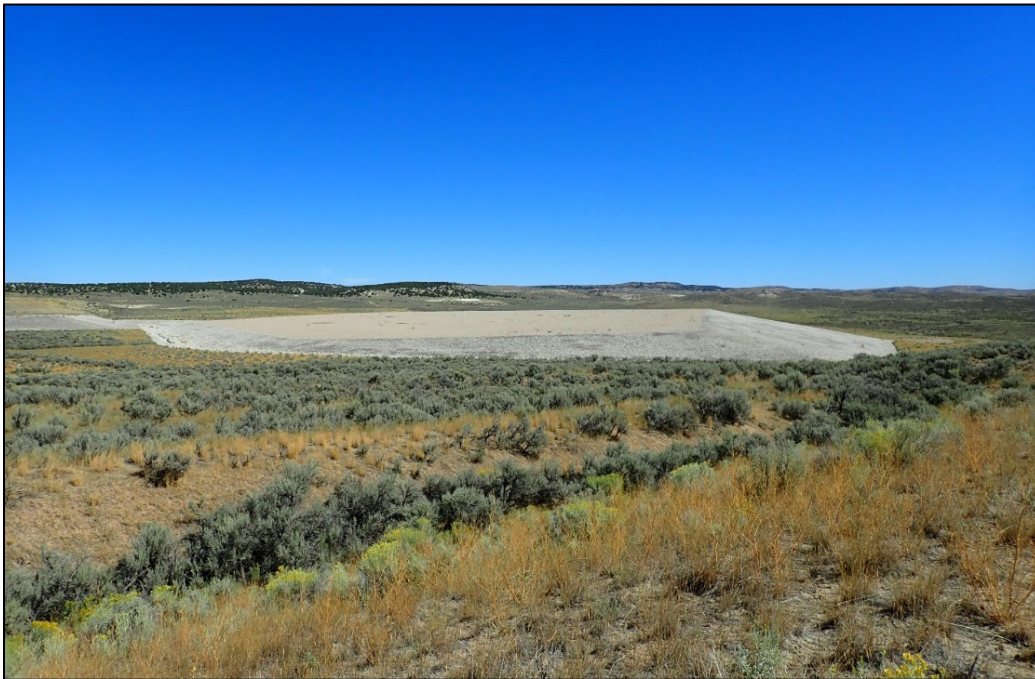
The disposal cell, completed in 1998, occupies 66 acres. The disposal cell is armored with riprap to control erosion and deter animal and human intrusion (PL-8). There was no evidence of erosion, settling, slumping, rock degradation, or other modifying processes that might affect the integrity of the disposal cell. Scattered shallow-rooted plants continue to establish on the disposal cell top and side slopes (PL-9); these plants do not affect the integrity of the cell. Deep-rooted plants and noxious weeds are controlled as required by the LTSP.

PL-8. Disposal Cell

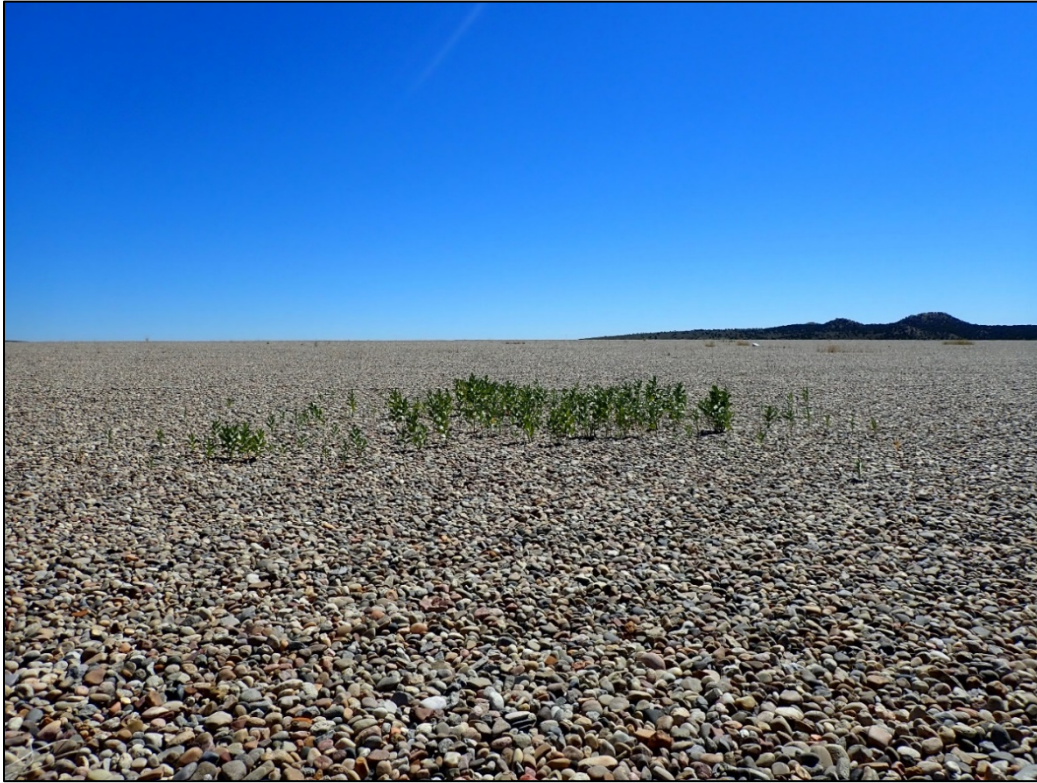
In accordance with the LTSP, annual visual inspections are conducted to verify the continued health of the onsite vegetation and to ensure that undesirable plant species (deep-rooted plants on the disposal cell cover and noxious weeds) do not proliferate on the site. Minor occurrences of noxious weeds and deep-rooted plants were noted on the disposal cell during the inspection. Annual noxious weed treatment will continue. Following reclamation, the disturbed soil surfaces on the site were revegetated with a mix of native and adaptive grasses to provide soil stability. These revegetated areas appeared to be healthy, with similar diversity and density as the surrounding non-disturbed areas.

PL-9. Vegetation on Top Slope of Disposal Cell

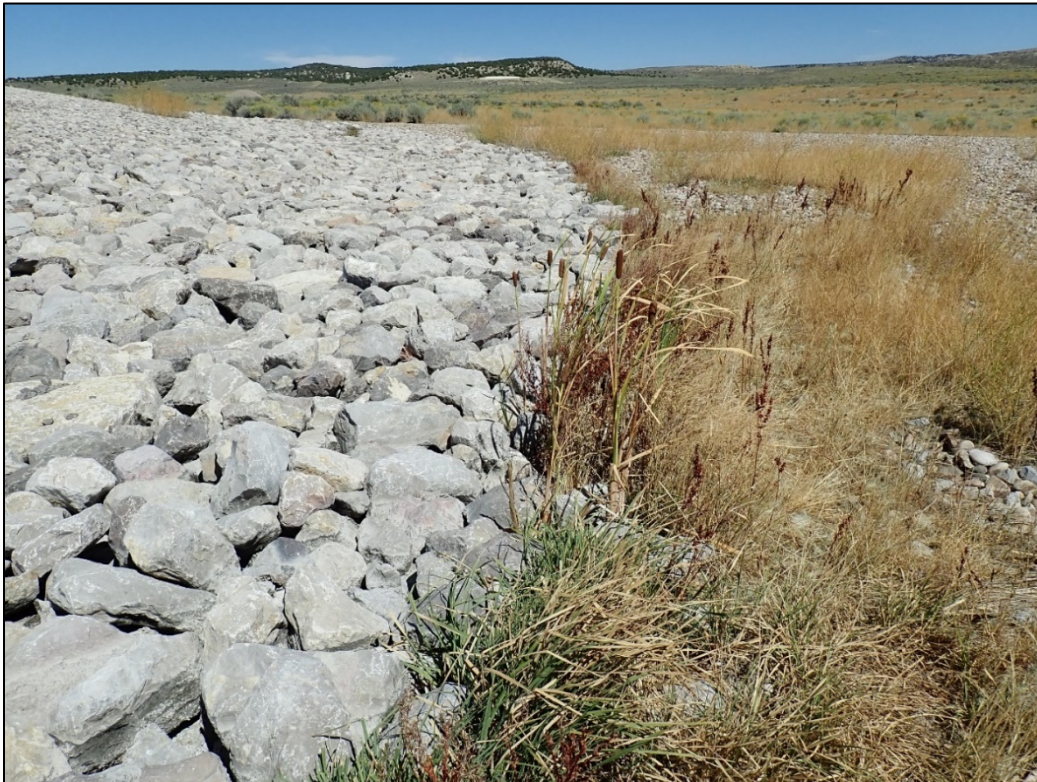
In accordance with the LTSP, inspectors looked for seeps on the east and southeast side slopes of the disposal cell, because slimes were encapsulated in this portion of the cell. No seeps were observed at the toe of the disposal cell in these areas. Cattails continue to grow at the toe of the east corner of the disposal cell, indicating the presence of moisture (PL-10). Stormwater runoff from the disposal cell discharges at this location, and standing water has been observed in this area during past inspections; no standing water was noted during the 2020 inspection. A 2003 laboratory analysis of evaporite minerals from this location confirmed that no constituents attributable to the disposal cell contents were present. No other maintenance needs were identified.

PL-10. Cattails Adjacent to Disposal Cell Toe Slope and Apron

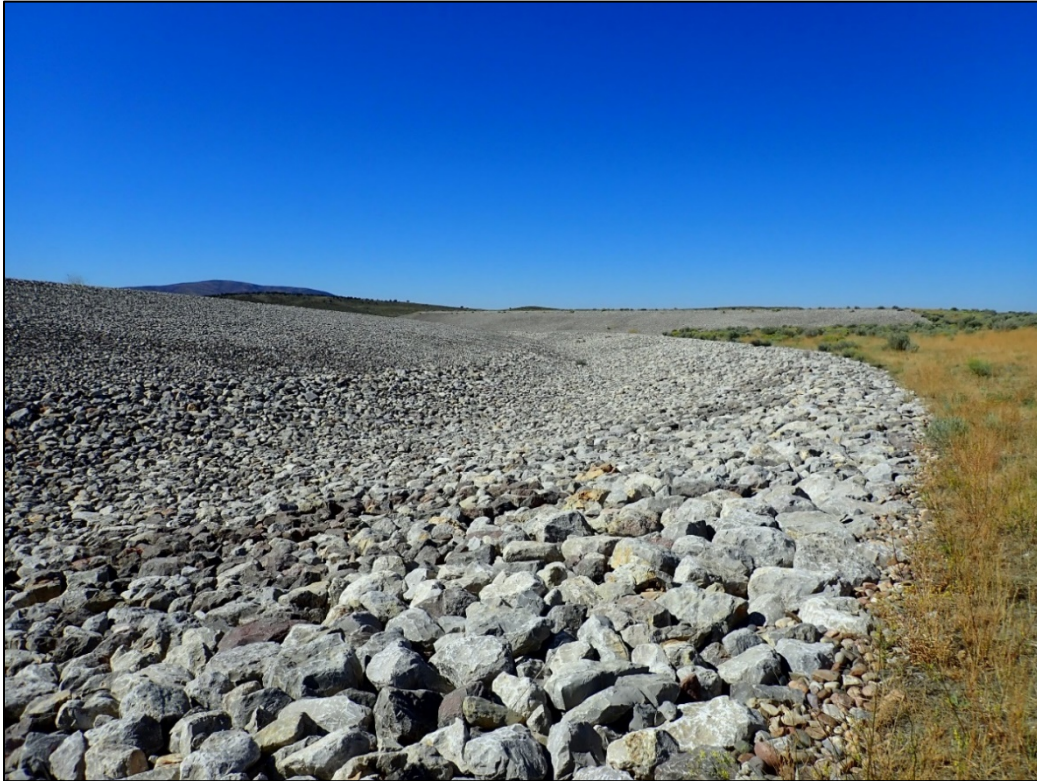
PL-11. Diversion Channel No. 1 and North Side Slope of Disposal Cell

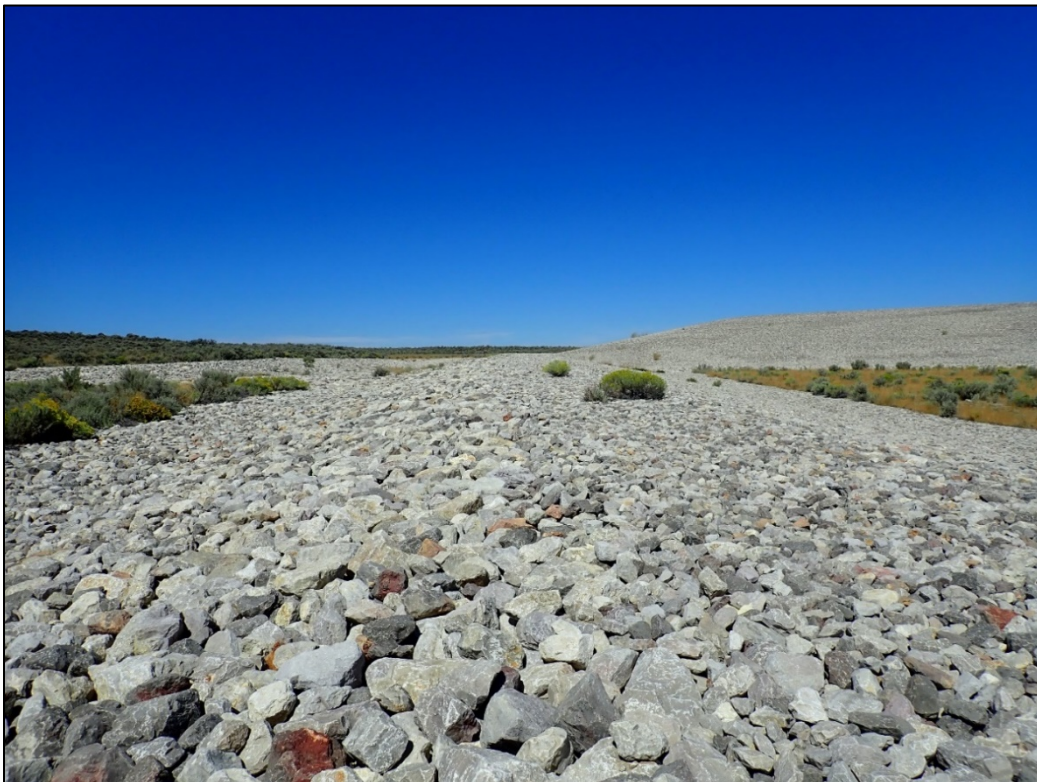
PL-12. Diversion Channel No. 1

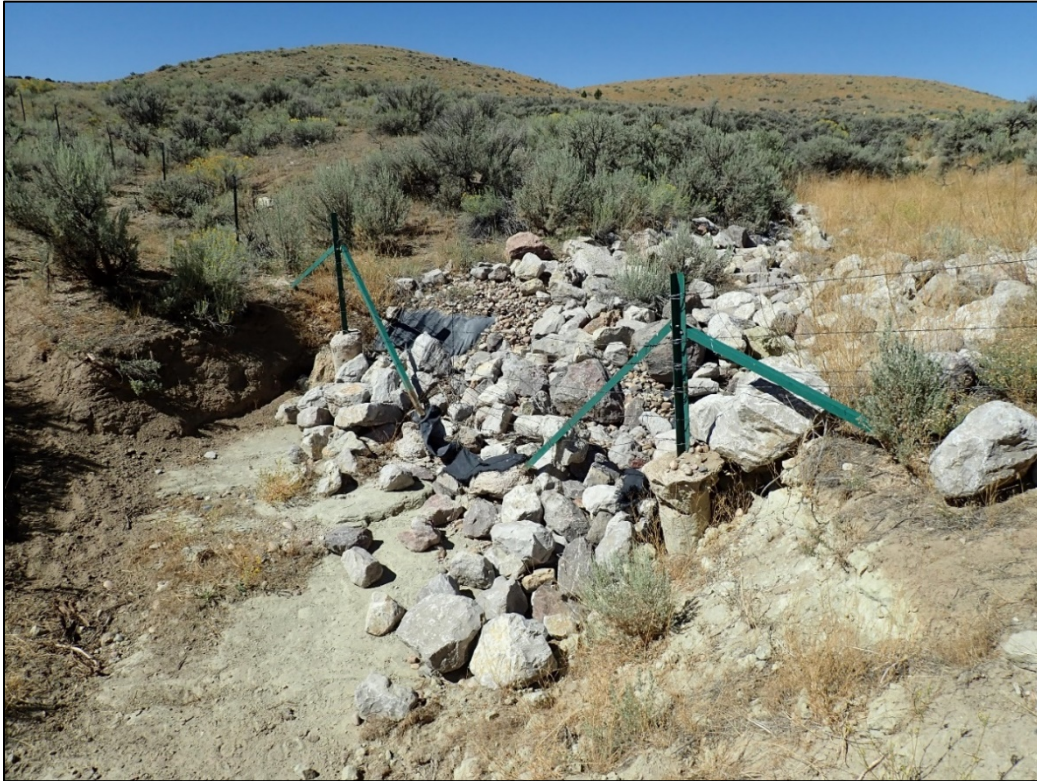
PL-13. Perimeter Fence near Outlet to Diversion Channel No.1

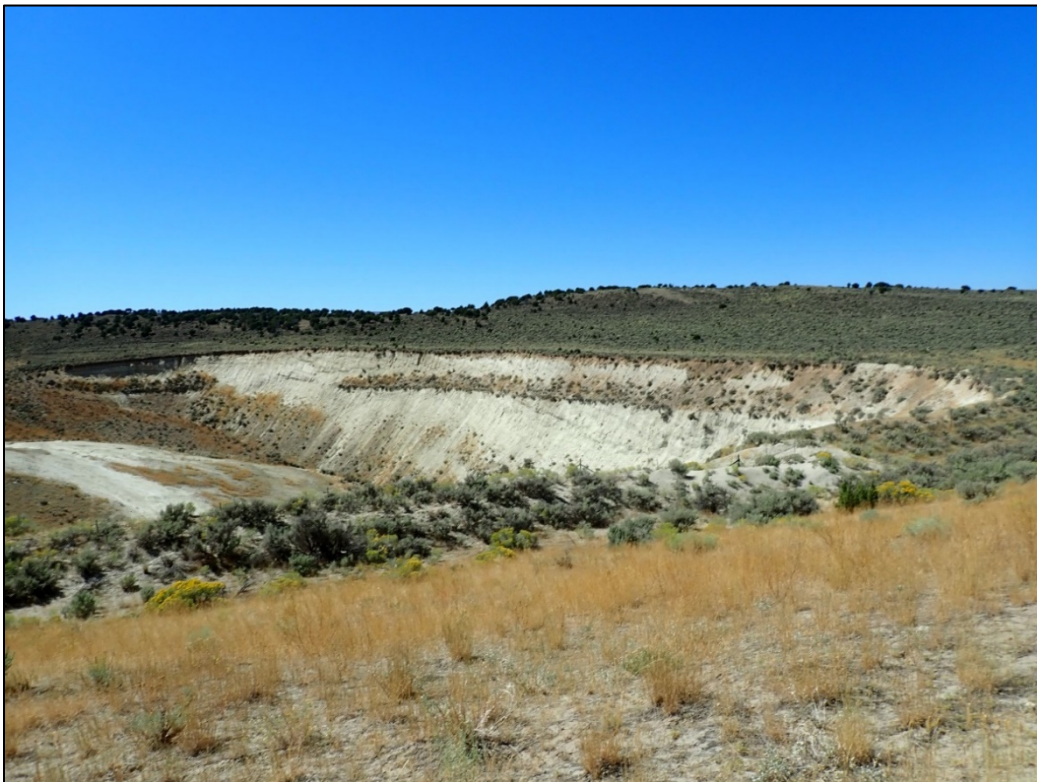
Directly south of the site is a former open-pit uranium mine known as the Johnson Pit (PL-14). Over time, slumping of the pit wall resulted in the pit encroaching several feet onto property now owned by DOE. This encroachment presents no threat to the integrity of the disposal cell and occurred before reclamation and transfer of the site to DOE for long-term surveillance and maintenance. This encroachment is visually monitored annually; it is periodically documented with photographs to assess whether there is any further slumping of the pit wall and to verify the integrity and functionality of the perimeter fence. There was no evidence of any additional encroachment of the pit onto the site at the time of the inspection. However, windblown sand continues to accumulate along the northern crest of the pit wall along the perimeter fence line (PL-15). The perimeter fence remains functional, but continued accumulation of sand will require vertically extending the fence or removing the sand. Inspectors will continue to monitor this area. No immediate maintenance needs were identified.

PL-14. Sand Accumulation Around Perimeter Fence with Johnson Pit in Background

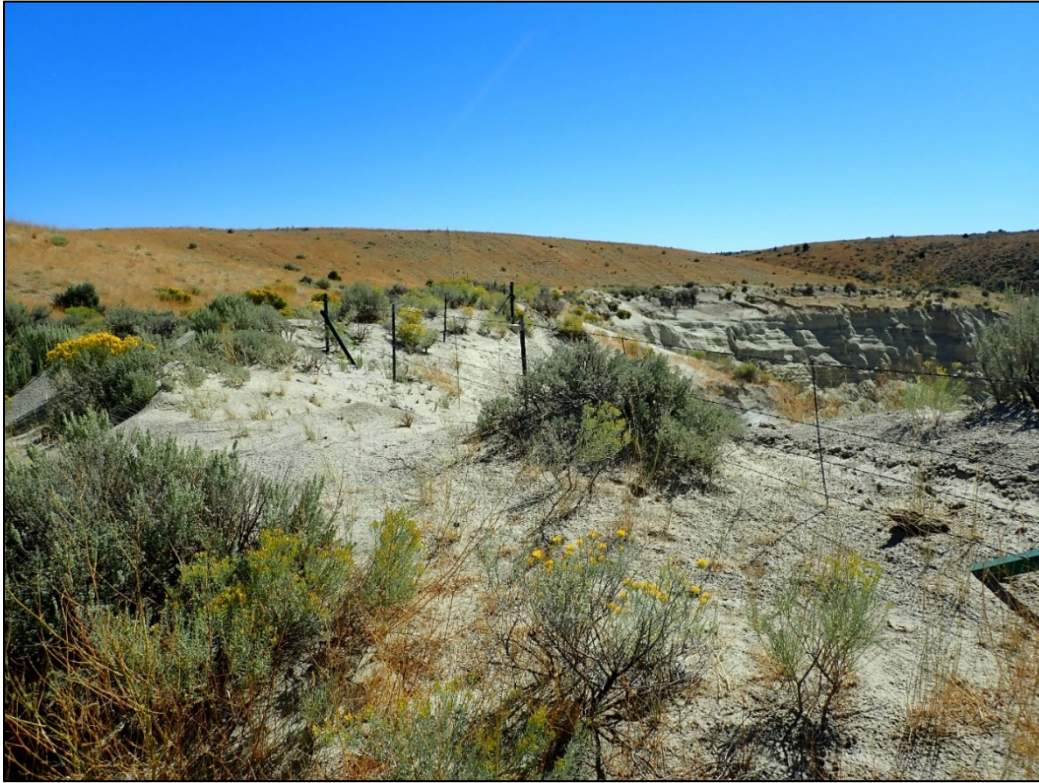
PL-15. Sand Accumulation Around Perimeter Fence near Johnson Pit
