13.0 Naturita, Colorado, Disposal Site

13.1 Compliance Summary

The Naturita, Colorado, Uranium Mill Tailings Radiation Control Act (UMTRCA) Title I Disposal Site (site) was inspected on June 10, 2020. No changes were observed on the disposal cell or in the associated drainage features. Inspectors identified several minor maintenance needs but found no cause for a follow-up inspection.

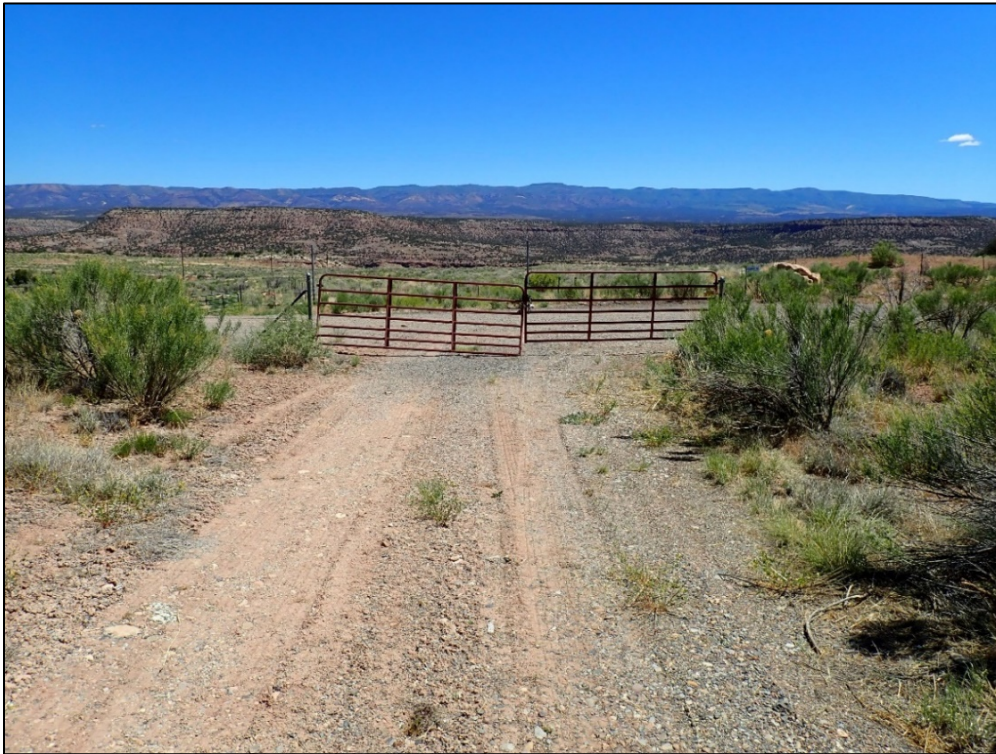
Access to the site is from Colorado Highway 141 to Montrose County Road EE22, which borders the northeast side of the site. Entrance to the site is through a locked steel gate directly off County Road EE22. One hinge on the entrance gate was damaged, but the gate was locked and functional (PL-1). The hinge was repaired after the inspection. The entrance sign, next to the entrance gate, was missing at the time of the inspection but replaced following the inspection. No other maintenance needs were identified.

PL-1. Site Entrance Gate with Detached Hinge

- Replacement of the entrance sign.
- Replacement of perimeter sign P5.
- Repair hinge on entrance gate.
- Repair of loose fence strands near perimeter signs P13 and P18.
- Installation of UAS warning signs at the entrance gate and between perimeter sign P7 and boundary monument BM-17.

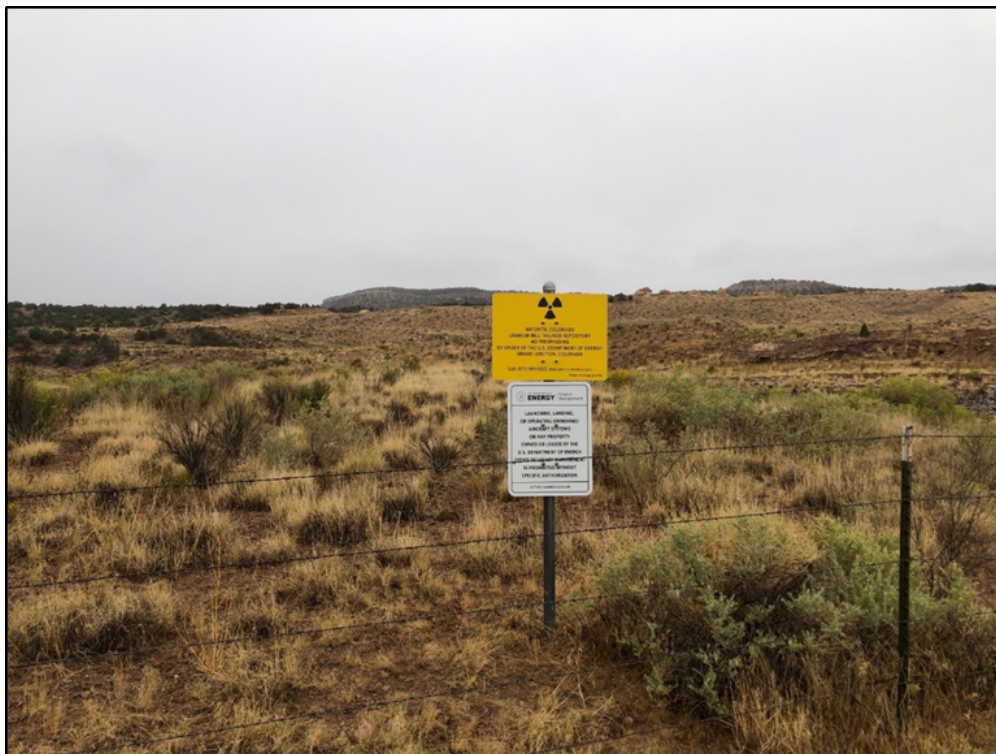
Two new unmanned aircraft system (UAS) warning signs were installed following the 2020 inspection. One sign was installed at the entrance area (PL-2), and the other was installed on the southeast corner of the site between perimeter sign P7 and boundary monument BM-17.

PL-2. New Entrance Sign with Unmanned Aircraft System Sign

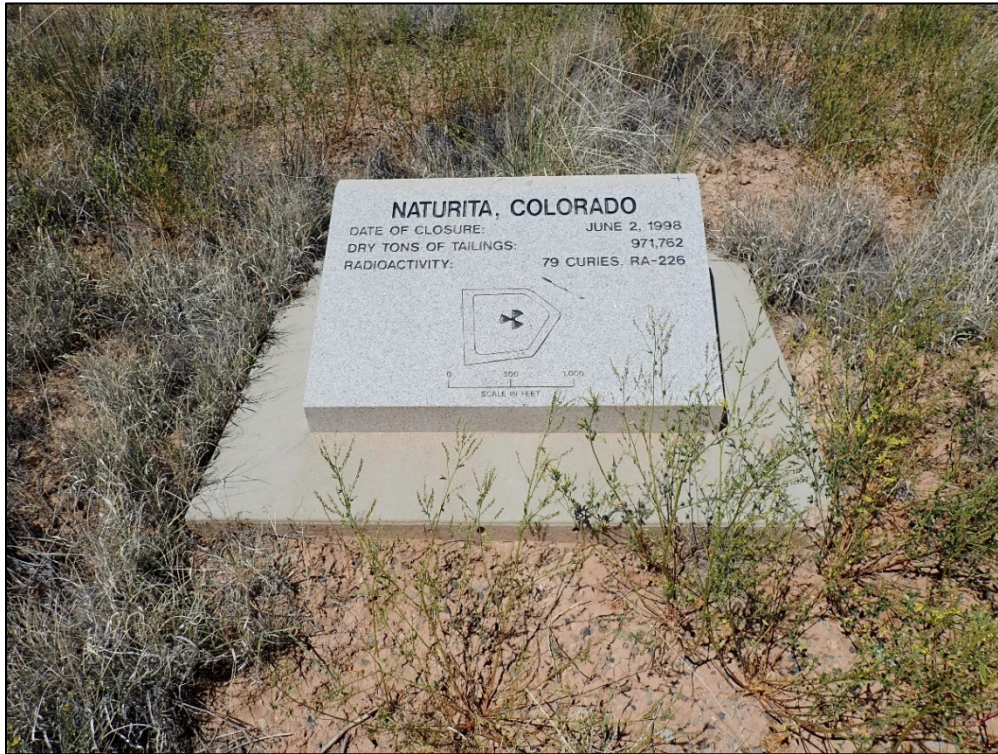
The site has two granite site markers. Site marker SMK-1 (PL-3) is just inside the entrance gate, and site marker SMK-2 is on the top slope of the disposal cell. No maintenance needs were identified.

PL-3. Site Marker SMK-1

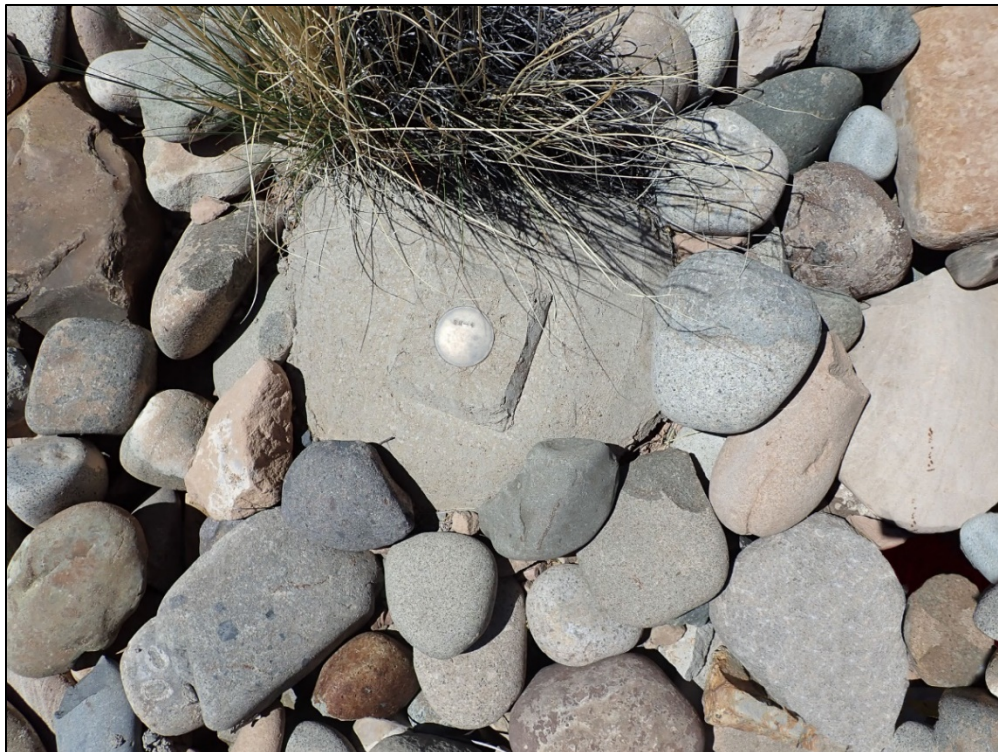
Three survey monuments and 14 boundary monuments delineate the property boundary. Boundary monuments BM-1 through BM-17 mark the property corners. Survey monuments SM-3, SM-4, and SM-11 represent boundary monuments BM-3, BM-4, and BM-11, respectively (PL-4). No maintenance needs were identified.

PL-4. Survey Monument SM-4

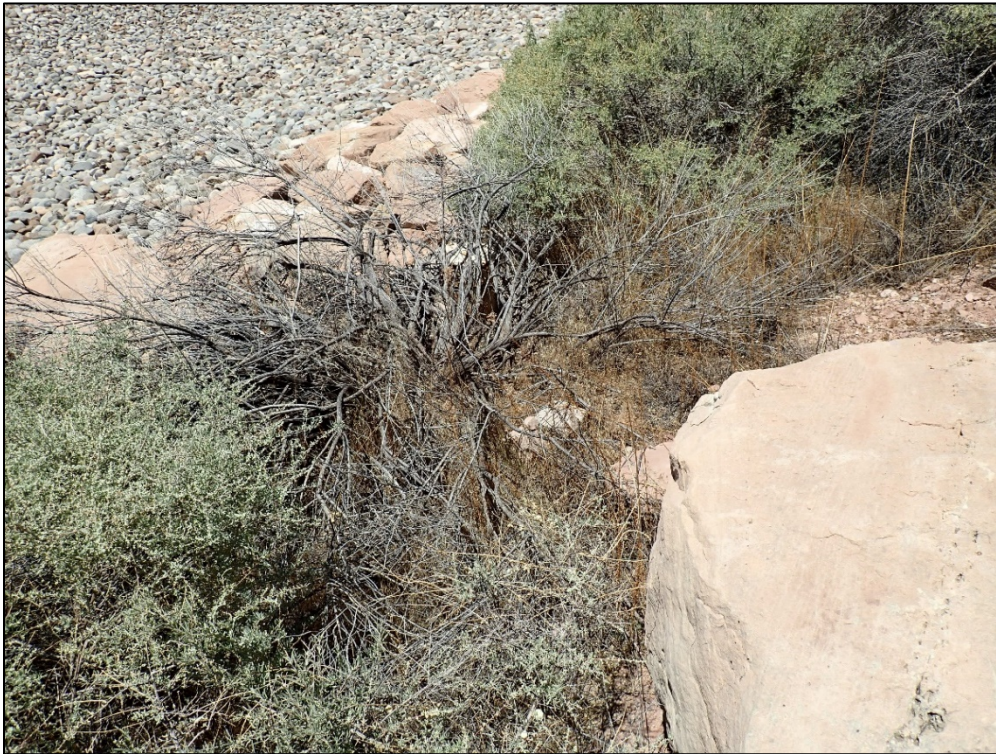
The site has five groundwater monitoring wells. The wellhead protectors were undamaged and locked. Monitoring wells CM93-1, BR95-3, and BR95-1 all were completely surrounded by woody vegetation (PL-5 and PL-6). Sampling of the wells is not required, and the vegetation will be addressed upon well abandonment, planned for fiscal year 2021. No immediate maintenance needs were identified.

PL-5. Overgrown Vegetation Around Well BR95-1

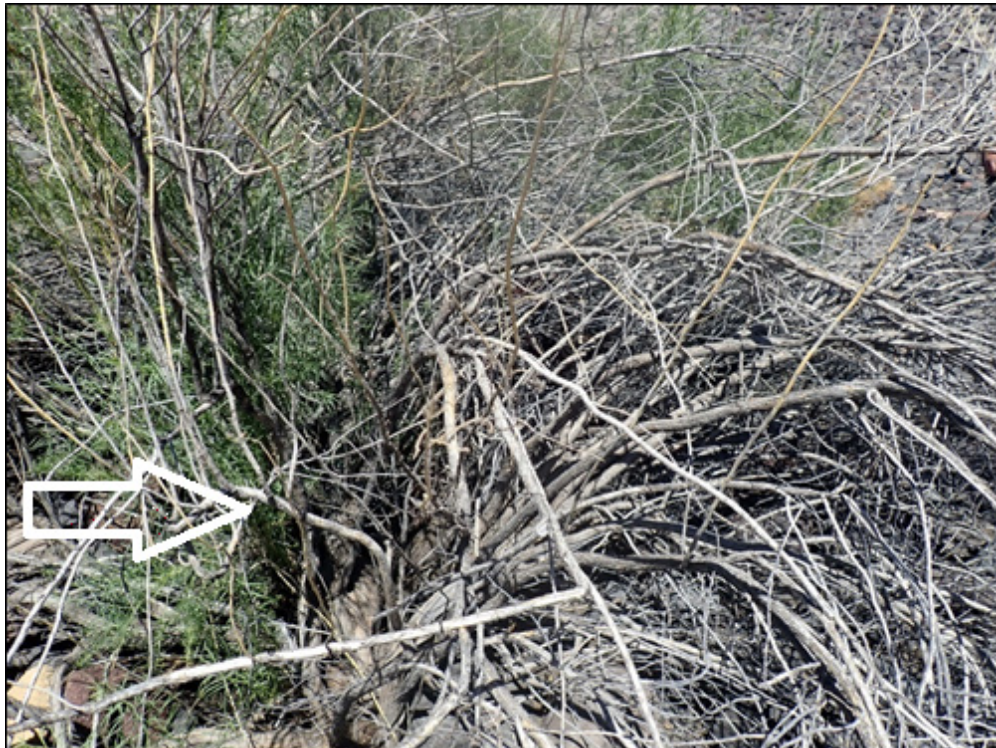
PL-6. Overgrown Vegetation Around Well CM93-1

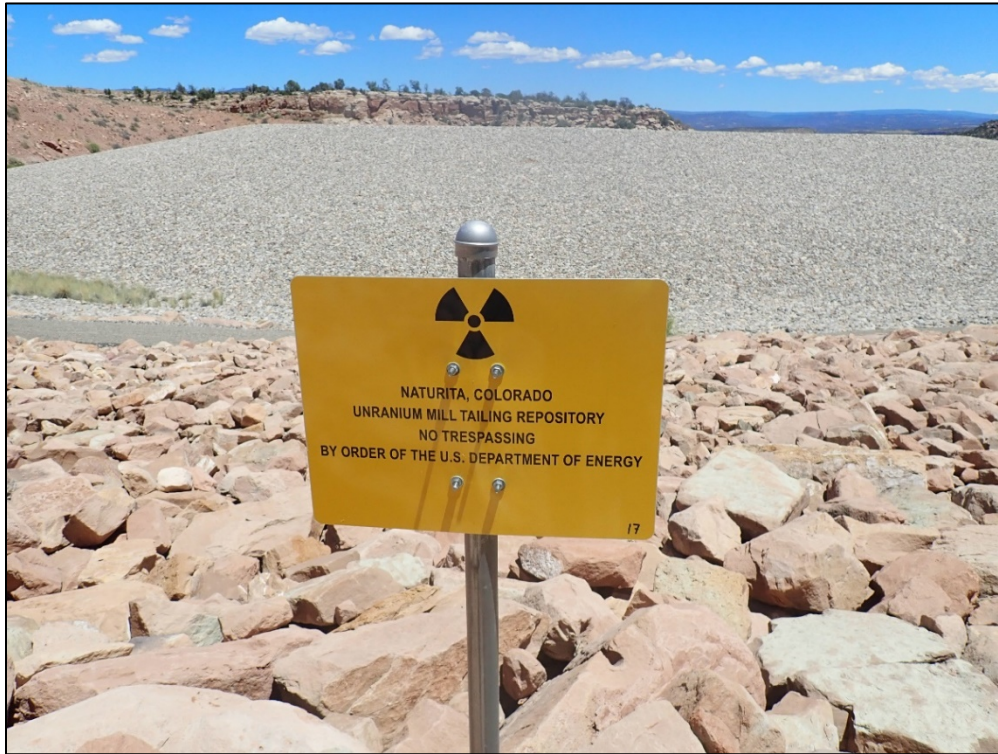
The disposal cell, completed in 1998, occupies 10 acres (PL-7). The disposal cell is armored with riprap to control erosion. The riprap is rounded, with larger diameter rock on the side slopes than on the top slope. There was no evidence of settling, slumping, erosion, rock degradation, or other modifying processes that might affect the integrity of the disposal cell.

PL-7. Perimeter Sign P17; Disposal Cell in Background

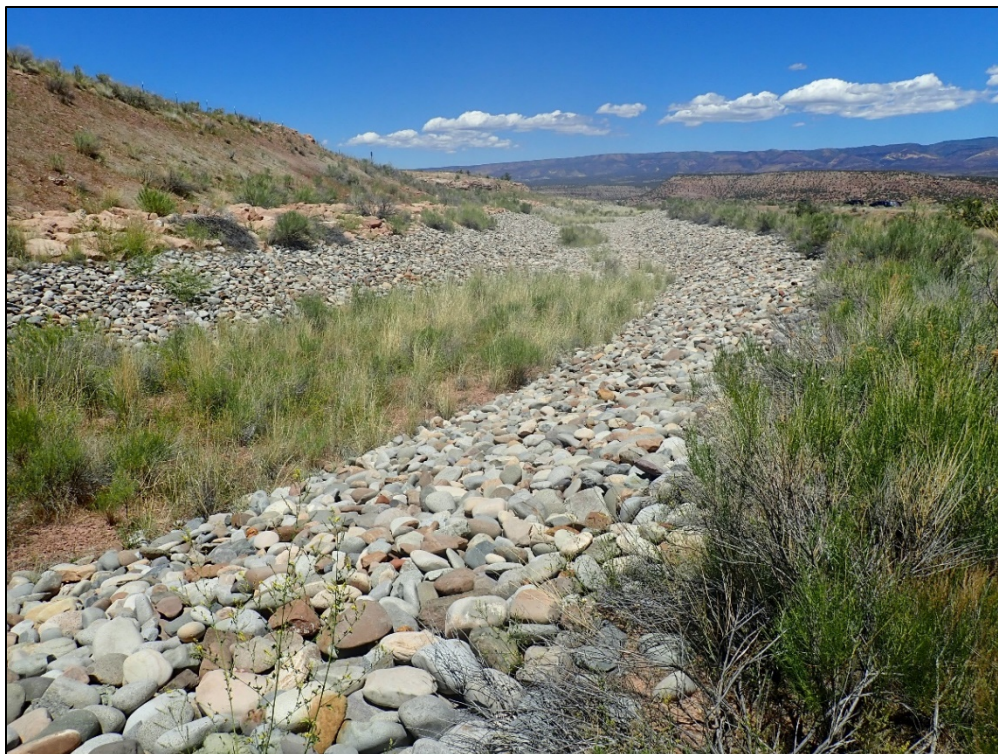
A riprap-armored interceptor channel, upgradient and northwest of the disposal cell, diverts stormwater and snowmelt runoff to the northeast under County Road EE22. Some sediment has eroded from the offsite area upslope from the channel and is being deposited in the channel. Sediment accumulation and associated vegetation have not adversely affected the performance of the interceptor channel (PL-8). Herbicide treatment of rabbitbrush plants is ongoing.

If volunteer plant growth or sedimentation occurs to the point that the function of engineered structures might be degraded, DOE will evaluate the potential impact and select appropriate responses (DOE 2019). A rabbitbrush plant (a deep-rooted woody species) growing in the deposited sediment in the interceptor channel was identified and will be treated before the next inspection. No other maintenance needs were identified.

PL-8. Sediment Accumulation and Vegetation in Interceptor Channel

Rabbitbrush growing in the interceptor channel will be treated before the next inspection.

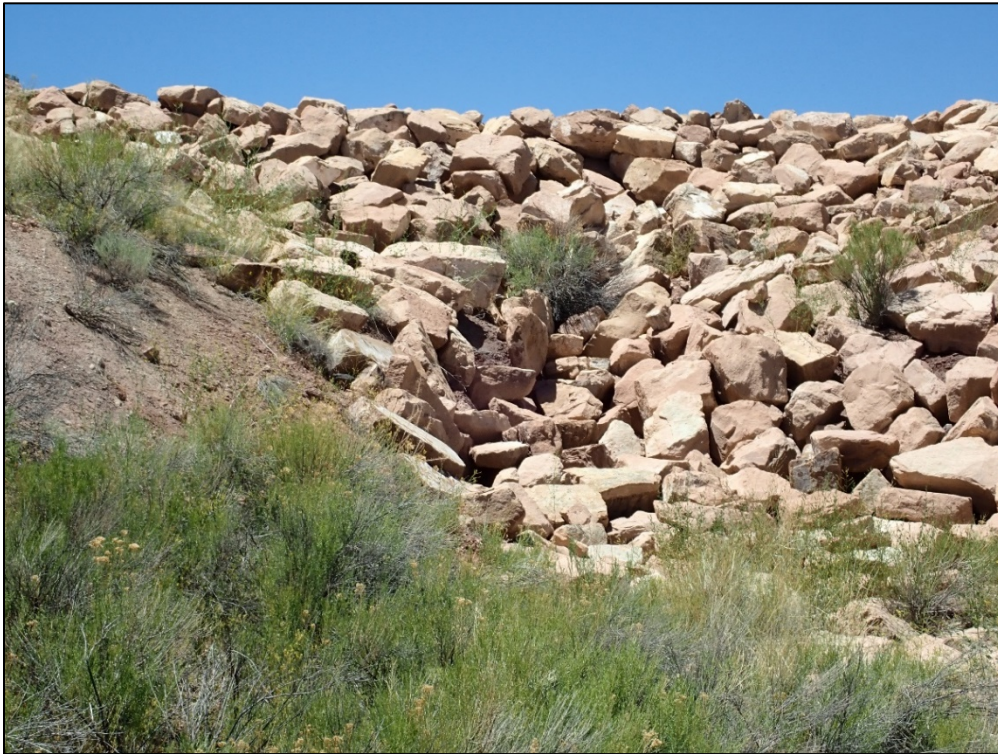
Headcutting erosion identified during the 2019 inspection within the spillway channel below the sedimentation pond on the outlying area northwest of the site (PL-9) continues to show signs of erosion within the channel. Sedimentation from this area appears to be deposited in the interceptor channel but does not pose a problem at this time. Inspectors will continue to monitor this area for ongoing erosion and resulting impacts, if any.

PL-9. Spillway Above Interceptor Channel
