## 16.0 Shiprock, New Mexico, Disposal Site

### 16.1 Compliance Summary

The Shiprock, New Mexico, Uranium Mill Tailings Radiation Control Act (UMTRCA) Title I Disposal Site (site) was inspected on October 13, 2020. No changes were observed on the disposal cell or in the associated diversion channels. Inspectors identified several minor maintenance needs but found no cause for a follow-up inspection. Groundwater monitoring to evaluate disposal cell performance is not required.

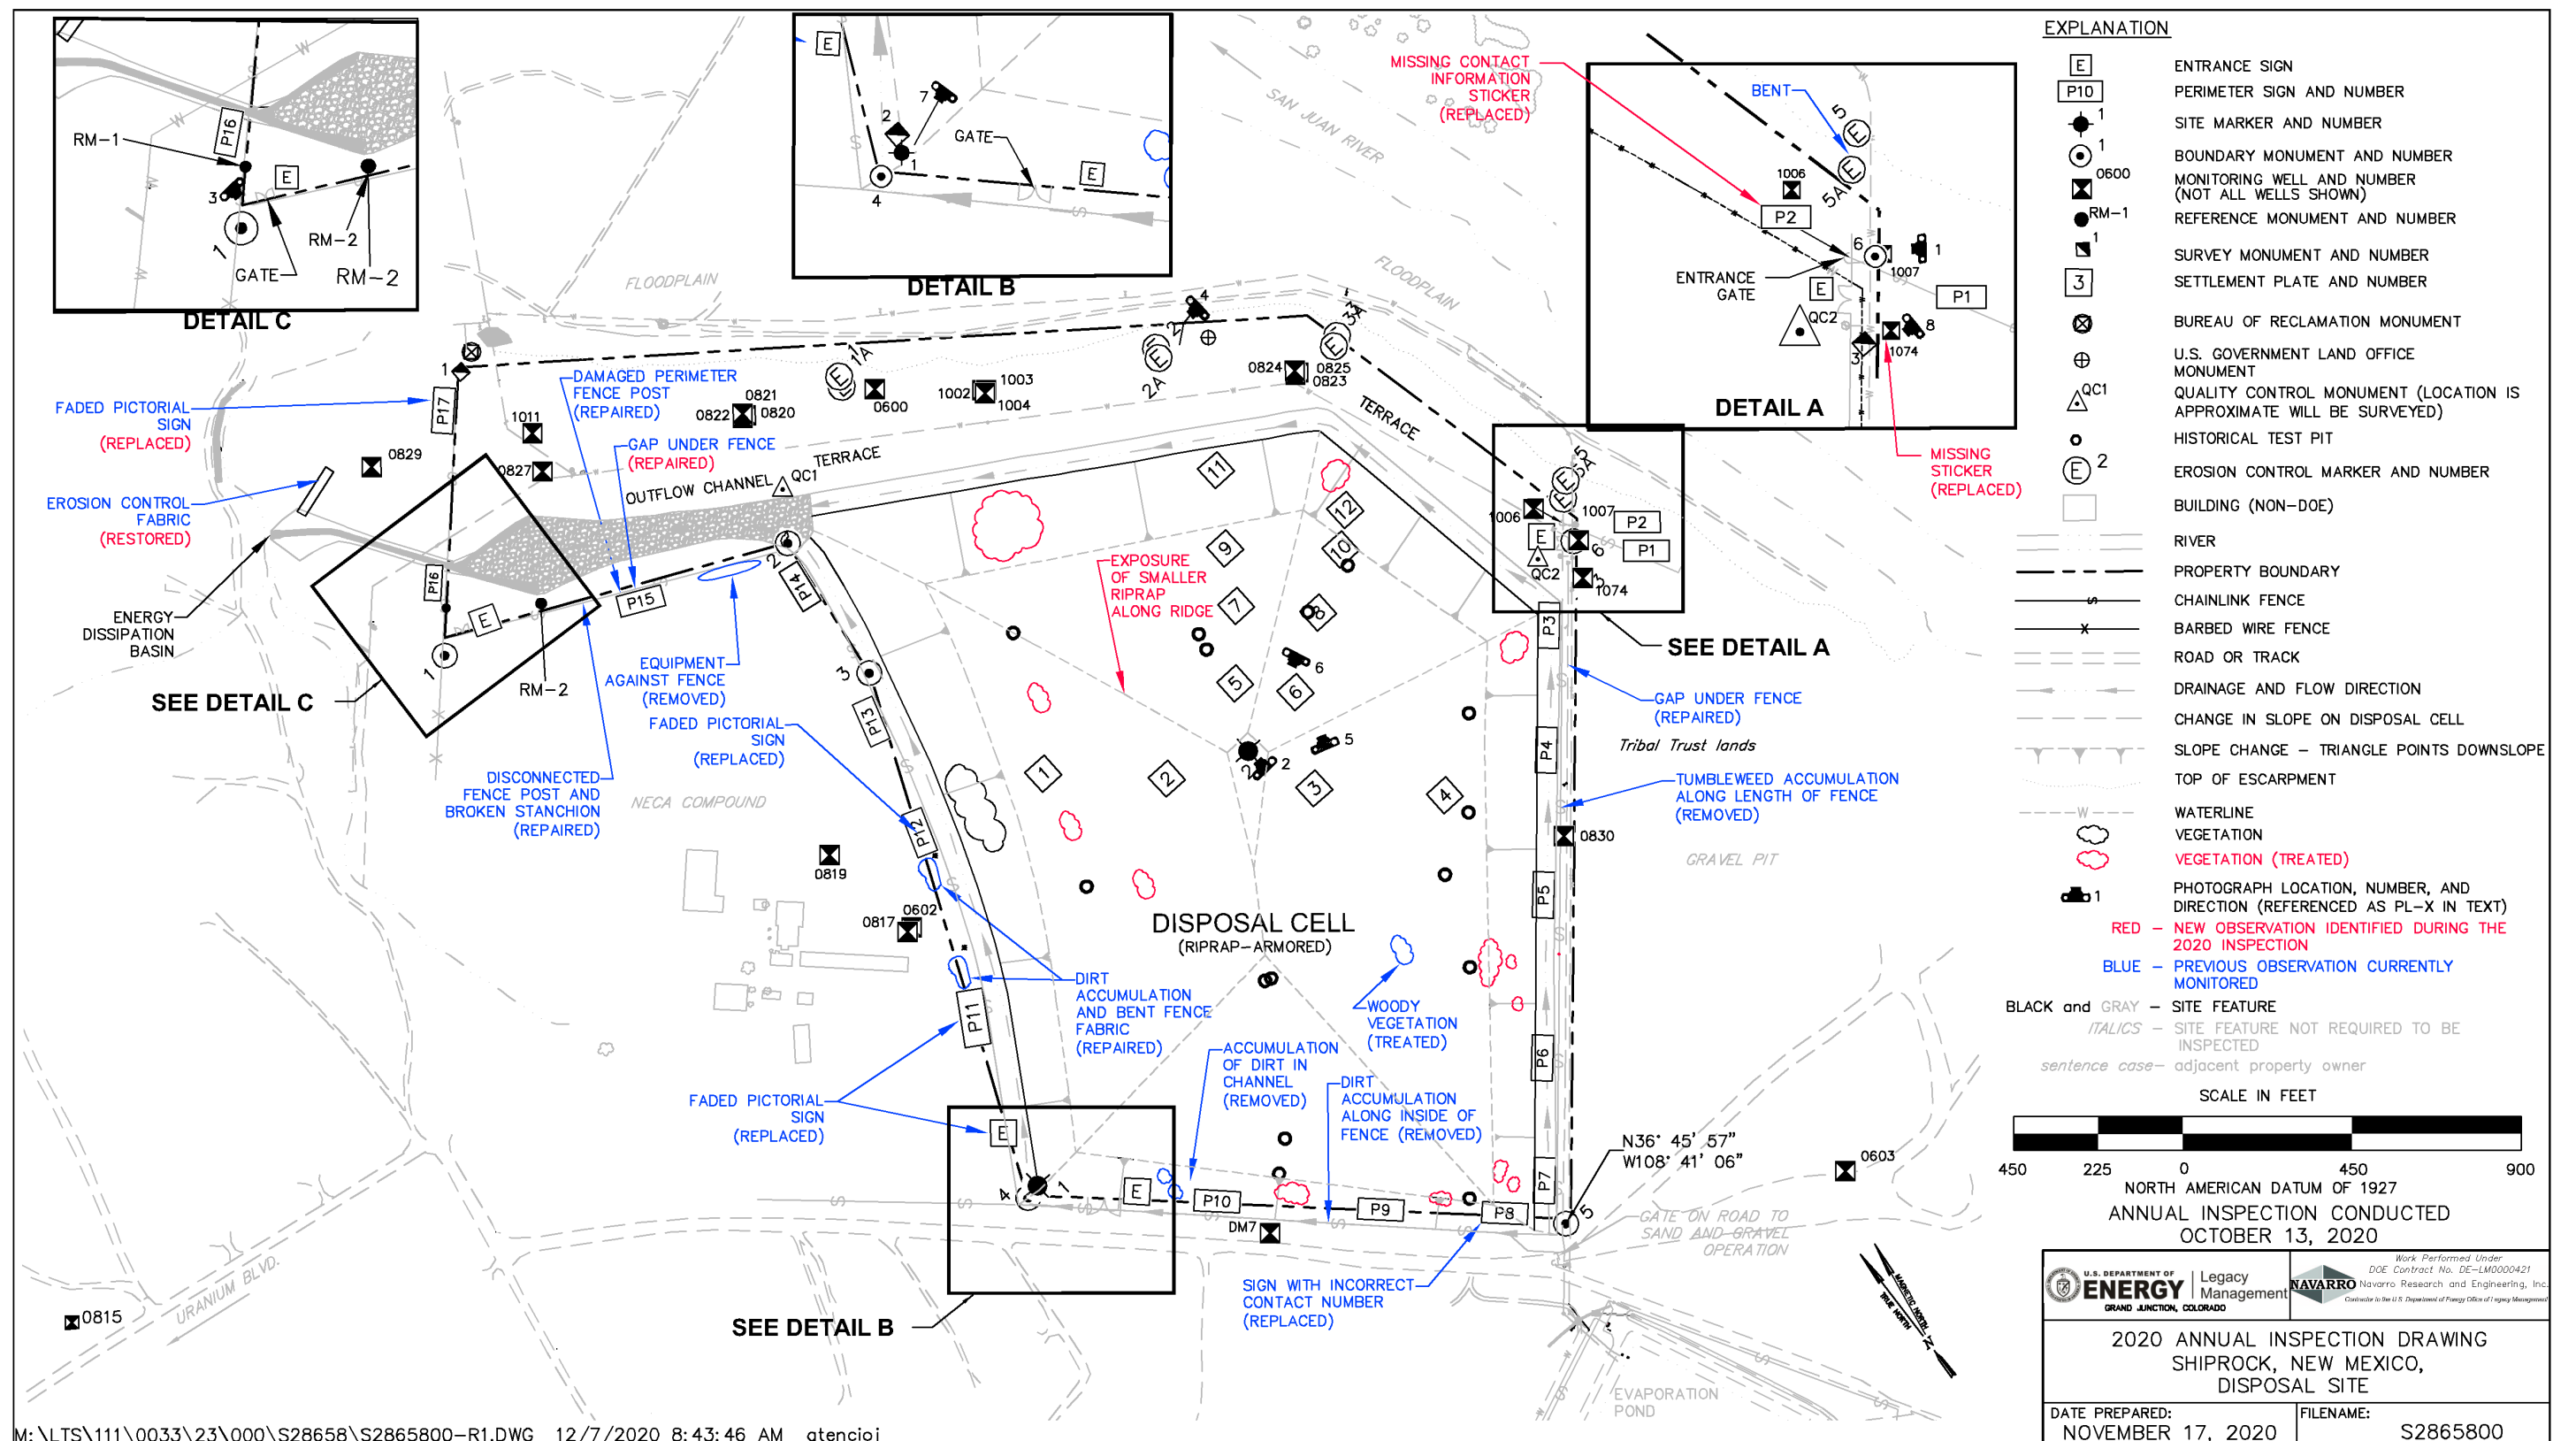
Figure 16-1. 2020 Annual Inspection Drawing for the Shiprock, New Mexico, Disposal Site

Figure 16-1 shows the locations of site features in black and gray font, including site surveillance features and inspection areas. Site features that are present but not required to be inspected are shown in italic font. Observations from previous inspections that are currently monitored are shown in blue text, and new observations identified during the 2020 annual inspection are shown in red. Inspection results and recommended maintenance activities associated with site surveillance features are included in the following subsections. Photographs to support specific observations are identified in the text and in Figure 16-1 by photograph location (PL) numbers. The photographs and photograph log are presented in Section 16.10.

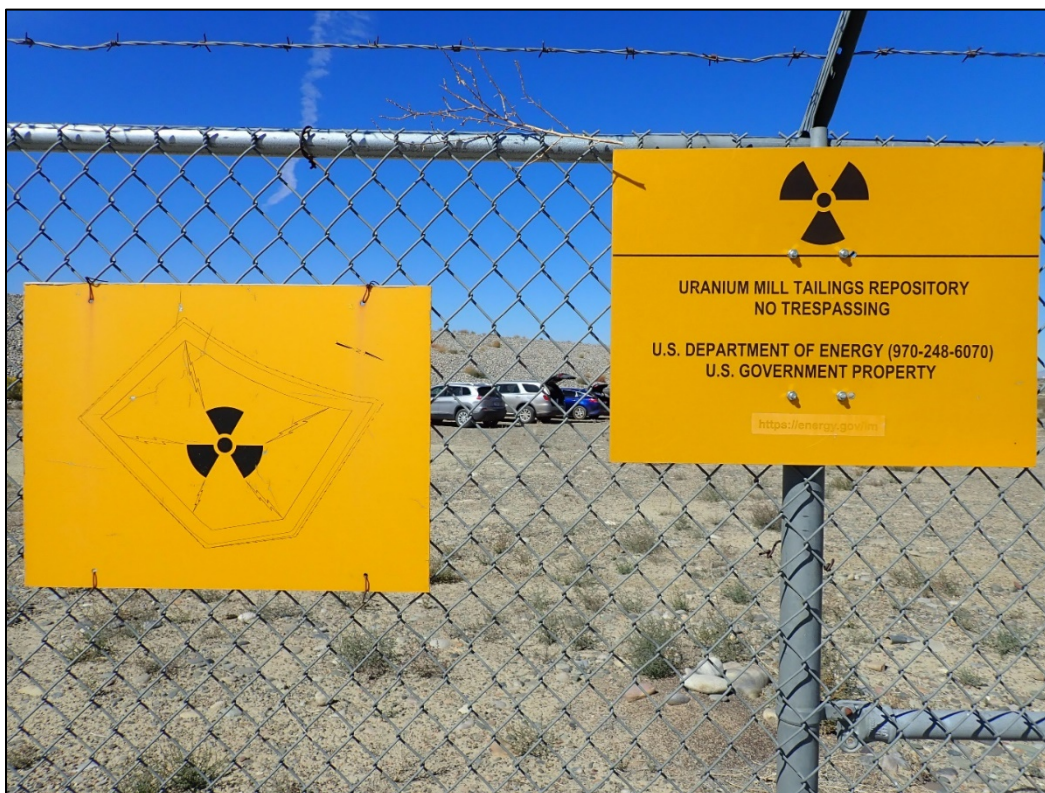
There are 17 pairs of perimeter signs, designated P1 through P17 (each pair consisting of one pictorial and one textual sign), positioned along the perimeter fence.<sup>1</sup> The pictorial signs near the southwestern entrance sign and perimeter signs P11, P12, and P17, replaced in 2019, were observed to be in good condition during the 2020 inspection. Perimeter sign P2 was observed to have a faded contact information sticker, which was replaced following the inspection (PL-1). No other maintenance needs were identified.

*PL-1. Pictorial Sign and Perimeter Sign P2 with Faded Information*

- Replacing the missing stickers on monitoring well 1074
- Replacing a faded sticker containing contact information on perimeter sign P2

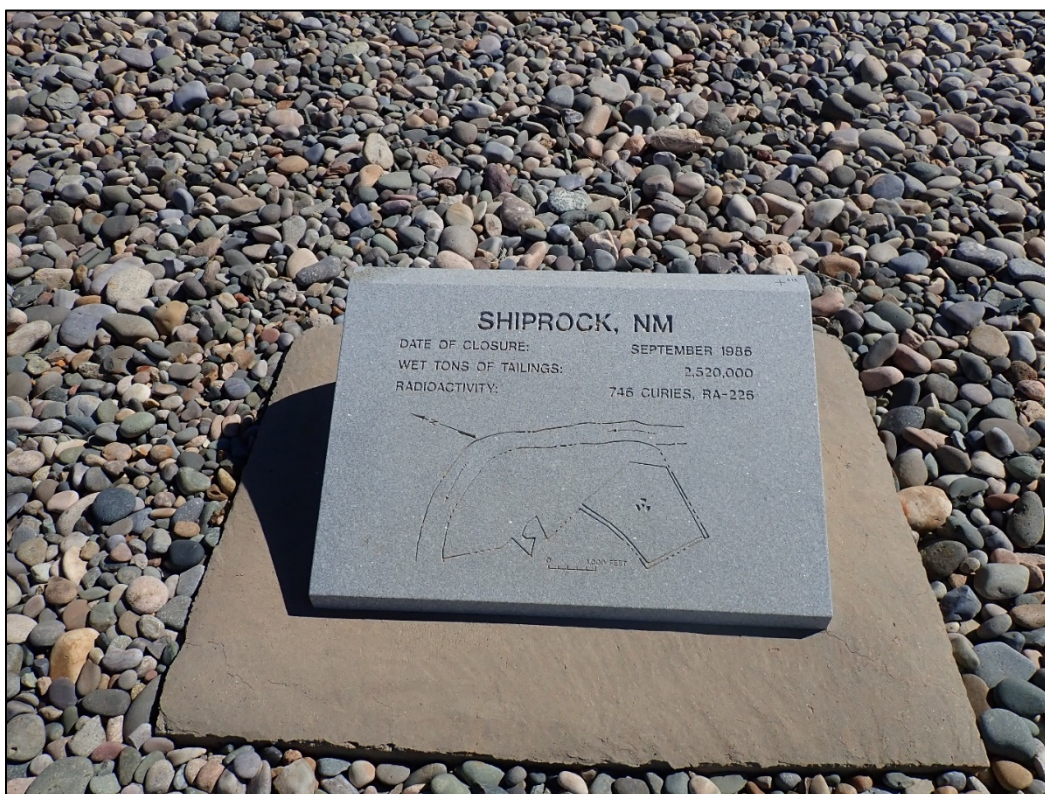
The site has two granite site markers. Site marker SMK-1 is just inside the west gate; minor cracks in its concrete base were resealed in 2018. Site marker SMK-2 (PL-2) is on the top slope of the disposal cell. No maintenance needs were identified.

*PL-2. Site Marker SMK-2*

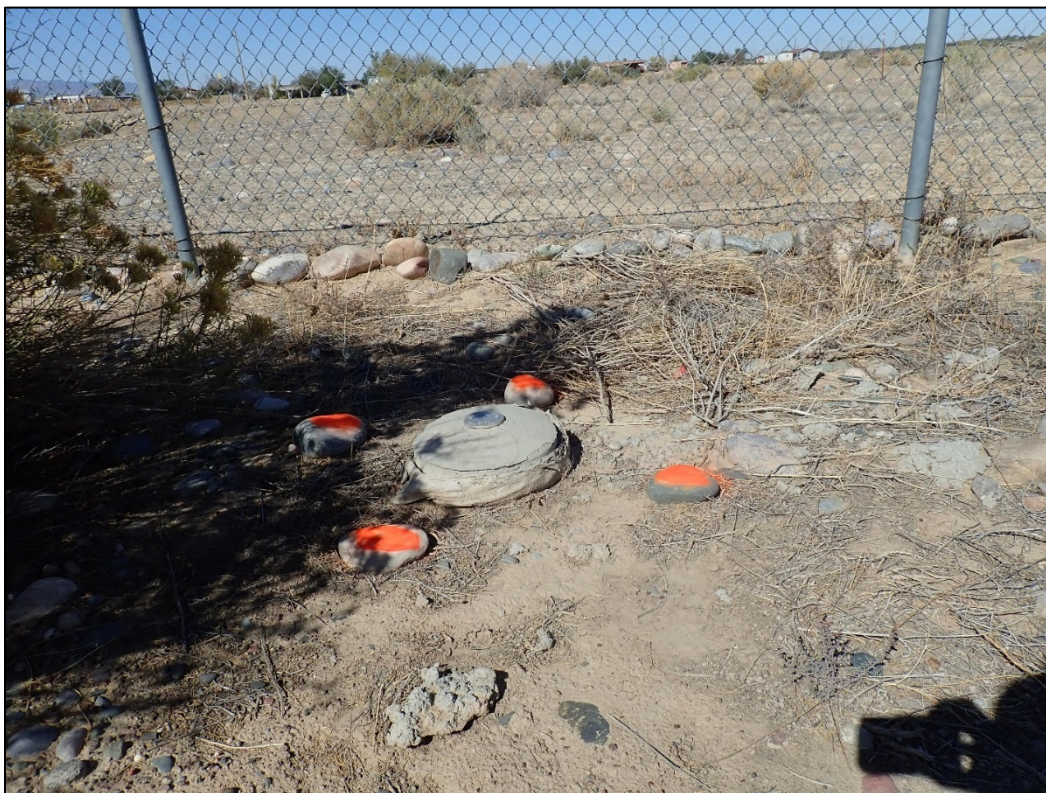
Three survey monuments and six boundary monuments delineate the property boundary. Two additional boundary monuments are offsite; monitoring of these monuments was discontinued in 1999 and 2003. Steel T-posts were installed next to all boundary monuments to help inspectors locate the monuments. The site map was updated with the more recent coordinates for boundary monument BM-6, as resurveyed in 2018. Boundary monument BM-1 (PL-3) was identified within the Navajo Engineering and Construction Authority yard and the location was added to the site map following the inspection. The GPS coordinates were resurveyed in 2019 following the inspection. The concrete at survey monument SM-1 is cracked, but the crack does not threaten the integrity of the marker. All boundary monuments were observed to be clear of vegetation and were visible during the 2020 inspection. No maintenance needs were identified.

*PL-3. Boundary Monument BM-1*

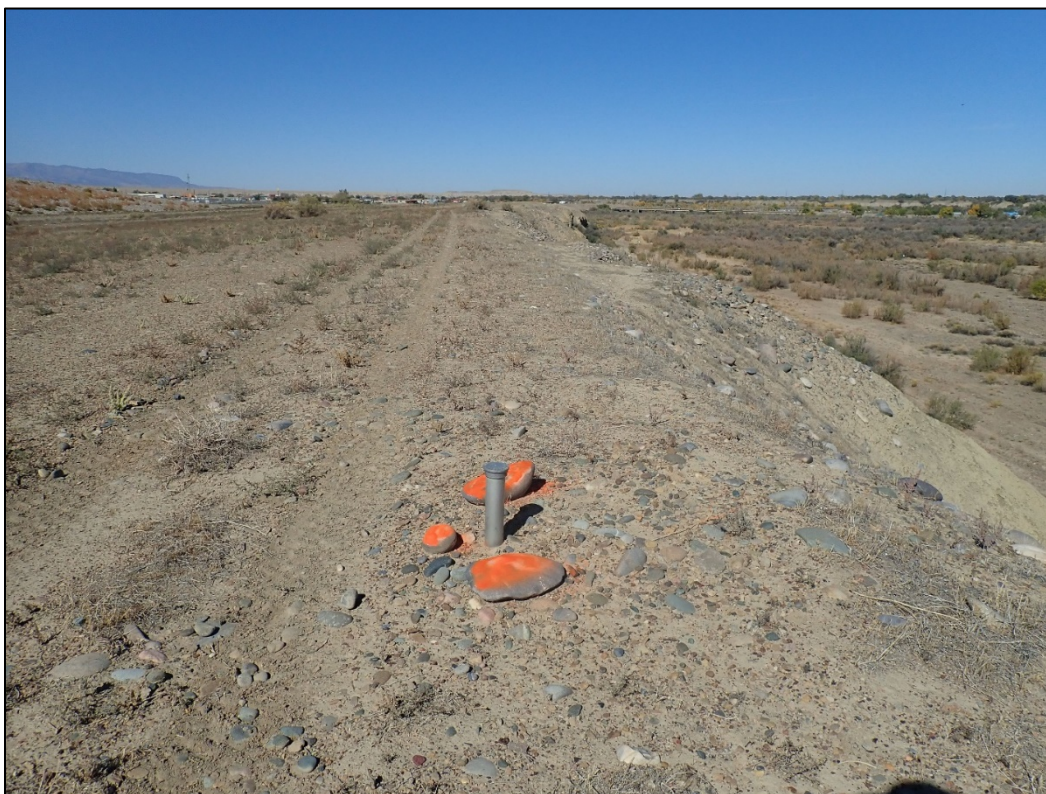
The site has four pairs of erosion control markers along the edge of the terrace escarpment (1/1A, 2/2A, 3/3A, and 5/5A) (PL-4). Erosion control markers 4 and 4A are not inspected; they were installed on the terrace east of the site in the gravel pit. Erosion control marker 5A, near the east entrance gate, was previously bent by a vehicle, but it is functional and does not require repair. No maintenance needs were identified.

*PL-4. Erosion Control Marker E-2*

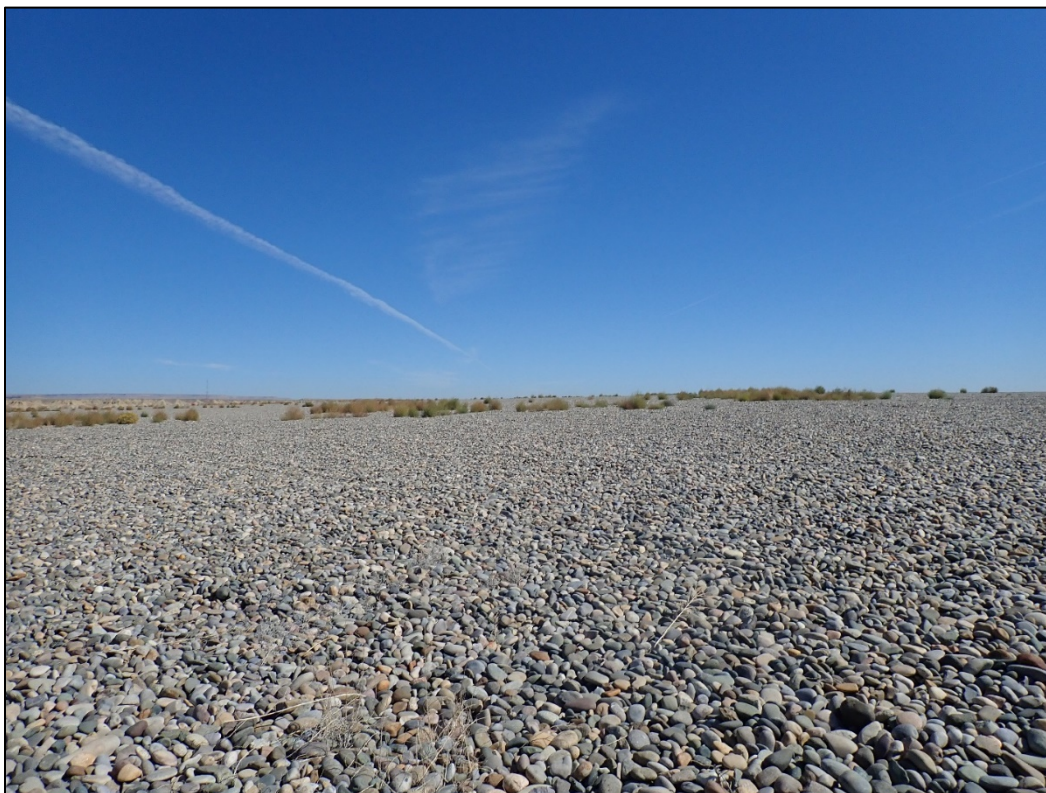
The disposal cell, completed in 1986, occupies 77 acres and is armored in riprap to control erosion and deter animal and human intrusion (PL-5). There was no evidence of erosion, settling, slumping, rock degradation, or other modifying processes that might affect the integrity of the disposal cell. Piezocones associated with a research project installed on the disposal cell cover in the past are no longer in use. Some of the filled piezocone pits have subsided slightly or were never completely backfilled, which resulted in shallow conical depressions in the cover. As reported in previous site inspection reports, the surface of the disposal cell contains numerous ruts associated with past vehicle traffic. An area where smaller riprap has been exposed was identified along the northern ridge of the disposal cell. This area will be monitored for further changes that might indicate erosion or degradation of the cover. The condition of other depressions and vehicle ruts is monitored annually and has not changed significantly since the 2014 inspection.

*PL-5. Disposal Cell Top Slope*

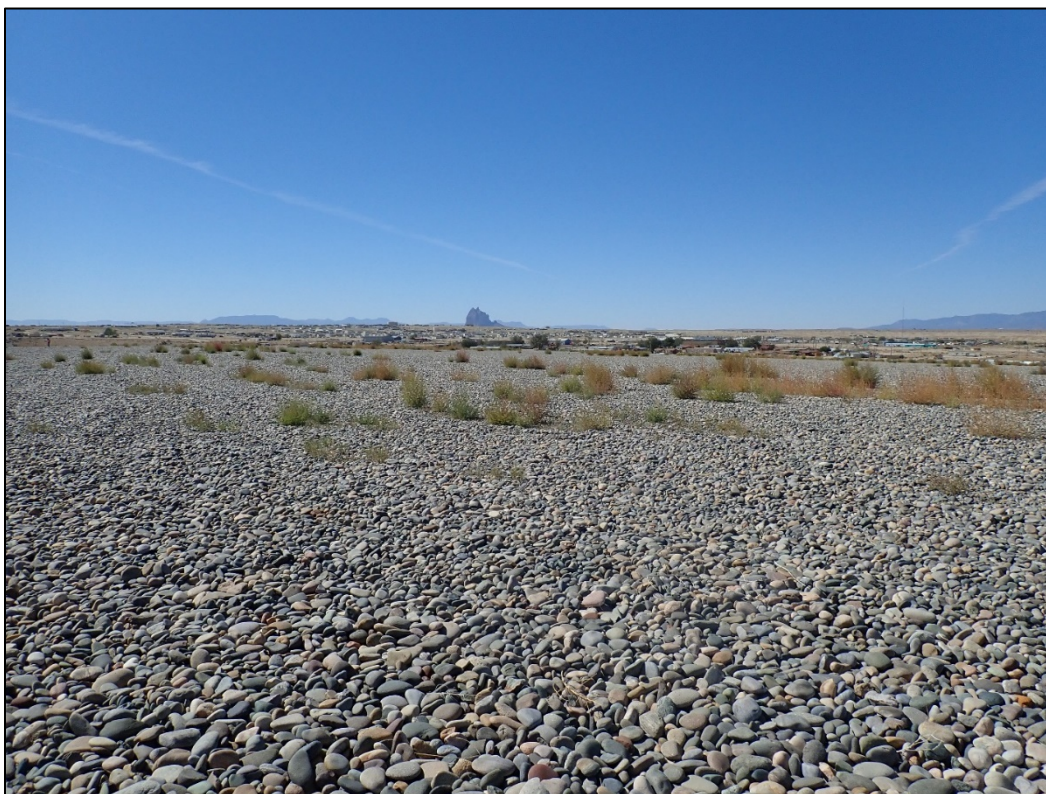
Windblown sediment has accumulated in the rock cover in several places. In accordance with the LTSP, woody, deep-rooted shrubs are controlled. Numerous woody shrubs found on the top and side slopes of the disposal cell (PL-6) were treated in 2020 before the inspection.

*PL-6. Disposal Cell Top Slope with Growing Vegetation*

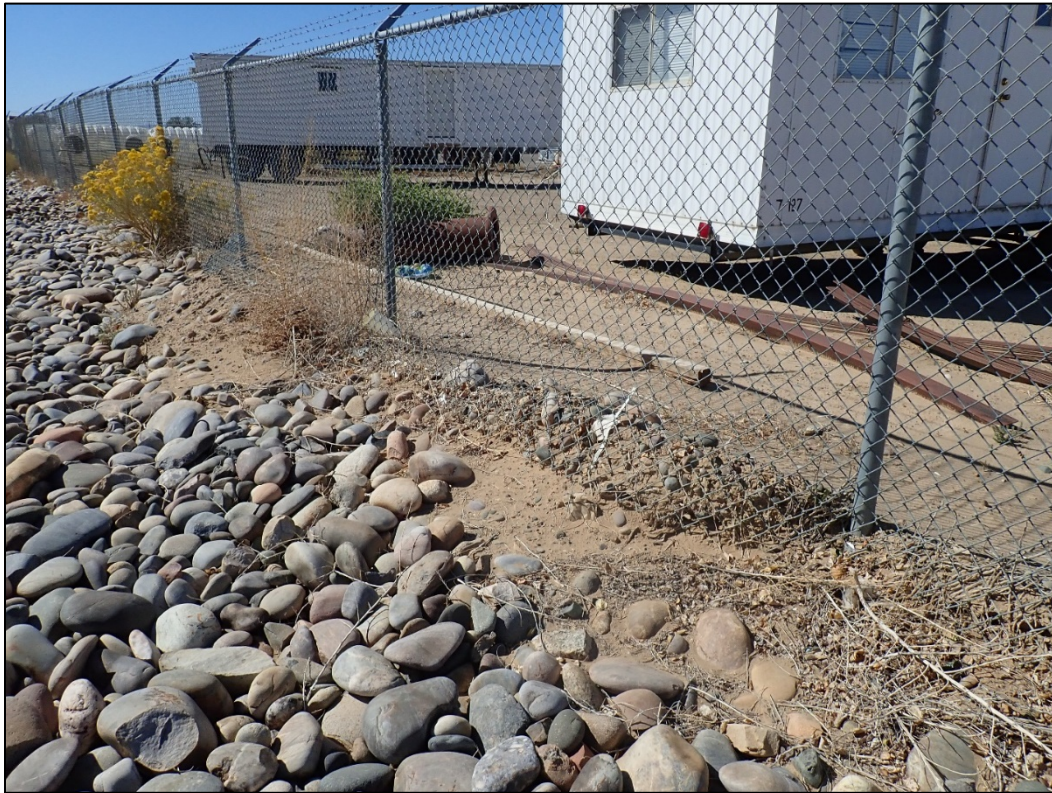
Diversion channels around the base of the disposal cell contained scattered vegetation, including several woody shrubs. The channel along the southwestern side of the disposal cell has accumulated sediment, and a significant amount of vegetation has grown (PL-7). It is possible that the sediment was generated from the maintenance of the road adjacent to the perimeter fence and has settled in the bottom of the channel. These shrubs do not adversely affect the performance of the diversion channel at this time and are not a concern, but they will continue to be monitored. Nonwoody plants were growing within the outflow channel, and woody vegetation was growing on the banks of the channel. No other maintenance needs were identified.

*PL-7. Sediment Accumulation Near Southwest Fence Line*

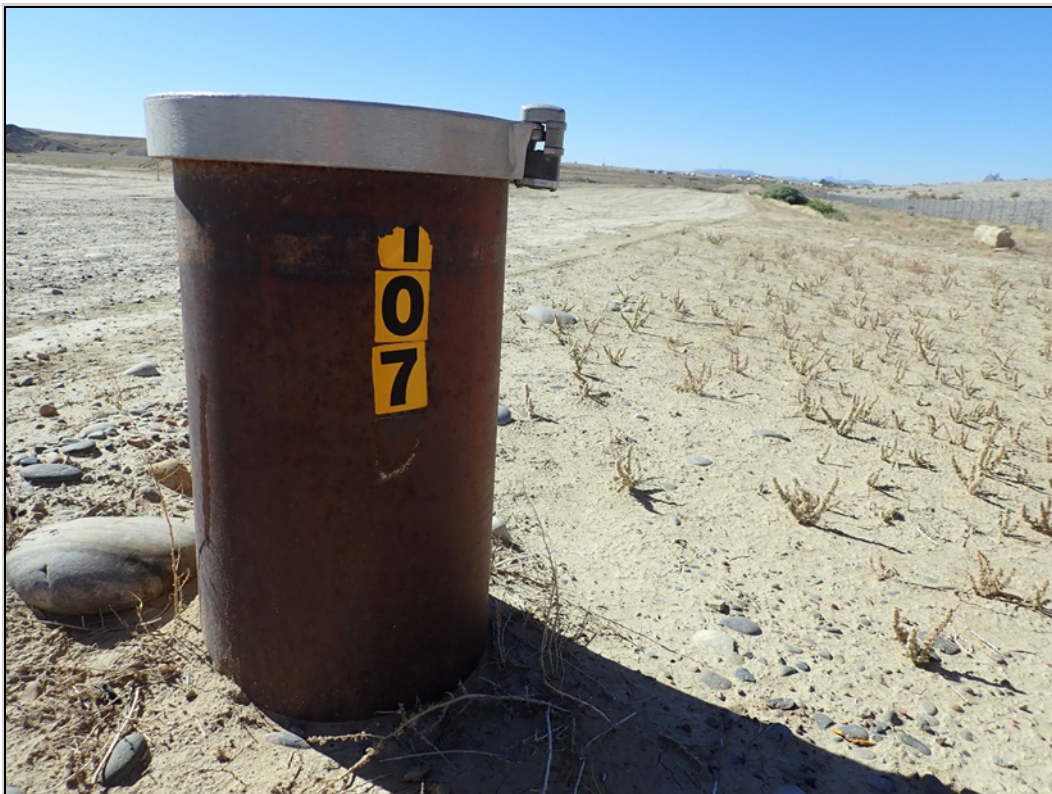
The terrace area is north and northeast of the disposal cell along the top of a steep escarpment. Other than annual weeds, little vegetation grows on the terrace. The edge of the escarpment varies between 175 and 345 feet from the base of the disposal cell and is prone to slumping. No new significant erosion was evident during the inspection in 2020. The LTSP states that the base of the terrace escarpment should be inspected for signs of seepage, and seeps were identified during early site inspections. However, this is no longer part of annual inspection, procedures as the seeps are now monitored as part of the groundwater compliance program for the site. Monitoring well 1074 was observed to be missing a No. 4 ID sticker, and the No. 1 ID sticker was damaged (PL-8). These stickers were replaced following the 2020 inspection. No maintenance needs were identified.

*PL-8. Missing ID Stickers on Monitoring Well 1074*
