15.0 Salt Lake City, Utah, Disposal Site

15.1 Compliance Summary

Figure 15-1. 2020 Annual Inspection Drawing for the Salt Lake City, Utah, Disposal Site

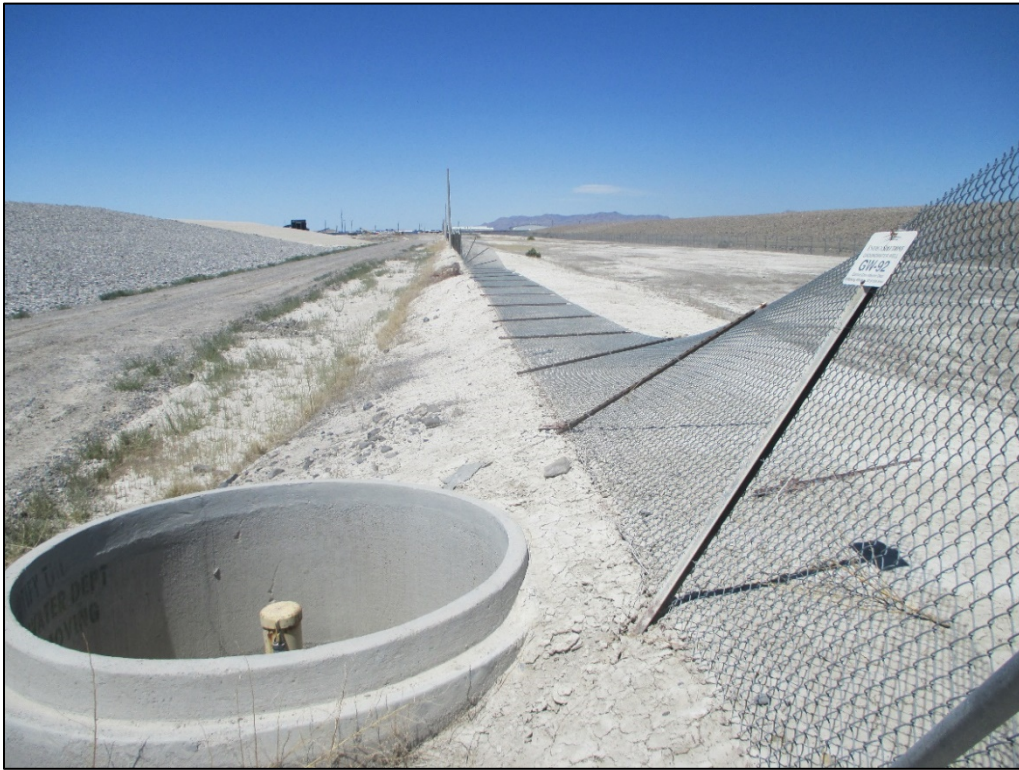
The site has two chainlink fences: the exterior EnergySolutions perimeter fence along the property boundary and the interior LM security fence that encloses the disposal cell and surface water diversion channels. There are 19 perimeter signs attached to the LM security fence. Perimeter sign P5 was observed to be damaged and broken and was replaced during the 2020 annual inspection. A section of the outer chainlink fence just north of Gate 64 was blown down (PL-1). EnergySolutions will repair the down section of fence in before the next inspection.

PL-1. EnergySolutions Fence Down

- Repair section of down fence just north of Gate 64

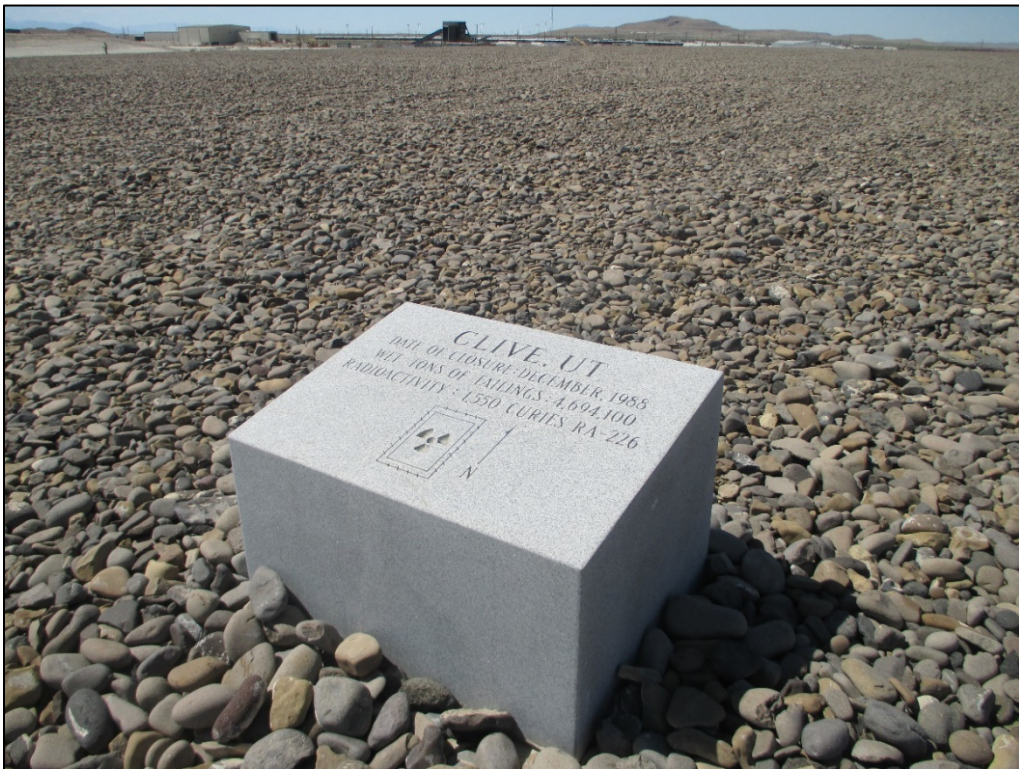
The site has two granite site markers. Site marker SMK-1 is just inside Gate 87 in the northwest corner of the site. Site marker SMK-2 is on the top slope of the disposal cell (PL-2). No maintenance needs were identified.

PL-2. Site Marker SMK-2

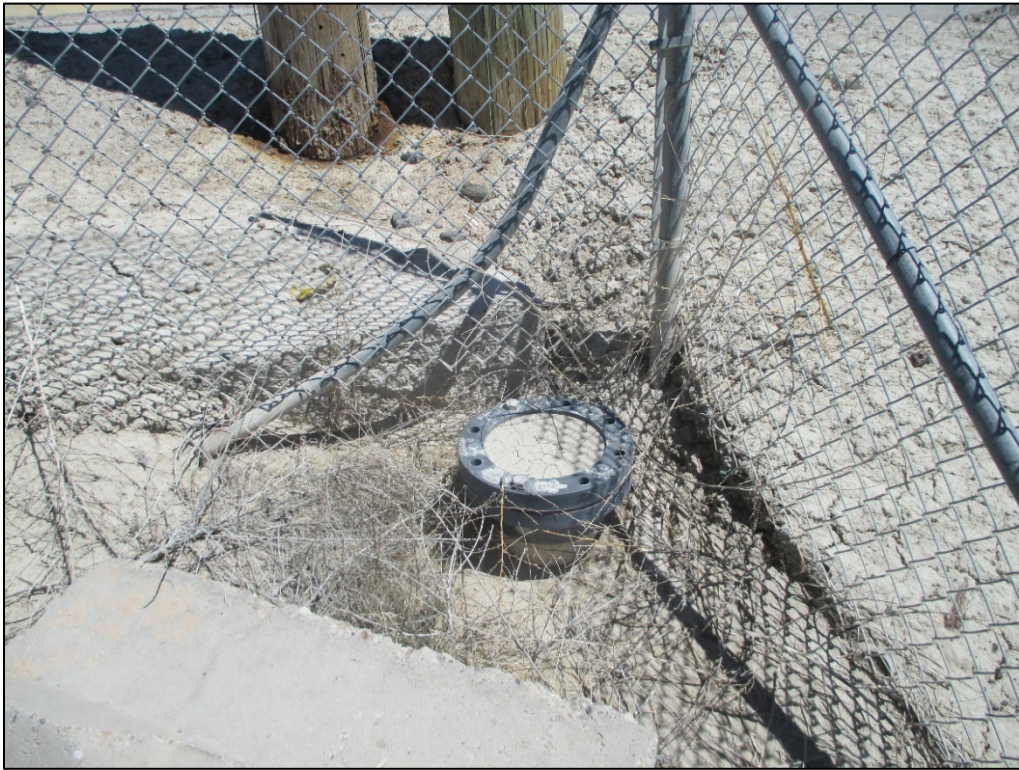
Four boundary monuments delineate the corners of the property boundary (boundary monuments BM-1 to BM-4). Protective casings that EnergySolutions installed over each boundary monument continue to protect the boundary monuments from damage by surrounding earthmoving activities (PL-3). No maintenance needs were identified.

PL-3. Protective Casing on Boundary Monument BM-3

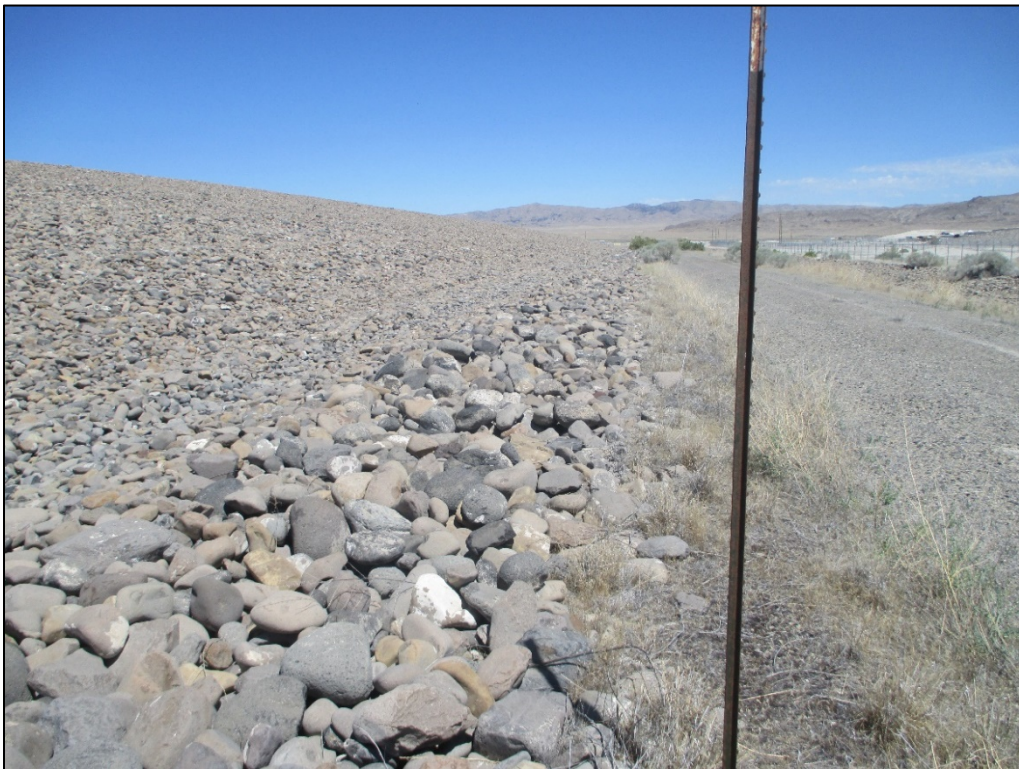
The disposal cell, completed in 1988, occupies 54 acres (PL-4). The disposal cell is armored with riprap to control erosion (PL-5 and PL-6). There were noticeable vehicle tracks on the east side slope of the disposal cell, but there was no evidence of erosion, settling, slumping, or other modifying processes that might affect the integrity of the disposal cell. No maintenance needs were identified.

PL-4. Disposal Cell, South Side Toe Drainage

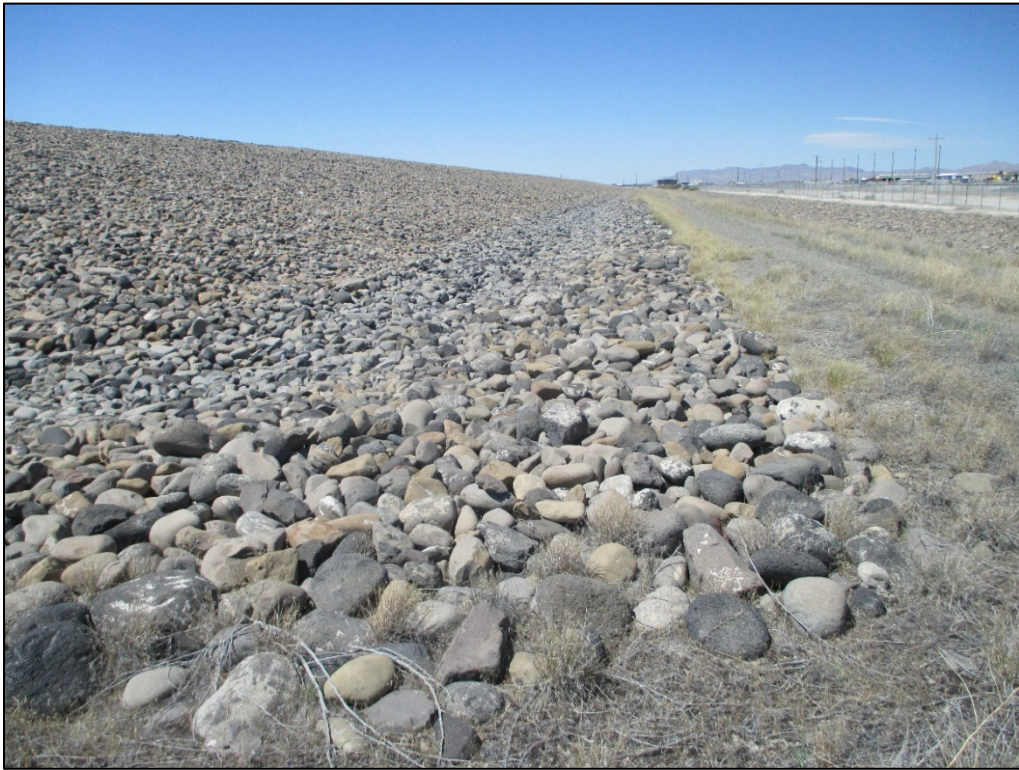
PL-5. Disposal Cell, East Side Toe Drainage

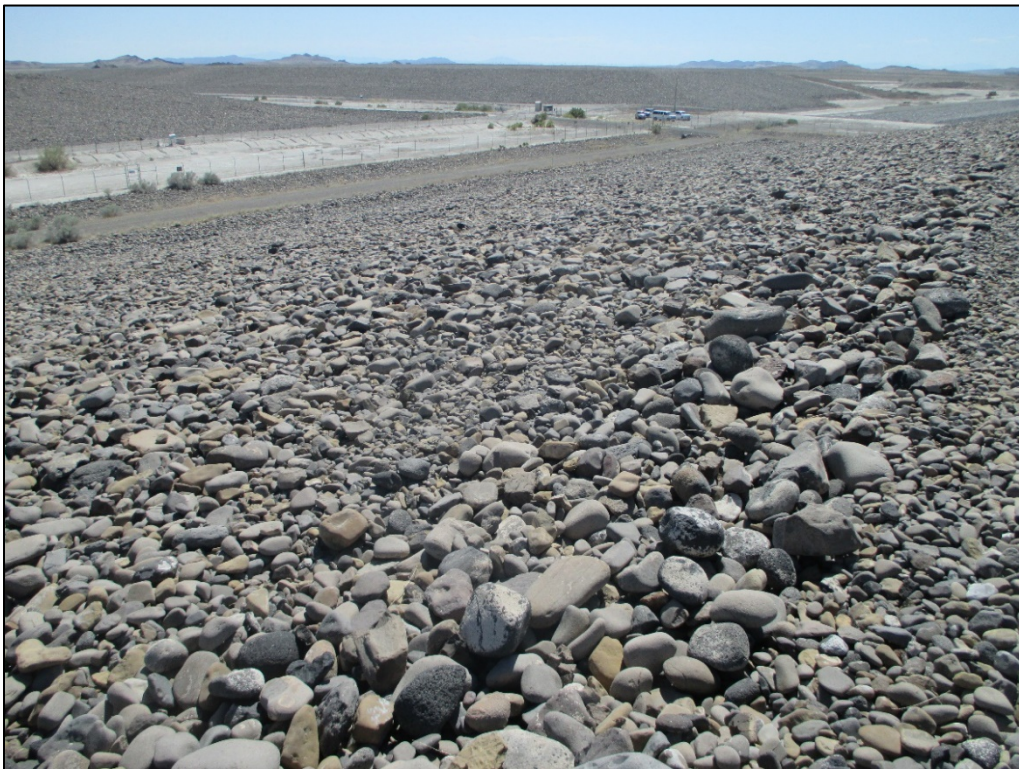
PL-6. Disposal Cell, West Side Apron

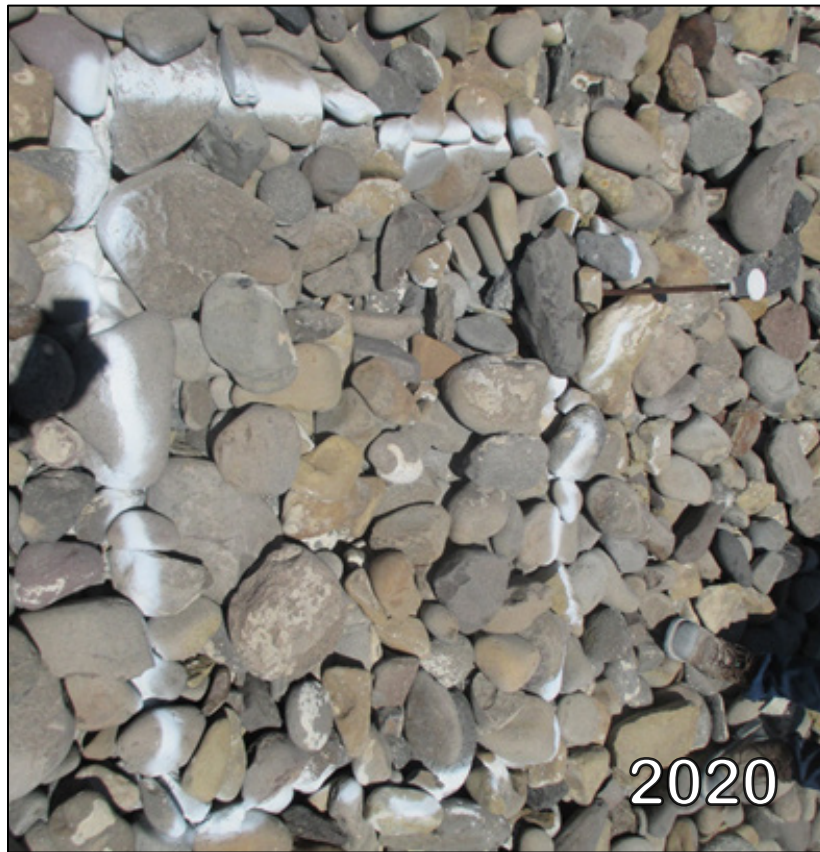
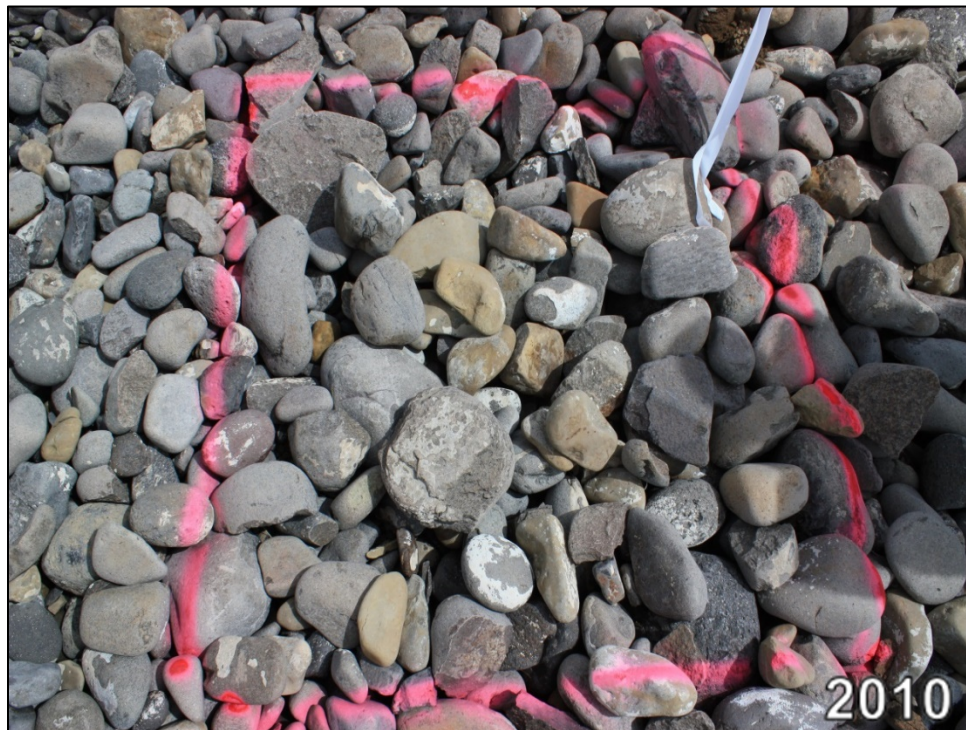
One of several types of rock used for the disposal cell erosion-protection riprap layer has exhibited minor degradation since the disposal cell was constructed. As a result, eight rock-quality monitoring plots, each measuring 1 square meter (indicated by Roman numerals I–VIII in Figure 15-1), were established in 2010 to monitor for continued rock degradation.

The rock type exhibiting degradation constitutes approximately 1%–10% of the riprap material; degradation of this less competent rock is thought to result from freeze-thaw weathering. Rock-quality monitoring plots are visually monitored and documented annually with photographs. Approximately 1%–10% of the rock in the plots exhibited signs of weathering during the 2020 annual inspection (PL-7 through PL-11), with no significant changes from the 2019 annual inspection. Comparisons to the initial 2010 rock-quality plot photographs indicate very little (if any) additional rock degradation since monitoring began. The minimal rock degradation observed to date has not reduced the effectiveness of the riprap cover. Rock-quality monitoring plots will continue to be visually monitored and documented annually with photographs to ensure that the riprap continues to protect the integrity of the disposal cell.

PL-7. (a) Rock Quality Plot No. 1—2020

PL-7. (b) Rock Quality Plot No. 1—2010 Photo for Comparison

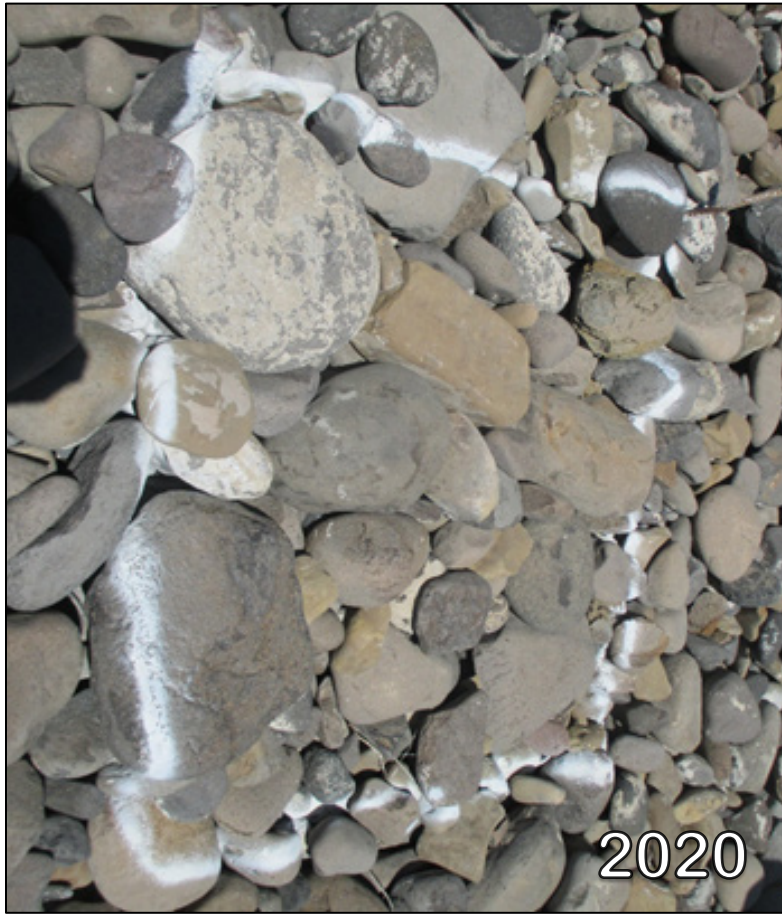
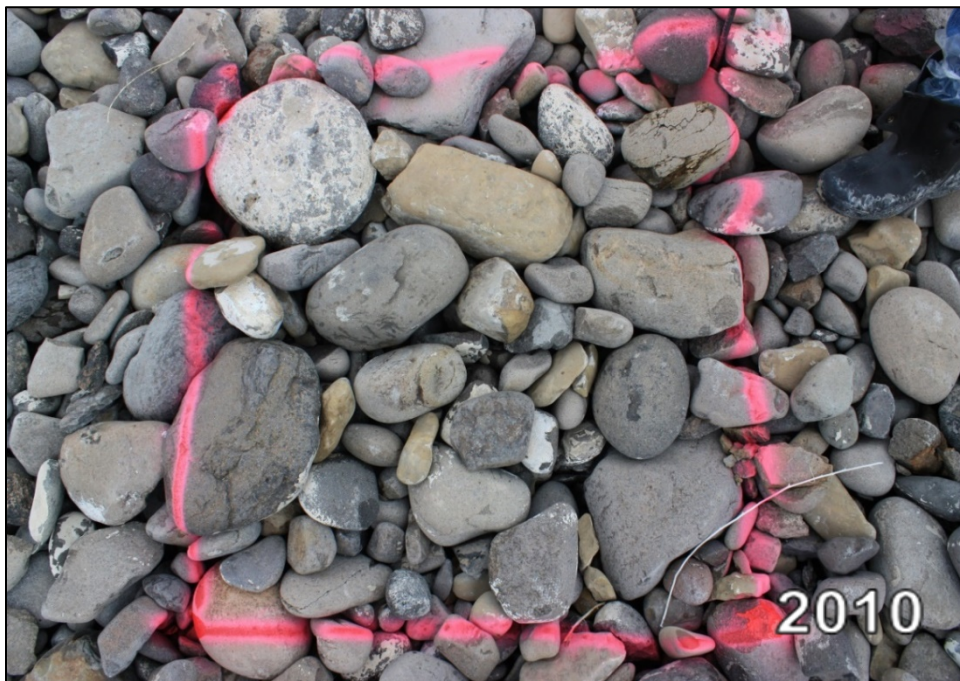
PL-8. (a) Rock Quality Plot No. II—2020

PL-8. (b) Rock Quality Plot No. II—2010 Photo for Comparison

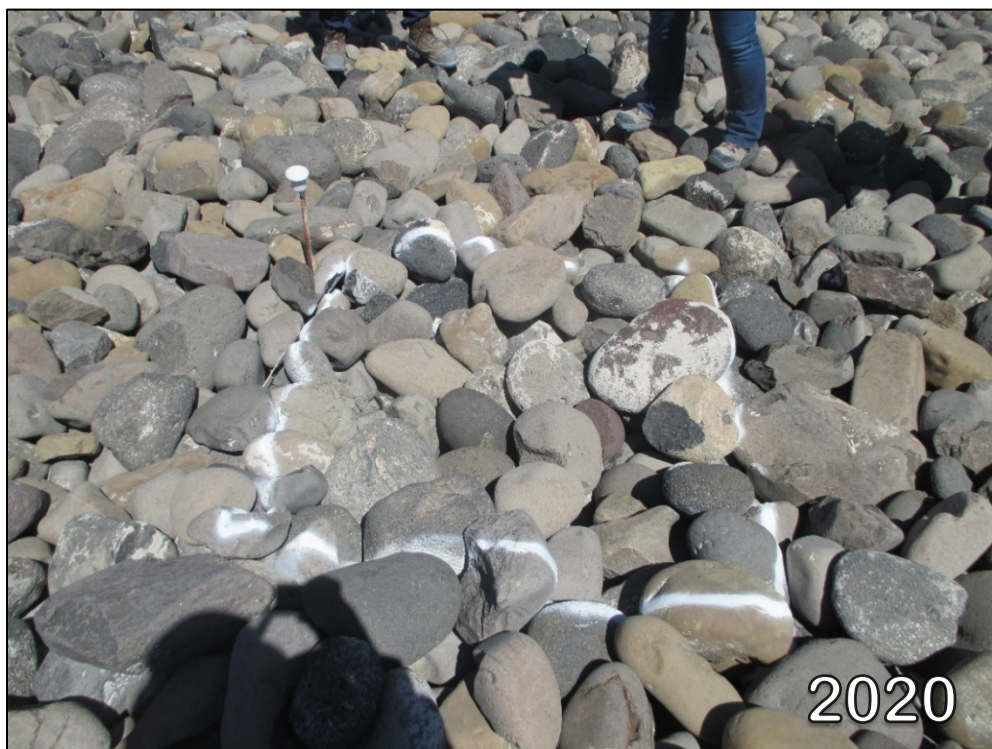
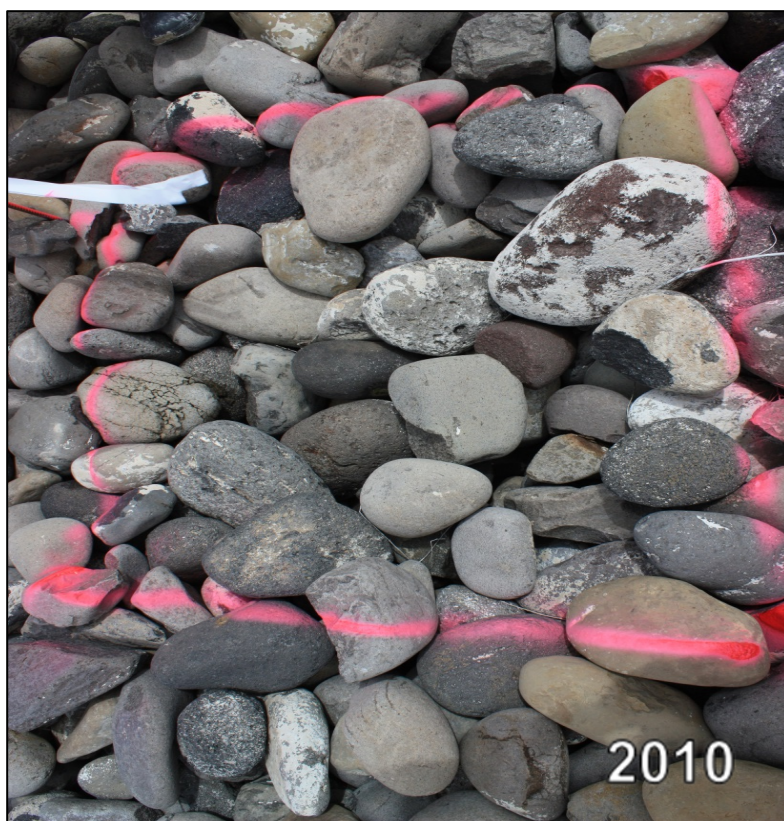
PL-9. (a) Rock Quality Plot No. III—2020

PL-9. (b) Rock Quality Plot No. III—2010 Photo for Comparison

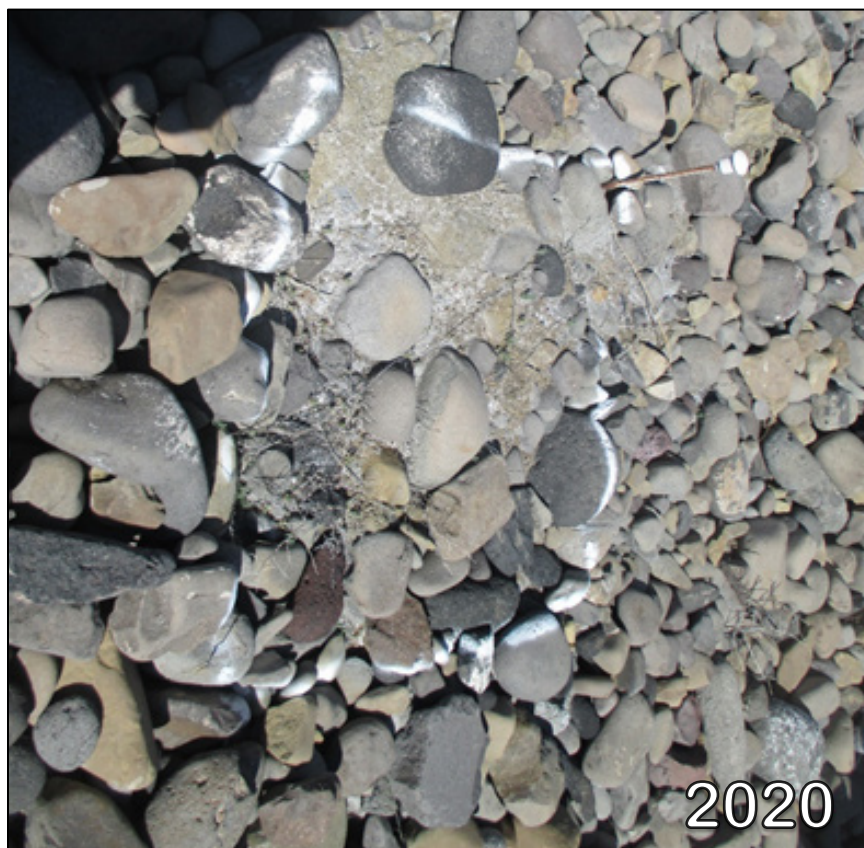
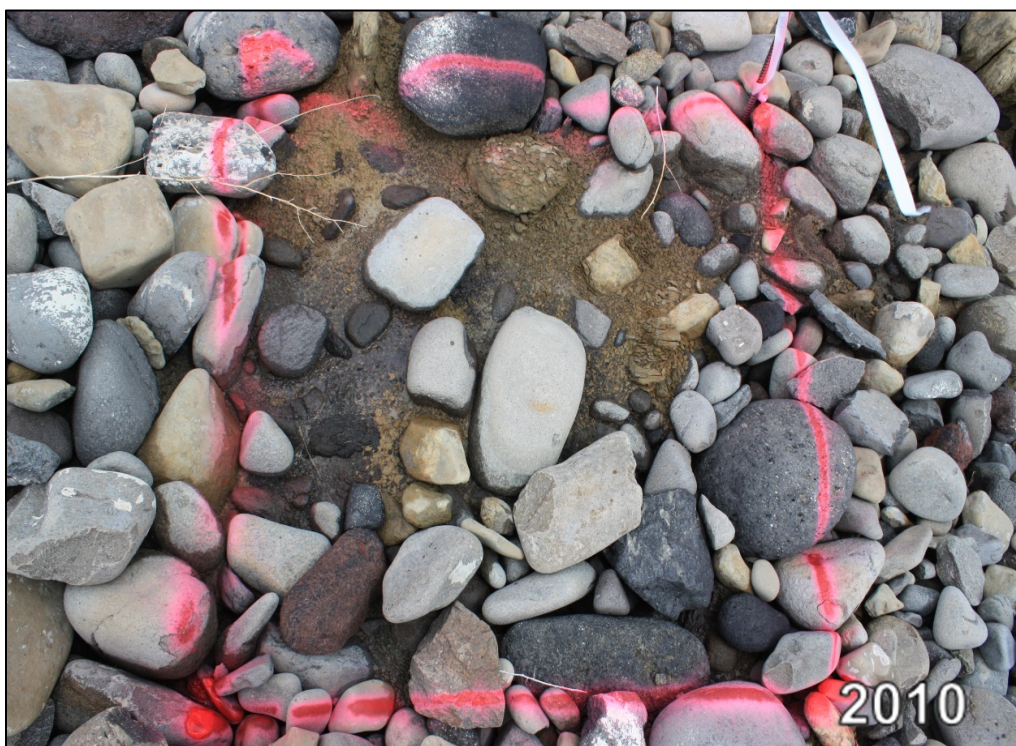
PL-10. (a) Rock Quality Plot No. IV—2020

PL-10. (b) Rock Quality Plot No. IV—2010 Photo for Comparison

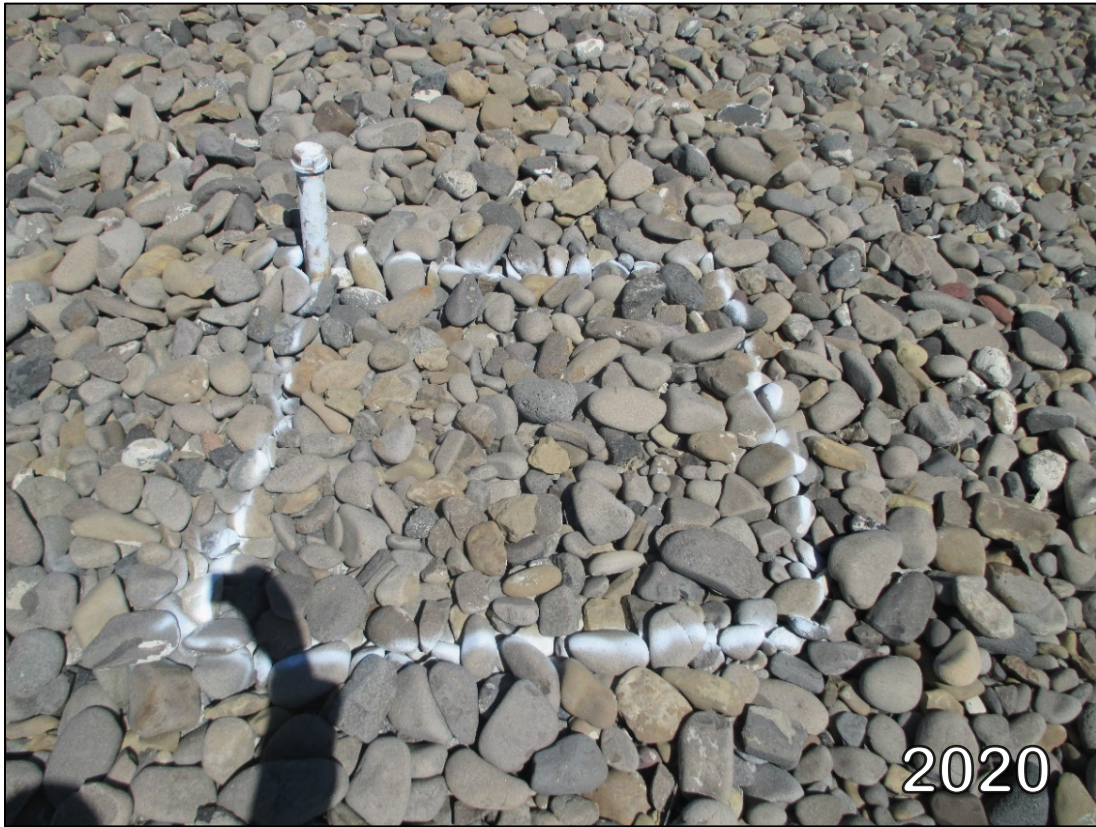
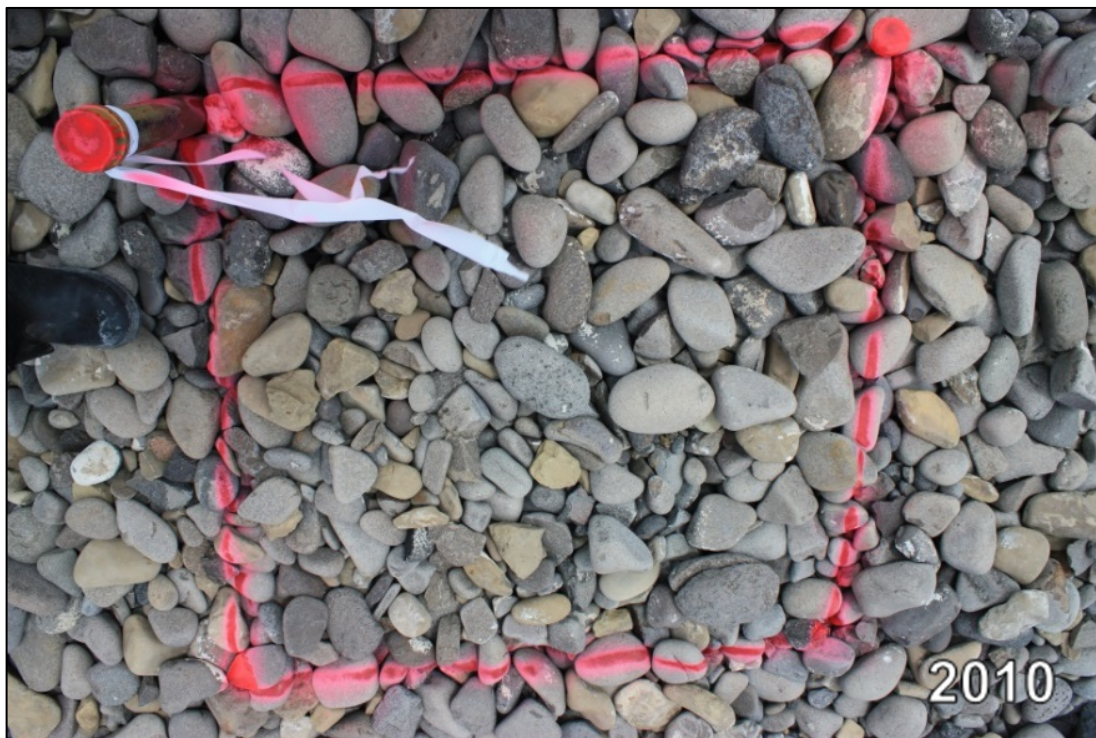
PL-11. (a) Rock Quality Plot No. VII—2020

PL-11. (b) Rock Quality Plot No. VII—2010 Photo for Comparison

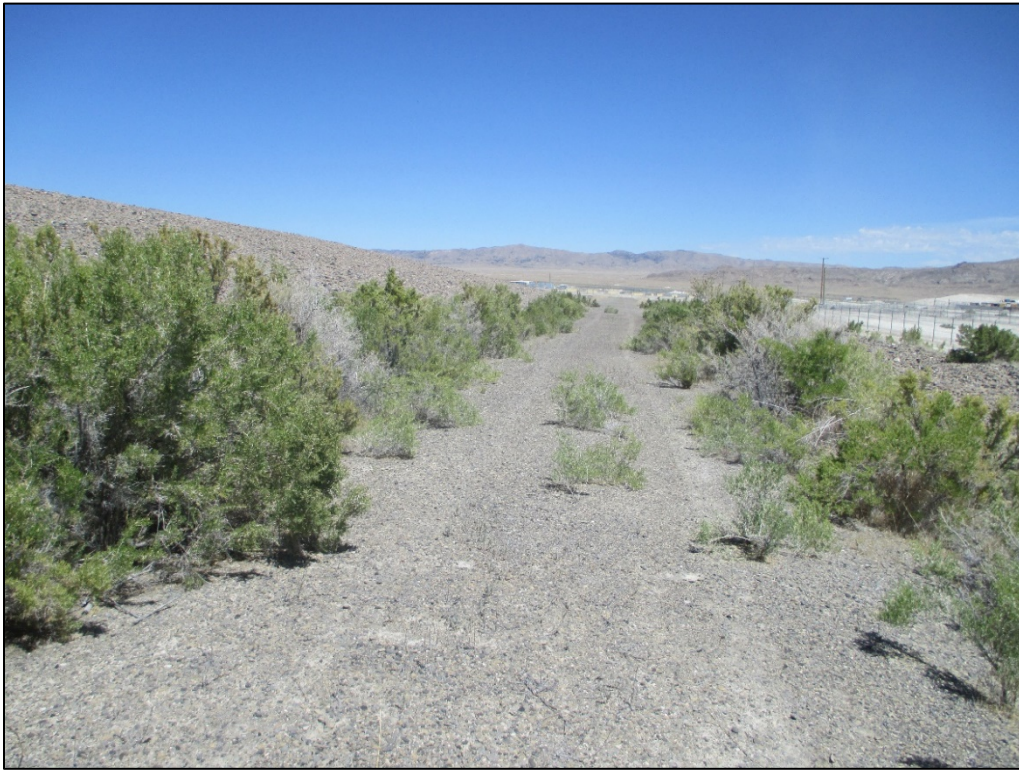
Inspectors examined the area between the toe of the disposal cell and the EnergySolutions security fence on the property boundary. No evidence of erosion was observed. Vegetation continues to encroach along the access road (PL-12), but the road remains functional, and no maintenance is required.

PL-12. Vegetation on Cell Perimeter Road

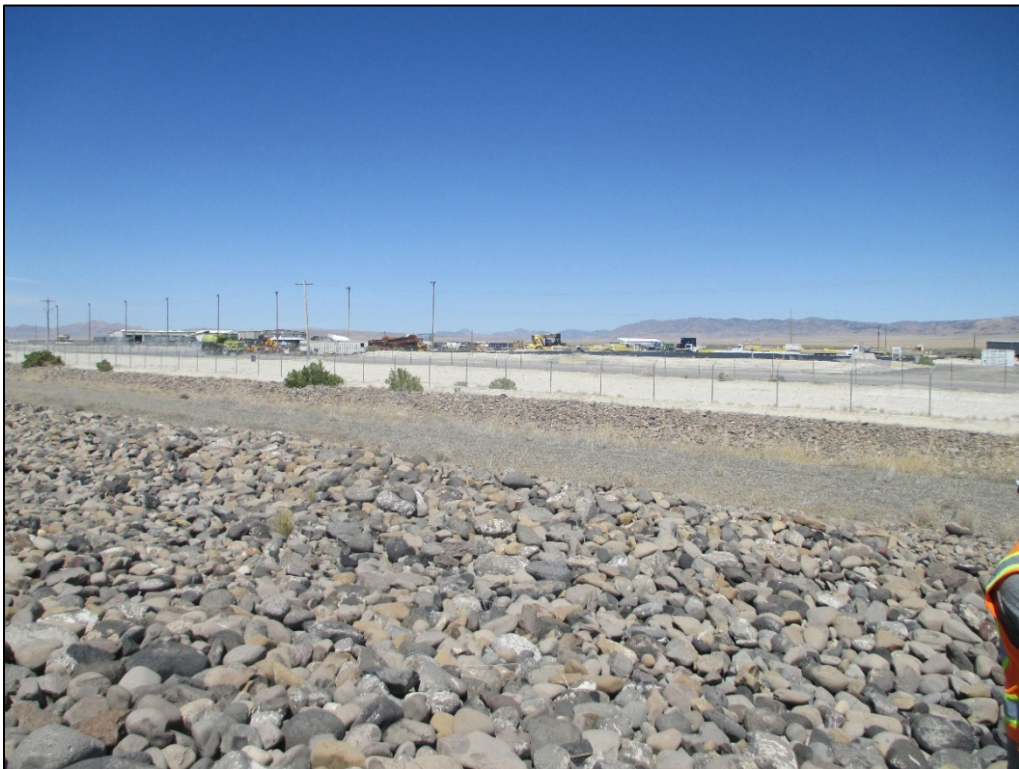
A variety of features and ongoing waste disposal activities that are managed by EnergySolutions surround the site (PL-13). The most obvious waste disposal activities are occurring directly west of the site where a Class A (i.e., low-level radioactive waste) disposal cell is being capped. On the northeast and east sides of the site, incoming wastes are unloaded from railcars and transferred to haul trucks; decontamination facilities are also present. Directly to the south is a completed low-level radioactive waste disposal cell, to the southwest is a waste disposal cell containing Atomic Energy Act Section 11e.(2) byproduct material, and to the southeast is an operating mixed-waste treatment and disposal facility. Administration, security, and maintenance buildings lie directly north-northwest of the site. A shredding facility, rotary dump, and railroad spur delivery loop are northwest of the site. These adjacent operations and facilities are not affecting the site.

PL-13. EnergySolutions Facility
