18.0 Spook, Wyoming, Disposal Site

18.1 Compliance Summary

The Spook, Wyoming, Uranium Mill Tailings Radiation Control Act (UMTRCA) Title I Disposal Site (site) was inspected on July 14, 2020. No changes were observed on the land surface of the disposal cell. Inspectors identified no maintenance needs and found no cause for a follow-up or contingency inspection. Groundwater monitoring is not required.

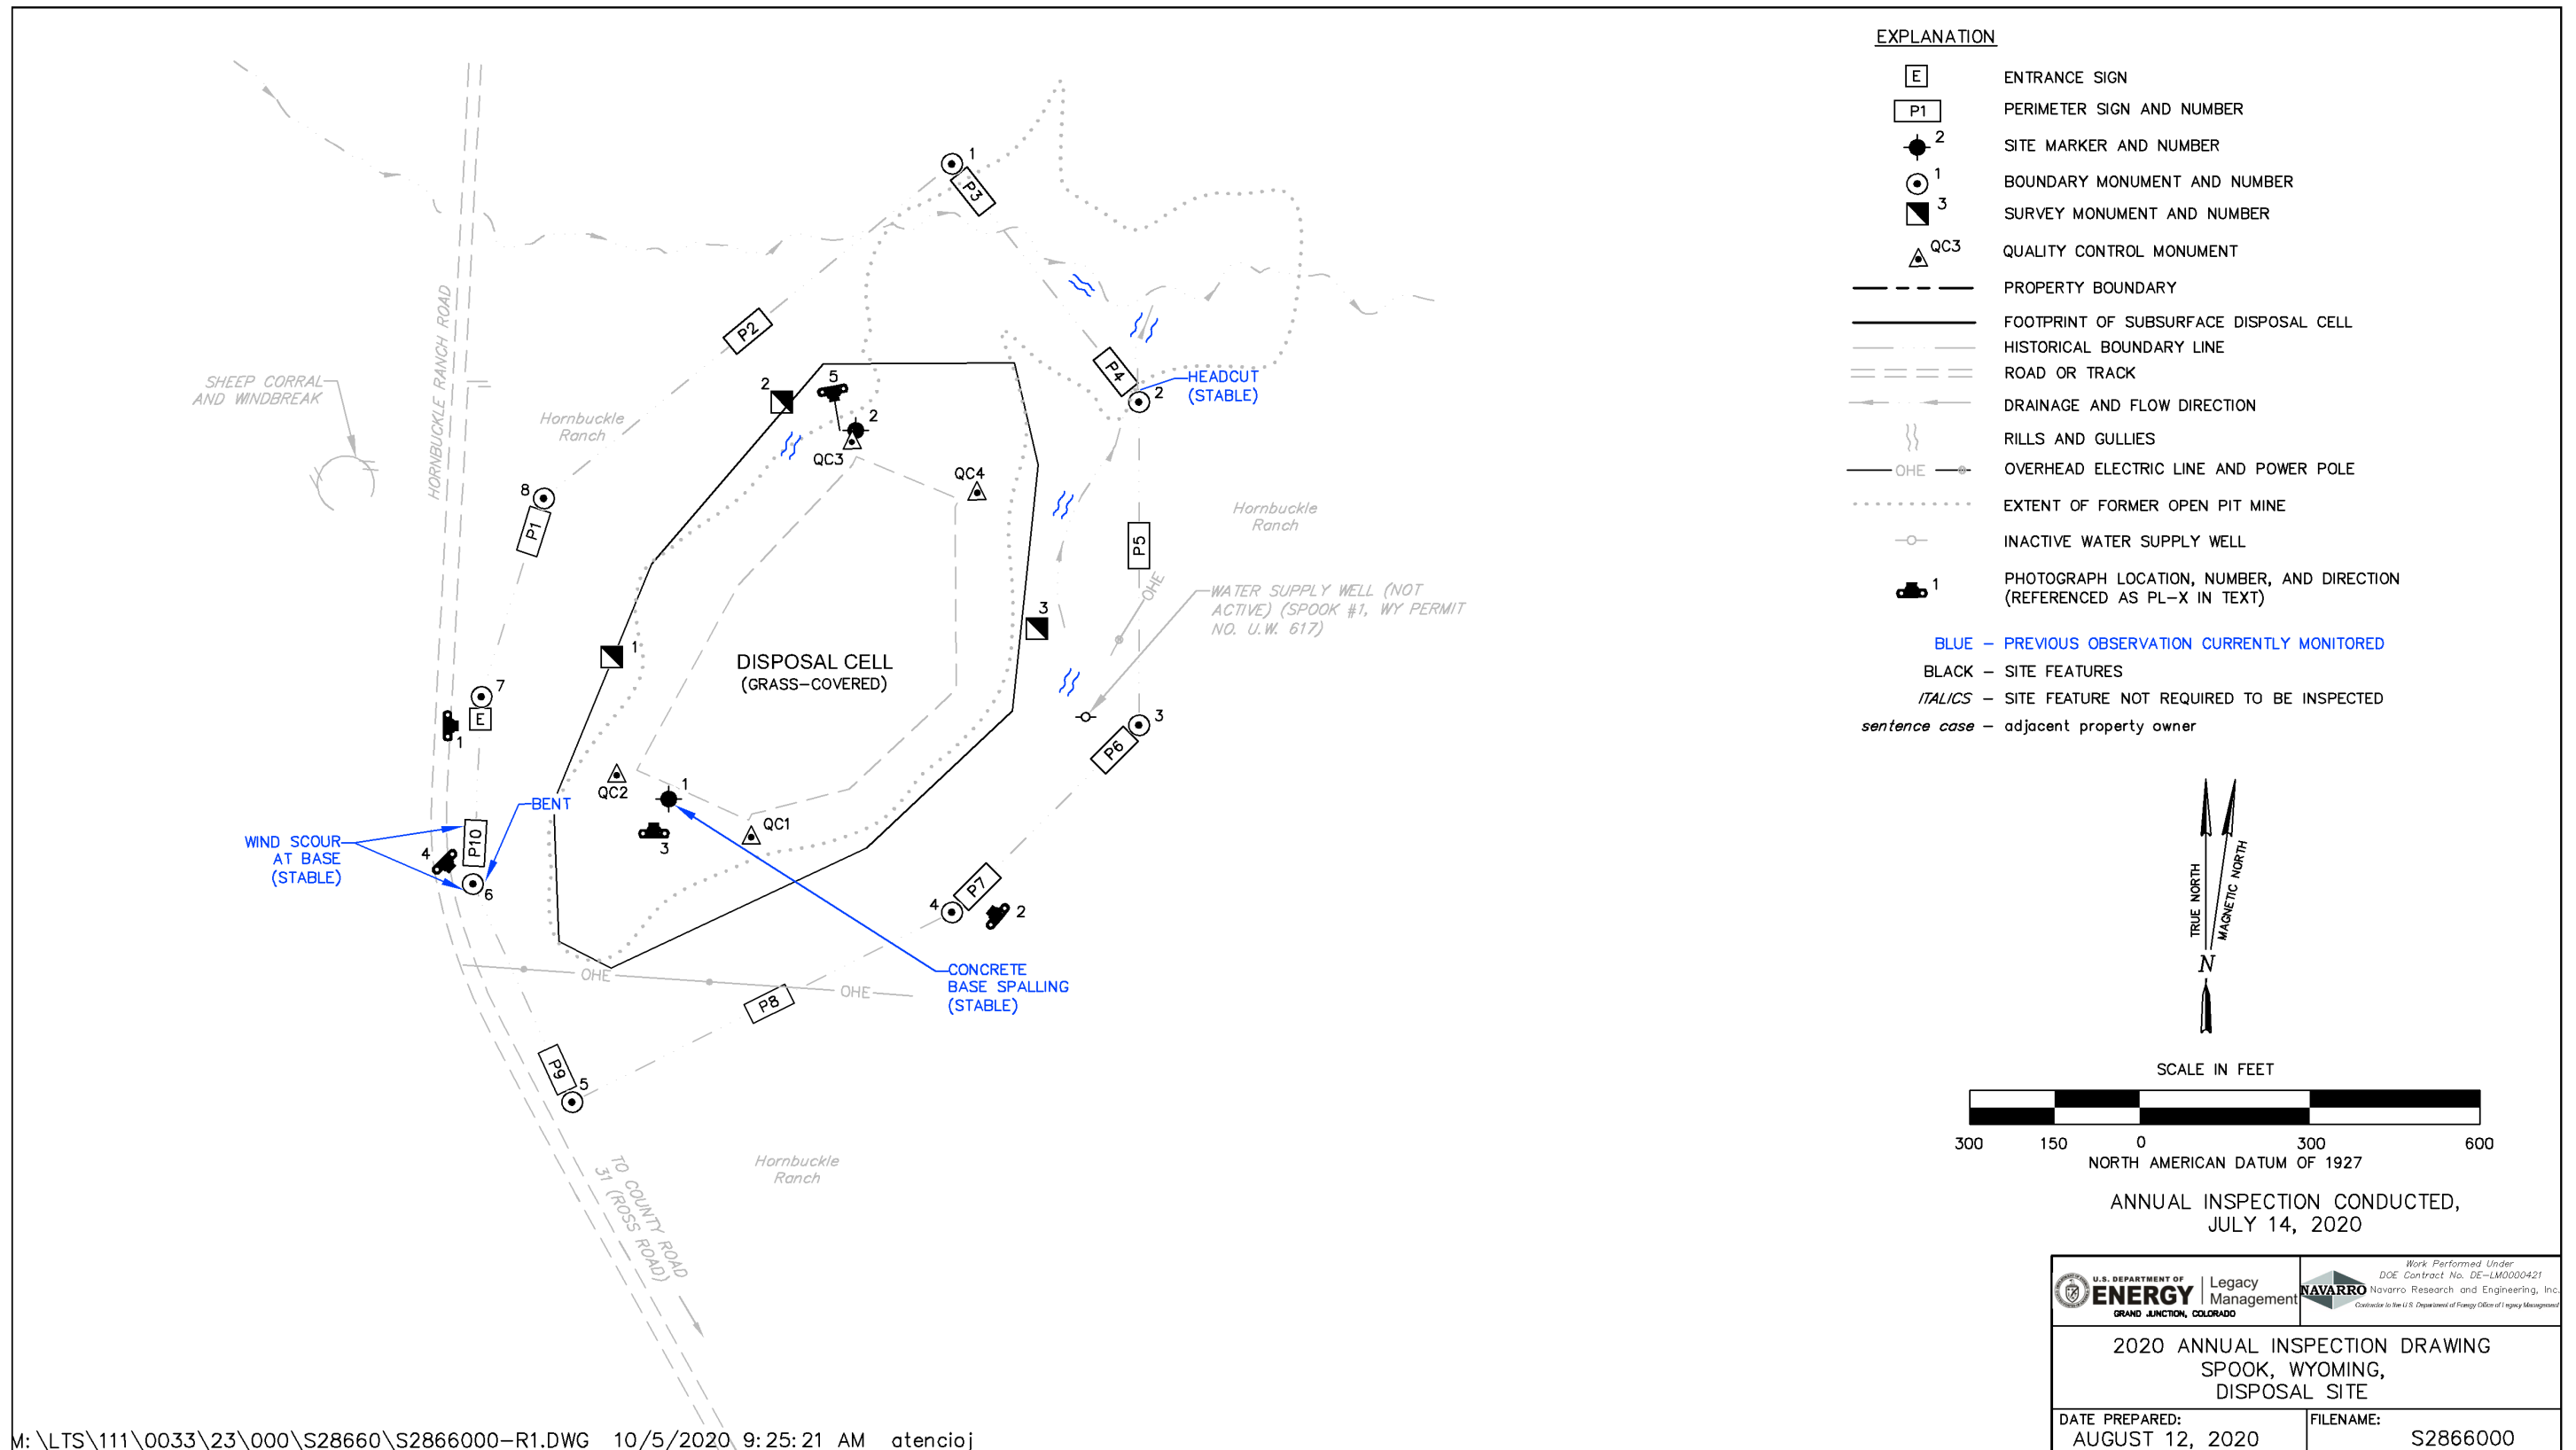
Figure 18-1. 2020 Annual Inspection Drawing for the Spook, Wyoming, Disposal Site

Figure 18-1 shows the locations of site features in black and gray font, including site surveillance features and inspection areas. Site features that are present but not required to be inspected are shown in italic font. Observations from previous inspections that are currently monitored are shown in blue text. There were no new observations in 2020. Inspection results and recommended maintenance activities associated with site surveillance features are included in the following subsections. Photographs to support specific observations are identified in the text and in Figure 18-1 by photograph location (PL) numbers. The photographs and photograph log are presented in Section 18.10.

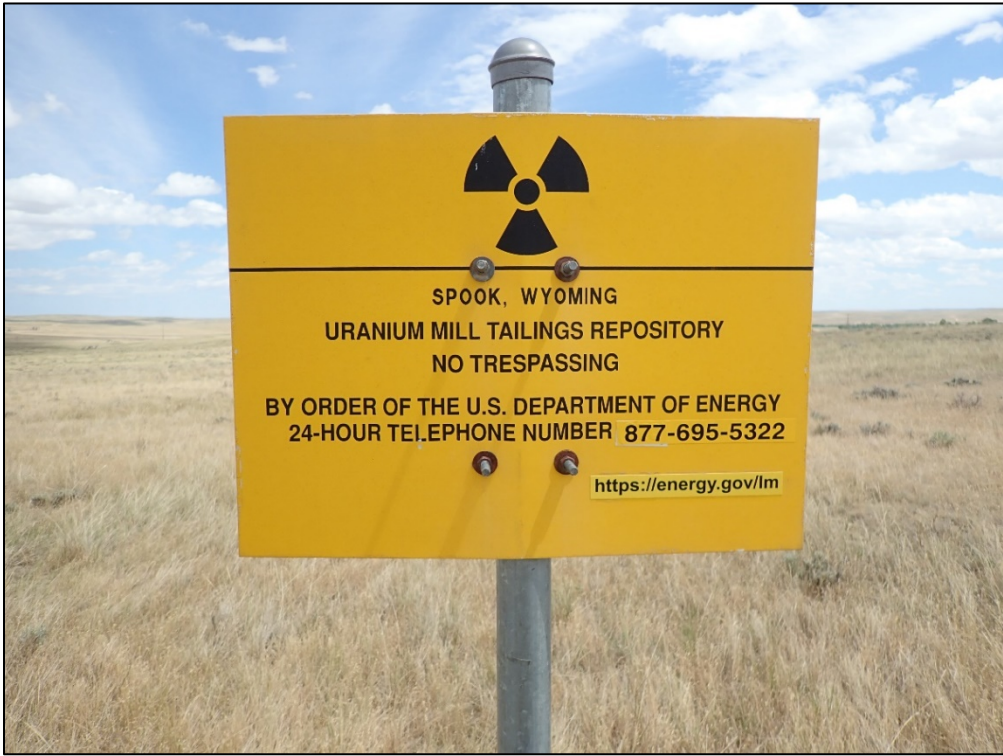
PL-1. Site Entrance Sign

Access to the site is from Wyoming Highway 95 from Glenrock or Wyoming Highway 93 from Douglas to Converse County Road 31 and onto Hornbuckle Ranch Road. Site access is maintained through perpetual easements across the Hornbuckle ranch. The road to the site is graded and hard packed and is maintained by the ranch. The entrance sign is mounted on a steel post set in concrete (PL-1). No maintenance needs were identified.

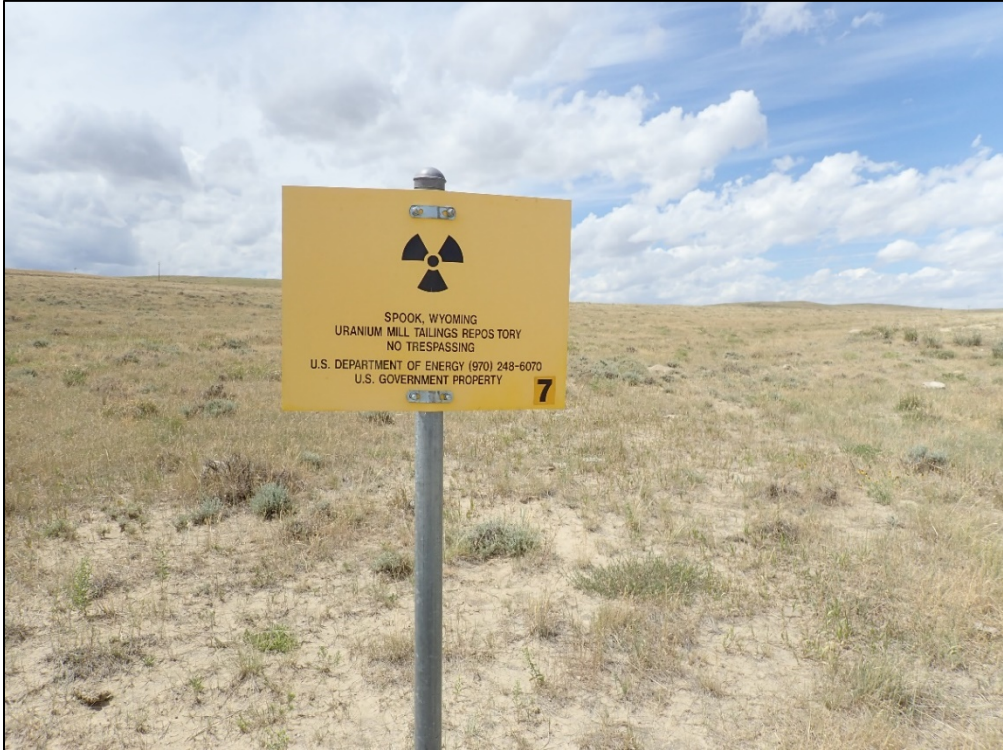
PL-2. Perimeter Sign P7

There are 10 perimeter signs, attached to steel posts set in concrete, positioned around the site outside the unfenced property boundary (PL-2). No maintenance needs were identified.

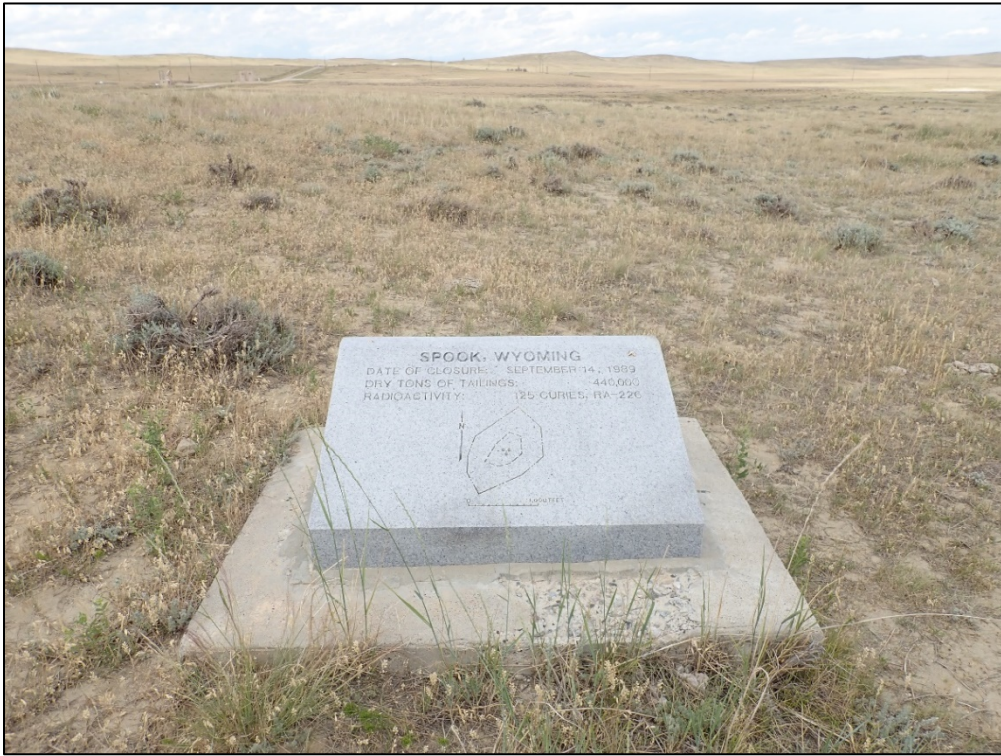
PL-3. Site Marker SMK-1

The site has two granite site markers. Site marker SMK-1 is at the south side of the disposal cell (PL-3). Its concrete base is damaged due to spalling but is stable; there were no apparent changes from the previous year. Site marker SMK-2 is at the north side of the disposal cell. No maintenance needs were identified.

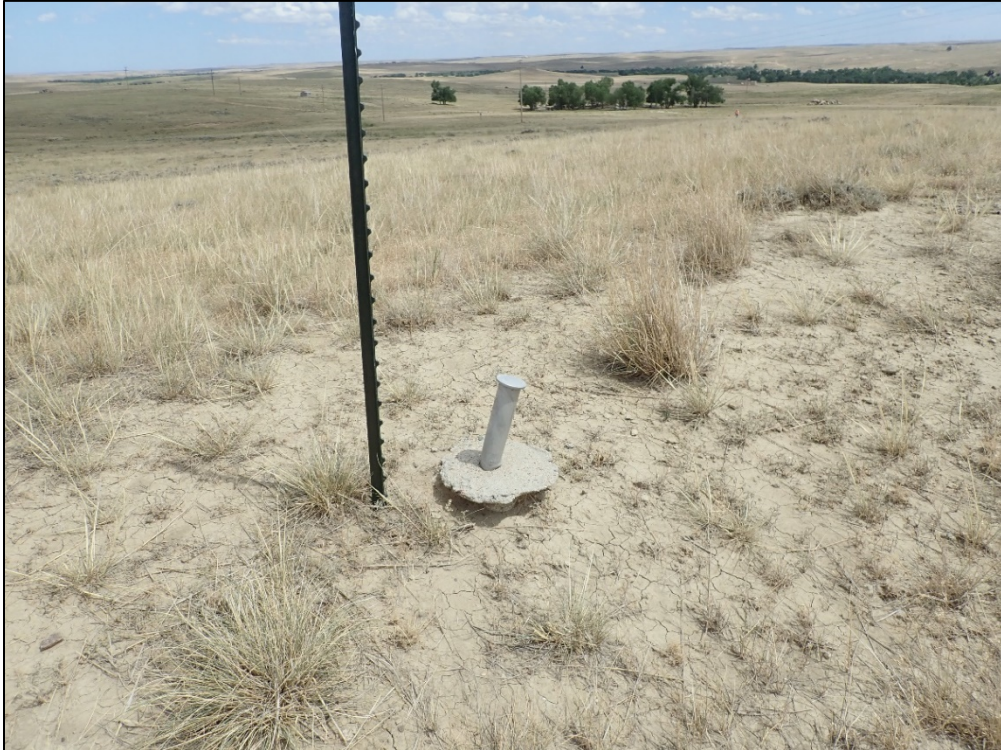
PL-4. Boundary Monument BM-6

The site has three survey monuments and eight boundary monuments. Boundary monument BM-6 is bent but stable (PL-4). The boundary monuments and a survey monument, as well as the perimeter signs, are outside the property boundary. The owner of the surrounding property (Hornbuckle ranch) is aware they are on his property but is not concerned. Therefore, the survey and boundary monuments and perimeter signs will remain at their current locations.

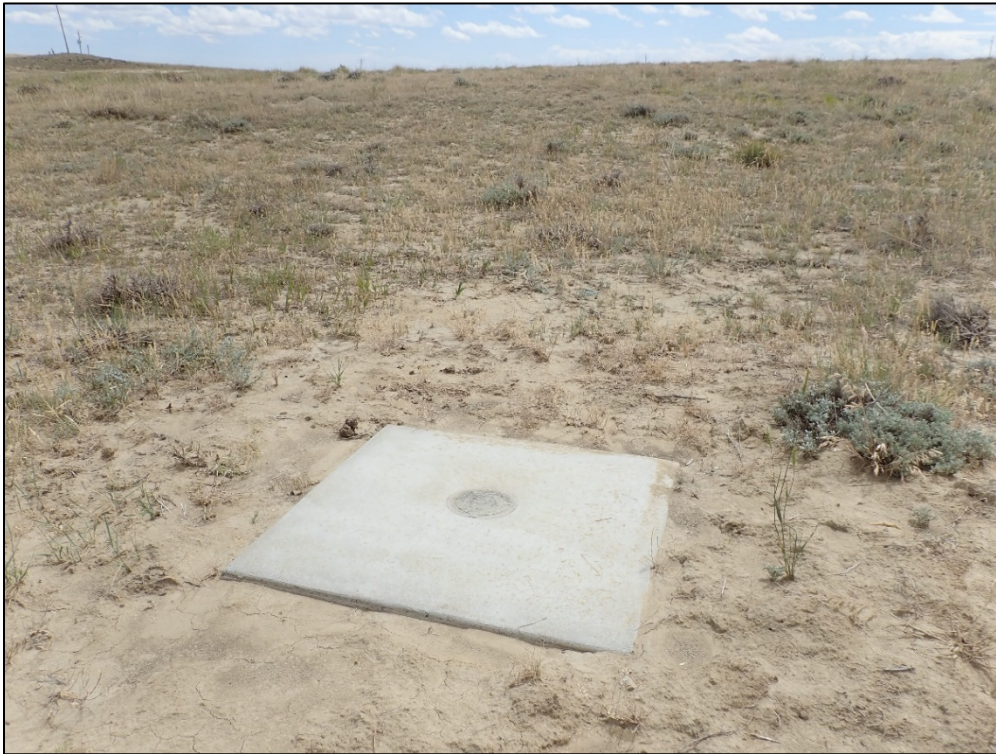
PL-5. Quality Control Monument QC3

Four aerial survey quality control monuments were installed in 2019 following the site inspection (PL-5). The quality control monument locations are shown in Figure 18-1. No maintenance needs were identified.
