17.0 Slick Rock, Colorado, Disposal Site

17.1 Compliance Summary

Figure 17-1. 2020 Annual Inspection Drawing for the Slick Rock, Colorado, Disposal Site

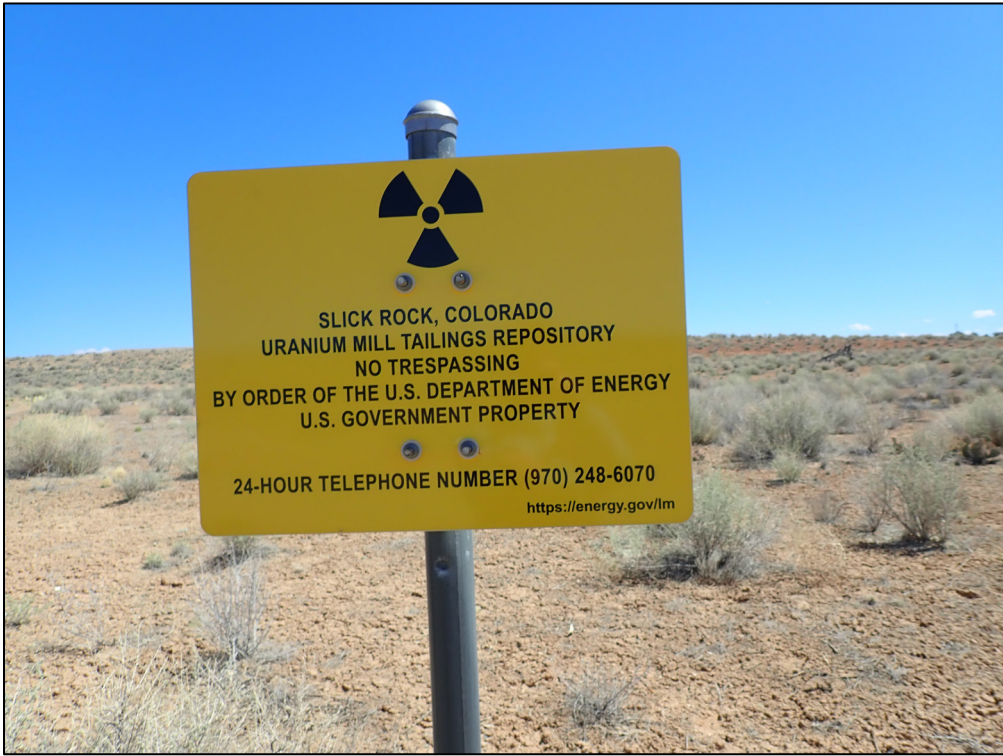
PL-1. Entrance Sign

Access to the site is from San Miguel County Road T11. Entrance to the site is through a chained and locked gate. The wire entrance gate was locked and is worn but remains functional. The entrance sign is next to the gate (PL-1). No maintenance needs were identified.

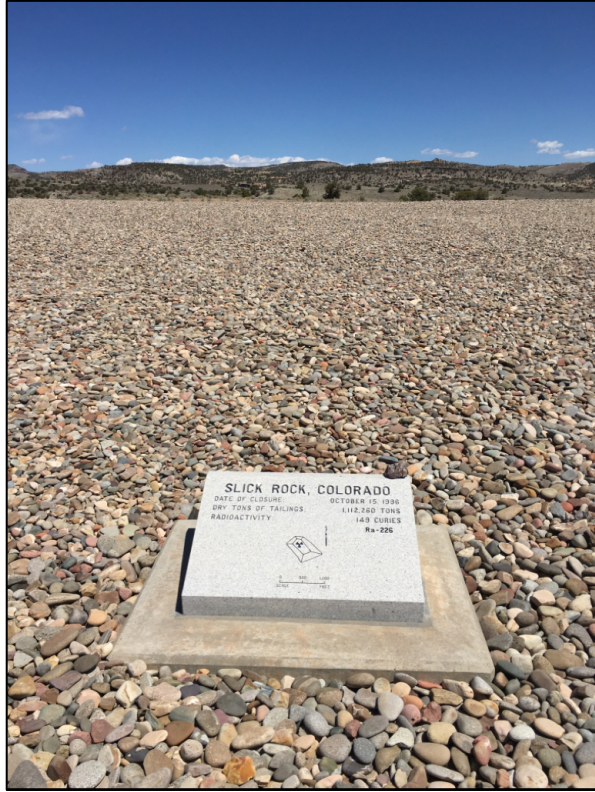
PL-2. Site Marker SMK-2

The site has two granite site markers. Site marker SMK-1 is just inside the entrance gate, and site marker SMK-2 is on top of the disposal cell (PL-2). Erosion near site marker SMK-1 is being monitored and will be repaired if it threatens the integrity of the marker. No immediate maintenance needs were identified.

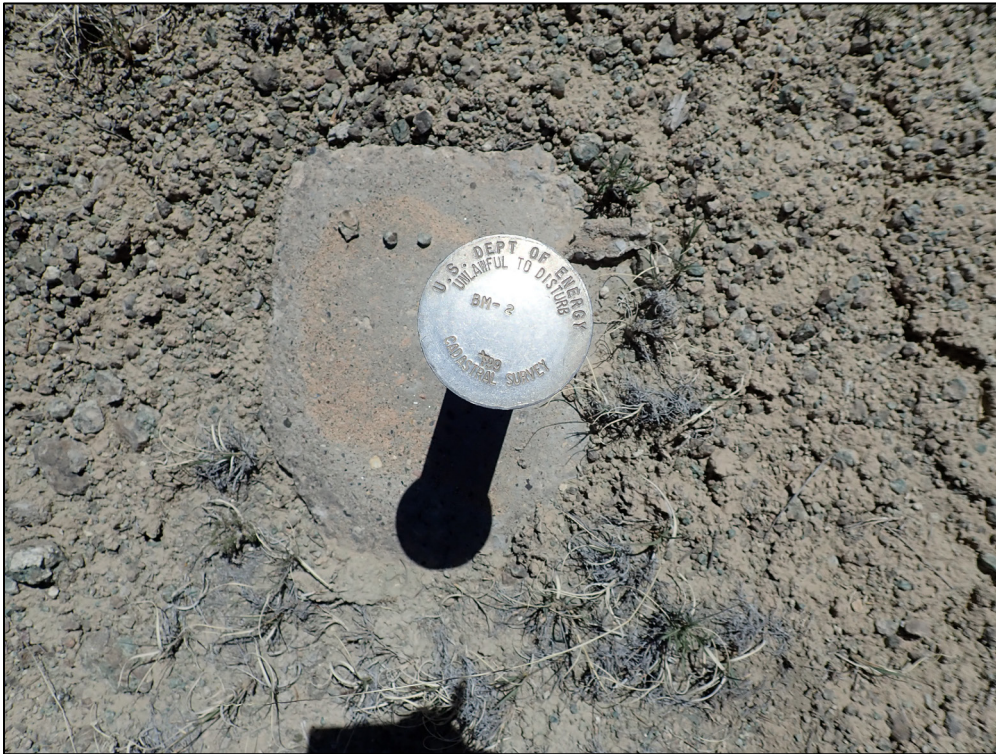
PL-3. Boundary Monument BM-2

The site has three survey monuments. Survey monument SM-2 was set in a low area and is frequently covered by several inches of soil. A T-post and rocks have been placed next to the monument to assist in locating this feature. Six boundary monuments delineate the corners of the site boundary (PL-3). Boundary monument BM-5 is difficult to locate. A T-post was installed for ease of location after the inspection. No other maintenance needs were identified.

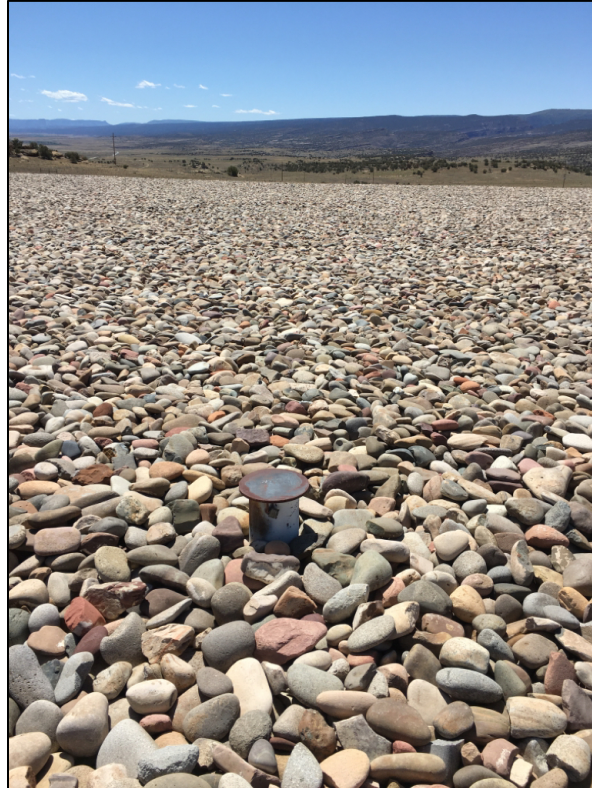
PL-4. Settlement Plate on Disposal Cell

The disposal cell, completed in 1996, occupies 12.9 acres and is armored with riprap, consisting of rounded, cobble-sized river rock to control erosion and deter animal and human intrusion (PL-4). The inspection found no evidence of erosion, settling, slumping, rock degradation, or other modifying processes that might affect the integrity of the disposal cell. No other maintenance needs were identified.

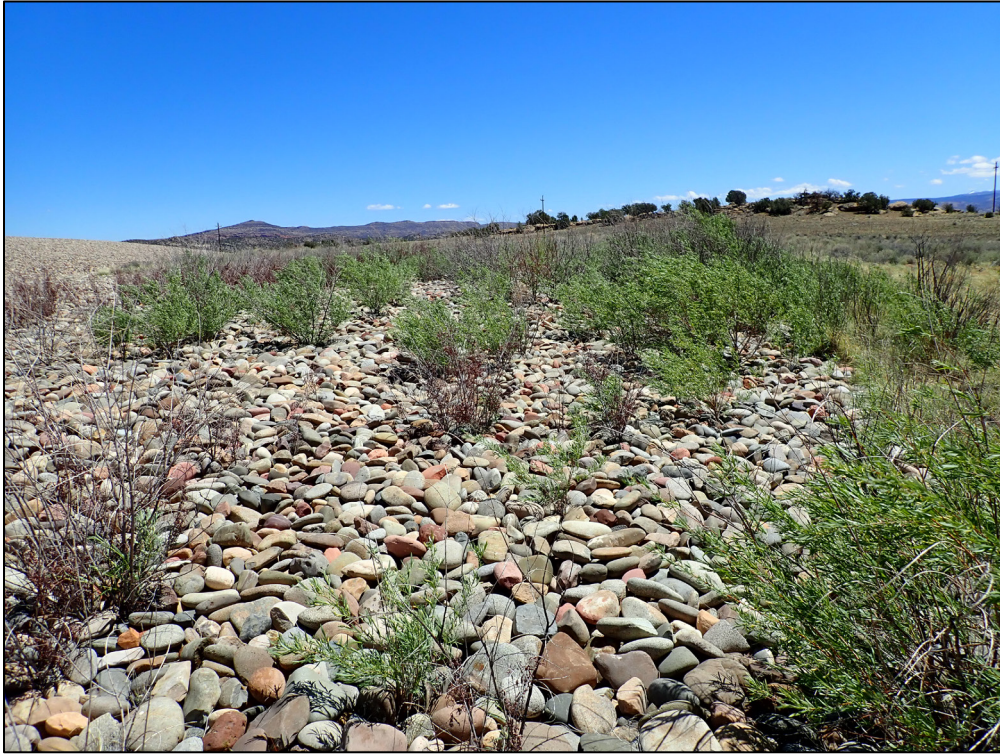
At the toe of the disposal cell side slopes is a key trench that encloses the disposal cell. The key trench, designed to convey stormwater runoff away from the disposal cell, is as much as 5 ft deep and 20 ft wide and filled with rock. Stormwater runoff from the key trench discharges to an apron at the south (downslope) corner of the disposal cell. The apron extends 50 to 200 ft beyond the key trench. The key trench and apron are covered with rounded cobble- and pebble-sized river rock. Willow brush (a deep-rooted species) is growing on a portion of the apron but is not considered to be detrimental to the integrity of the disposal cell (PL-5). No other maintenance needs were identified.

PL-5. Willows on Disposal Cell Toe

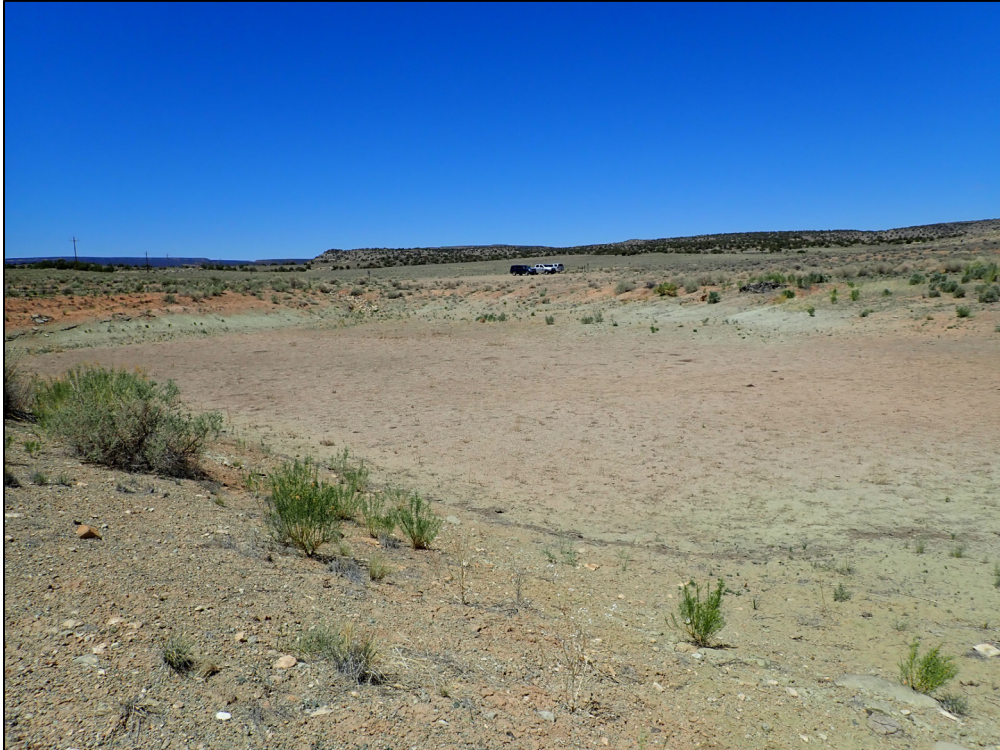
The area around the disposal cell includes the retention pond. Surface drainage from the disposal cell flows south from the apron into the retention pond, which is constructed in a channel tributary to Joe Davis Canyon. An outflow channel below the pond is lined with rounded riprap for a short distance. The pond was dry at the time of inspection (PL-6).

PL-6. Retention Pond

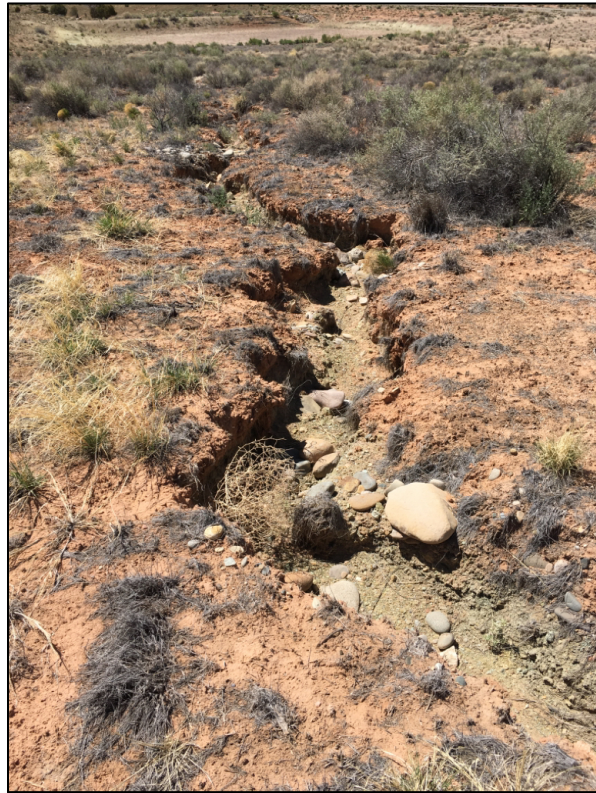
The site was originally graded for sheet flow from the apron to the retention pond. Rills have been developing since 1998 on the northwest side of the retention pond and now are 3 ft deep or deeper adjacent to the pond and shallower farther upslope. Most of the rills are stabilizing. One gully identified in an earlier inspection appears to have deepened (PL-7). Stabilization options will be evaluated before the next inspection. No other maintenance needs were identified.

PL-7. Deep Erosional Gully

- Treatment of noxious weeds growing near the retention pond.
- Evaluation of stabilization options to address the growing erosional gully between the disposal cell apron and retention pond.

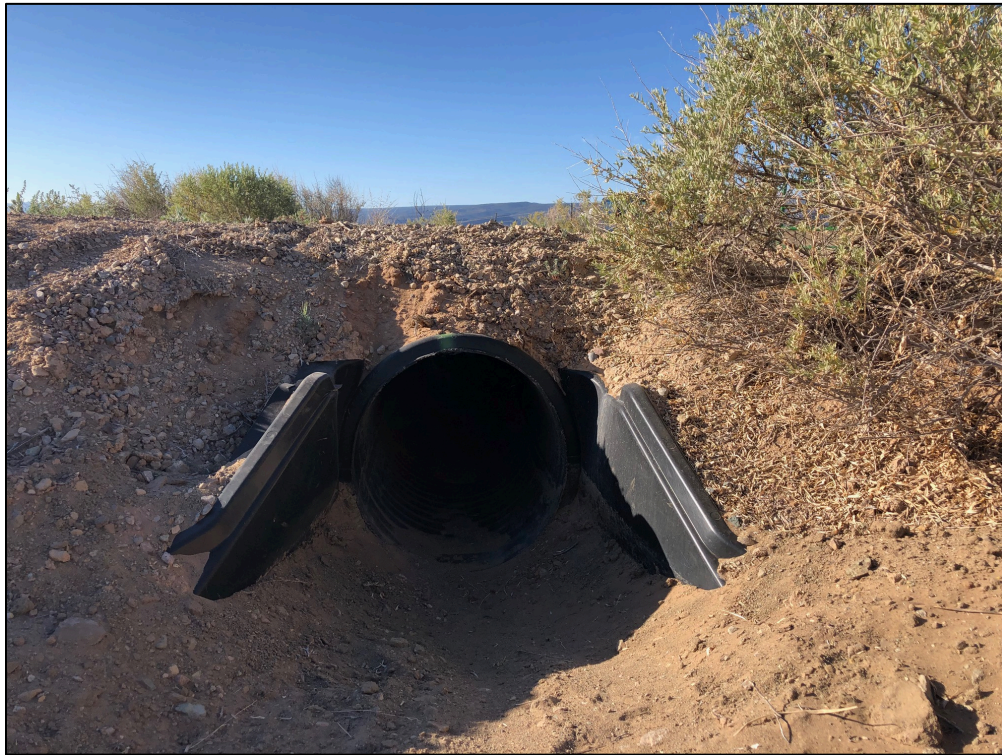
The two occluded culverts identified in the 2019 inspection were cleaned out following the inspection (PL-8). No other maintenance needs were identified.

PL-8. Cleaned-Out Culvert
