19.0 Tuba City, Arizona, Disposal Site

19.1 Compliance Summary

Figure 19-1. 2020 Annual Inspection Drawing for the Tuba City, Arizona, Disposal Site

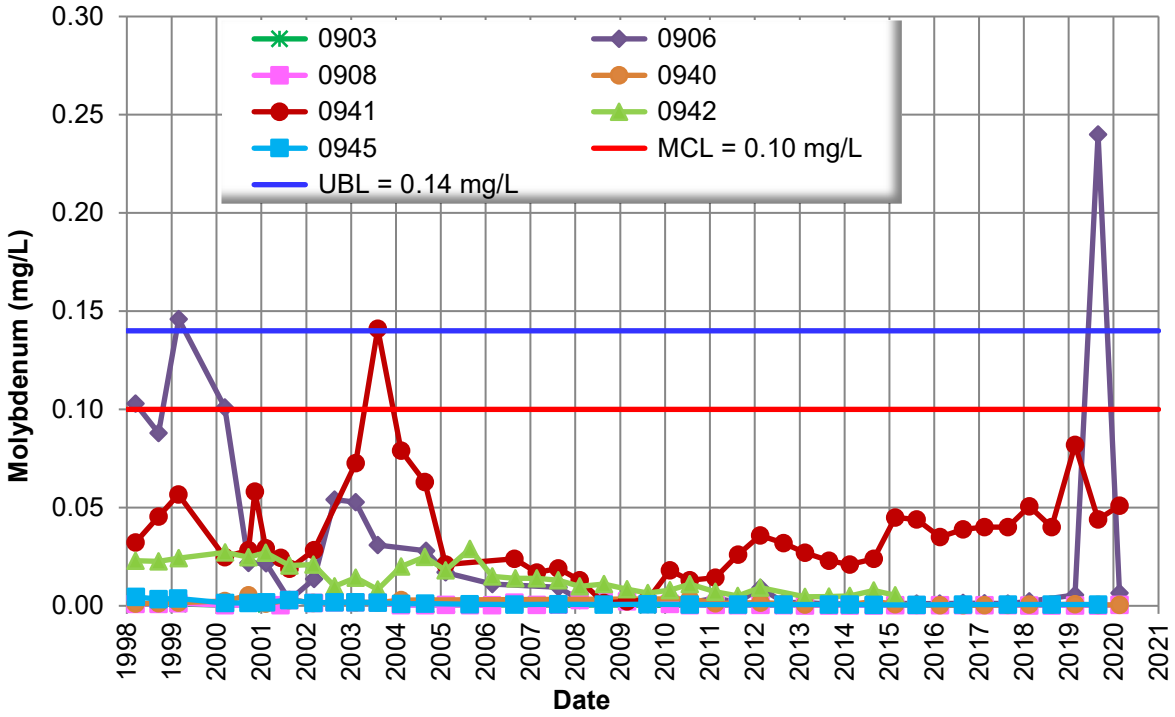
Figure 19-3. Molybdenum in Groundwater at the Tuba City, Arizona, Disposal Site

Since 2004, molybdenum concentrations have been below both the 0.10 milligram per liter (mg/L) MCL and the 0.14 mg/L UBL in all LTSP evaluative wells except well 0906 in August 2019 (Figure 19-3). Molybdenum concentrations in the westernmost downgradient well 0908 and in distal downgradient well 0903 (approximately 1250 feet south of the site perimeter) continue to be comparable to concentrations in background well 0945. Well 0906 exceeded the UBL for molybdenum in August 2019 for the first time since 1999. The UBL exceedance in well 0906 was measured during the 2019 pumping campaign. In February 2020, when there was no pumping, the molybdenum concentration in well 0906 decreased below the MCL.

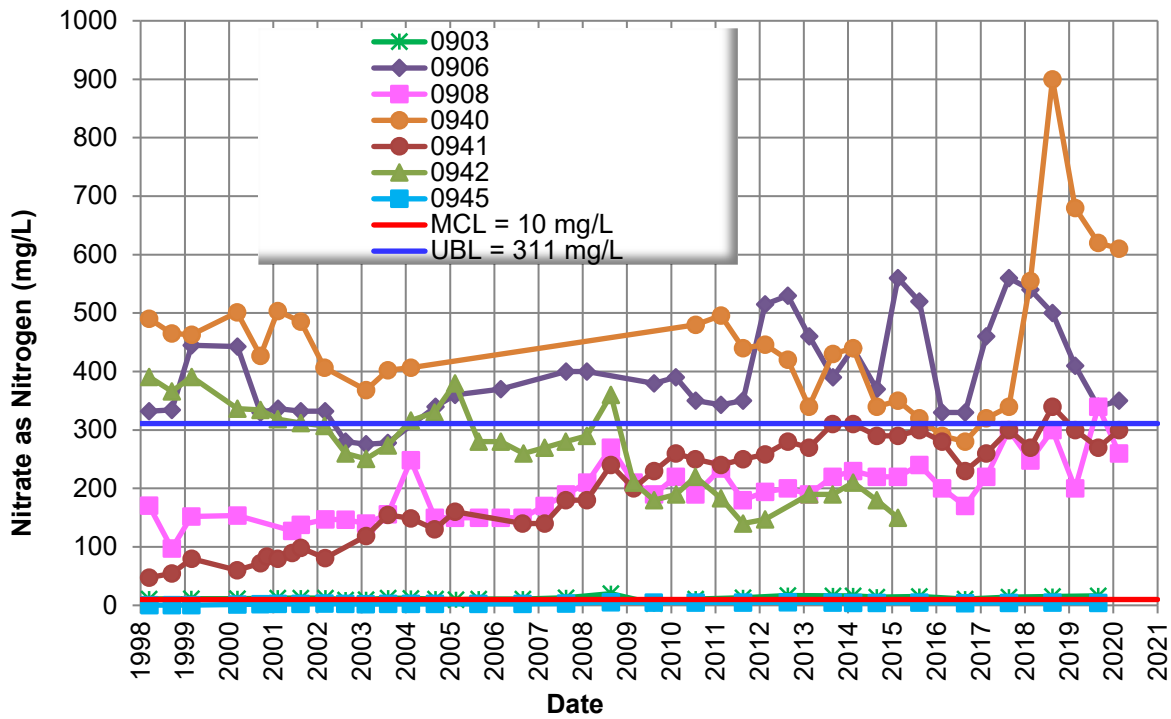
Figure 19-4. Nitrate in Groundwater at the Tuba City, Arizona, Disposal Site

Nitrate concentrations have historically exceeded the 10 mg/L MCL in all LTSP evaluative wells, except background well 0945 (Figure 19-4). Exceedances of the 311 mg/L UBL were observed at compliance wells 0906 (350 mg/L) and 0940 (610 mg/L) in February 2020. Nitrate concentrations in well 0908 dropped below the UBL in February 2020 after exceeding it for the first time in August 2019. Nitrate concentrations in distal downgradient well 0903 have regularly exceeded the MCL since 2004 but remained below the UBL in 2020.

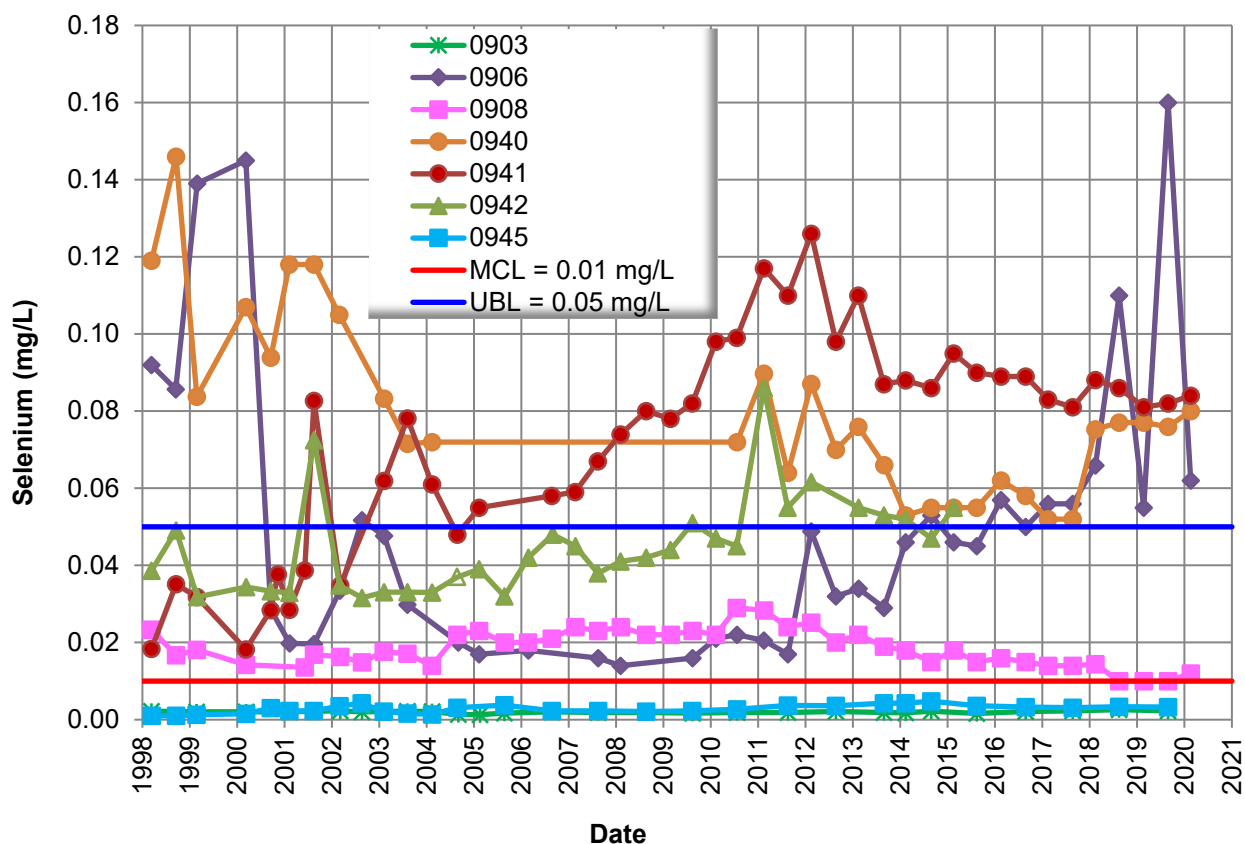
Figure 19-5. Selenium in Groundwater at the Tuba City, Arizona, Disposal Site

Selenium concentrations have historically exceeded the 0.01 mg/L MCL in all LTSP evaluative wells except background well 0945 and distal well 0903 (Figure 19-5). Concentrations in well 0908 exceeded the UBL for selenium in 1997 and have since remained at or slightly above the 0.01 mg/L MCL since August 2018. Selenium concentrations in well 0942 exceeded the UBL in February 2015, and that well has not been sampled since. Concentrations continued to exceed the 0.05 mg/L UBL in wells 0906, 0940, and 0941, all of which are immediately downgradient of the disposal cell. Selenium concentrations increased in well 0906 to 0.16 mg/L during the high-intensity pumping campaign in August 2019, the highest level since 1997. Selenium concentrations increased in well 0941 from 0.018 mg/L in 1998 to 0.08 mg/L in 2020. Selenium concentrations in distal downgradient well 0903 have consistently been below both the UBL and the MCL and, since late 2004, below levels measured in background well 0945.

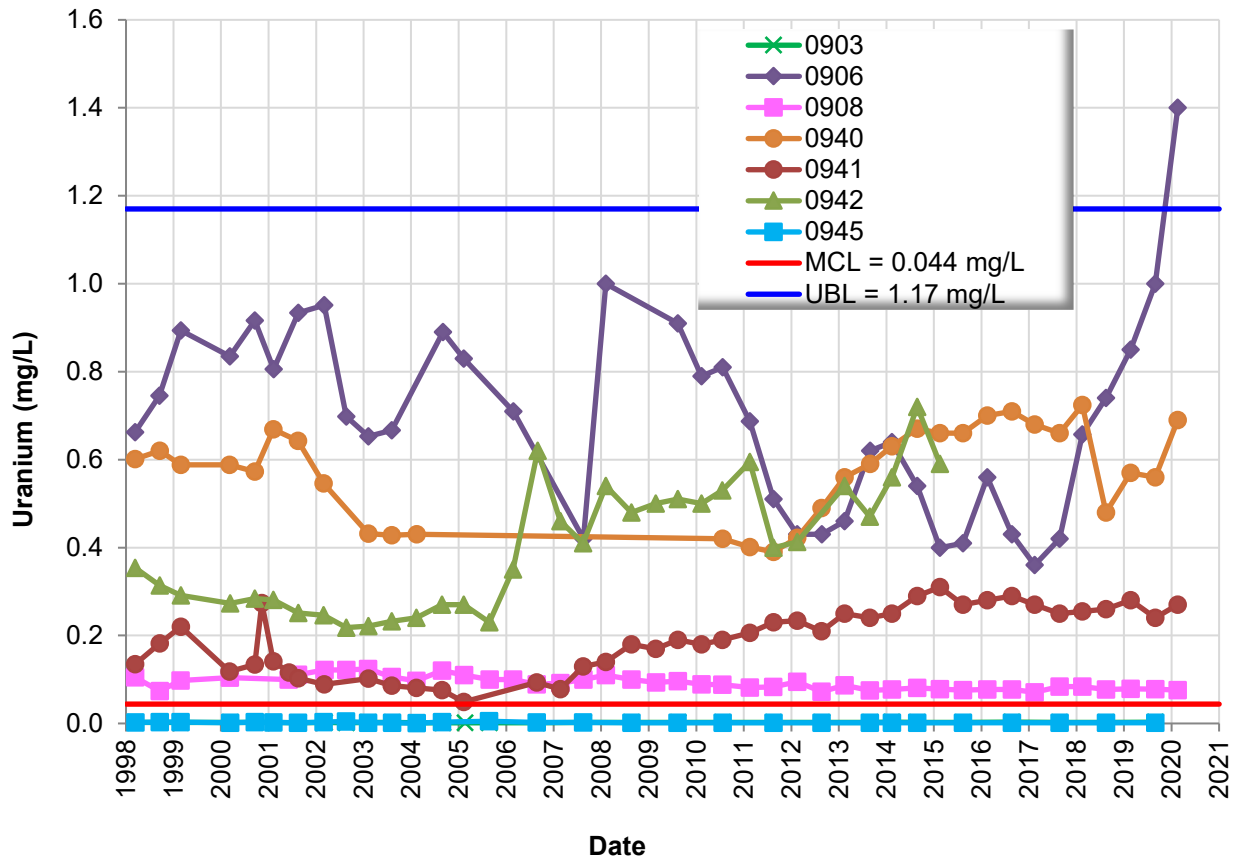
Figure 19-6. Uranium in Groundwater at the Tuba City, Arizona, Disposal Site

Uranium concentrations have historically exceeded the 0.044 mg/L MCL in all compliance wells except for distal downgradient well 0903 and background well 0945, both of which have always been below the MCL (Figure 19-6).

Uranium concentrations in central downgradient well 0941 have gradually increased since 2005 from 0.05 mg/L to 0.27 mg/L. Concentrations in well 0906 have more recently increased from 0.36 mg/L in February 2017 to 1.4 mg/L in February 2020. The February 2020 concentration is above the UBL of 1.17 UBL and is the first recorded UBL exceedance of uranium at the site.

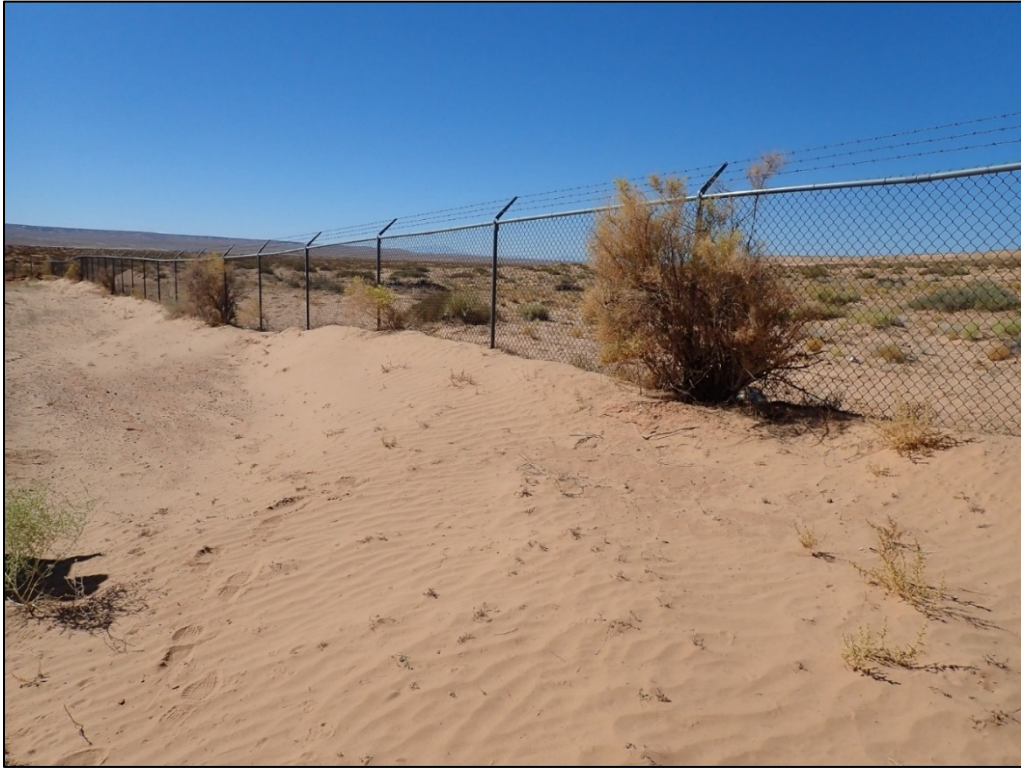
A chainlink perimeter fence encloses the site. Windblown sand continues to accumulate along the western perimeter fence and road (PL-1) and in a few areas along the western end of the north perimeter fence. The sand accumulation is not of concern at this time. Inspectors found numerous animal burrows (PL-2) and areas of erosion beneath the fence (PL-3). Gaps beneath the fence on the east side need to be repaired, and accumulated tumbleweeds need to be cleared from the fence near perimeter sign P25.

PL-1. Sand Accumulation and Treated Woody Vegetation Along West Fence

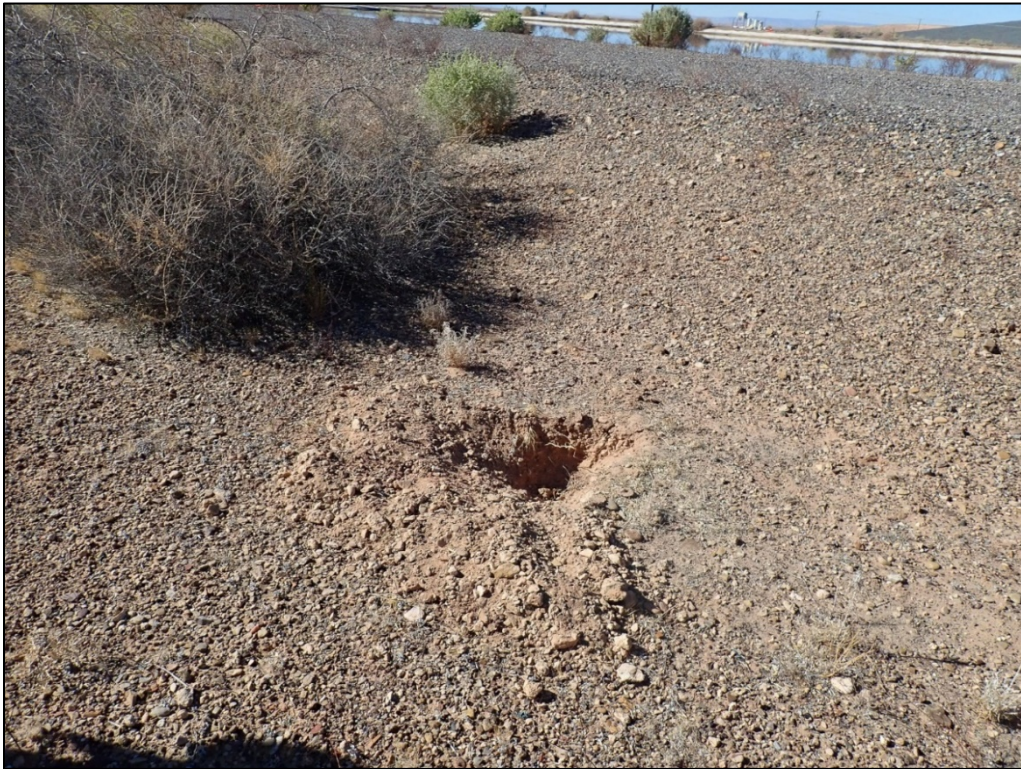
Thirty pairs of perimeter signs, designated P1 through P30, are attached to steel posts set in concrete directly inside and along the perimeter fence. One of the sign pairs is textual, and the other is pictorial. All were legible and stable, with the exception of the P24 pictorial sign, which is becoming faded (PL-4), and the P9 signpost, which is being undercut at its base from wind erosion. Two faded signs warning of high voltage need to be replaced near perimeter sign P12. Erosion under the fence near P16 and P28 was repaired last year, but there is new erosion that needs to be repaired. No other maintenance needs were identified.

PL-2. Animal Burrow

- Repair of gaps beneath the fence created by animals and soil erosion.
- Replacement of the P24 pictorial perimeter sign.
- Repair of P9 perimeter signpost's exposed base, which was undercut by erosion.
- Replacement of two caution signs near perimeter sign P12 warning of high voltage.
- Removal of tumbleweeds from the chainlink fence near perimeter sign P25.
- Removal of small trash and debris pile near perimeter sign P9.

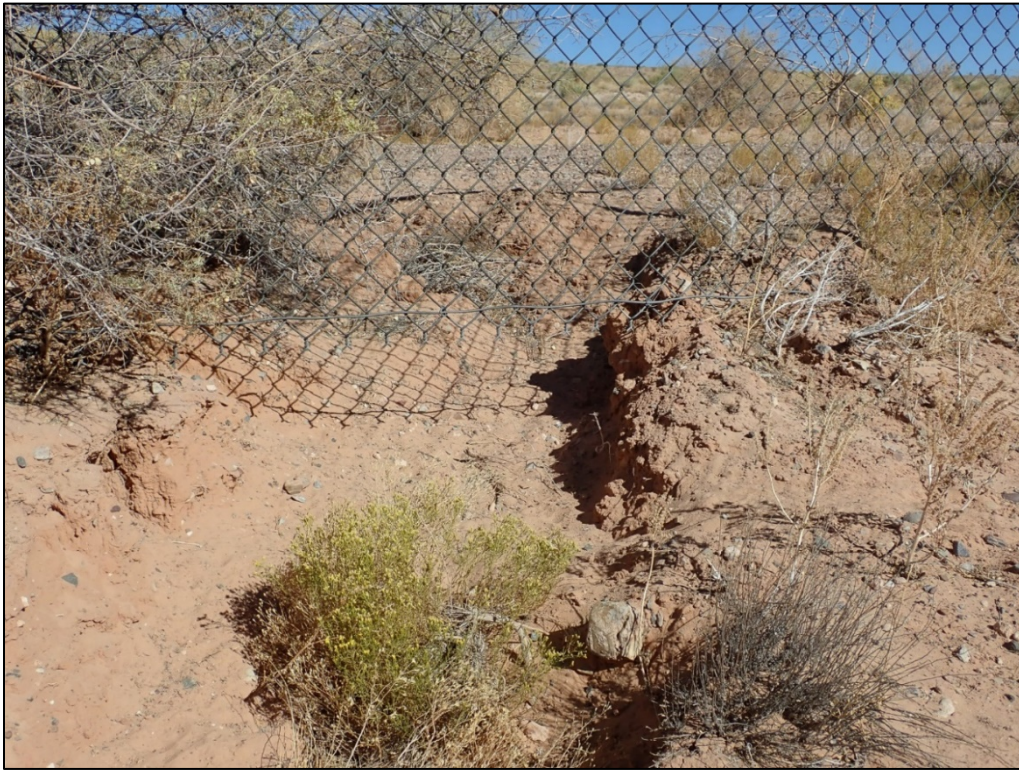
PL-3. Erosion Under Fence

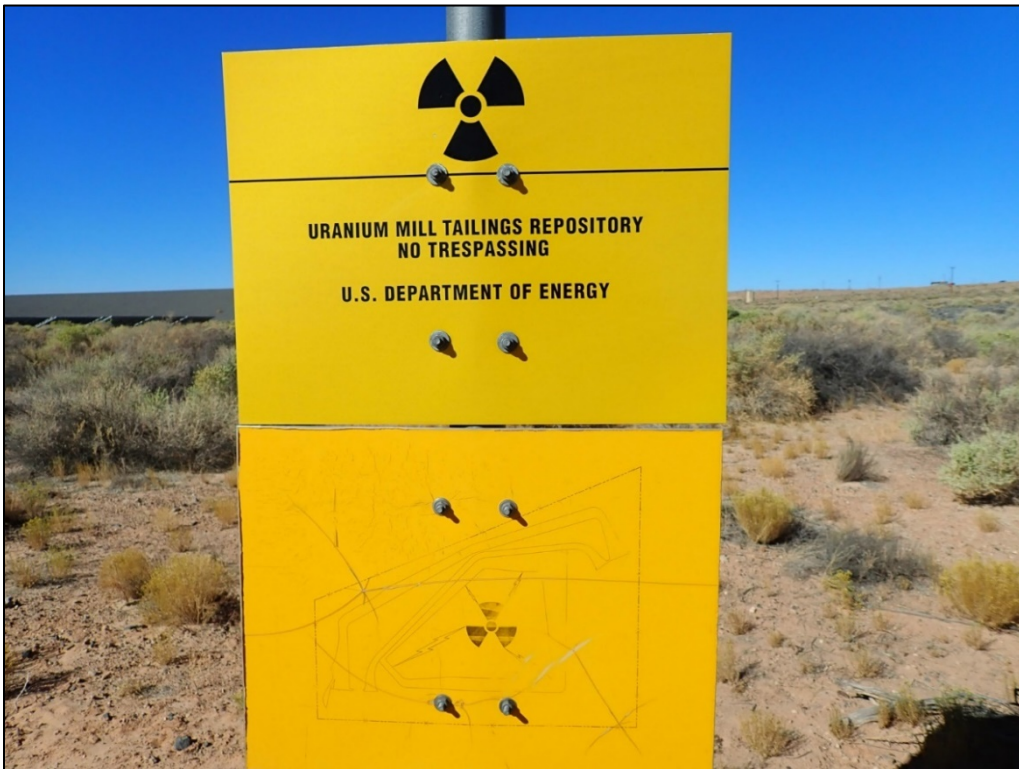
PL-4. Faded Pictorial Perimeter Sign P24

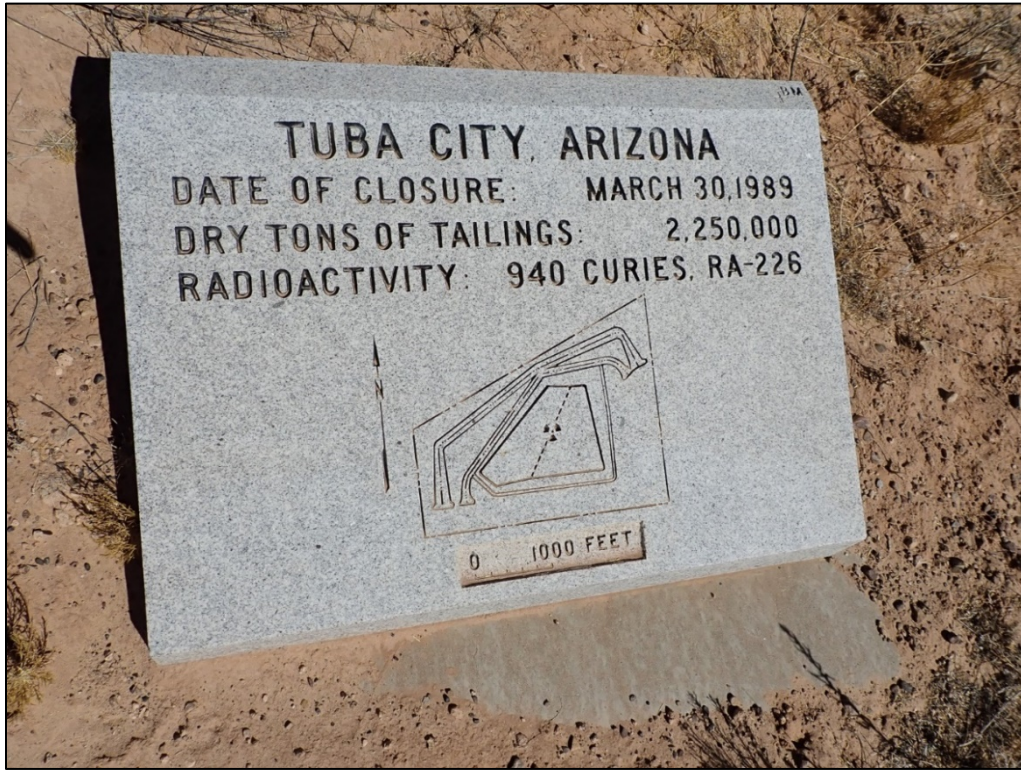
The site has two granite site markers. Site marker SMK-1 (PL-5) is just inside the entrance gate, and site marker SMK-2 is on the top slope of the disposal cell. No maintenance needs were identified.

PL-5. Site Marker SMK-1

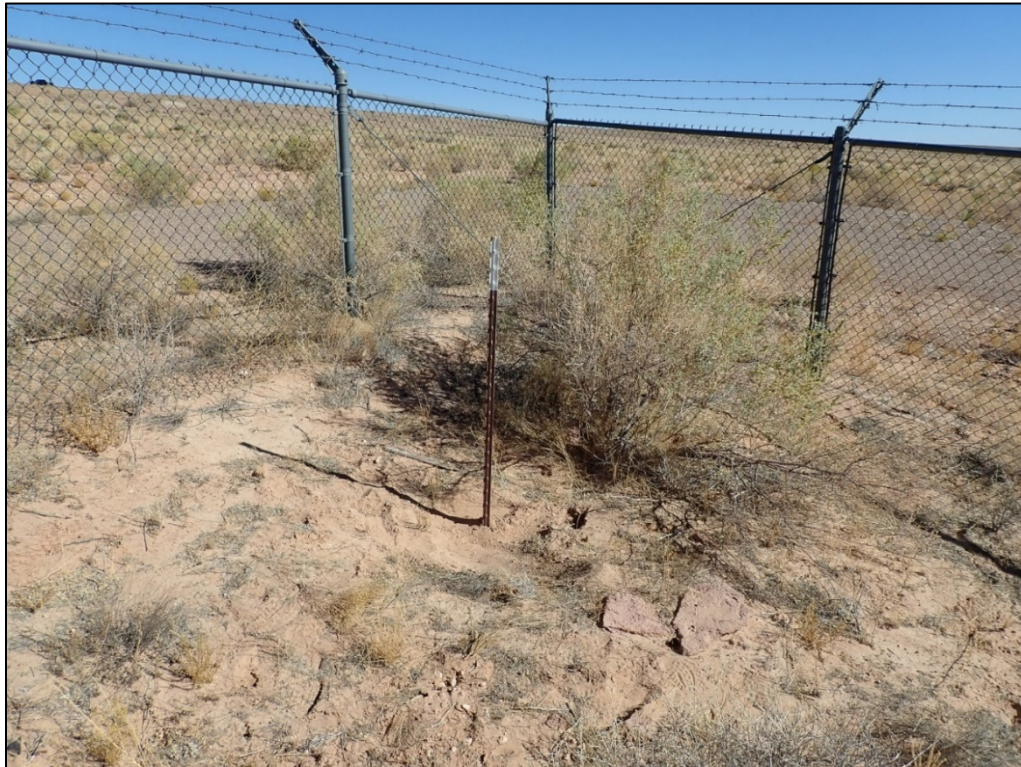
One boundary monument and three combined survey and boundary monuments delineate the corners of the site. Combined survey and boundary monuments SM/BM-1 and SM/BM-3 tend to get covered with windblown sand and are marked with steel T-posts. Only survey and boundary monument SM/BM-3 was found in this condition during the inspection. SM/BM-3 was cleared and exposed for visual detection during the inspection (PL-6). All four survey and boundary monuments were located and in good condition. No other maintenance needs were identified.

PL-6. Survey/Boundary Monument SM/BM-3 with Sand Accumulation

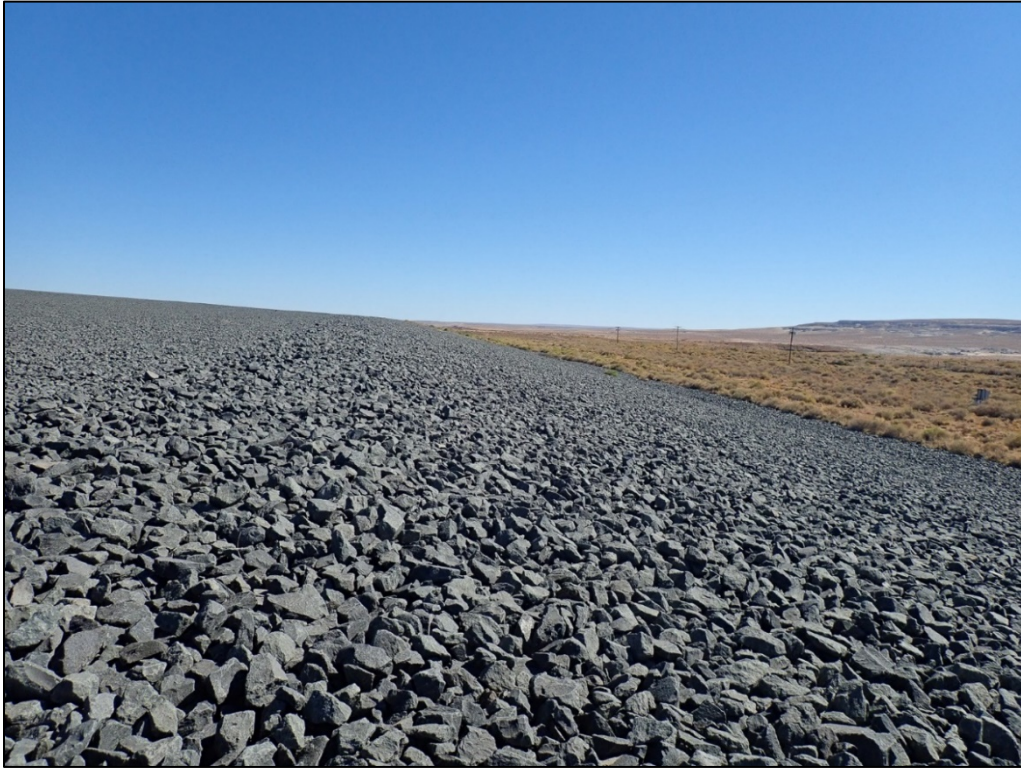
The disposal cell, completed in 1989, occupies 50 acres. The disposal cell is armored with riprap to control erosion and deter animal and human intrusion (PL-7). There was no evidence of erosion, settling, slumping, or other modifying processes on the disposal cell.

PL-7. Disposal Cell Top and Side Slope

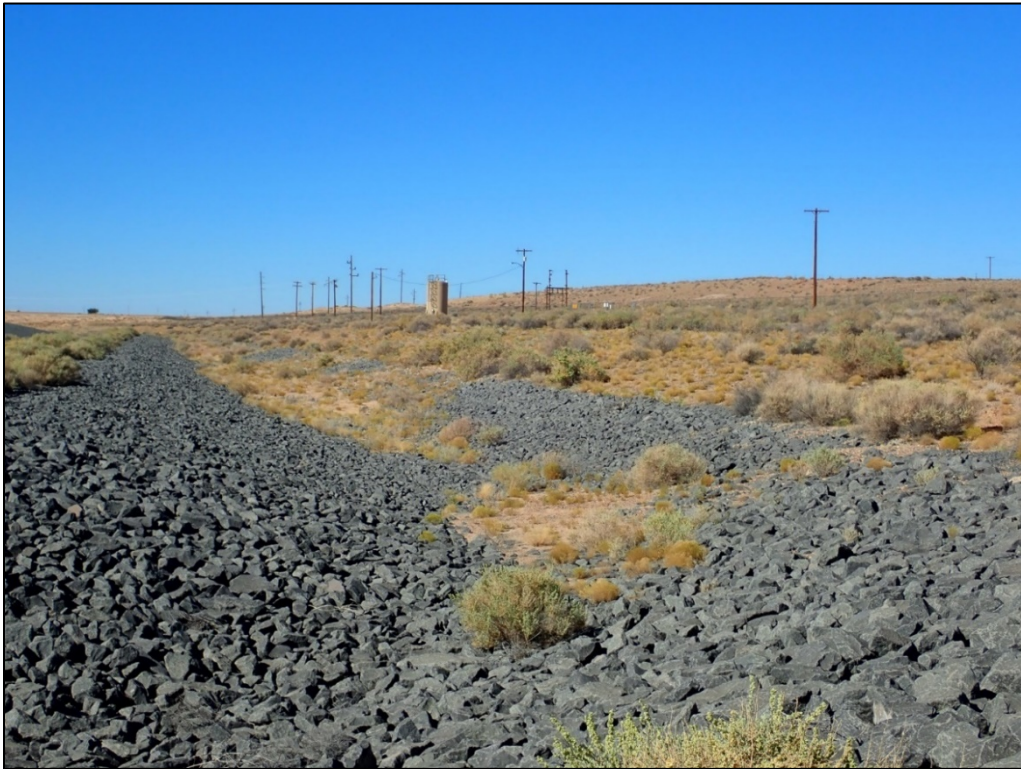
The disposal cell is protected from stormwater runoff by a disposal cell apron ditch and a diversion channel, both armored with riprap and located along the north and northwest sides of the disposal cell. Windblown sand and vegetation accumulate in the apron ditch and the diversion channel (PL-8) along the north and northwest sides of the disposal cell. This sand deposition and associated vegetation establishment have not adversely affected the performance of these structures. No evidence of recent or past water flows was observed in the apron ditch or the diversion channel.

PL-8. Diversion Channel

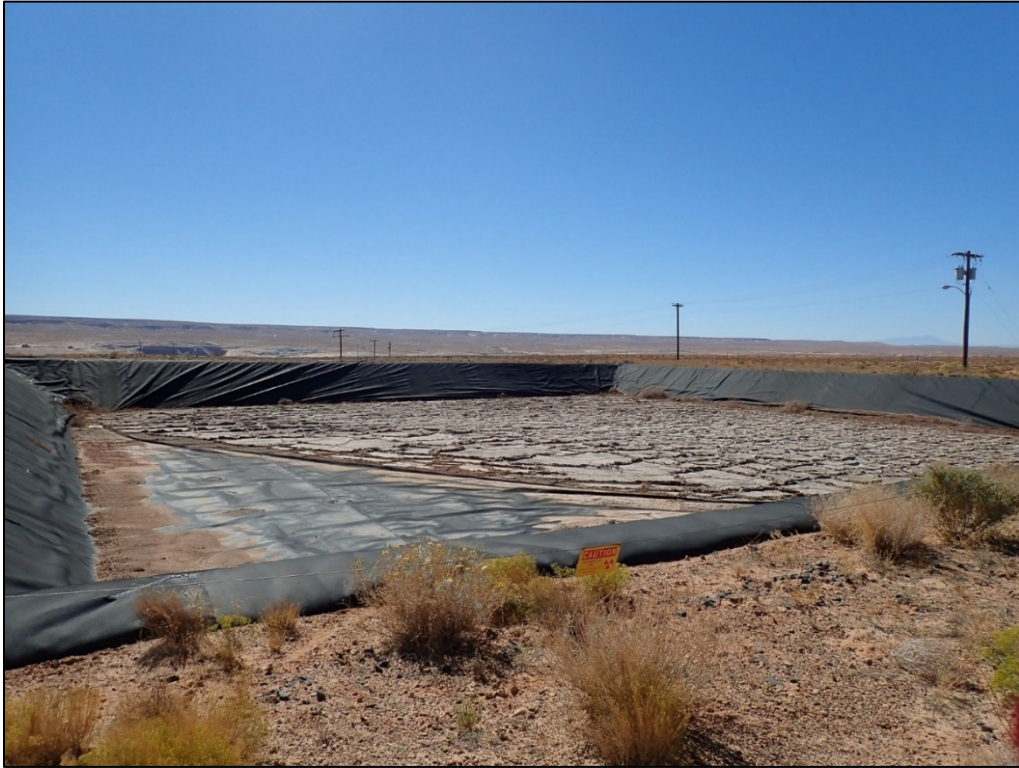
The remaining evaporation pond, filled minimally with windblown sand and evaporites, is retained as a backup for the main evaporation pond on the east side of the site. The steel cable and caution signs surrounding the pond were in good condition. The high-density polyethylene liner was in good condition. Lastly, the plastic geofabric that stabilizes the south-facing slope of the pond is still exposed (PL-10). No repairs of the geofabric are needed at this time, as it

PL-9. Inactive, Lined Evaporation Pond

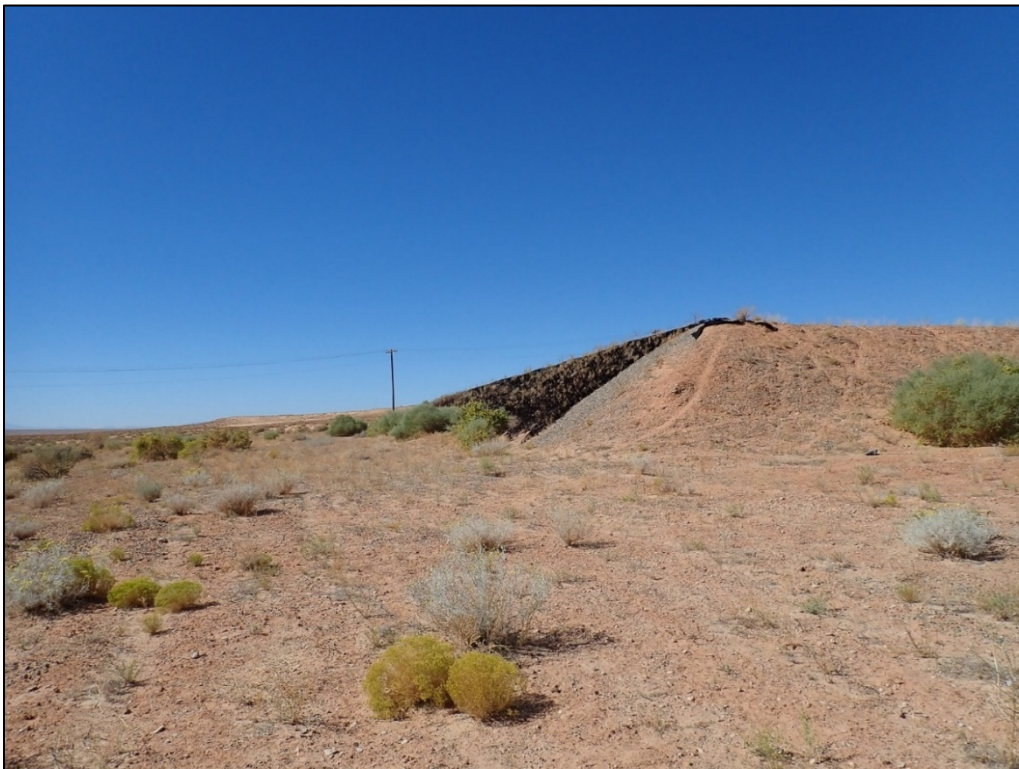
remains mostly buried and continues to stabilize the slope. Inspectors will continue to monitor this area. No other maintenance needs were identified.

PL-10. Exposed Geofabric on South Side of Inactive, Lined Evaporation Pond

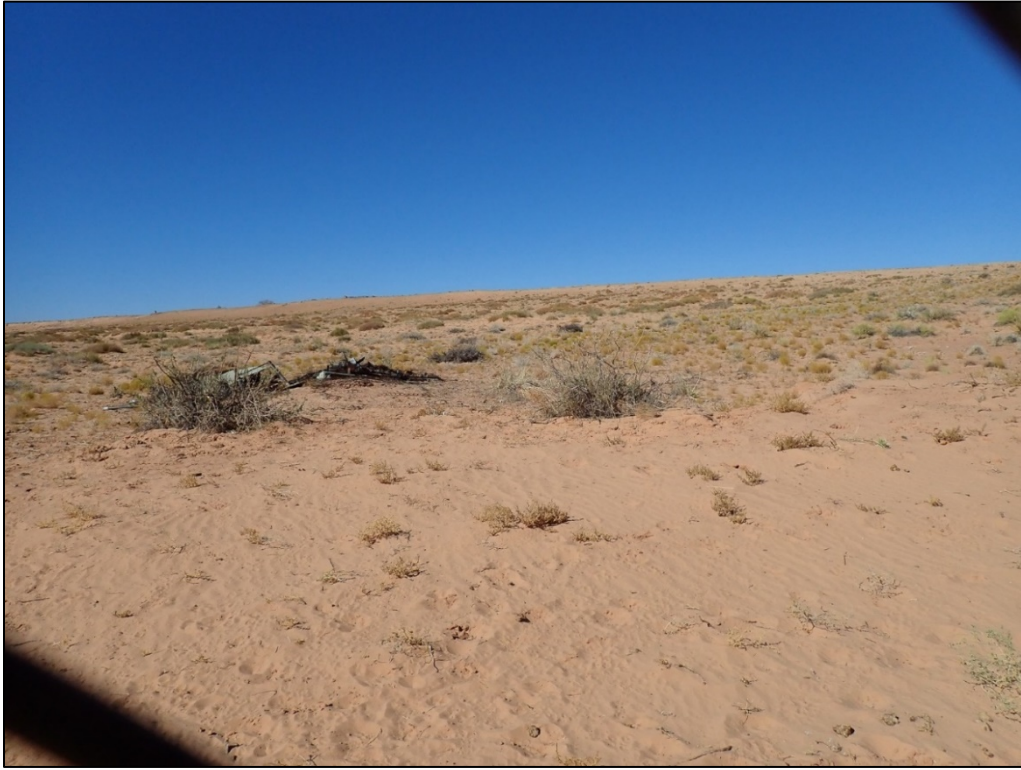
The area beyond the site boundary for a distance of 0.25 mile was visually observed for erosion, changes in land use, or other phenomena that might affect the long-term integrity of the site. A small pile of trash and debris was observed offsite on the west side near perimeter sign P9 (PL-11) and will be removed. No other issues were identified.

PL-11. Offsite Trash and Debris Pile
