SUBJECT: Transmittal of the June 2017 Fernald Quarterly Inspection Report

FERNALD PRESERVE

On-Site Disposal Facility Inspection Photographs

June 2017

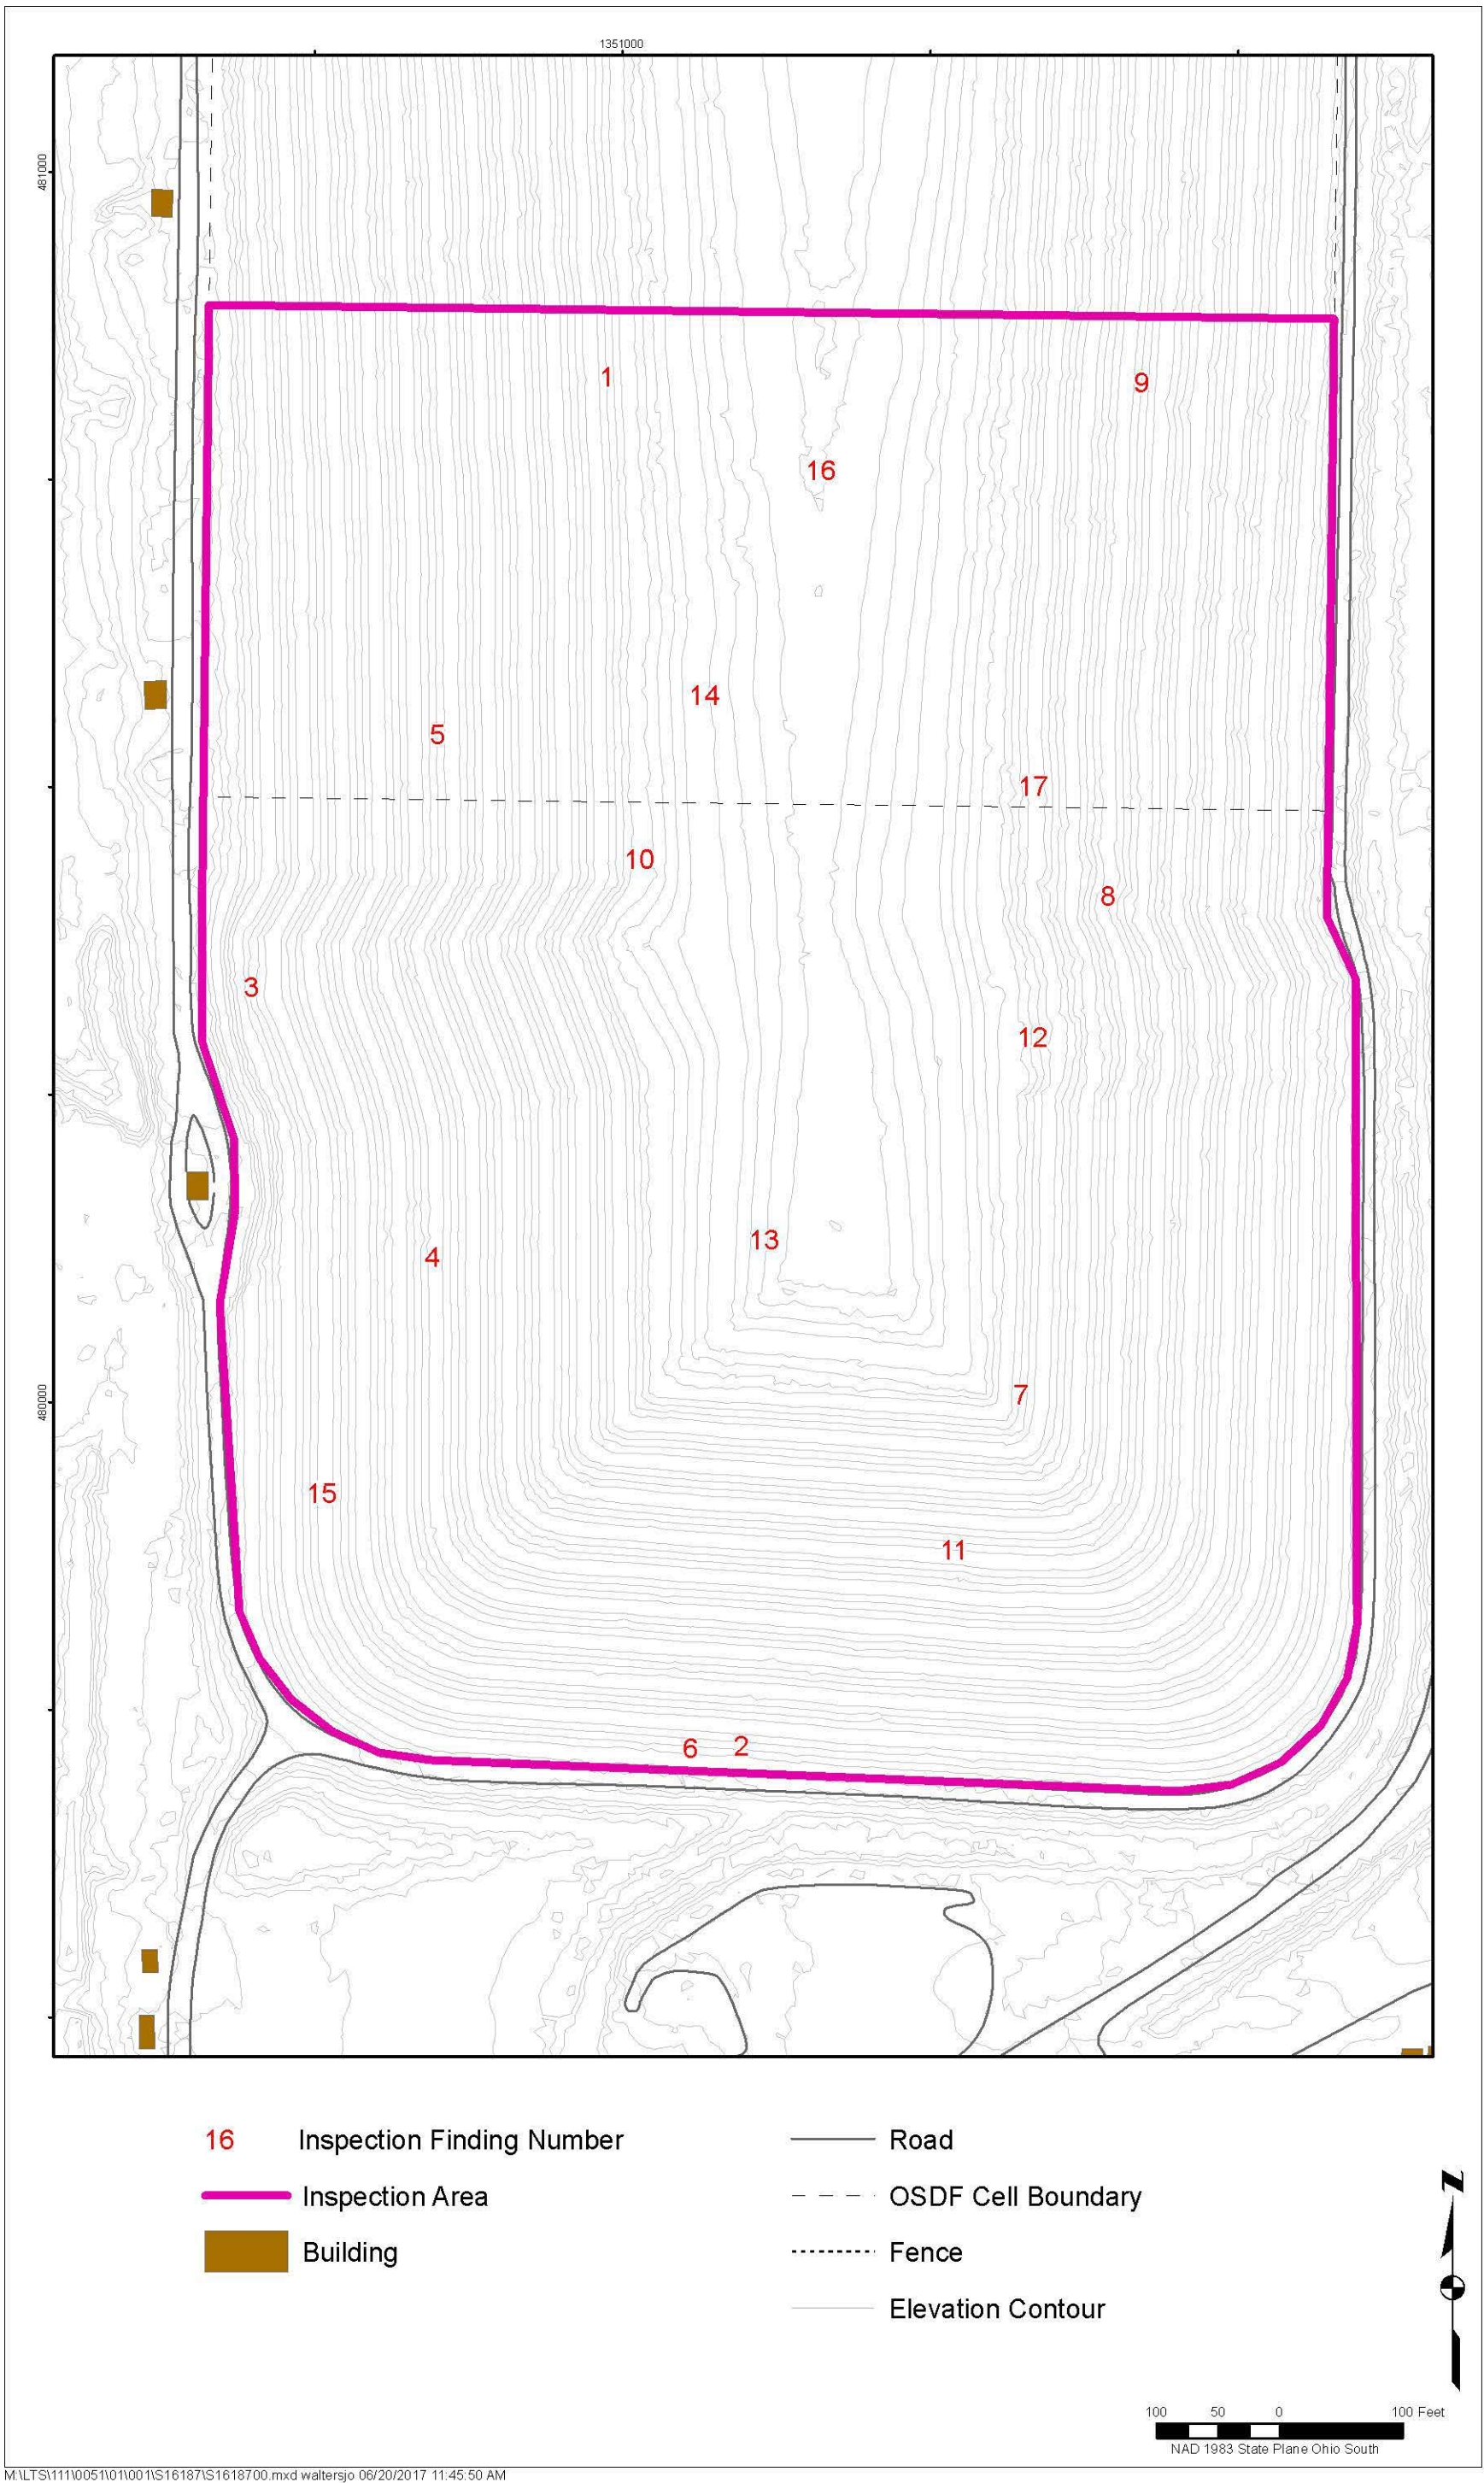
Figure 1
March 29, 2017 OSDF Cells 7 and 8 Post Burn Inspection Findings

The OSDF prescribed burn follow-up inspection of cell caps 7 and 8 took place on March 29 (Figure 1). The inspection included a walk-over of both cell caps. Findings included debris, animal burrows and invasive vegetation. Inspecting the caps following a burn allows for a more thorough inspection of the cap, as all vegetation and thatch have been removed. Findings such as debris, animal burrows, erosion, and rocks, are more visible and easier to identify. Under normal circumstances, the vegetation on the cap obstructs the view of the cap surface.

Map No.	Location	GPS?	Type of Finding	Description	Photo (See Additional Notes)
1	Cell 7, top west 6:1 slope	Yes	Debris	Debris - glazed tile and concrete	03292017_40_01
2	Cell 8, south face	Yes	Rock	Several, 2 flagged	03292017_40_02
3	Cell 8, west toe	No	Other	Matting	
4	Cell 8, middle of west slope	No	Biointrusion	Appears animal was digging for rodents	
5	Cell 7, middle west slope	No	Vegetation	Teasel patch	
6	Cell 8, south toe	No	Debris	Brick	
7	Cell 8, east slope	No	Debris	Asphalt	
8	Cell 8, east slope	No	Vegetation	Teasel patch	
9	Cell 7, east slope	No	Vegetation	Teasel patch	
10	Cell 7, west side near top	Yes	Debris	2 bricks	03292017_42_01; 03292017_42_02
11	Cell 8, south east slope	Yes	Rock	2 rocks, flag between them	03292017_42_03; 03292017_42_04
12	Cell 8, top	No	Vegetation	Teasel	
13	Cell 8, top	No	Vegetation	Teasel

Map No.	Location	GPS?	Type of Finding	Description	Photo (See Additional Notes)
14	Cell 7, west slope near top	Yes	Biointrusion	Animal burrow	03292017_43_01
15	Cell 8, west slope	Yes	Biointrusion	Animal burrow	03292017_41_01
16	Cell 7, top	No	Vegetation	Teasel	
17	Cell 7, east slope at south end	No	Vegetation	Teasel

1.) This inspection was a walk-down of Cell Caps 7 and 8, following a prescribed burn of the same area on March 9, 2017. 2.) The files listed in the "Photo" column are photographs of the individual findings and are used for field identification. The photographs are available upon request.

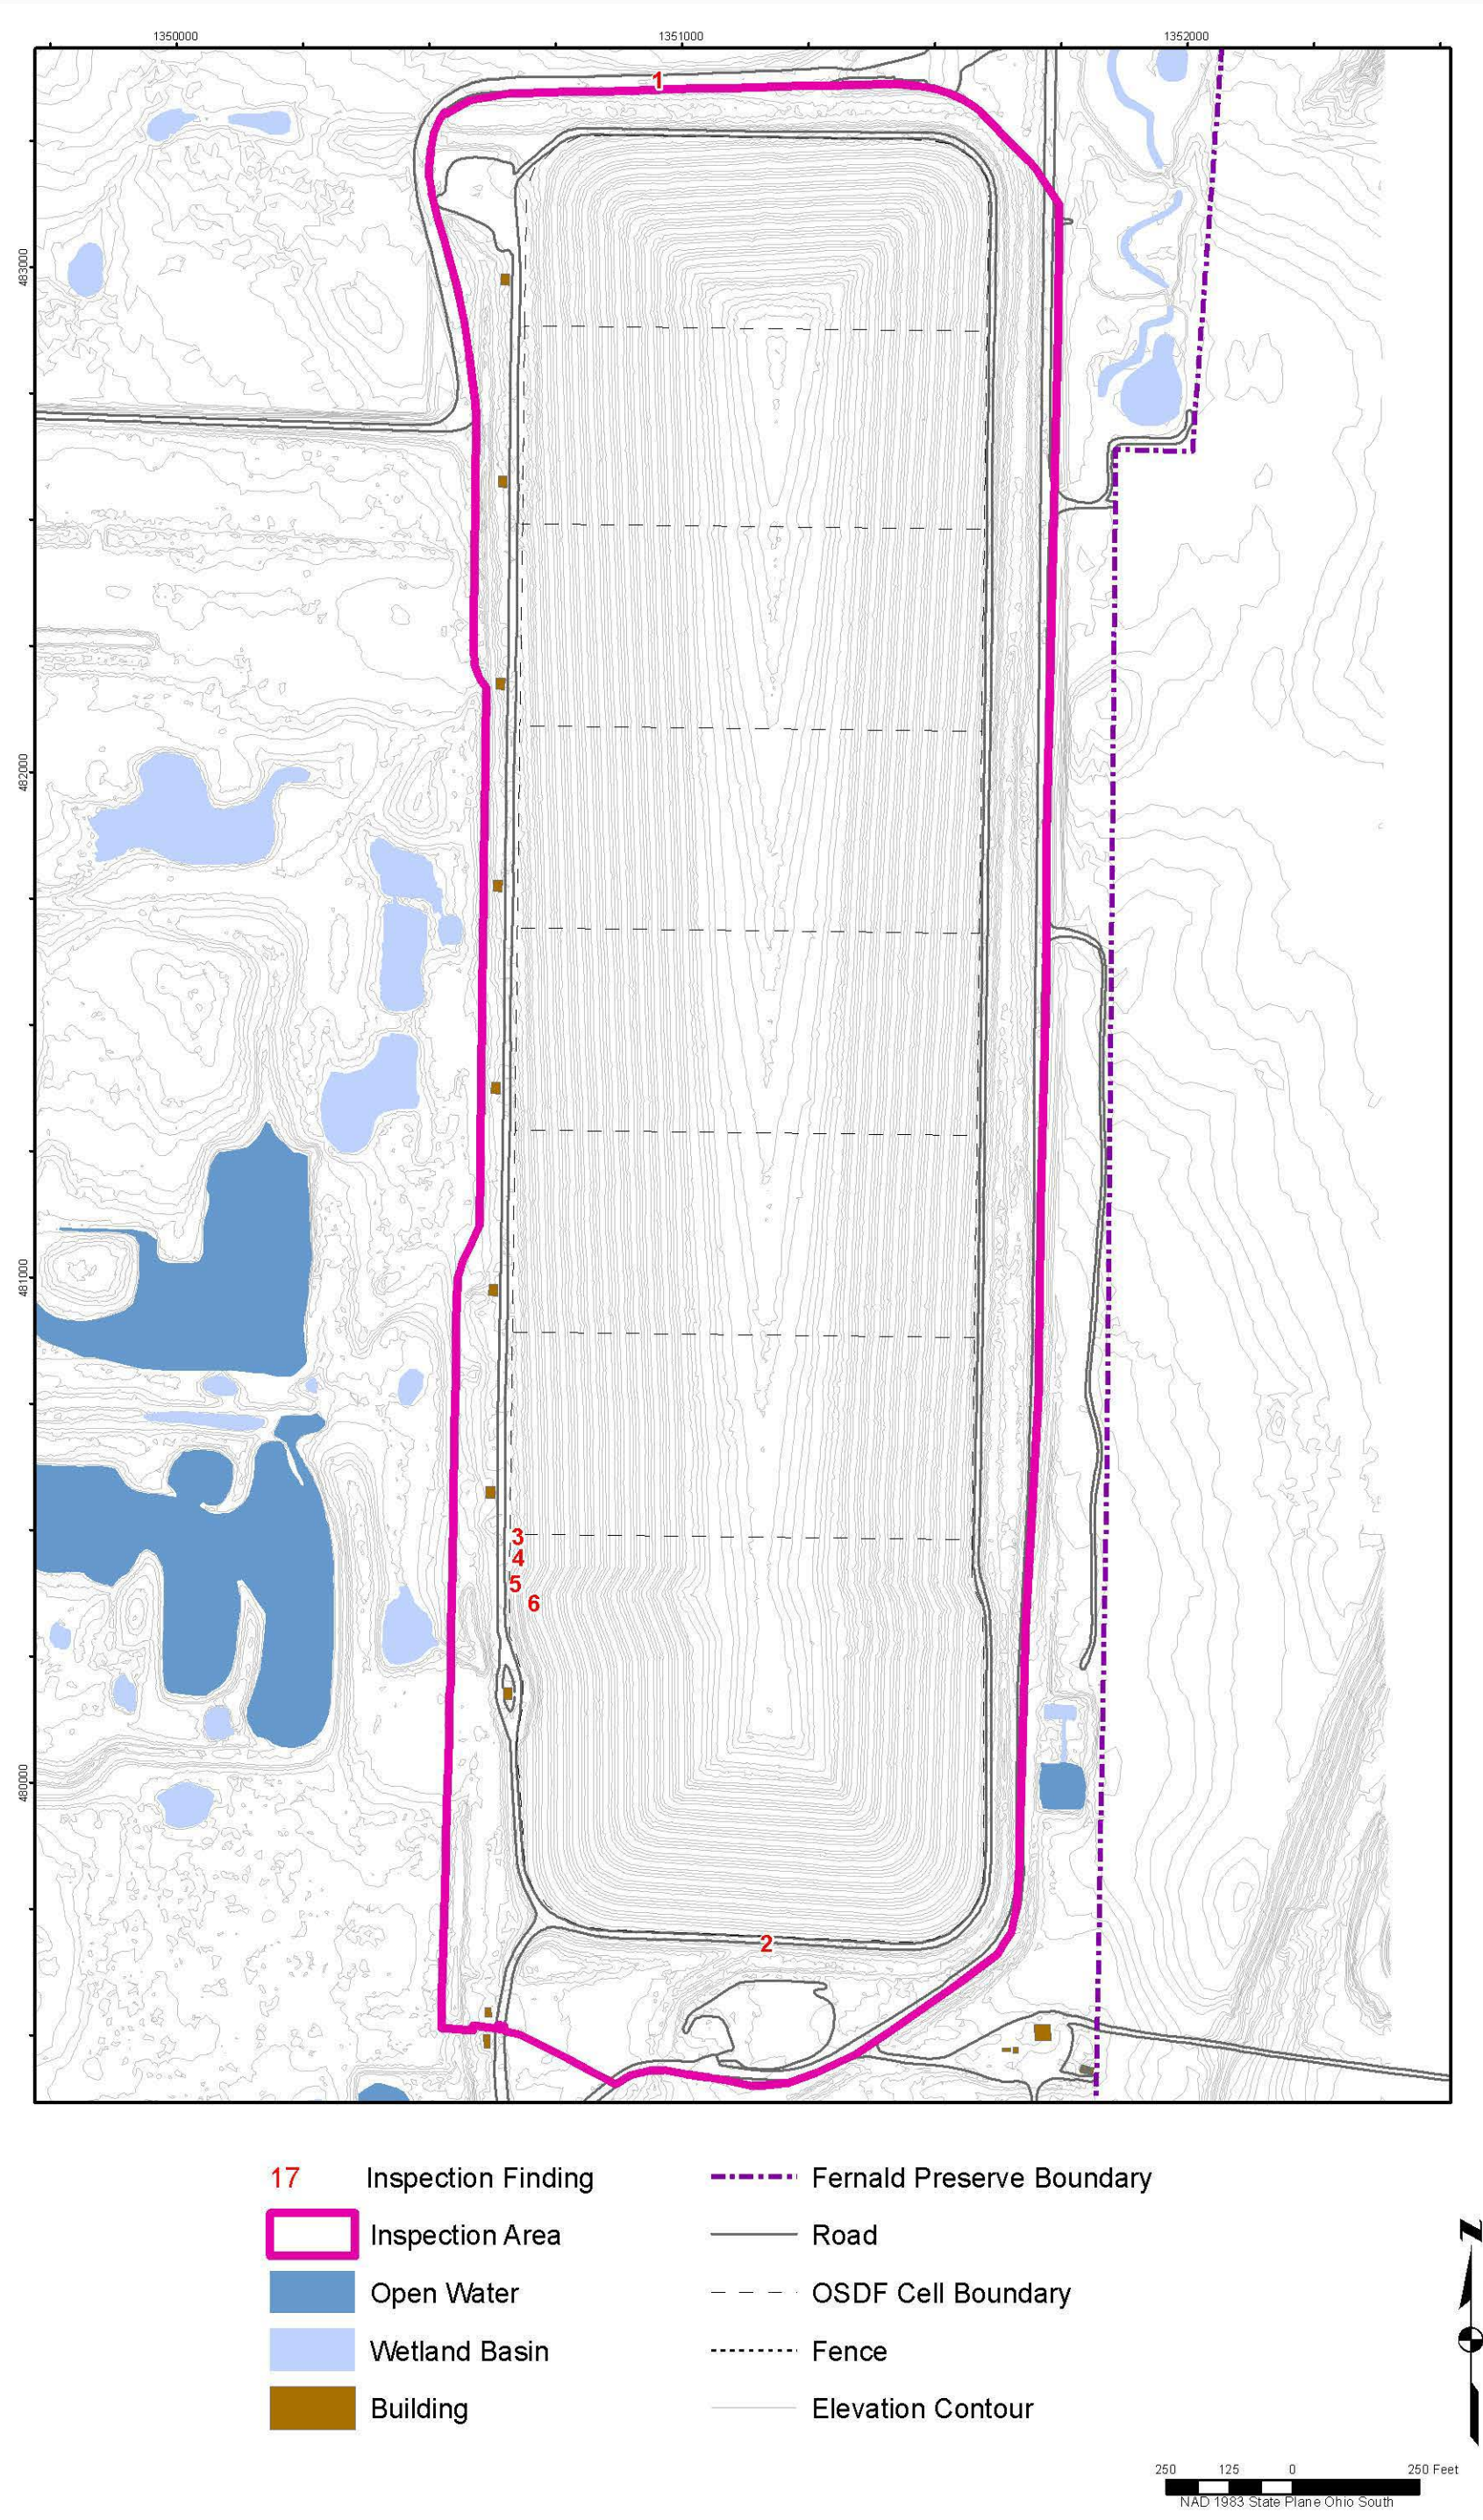
Figure 2
June 7, 2017 OSDF Inspection Findings

The June 2017 OSDF inspection took place on June 7 and included a walk-down inspection of the OSDF toe, drainages, and fence line (Figure 2). There were numerous findings of unwanted vegetation, both herbaceous and woody, in the drainages and along the toe. Each individual vegetation finding is not identified on the map. Herbicide will be applied to all unwanted vegetation. There are also a couple of animal burrows that need repaired as well as some erosion on the access road and at an old animal burrow.

Map No.	Location	GPS?	Type of Finding	Description	Photo (See Additional Notes)
1	Cell 1, west end of north fenceline	Yes	Signage	Radiological control sign fell off fence	06072017_41_02
2	Cell 8, gravel roadway along south face	No	Erosion	The gravel road is developing an erosion rill, washing gravel into south drainage	
3	Cell 7/8 boundary at west toe	No	Biointrusion	2 goundhog holes	
4	Cell 8, west toe at riprap	No	Erosion	Erosion at old groundhog hole	
5	Cell 8, west toe	No	Rock	Rocks	
6	Cell 8, west toe	Yes	Biointrusion	Groundhog hole	06072017_44_01
NA	Outer drainage	No	Vegetation	Invasive herbaceous and unwanted woody vegetation	
NA	West inner drainage	No	Vegetation	Invasive herbaceous and unwanted woody vegetation	
NA	Toe of OSDF	No	Vegetation	Invasive herbaceous and unwanted woody vegetation

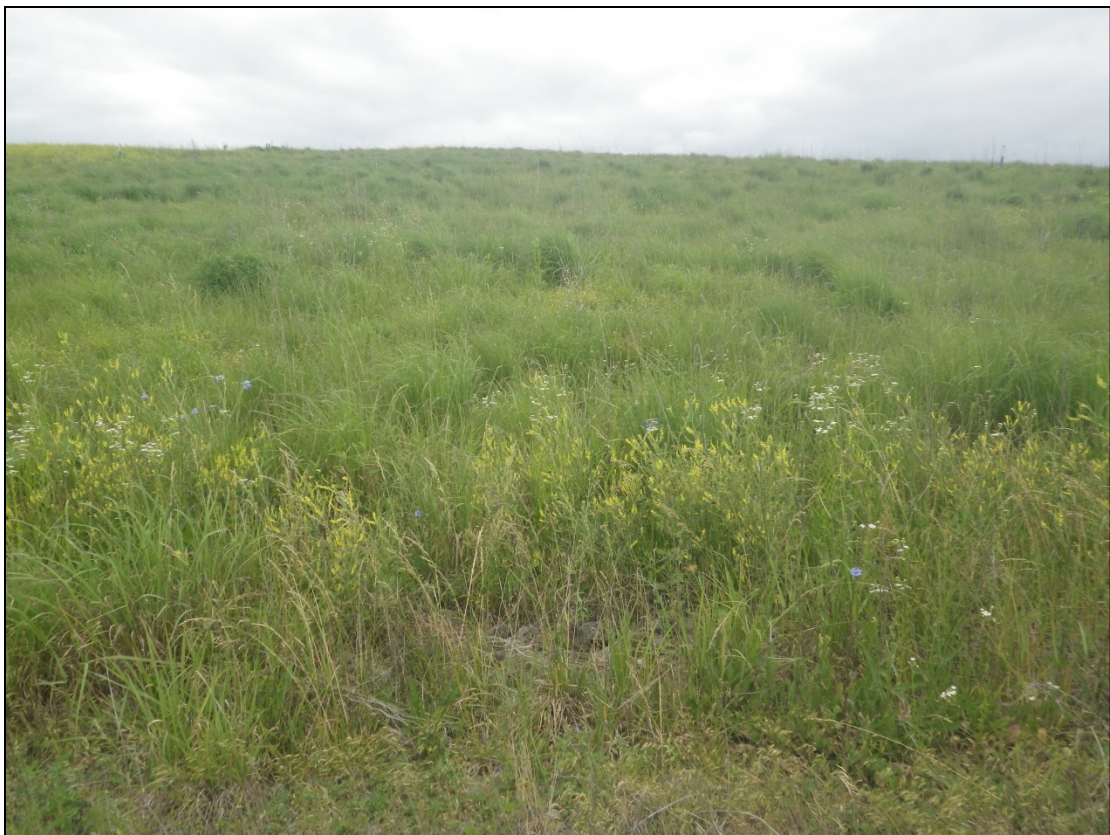
IMGP6196

East Face Cell 1

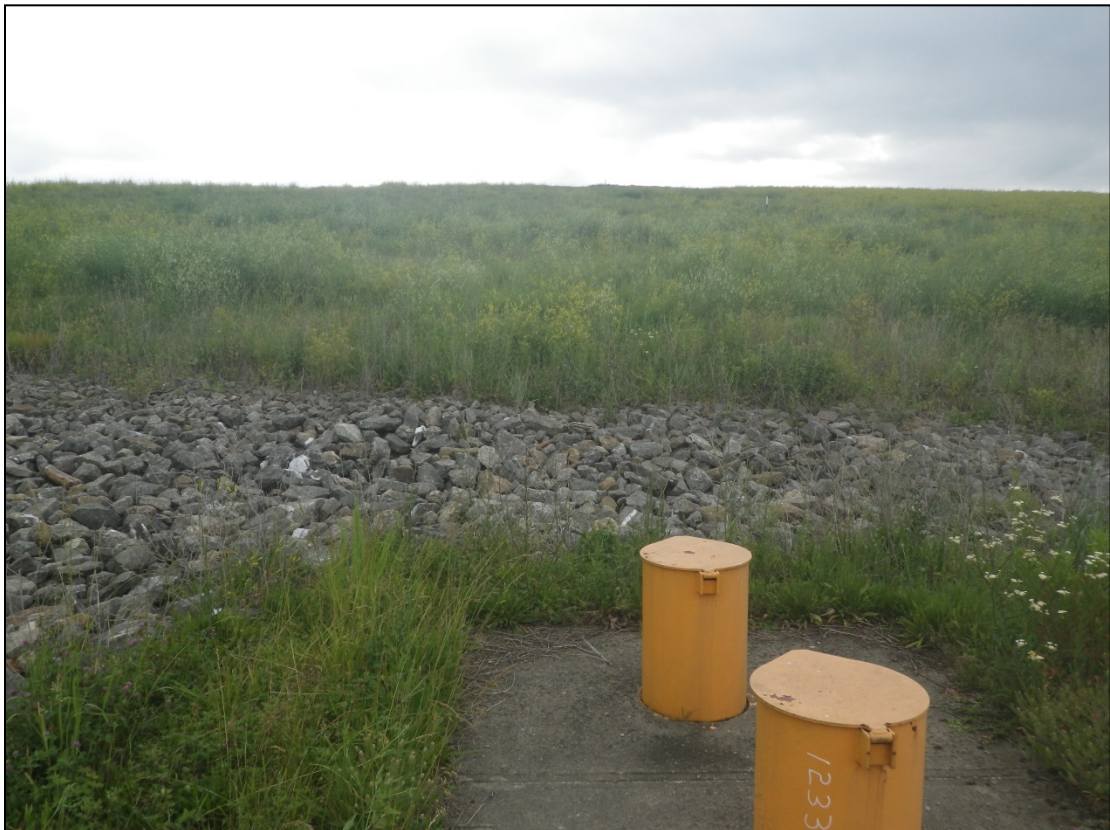
IMGP6173

West Face Cell 1

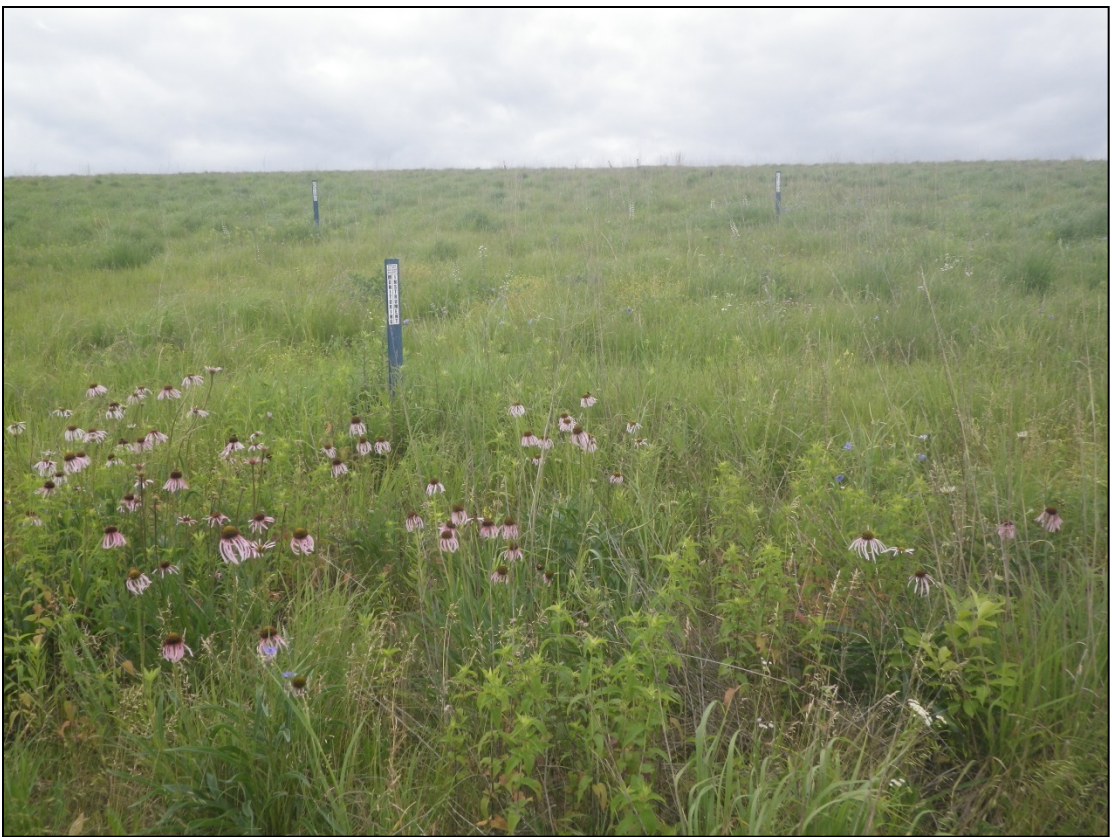
IMGP6199

North Face Cell 1

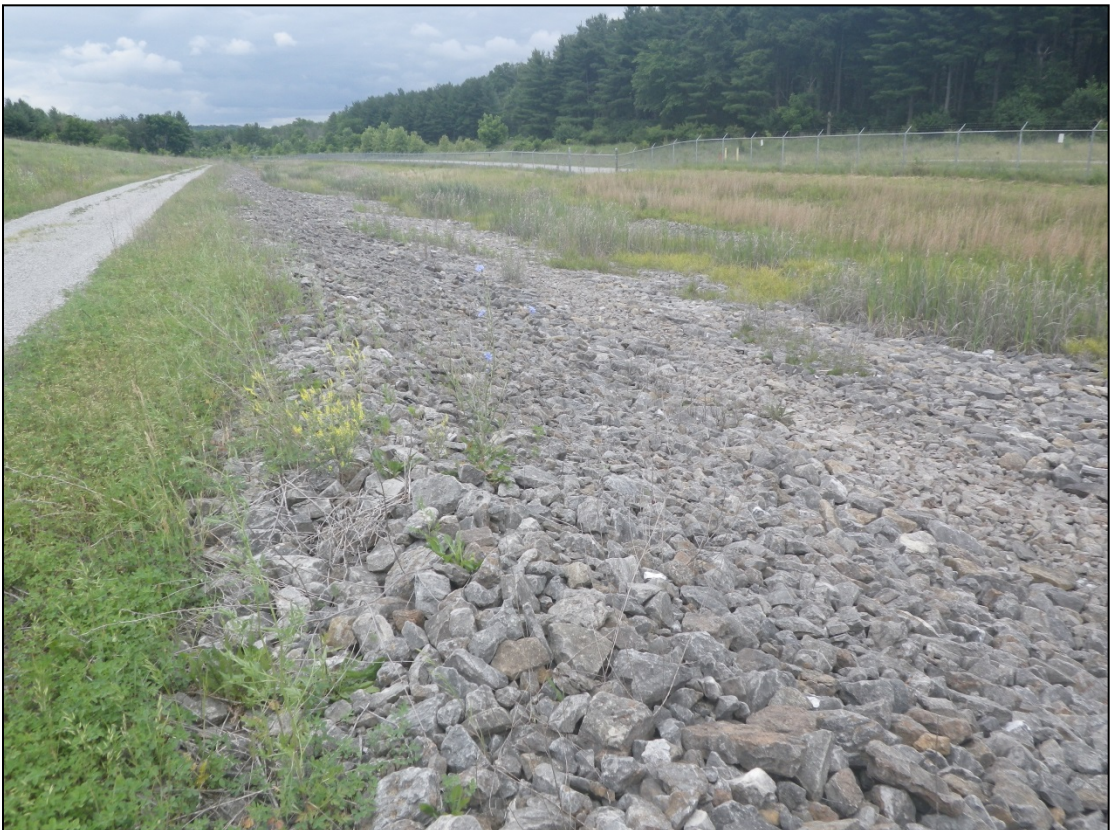
IMGP6198

North Drainage (looking west)

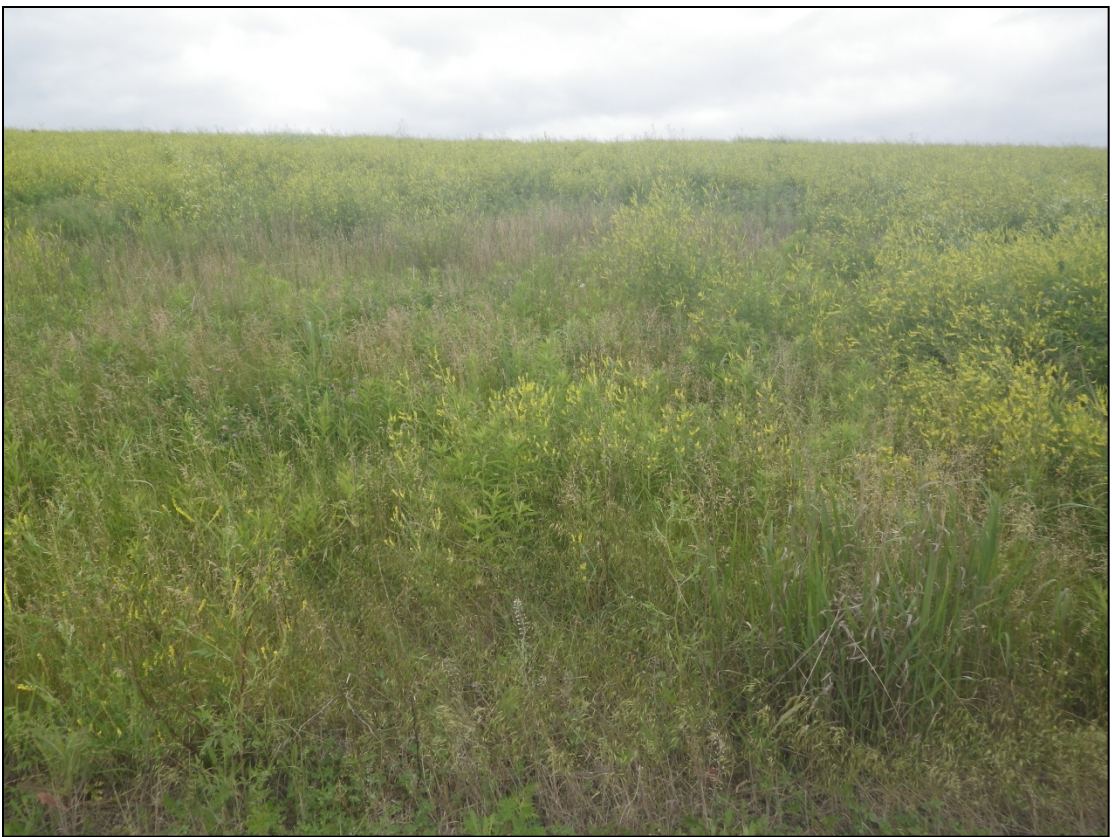
IMGP6195

East Face Cell 2

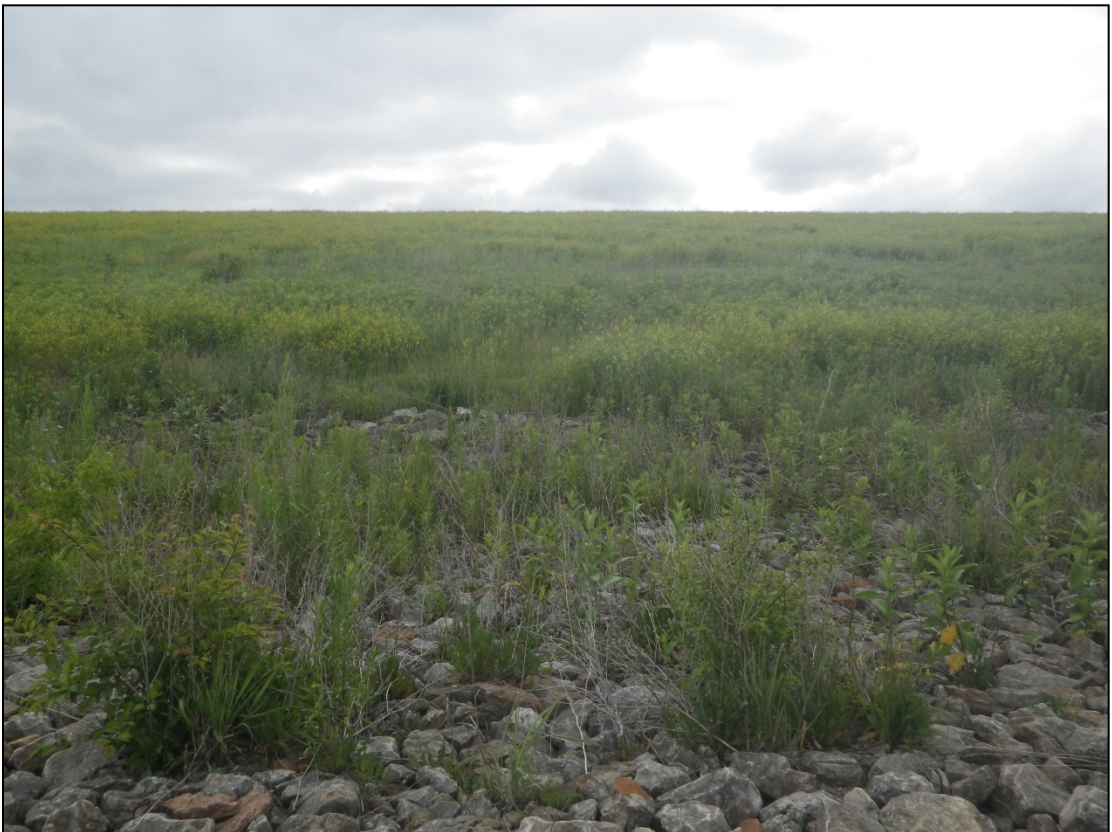
IMGP6174

West Face Cell 2

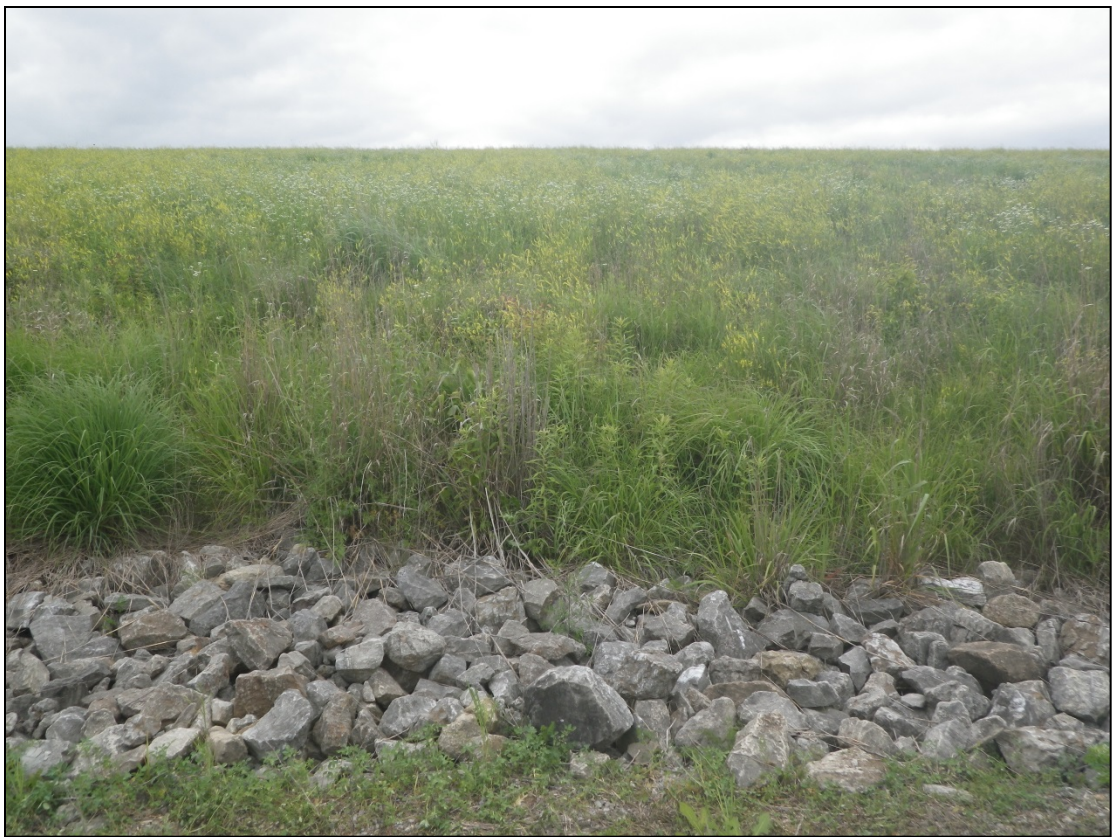
IMGP6194

East Face Cell 3

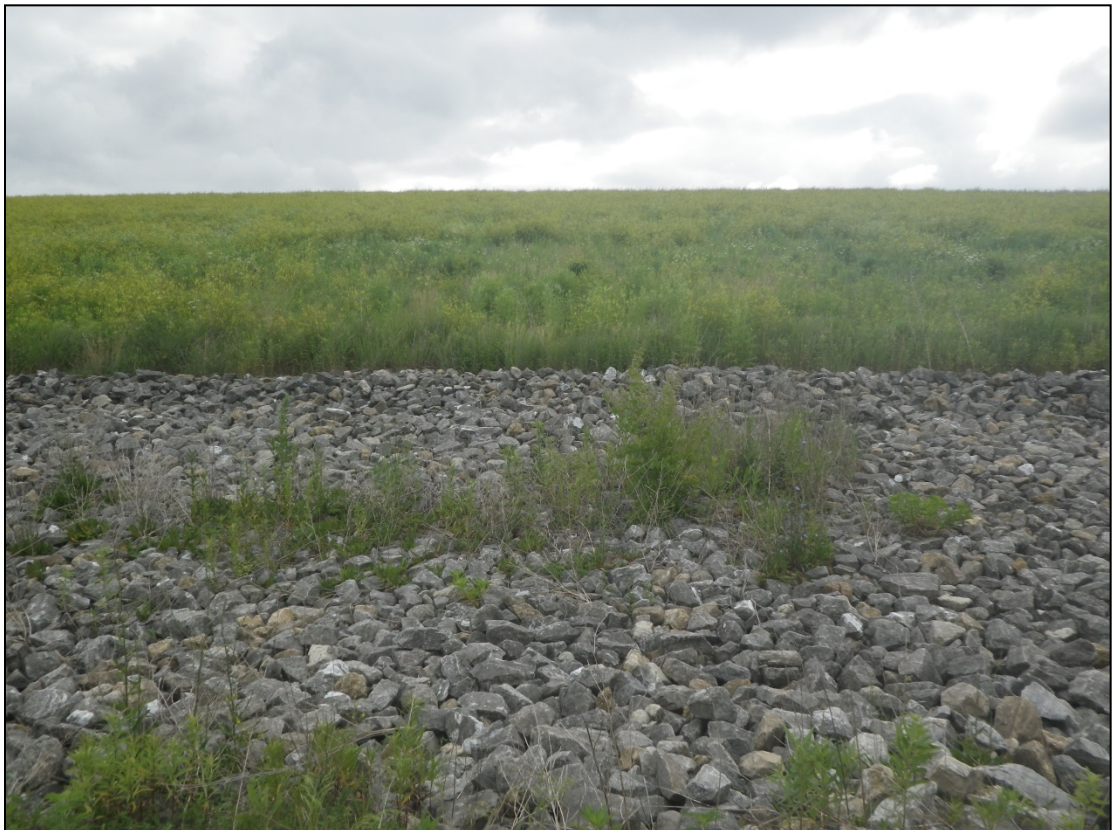
IMGP6175

West Face Cell 3

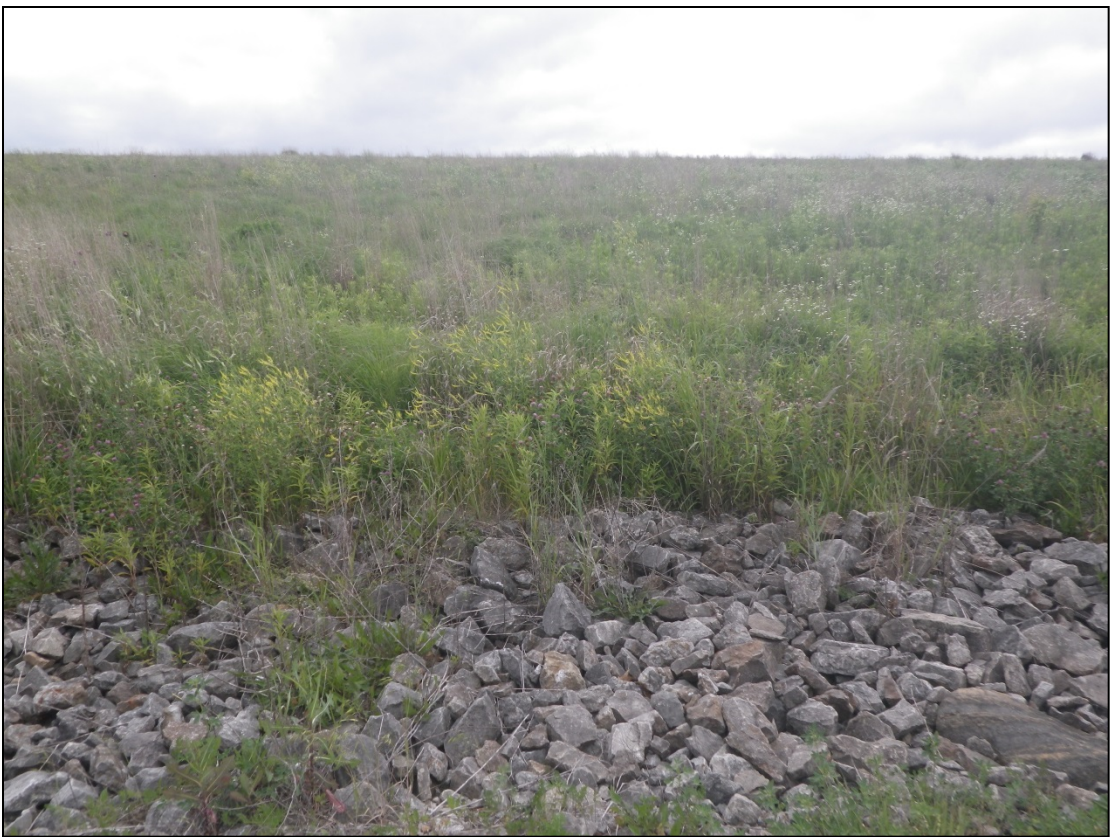
IMGP6192

East Face Cell 4

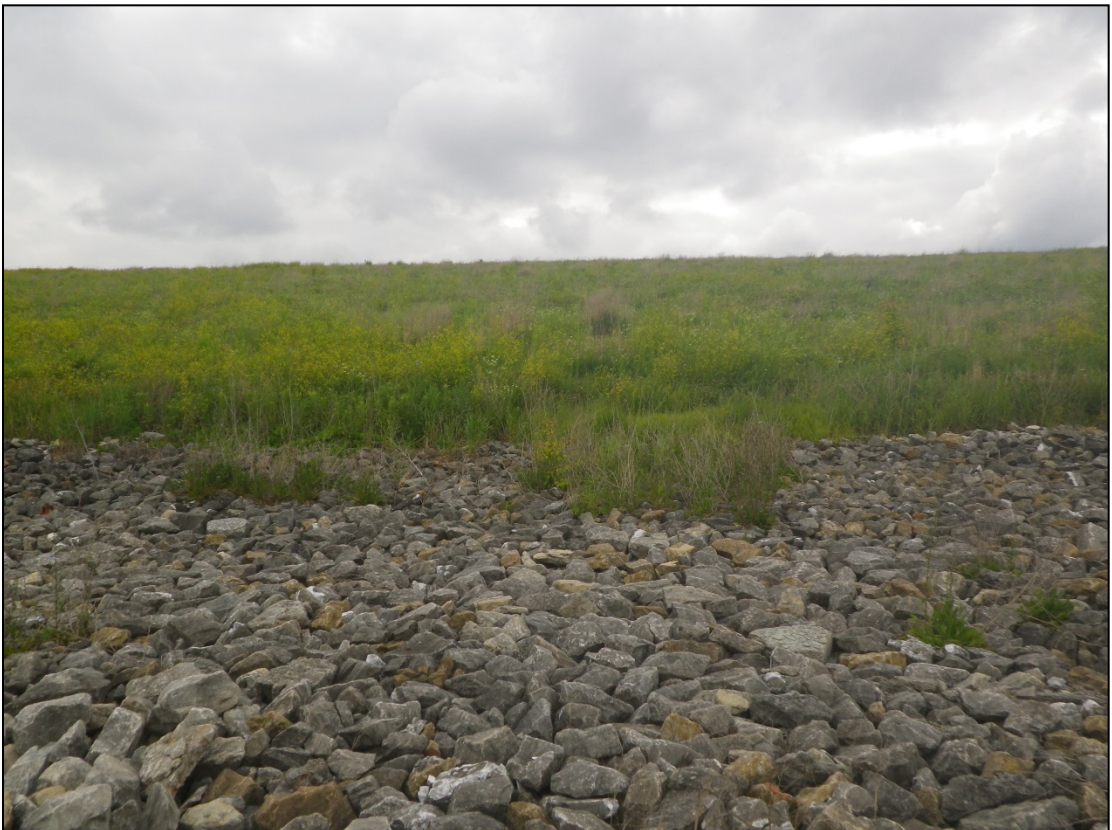
IMGP6176

West Face Cell 4

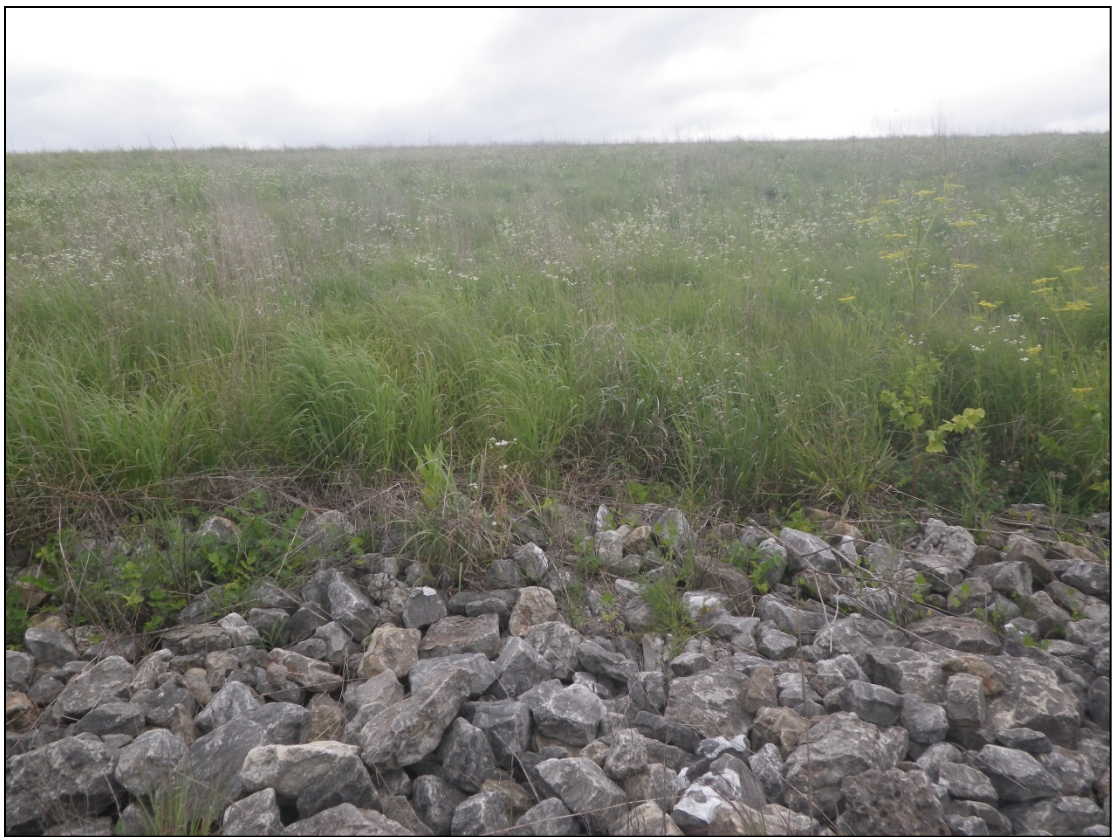
IMGP6191

East Face Cell 5

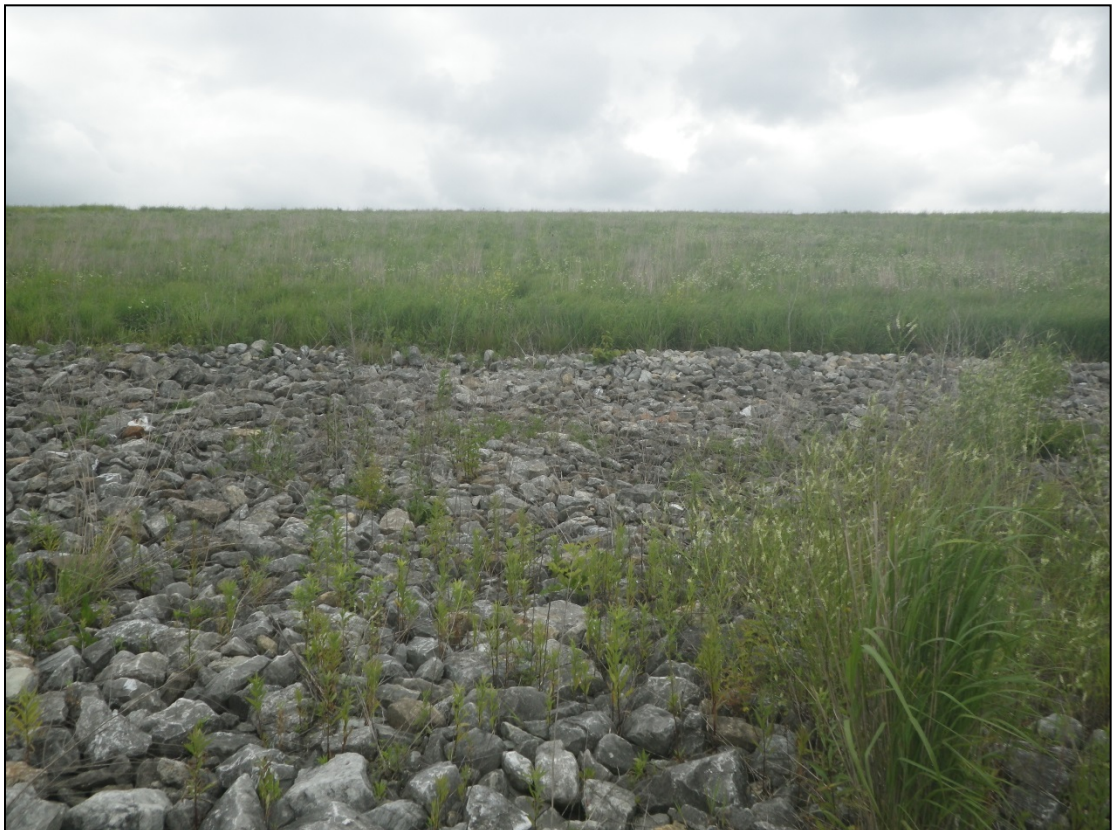
IMGP6178

West Face Cell 5

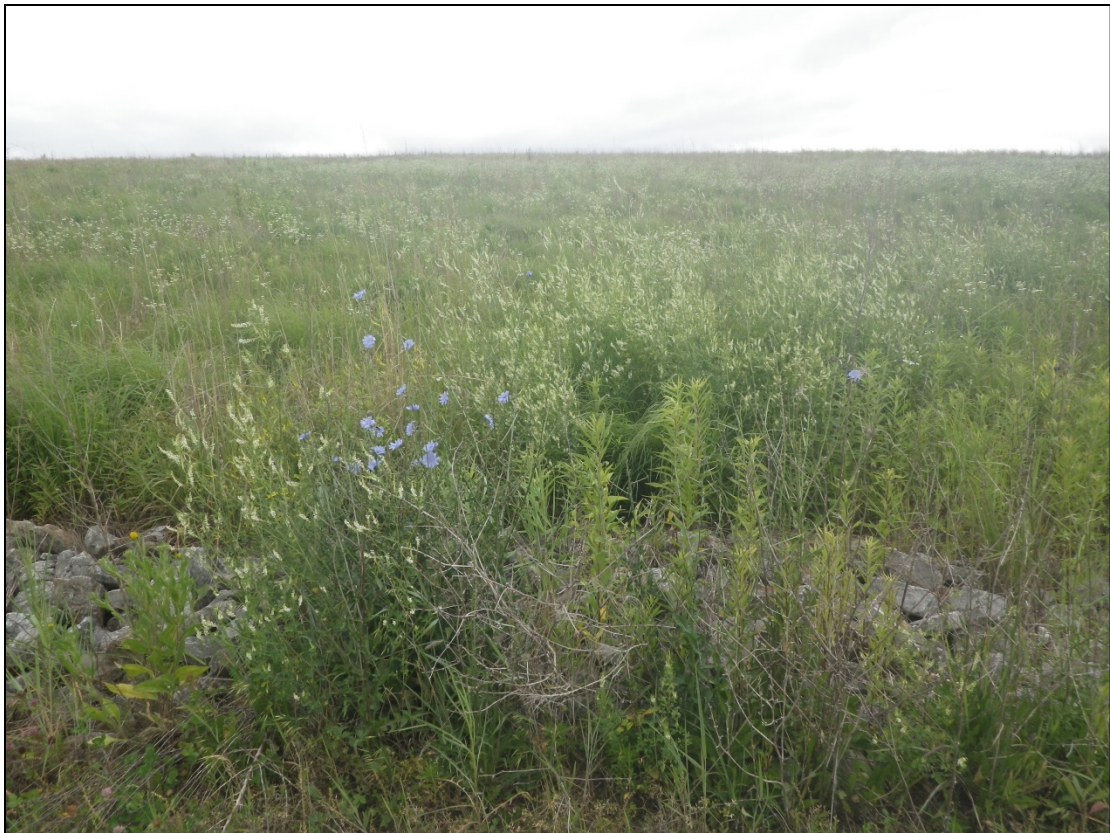
IMGP6190

East Face Cell 6

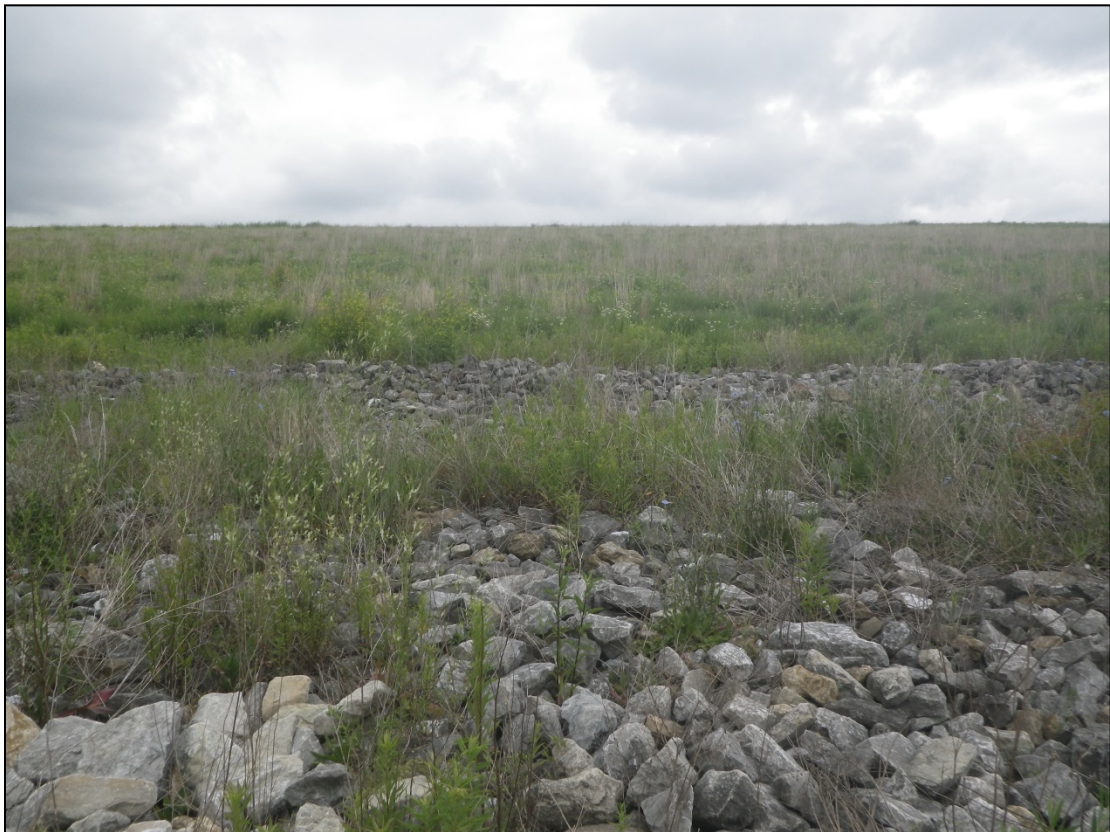
IMGP6179

West Face Cell 6

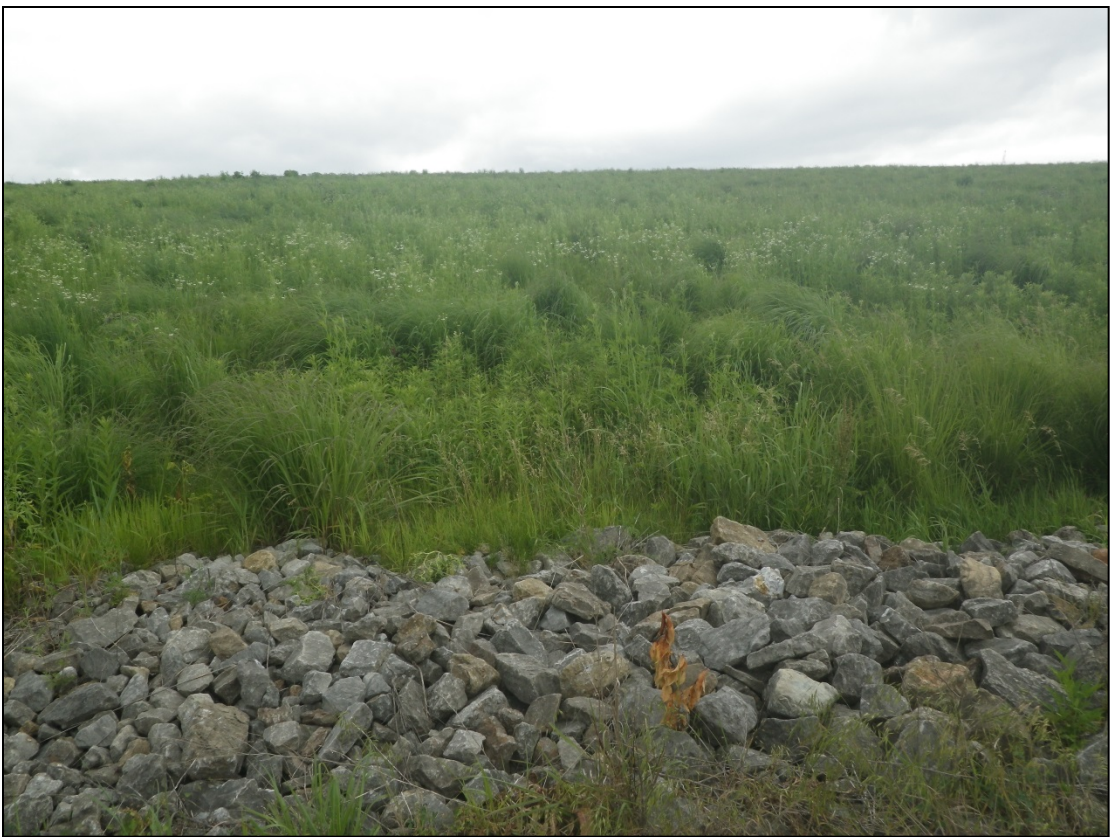
IMGP6188

East Face Cell 7
