SUBJECT: Transmittal of the June 2017 Fernald Quarterly Inspection Report

FERNALD PRESERVE

On-Site Disposal Facility Inspection Photographs

June 2017

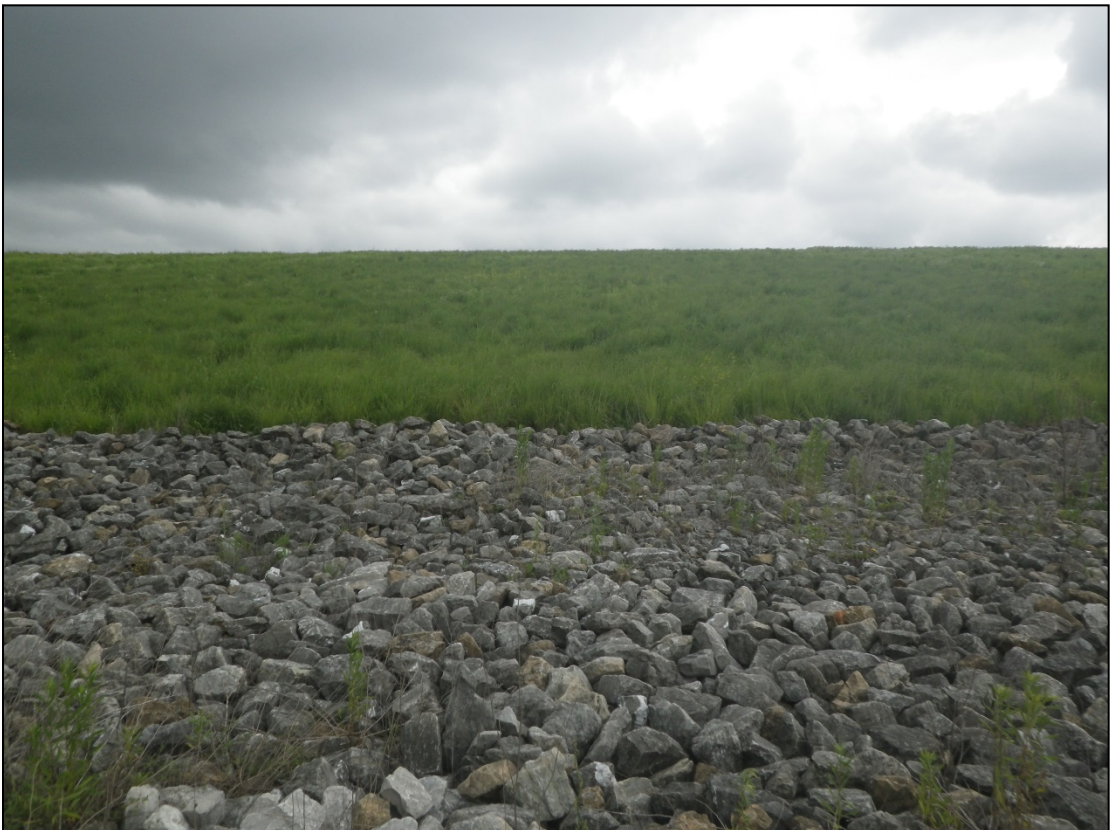
IMGP6180

West Face Cell 7

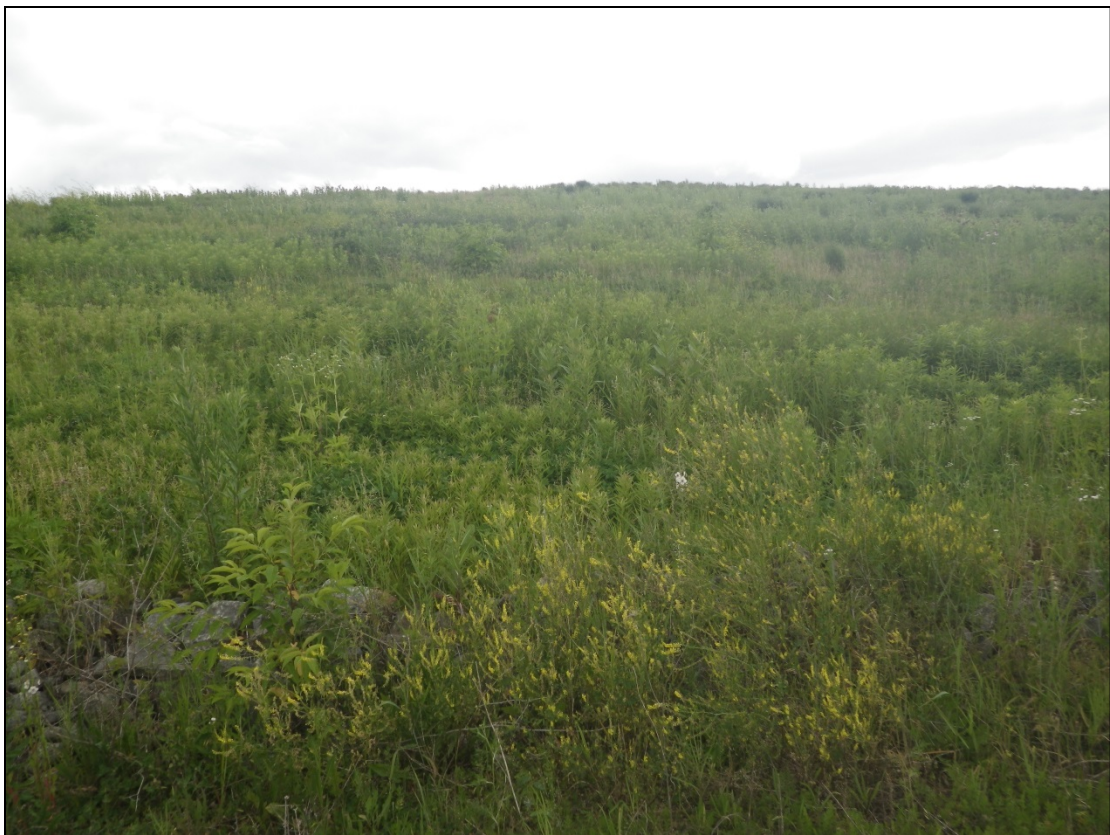
IMGP6187

East Face Cell 8

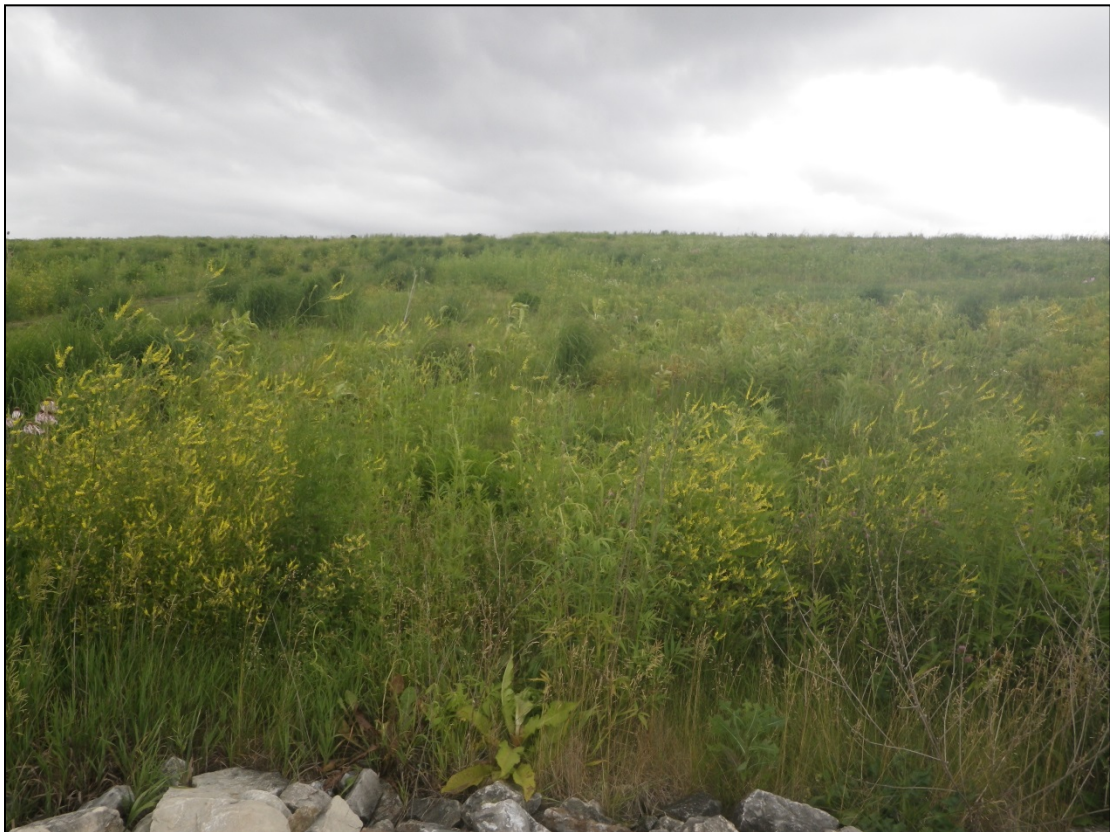
IMGP6184

West Face Cell 8

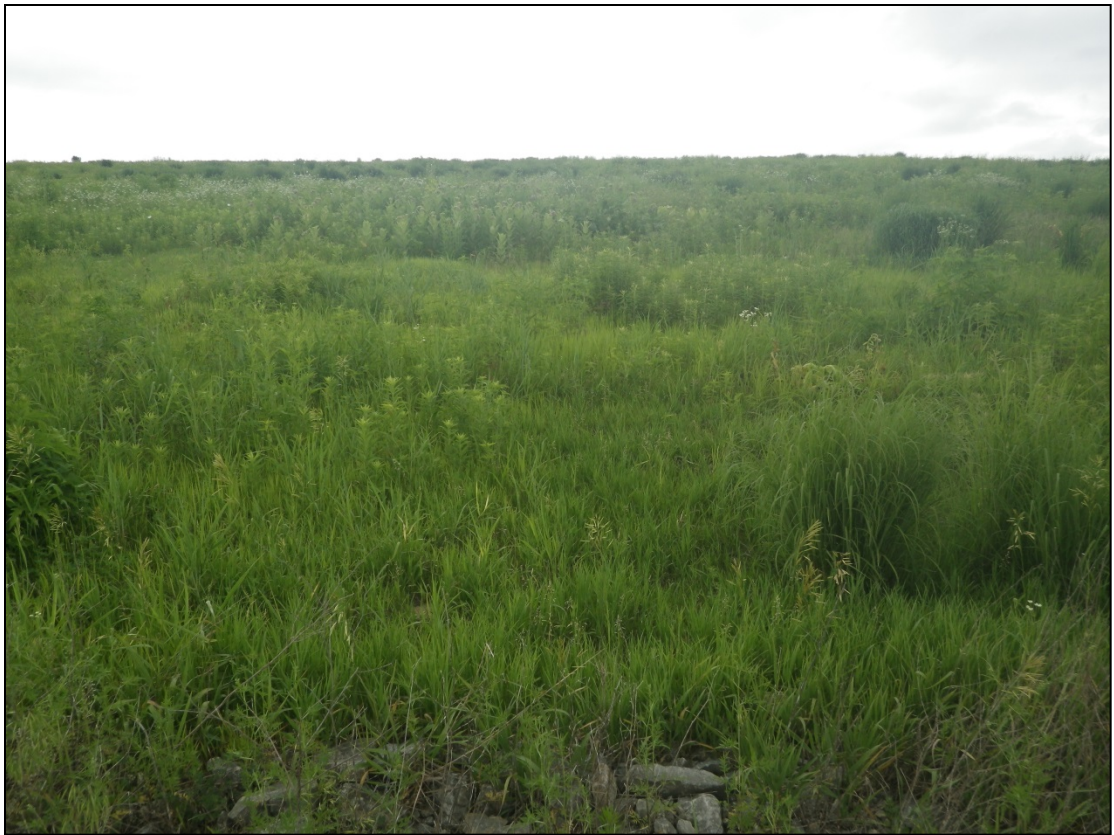
IMGP6185

South Face Cell 8

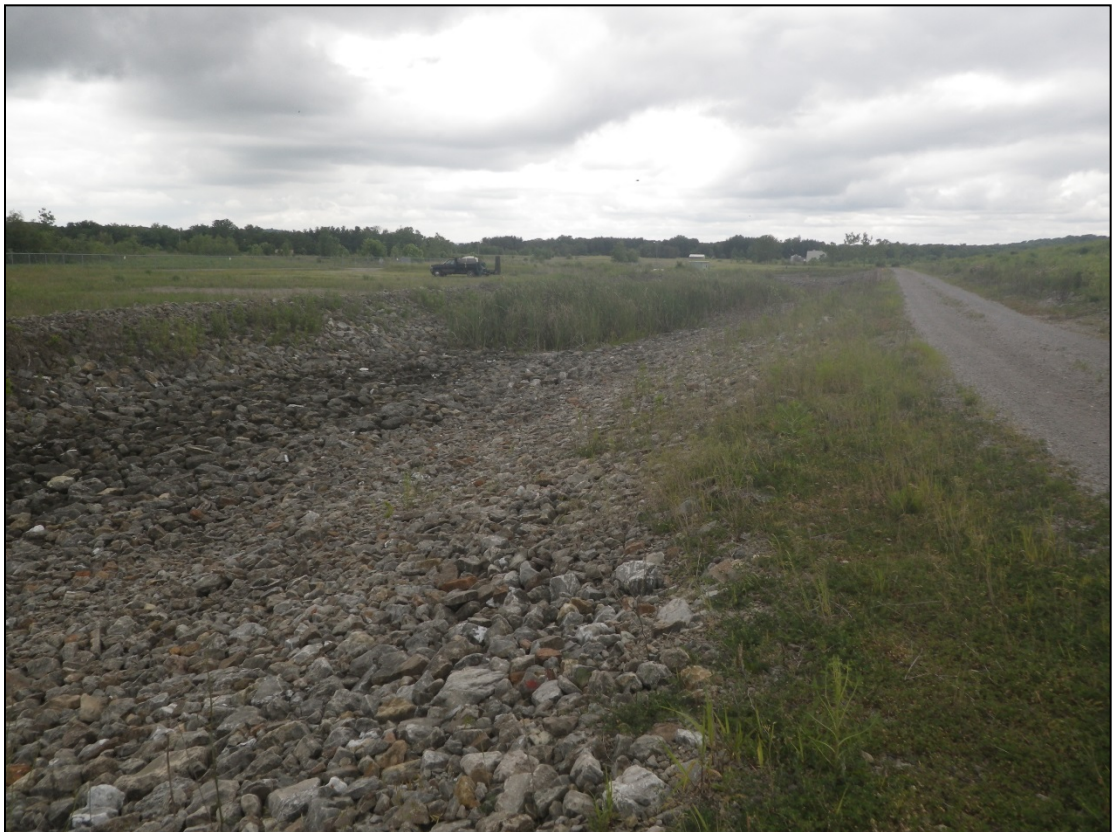
IMGP6186

South Drainage (looking west)

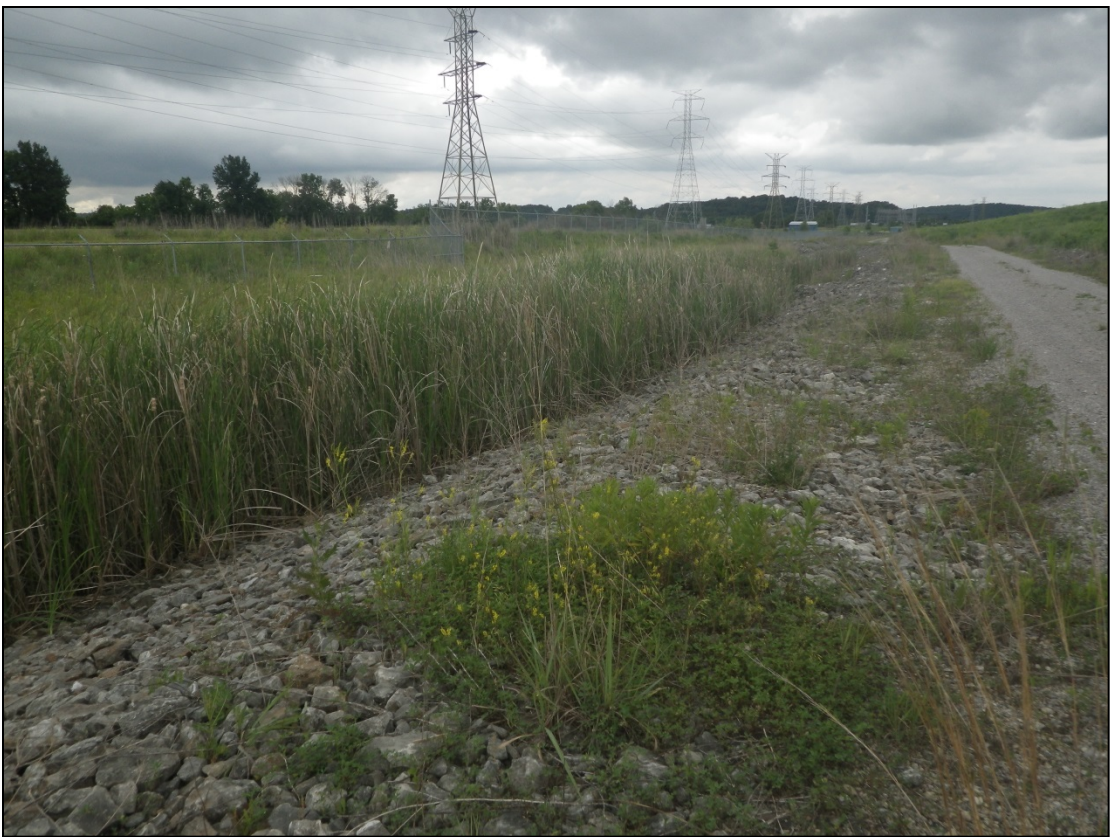
IMGP6189

East Drainage Cell 7 (looking south)

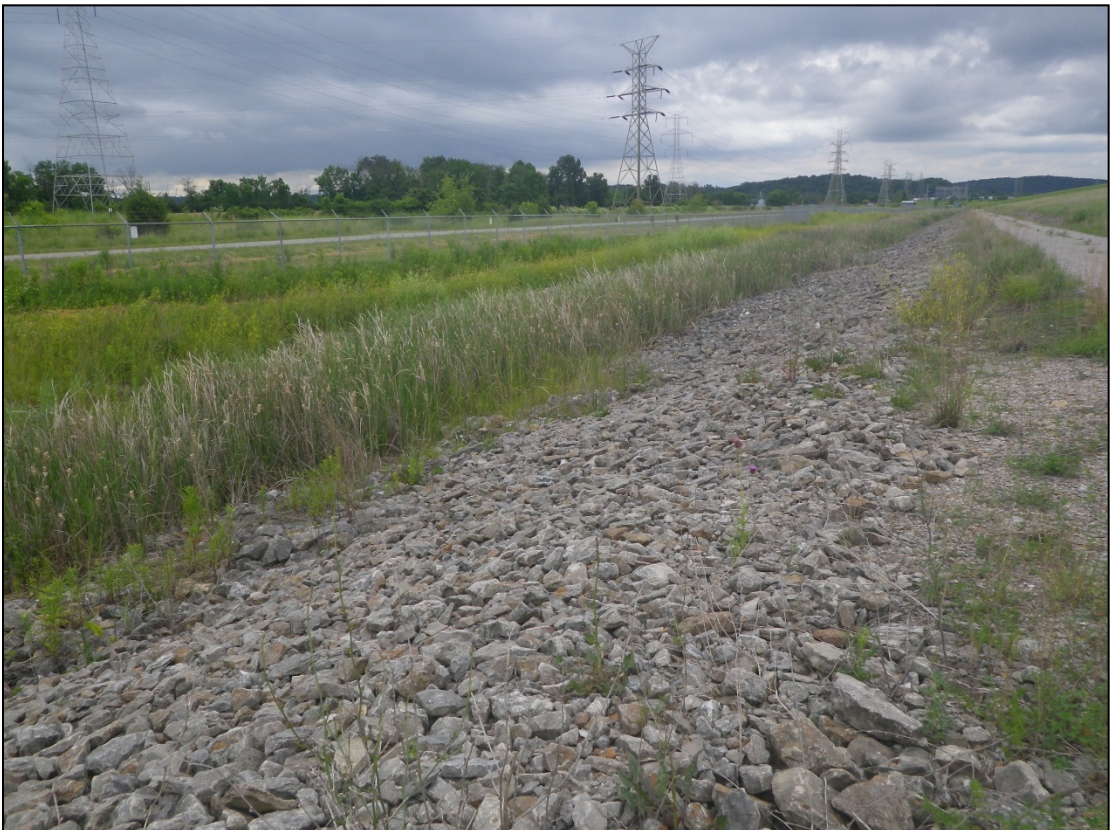
IMGP6193

East Drainage Cell 4 (looking south)

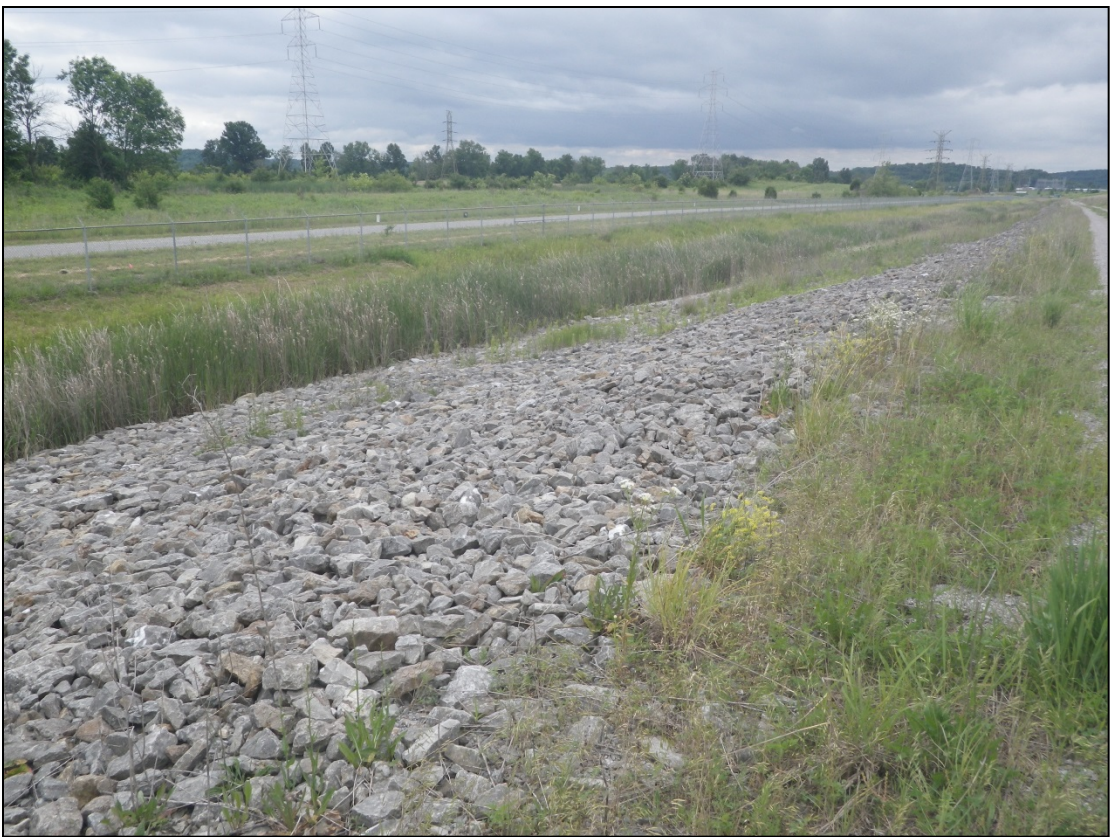
IMGP6197

East Drainage Cell 1 (looking south)

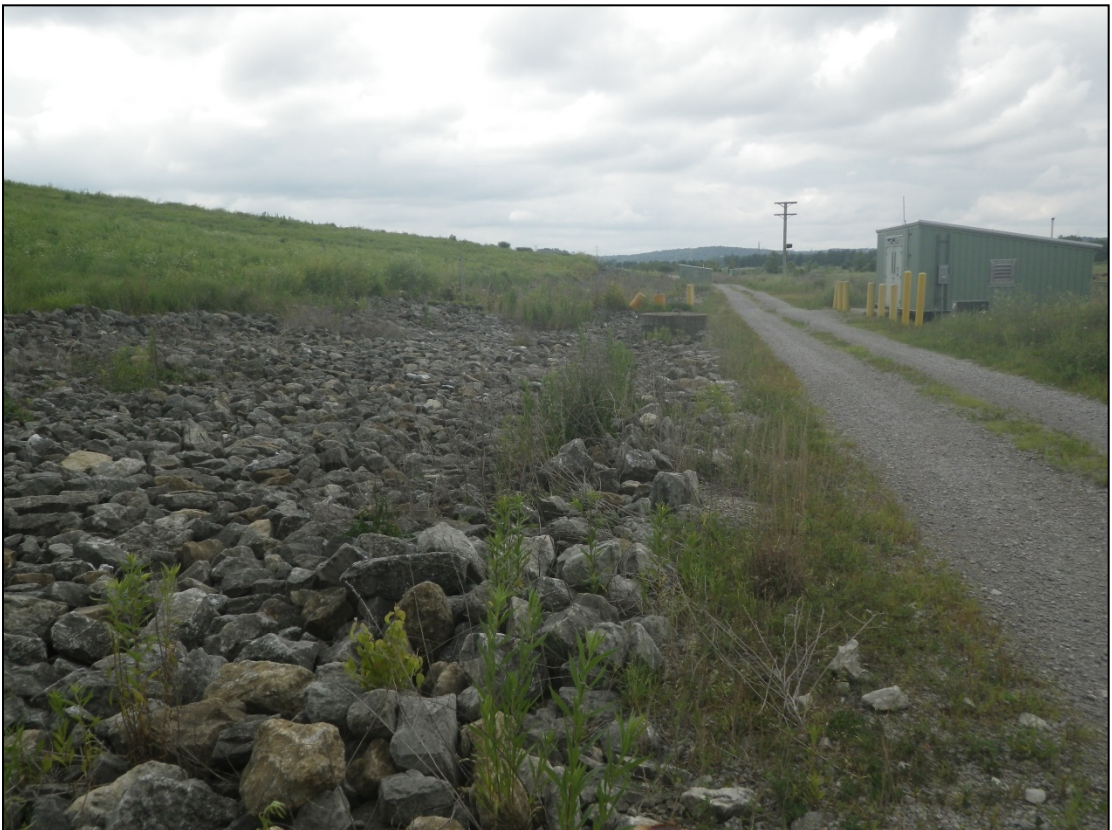
IMGP6181

West Inner Drainage Cell 7 (looking south)

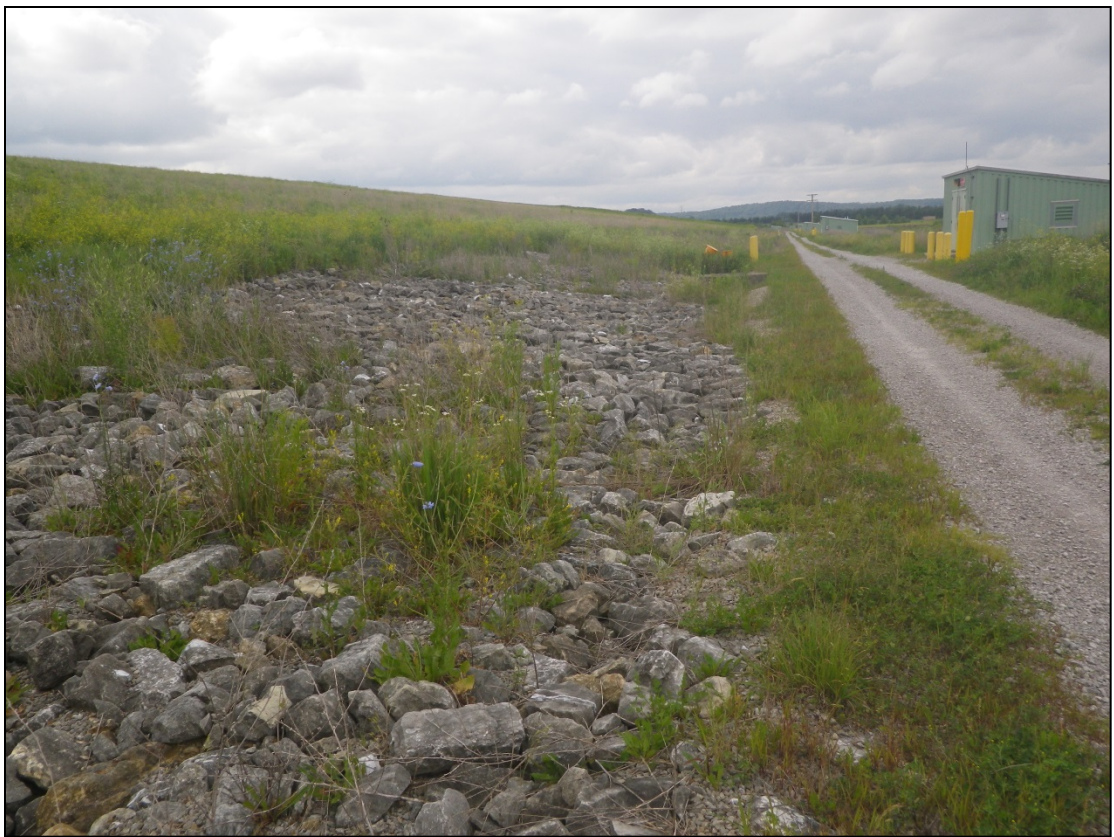
IMGP6177

West Inner Drainage Cell 4 (looking south)

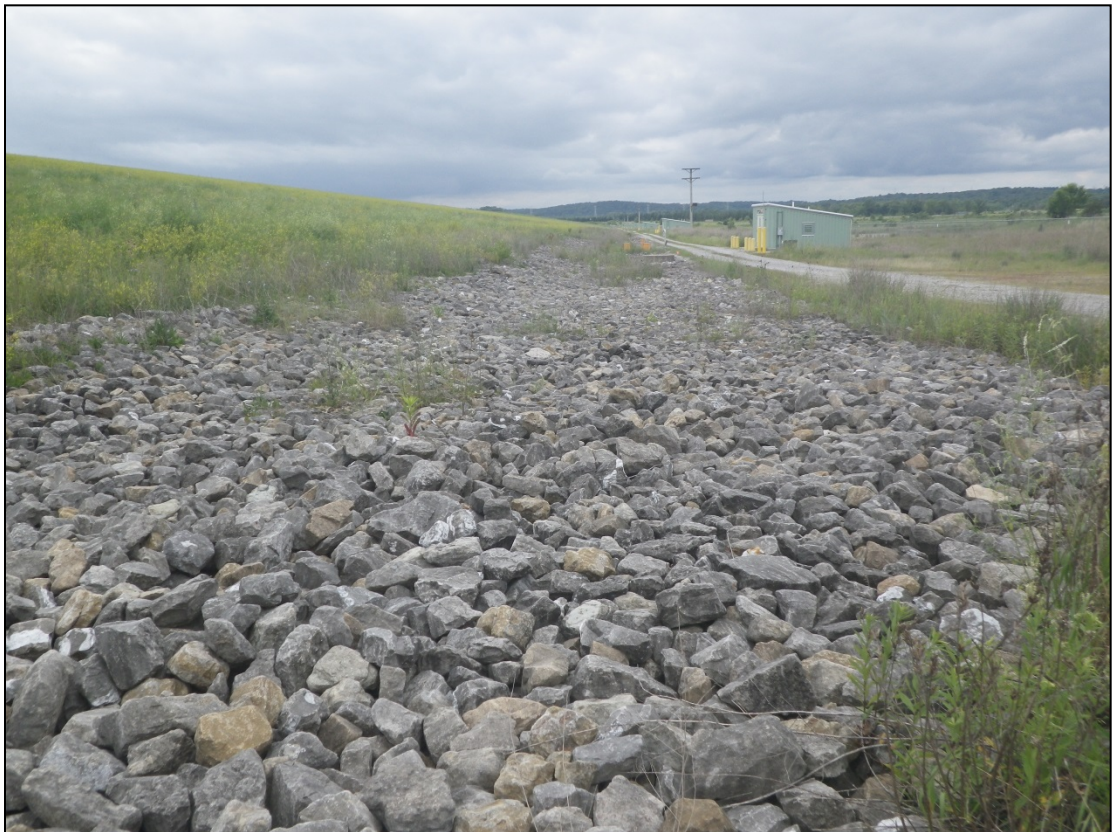
IMGP6200

West Inner Drainage Cell 1 (looking south)

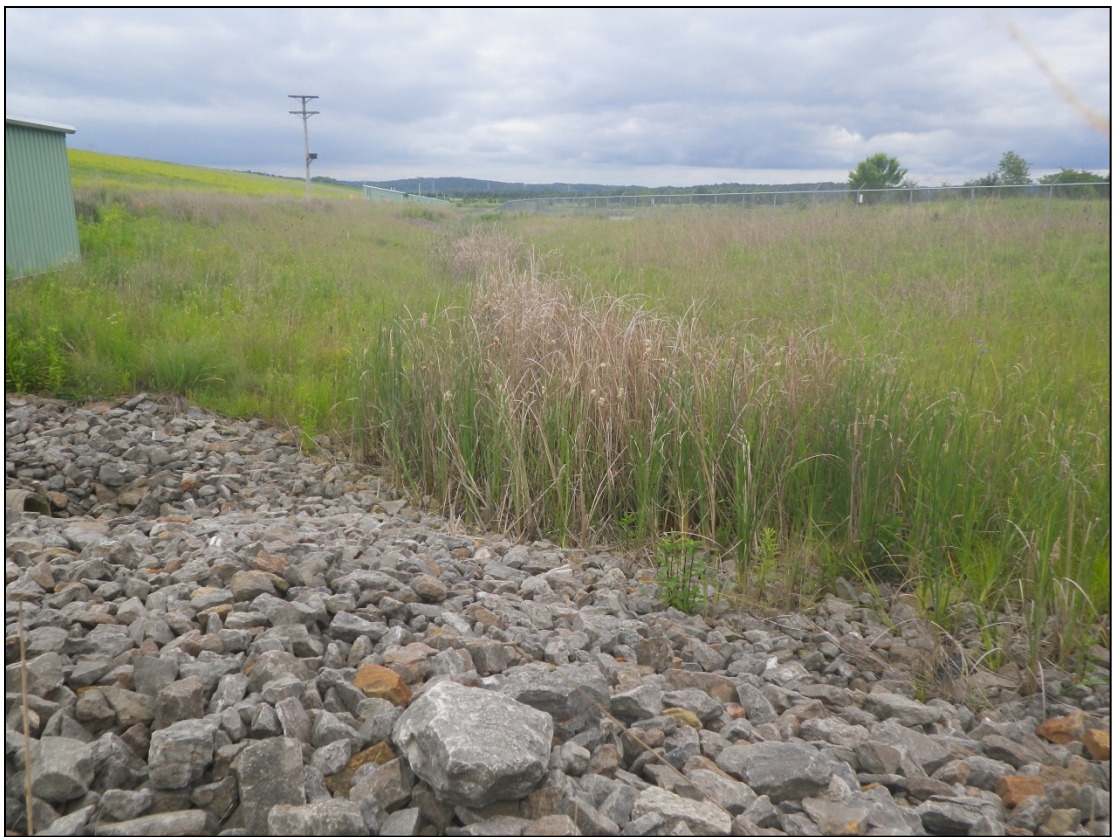
IMGP6201

West Outer Drainage Cell 1 (looking south)

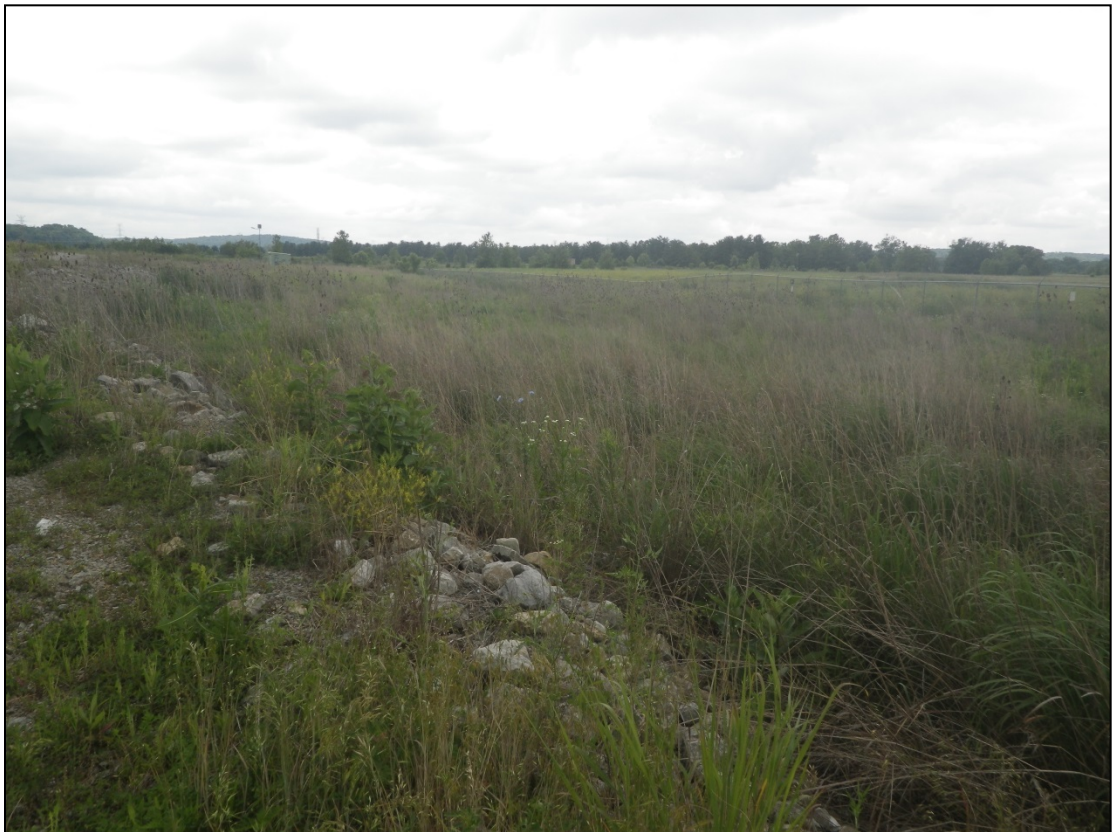
IMGP6183

West Outer Drainage Cell 8 (looking south)

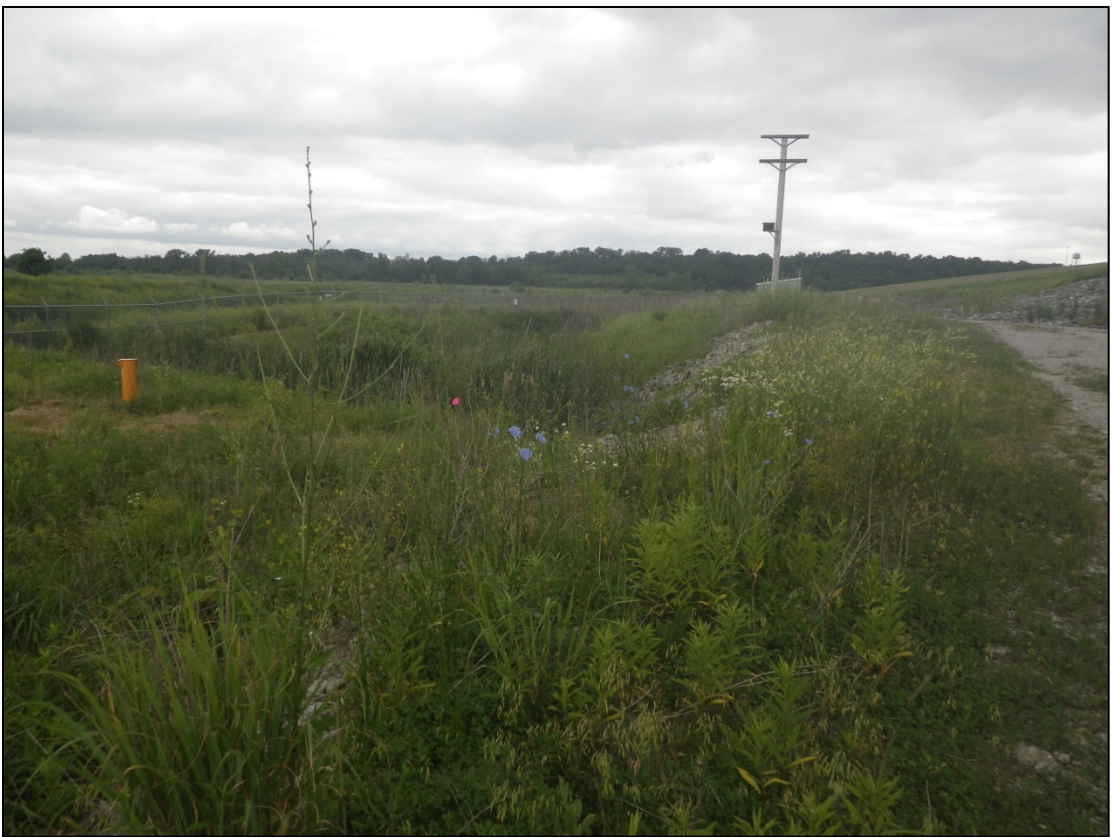
IMGP6182

West Outer Drainage Cell 8 (looking north)
