Subject: Transmittal of the December 2018 Fernald Quarterly Inspection Report

Fernald Preserve Field Walkdown Inspection Summary

Fernald Preserve OSDF Walkdown Inspection Summary

On-Site Disposal Facility Inspection Photographs

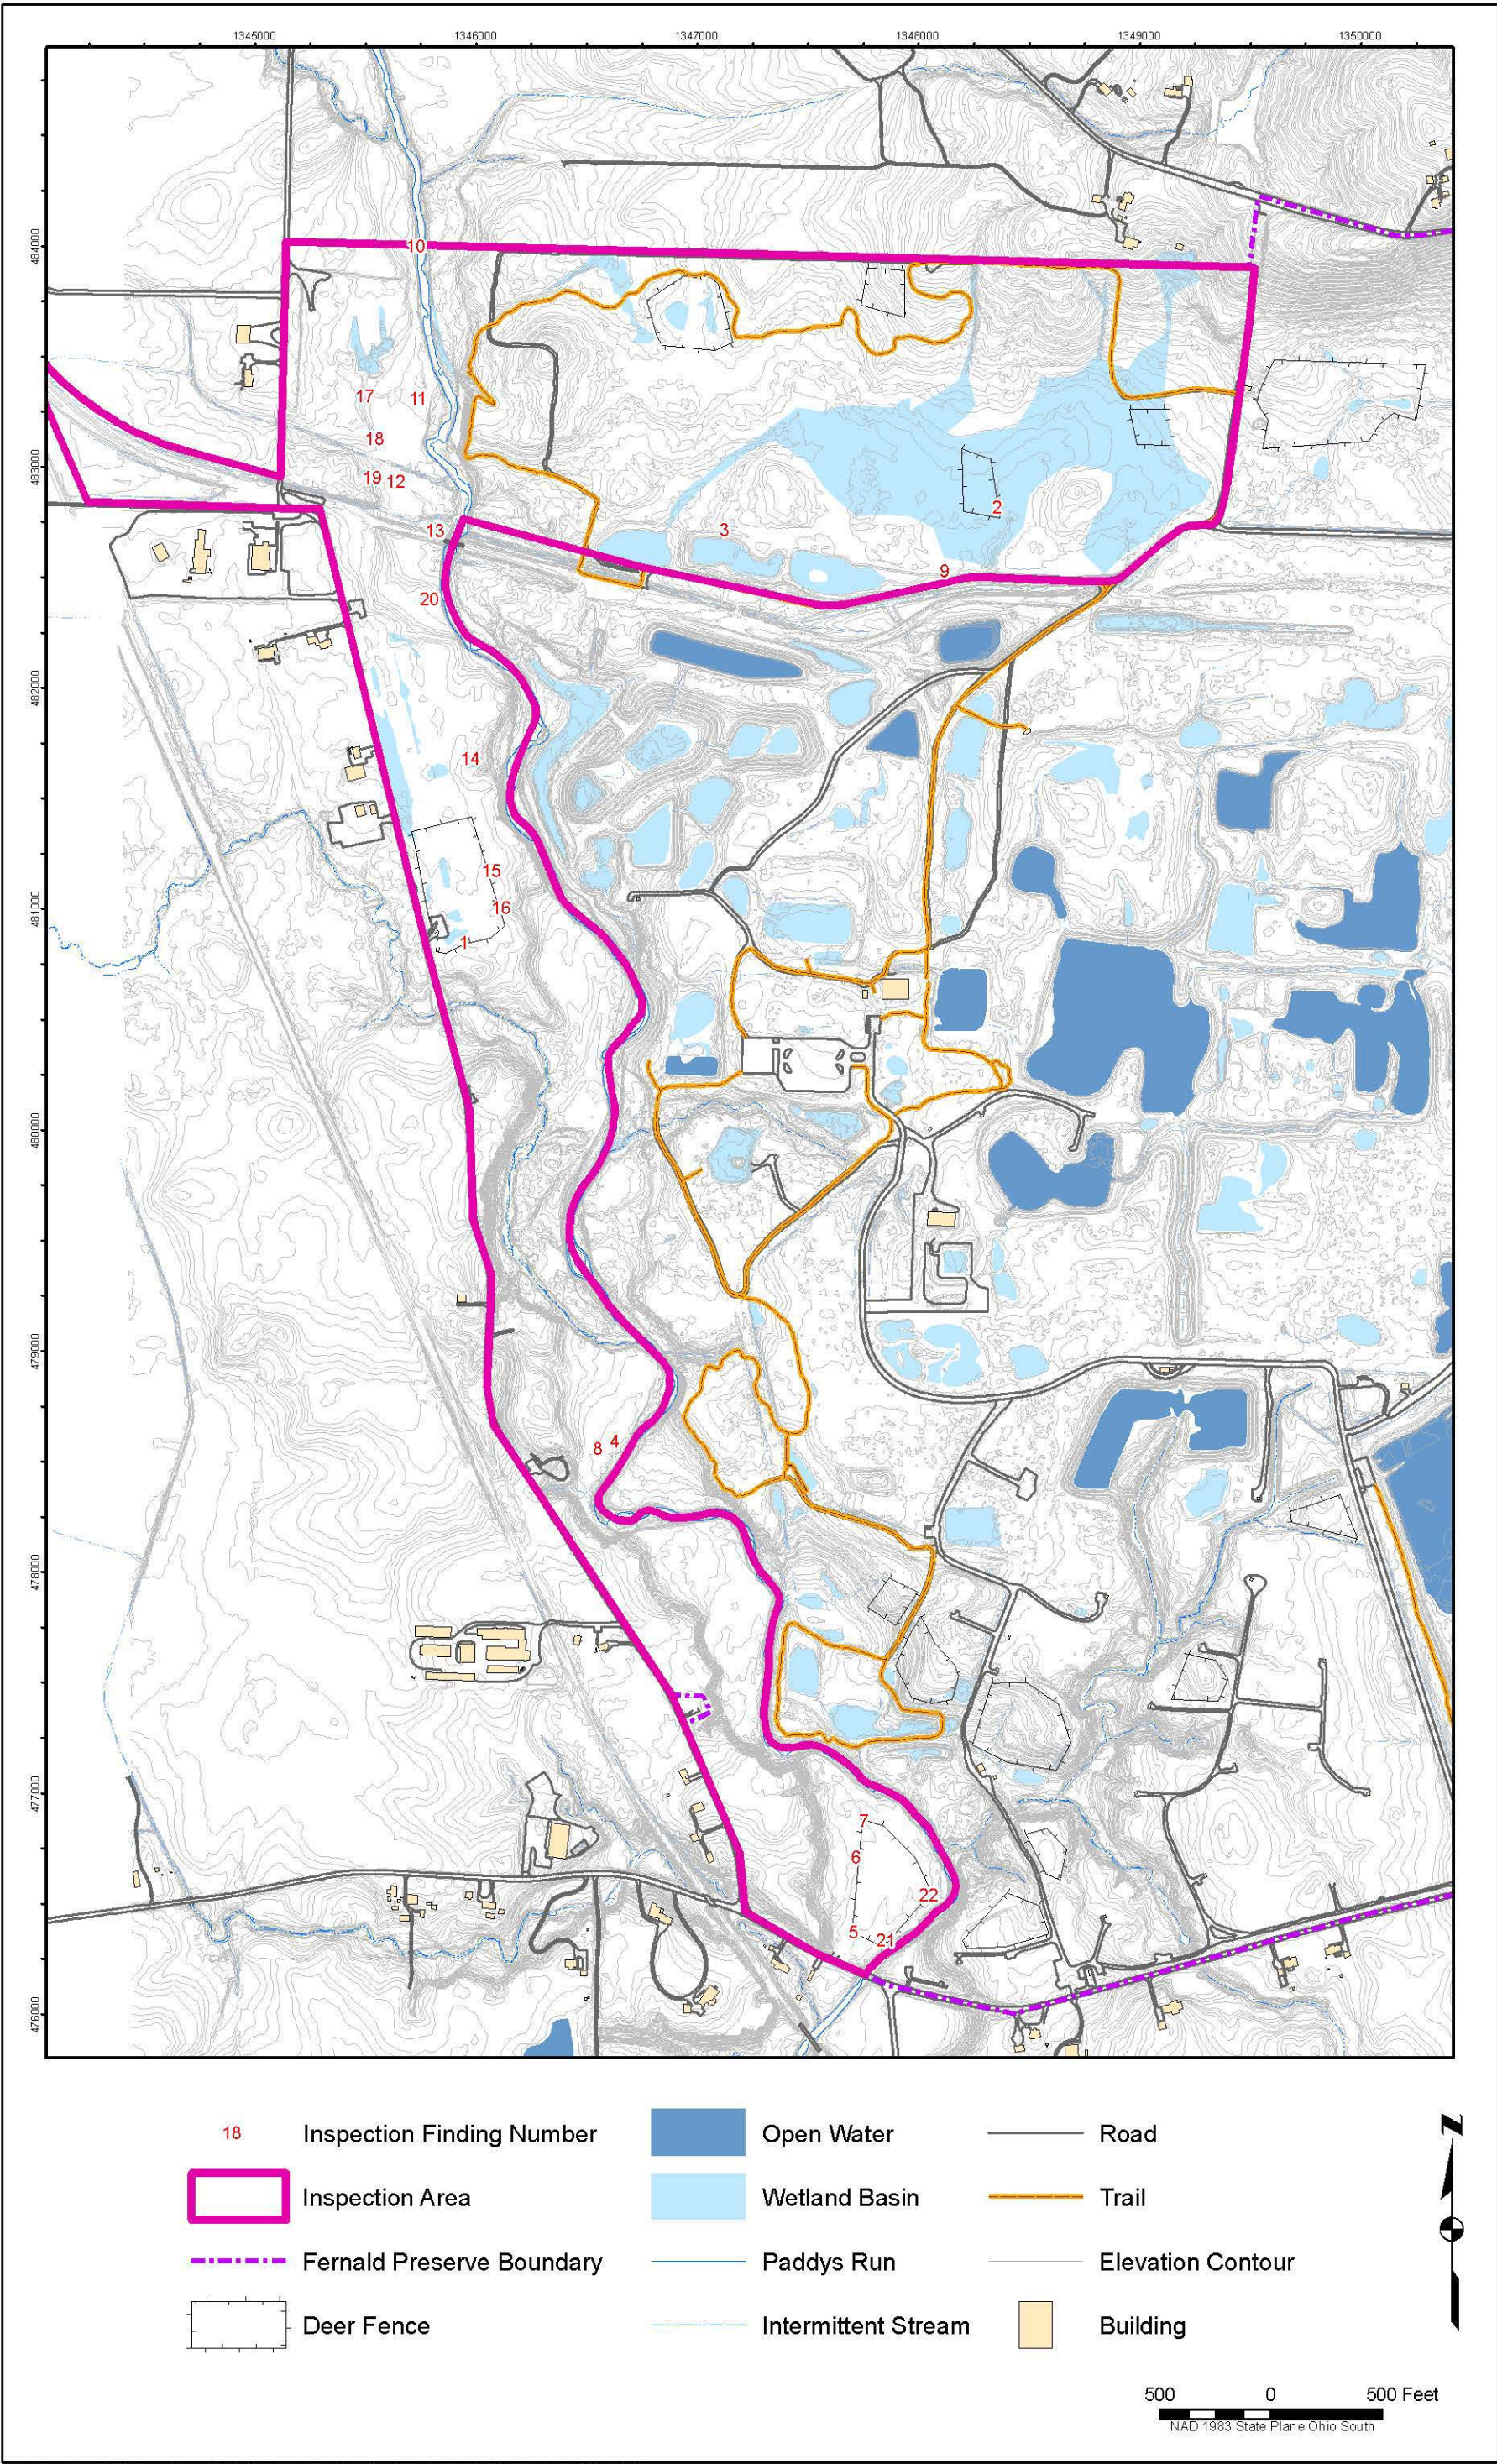
Figure 1
West Quadrant Inspection Findings, December 2018

Map No.	Location	GPS?	Type of Finding	Description	Photo
1	South side of deer fence	Yes	Fencing	Hole in deer fence	12132018_42_01
2	East side of deer fence	No	Fencing	Japanese honeysuckle pulling fence down pole	
3	North side of former chain link deer fence	No	Fencing	Concrete from fence posts left in ground following fence removal	
4	South end of floodplain	Yes	Fencing	Old deer cages and metal posts on ground	12132018_44_01; 12132018_44_02
5	South end of deer fence	Yes	Fencing	Fence is falling	12132018_41_01
6	West side of deer fence	Yes	Fencing	Deer fence falling	12132018_41_02
7	Northwest section of deer fence	Yes	Fencing	Deer fence falling	12132018_41_03
8	South end of floodplain	Yes	Fencing	Deer cages and metal posts on ground	12132018_41_04
9	East end of former chainlink fence	Yes	Fencing	6" diameter pipe from former chain link fence left in the ground; open hole	12132018_41_05
10	North perimeter sign at Paddys Run	Yes	Signage	Sign turned	12132018_43_01

11	Floodplain	Yes	Fencing	Tree tubes need removed	12132018_43_02
12	In wooded area	Yes	Fencing	Tree tubes need removed	12132018_43_03
13	West gate of railroad trestle	Yes	Fencing	Fencing overgrown with vegetation	12132018_43_04

Map No.	Location	GPS?	Type of Finding	Description	Photo
14	Edge of woodlot	Yes	Debris	Wooden plank	12132018_43_05
15	East side of deer fence	Yes	Fencing	Deer fence is down	12132018_43_06
16	East side of deer fence	Yes	Fencing	Hole in fence	12132018_43_07
17	Just south of pond, left of mowed path	No	Fencing	Tree tube needs removed	
18	Approximately 20 feet north of drainage ditch	No	Fencing	Tree tubes need removed	
19	On south side of drainage	No	Fencing	Tree tubes need removed	
20	Inside mowed path at treeline	No	Signage	Two "Danger/Steep Grade" signs are off posts	
21	Southeast section of fence	Yes	Fencing	Tree on fence	12132018_40_01
22	Northeast section of fence	Yes	Fencing	Fence is down	12132018_40_02

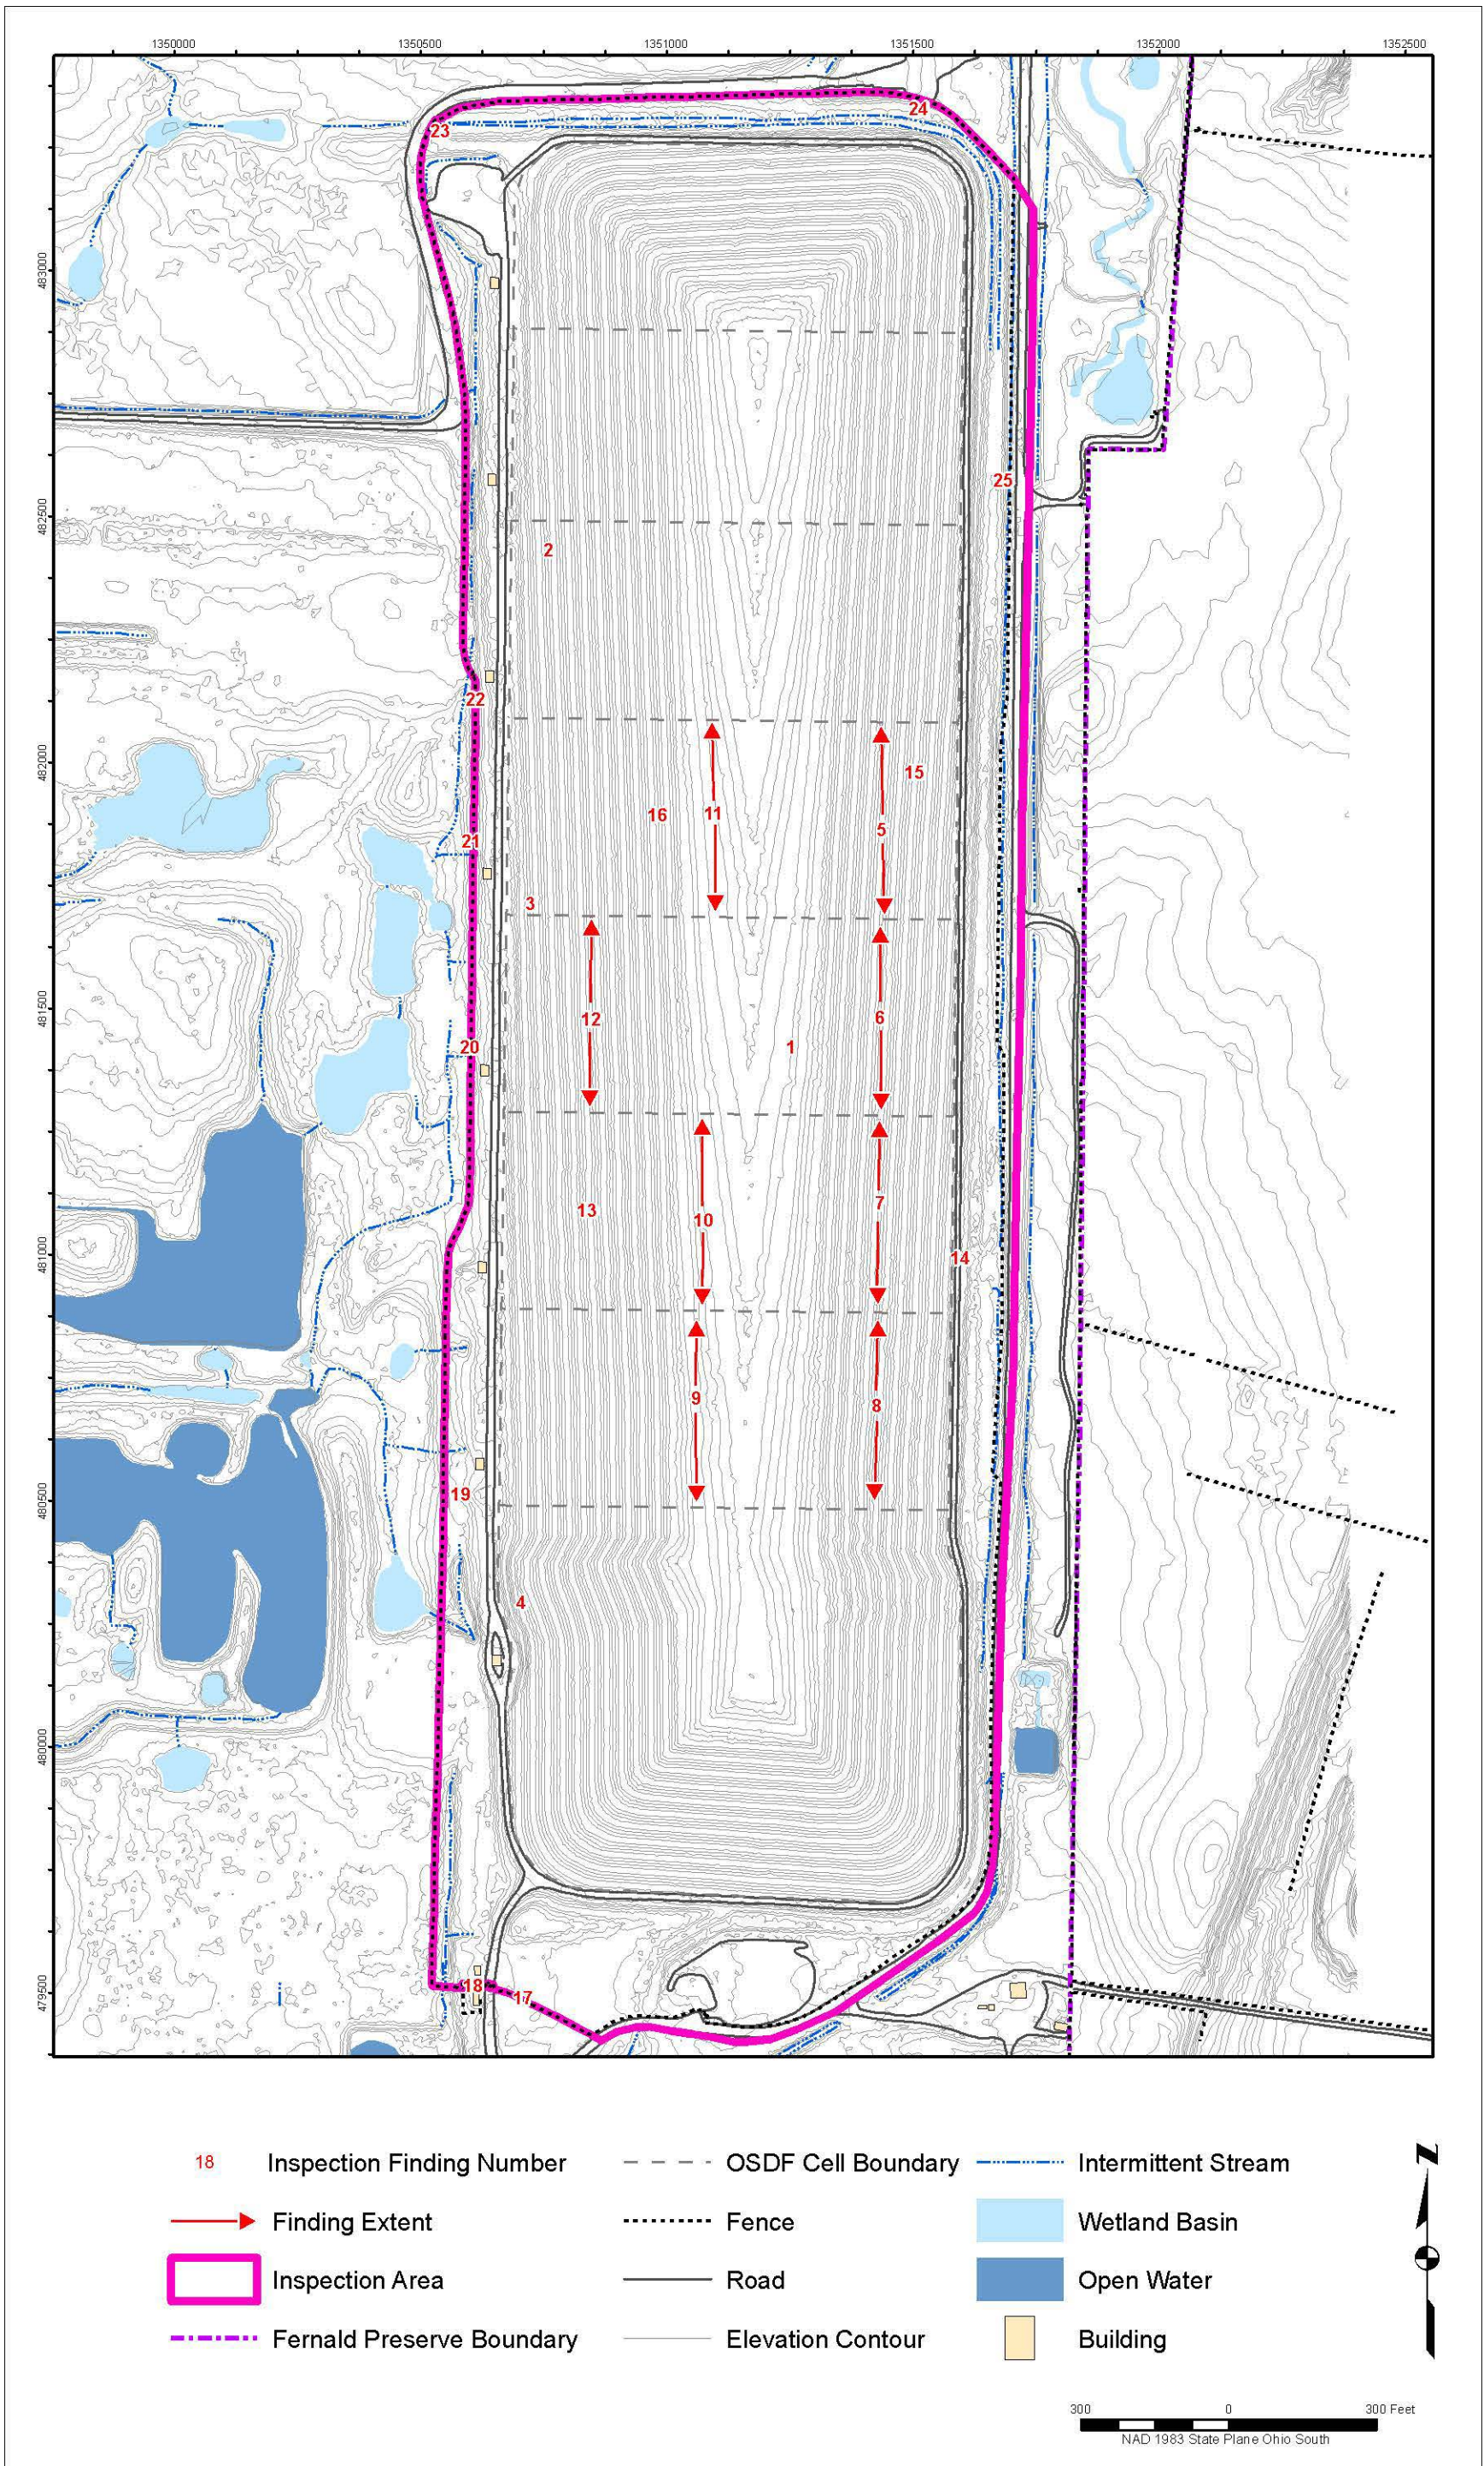
Figure 2
OSDF Inspection Findings, December 2018

Map No.	Location	GPS?	Type of Finding	Description	Photo
1	Cell 5, east 6:1 slope, top, south end	No	Vegetation	Woody vegetation (trees and honeysuckle)	
2	Cell 3, west toe	Yes	Vegetation	Teasel and bare area	12052018_43_01
3	Cell 4, west toe	Yes	Biointrusion	Groundhog hole	12052018_43_02
4	Cell 8, west toe, edge of riprap	No	Biointrusion	Animal burrow	
5	Cell 4, east 6:1 slope	No	Vegetation	Woody vegetation (trees) across east slope	
6	Cell 5, east 6:1 slope	No	Vegetation	Woody vegetation (trees) across east slope	
7	Cell 6, east 6:1 slope	No	Vegetation	Woody vegetation (trees)	
8	Cell 7, east 6:1 slope	No	Vegetation	Woody vegetation (trees) less dense	
9	Cell 7, west 6:1 slope, top	No	Vegetation	Woody vegetation (trees)	
10	Cell 6, west 6:1 slope, top	No	Vegetation	Woody vegetation (trees) more dense	
11	Cell 4, west 6:1 slope, top	No	Vegetation	Woody vegetation (trees)	
12	Cell 5, west 6:1 slope	No	Vegetation	Woody vegetation (trees)

13	Cell 6, west 6:1 slope	No	Vegetation	Woody vegetation (trees)	
14	Cell 6, east toe, south end	Yes	Biointrusion	Animal burrow	12052018_41_01

Map No.	Location	GPS?	Type of Finding	Description	Photo
15	Cell 4, east slope	Yes	Vegetation	Woody vegetation (pear tree)	12052018_42_01
16	Cell 4, west, near top	No	Vegetation	Woody vegetation	
17	Cell 8, east of the south entrance gate	No	Signage	Sign is down	
18	Cell 8, west of the south entrance gate	No	Signage	Sign is down	
19	Cell 7, west drainage, at fence	No	Vegetation	Woody vegetation (cedar)	
20	Cell 5, west drainage, at fence	No	Vegetation	Woody vegetation (pear)	
21	Cell 4, west drainage, at midpoint of fence (outside)	No	Debris	Concrete	
22	Cell 3, west drainage, at fence (outside)	No	Erosion	Minor erosion	
23	Cell 1, northwest corner drainage, at fence, north of gate	No	Vegetation	Woody vegetation (pear trees)	
24	Cell 1, northeast drainage, at corner of fence	No	Vegetation	Woody vegetation (pear trees)	
25	Cell 2, east drainage	No	Vegetation	Woody vegetation (cottonwood)

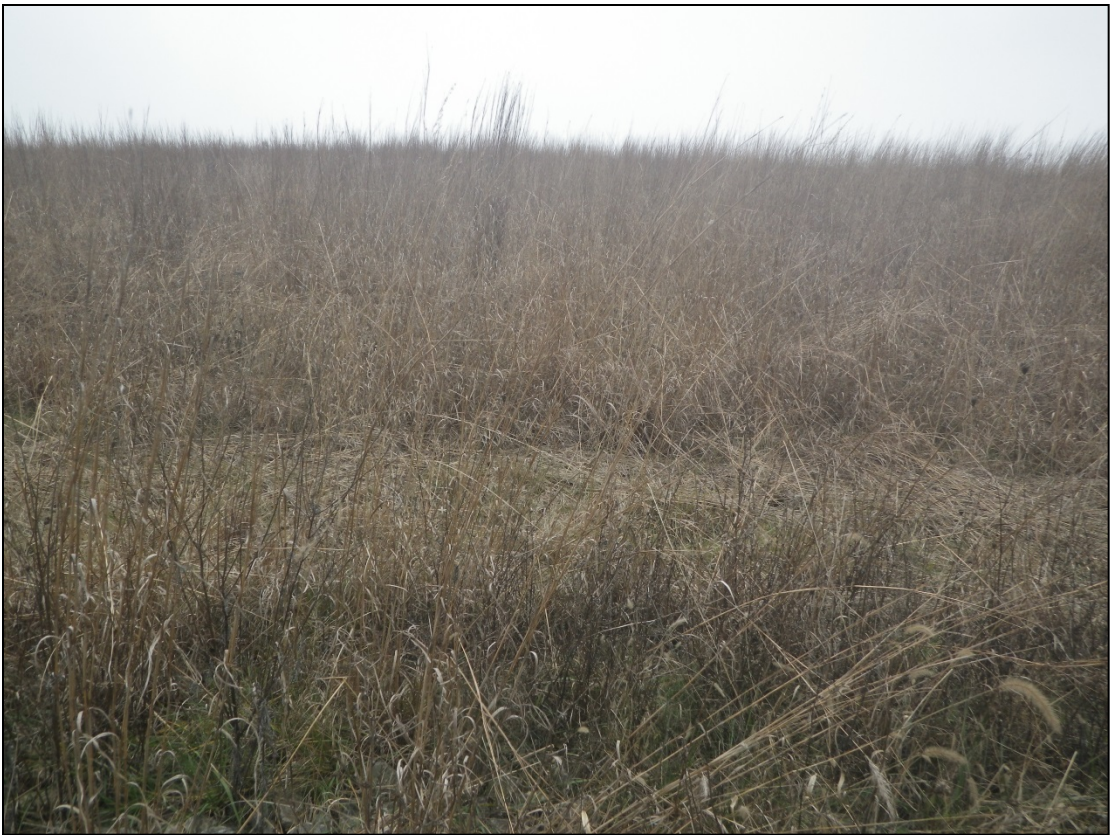
IMGP7096

East Face Cell 1

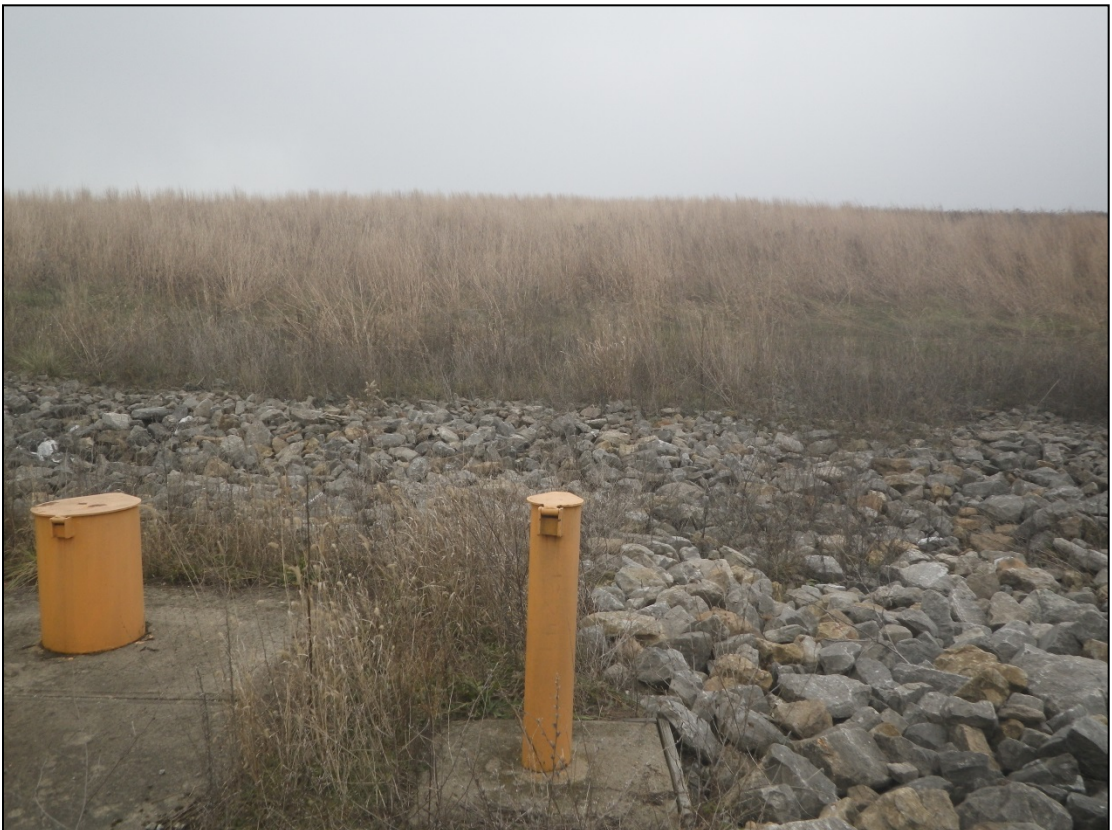
IMGP7091

West Face Cell 1

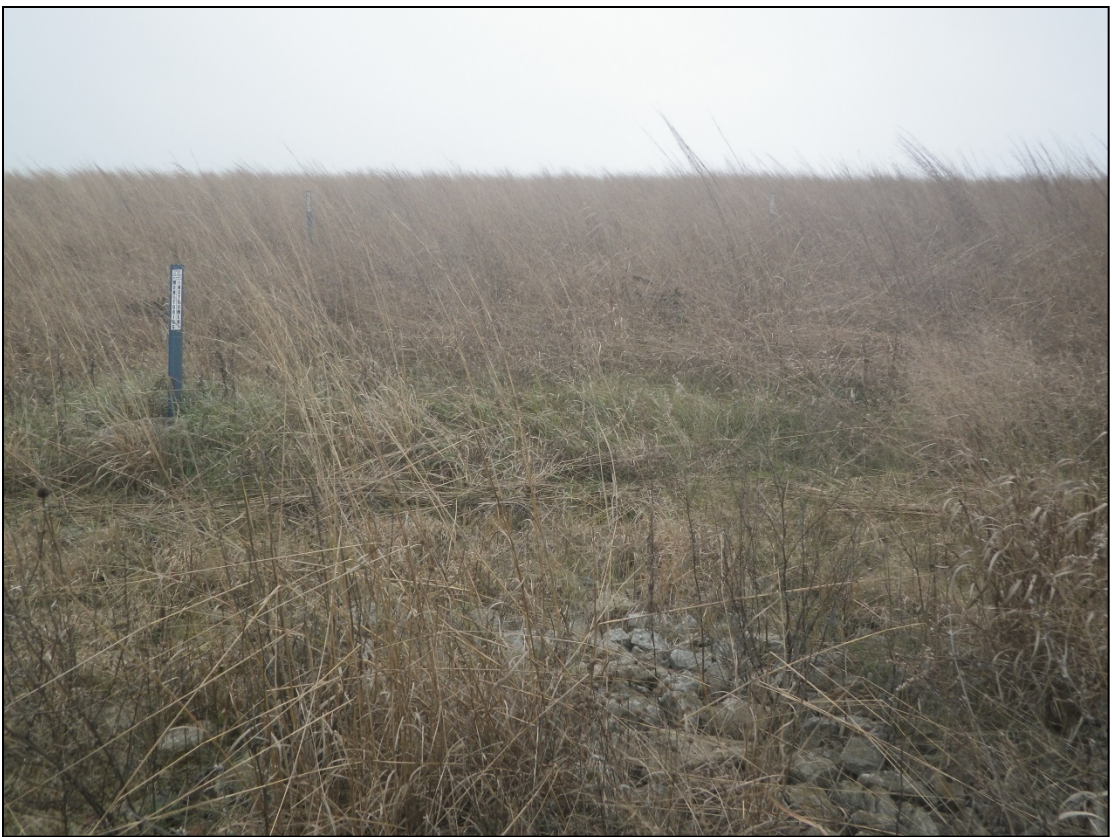
IMGP7094

North Face Cell 1

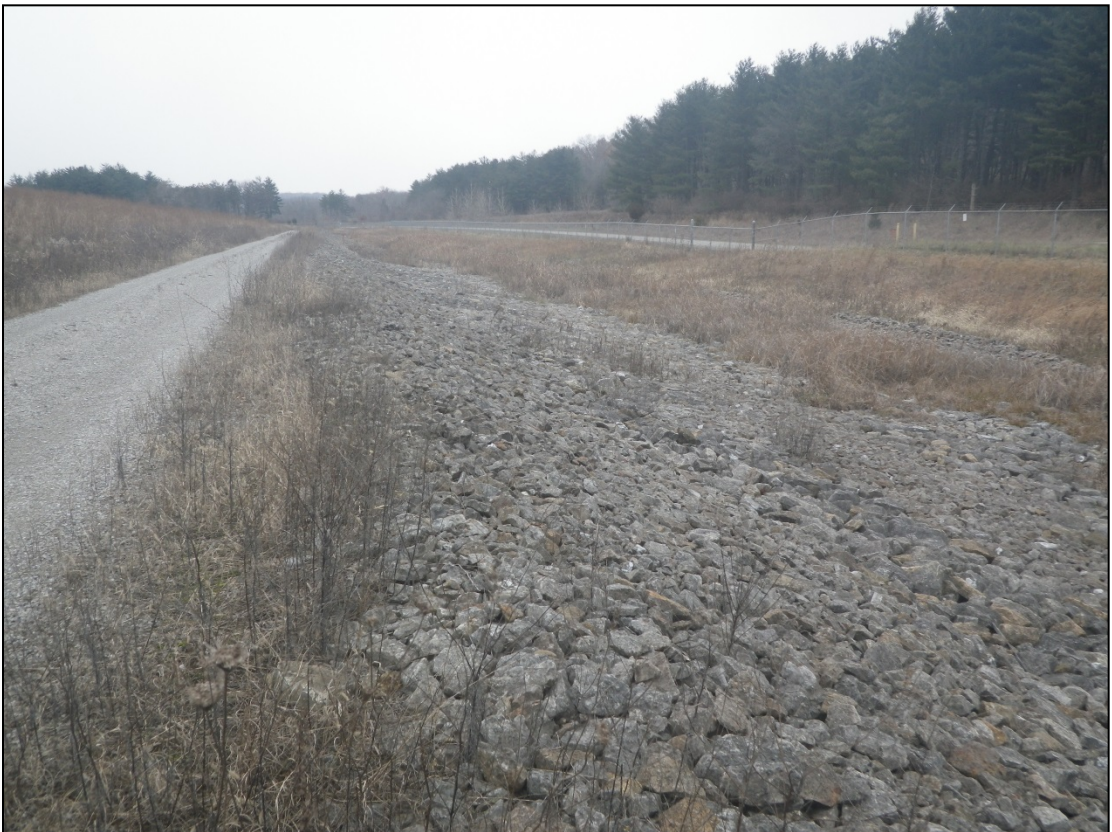
IMGP7095

North Drainage (looking west)

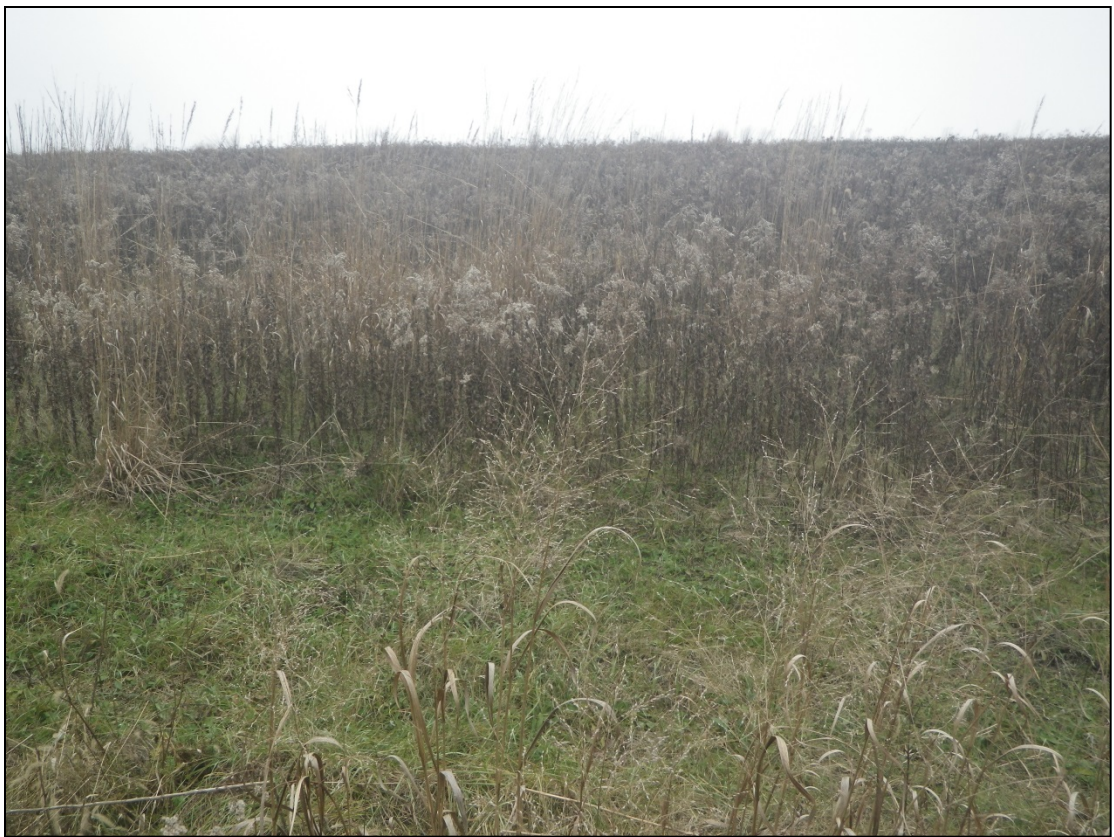
IMGP7098

East Face Cell 2

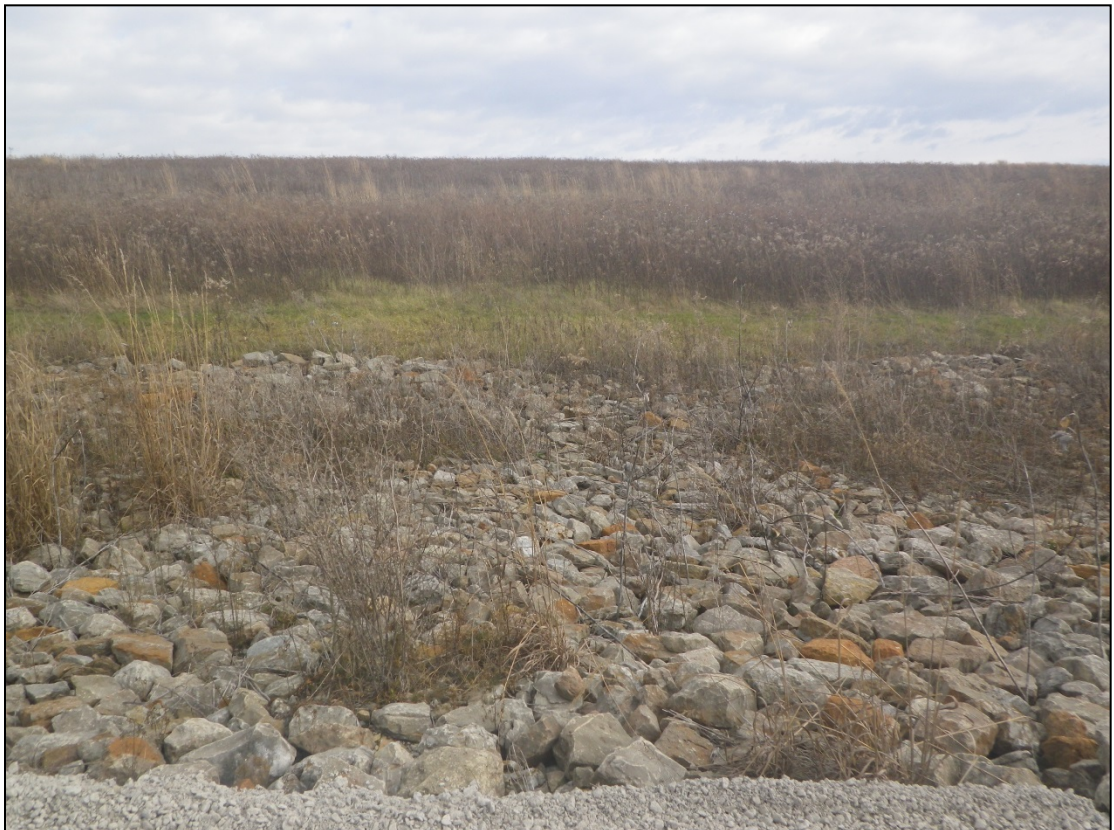
IMGP7109

West Face Cell 2

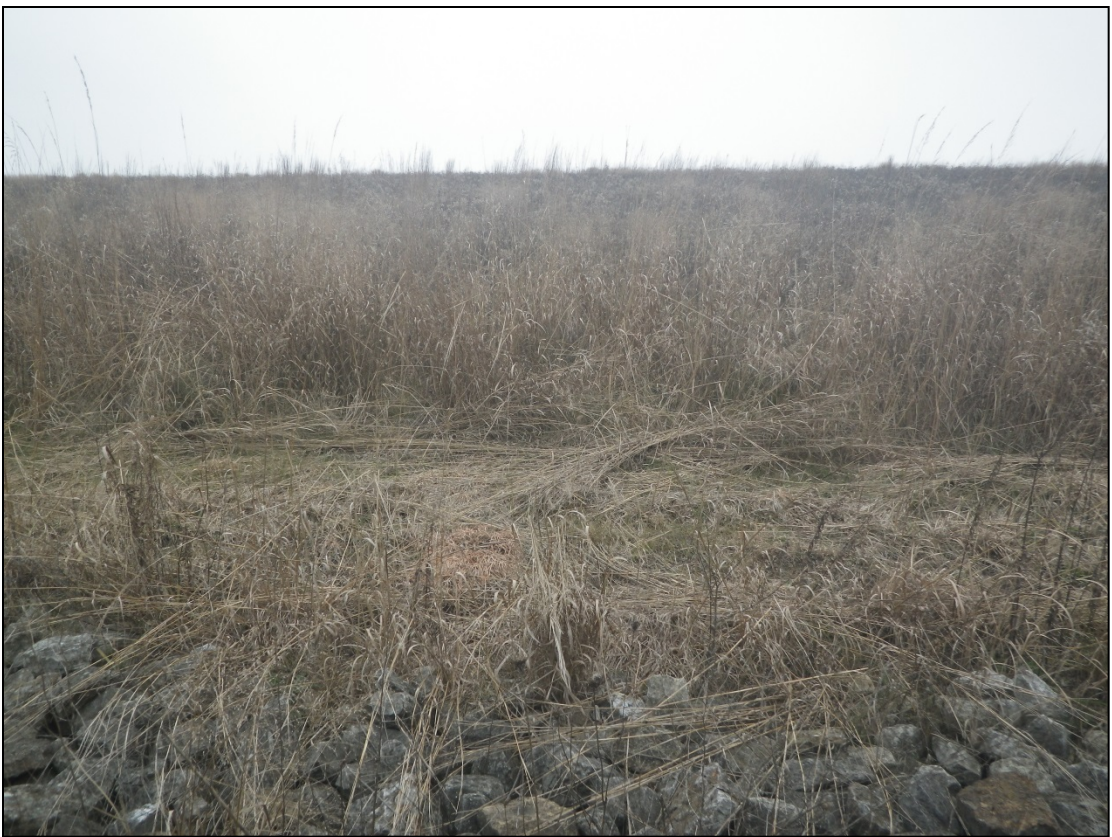
IMGP7099

East Face Cell 3

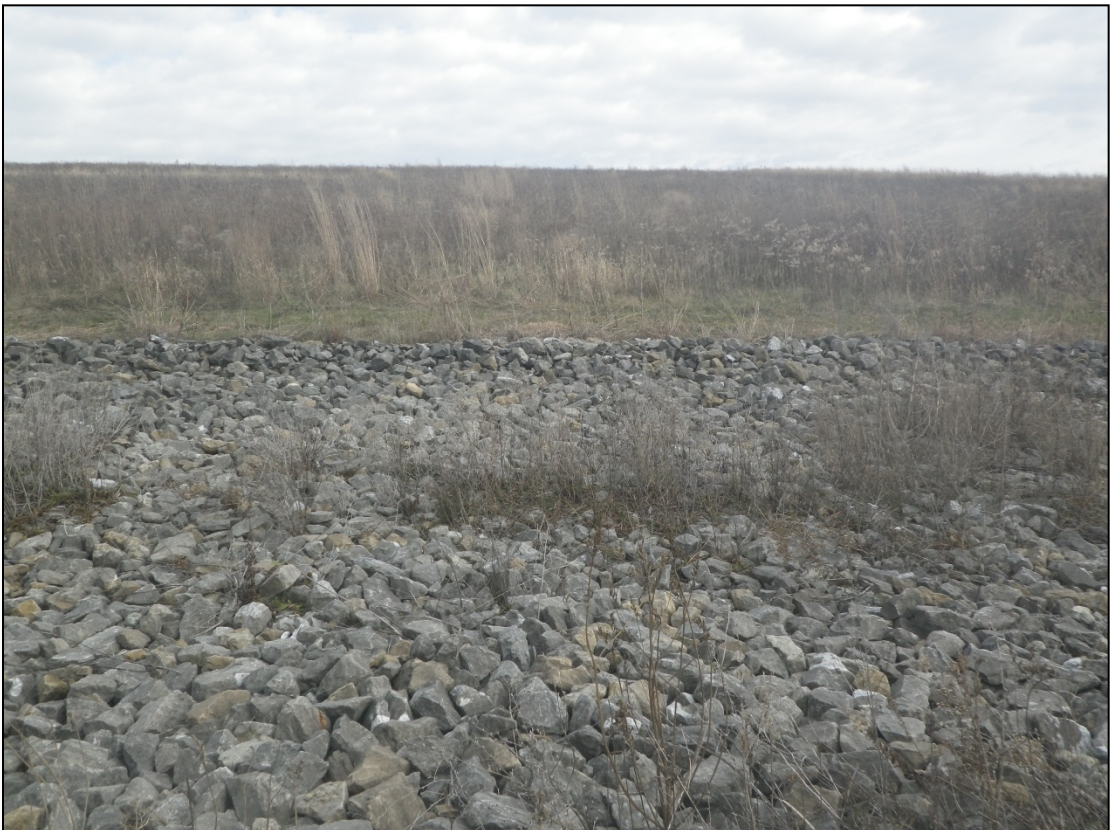
IMGP7110

West Face Cell 3

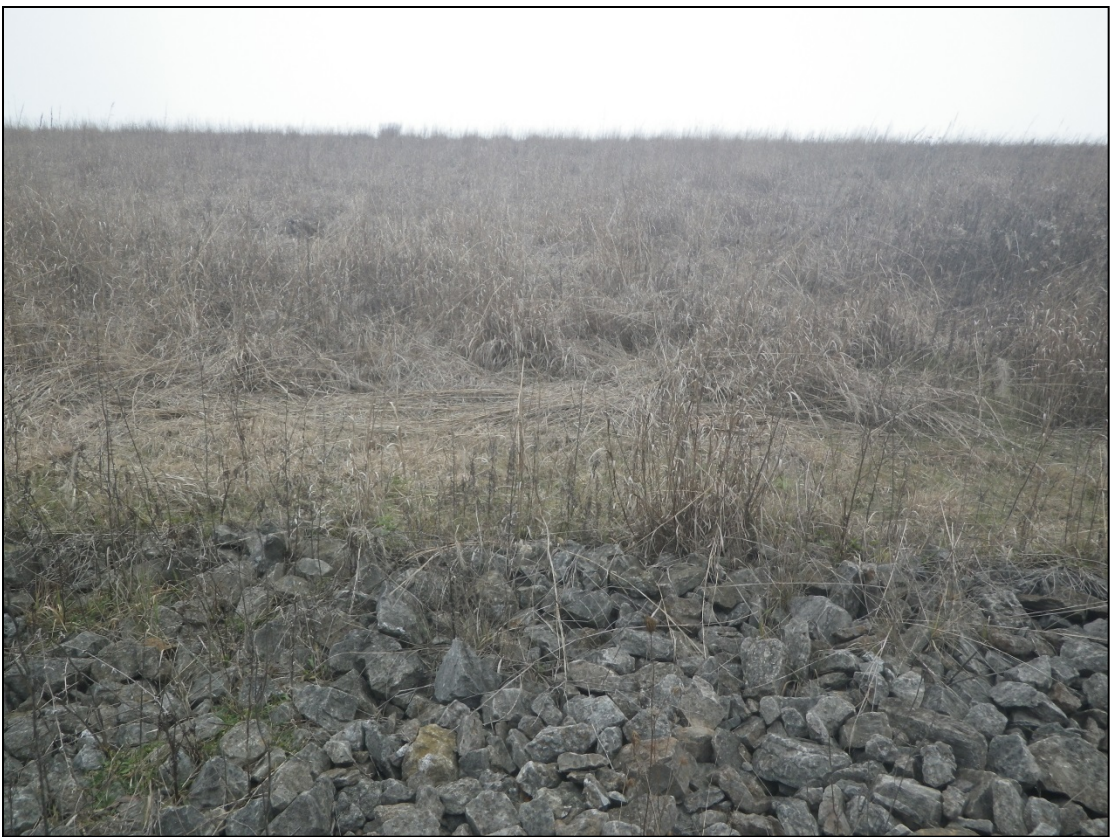
IMGP7100

East Face Cell 4

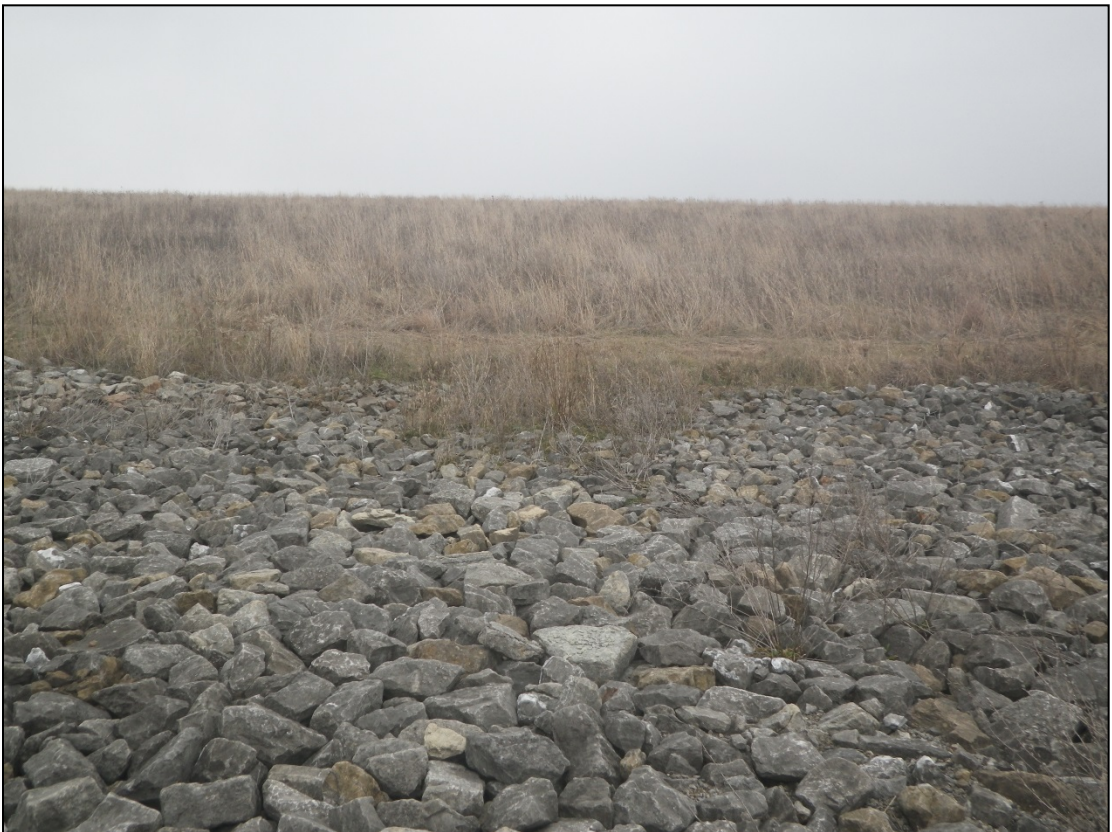
IMGP7089

West Face Cell 4

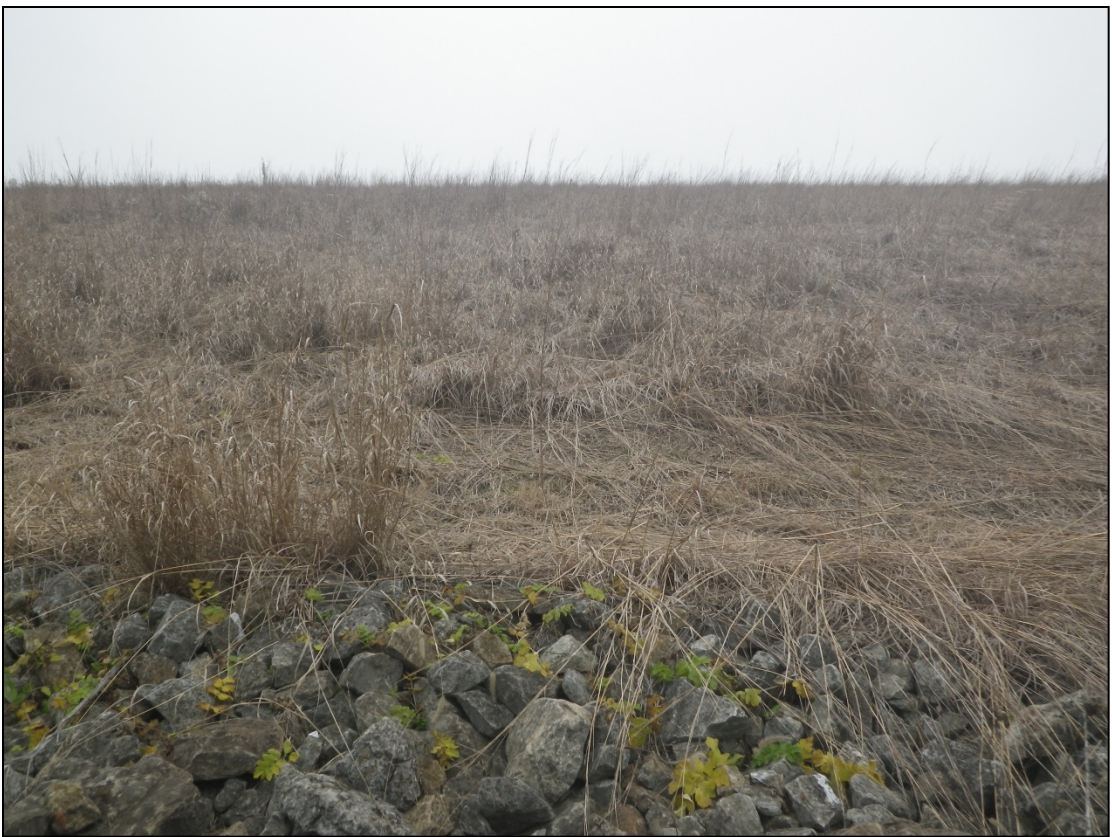
IMGP7102

East Face Cell 5

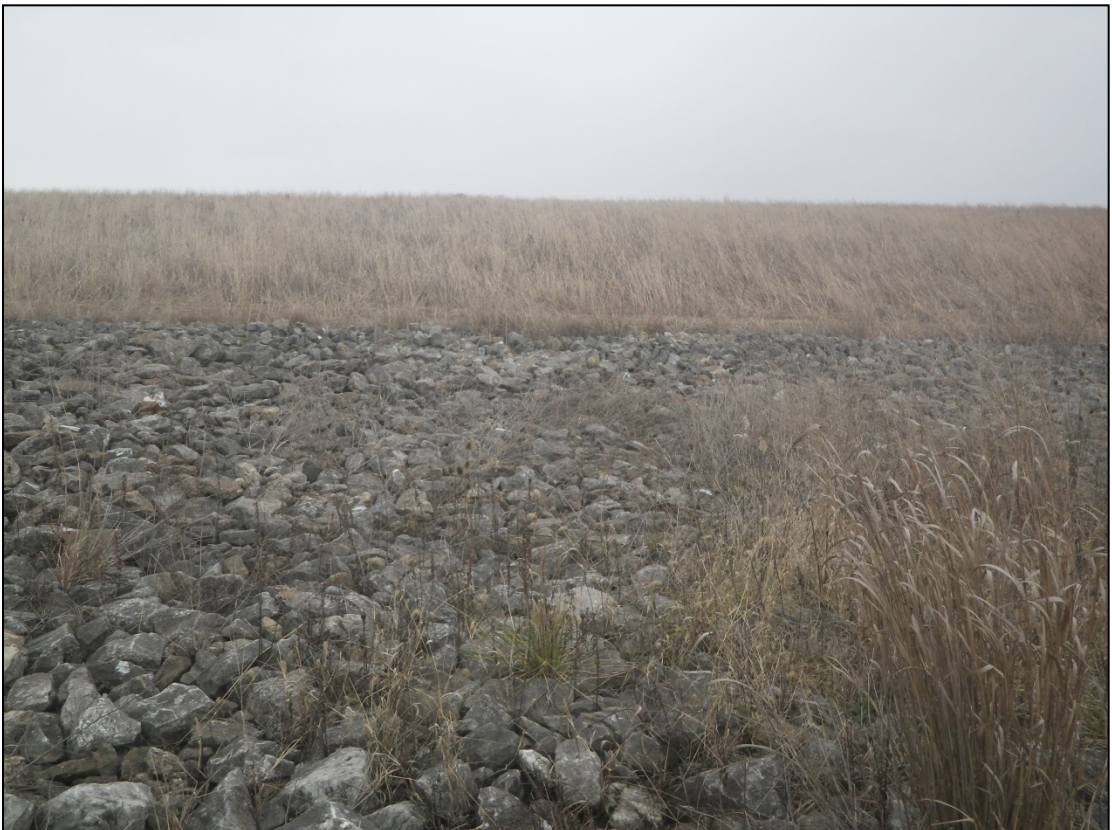
IMGP7087

West Face Cell 5

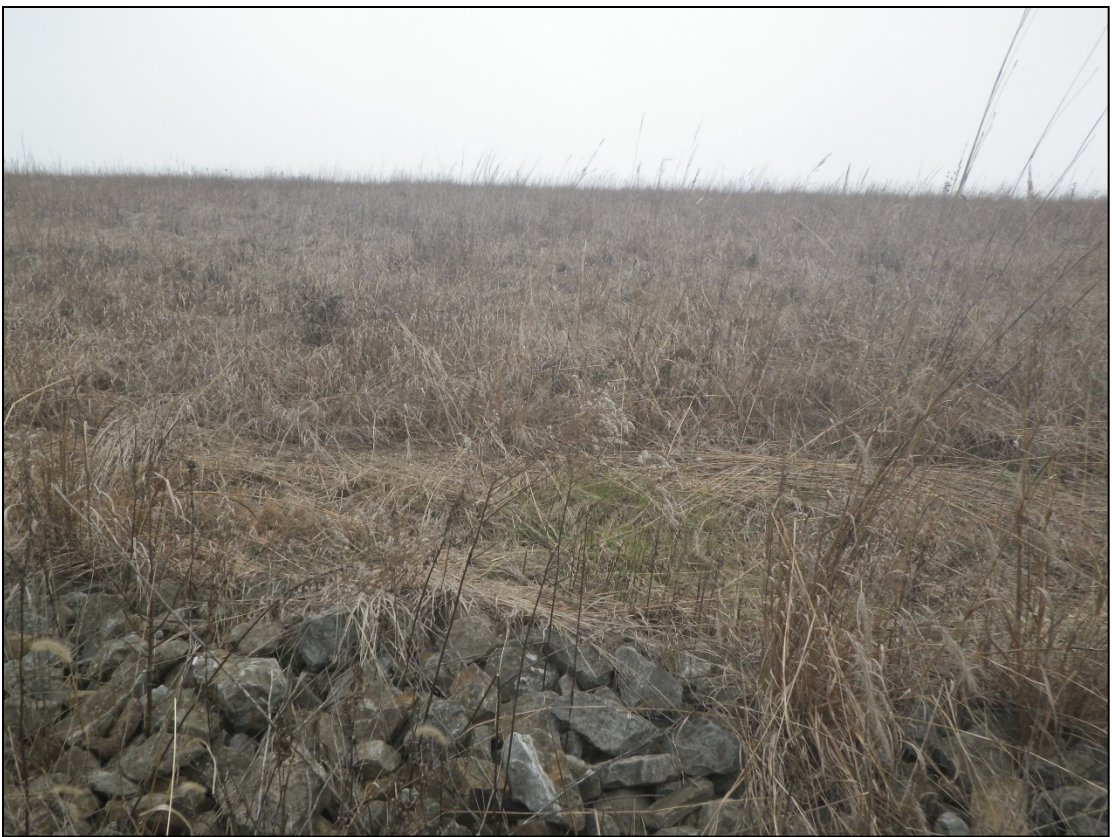
IMGP7103

East Face Cell 6

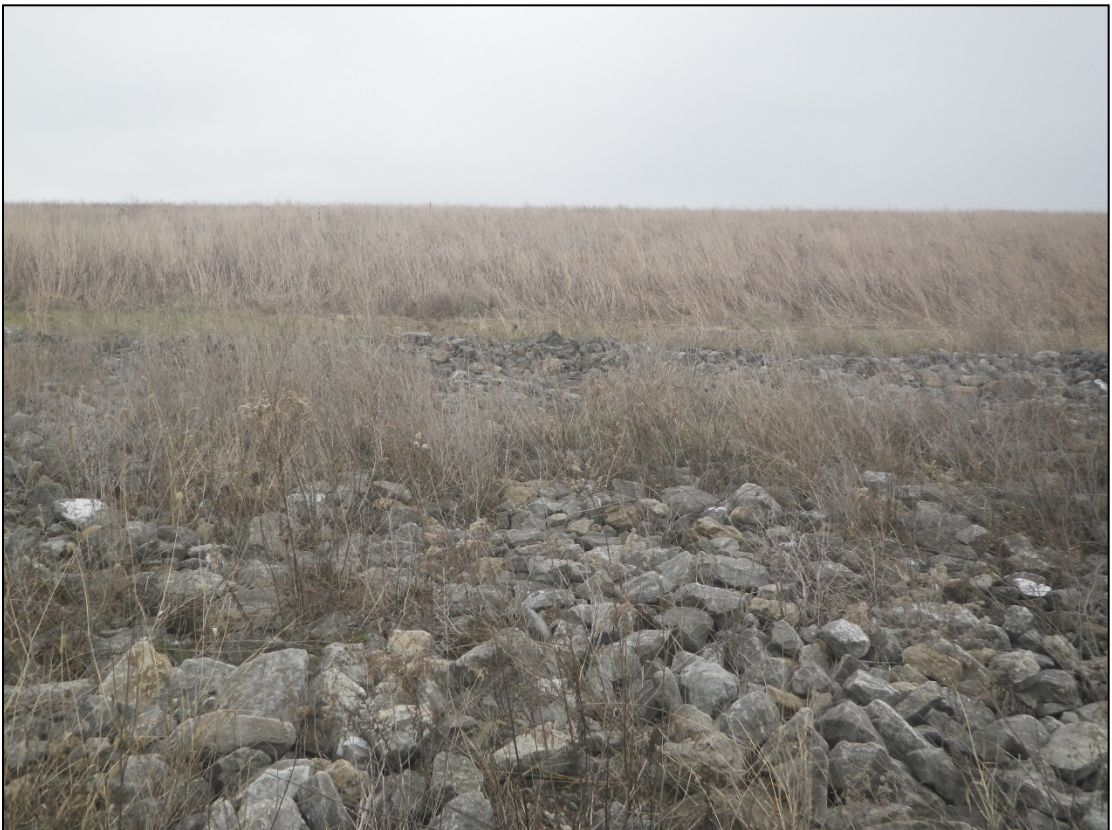
IMGP7086

West Face Cell 6

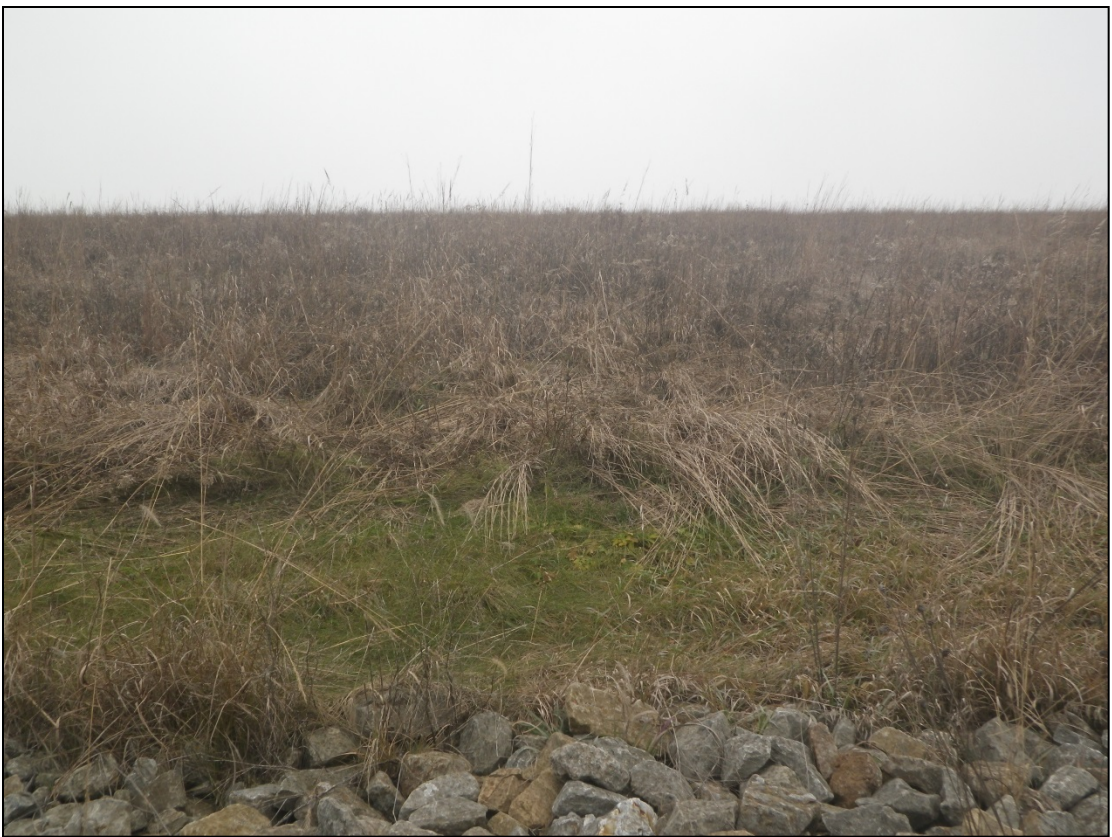
IMGP7104

East Face Cell 7
