Subject: Transmittal of the December 2018 Fernald Quarterly Inspection Report

Fernald Preserve Field Walkdown Inspection Summary

Fernald Preserve OSDF Walkdown Inspection Summary

On-Site Disposal Facility Inspection Photographs

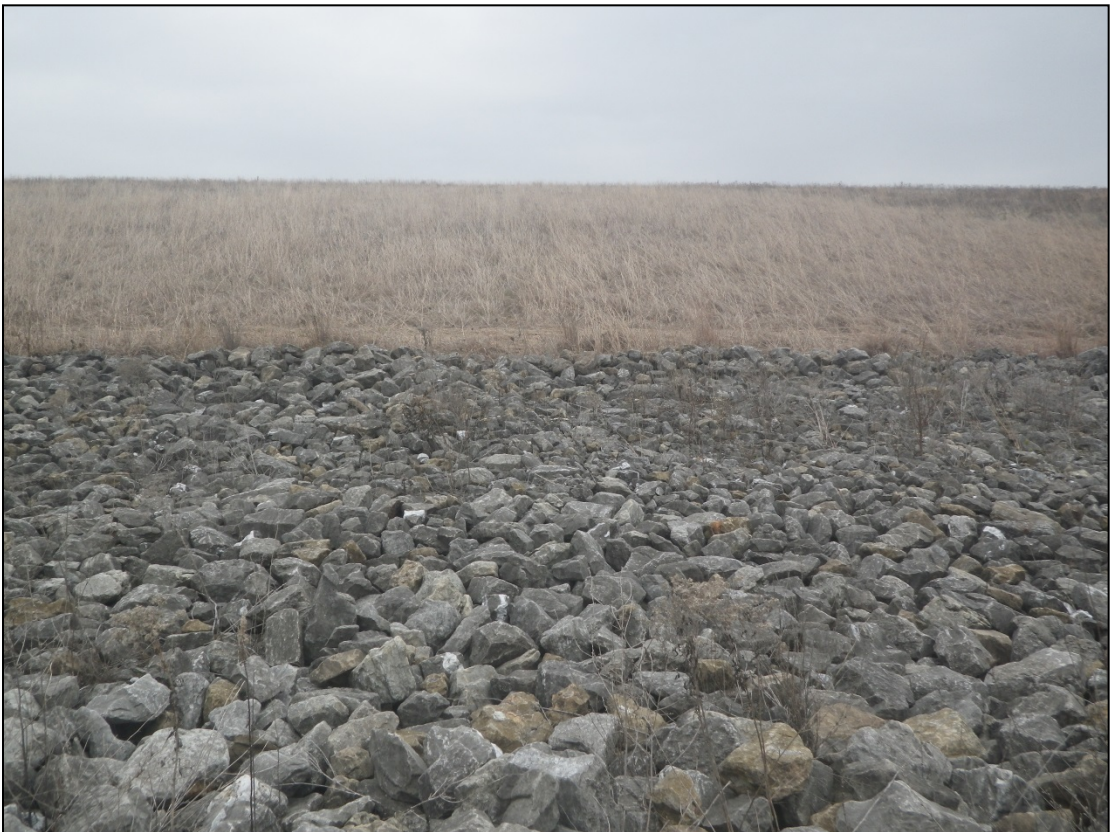
IMGP7084

West Face Cell 7

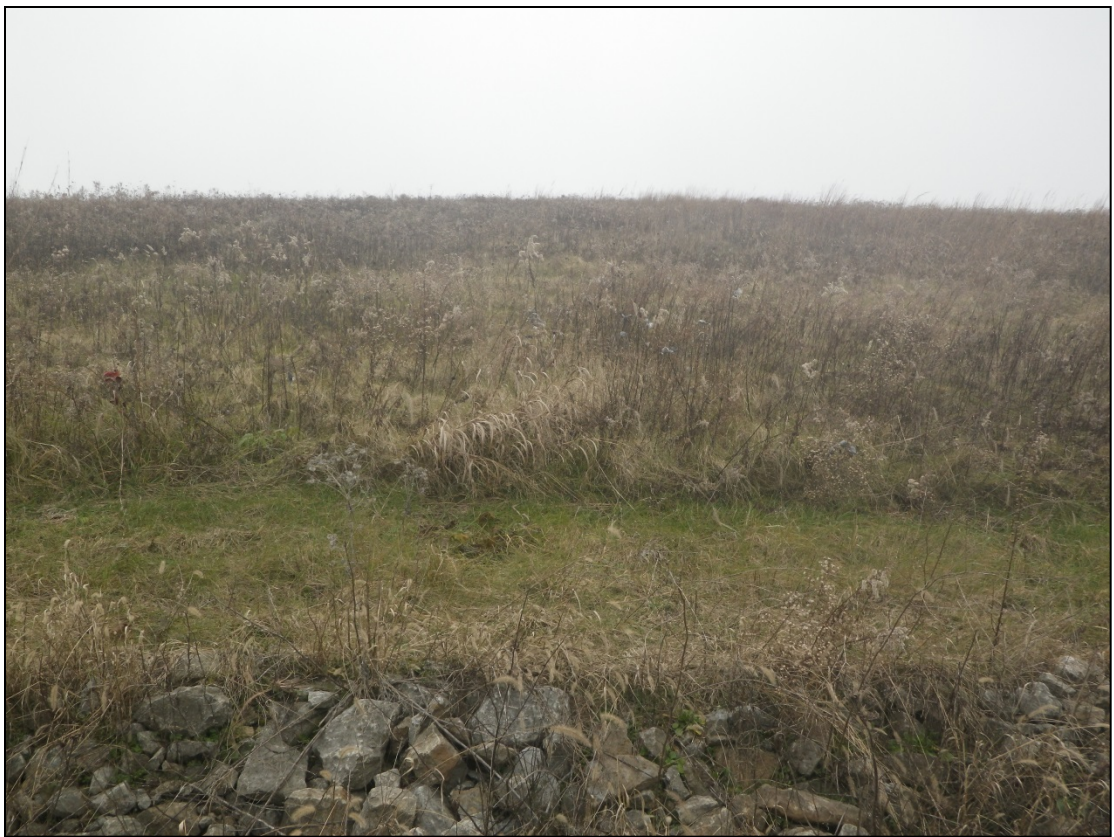
IMGP7106

East Face Cell 8

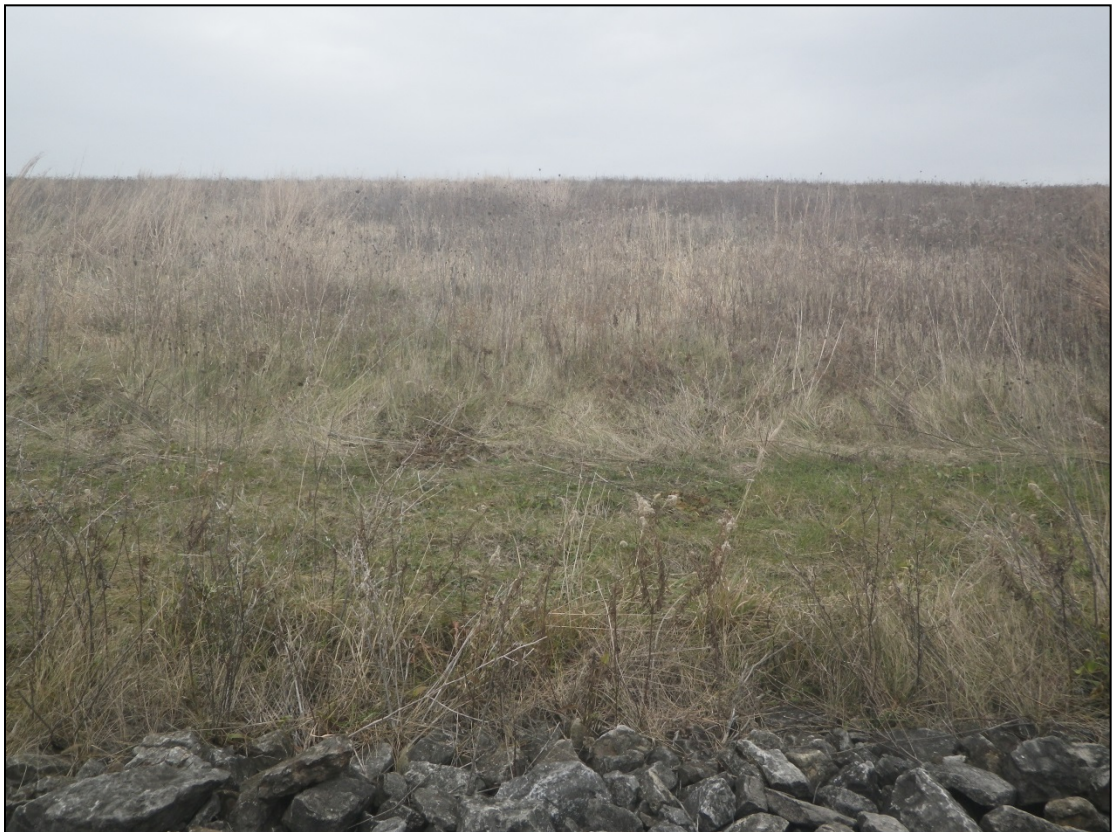
IMGP7081

West Face Cell 8

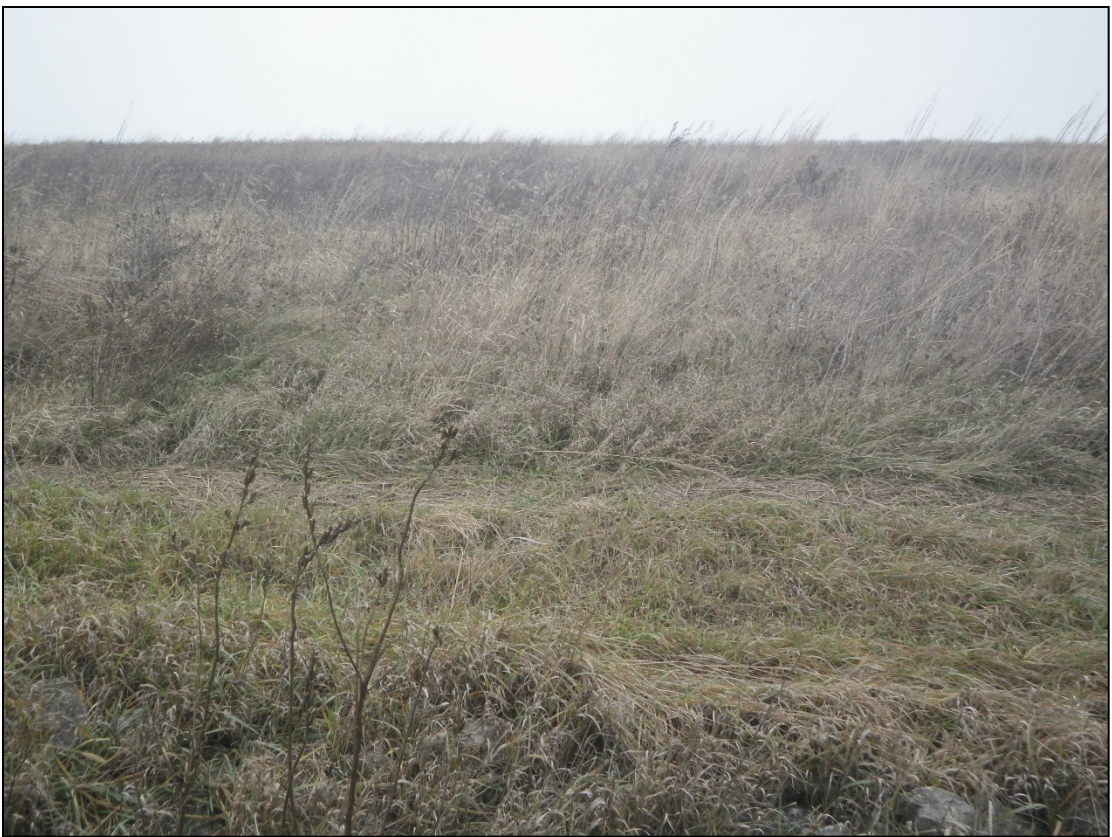
IMGP7108

South Face Cell 8

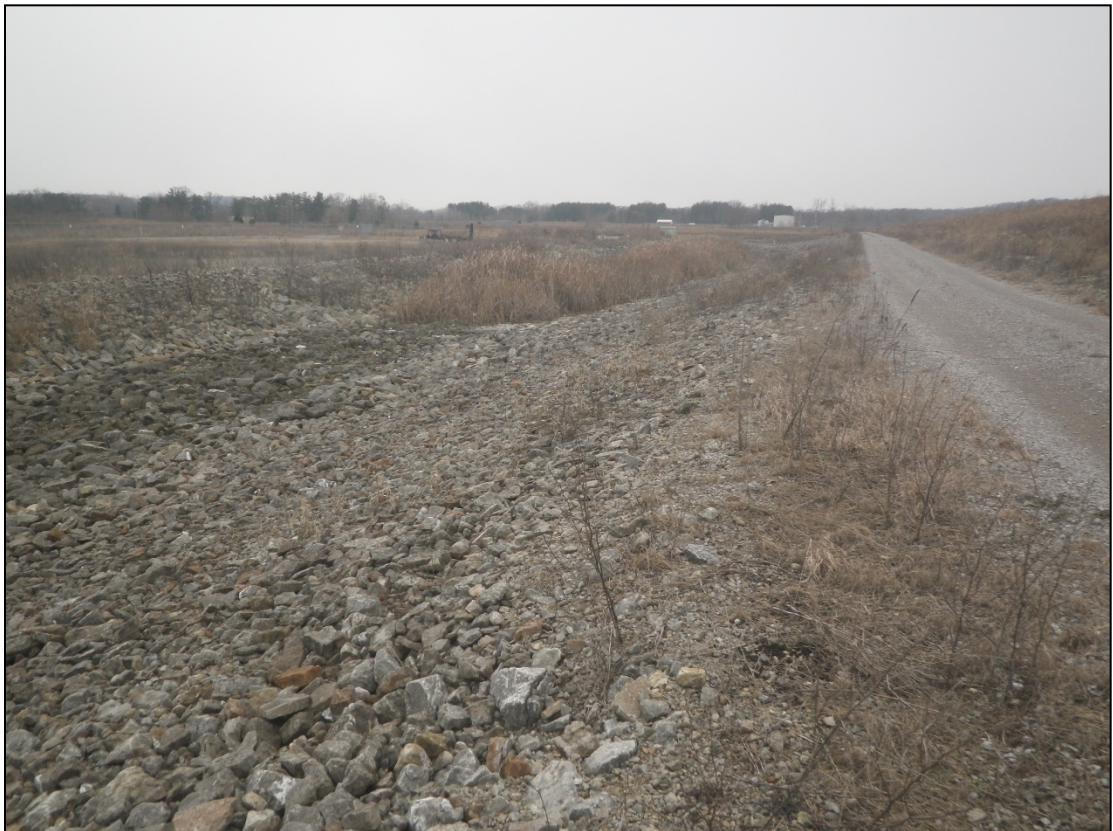
IMGP7107

South Drainage (looking west)

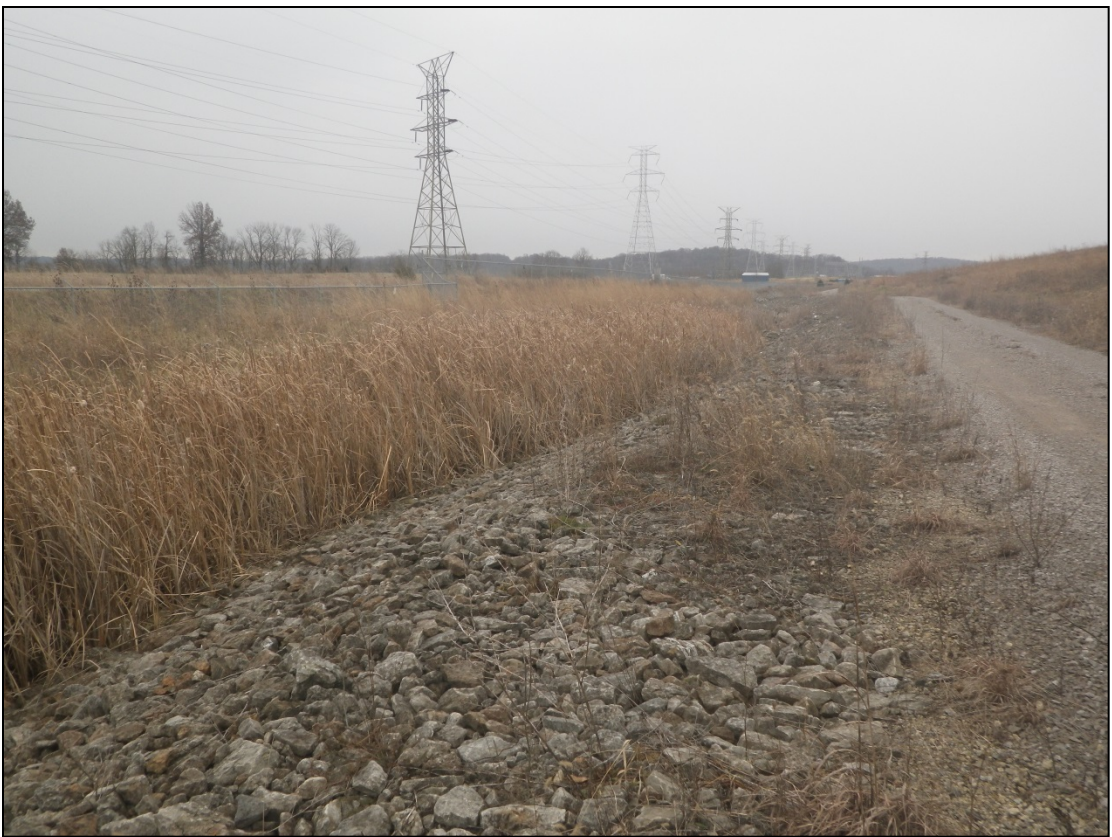
IMGP7105

East Drainage Cell 7 (looking south)

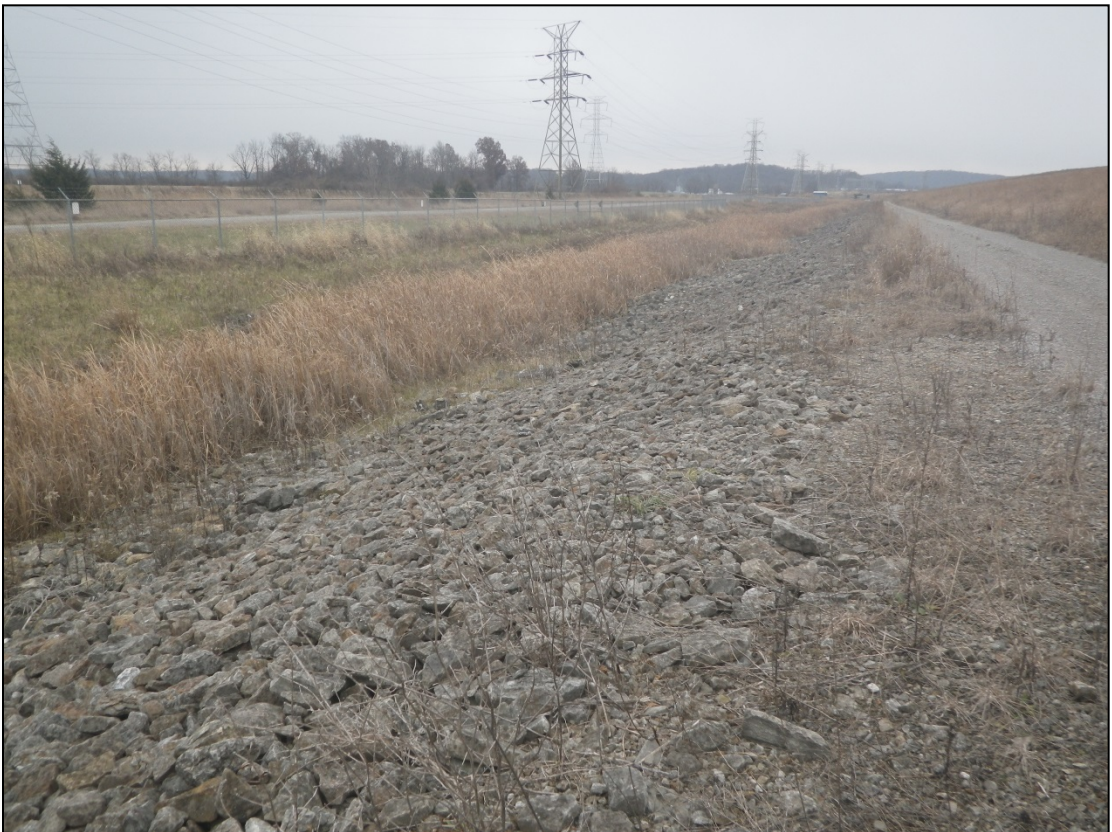
IMGP7101

East Drainage Cell 4 (looking south)

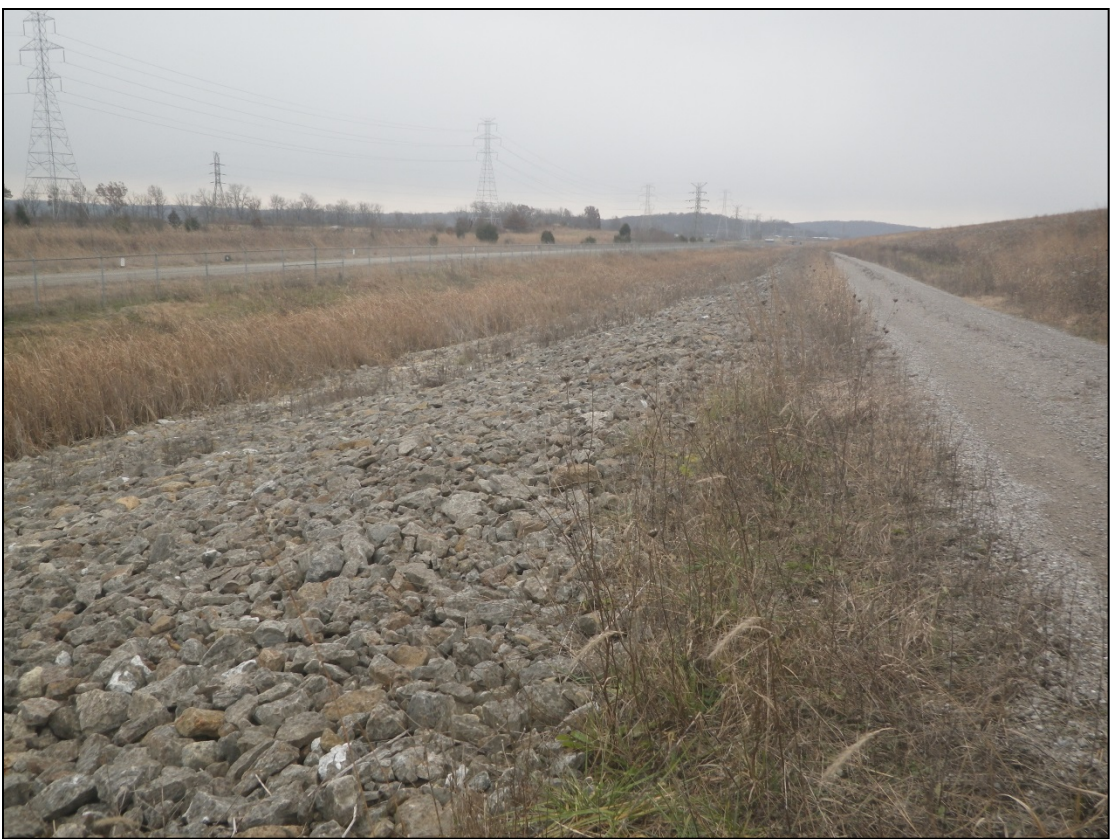
IMGP7097

East Drainage Cell 1 (looking south)

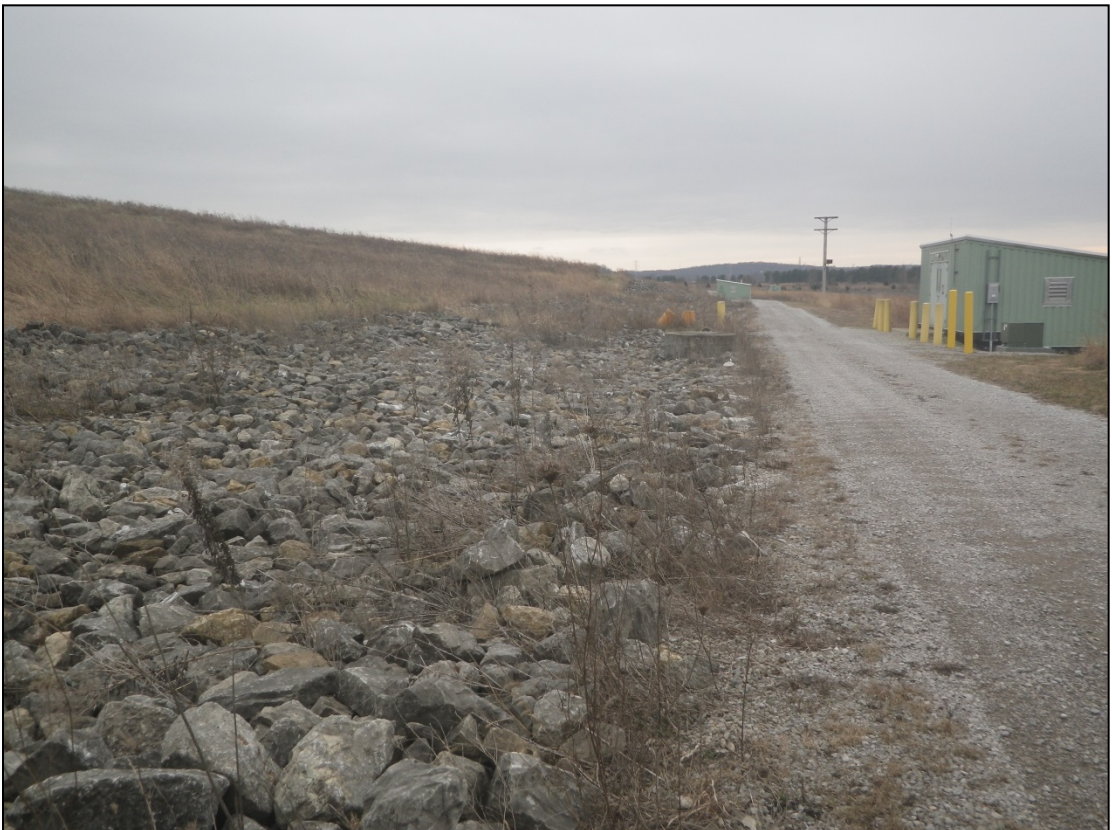
IMGP7085

West Inner Drainage Cell 7 (looking south)

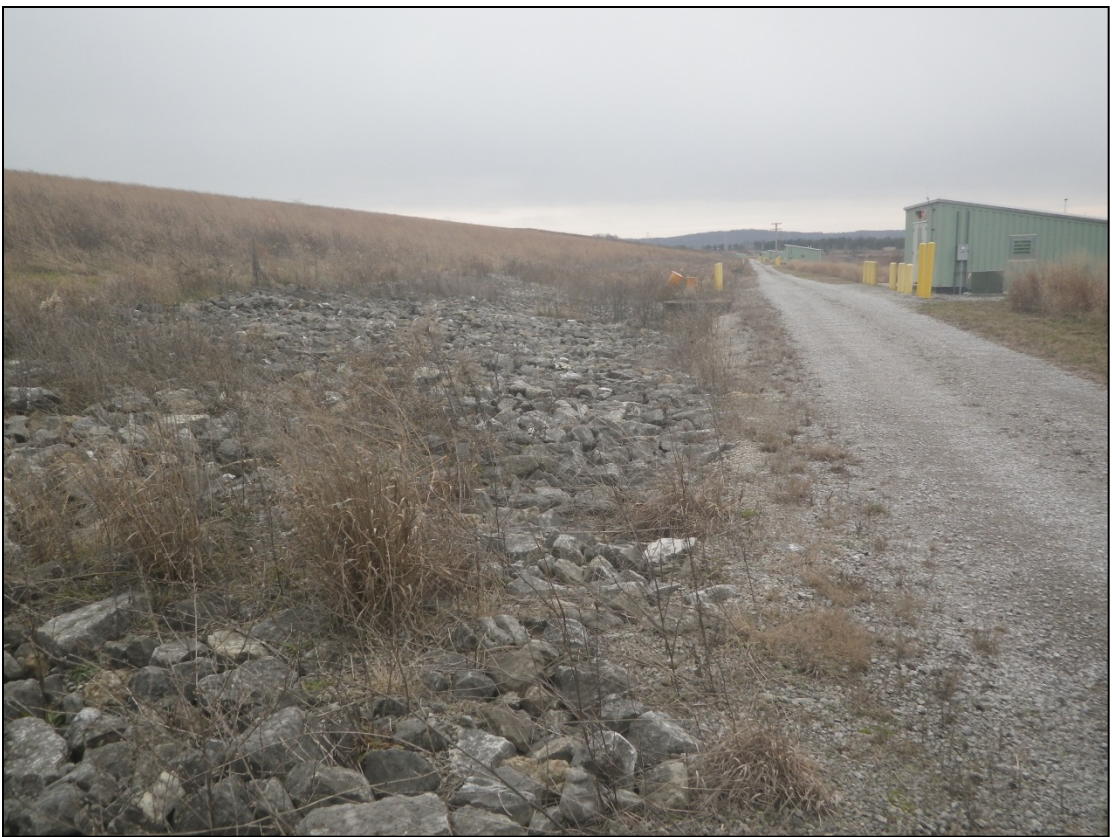
IMGP7089

West Inner Drainage Cell 4 (looking south)

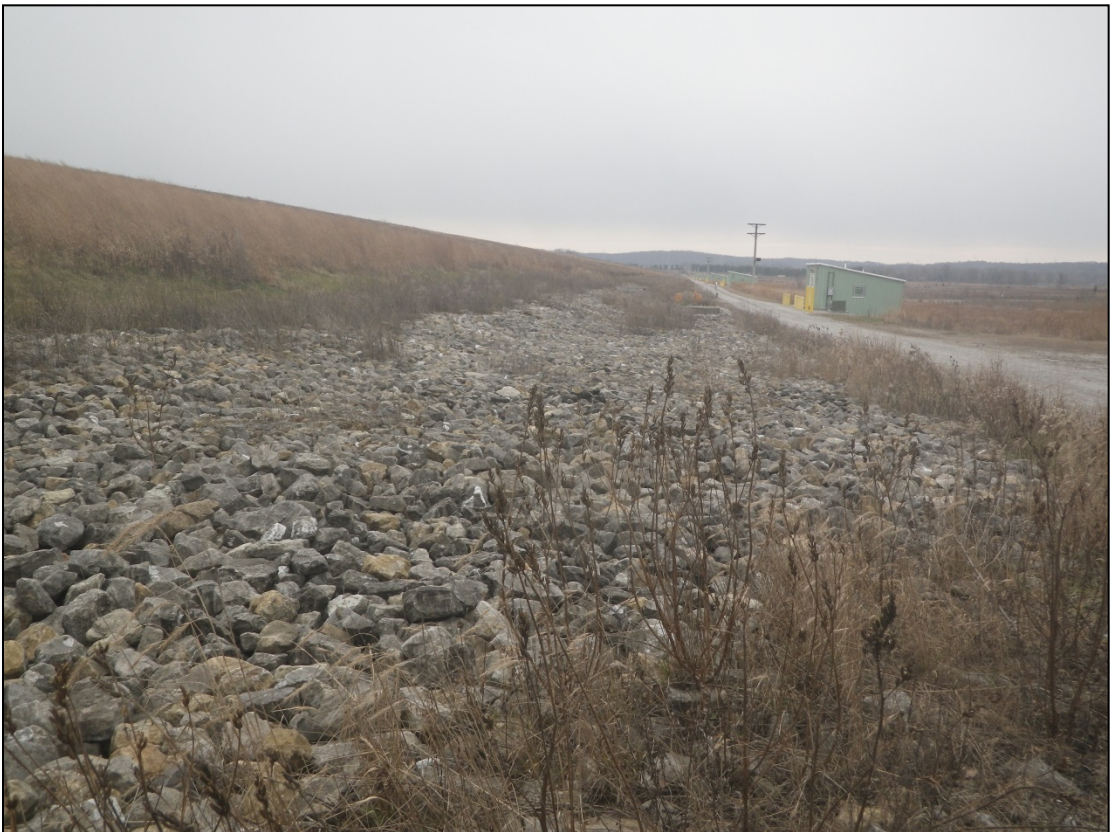
IMGP7093

West Inner Drainage Cell 1 (looking south)

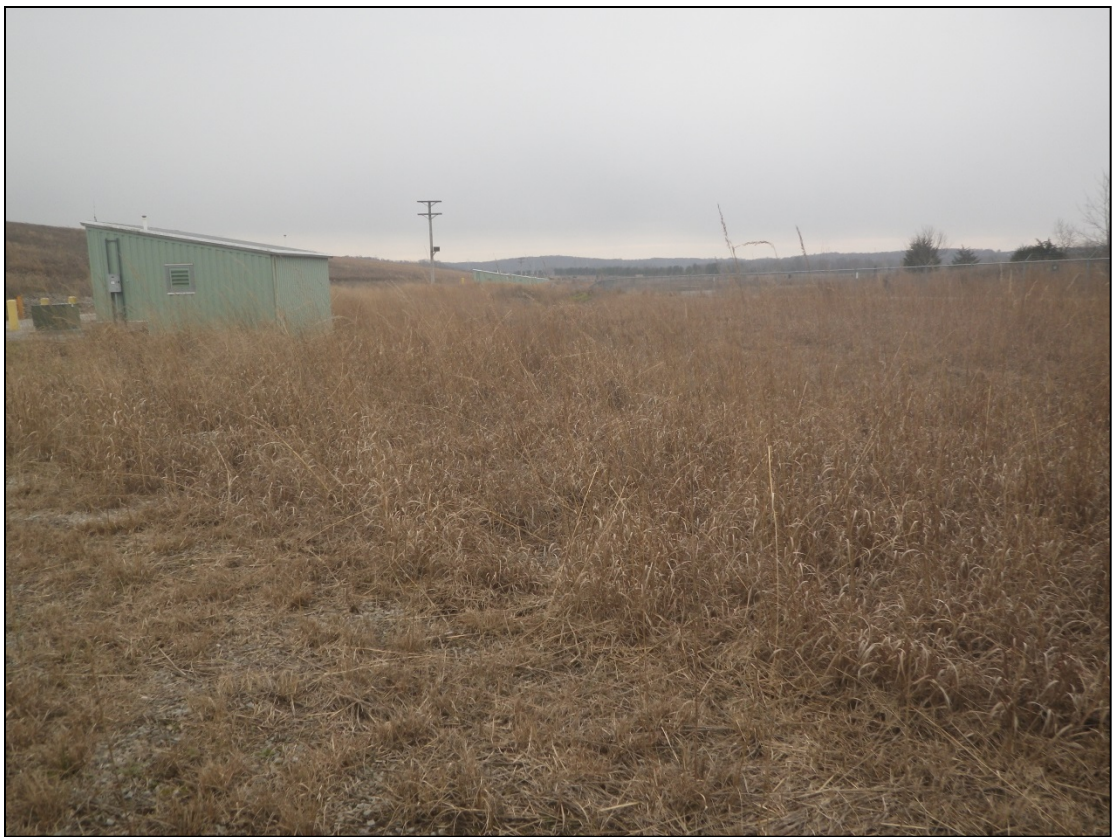
IMGP7092

West Outer Drainage Cell 1 (looking south)

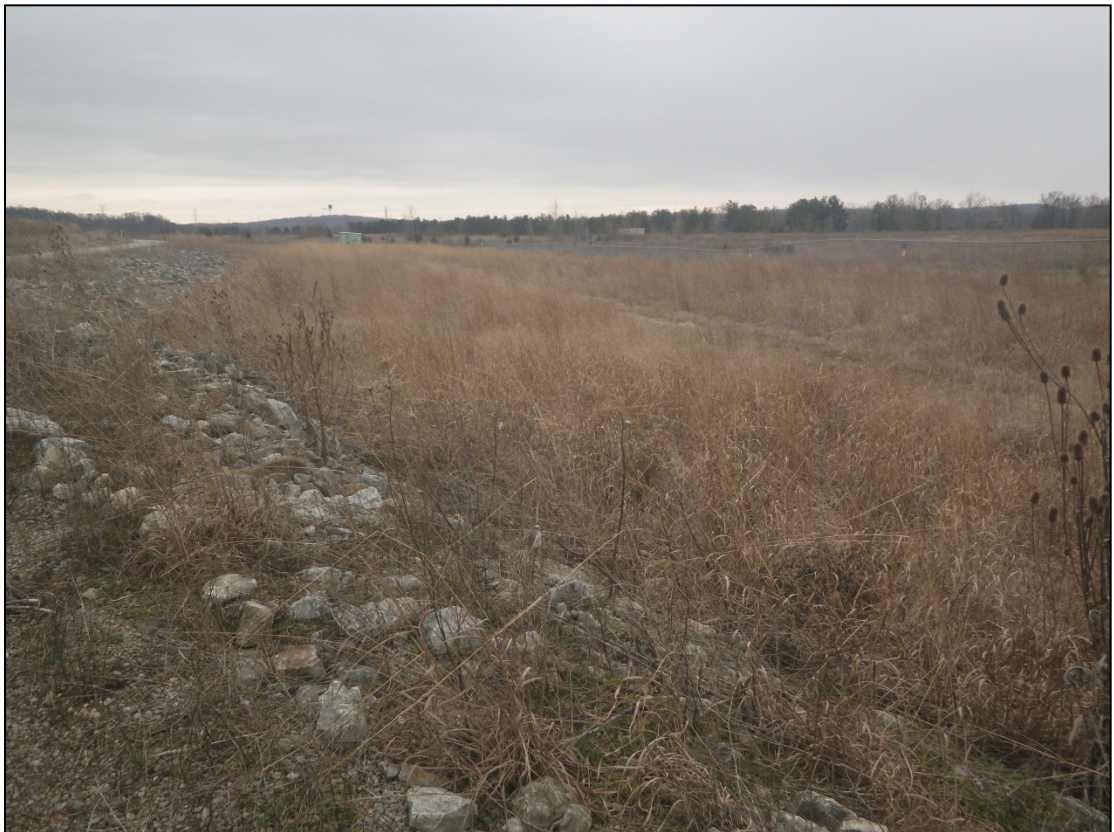
IMGP7082

West Outer Drainage Cell 8 (looking south)

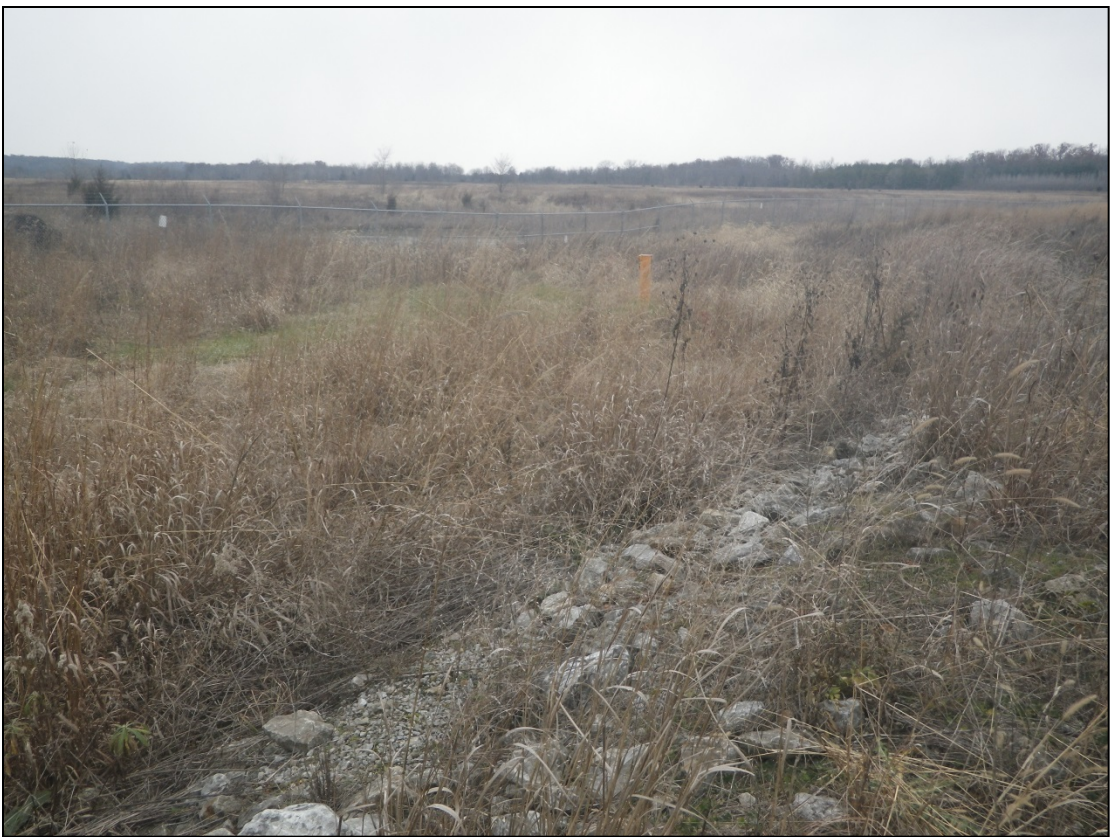
IMGP7083

West Outer Drainage Cell 8 (looking north)
