2019 Annual Inspection Report for the DOE Monticello, Utah, Mill Tailings Site and Monticello Vicinity Properties

December 2019

U.S. DEPARTMENT OF
ENERGY

Legacy
Management

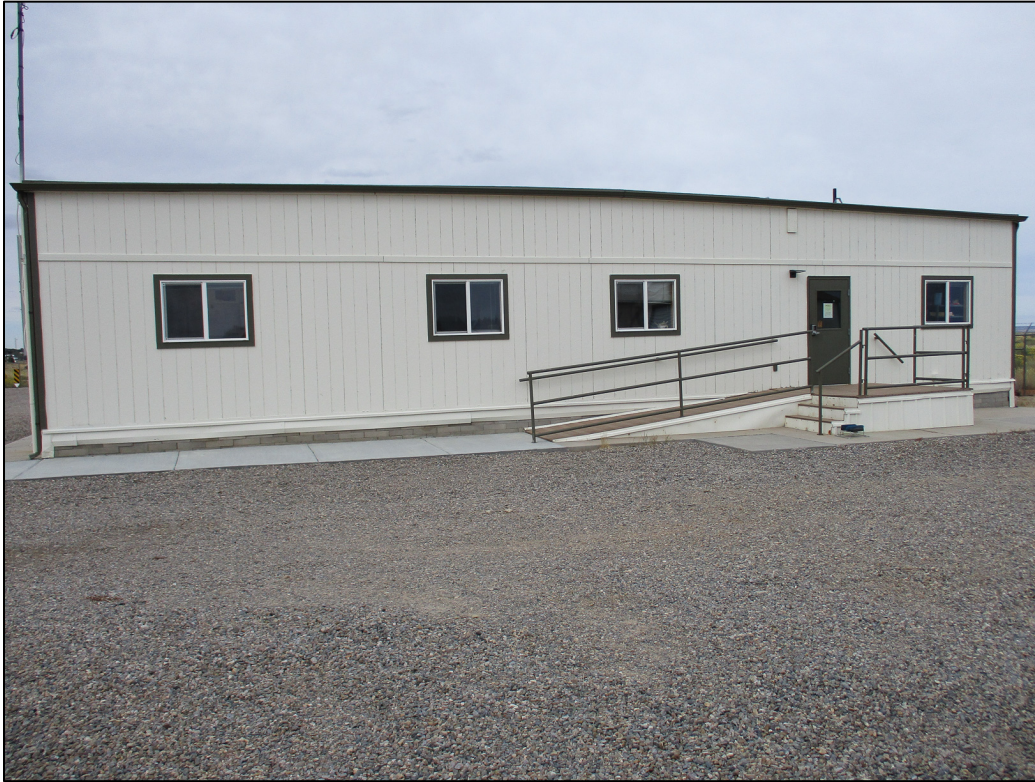
PL-1. Monticello Field Office Building

The Monticello field office buildings and associated structures were in excellent condition and well-maintained (PL-1). Four new HVAC units were installed (PL-2). A new electric gate was installed at the front main entrance (PL-3). New electrical wiring was installed to both storage sheds (PL-4). Site access signs displaying contact information were visible, and the new signs containing updated information were in place and in good condition. The site's paved access road was in very good condition.

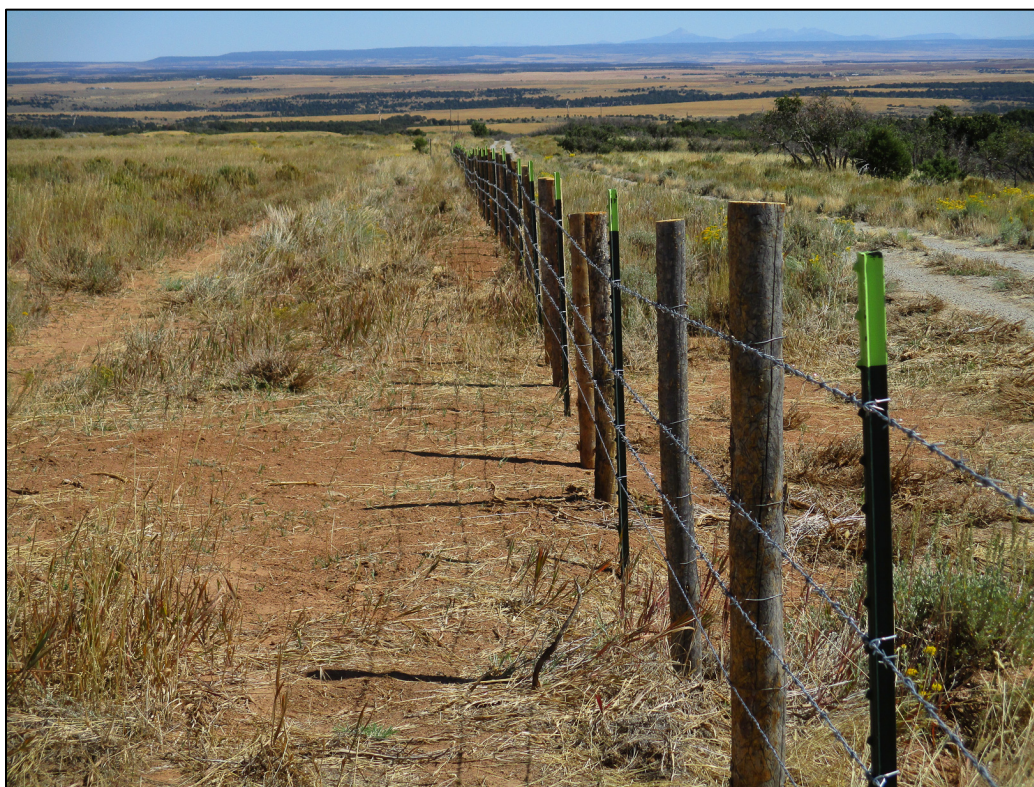
PL-7. New Section of Wildlife-Friendly Fence

In July, approximately 7861 feet of old southeastern perimeter fence was replaced with a new wildlife-friendly fence (PL-7). No evidence of vandalism or areas of excessive tumbleweed or debris buildup was present.

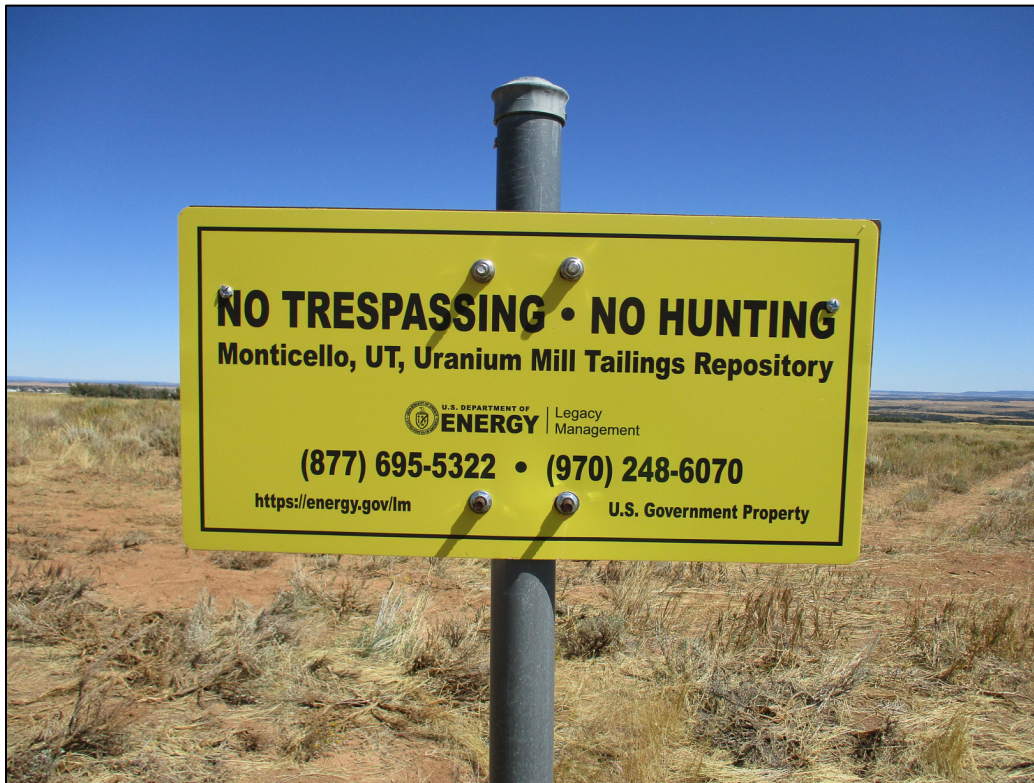
PL-8. Perimeter Sign P39

All perimeter signs were in good condition (PL-8). Black-numbered decals to identify sign numbers were in good condition.

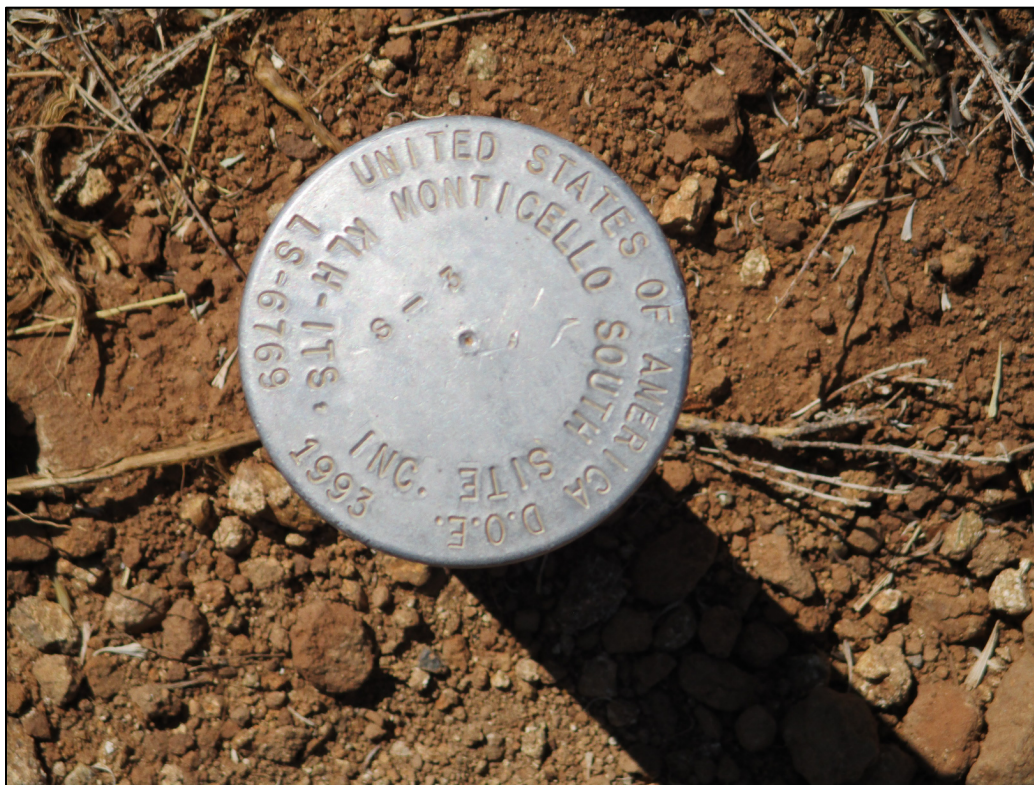
PL-9. Boundary Survey Marker S-3

All six boundary markers were located during the inspection, and all were in good condition (PL-9). PL-9 is a one photo representation of a boundary survey marker. Photos of all six boundary markers are kept in the annual inspection photo log.

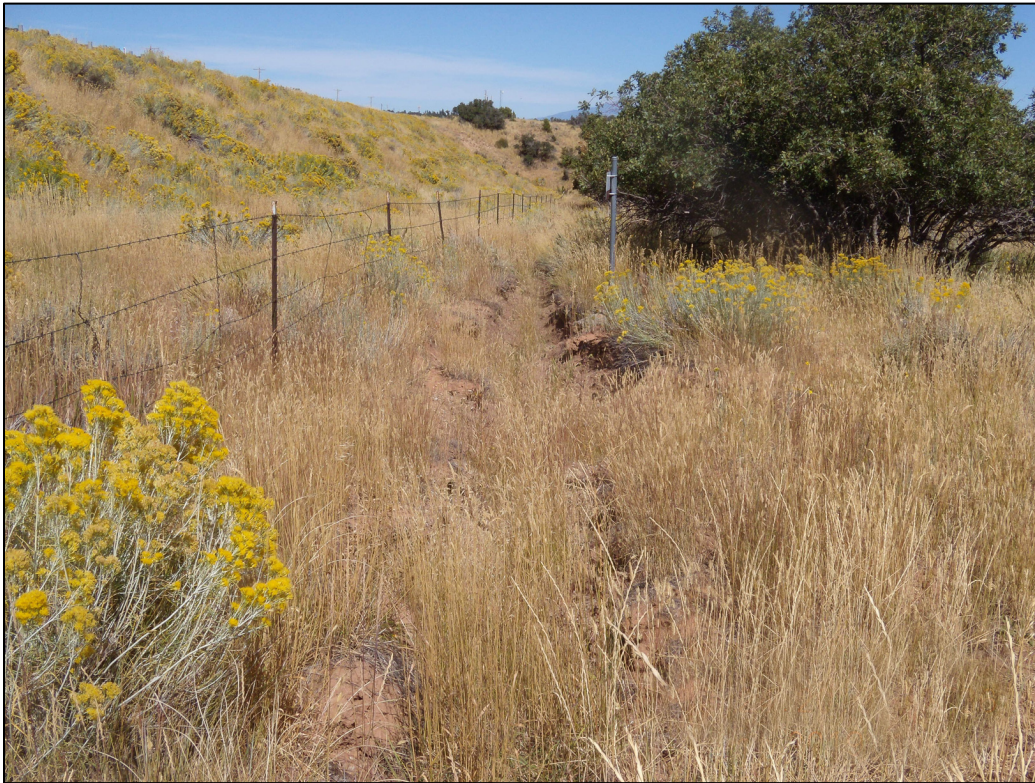
Erosion channels and drainages around the site perimeter were generally well-vegetated and had not significantly changed since the 2018 annual inspection. Erosion controls and revegetated areas related to the GRO system were in good condition, and no major erosional areas were noted. The deep gully on the west edge of the disposal site described in previous inspection reports has changed since 2018 (PL-10), as increased vegetation from a high precipitation year has stabilized much of it. The gully does not threaten the integrity of site features but will continue to be monitored.

PL-10. Looking North Toward Perimeter Sign 1 Where Erosion Channel Shows Increased Vegetation

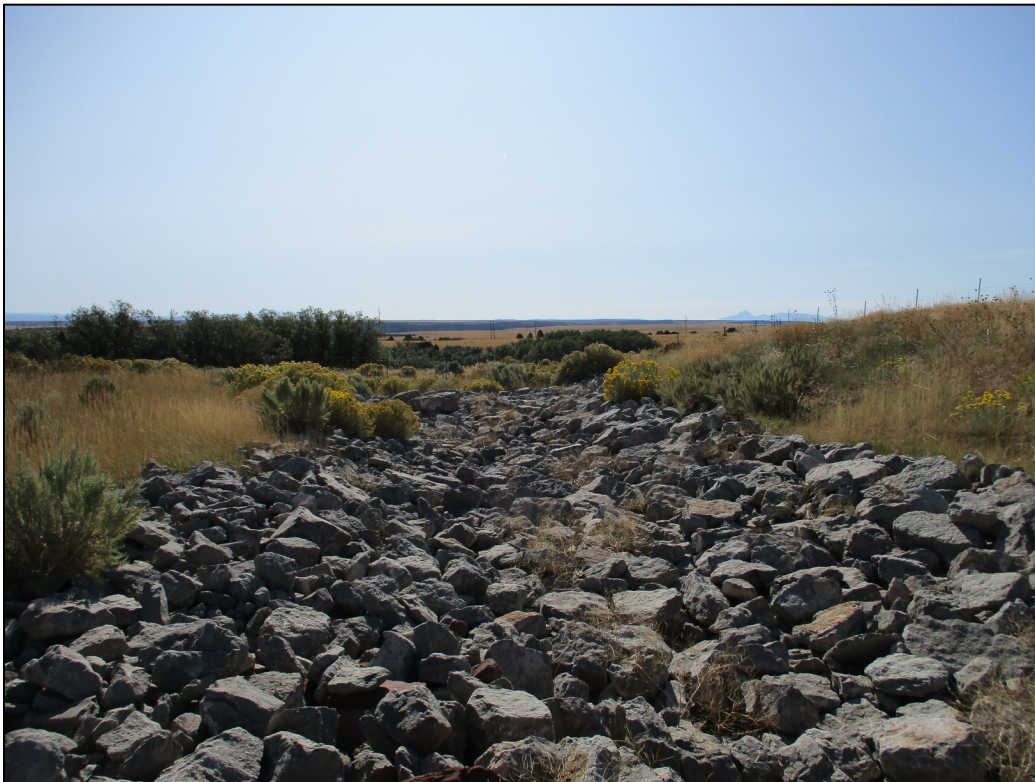
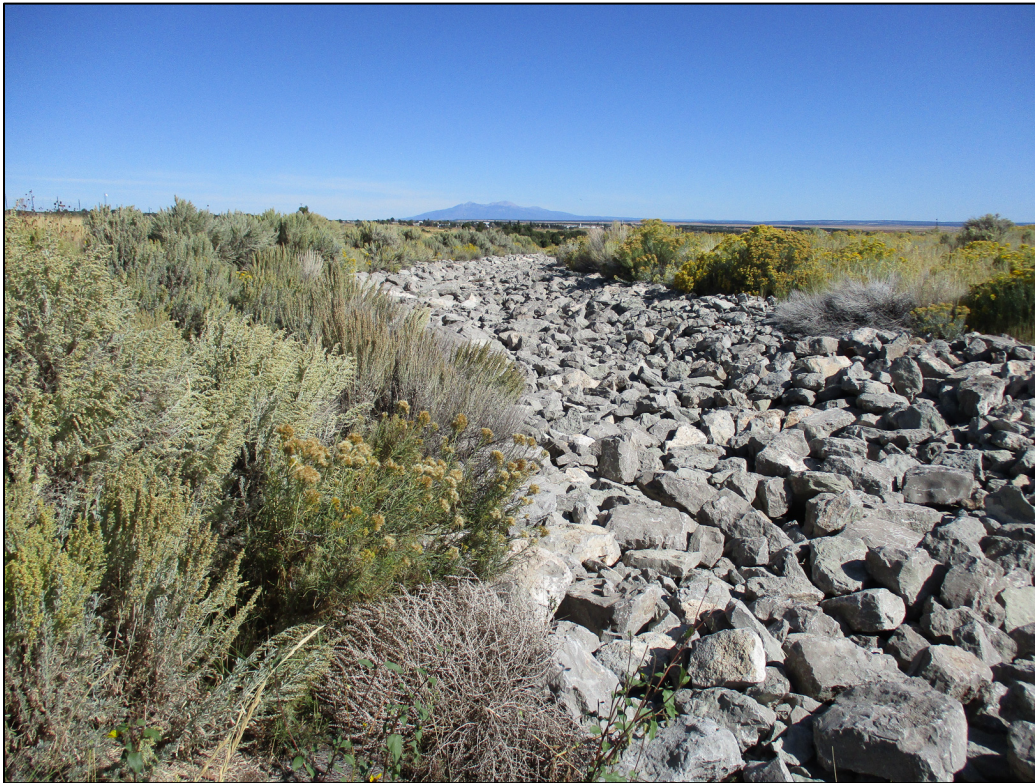
The South and West Drainage Channels were in very good condition, with no evidence of new erosion (PL-11 and PL-12). Shrubs observed in portions of the ditches do not block potential flow, and burrows from small rodents that are found in places along the margin of the ditches do not threaten their integrity.

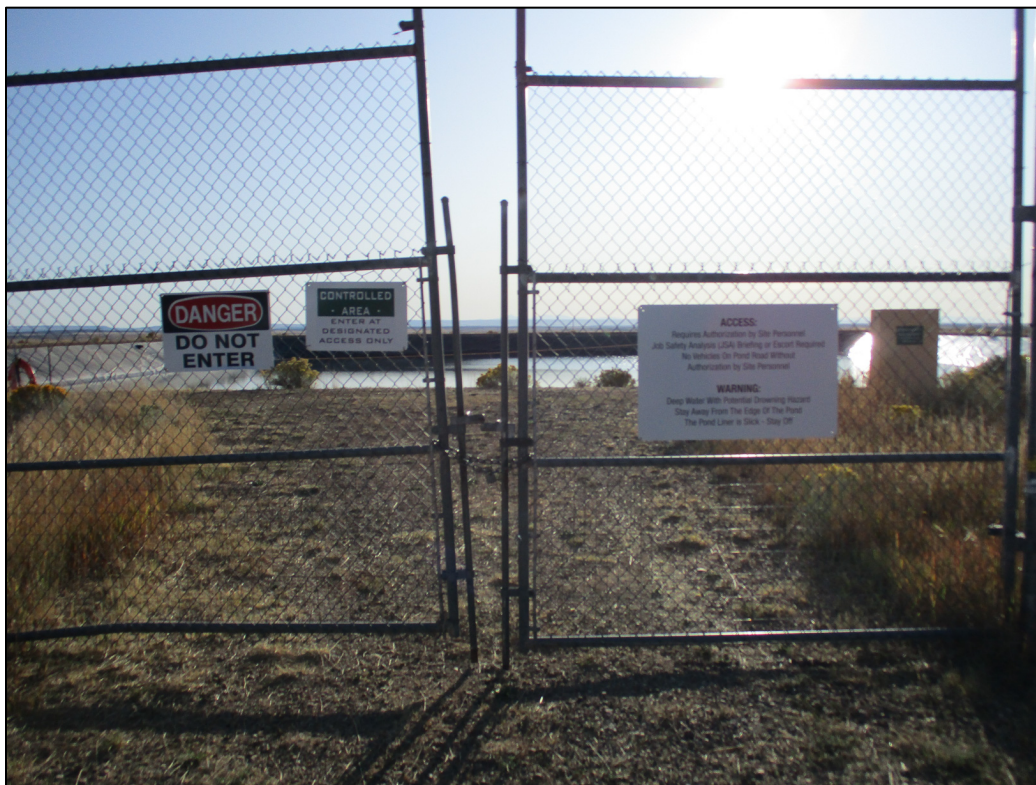
PL-13. Pond 4 Entry Gate

All gates were in good working condition. Warning signs on the perimeter fence were easily visible and legible. There was no evidence of vandalism or trespass, and all gates were locked at the time of the inspection (PL-13).

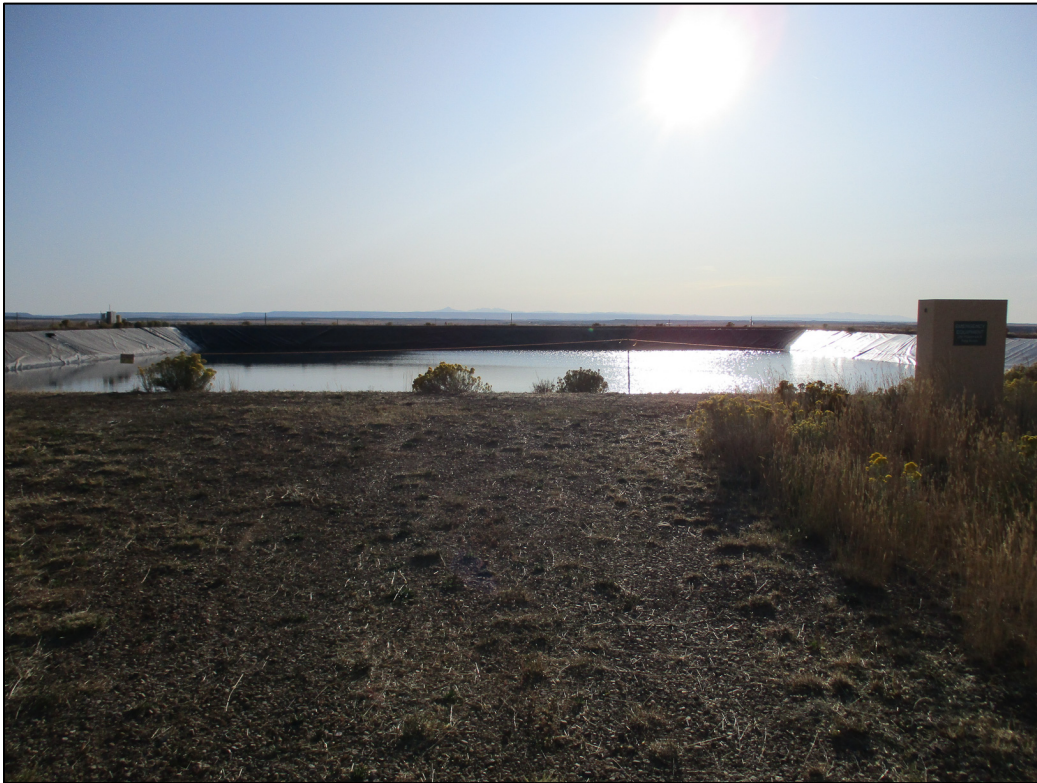
PL-14. Pond 4, Looking East

The pond's radiological rope barrier was intact and in good condition. The excess vegetation along the pond's access road was mowed in May. Animal burrows made by voles and other small rodents were visible on and below the pond's berm on all sides. However, no large burrows that might threaten the berm's integrity were found. Vegetation on the slopes of the berm was well-established and healthy. Pond 4 is shown in PL-14.

The water in Pond 4 was approximately 8.0 feet deep at the time of the inspection, due mostly to the operation of the GRO system. Only the exposed liner is inspected. No visible evidence of holes or other damage to the pond liner was observed.

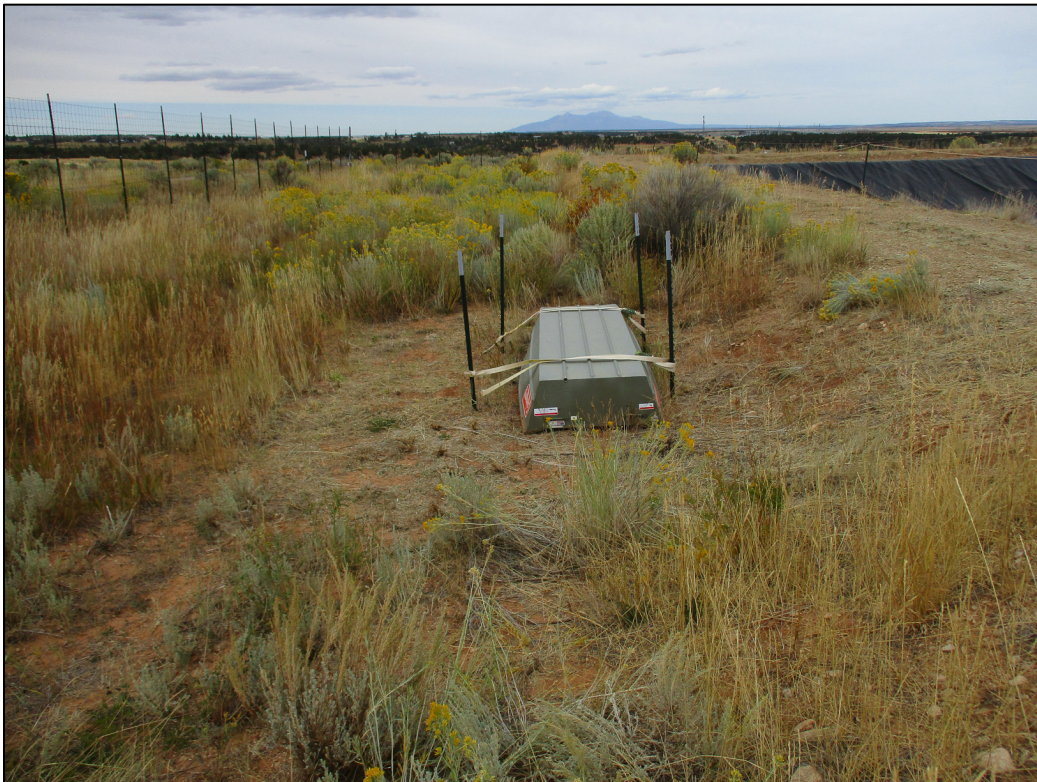
PL-15. Mowed Vegetation Around Pond 4 Skiff

Lifesaving rings and a rescue and work skiff were present and easily accessible near the pond. Vegetation around the work and safety skiff was mowed for accessibility (PL-15). Cabinets containing water rescue equipment were also highly visible, adequately labeled, and in good condition.

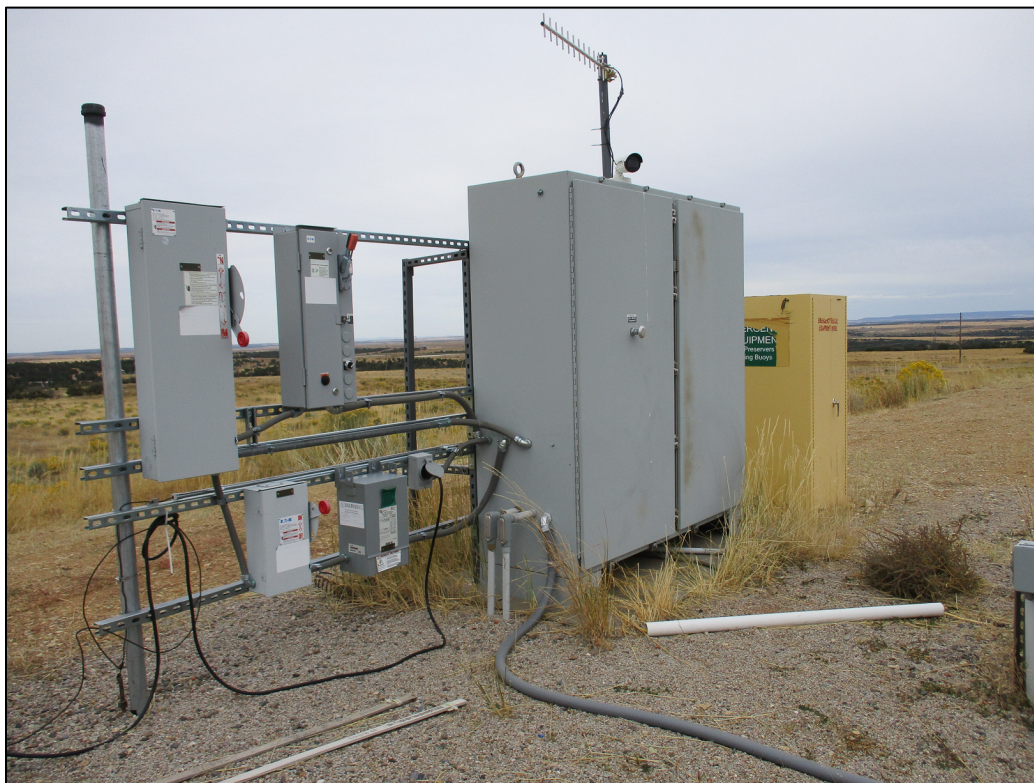
PL-16. Pond 4 LCRS/LDS Control Cabinet

The weatherproof LCRS and LDS control cabinet was in good condition. Electrical upgrades to it were done in May (PL-16). Operation of the Pond 4 LCRS and LDS is described in Section 2.1.6.

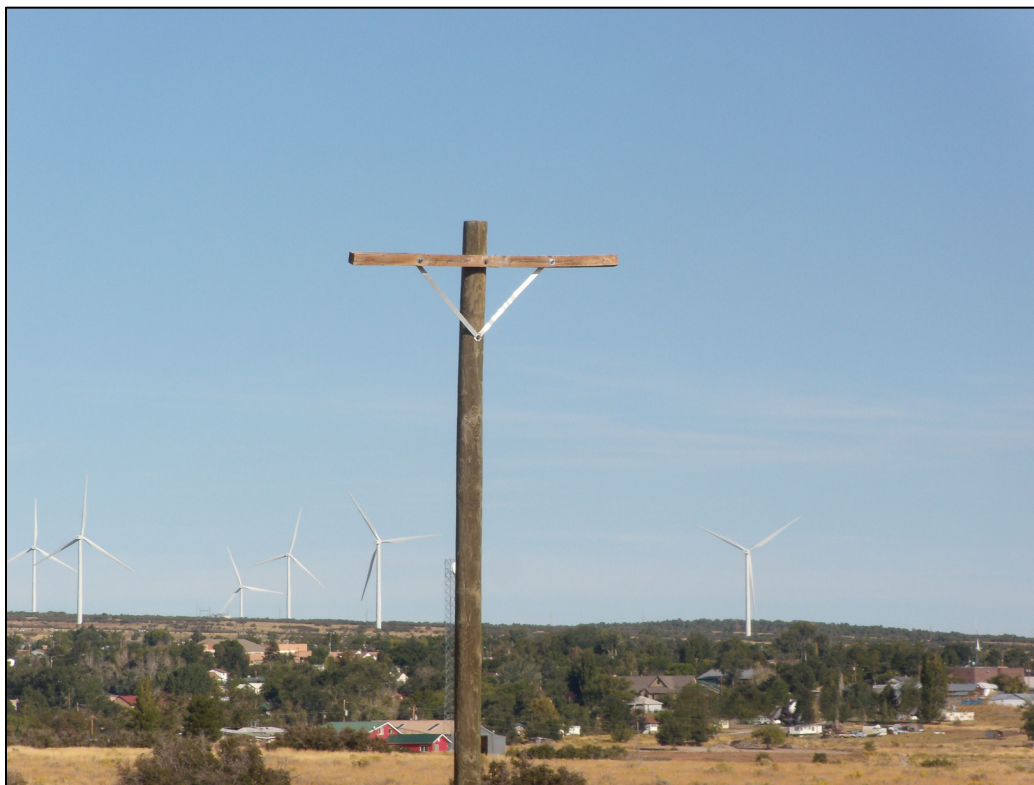
PL-19. Northeast Raptor Perch with Repaired Support

The gravel road surrounding the disposal cell and the road to Pond 4 were in very good condition. Material was added to the access road to create positive drainage. Water bars on the access road to the transfer building were in good condition. The wildlife fence and gate apertures were functional and showed no evidence of vandalism. Damaged sections of the wildlife fence were apparent, but the fence remained functional; however, there is one section of the fence near perimeter sign 4 that needs repaired. All gates in the wildlife fence were open. Both site monuments (PL-17)—one at the west access gate inside the wildlife fence and one at the apex of the disposal cell (PL-18)—were present and intact. Six raptor perches, installed near the disposal cell cover in 2007, were also in good condition, and the detached supporting beam brace on one perch was repaired (PL-19).

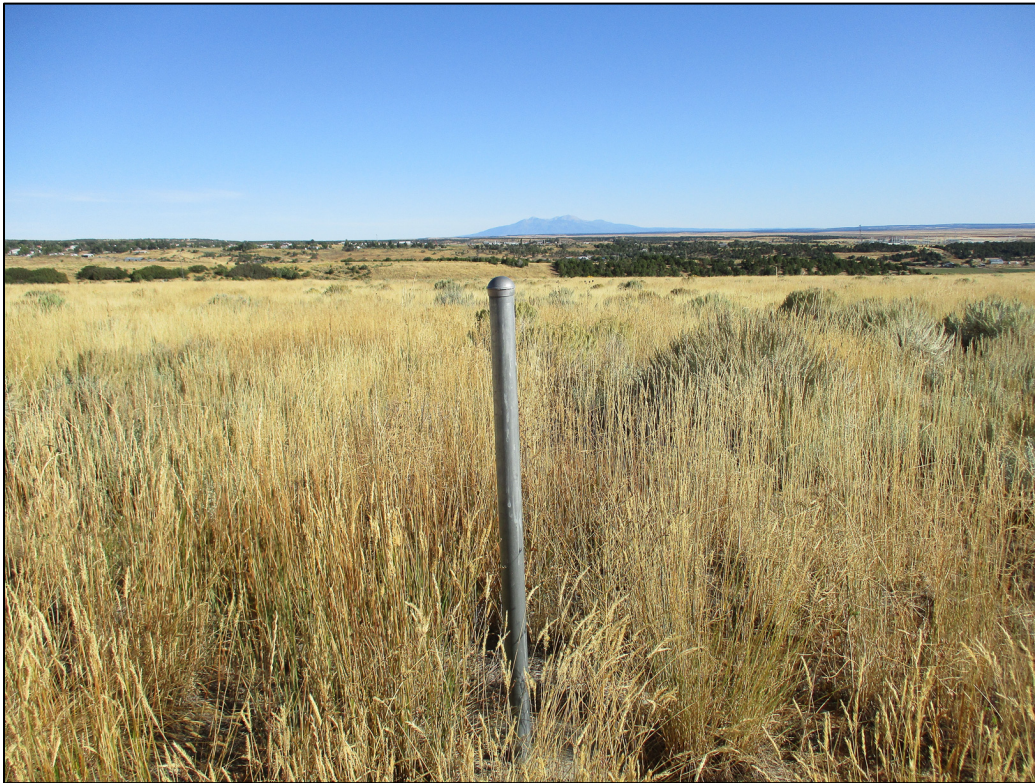
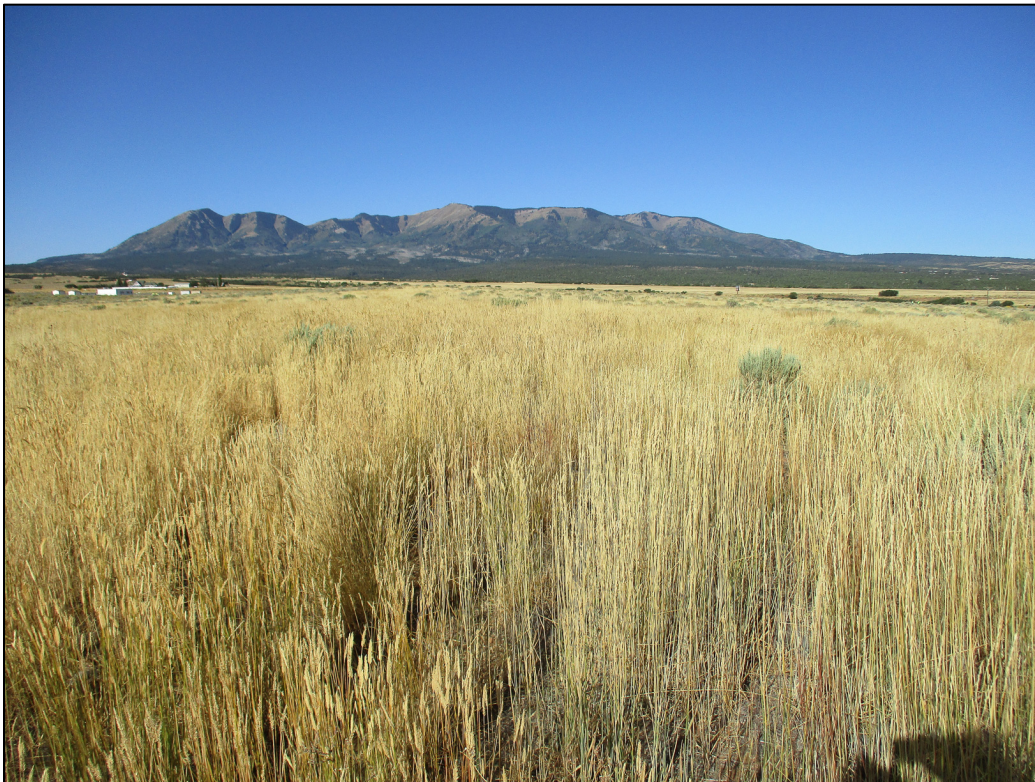
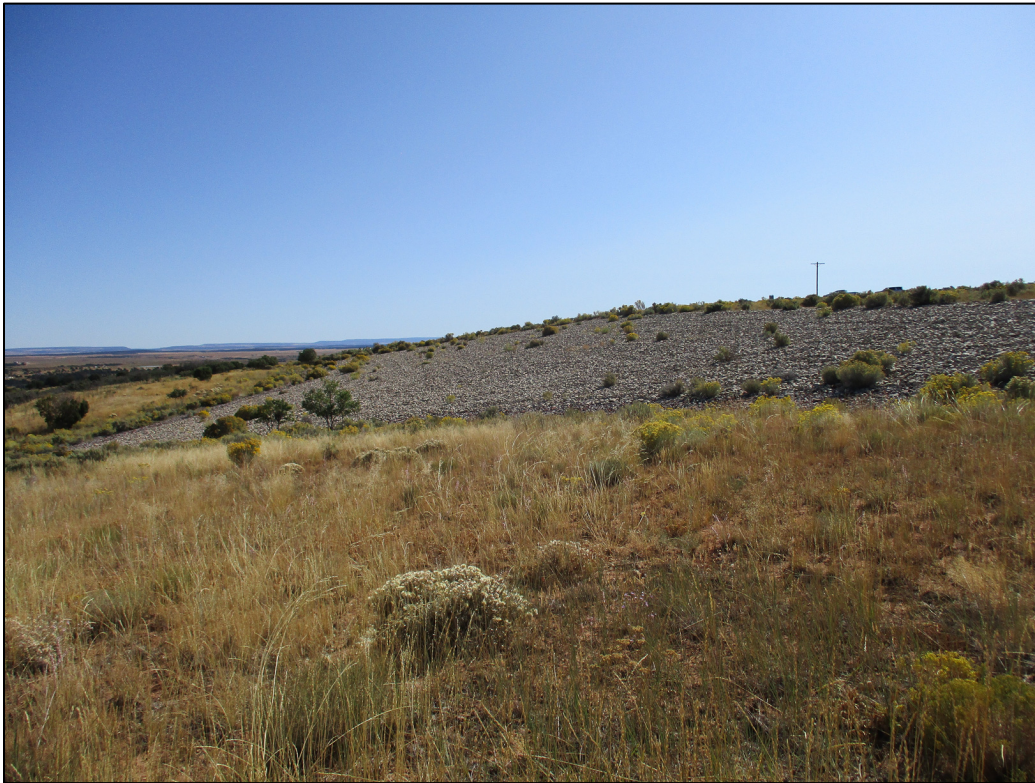
Desirable plants remained well-established on the cover, and no significant barren or eroded areas were identified (PL-20, PL-21, and PL-22). No damage to vegetation or soils from rainstorms was apparent, and no species of phreatophyte shrubs were growing on the cover. As in recent years, there were a large number of healthy young sagebrush (*Artemisia tridentata*) plants. The small quantity of field bindweed (*Convolvulus arvensis*), which the State of Utah lists as a Class C noxious weed, was still present on the cover, but control was not necessary.

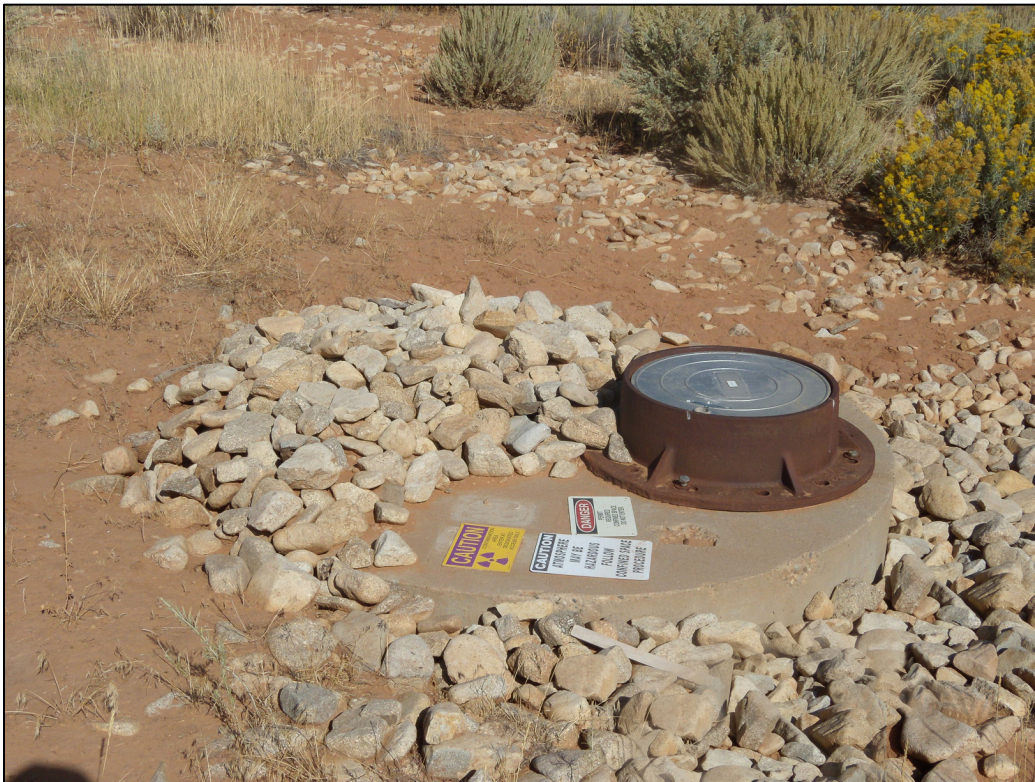
PL-23. Manhole #4, Looking North

The manholes are restricted areas and were not entered during the annual inspection, but the exteriors were observed and were in good condition (PL-23). All five manhole covers were

secure and operable. Appropriate safety warnings and entry procedures were posted on all of the manholes, exterior pump access ports were undamaged, telemetry surface installations were in good condition, and no leakage or drainage was evident. Covers of the inoperable video ports were locked and secure.

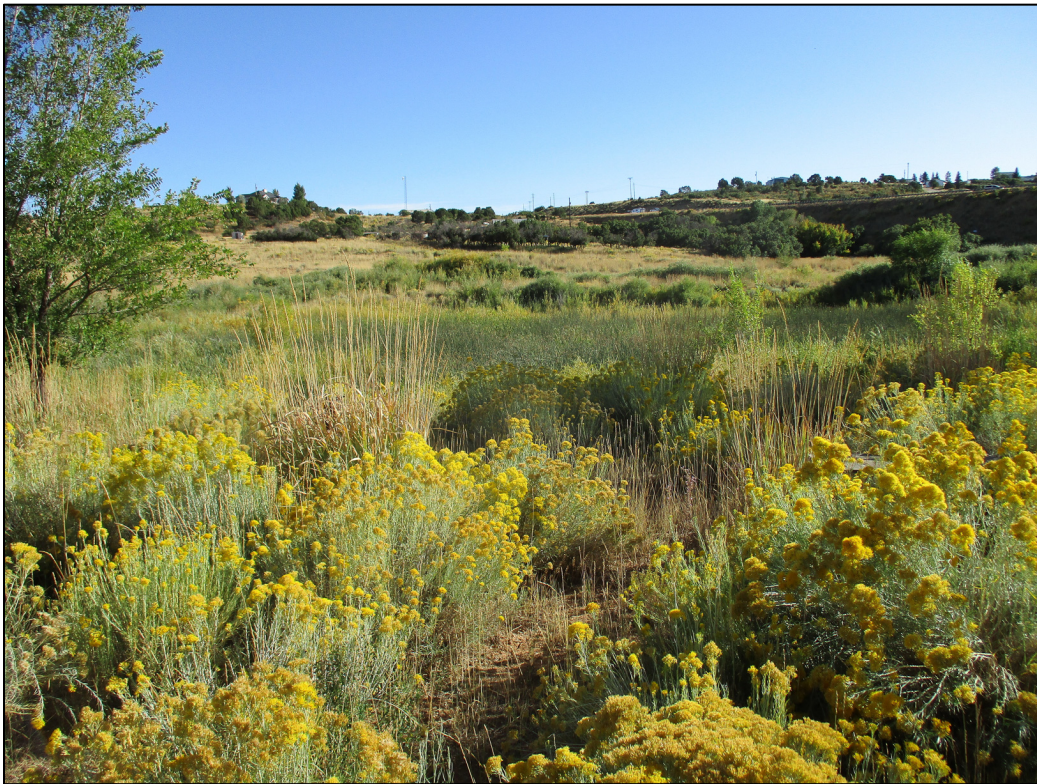
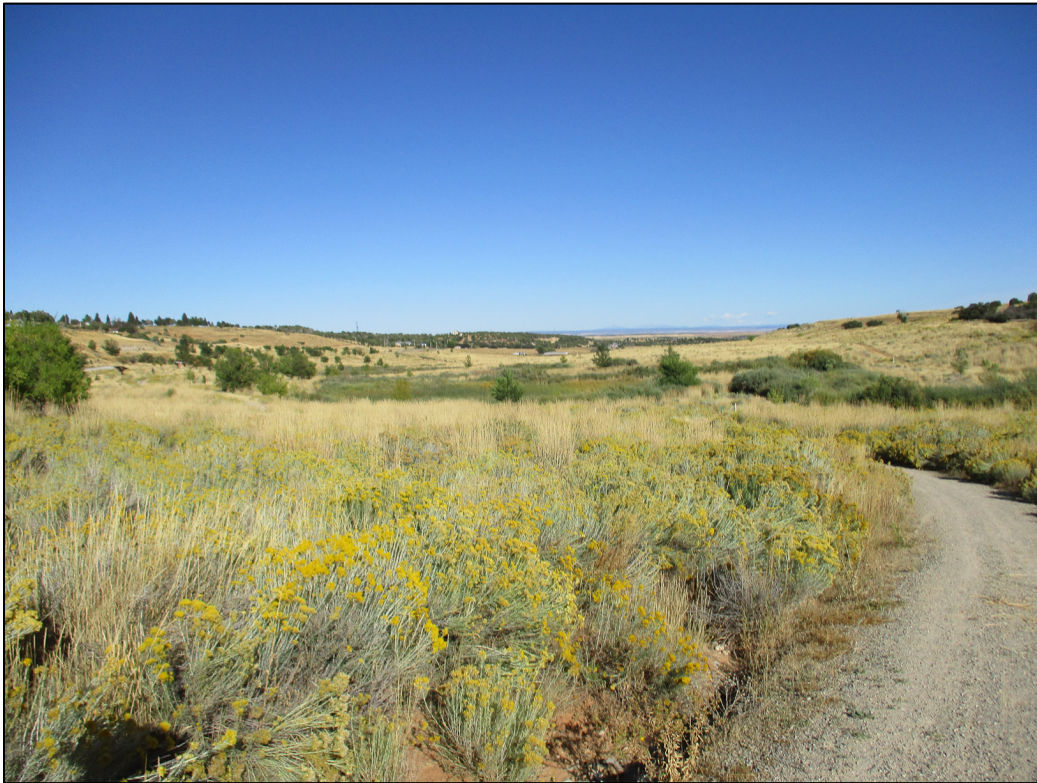
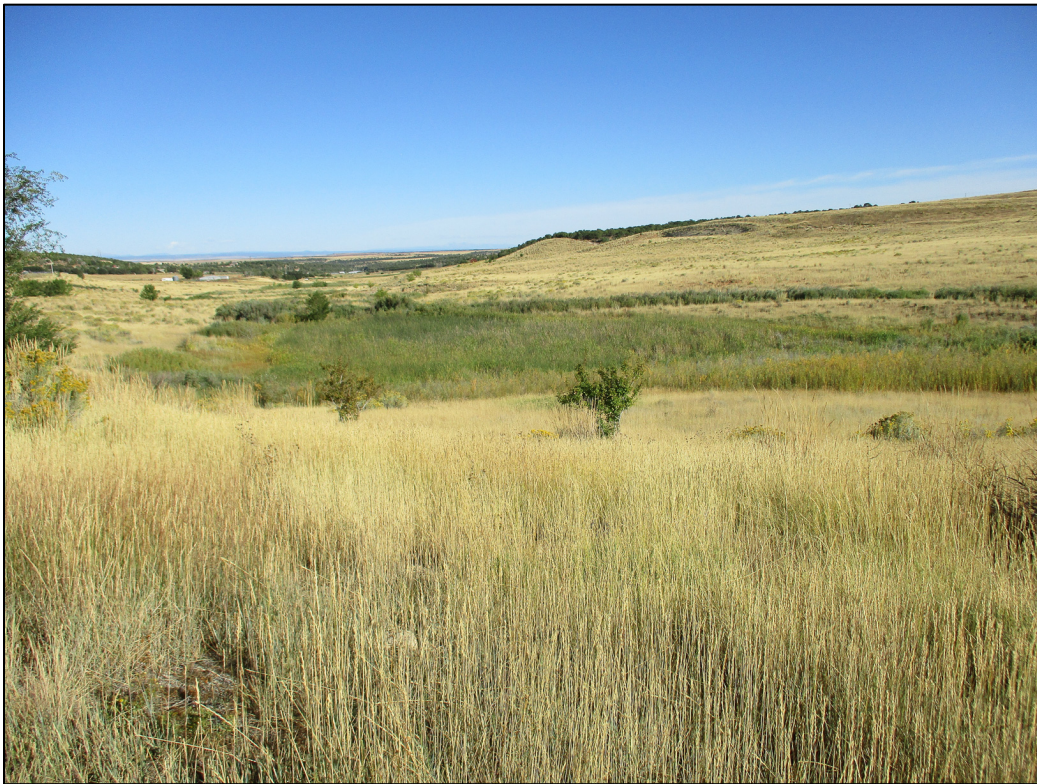
Wetlands 1, 2, and 3 on the former mill site (Figure 4) were ecologically healthy, and no evidence of damage by human activity or natural causes was apparent (PL-27, PL-28, and PL-29).

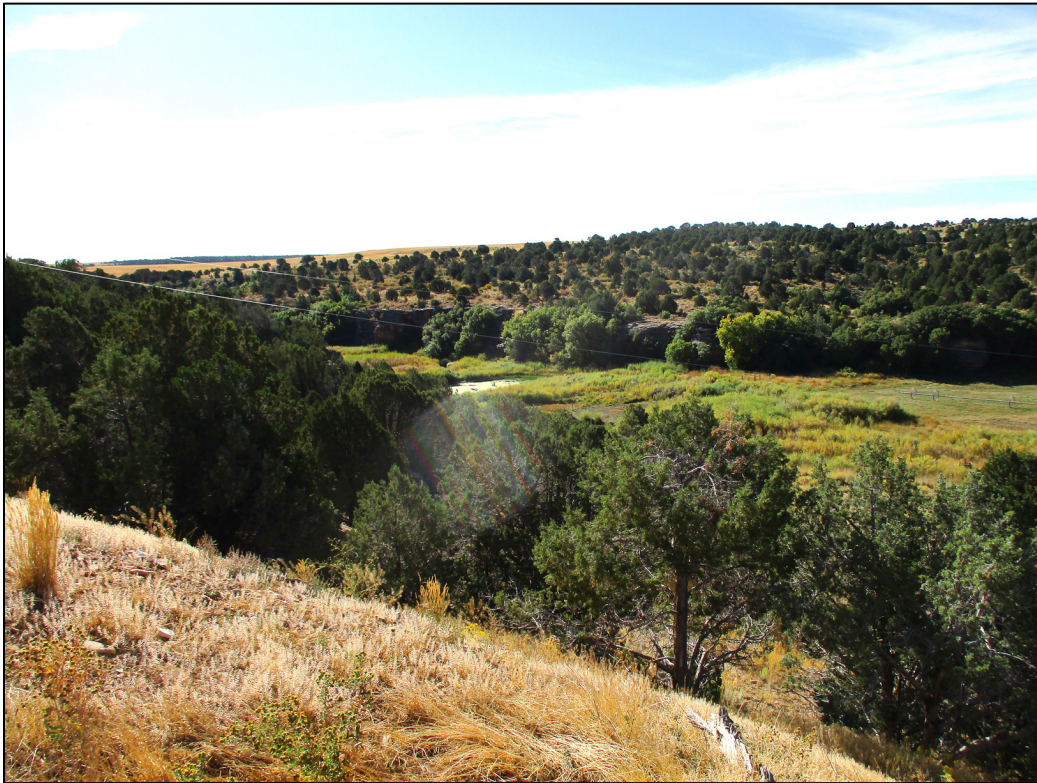
PL-32. Montezuma Canyon, View Downstream

Properties in the Montezuma Creek Restrictive Easement Area are inspected on a regular basis by onsite and water sampling personnel; during these visits, no evidence of significant erosion or soil removal from the restricted areas of these properties was noted. In 2019, portions of Montezuma Canyon were inspected from observation points above the area, and no evidence of land-use changes or disturbance to the easement area was found. Observations in the easement area (PL-32) are recorded in Appendix A, Section V.

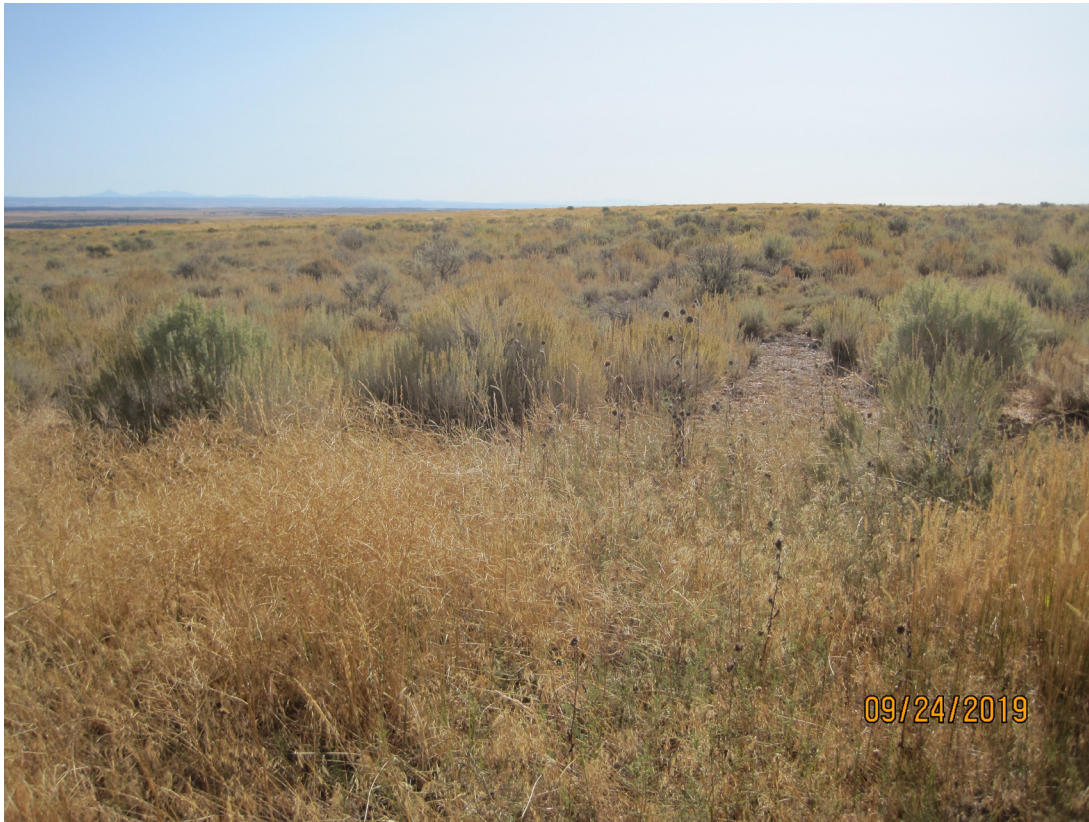
Figure No. 1, Over top slope cover, September 24, 2019

The site was in good to excellent condition during the inspection. A good amount of winter precipitation allowed vegetation on the top and vegetated side slope to be in a healthy growth condition. No serious geotechnical problems were identified on the repository or site. Figure No. 1 shows the overall cover conditions.

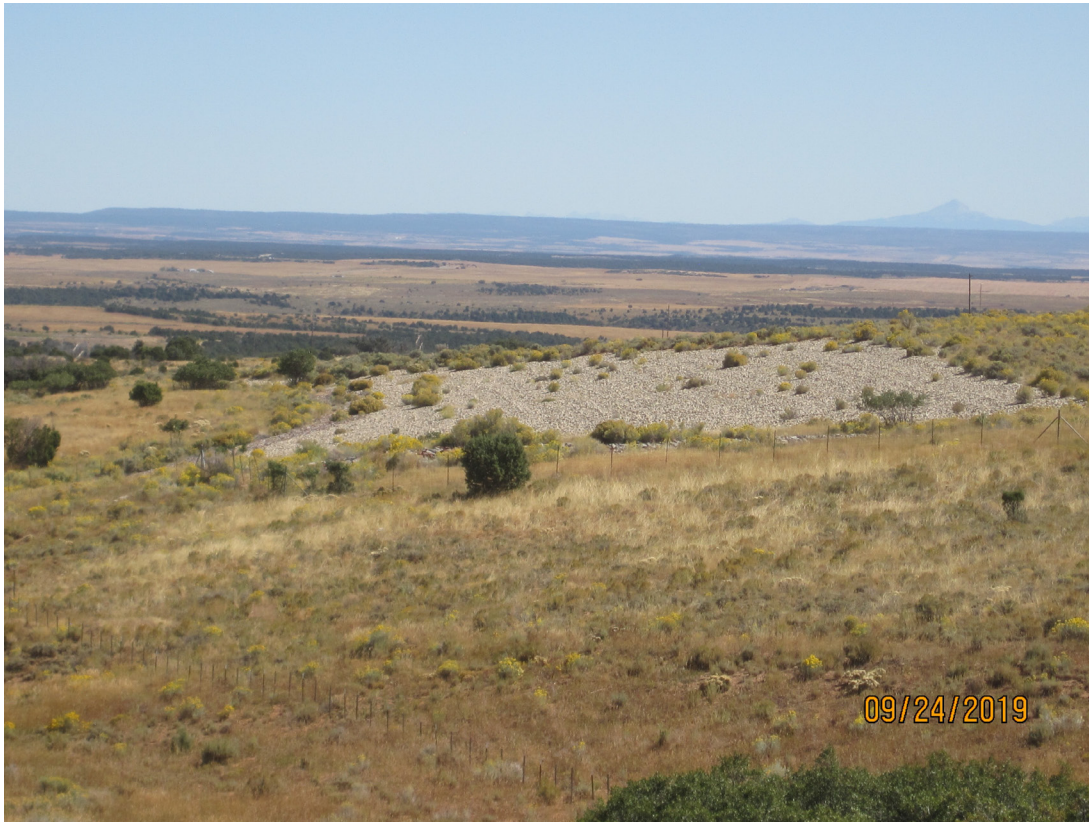
Figure No. 2, Northwest riprap slope seen from U.S. Highway 191

The northwest riprap side slope was initially visited and found to be in excellent condition as evident in Figure No. 2. The slope is protected against erosion by diorite riprap (as shown in Figure No. 3), and materials were in excellent condition. Shallow channels with occasional shallow rills were found on the soil/rock interface of the side slope, above the riprap slope indicating surface flow probably from melting snow cover and/or precipitation. These features do not currently pose any difficulties, however continued monitoring is needed to ensure erosional problems are not created.

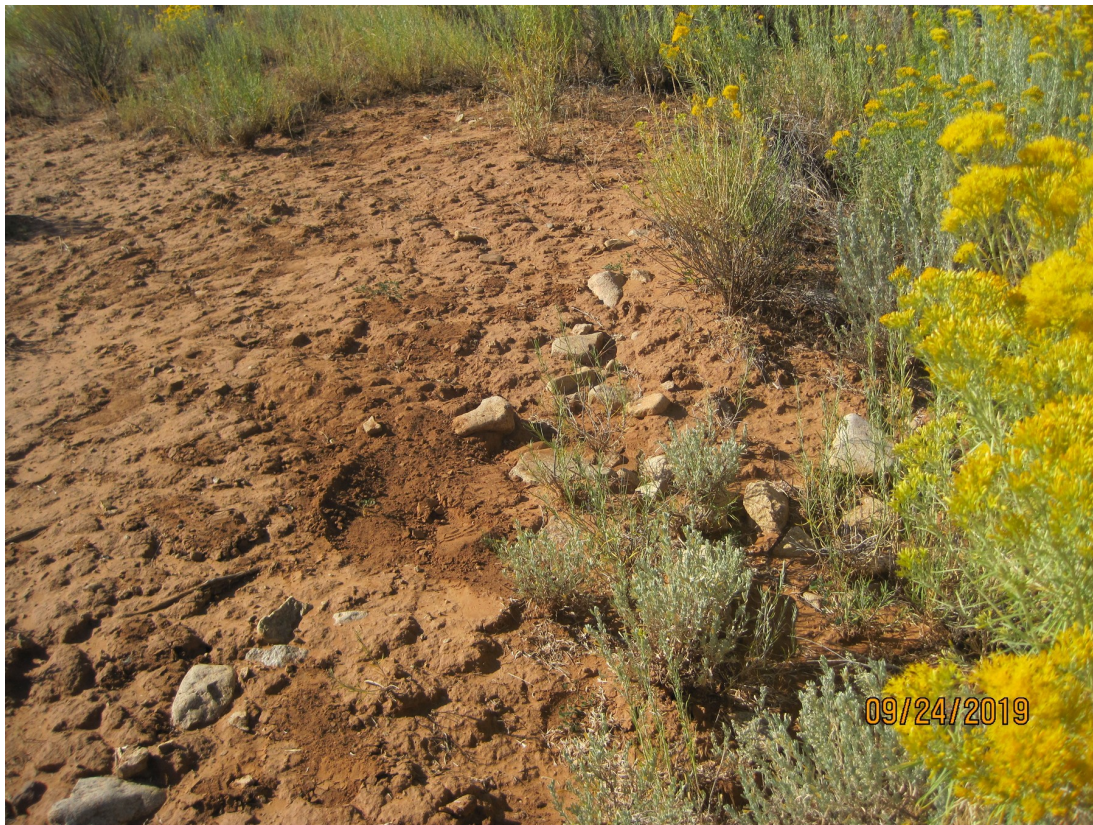
Figure No. 4, Sediment at top of northwest slope

Some sediment is currently being transported to the edge of riprap slopes (see Figure No. 4). This is identical to processes working on vegetated side slopes above rock filled channels/aprons (shown on Figure No. 5) located at the base of slopes. Flow in apron/channels does not appear to be affected, and is not considered a problem. In each of these cases vegetation is establishing in the sediment and does not pose in erosion problems. However, these examples of minor erosion should continue to be monitored. Some break down of sandstone rock is evident, as seen in Figure No 6. This breakdown is not ubiquitous, nor widespread and is not considered a problem.

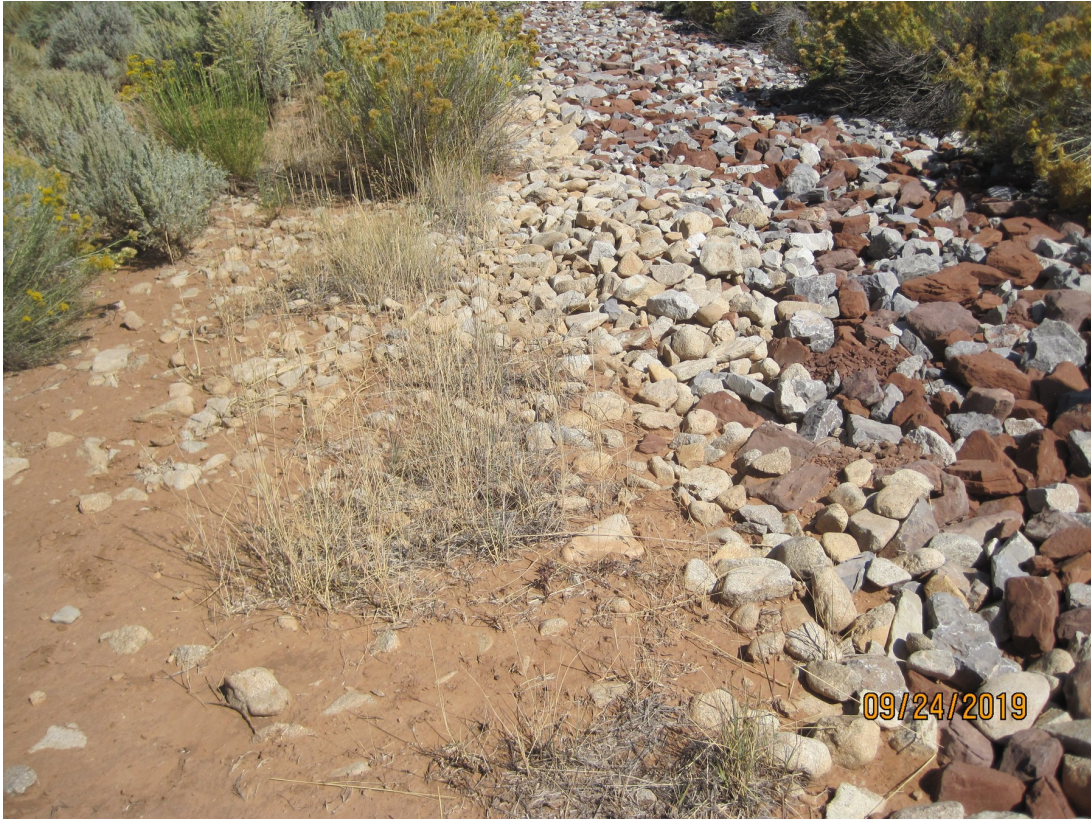
Figure No. 5, Sediment transport into toe apron, east side slope

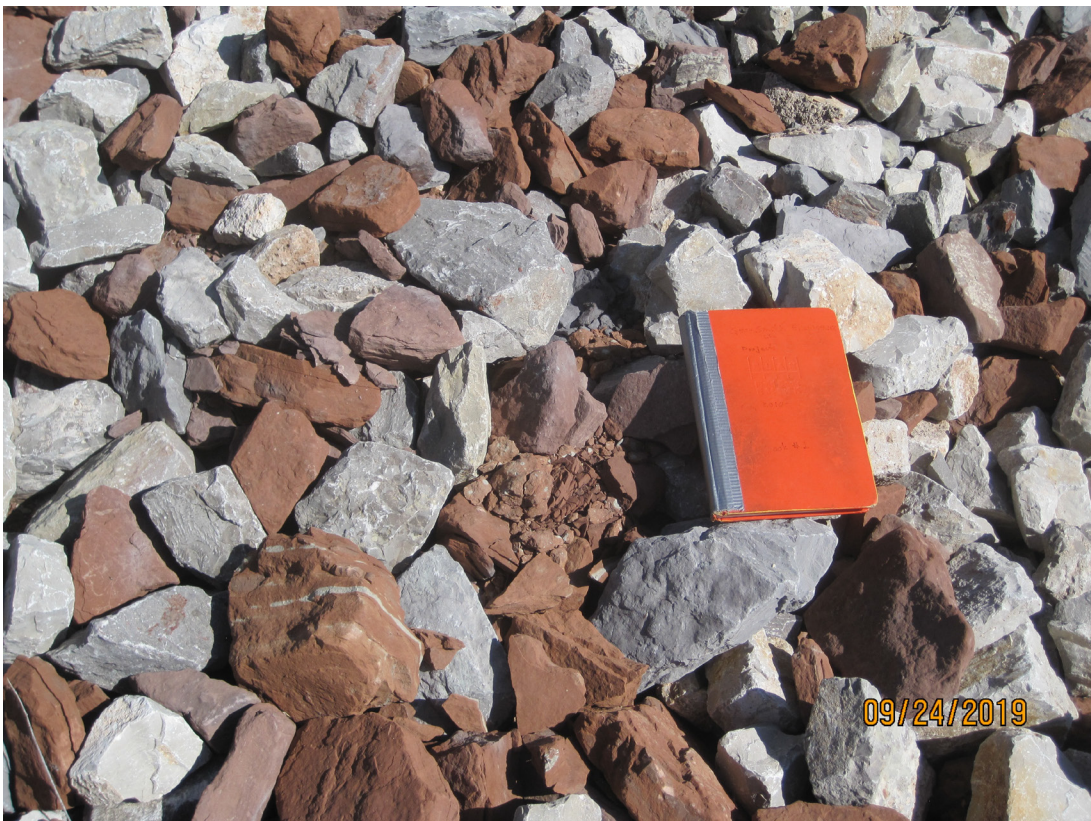
Figure No. 6, Break down of sandstone rock, east side slope apron
