2019 Annual Inspection Report for the DOE Monticello, Utah, Mill Tailings Site and Monticello Vicinity Properties

December 2019

U.S. DEPARTMENT OF
ENERGY

Legacy
Management

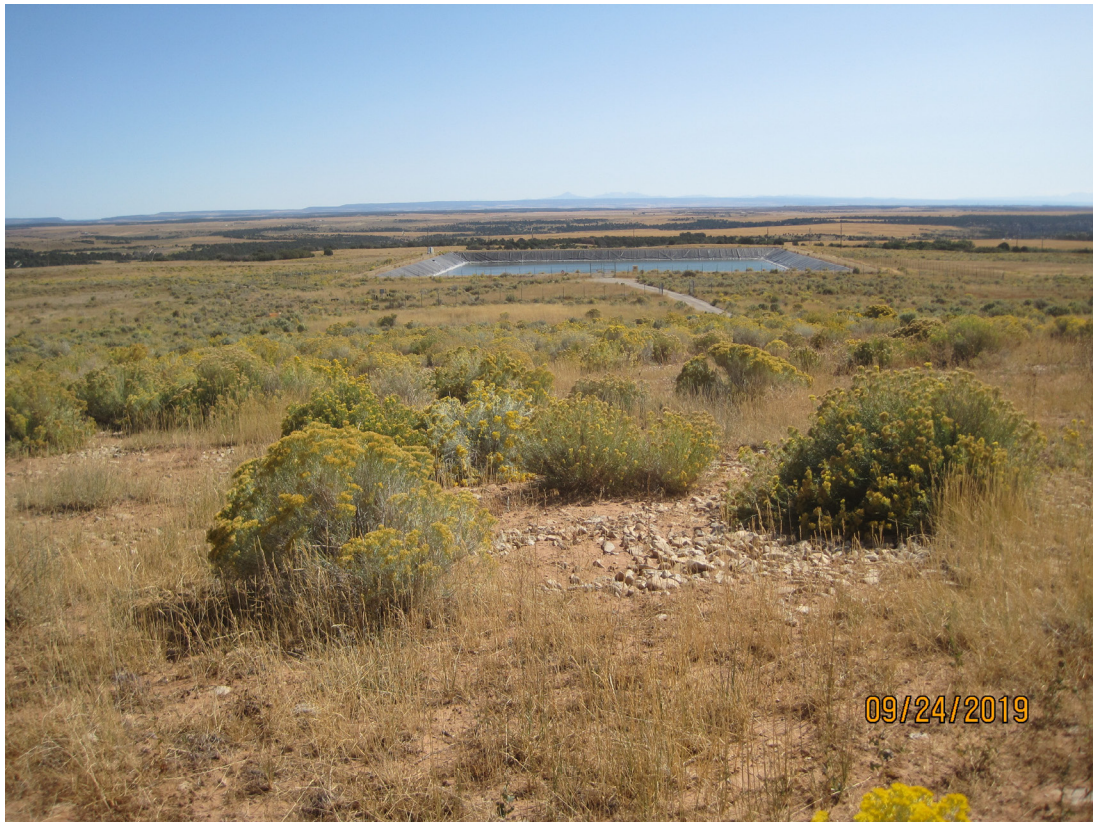
Figure No. 7, Pond 4 from east side slope

No problems were reported at either Pond 4 (see Figure No. 7), nor the ground water transfer building, so neither of these facilities was visited for the geotechnical inspection. As seen in Figure No. 7, Pond 4 is in good condition.
