2020 Annual Inspection Report for the DOE Monticello, Utah, Mill Tailings Site and Monticello Vicinity Properties

December 2020

U.S. DEPARTMENT OF
ENERGY

Legacy
Management

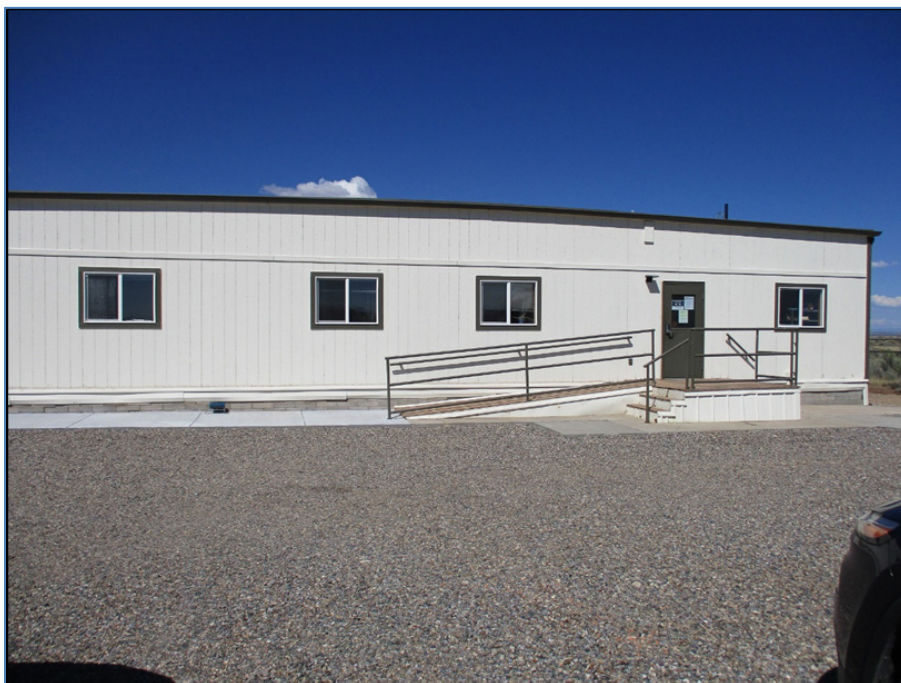
PL-1. Monticello Field Office Building

The Monticello field office buildings and associated structures were in excellent condition and well-maintained (PL-1, PL-2, PL-3, PL-4). The exhaust fans in the restrooms were replaced and battery-backup systems were installed since the last annual inspection. Site access signs displaying contact information were visible, and the new signs containing updated information were in place and in good condition. The site's paved access road was in very good condition.

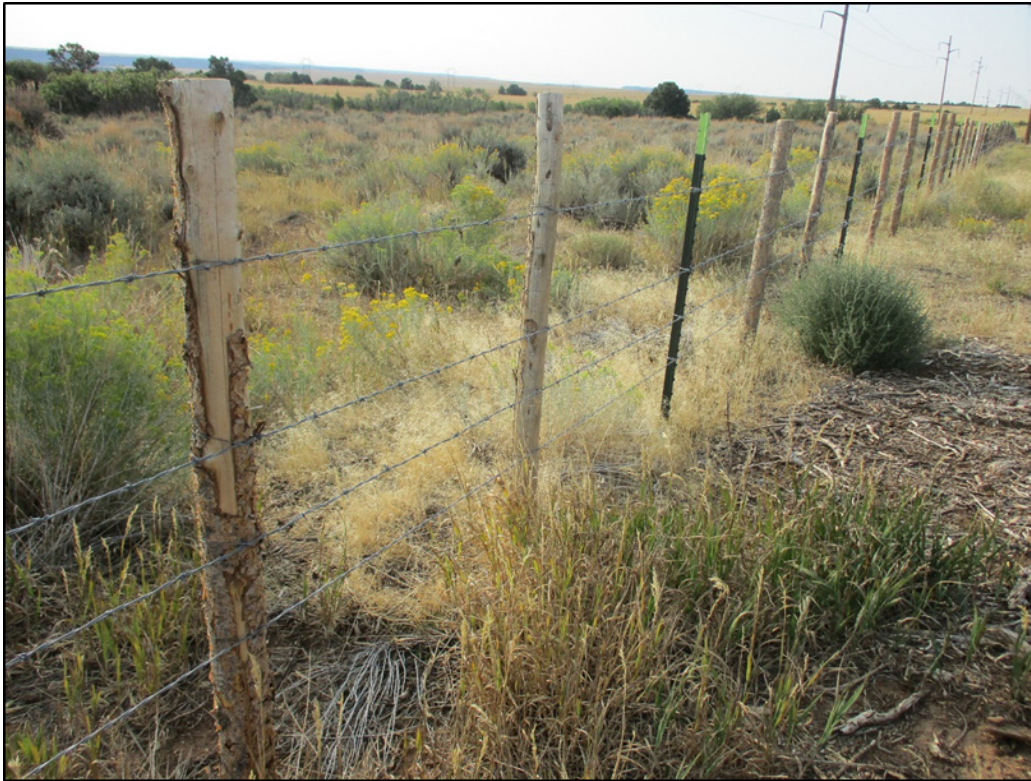
PL-7. South Boundary of Wildlife-Friendly Fence

The southeastern perimeter wildlife-friendly fence was in good condition (PL-7). There was no evidence of vandalism or areas of excessive tumbleweed or debris buildup.

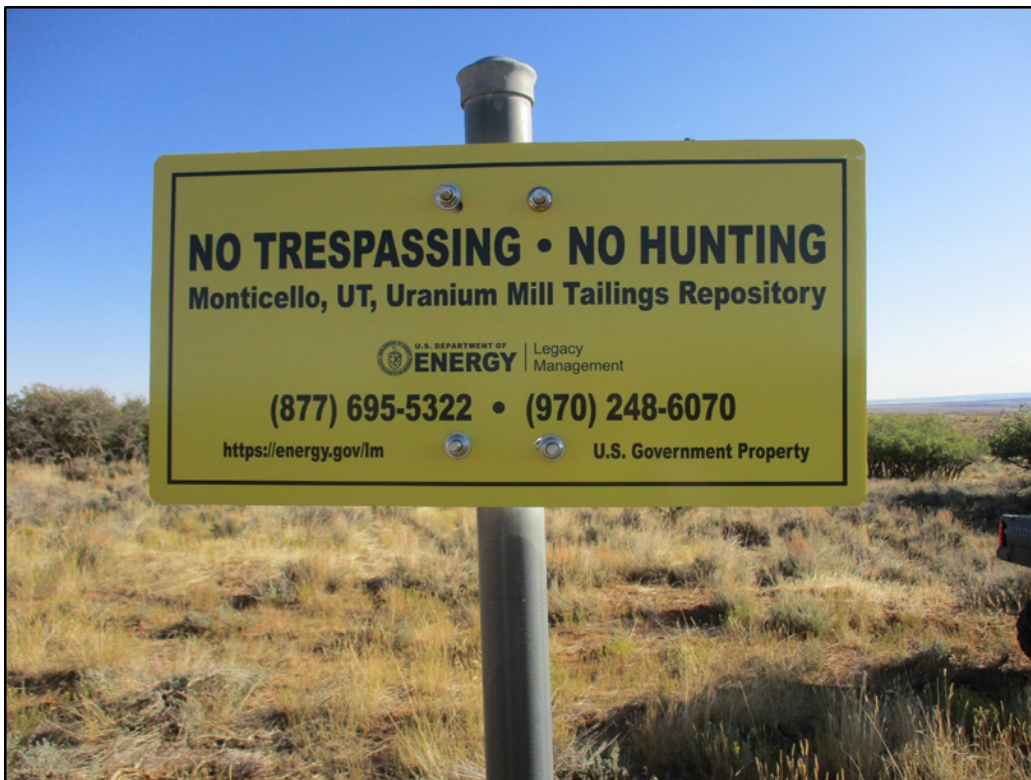
PL-8. Perimeter Sign P32

All perimeter signs were in good condition (PL-8). Black-numbered decals to identify sign numbers were in good condition.

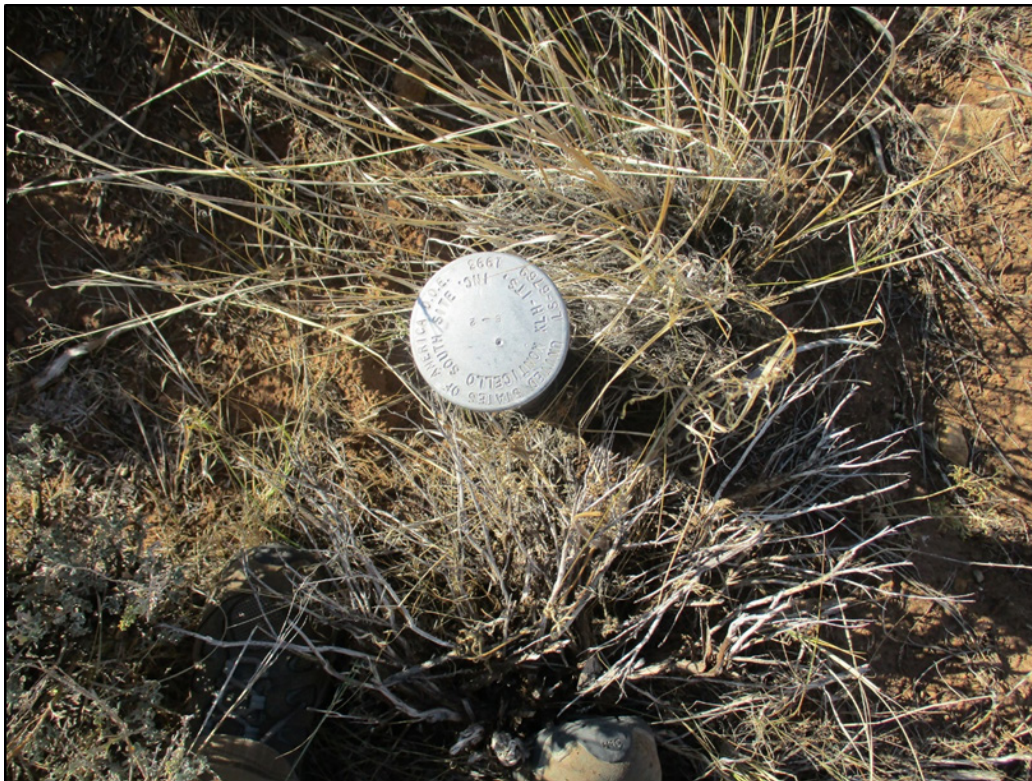
PL-9. Boundary Survey Marker S-2

All six boundary markers were located during the inspection, and all were in good condition (PL-9). PL-9 is a photograph of one of the boundary survey markers. Photographs of all six boundary markers are kept in the annual inspection photograph log.

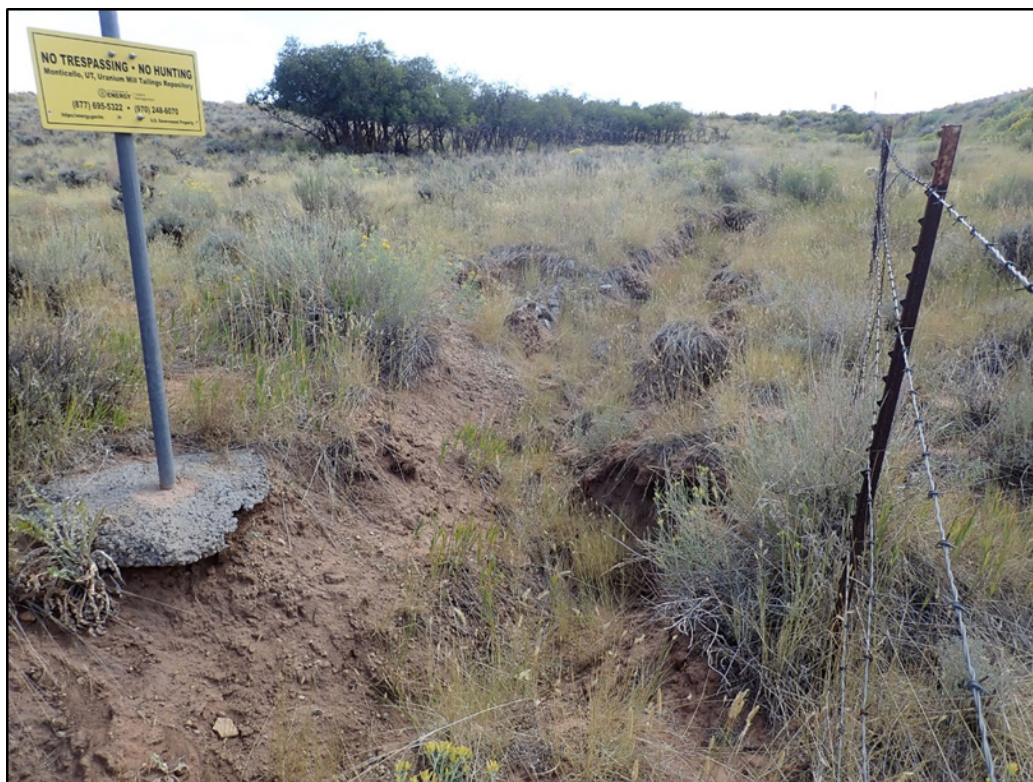
PL-10. Looking North Toward Perimeter Sign 1 (No Change in Erosion Channel)

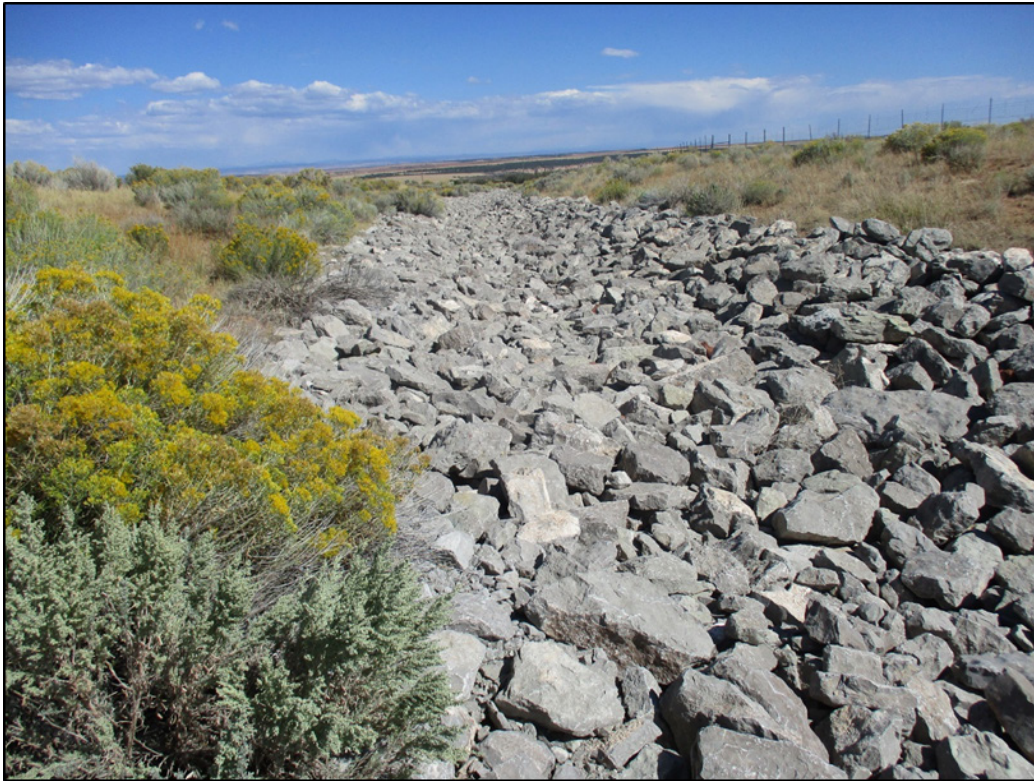
PL-11. South Drainage Channel, Looking East

The South and West Drainage Channels were in very good condition (PL-11 and PL-12). Small erosion rills were observed on the West Drainage Channel. The rills did not impact the integrity of the area and repairs were made as a maintenance item on October 5, 2020. Shrubs observed in portions of the channels do not block potential flow, and burrows from small rodents that are found in places along the margin of the channels do not threaten their integrity.

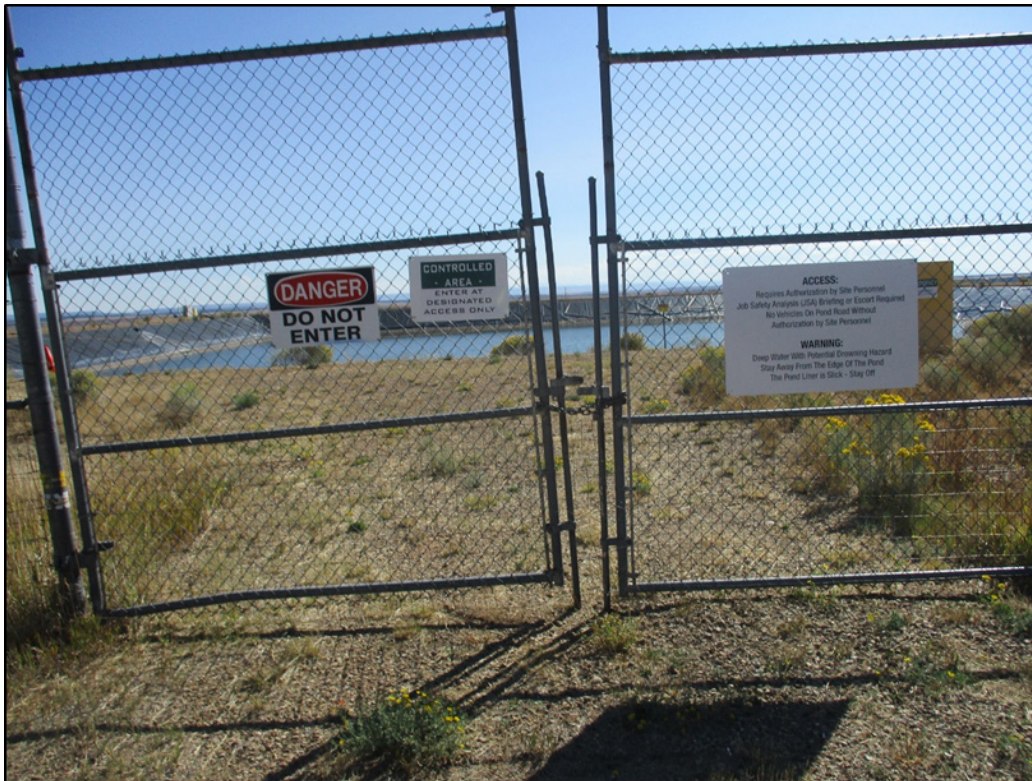
PL-13. Pond 4 Entry Gate

All gates were in good working condition. Warning signs on the perimeter fence were easily visible and legible. There was no evidence of vandalism or trespass, and all gates were locked at the time of the inspection (PL-13).

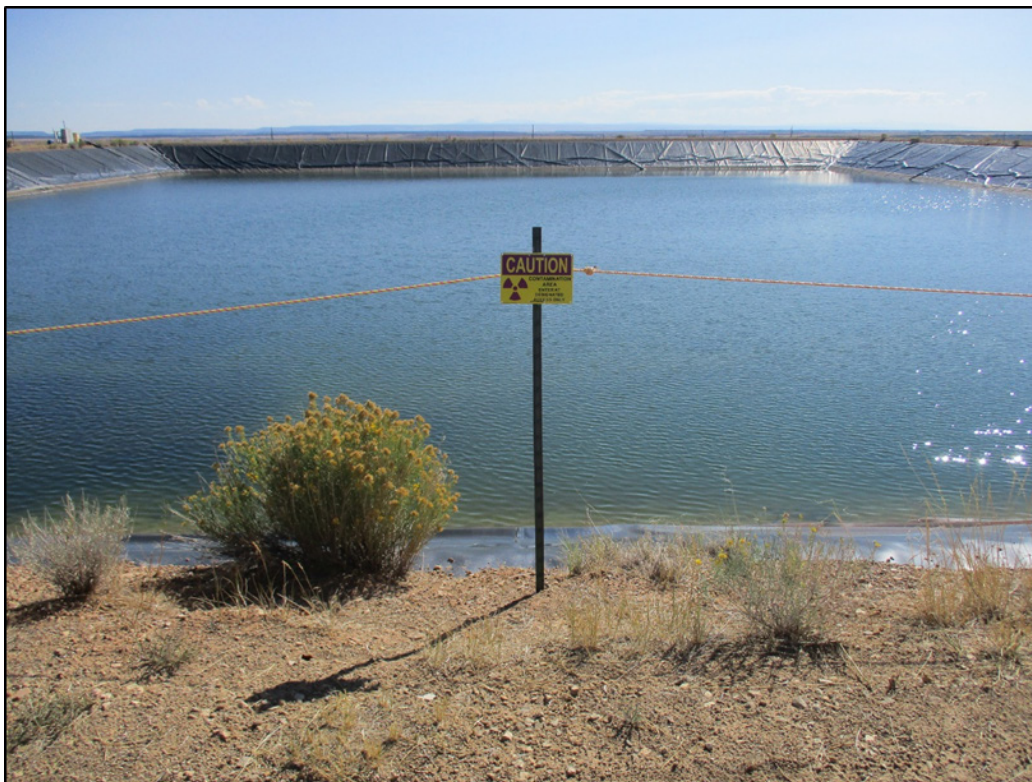
PL-14. Pond 4, Looking East

The pond's radiological rope barrier was intact and in good condition. The excess vegetation along the pond's access road was mowed in May 2020. Animal burrows made by voles and other small rodents were visible on and below the pond's berm on all sides. However, no large burrows that might threaten the berm's integrity were found. Vegetation on the slopes of the berm was well-established and healthy. Pond 4 is shown in PL-14. The fence around Pond 4 was in good condition (PL-16).

The water in Pond 4 was approximately 6.5 feet deep at the time of the inspection, due mostly to the operation of the GRO system. Only the exposed liner is inspected. No visible evidence of holes or other damage to the pond liner was observed.

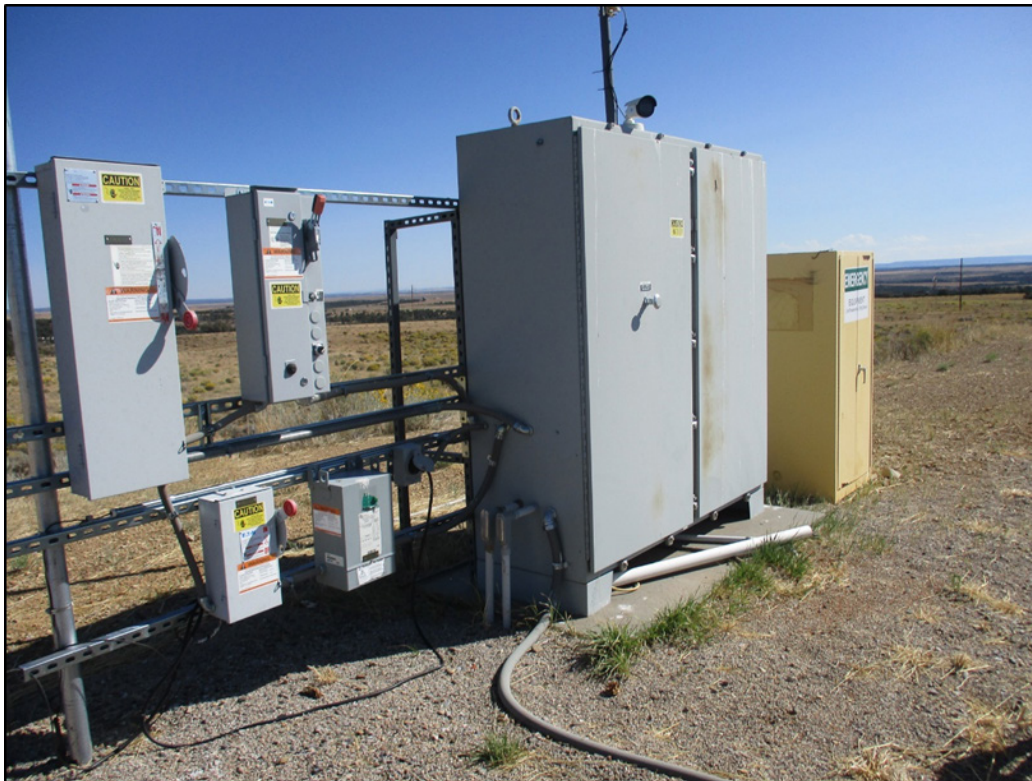
PL-15. Pond 4 LCRS/LDS Control Cabinet

The weatherproof LCRS and LDS control cabinet was in good condition (PL-15). Operation of the Pond 4 LCRS and LDS is described in Section 2.1.6.

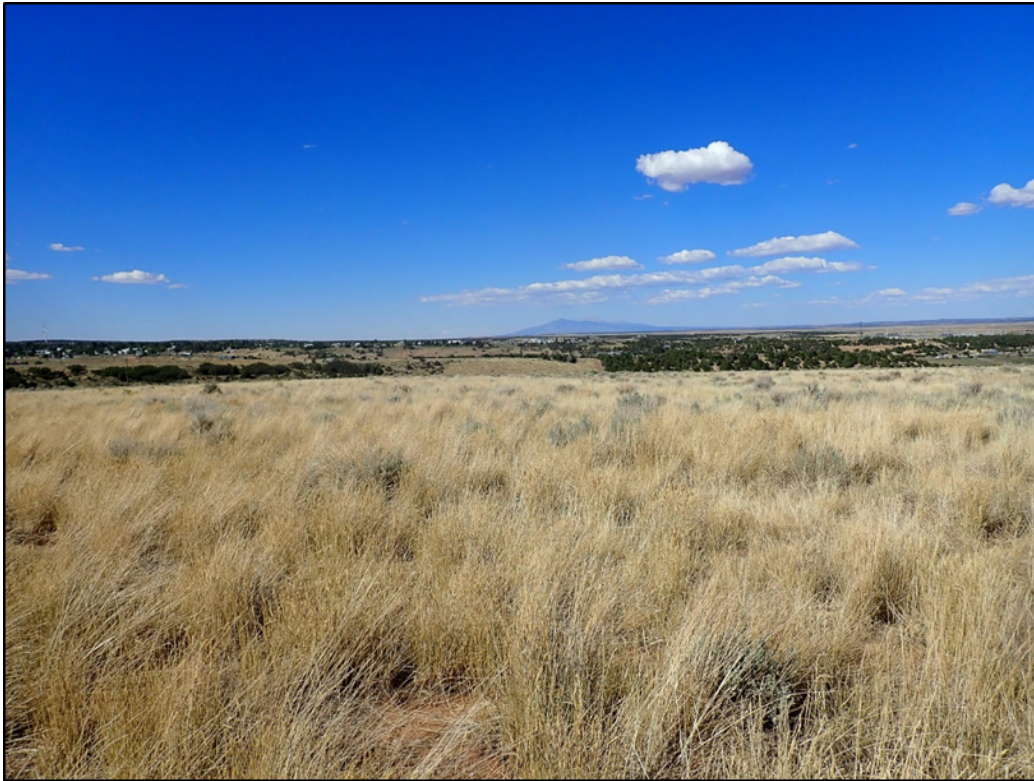
PL-19. Top of Disposal Cell Cover, Looking North

Desirable plants remained well-established on the cover, and no significant barren or eroded areas were identified (PL-19, PL-20, and PL-21). No damage to vegetation or soils from rainstorms was apparent, and no species of phreatophyte shrubs were growing on the cover. As

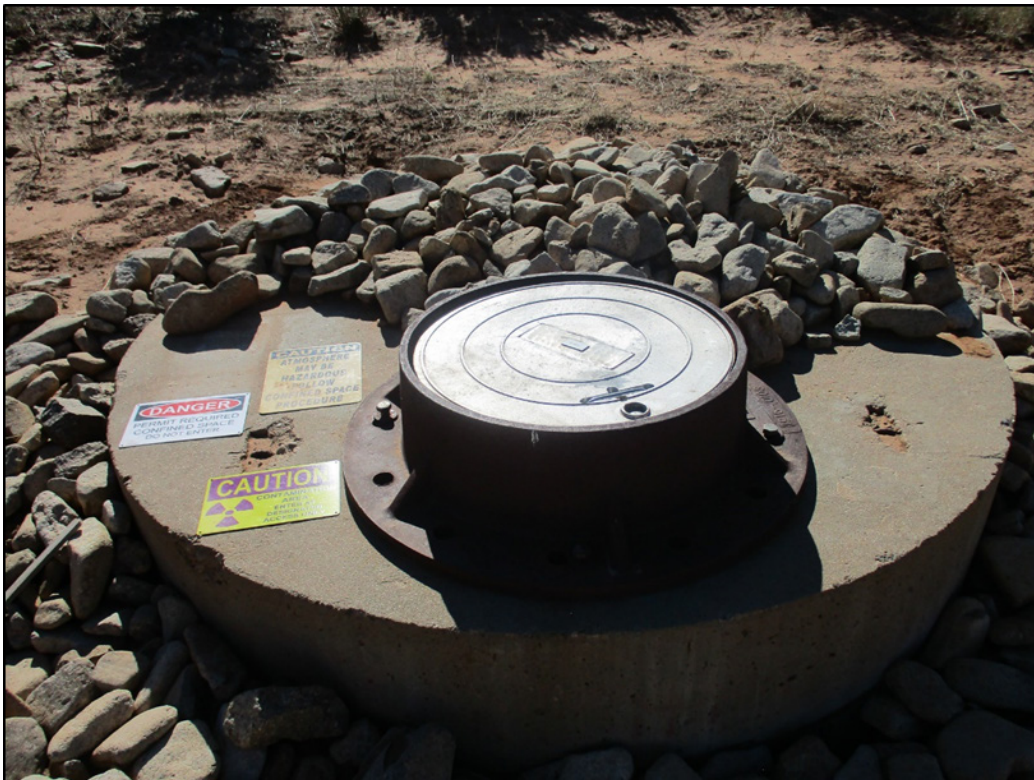
PL-22. Manhole #4

The manholes are restricted areas and were not entered during the annual inspection, but the exteriors were observed (PL-22). All five manhole covers were secure and operable. Appropriate safety warnings and entry procedures were posted on all the manholes, exterior pump access ports were undamaged, telemetry surface installations were in good condition, and no leakage or drainage was evident. Covers of the inoperable video ports were locked and secure.

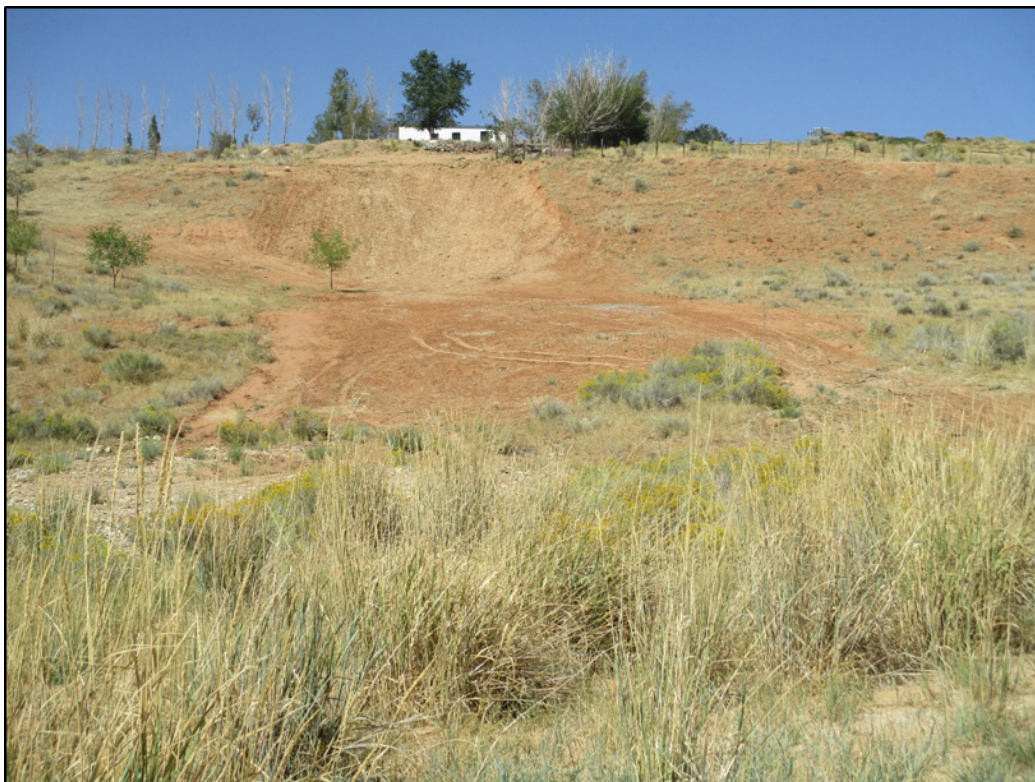
PL-28. Embankment on Property MP-100181 Showing Repaired Water Line Break Erosion

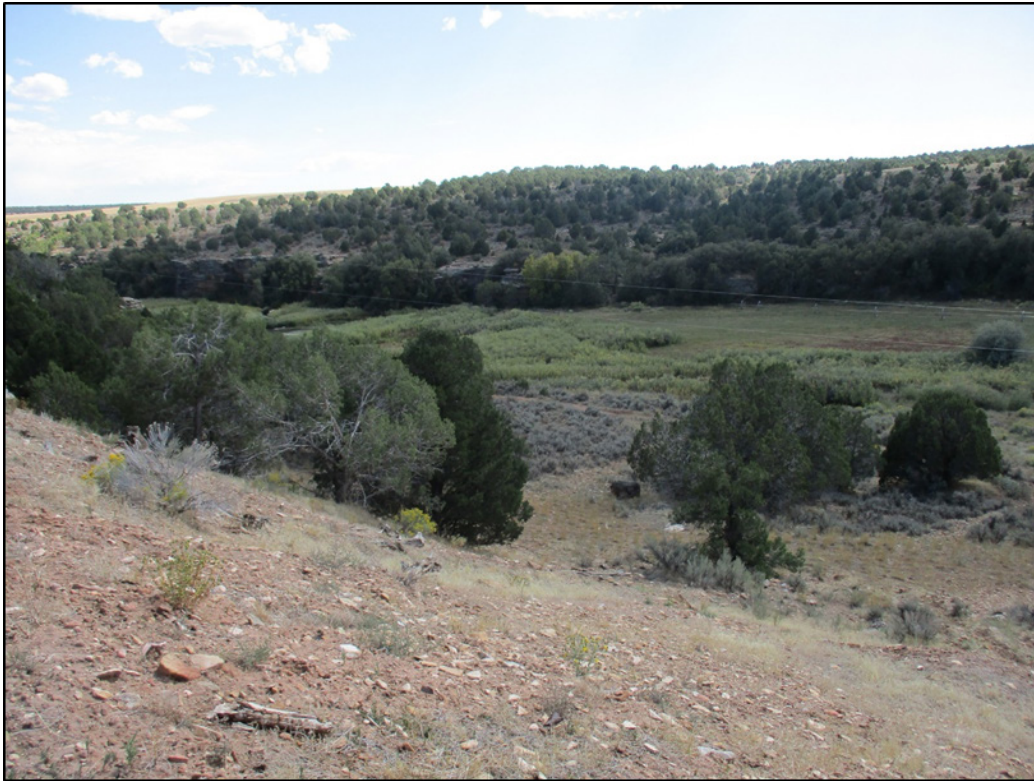
PL-31. Montezuma Canyon, View Downstream

Properties in the Montezuma Creek Restrictive Easement Area are inspected on a regular basis by onsite and water sampling personnel; during these visits, no evidence of significant erosion or soil removal from the restricted areas of these properties was noted. In 2020, portions of Montezuma Canyon were inspected from observation points above the area, and no evidence of

land-use changes or disturbance to the easement area was found. Observations in the easement area (PL-31) are recorded in Appendix A, Section V.

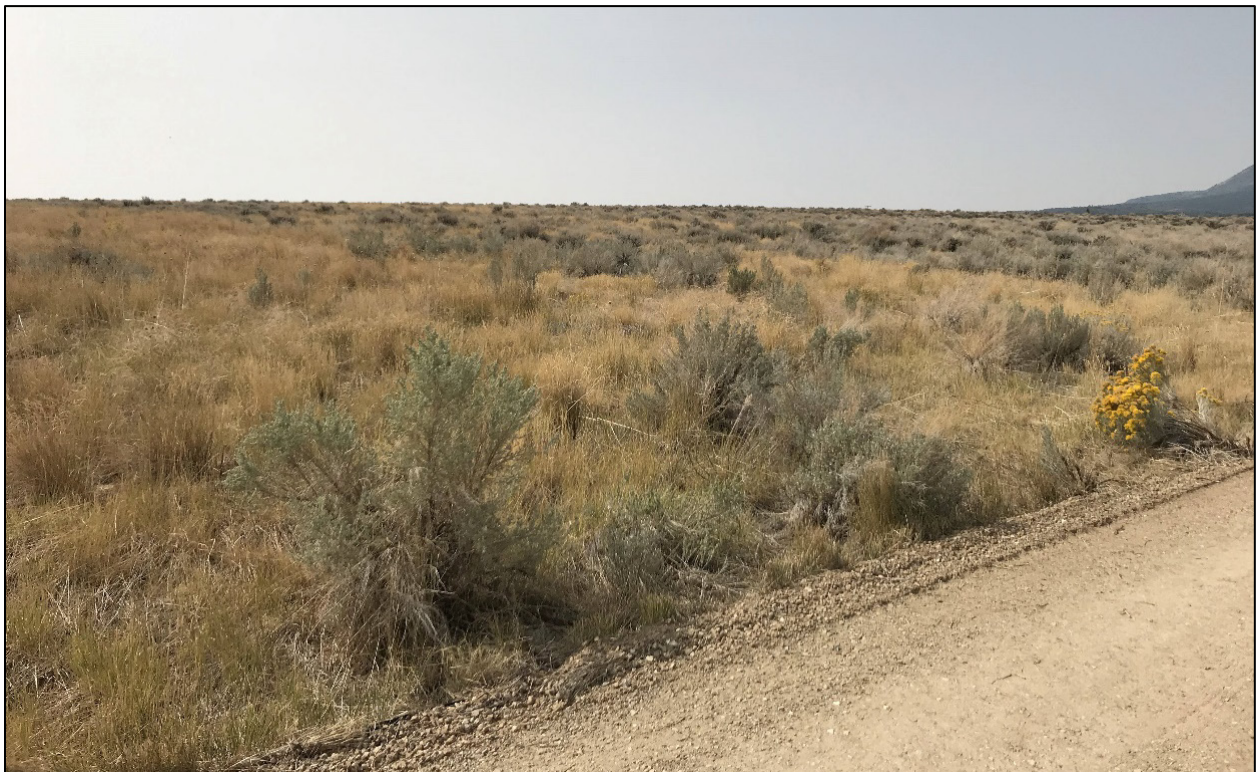
The overall site was in good to excellent condition during the inspection. Vegetative growth on the vegetated top and side slopes continues to be in a generally healthy growth condition. Vegetation was sparser on some areas of the side slopes, which is slowly leading to erosion of exposed soils and filling of the transition between the vegetated and riprap covered side slope areas. Ongoing monitoring is recommended at this time to assess whether the erosion will cause more serious issues in the future; however, at this time annual monitoring is adequate to address this monitoring suggestion. Despite some spots of side slope erosion, no serious geotechnical problems were identified on the repository or the site. Figure B-1 shows the overall cover conditions on top of the repository.

Figure B-1. Top Slope Vegetation Cover, September 16, 2020

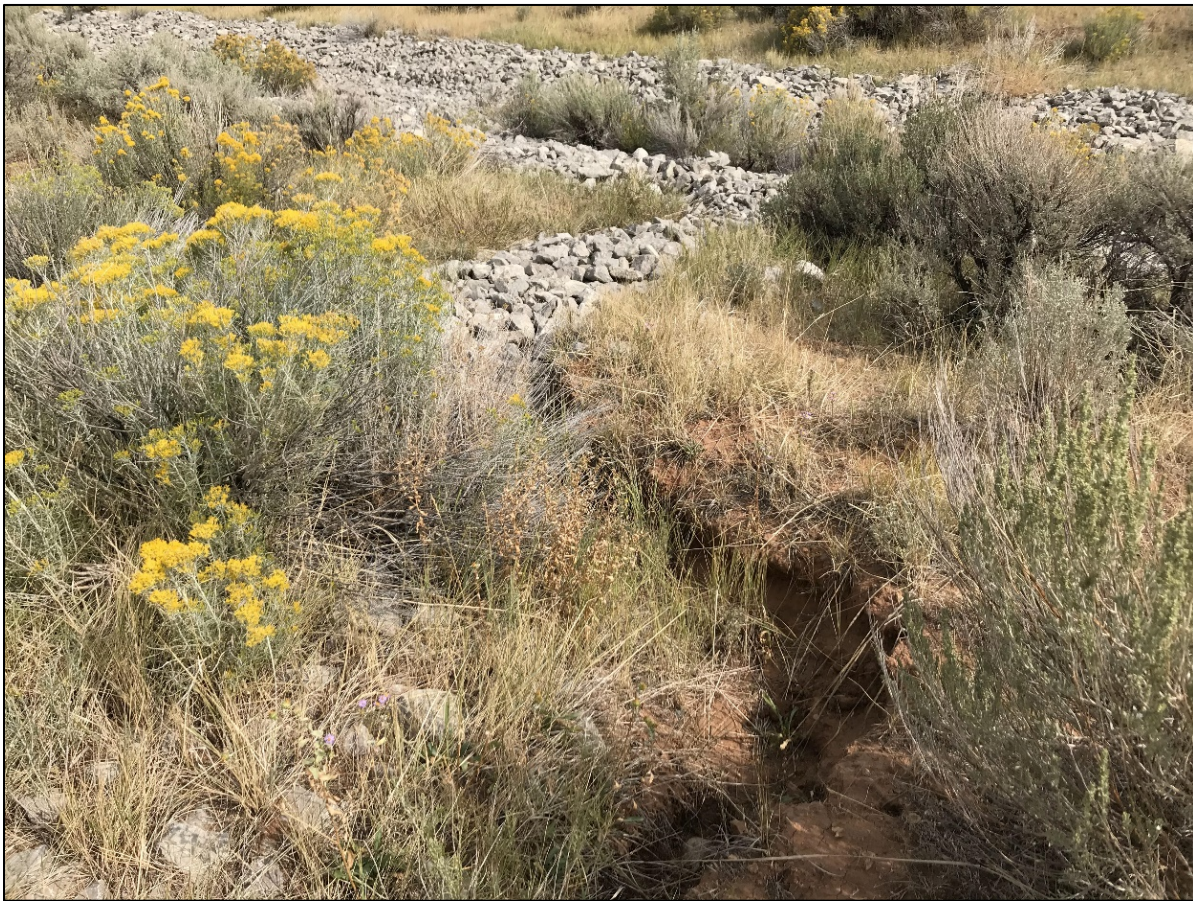
An expanding rill was observed to be bypassing riprap armor feeding into the West Drainage Channel. The bypassing is occurring along the edge of the riprap apron leading into the drainage channel. Turbulent conditions are likely forming at this transition point and have likely been developing the rill for some time. The recommended solution to remedy this feature is to excavate out an area larger than the erosion rill and provide additional riprap fill to adjust for the modified flow conditions being encountered. Future work may also be required if the flow continues to bypass the remediated area; therefore, care should be taken to promote drainage into the riprap channel. Figure B-2 shows the erosion rill. No rock degradation was observed within the West Drainage Channel. The outfall of the South Drainage Channel was observed and no issues were noted during this inspection.

Figure B-2. West Drainage Channel Erosion

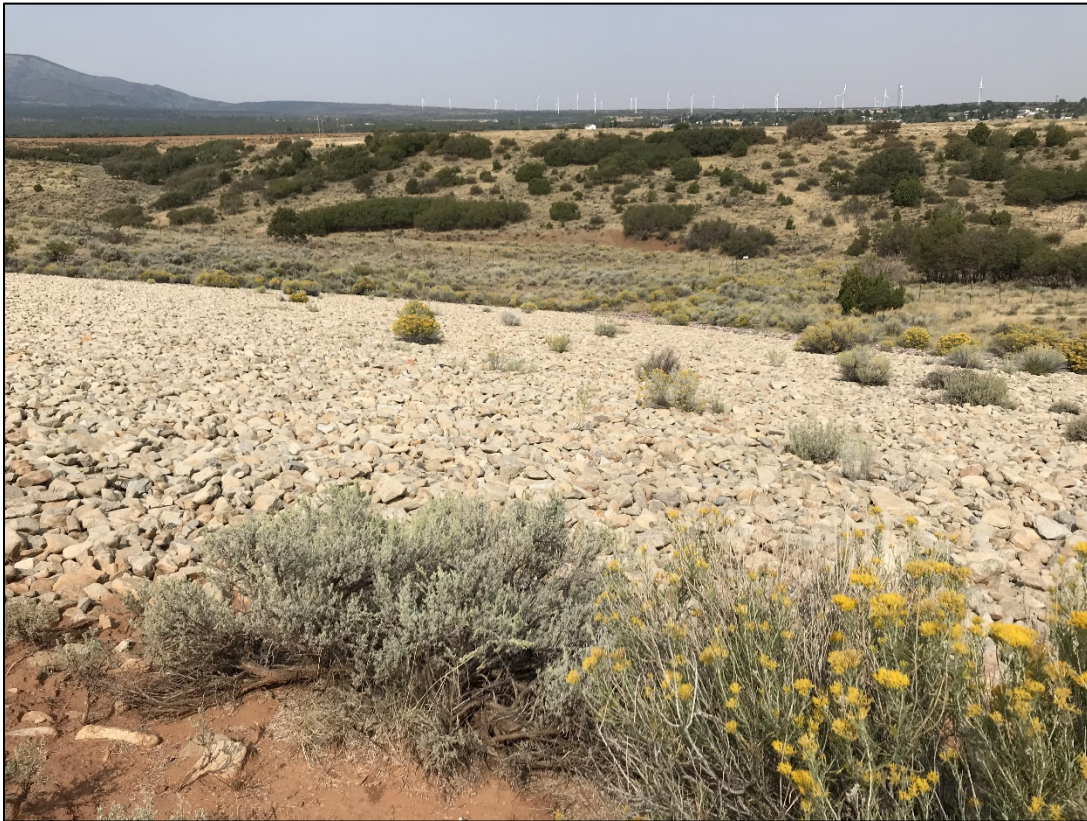
Figure B-3. Northwest Riprap Side Slope

The northwest riprap-covered side slope was found to be in good condition. The slope is protected against erosion by diorite riprap (as shown in Figure B-3), which appeared in great condition. Shallow channels with occasional shallow rills were found along the soil/rock interface of the side slope. The channels and rills above the riprap slope were formed from surface flow from a combination of melting snow cover and/or precipitation (as shown in Figure B-4). These features do not currently pose any difficulties, but continued monitoring is required to ensure erosion features do not create any problems such as undermining of the soil/rock interface or the rock slope below.

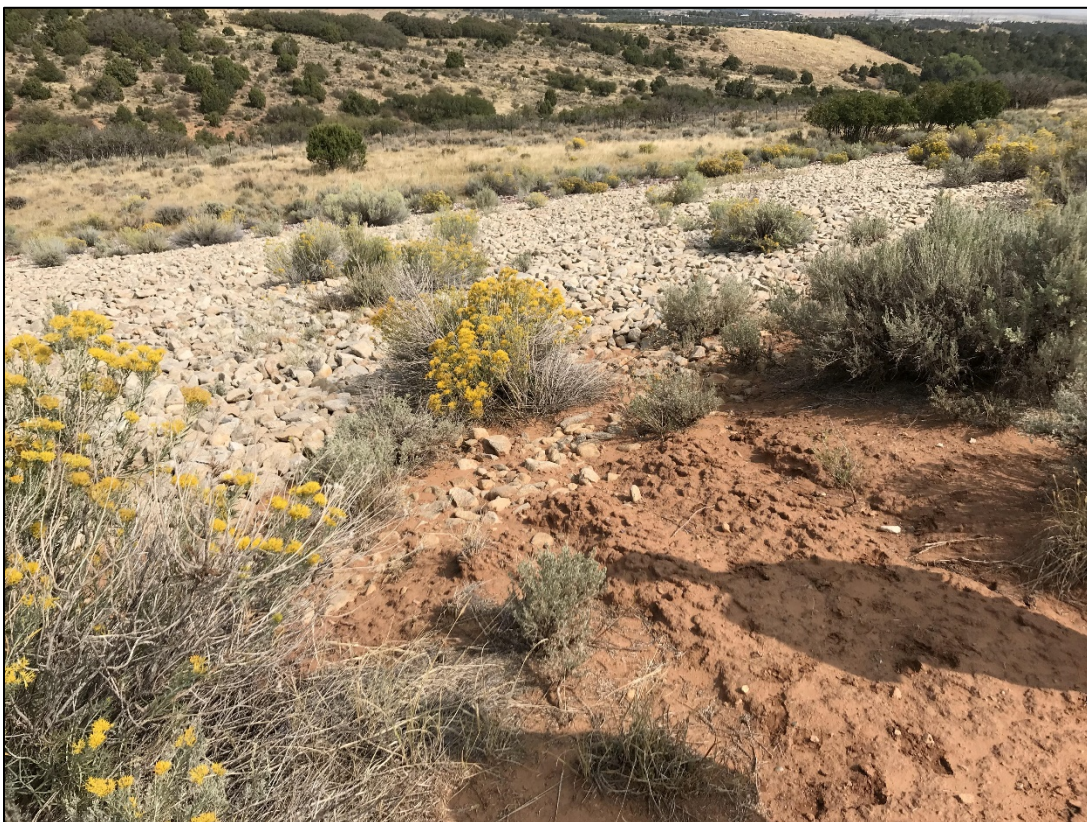
Figure B-4. Sediment at Top of Northwest Slope

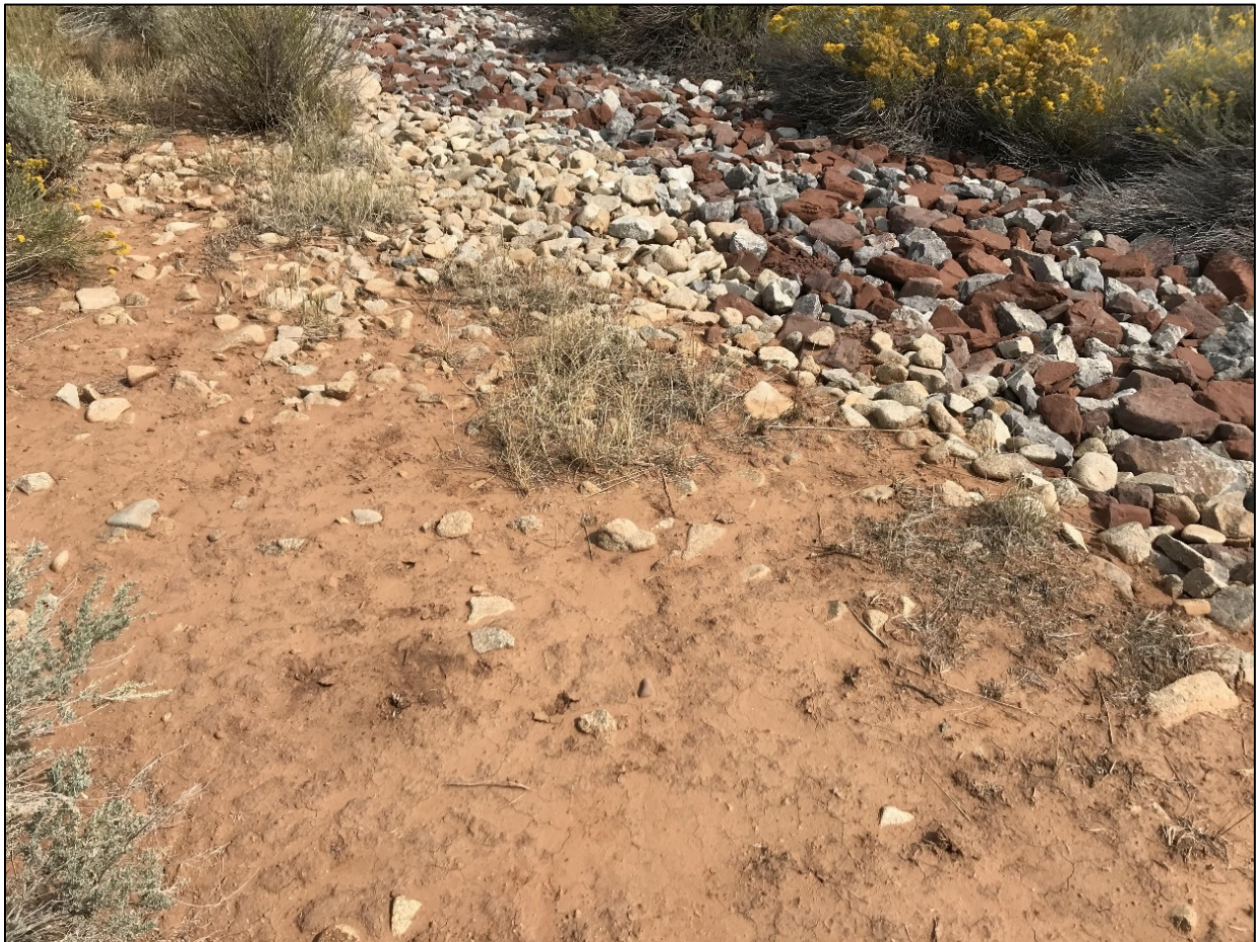
Sediment is being transported to the edge of thickened riprap toe at the bottom of the northeastern and eastern side slopes (as shown Figure B-5). The performance intent of the riprap toe does not appear to be impacted and therefore these erosion features are not considered an issue. In each of these cases, vegetation is establishing within the sediment and does not currently pose any increased problems for long-term erosion protection. These minor erosion features should continue to be monitored during the annual site inspections. Some surface wearing and fracturing of sandstone rock (as shown in Figure B-6) within the riprap toe has been regularly observed during recent inspections. This breakdown is not ubiquitous or widespread, and it is not considered a problem.

Figure B-5. Sediment Transport into East Thickened Riprap Toe

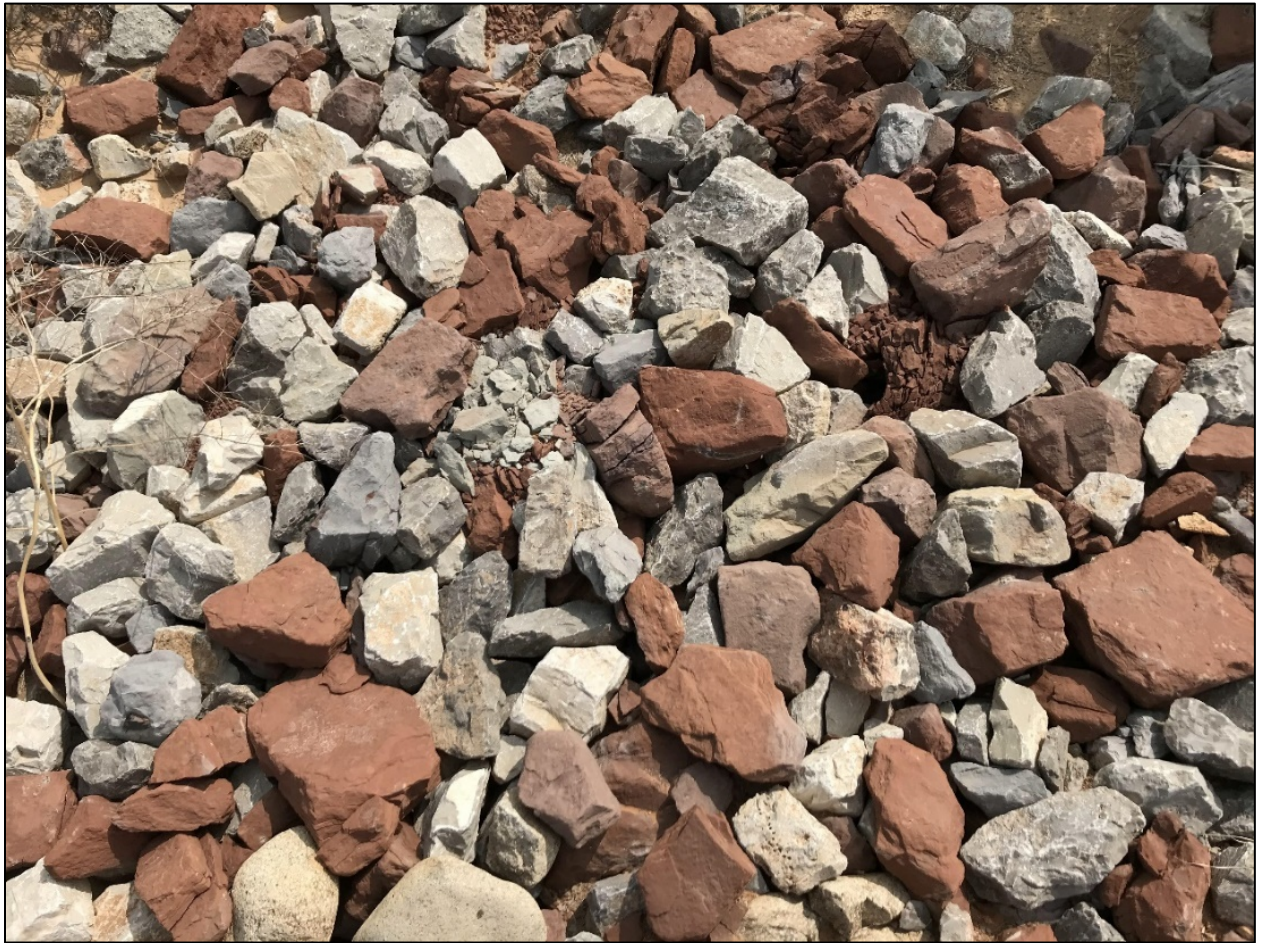
Figure B-6. Breakdown of Sandstone Rock, East Thickened Riprap Toe

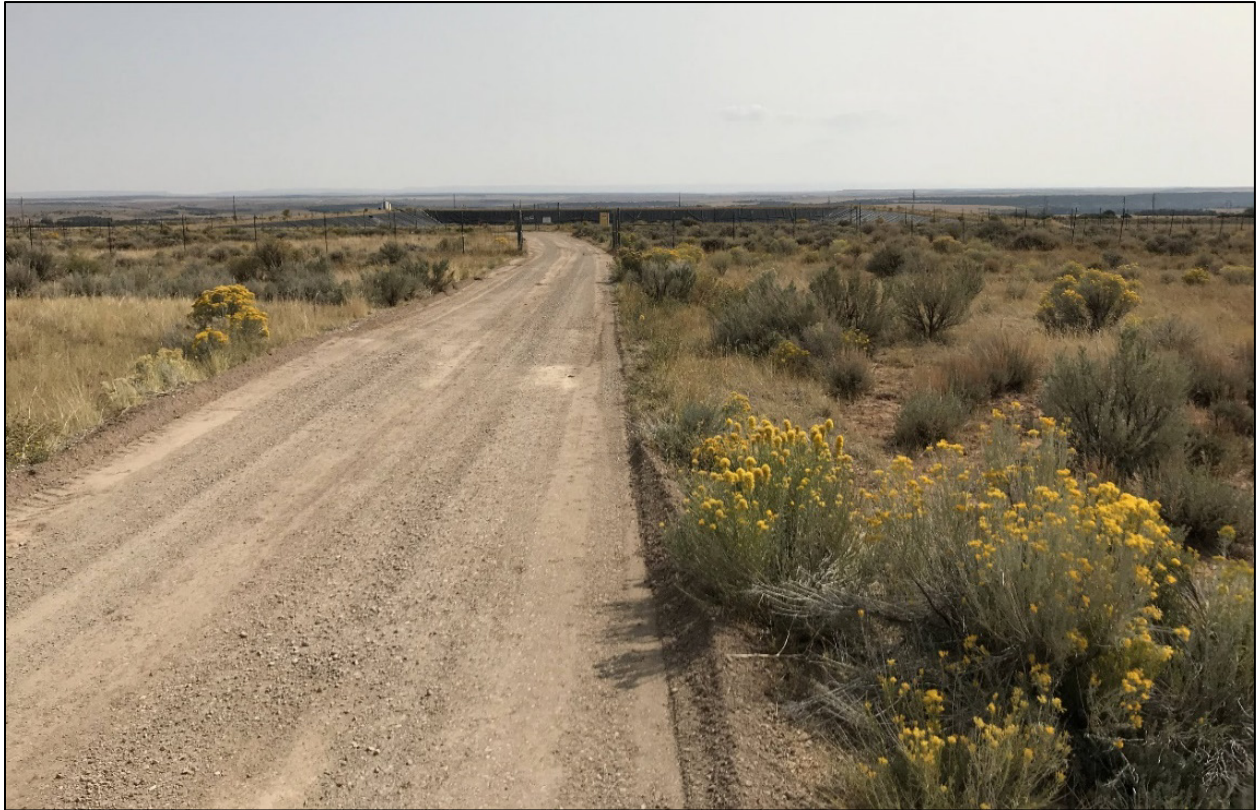
Figure B-7. Pond 4 from East

No problems were reported at Pond 4 (Figure B-7) and the groundwater transfer building, so neither of these facilities were visited during the geotechnical inspection. Pond 4 continues to be in a stable condition and no major issues were brought to the attention of either Mr. Mueller or Mr. Oliver.
