2021 Annual Inspection Report for the DOE Monticello, Utah, Mill Tailings Site and Monticello Vicinity Properties

December 2021

U.S. DEPARTMENT OF
ENERGY

Legacy
Management

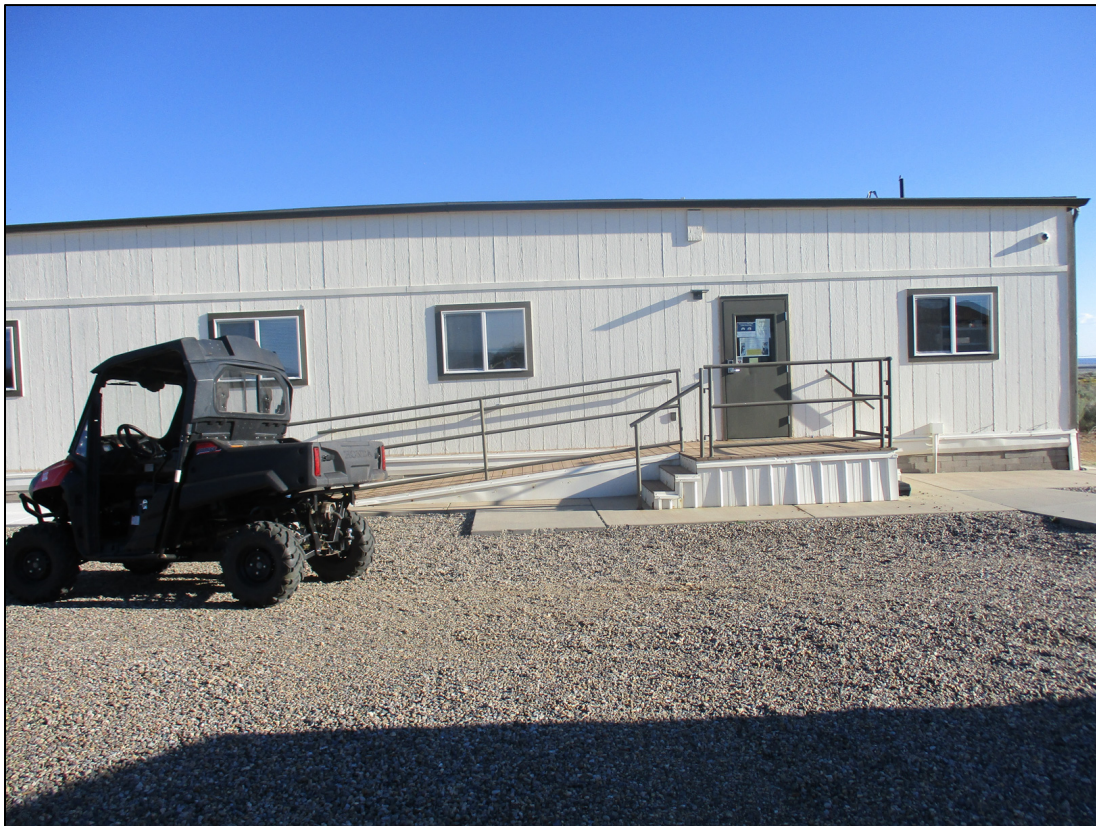
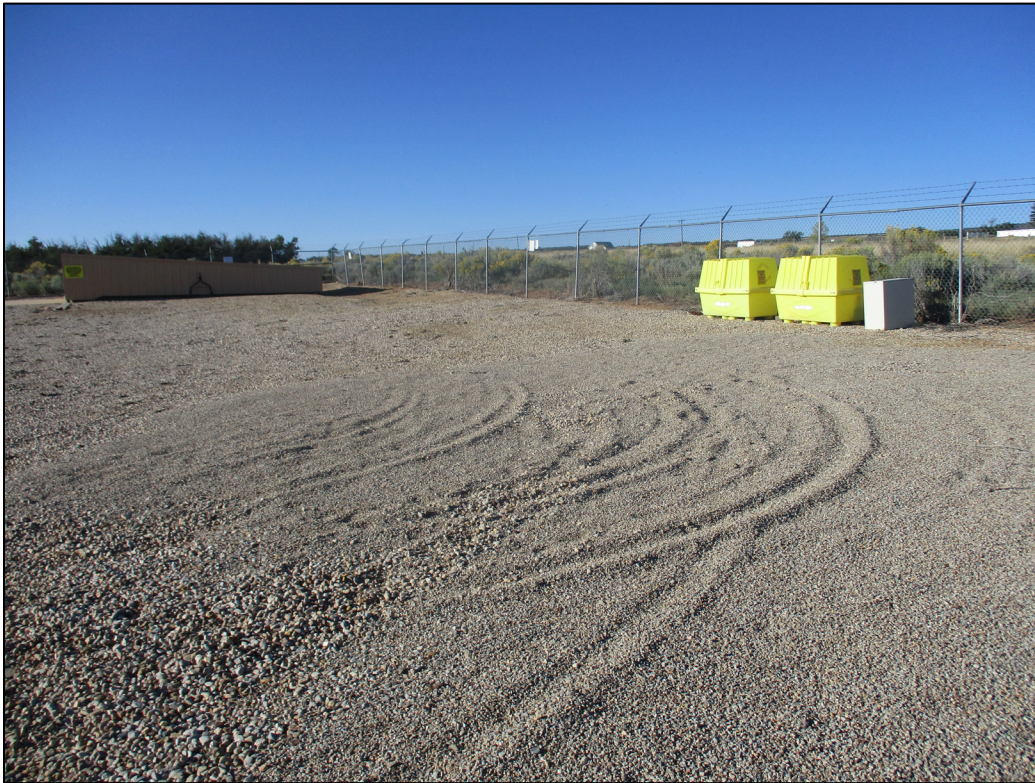
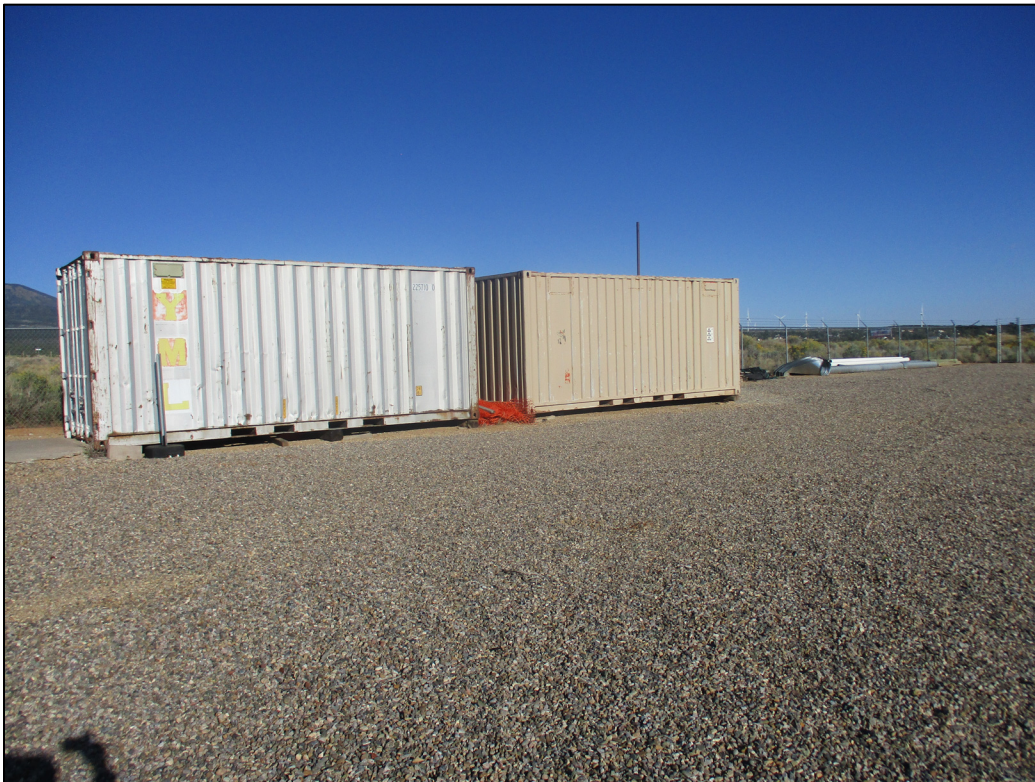
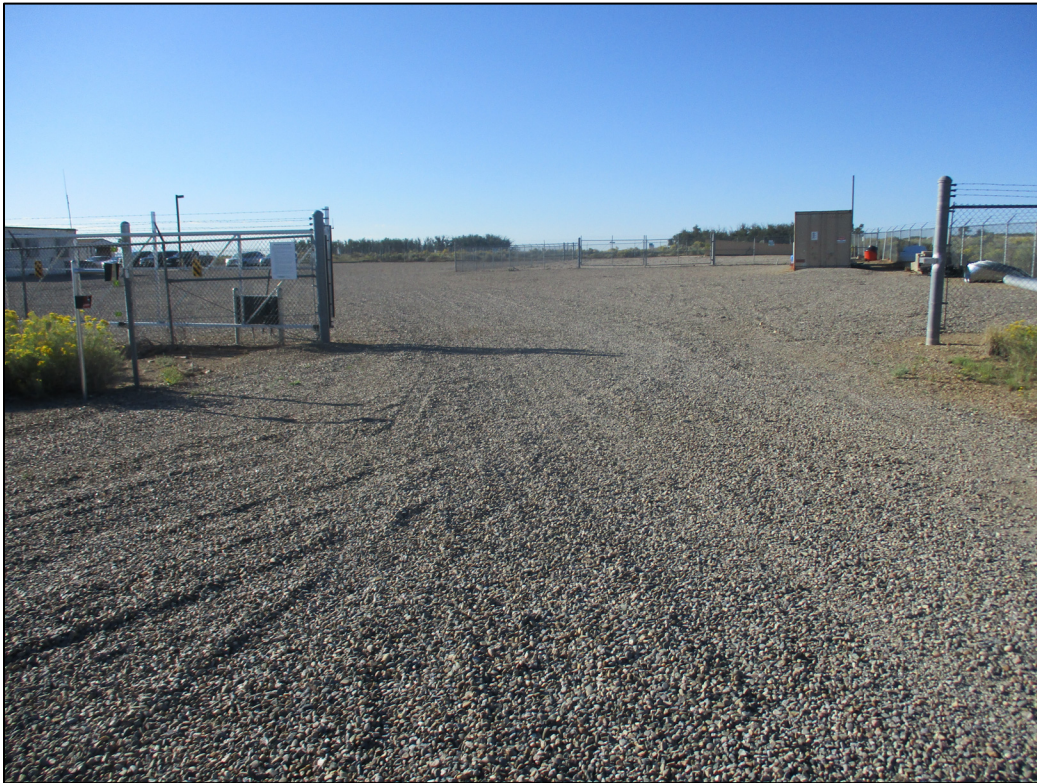
The Monticello field office buildings and associated structures were in excellent condition and well-maintained (PL-1, PL-2, PL-3, PL-4). New video surveillance cameras were installed inside and outside of the main office building. Site access signs displaying contact information were visible, and the new signs containing updated information were in place and in good condition. The site's paved access road was in very good condition.

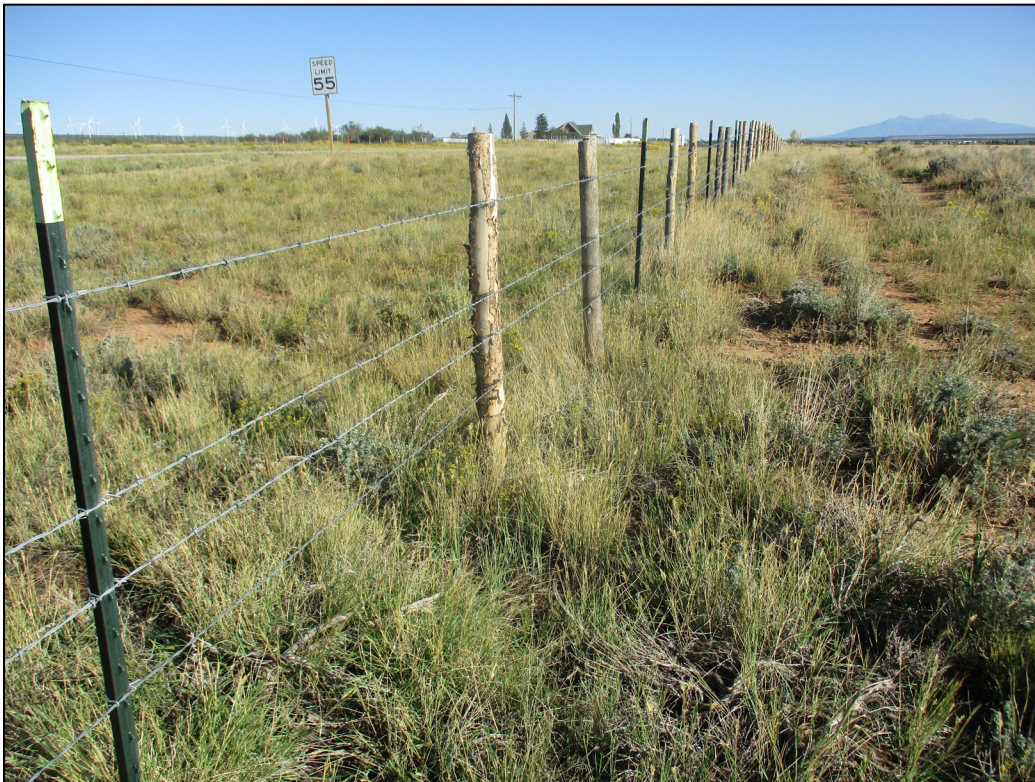
PL-7. West Boundary of Wildlife-Friendly Fence

The southwestern perimeter wildlife-friendly fence was in good condition (PL-7). There was no evidence of vandalism or areas of excessive vegetation or debris buildup.

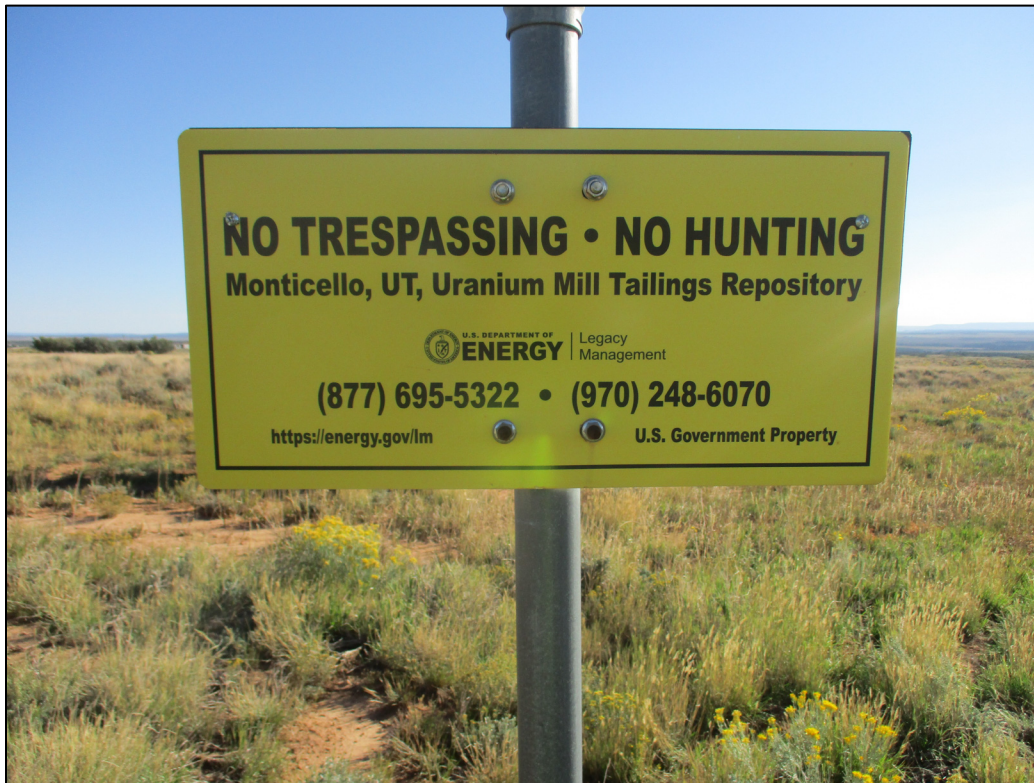
PL-8. Perimeter Sign P38

All perimeter signs were in good condition (PL-8). Black-numbered decals to identify sign numbers were in good condition.

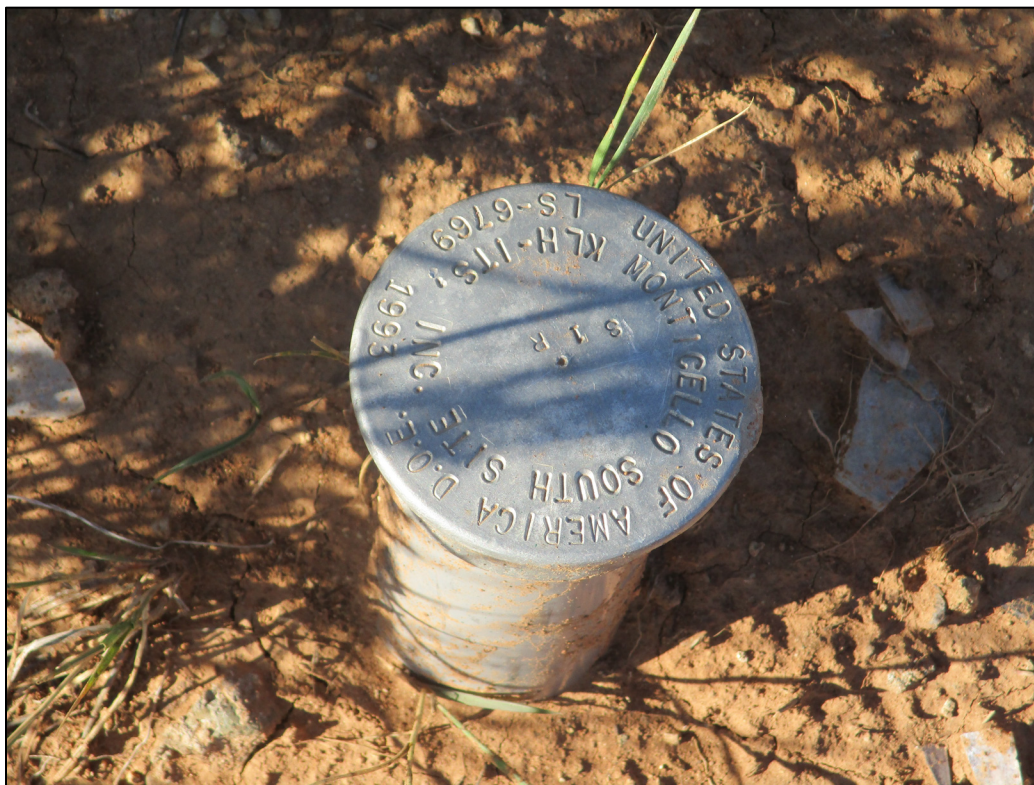
PL-9. Boundary Survey Marker S-1

All six boundary markers were located during the inspection, and all were in good condition (PL-9). PL-9 is a photograph of one of the boundary survey markers. Photographs of all six boundary markers are kept in the annual inspection photograph log.

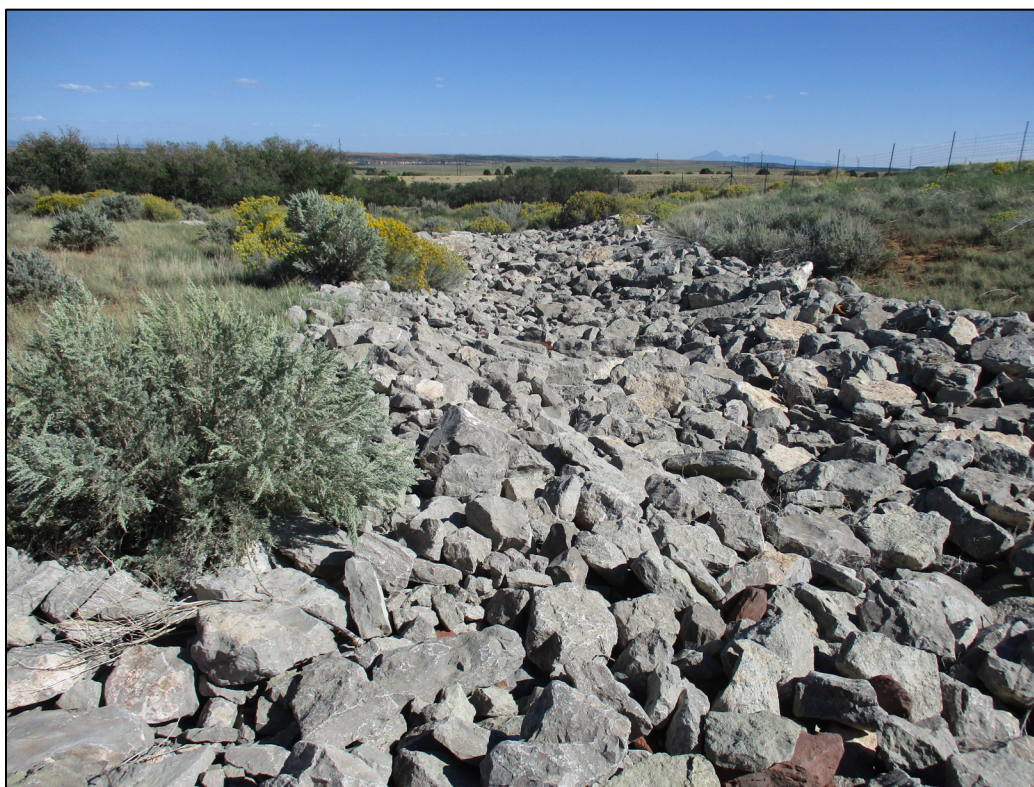
PL-11. South Drainage Channel, Looking East

The South and West Drainage Channels were in very good condition (PL-11 and PL-12). Small erosion rills, repaired in October of 2020, on the West Drainage Channel were in good condition (PL-13). Shrubs observed in portions of the channels were removed and treated in July 2021. Burrows from small rodents that are found in places along the margin of the channels do not threaten their integrity.

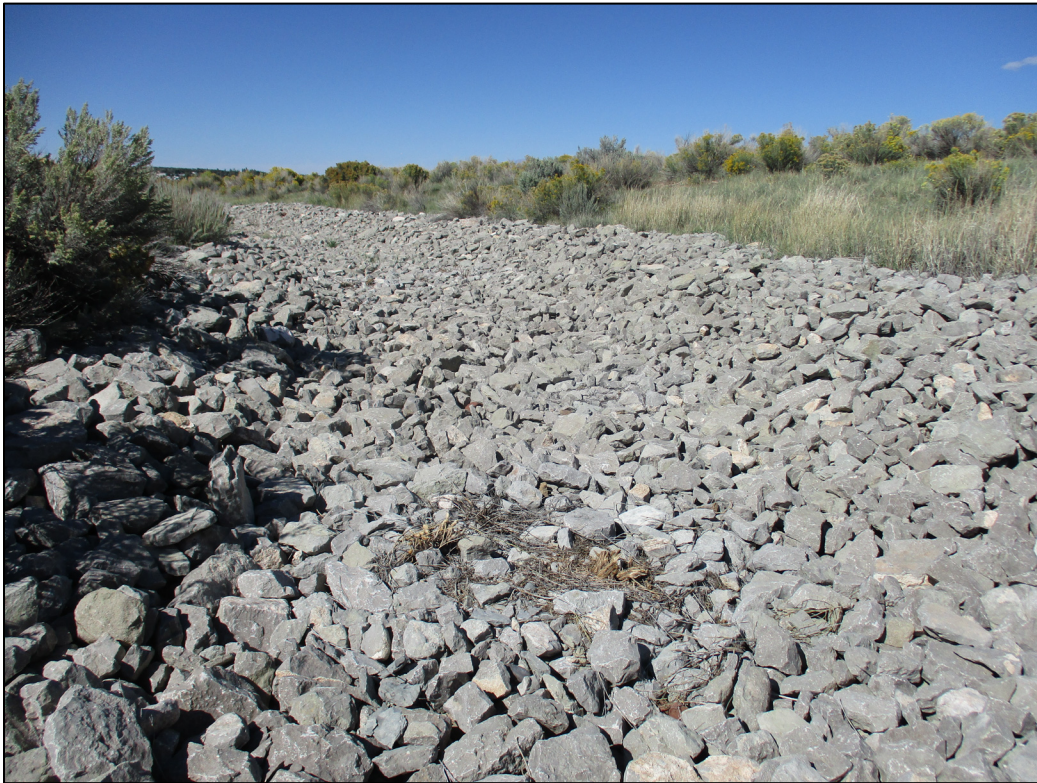
PL-12. Brush Removal in West Drainage Channel, Looking North

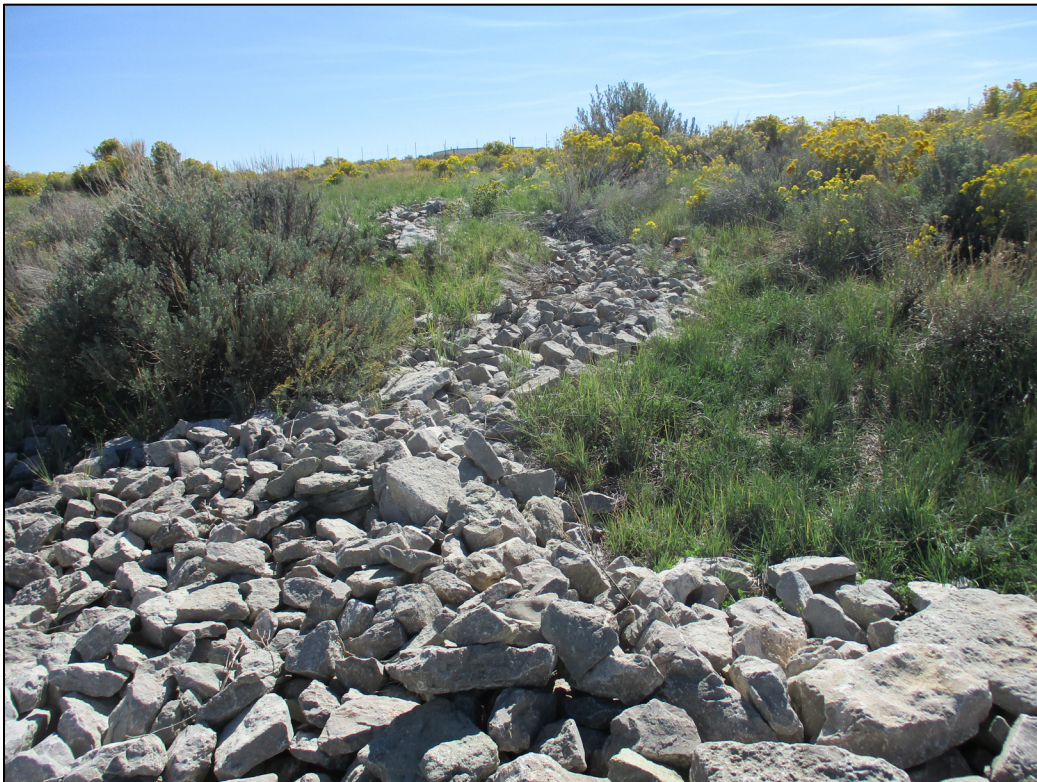
PL-13. West Drainage Channel, 2020 Erosion Repairs

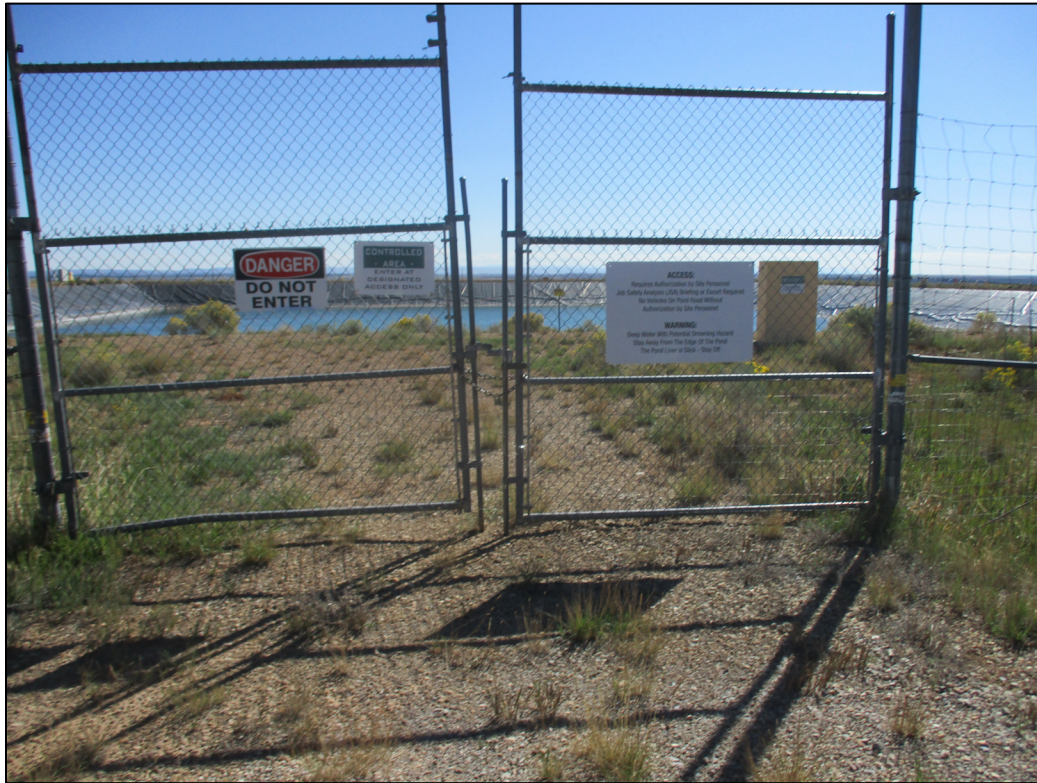
PL-14. Pond Entrance Gate

All gates were in good working condition. The name of the former LMS contractor, Navarro Research and Engineering, Inc., was replaced by the name of the current contractor, RSI EnTech, LLC on the sign at the entrance of the site. Warning signs on the perimeter fence were easily visible and legible. There was no evidence of vandalism or trespass, and all gates were locked at the time of the inspection (PL-14).

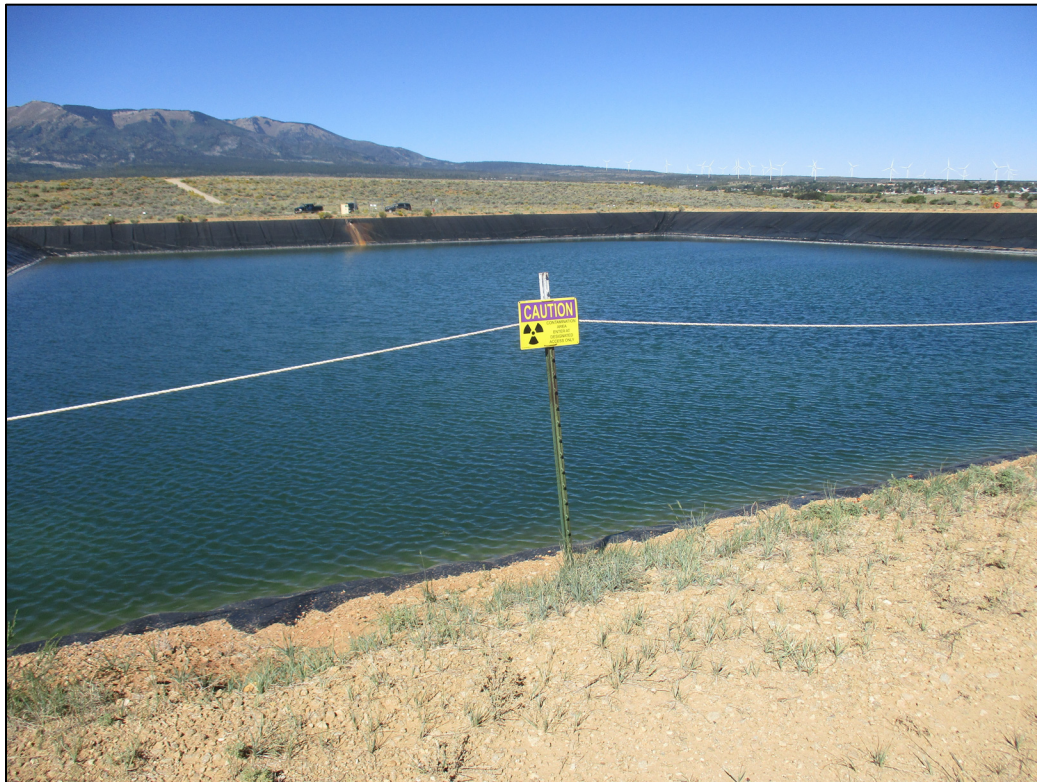
PL-15. Pond 4, Looking West

The pond's radiological rope barrier was intact and in good condition. The excess vegetation along the pond's access road was mowed in September 2021. This year, animal burrows made by voles and other small rodents were visible on and below the pond's berm on all sides. However, no large burrows that might threaten the berm's integrity were found. Vegetation on the slopes of the berm was well-established and healthy. Pond 4 is shown in PL-15. The fence around Pond 4 was in good condition.

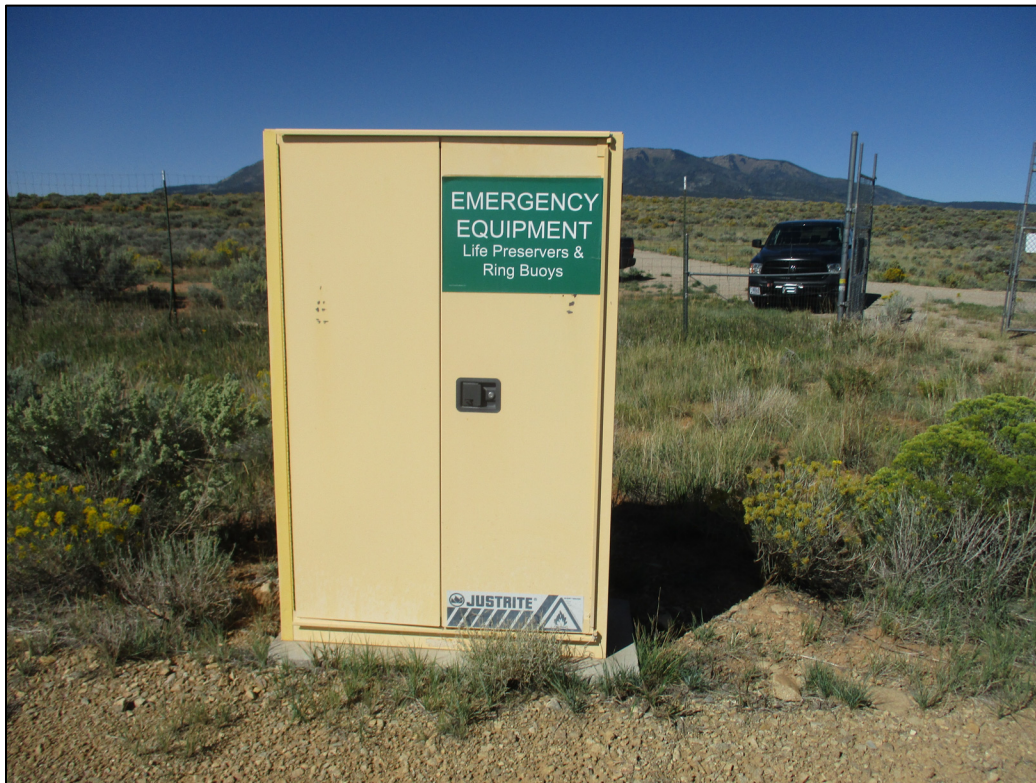
PL-16. Pond 4 Safety Cabinet

Lifesaving rings and a rescue and work skiff were present and easily accessible near the pond. Cabinets containing water rescue equipment were also highly visible, adequately labeled, and in good condition (PL-16).

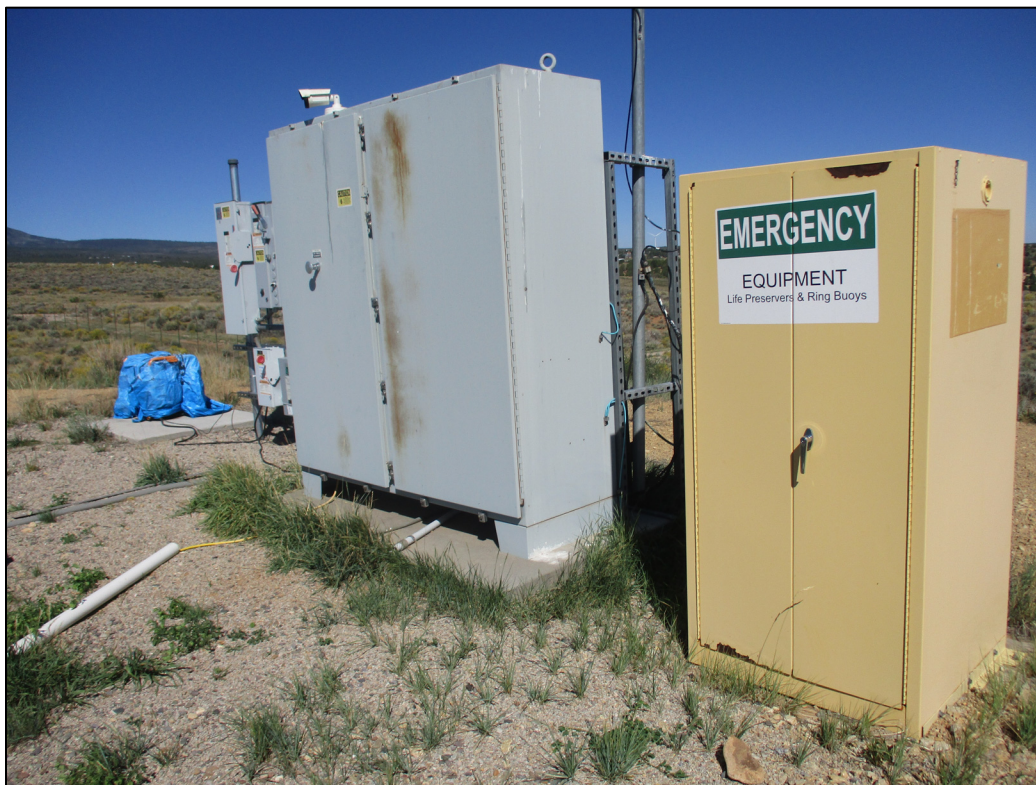
PL-17. Pond 4 LCRS/LDS Control Cabinet

The weatherproof LCRS and LDS control cabinet was in good condition (PL-17). Operation of the Pond 4 LCRS and LDS is described in Section 2.1.6.

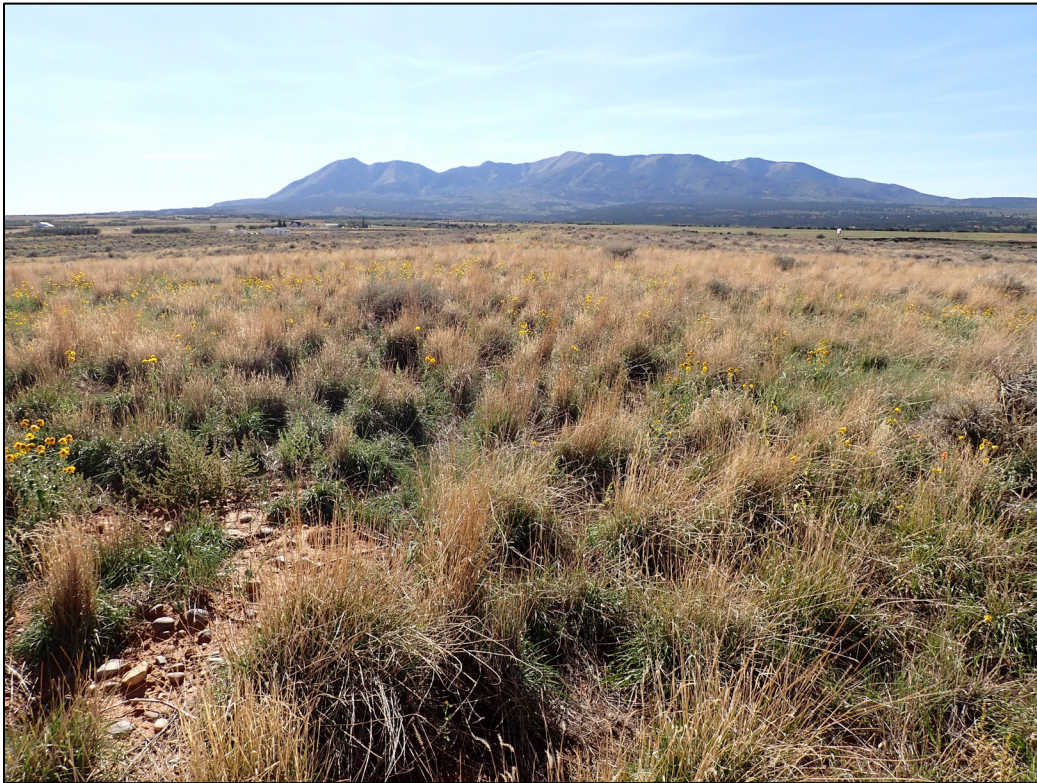
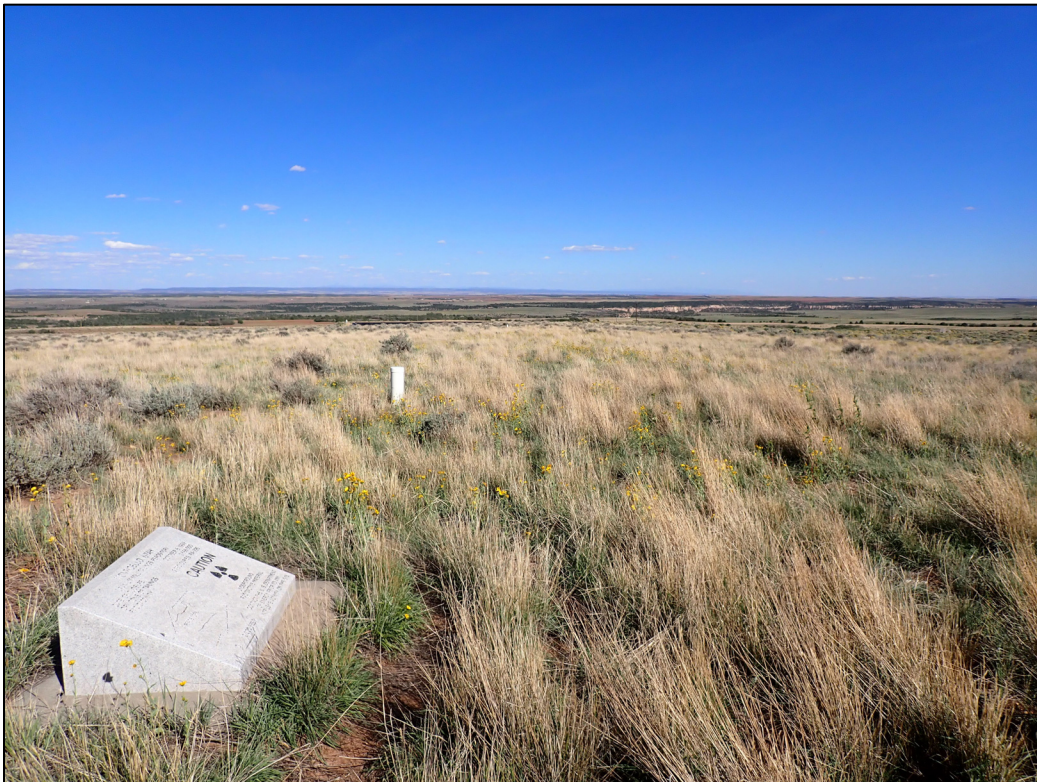
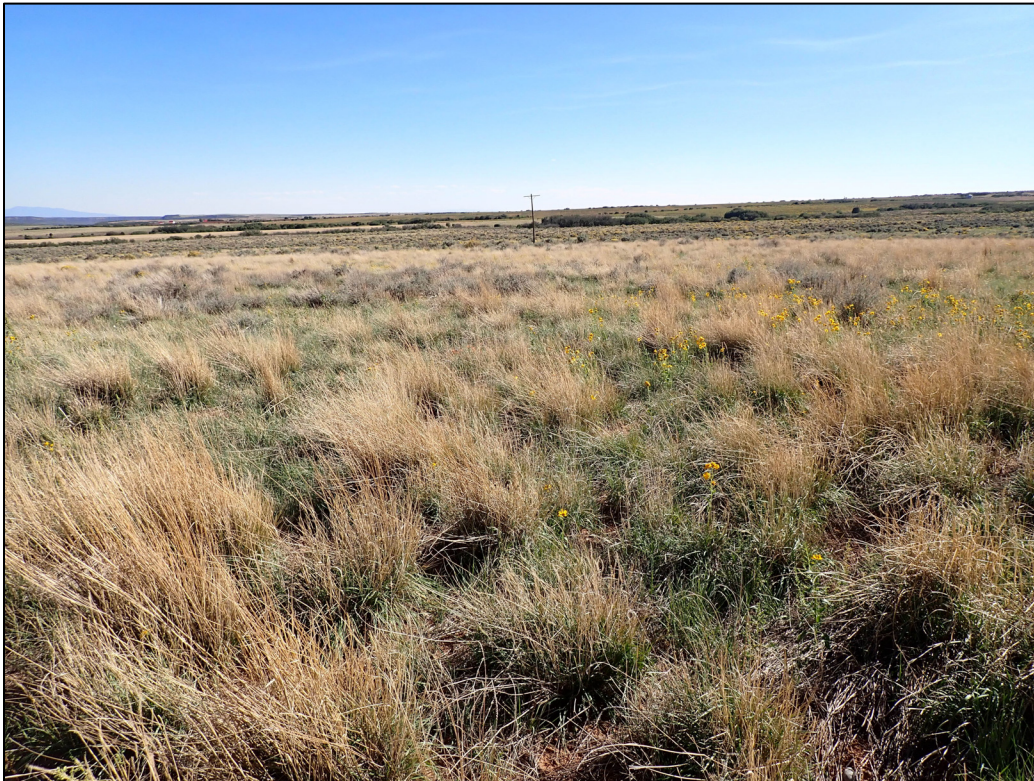
Desirable plants remained well-established on the cover, and no significant barren or eroded areas were identified (PL-20, PL-21, and PL-22). No damage to vegetation or soils from rainstorms was apparent, and no species of phreatophyte shrubs were growing on the cover. As in recent years, there were many healthy young sagebrush (*Artemisia tridentata*) plants. The small quantity of field bindweed (*Convolvulus arvensis*), which the State of Utah lists as a Class C noxious weed, was still present on the cover, but control was not necessary.

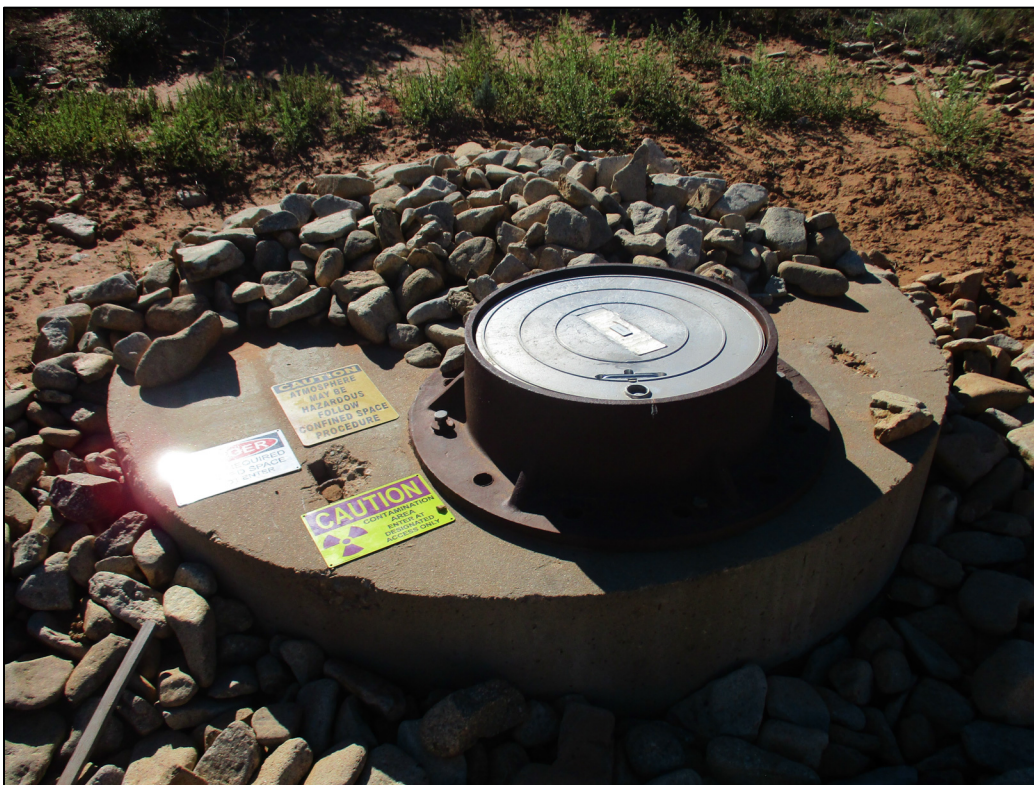
PL-23. Manhole 4

The manholes are restricted areas and were not entered during the annual inspection, but the exteriors were observed (PL-23). Manhole 1 was opened, and the interior observed from the outside (PL-24). The other four manhole covers were secure and operable. Appropriate safety warnings and entry procedures were posted on all the manholes, exterior pump access ports were undamaged, telemetry surface installations were in good condition, and no leakage or drainage was evident. Covers of the inoperable video ports were locked and secure.

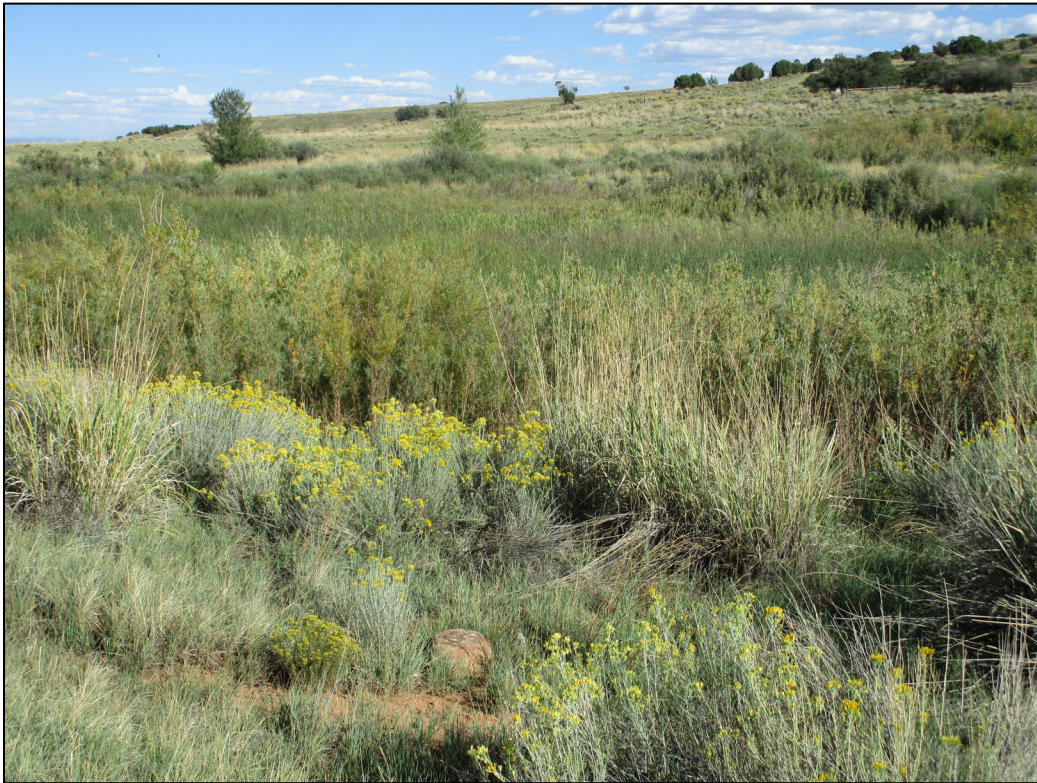
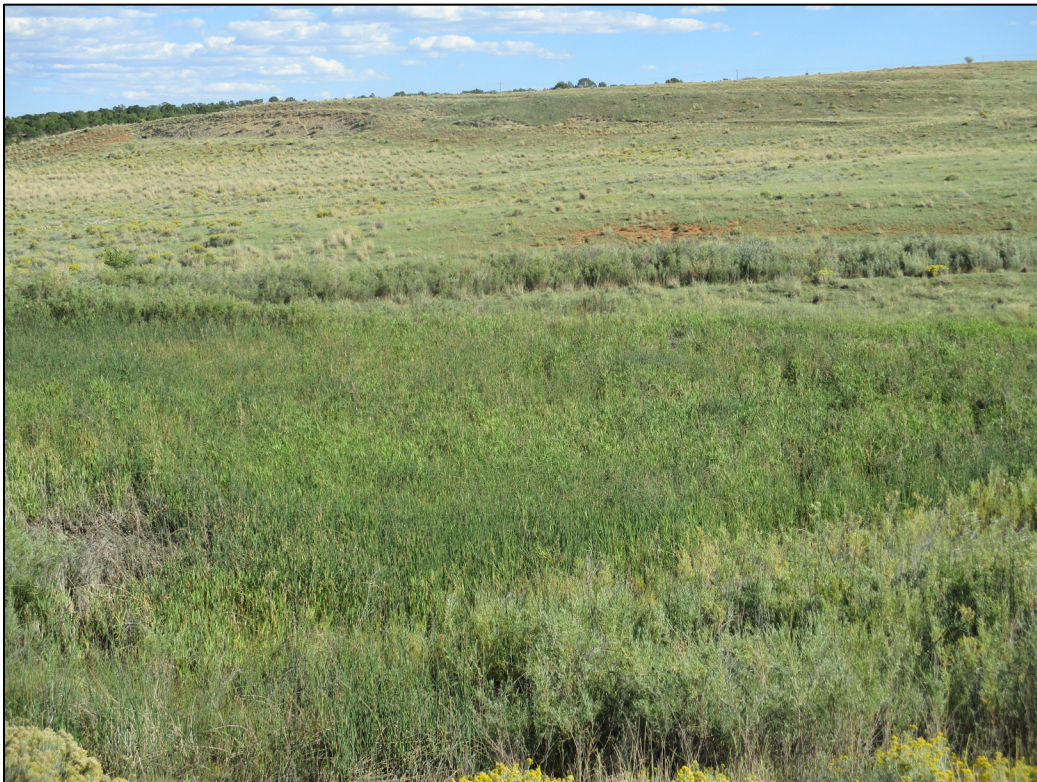
Wetlands 1, 2, and 3 are ecologically healthy and undamaged (PL-28, PL-29). There was no evidence of damage from human activity or natural causes. Erosion from the upgradient June 2020 waterline break will continue to be monitored due to its proximity to Wetland 2.

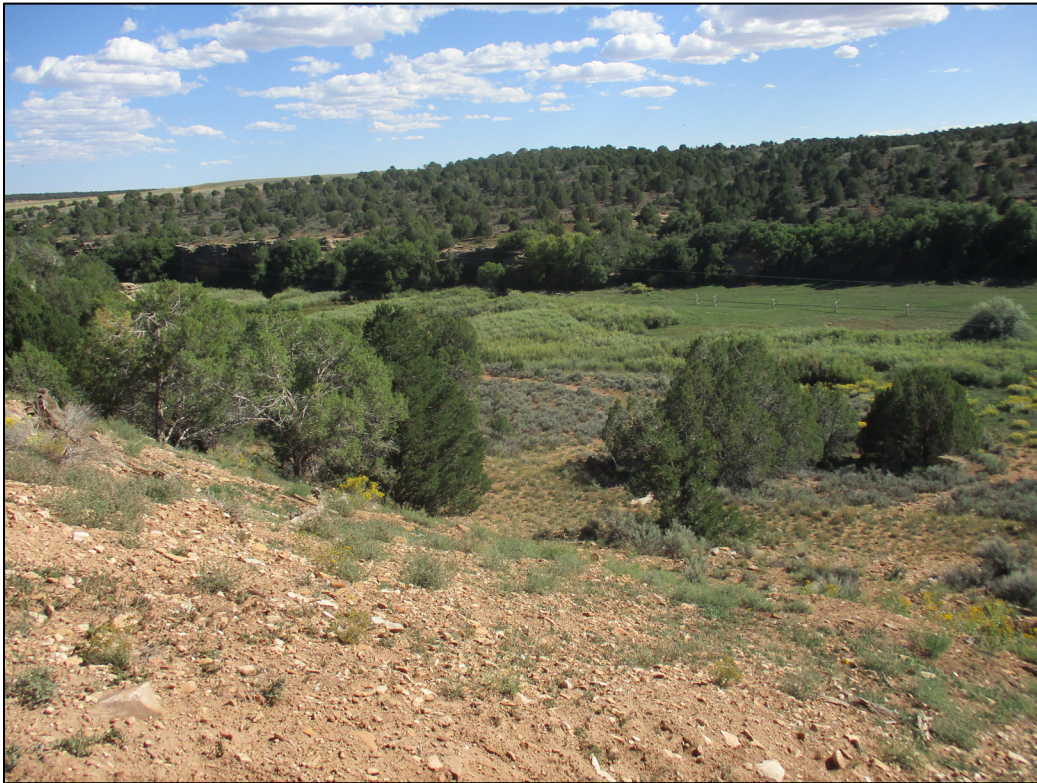
PL-32. Montezuma Canyon, View Downstream

Properties in the Montezuma Creek Restrictive Easement Area are inspected on a regular basis by onsite and water sampling personnel; during these visits, no evidence of significant erosion or soil removal from the restricted areas of these properties was noted. During the 2021 annual inspection, portions of Montezuma Canyon were inspected from observation points above the area, and no evidence of land-use changes or disturbance to the easement area was found. Observations in the easement area (PL-32) are recorded in Appendix A, Section V.

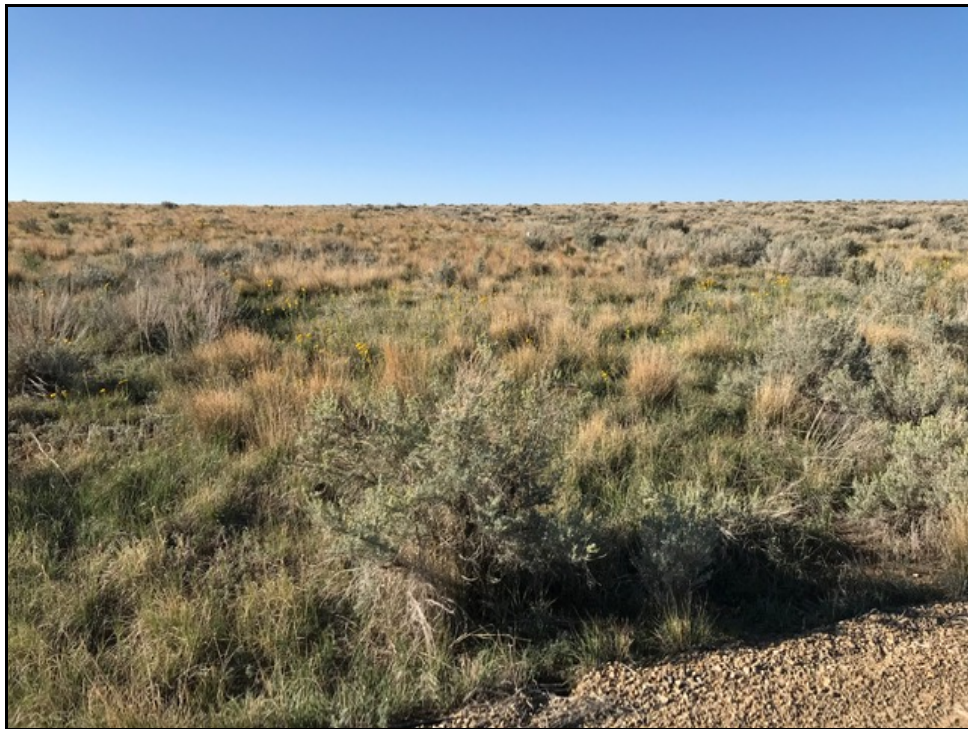
Figure B-1. Top Slope Cover, September 15, 2021

The disposal cell was found to be in satisfactory condition during the inspection. Vegetation on the disposal cell cover and side slopes continues to be healthy. No disposal cell performance concerns were identified during the inspection. Figure B-1 shows the overall cover conditions on top of the disposal cell.

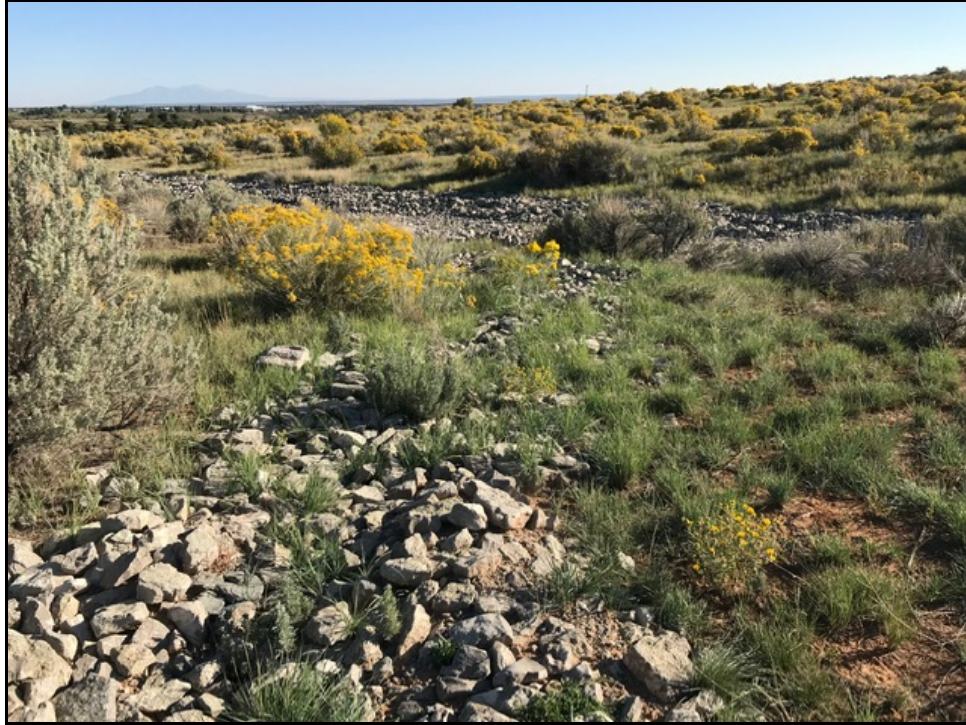
Figure B-2. West Drainage Channel Erosion Repair

During the 2020 inspection, inspectors noted an expanding rill that had formed by runoff bypassing riprap armor feeding into the west drainage channel. The rill was subsequently filled with additional riprap to arrest the headcutting. During the 2021 inspection, the riprap appeared to be working well and no new erosion showed despite significant rainfall in late summer of 2021. Vegetation was thriving in and around the repaired area, further stabilizing the soils. Figure B-2 shows the repaired erosion in the west drainage channel. The outfall of the southern diversion ditch was observed, and no issues were noted during this inspection.

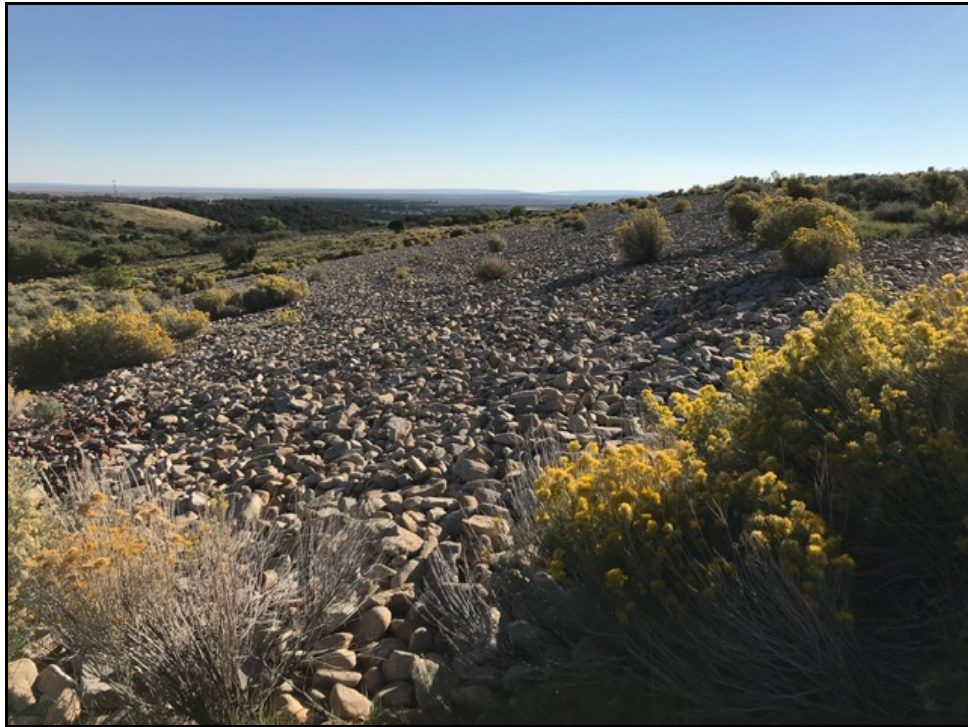
Figure B-3. Northwest Riprap Side Slope

The northwest riprap-covered side slope was found to be in satisfactory condition. The slope is protected against erosion by diorite riprap (Figure B-3), which also appeared to be in satisfactory condition. No evidence of movement or settling was observed. Some areas of the side slopes outside the tailing's footprint contain relatively sparse vegetation growth, allowing minor erosion of exposed soils which are being deposited at the transition between the vegetated and riprap-covered areas. Shallow rills were found along the uphill soil/rock interface of the side slope (Figure B-4). These rills are not currently a cause for concern; however, continued monitoring is recommended to ensure erosion features do not dramatically expand unexpectedly. At this time, the annual site inspection is adequate to address this monitoring recommendation.

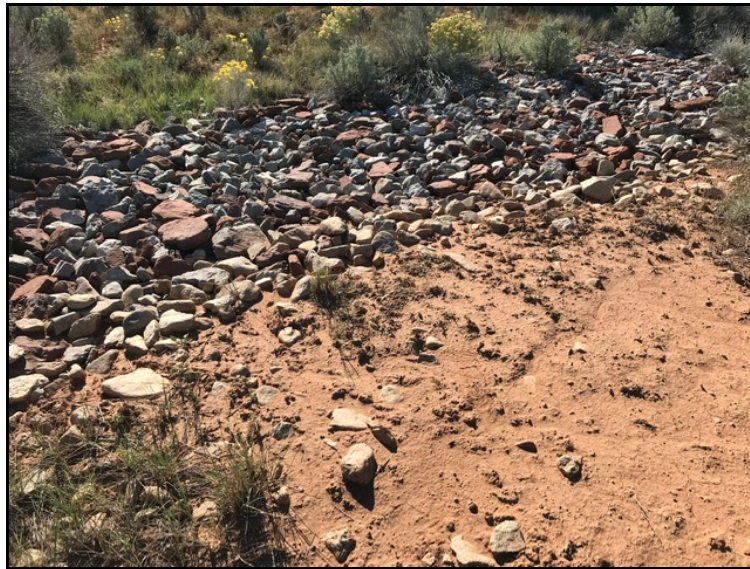
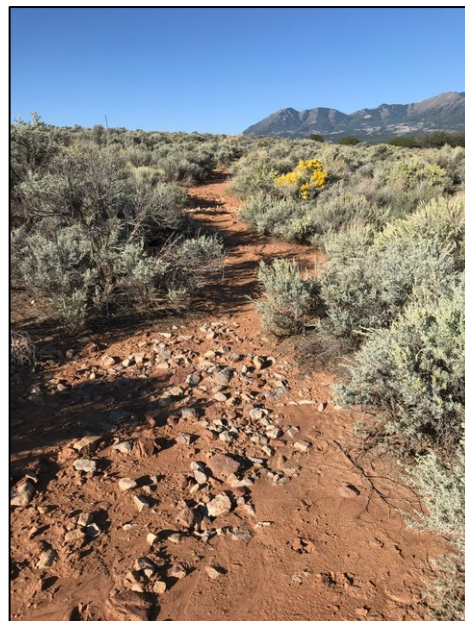
Sediment appears to be eroding onto the thickened riprap toe trench along the bottom of the disposal cell's north, northeastern, and eastern side slopes (Figure B-5 and Figure B-6). The amount of sediment is most significant on the north side slope, where the toe trench is almost completely covered. The toe trenches are not designed to collect or transport water. The purpose of the toe trenches is to halt any headcutting that is advancing toward the toe of the slope from below. Therefore, the sediment accumulation is purely cosmetic and does not affect the performance intent of the riprap toe. These erosion features should not be considered an issue. These minor erosion features should continue to be monitored during annual site inspections.

Figure B-5. Sediment Transport onto East Thickened Riprap Toe

Figure B-6. Sediment Transport onto North Thickened Riprap Toe

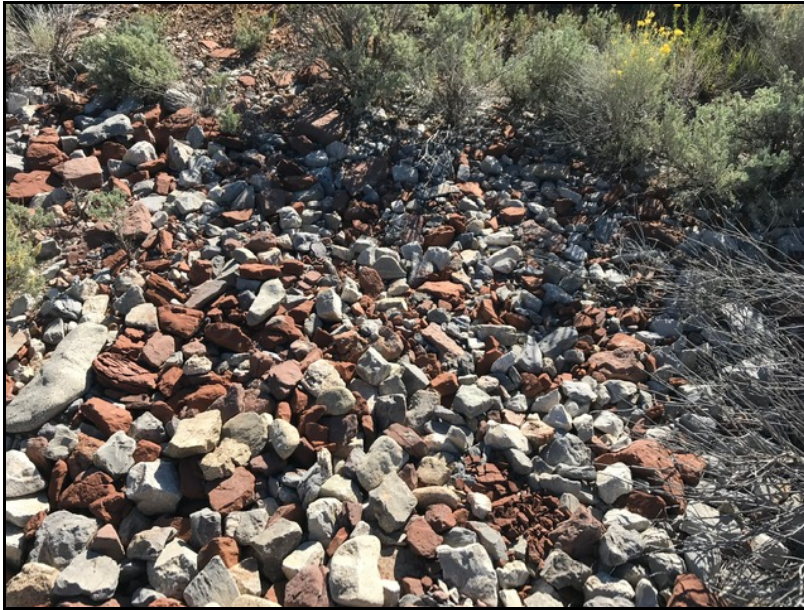
Some surface wearing and fracturing of sandstone rock (Figure B-7) has been continuously observed within the riprap toe, according to recent inspection reports. This breakdown is likely only occurring at the surface and should not be considered a problem.

Figure B-7. Breakdown of Sandstone Rock, East Thickened Riprap Toe
