2021 Annual Inspection Report for the DOE Monticello, Utah, Mill Tailings Site and Monticello Vicinity Properties

December 2021

U.S. DEPARTMENT OF
ENERGY

Legacy
Management

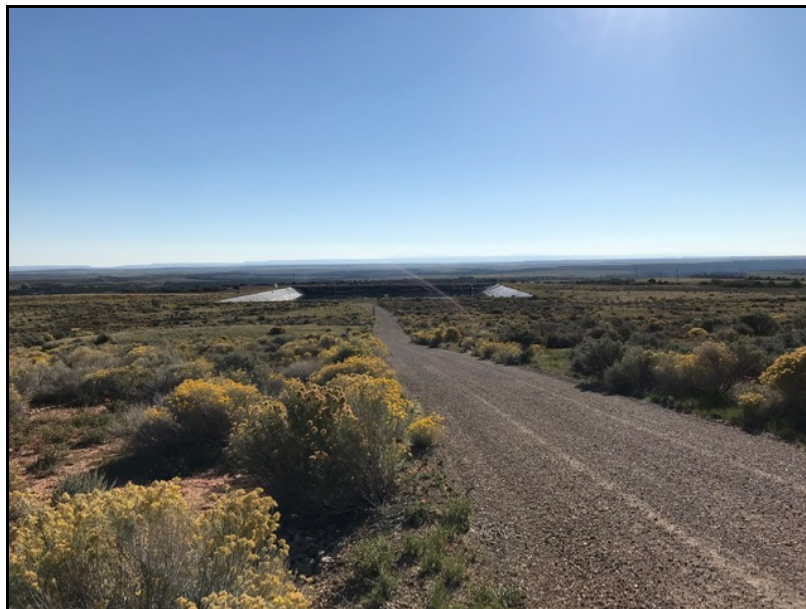
Figure B-8. Pond 4 From East

No problems were reported at either Pond 4 (Figure B-8) or the groundwater collection and transfer building, so these were not visited during the engineering inspection. Pond 4 continues to be in a stable condition, and no major issues were identified.
