Monticello, Utah, National Priorities List (NPL) Sites Federal Facility Agreement (FFA) Quarterly Report: October 1–December 31, 2024

February 2025

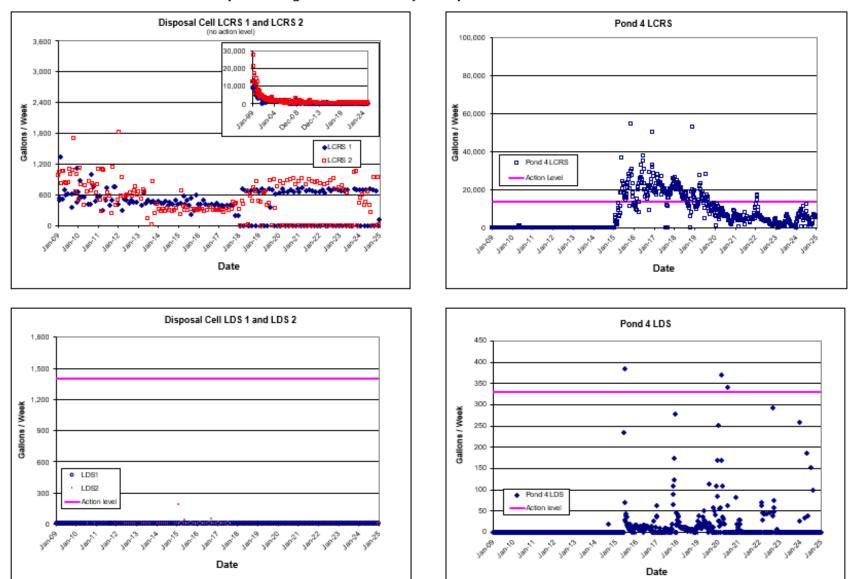
Figure B-1. Graphs Showing Performance History for Disposal Cell and Pond 4 LCRS and LDS

- Leachate production from the disposal cell was approximately 290 gallons per week combined for sumps LCRS 1 and LCRS 2. There is no action level for the disposal cell LCRS. See Appendix B for a graphical depiction of leachate production history.

- Findings for the Pond 4 LCRS and LDS for this quarter are as follows:
 - Water collection at the Pond 4 LCRS continued but did not exceed the action level this quarter (Appendix B)
 - Water collection at the Pond 4 LDS remained below the action level (Appendix B)
