ROCKY FLATS SITE REGULATORY CONTACT RECORD 2021-04

Purpose: East Trenches Plume Treatment System (ETPTS) discharge line replacement

Contact Record Approval Date: December 13, 2021

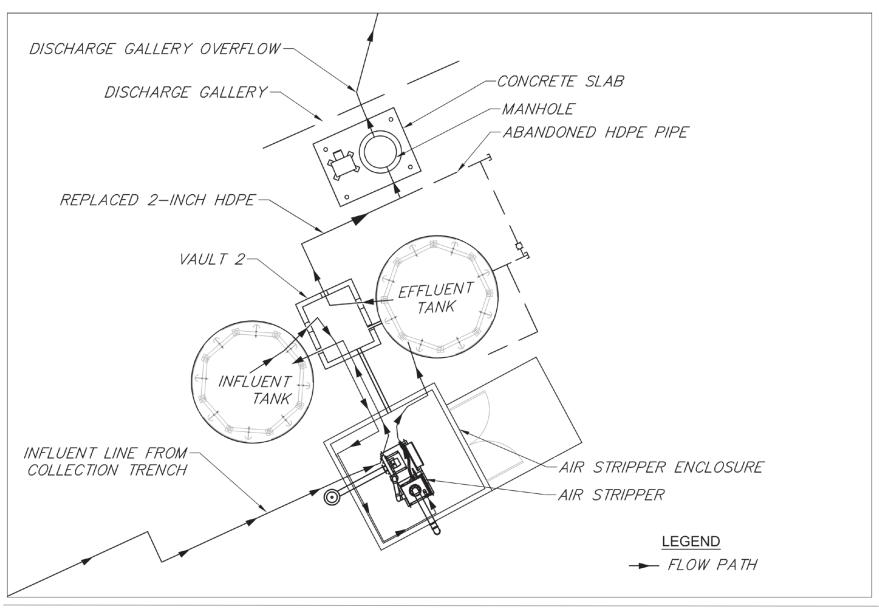
Figure 1. ETPTS Design Layout

On the morning of Tuesday, September 14, 2021, Legacy Management Support (LMS) staff identified an ETPTS pump that had malfunctioned. It was determined that the pump had burned out because the effluent discharge line was clogged with calcium scale. This pump, which is in the effluent tank of the ETPTS (Figure 1), pumps treated groundwater to the ETPTS effluent discharge gallery. Since the burned-out pump was identified within hours of failure and response actions (see "Immediate Response" section below) were implemented immediately, all treated water was maintained within the system while the effluent tank pump was inoperable, and normal treatment operations were uninterrupted.

Because of the temporary line's vulnerability to environmental conditions, such as freezing temperatures and disturbance by wildlife, the below ground line needed to be replaced as soon as feasible. On October 12, 2021, the clogged line was removed and replaced with approximately 13 feet (ft) of 2-inch high-density polyethylene (HDPE) pipe, which connected the ETPTS effluent vault with the effluent manhole. The line replacement required an excavation approximately 17 ft long by 6 ft wide with a varying depth of 2–5 ft. Photo 1 illustrates the general size of the excavation and the configuration of the newly installed discharge line.

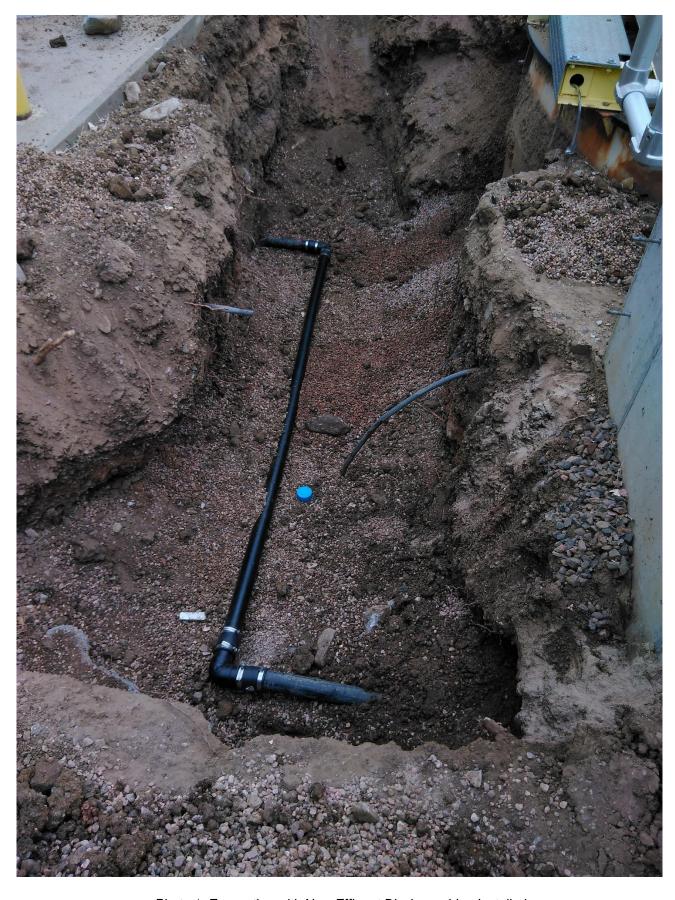
Photo 1. Excavation with New Effluent Discharge Line Installed

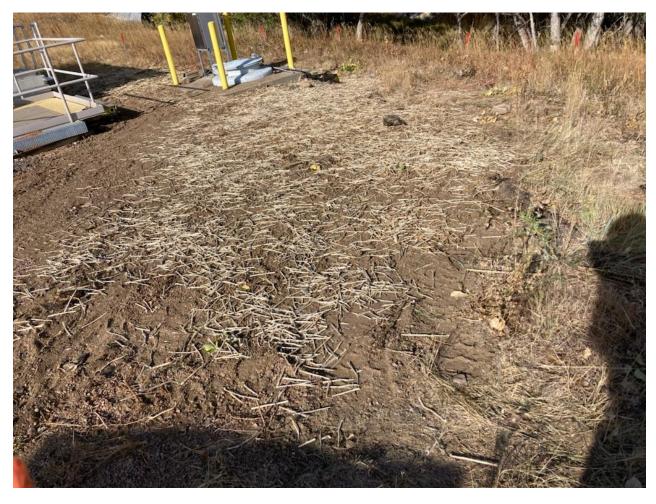
Photo 2. Work Area After Line Replacement and Backfill

Soil from the excavation was temporarily stored on the parking area just east of the ETPTS effluent tank and manhole and managed in accordance with all applicable or relevant and appropriate requirements as listed in Table 21 of the 2006 *Corrective Action Decision/Record of Decision* and consistent with the then in-effect approved *Erosion Control Plan for Rocky Flats Property Central Operable Unit* (currently, DOE-LM/1497-2007). Upon completion of the line replacement, all excavated soil was placed back into the excavation and compacted (photo 2).
