Rocky Flats Site, Colorado, Report Summary

First Quarter 2023

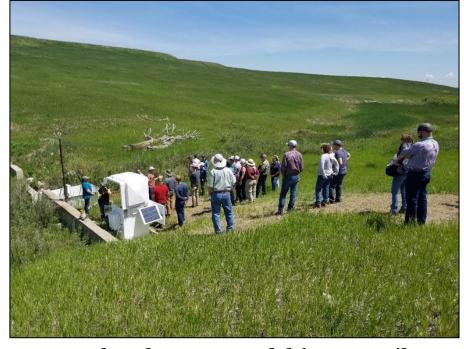
Rocky Flats Stewardship Council tour at GS10

- 12-month rolling average uranium concentrations at location GS10 were above the RFLMA standard of 16.8 μg/L starting on March 31, 2023
 - Reportable condition under RFLMA
 - See RFLMA Contact Record 2023-01
 - Reportable condition concentrations were 18.4-19.2 mg/L
 - Uranium no longer reportable as of May 31, 2023
 - Concentrations at Walnut Creek Point of Compliance (downstream of GS10) remained well below 16.8 μg/L

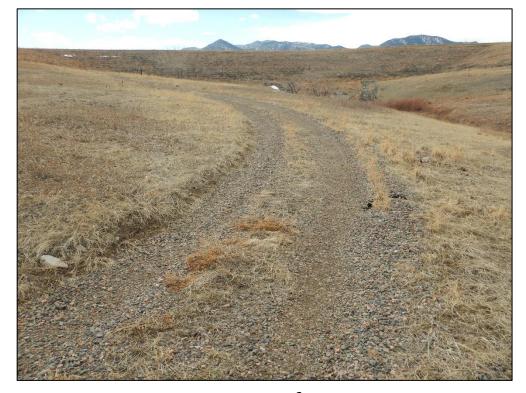
PLF east face

- Performed quarterly inspection on February 21, 2023
- No inspections in response to significant precipitation events were required in the first quarter
- Landfill is in good condition
 - No issues identified during inspection

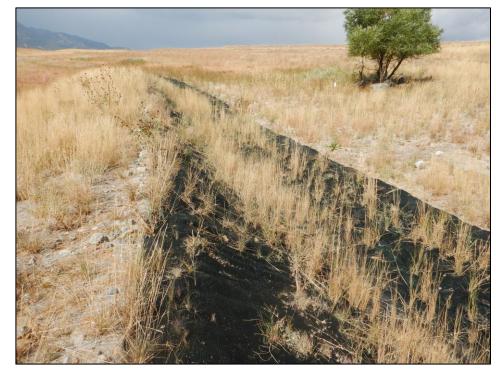
OLF Berm Seven with Turf Reinforcement Mat

- Monthly inspections performed on January 17, February 21, and March 23, 2023
- No inspections in response to significant precipitation events were required in the first quarter
- In addition, OLF is walked down weekly as a best management practice
- Routine maintenance performed on berms, channels, and erosion controls
- Landfill in good condition
 - No slumping observed
- Settlement monuments surveyed quarterly
 - Vertical settling at each monument was within design limits
