**2025 Annual Land-Use Covenant
Inspection Report
for DOE Areas at the Laboratory
for Energy-Related Health
Research/Old Campus
Landfill Superfund Site
University of California, Davis**

January 2026

U.S. DEPARTMENT OF
ENERGY

Legacy
Management

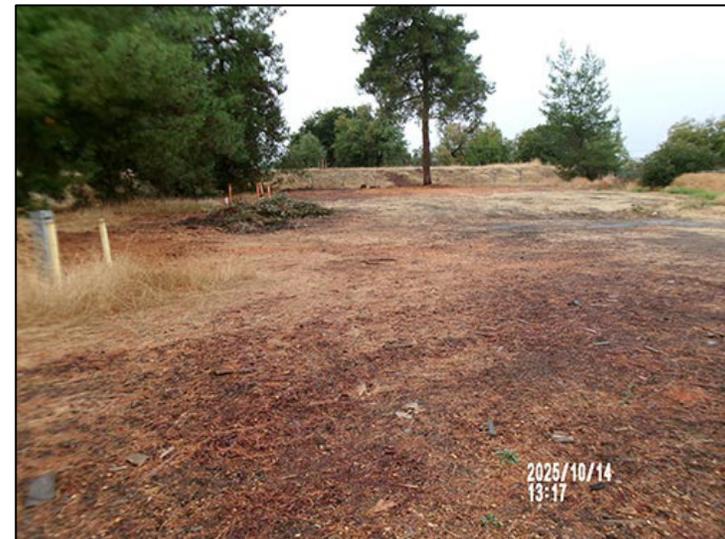
View West of SWT Area: Shoulder of Old Davis Road in Background; Ra/Sr Treatment Systems Area Tree Debris in Center Left of Photo (Photo No. 155)

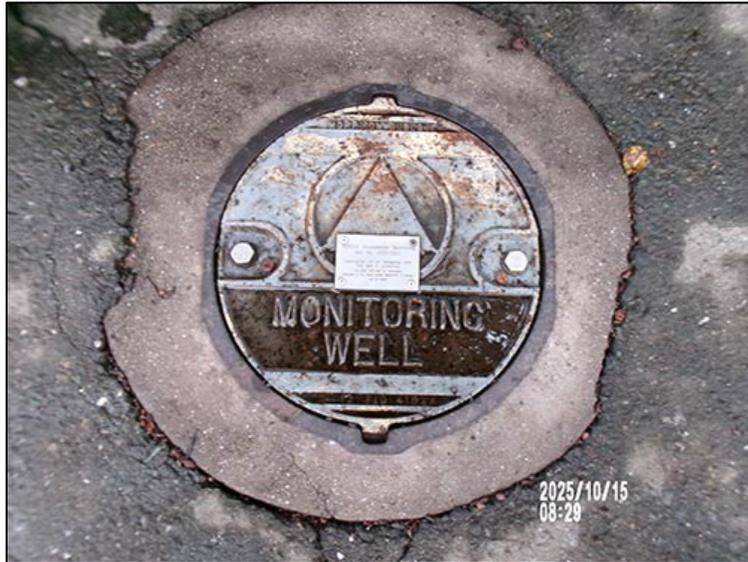
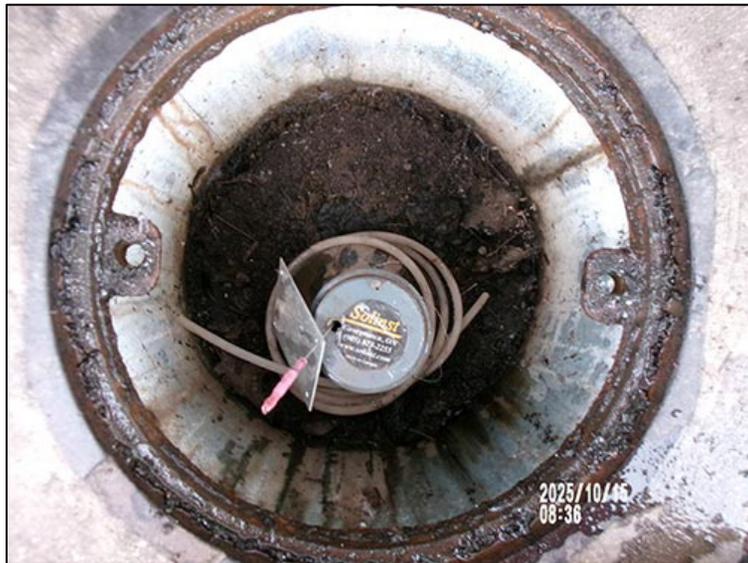
Remedial Design/Remedial Action Work Plan (DOE 2010), except for the pump in well UCD1-021, which did not produce water when tested. The pump in well UCD1-021 produced water at the low end of the target flow rate range when tested in the previous reporting period, but this pump was not repaired or replaced during this reporting period because it was found to produce sufficient flow during sample collection on February 10, 2025. The plan to repair or replace the pump in well UCD1-021 is presented in Appendix F.

UCD1-021 Wellhead (Photo No. 251)

UCD1-021 Interior (Photo No. 253)

Well UCD1-021: Poor performance of dedicated pump	12/9/2024	No repair: Pump verified to produce sufficient flow rate for sample collection	2/10/2025	NA
Well UCD1-069: Pump controller port plug missing	10/8/2024	Repair completed: Installed new pump controller port plug	4/24/2025	0708
Well UCD1-071: Vault lid bolt has stripped threads and concrete apron surrounding wellhead is cracked	10/7/2024	Repair completed: Installed new bolt and concrete apron	5/6/2025	0286
Well UCD1-072: Bolt hole below vault lid has thread corrosion	10/8/2024	Repair completed: Cleaned bolt hole and installed new bolt	5/6/2025	0255
Well UCD1-072: ID Plate cable attachment is blocking casing cap seal	10/8/2024	Repair completed: Moved attachment location of ID plate cable	5/6/2025	0258
Well UCD1-021: Dedicated pump not producing flow	12/4/2025	Repair planned: Repair or replace dedicated pump	TBD	NA
Well UCD1-023: Inner vault ID plate is becoming illegible	10/15/2025	Repair completed: Cleaned ID plate	12/4/2025	382

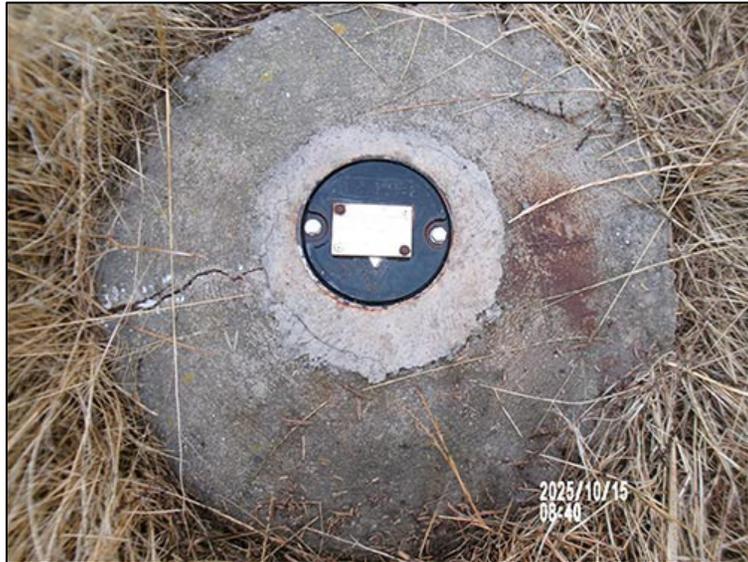
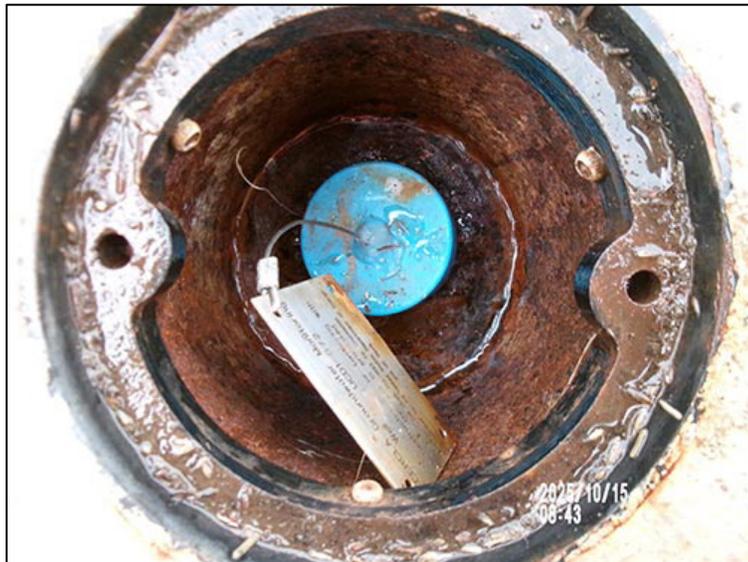
UCD1-070 standpipe	272 273	274 390	No	Yes	Yes	Yes	Yes ⁷	No	
UCD1-071 flush	286 403	291 292	No	Yes	Yes	Yes	Yes ⁷	No	
UCD1-072 flush	255 257	258 259	No	Yes	Yes	No	Yes ⁷	Yes	Vault lid gasket needs replacement.
UCD1-073 standpipe	321 322	325 326	No	Yes	Yes	Yes	Yes ⁷	No

UCD1-072 Wellhead (Photo No. 255)

UCD1-072 Interior (Photo No. 258)

Well UCD1-068: Inner vault ID plate is becoming illegible	10/15/2025	Repair completed: Cleaned ID plate	12/4/2025	399
Well UCD1-069: Inner vault ID plate is becoming illegible	10/15/2025	Repair completed: Replaced ID plate	12/4/2025	387
Well UCD1-069: Inner vault ID plate cable is wearing out	10/15/2025	Repair planned: Repair or install new ID plate cable	TBD	NA
Well UCD1-069: Vault lid gasket not sealing	10/15/2025	Repair planned: Install new vault lid gasket	TBD	NA

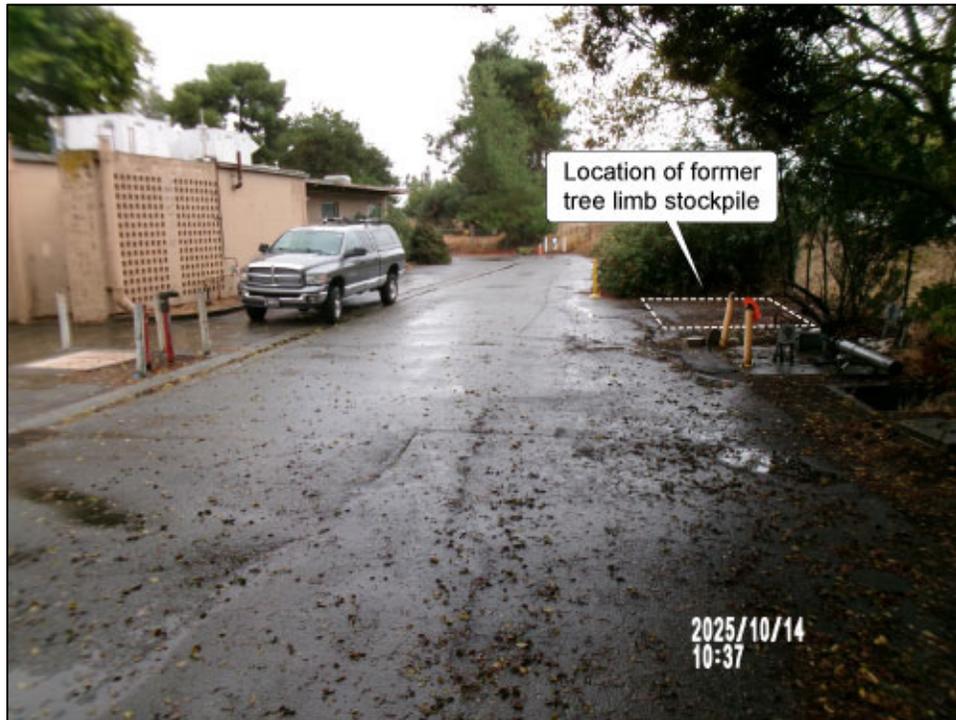
Photo F-1. View South of Southern Portion of Ra/Sr Treatment Systems Area Showing Location in Right Mid-Ground where Tree Limb Stockpile Was Formerly Staged Under Approved Permit in 2025 (Photo No. 0072)

Maintenance Item	Date Identified	Description of Completed or Planned Action	Date Completed	Completion Photo No.
Disposal of vegetation debris stockpiles located in Ra/Sr Treatment Systems and SWT Areas	1/19/2023, 10/8/2024	Repair completed: Stockpiles containing Ra/Sr Treatment Systems and SWT Areas vegetation waste disposed in 2025 under approved permit	10/14/2025	0072 0302
Disposal of vegetation debris stockpiles located in UC Davis Southern Trenches Area containing EDPs vegetation waste	10/8/2024	Repair completed: Stockpiles containing EDPs vegetation waste disposed in 2025 under approved permit	10/14/2025	0309
Monument 19: Delineator broken at base and fallen	10/7/2024	Repair completed: Delineator reinstalled	9/30/2025	0203
Oleander shrub 16203: Missing tag	10/8/2024	Repair completed: Installed new tree tag	4/24/2025	0715
White mulberry tree 16211: Tag becoming obscured by tree growth	10/8/2024	Repair completed: Installed new tree tag	4/24/2025	0721

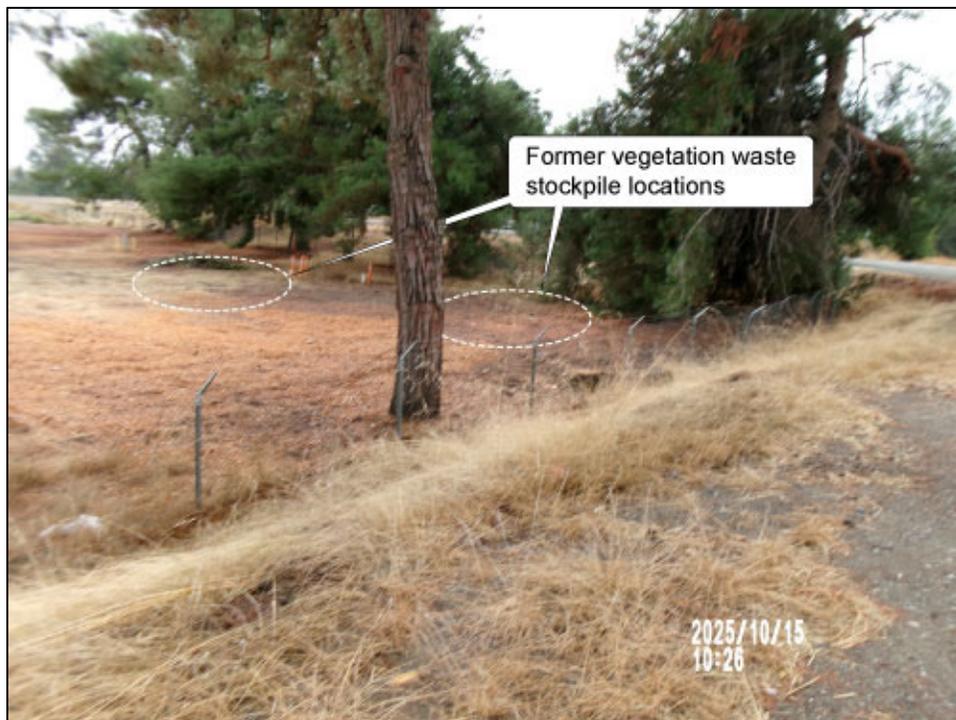
Photo F-2. View Southeast into Southwest Trenches Area from Shoulder of Old Davis Road Showing Area Where Southwest Trenches Area Vegetation Waste Stockpiles Were Removed and Disposed of Under Approved Permit in 2025 (Photo No. 0302)

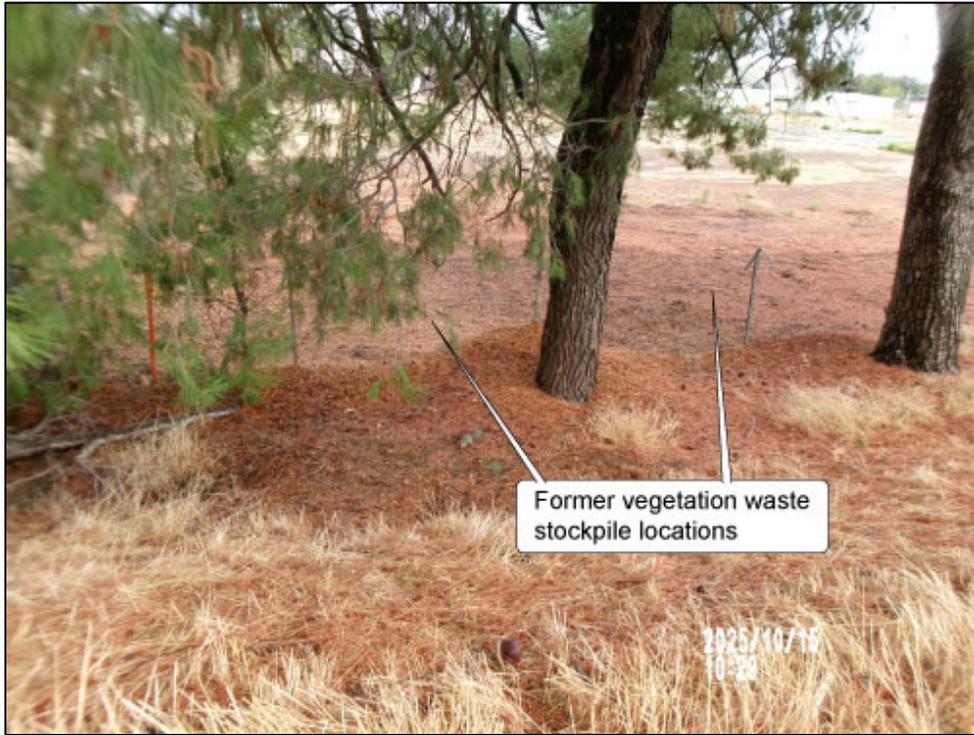
Photo F-3. View Northeast of UC Davis Southern Trenches Area Showing Area Where Stockpiles Containing Eastern Dog Pens Area Vegetation Waste Were Removed and Disposed of Under Approved Permit in 2025; Monument 18 Delineator in Center Left (Photo No. 0309)

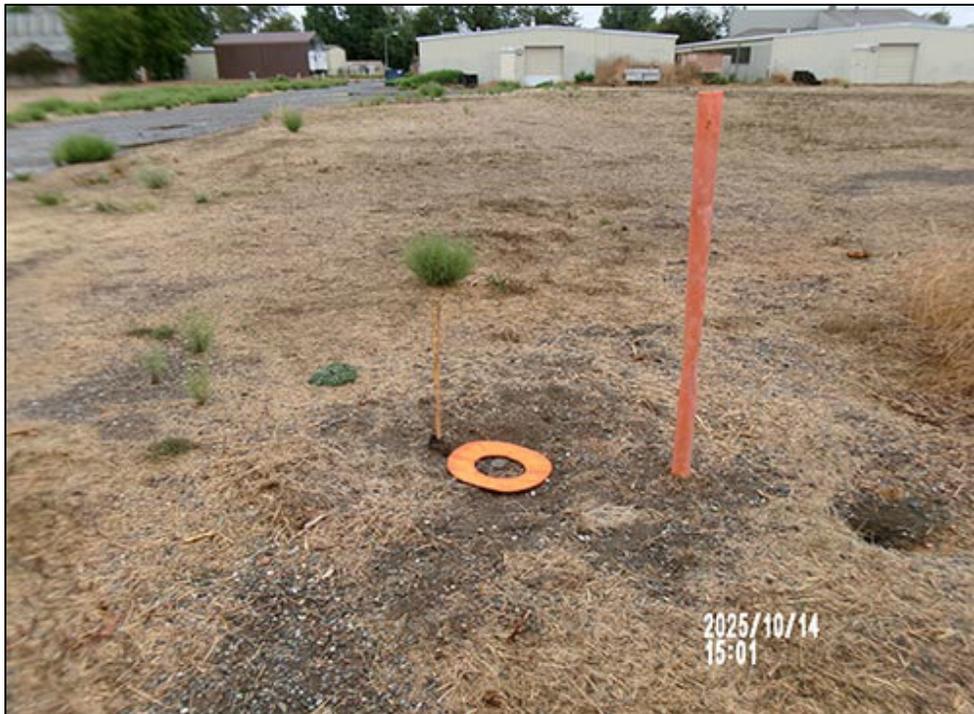
Photo F-4. View North: Reinstalled Delineator adjacent to Survey Monument 19; Geriatrics Buildings in Top Center (Photo No. 0203)

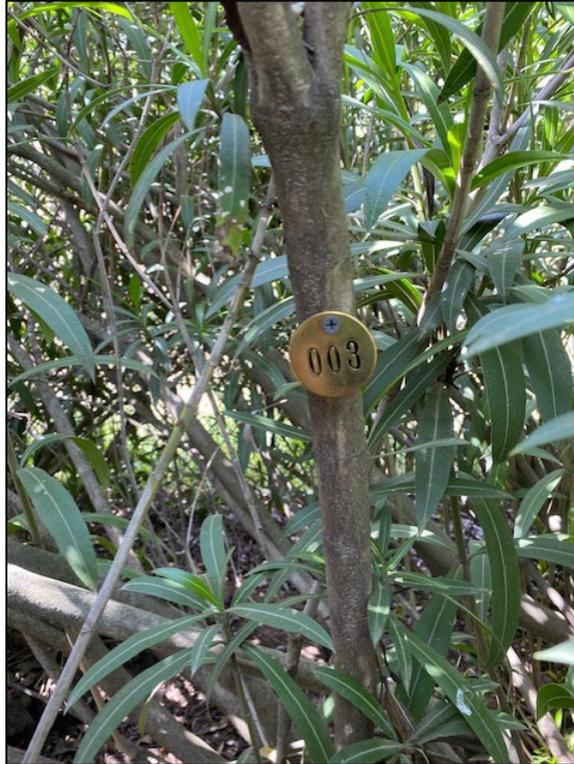
Photo F-5. Tree 16203: New Tag Installed on Shrub Limb (Photo No. 0715)

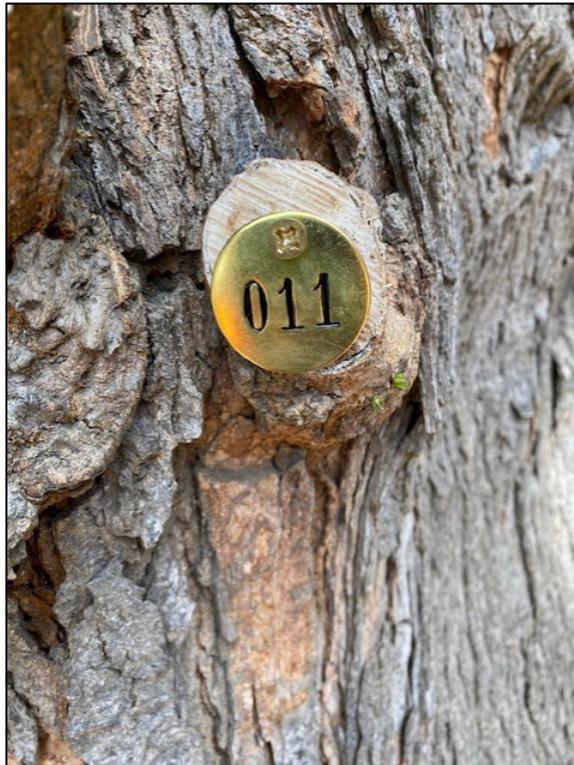
Photo F-6. Tree 16211: New Tag Installed on Tree Trunk (Photo No. 0721)

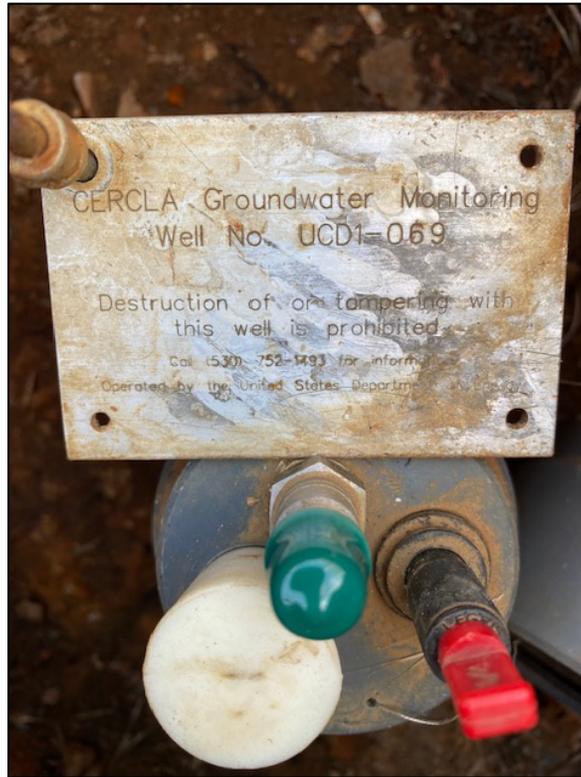
Photo F-7. Well UCD1-069: New Plug Installed on Pump Controller Port (Photo No. 0708)

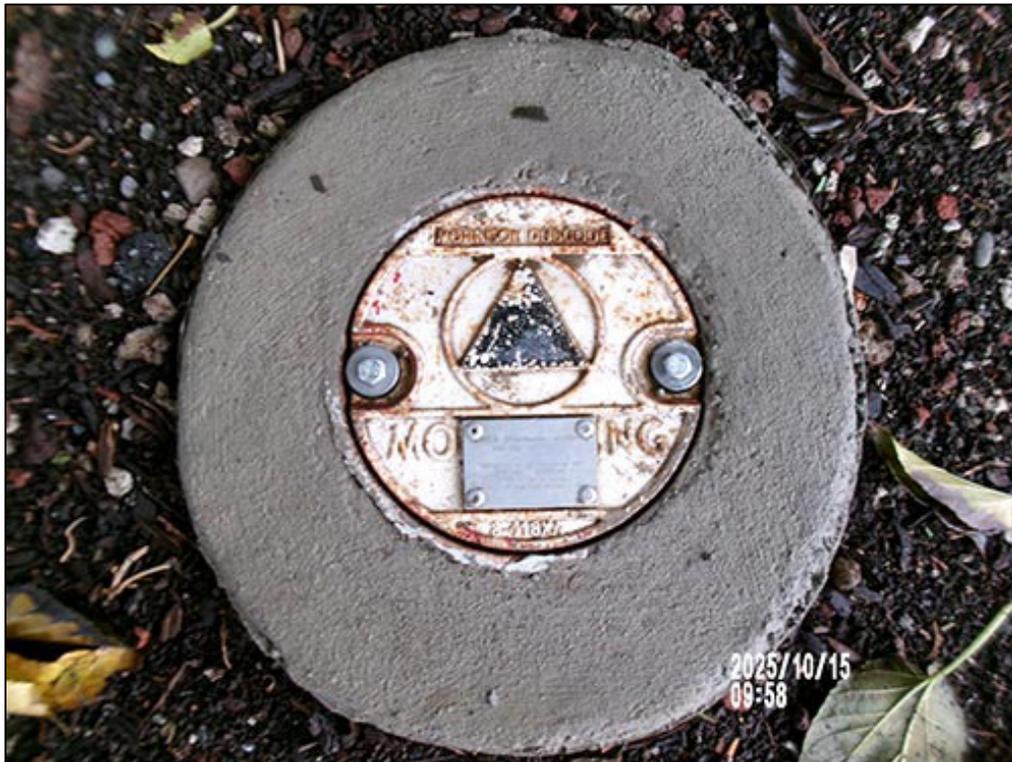
Photo F-8. Well UCD1-071: New Vault Lid Bolts and New Concrete Apron Surrounding Wellhead Installed (Photo No. 0286)

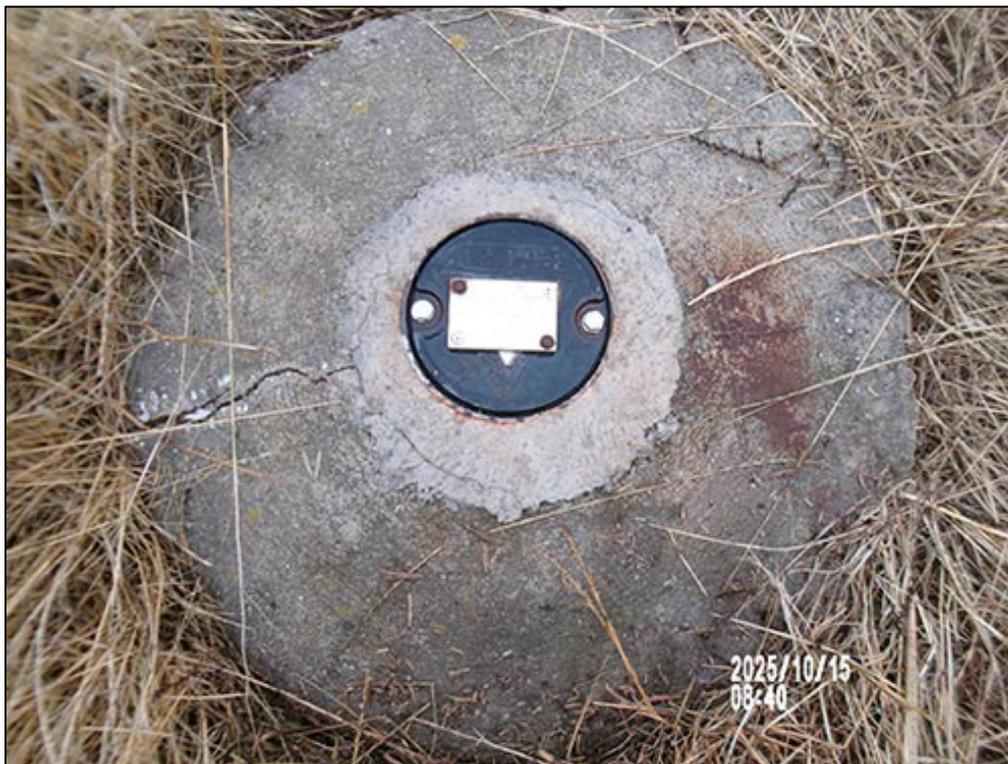
Photo F-9. Well UCD1-072: Bolt Holes Cleaned and New Vault Lid Bolts Installed (Photo No. 0255)

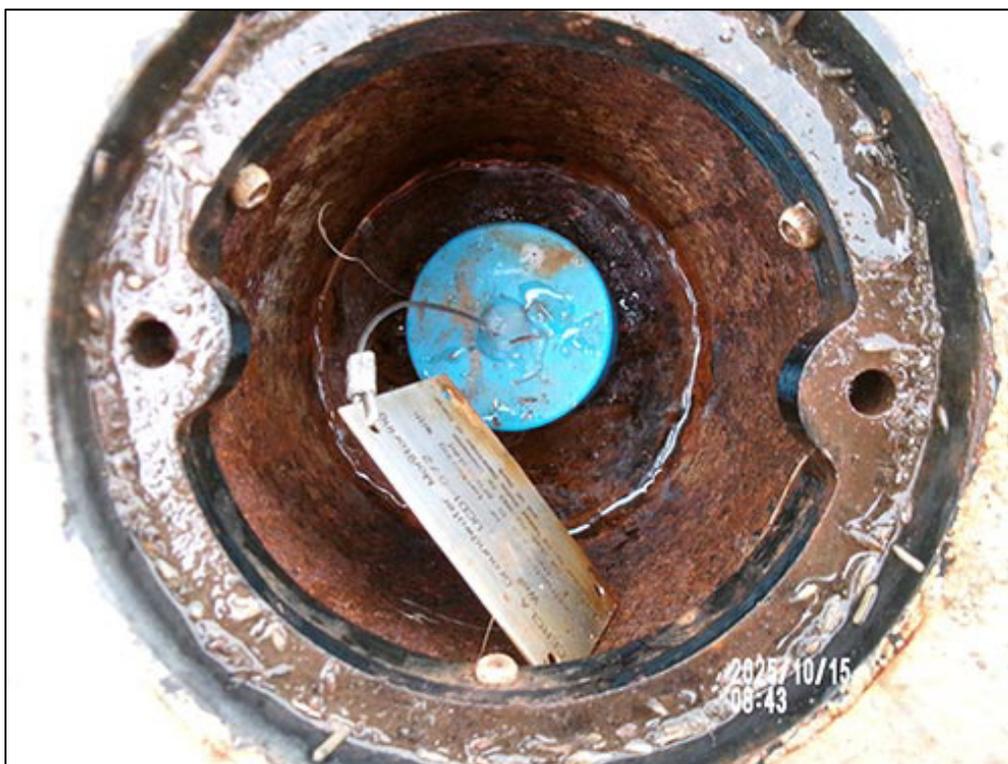
Photo F-10. Well UCD1-072: Interior Well ID Plate Cable Reattached to Top of Well Casing Cap (Photo No. 0258)

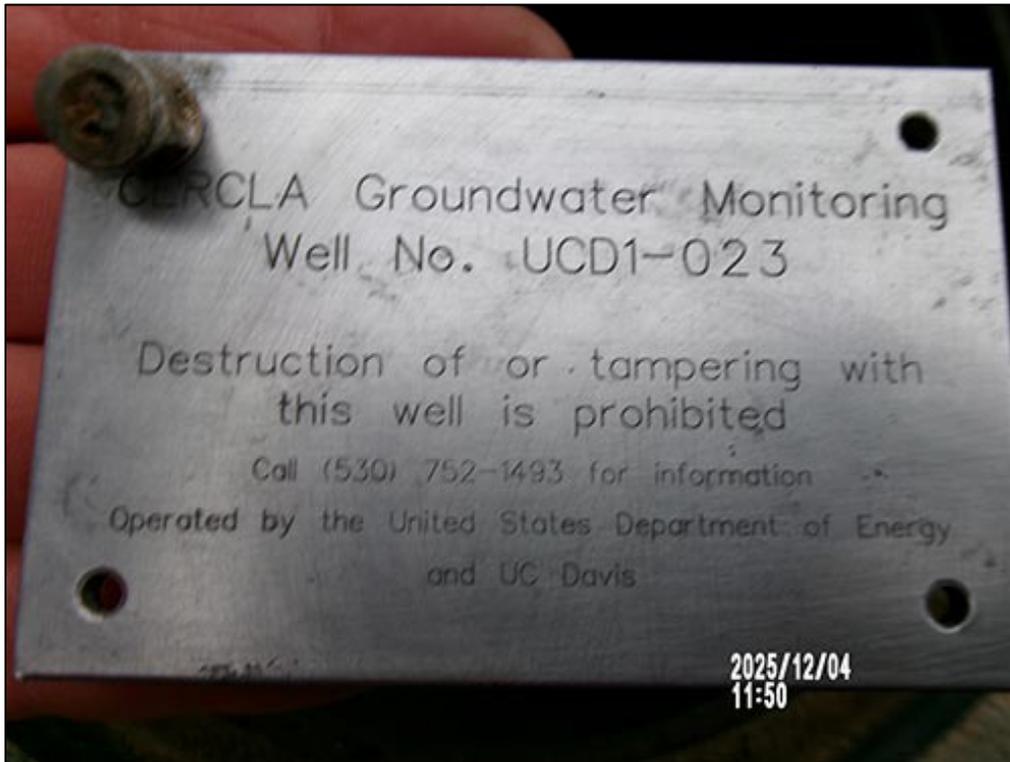
Photo F-11. Well UCD1-023: Inner Vault ID Plate Cleaned (Photo No. 0382)

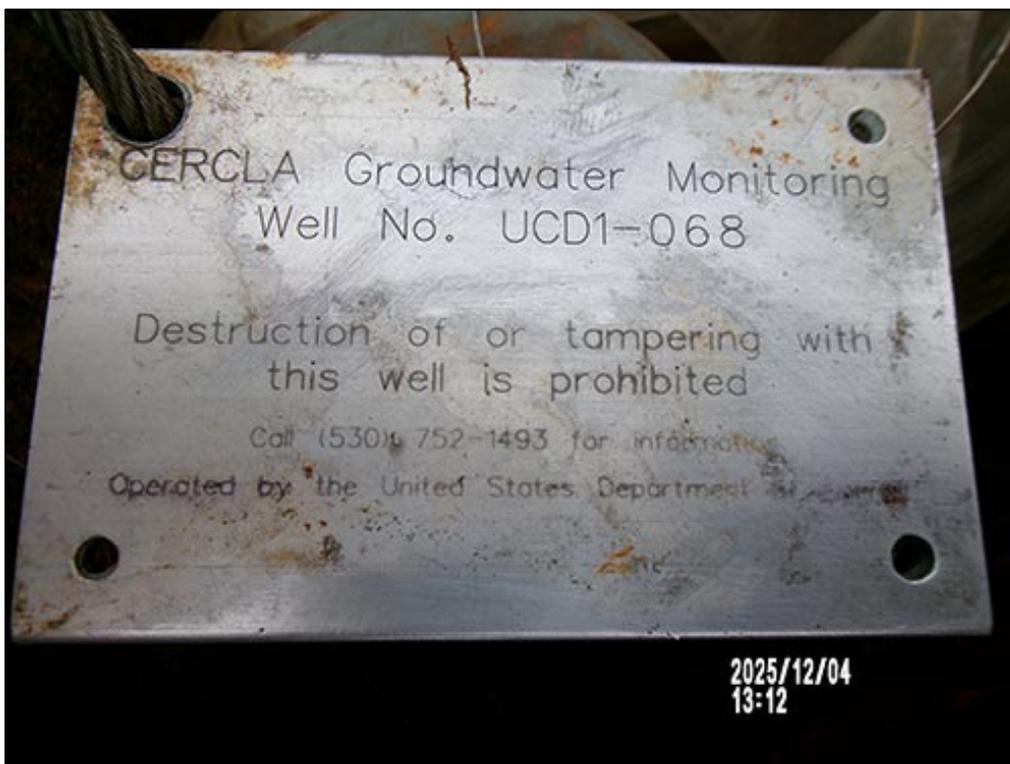
Photo F-12. Well UCD1-068: Inner Vault ID Plate Cleaned (Photo No. 0399)

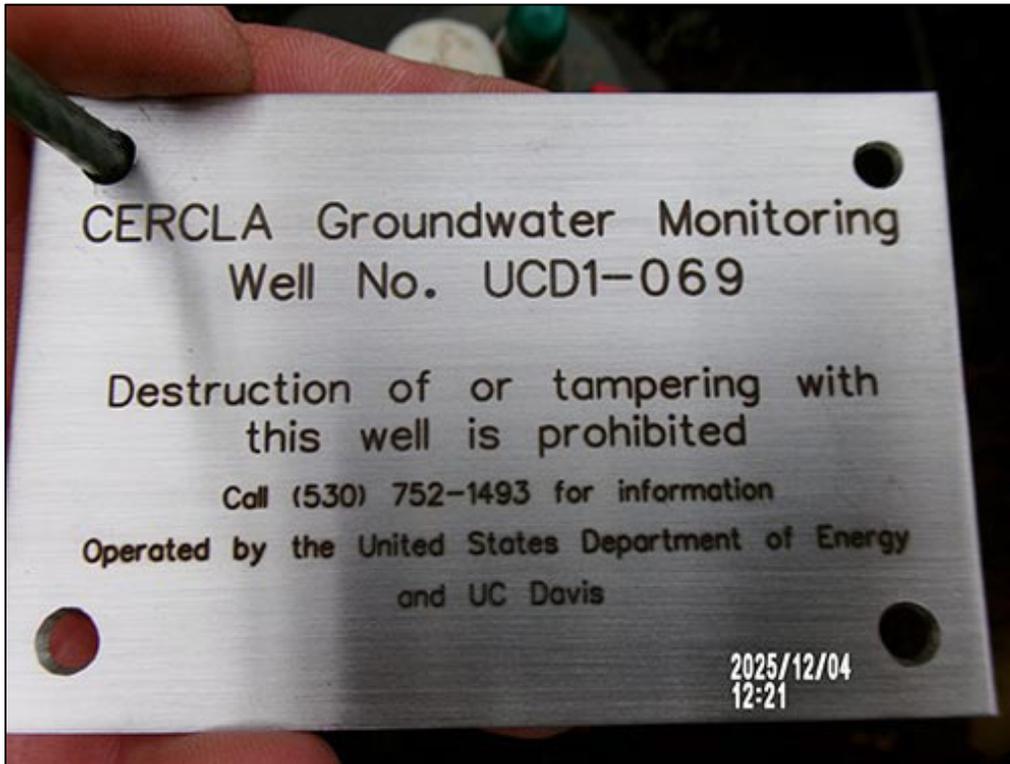
Photo F-13. Well UCD1-069: Inner Vault ID Plate Replaced (Photo No. 0387)

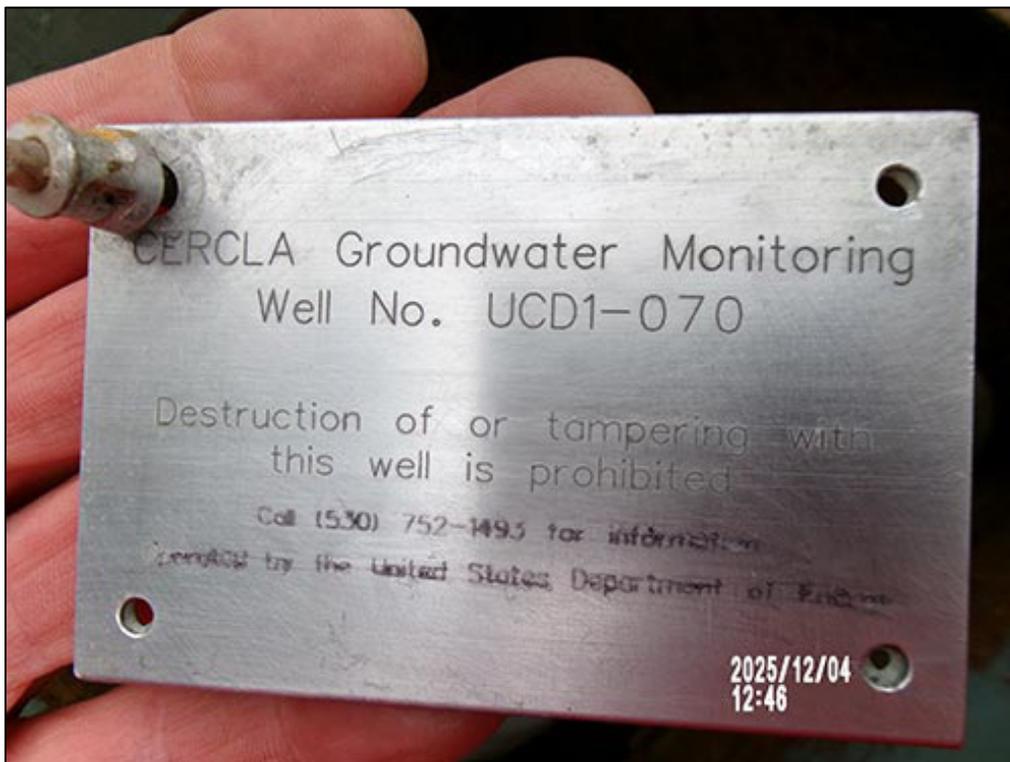
Photo F-14. Well UCD1-070: Inner Vault ID Plate Cleaned (Photo No. 0390)

Maintenance Item	Date Identified	Description of Completed or Planned Action	Date Completed	Completion Photo No.
Well UCD1-070: Inner vault ID plate is becoming illegible	10/15/2025	Repair completed: Cleaned ID plate	12/4/2025	390
Well UCD1-071: Vault lid ID plate is becoming illegible	10/15/2025	Repair completed: Cleaned ID plate	12/4/2025	403
Well UCD1-072: Vault lid gasket not sealing	10/15/2025	Repair planned: Install new vault lid gasket	TBD	NA
Shrubs 16203 and 16209: Tags inaccessible for photography due to new growth of shrubs	10/15/2025	Repair planned: Locate and move tags to accessible locations or install new tags	TBD	NA
Tree Tag 056: Tag difficult to access for photography due to new growth of lower tree limbs	10/15/2025, 12/4/2025	Repair planned: Move tag to accessible location	TBD	NA
New sapling over 6 feet in height found in Ra/Sr Treatment Systems Area	10/15/2025	Repair planned: Install tag on new sapling	TBD	NA

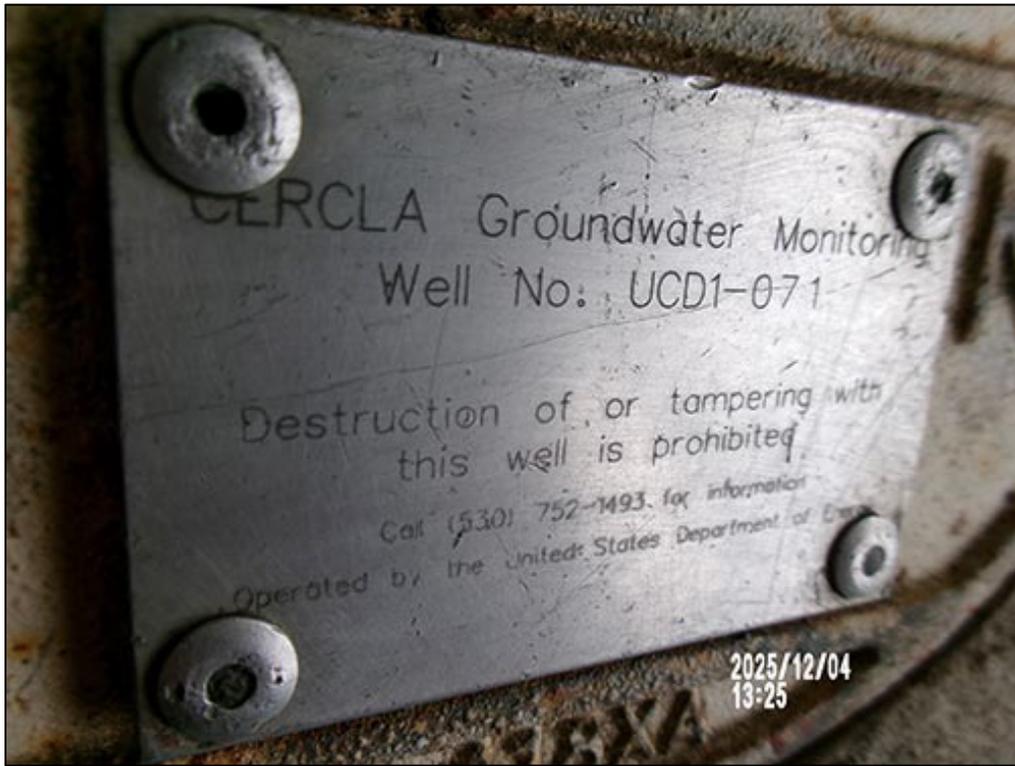
Photo F-15. Well UCD1-071: Vault Lid ID Plate Cleaned (Photo No. 0403)
