## 4.0 Maybell West, Colorado, Disposal Site

### 4.1 Compliance Summary

Figure 4-1. 2024 Annual Inspection Drawing for the Maybell West, Colorado, Disposal Site

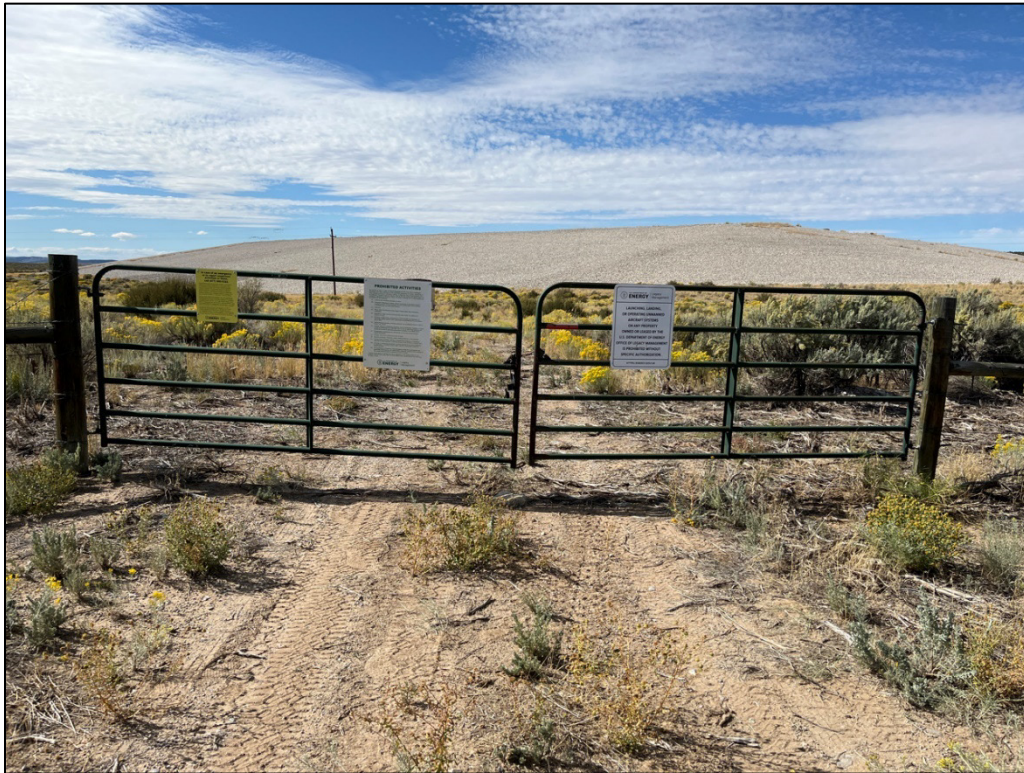
The access road was passable, and no maintenance needs were identified. The entrance gate, a standard tubular metal stock gate, is near the southeast corner of the site. No maintenance needs were identified.

The entrance sign is mounted on a metal T-post directly south of the entrance gate (PL-1). Ten warning or perimeter signs are mounted on metal T-posts around the site. No other maintenance needs were identified.

*PL-1. Entrance Gate*

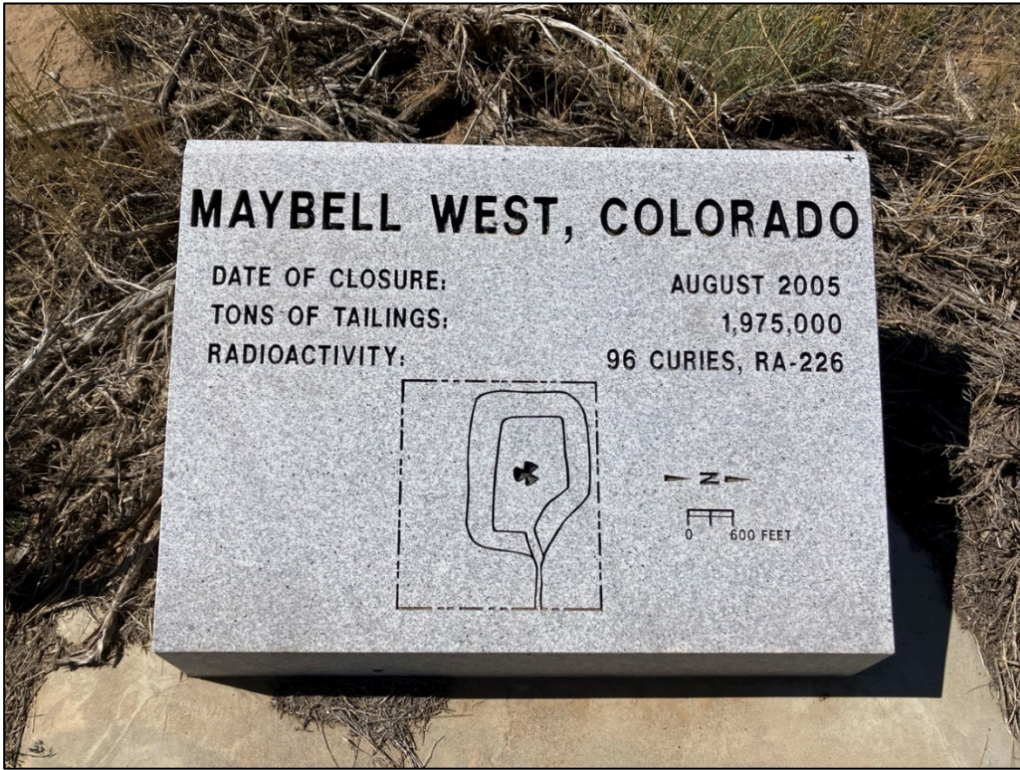
The site has one granite site marker near the entrance gate (PL-2). There is minimal cracking in the cement at the base of the site marker. It does not affect the integrity of the marker. No maintenance needs were identified.

*PL-2. Site Marker*

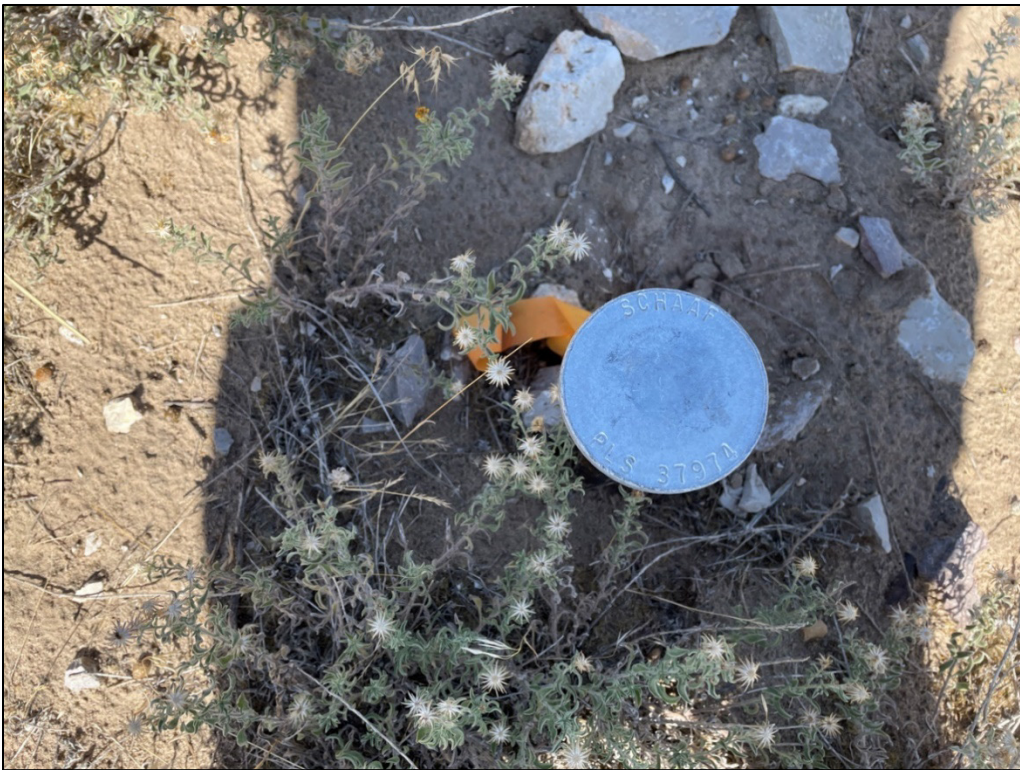
Eight boundary monuments are on the site boundary outside the fenced area. Four of the monuments are at the property corners, and the other four define an approximate 20-foot offset along the north and south boundaries where the private land that LM acquired in fee adjoins the BLM withdrawal area on the western portion of the site. Boundary monuments BM-3 and BM-6 (capped pieces of rebar) define the two 20-foot offsets. Boundary monument BM-3 was missing. It was surveyed and replaced in 2024 (PL-3). No additional maintenance needs were identified.

*PL-3. Boundary Monument BM-3*

- The noxious weeds identified on the top slope of the disposal cell were treated with herbicide
- Fence repair was completed on the northern and southern sides of the site
- Boundary monument BM-3 was replaced and resurveyed

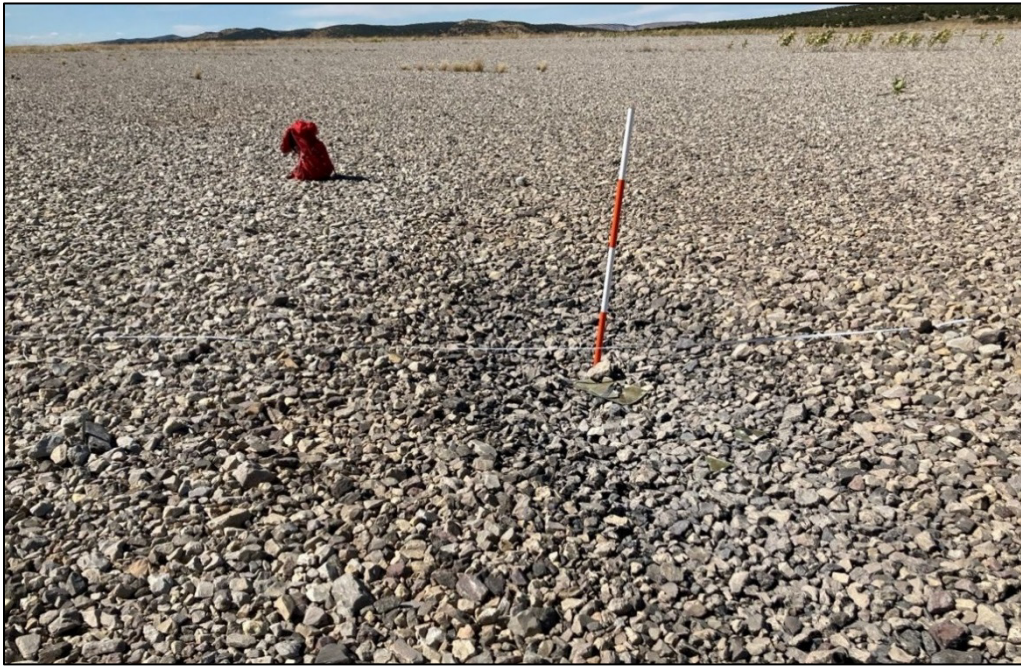
The disposal cell is on the reclaimed site of a former heap leach processing area. The top slope of the riprap-armored disposal cell occupies about 60 acres of the site. The top of the disposal cell showed no signs of significant erosion, settling, or other modifying processes that would affect disposal cell integrity. However, four small, shallow depressions have been observed (just north of Diversion Channel No. 1) since the site transitioned to DOE in 2010. These depressions appear to be the result of settlement of the underlying materials since completion of the disposal cell. Depression No. 1 was discovered during the initial annual inspection in 2010 (PL-4). A second smaller and shallower depression (Depression No. 2) was first noted just west of the first depression during the 2016 annual inspection. A third depression (Depression No. 3) was first observed during the 2018 annual inspection (PL-5). A fourth depression (Depression No. 4), east of the previous three depressions, was noted during the 2023 inspection (PL-6). Depression No. 4 does not appear to be new, but it was not specifically noted during previous inspections. During the 2024 inspection, Depression Nos. 1–4 appeared to be approximately the same size, as observed during the 2023 annual inspection.

An LMS engineer participated in the 2023 inspection to evaluate the depressions on the top of the cell. Depression Nos. 1, 2, and 4 are shallow and widespread; these are likely settlement made more evident by accumulating surface water that is infiltrating and forcing additional consolidation as it flushes through the cover and waste profile. This is not a concern from a risk standpoint, and it is anticipated that additional features become more prominent and easier to identify with each inspection. Several minimally visible depression features were noticed while inspectors walked the western half of the cover. These features might become more noticeable over the years. Depression No. 3 is a very localized but deep depression that is concerning due to its depth to relative size. It is recommended to continue monitoring it and to perform localized light detection and ranging (lidar) testing or even standard land surveying of the area.

*PL-4. Depression No. 1*

All four depressions will continue to be measured during annual inspections to determine if additional, more significant settlement is occurring. Aerial surveys are currently scheduled to be conducted every 5 years to assist in monitoring the depressions. No standing water was observed in any of the depressions during the inspection. These depressions currently do not threaten the integrity or performance of the disposal cell. No maintenance needs were identified.

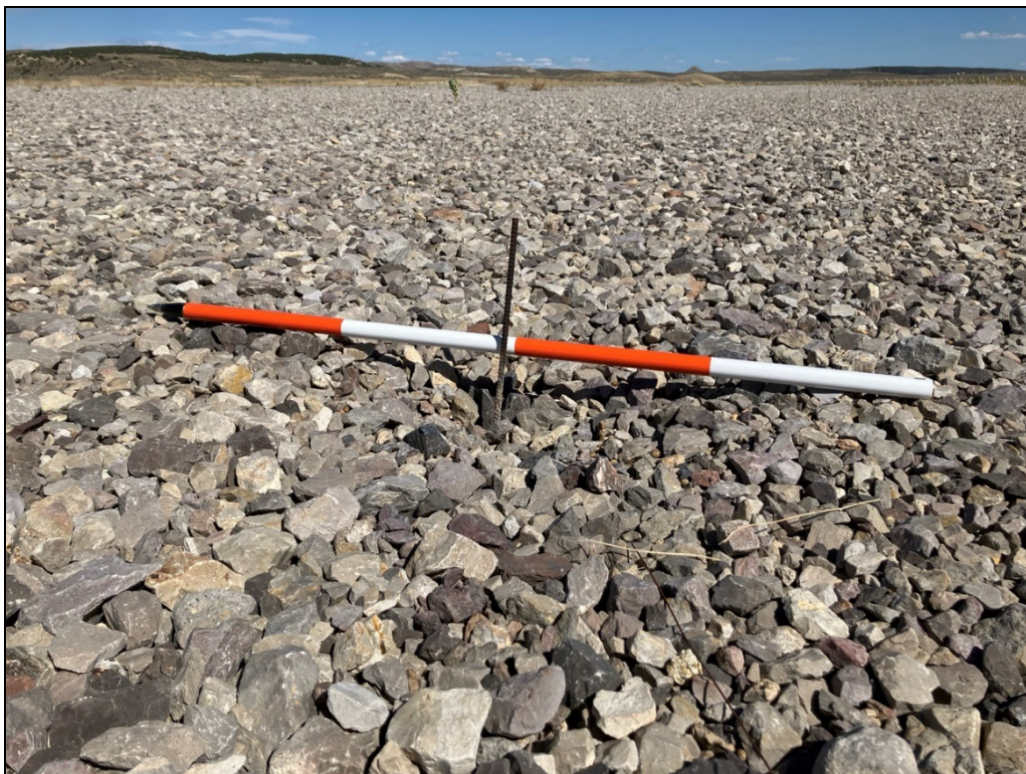
*PL-5. Depression No. 3*

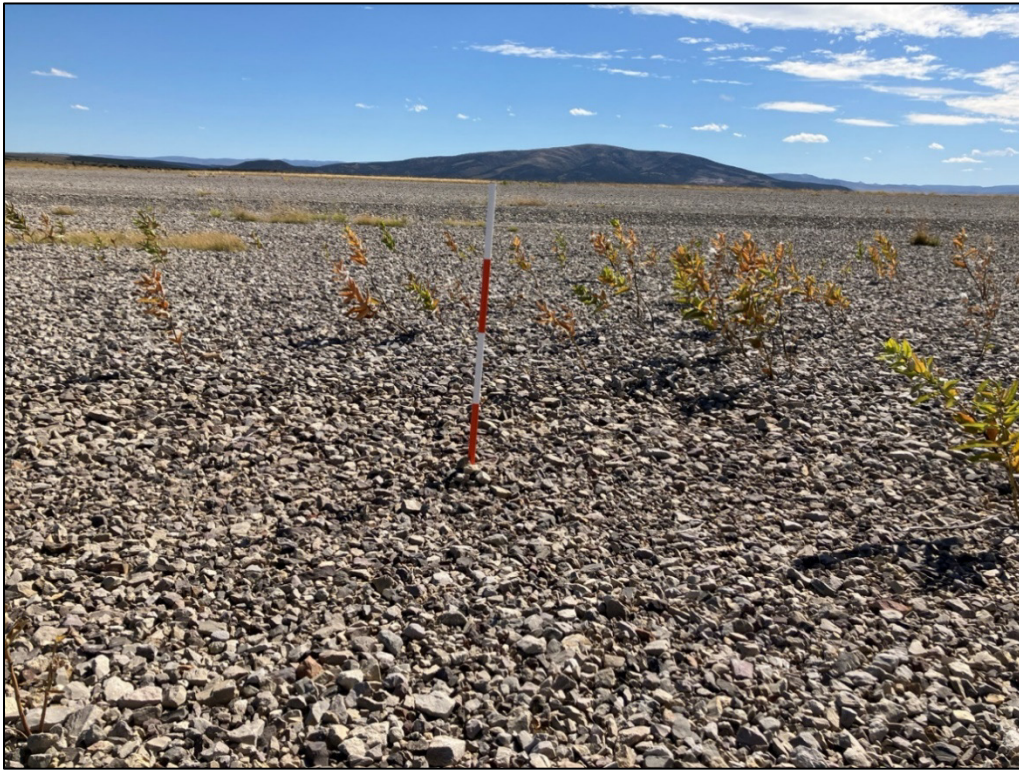
*PL-6. Depression No. 4*

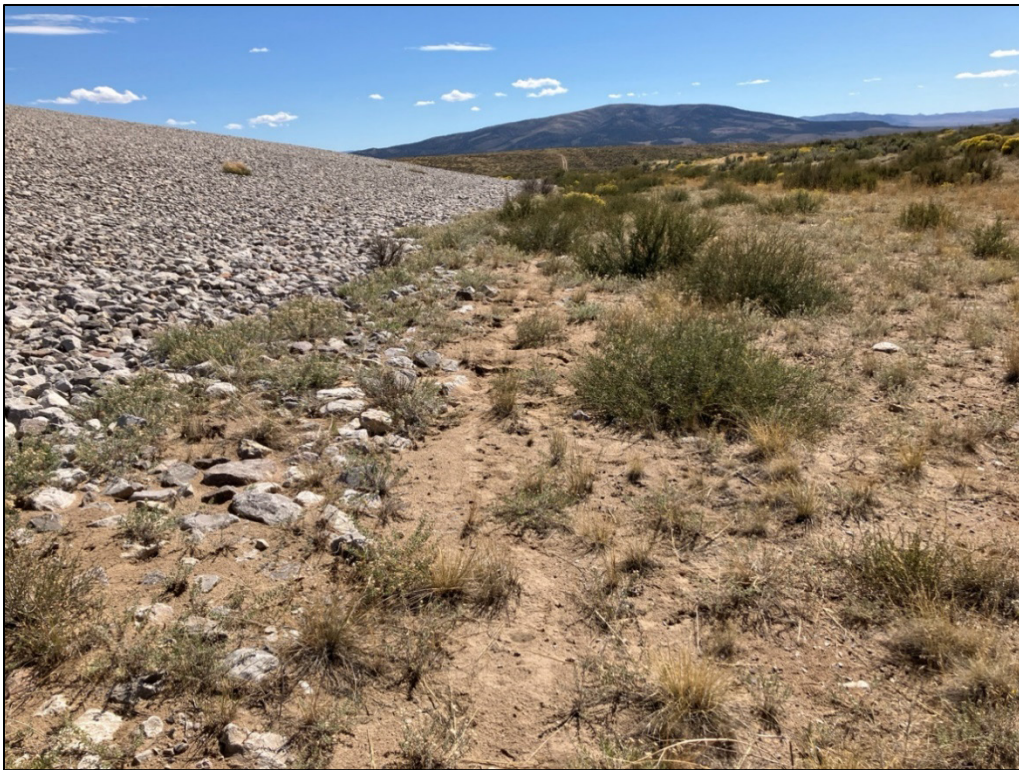
The disposal cell was designed to control surface water runoff resulting from a probable maximum flood event. The side slopes of the disposal cell were constructed with a 20% slope and are covered with a 1-foot-thick layer of riprap. Minor sediment accumulation observed at the base of the apron below the northwest side slope appears to be windblown (PL-7), and there was no evidence of side slope instability, erosion, or settlement. This area of sediment accumulation will continue to be monitored to ensure that the toe drain and side slope are functioning properly.

*PL-7. Sediment Accumulation*

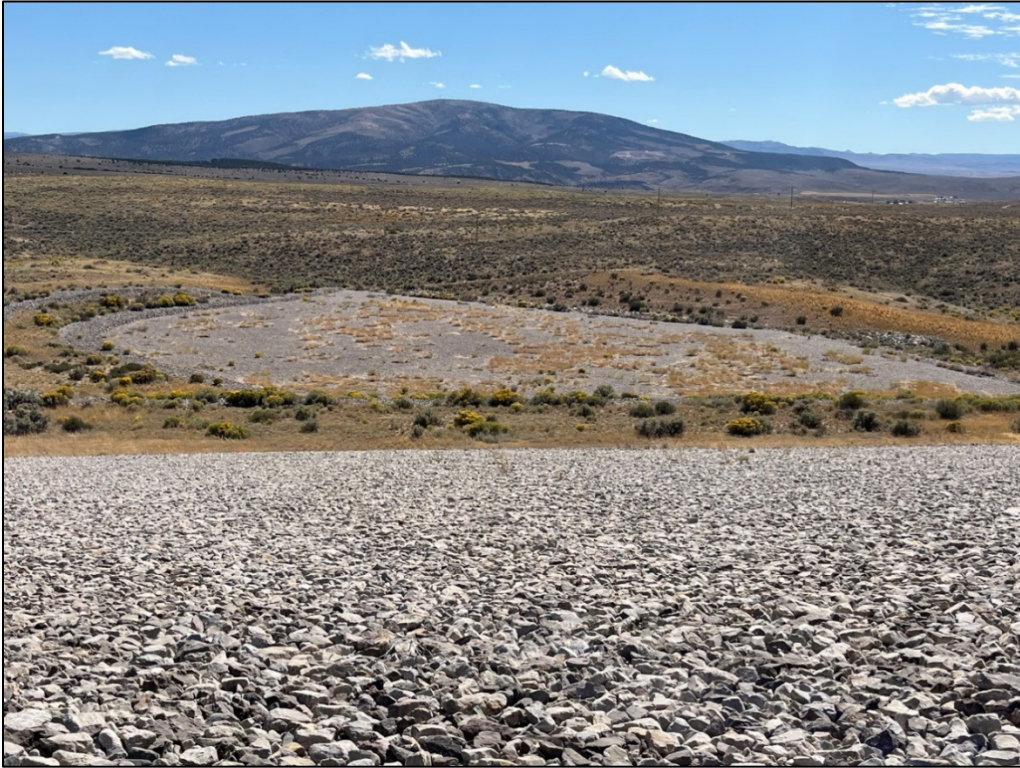
The ancillary cell (PL-8) was constructed to contain waste materials associated with the reclaimed evaporation pond area. It slopes gently toward the southwest. A rock berm wraps around its eastern and northern sides to protect it from surface water runoff. Small depressions were observed previously on the west end of the ancillary cell on the crest and toe of the side slope (PL-9). These are very likely channelized flow from the cover eroding out areas of the top to side slope transition. During the 2024 inspection, it was noted that these depressions appeared to be smaller and self-healing. None of the depressions are impacting the performance of the

cell, but they will continue to be monitored. Various species of deep-rooted vegetation are present on the top and side slopes of the ancillary cell.

*PL-8. View of Ancillary Cell from Top of Disposal Cell*

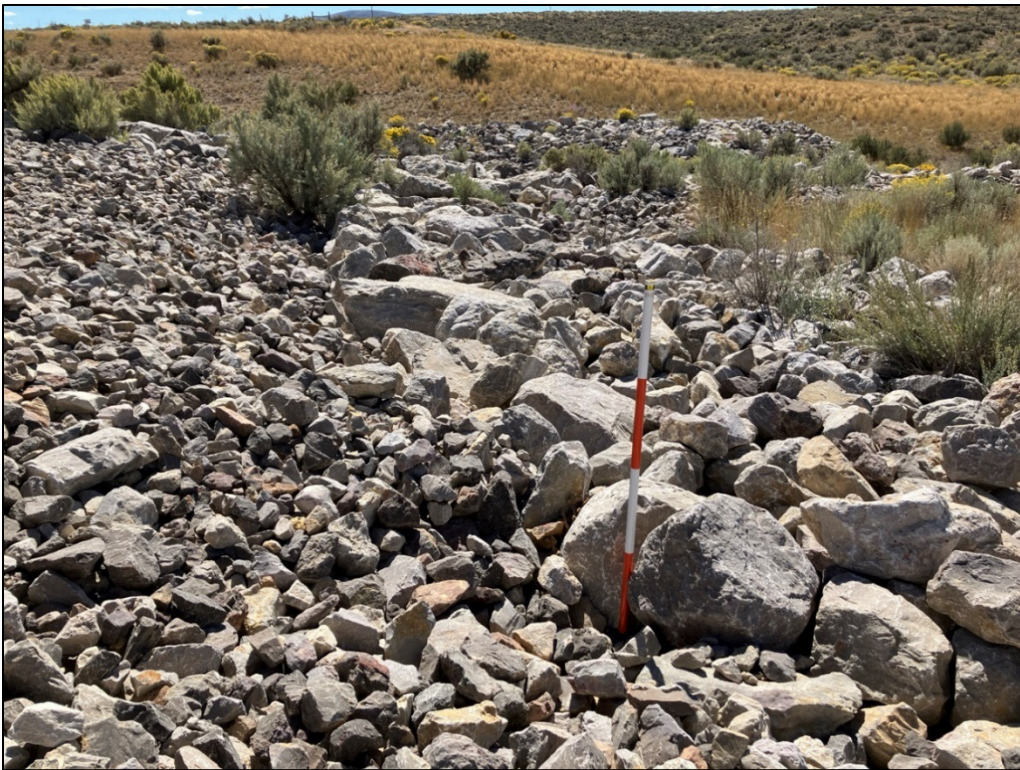
*PL-9. Depressions on Ancillary Cell*

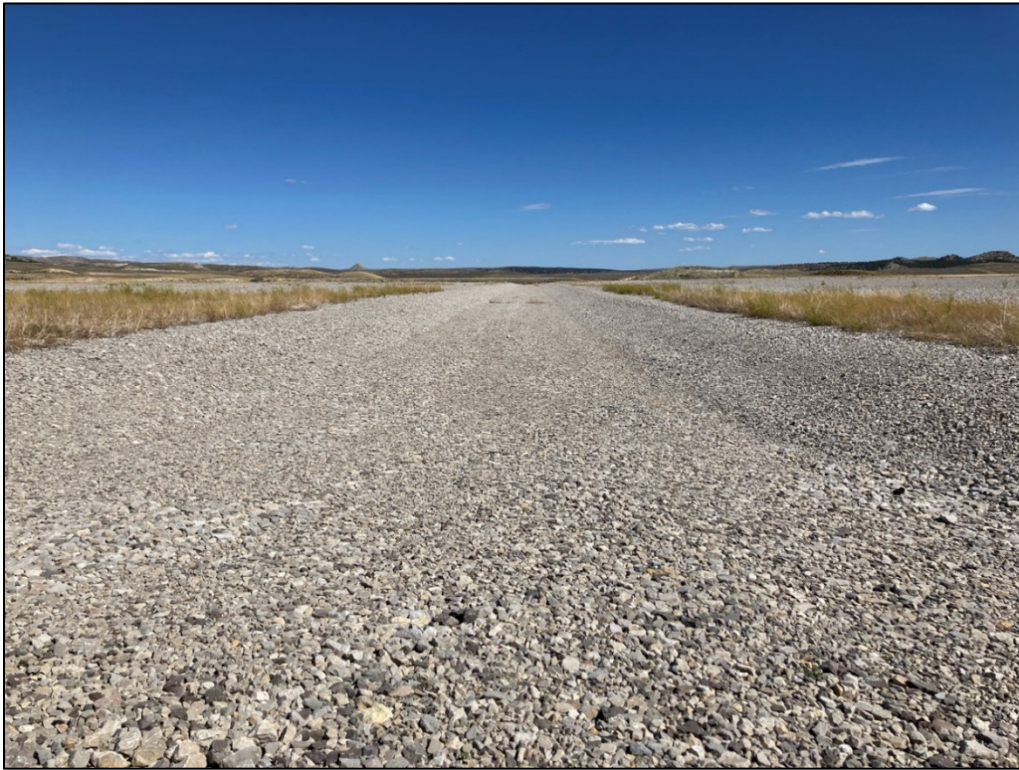
Final surface conditions at the site include a combination of rock armoring and contouring to achieve the surface water drainage control and erosion protection necessary to satisfy the design longevity requirements. The top slope of the disposal cell was designed to drain surface water runoff to the center and into riprap-armored Diversion Channel No. 1 (PL-10), which is graded toward and then down the east side slope of the disposal cell. Surface water runoff ultimately discharges into Rob Pit east of the site. An erosion protection structure, referred to as the Launch Rock Erosion Protection Basin, was constructed at the outfall of Diversion Channel No. 1 to protect the disposal cell from headcutting that may occur from the deep channel that runs into Rob Pit. Diversion Channel No. 2 runs along the south side of the ancillary cell to convey surface water runoff away from the ancillary cell. The diversion channels and outlet channel of the Launch Rock Erosion Protection Basin continue to function as designed.

*PL-10. Diversion Channel No. 1*

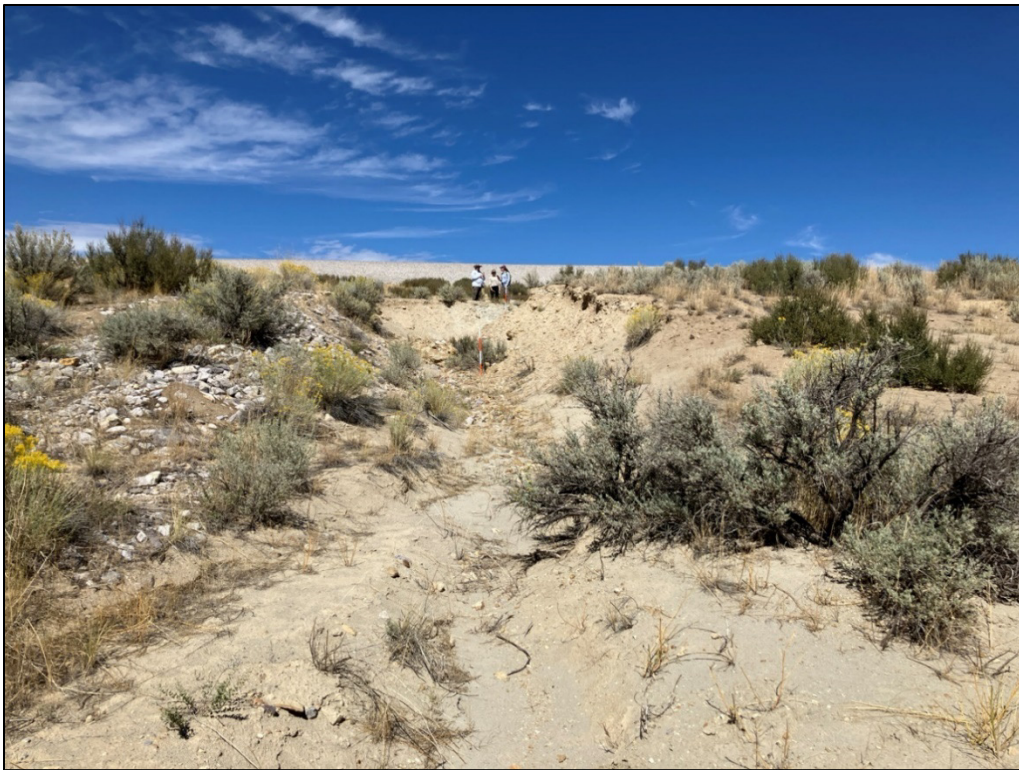
The rock berm that runs along the northern edge of the ancillary cell continues west across the slope south of the disposal cell to protect the disposal cell against erosion and headcutting. Several gullies (PL-11) and rills have developed on this south slope but do not threaten the integrity of the disposal cell. The gullies will continue to be monitored and repaired as needed. No maintenance needs were identified.

*PL-11. Gully near Rock Berms*
