**2024 Inspection and Status
Report for the Boiling Nuclear
Superheater (BONUS)
Decommissioned Reactor Site,
Rincón, Puerto Rico**

September 2024

U.S. DEPARTMENT OF
ENERGY

Legacy
Management

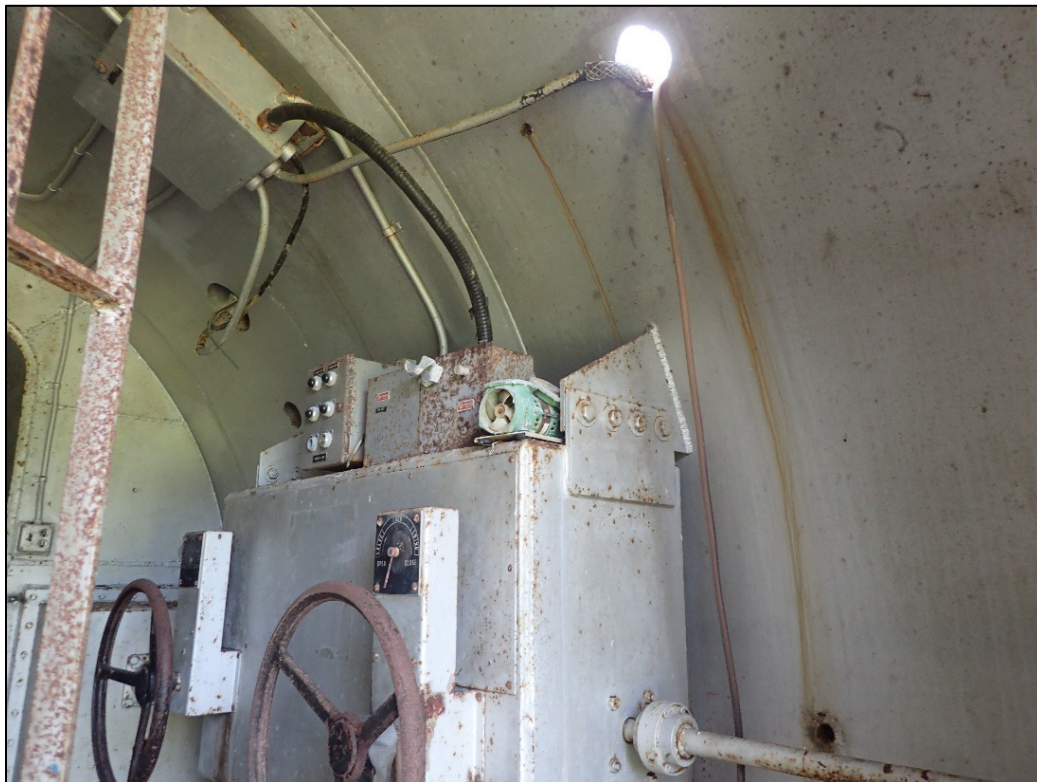
Inspectors observed that an opening in the side of Airlock 2 has what appears to be an electric cord running through it. This opening should be closed to protect the interior of the containment dome (PL-1).

PL-1. Opening to Outside in Airlock 2

- A few small areas of the dome should be repainted to help protect the dome from corrosion.
- Remaining hurricane damage to the perimeter fence should be repaired. PREPA should consider replacing the fence should funding become available.
- The opening in Airlock 2 should be closed.

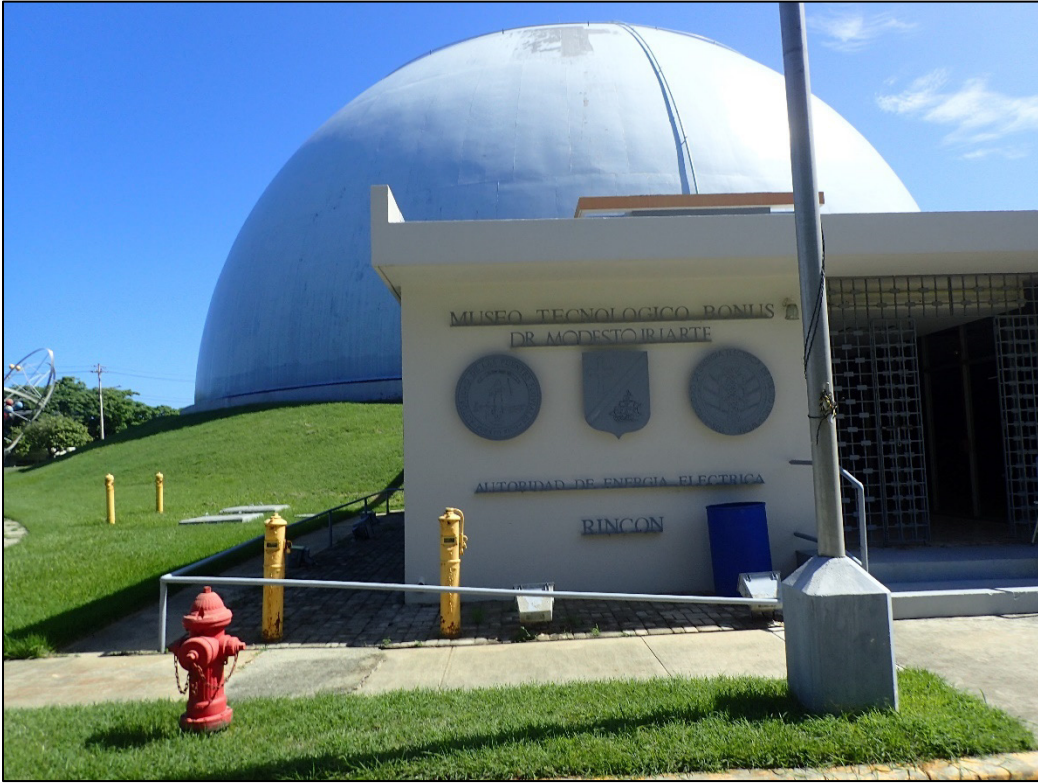
The outer surface of the dome was reconditioned and painted in 2013 (PL-2) (PL-3). Paint in a few areas of the dome was damaged during the 2017 hurricanes and needs to be repainted.

PL-2. Containment Dome

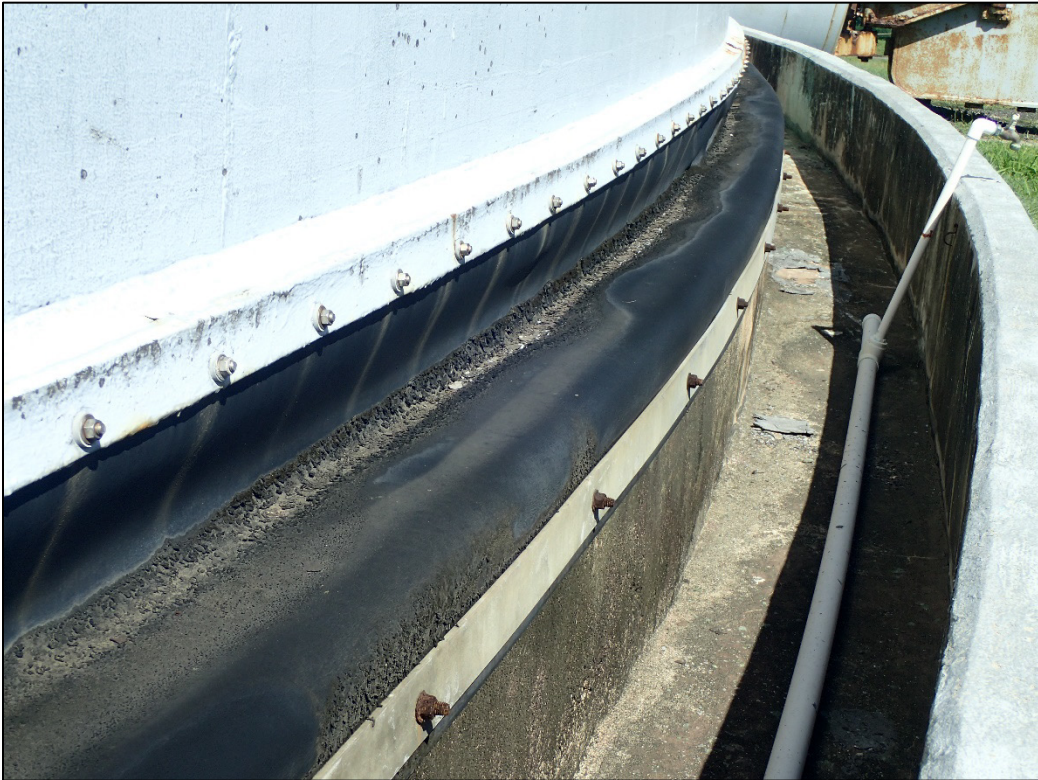
A rubber seal is installed around the base of the containment dome to keep water from seeping into the building. In 2010, the seal was observed to be cracked, ripped, and missing in some spots. Evidence of water seepage was observed in a few spots along the top of the basement wall inside the containment dome, which indicated that the seal was leaking in those areas. PREPA installed a secondary rubber seal over the damaged primary seal to carry water away from the underlying damaged seal. Water can collect on top of the seal and then evaporate (PL-3). It is believed that water collected in this way serves to weaken the integrity of the seal. Should this continue, a fix may be needed in the future to correct this situation. No evidence of recent water seepage was observed along the top of the basement wall in the containment building during this year's inspection, which indicates that the secondary seal is functioning properly.

PL-3. Seal Along Base of Dome

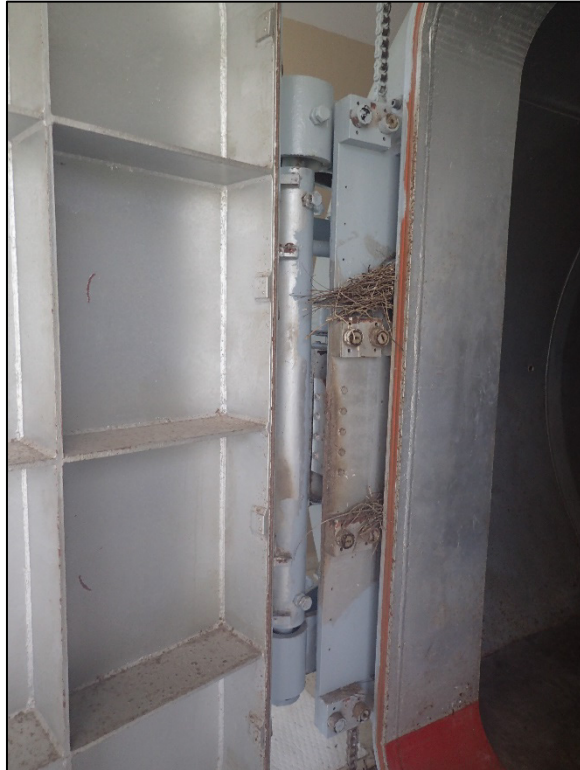
Bird nests were observed in the Airlock 1 (PL-4). It is recommended that these bird nests be removed.

PL-4. Bird Nests in Airlock 1

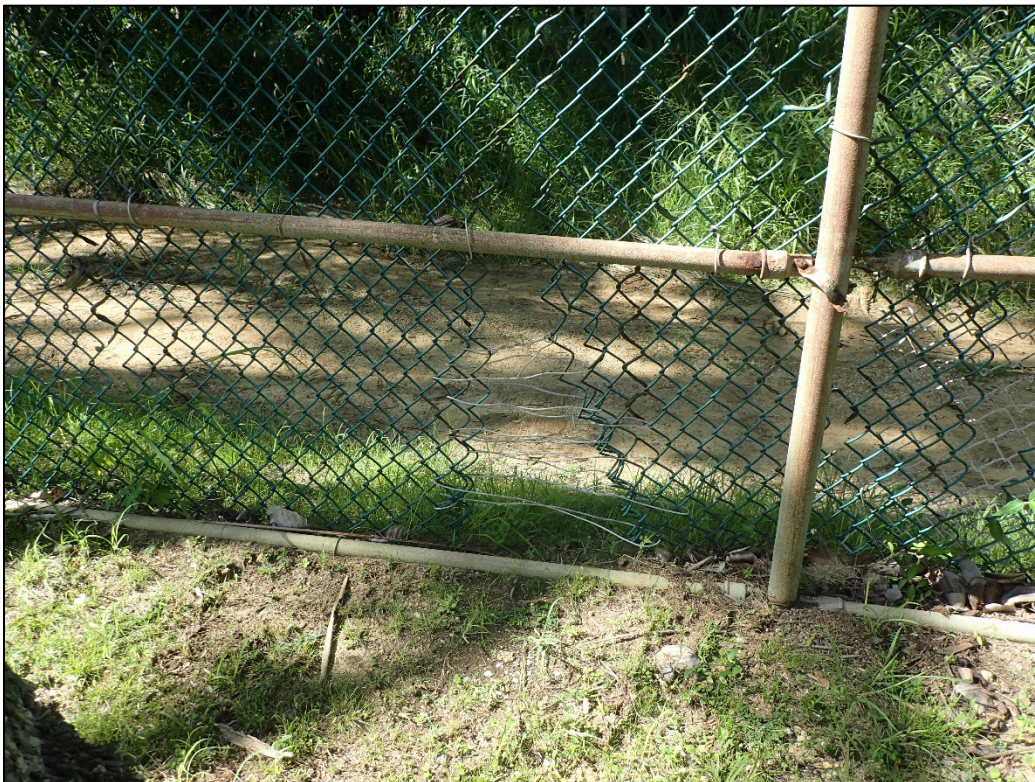
Upon arrival, the security guard was present, and the gate was closed and locked. The on-duty security guard allowed the inspection team to enter the grounds. The perimeter security fence was found to be in poor condition. The fabric of the fence had been repaired in several areas (PL-5). No openings or gaps were observed in the fence fabric. The top rail in many areas was bent or damaged. Barbed wire was missing along most of the fence (PL-6). It is recommended that the fence be further repaired if funding becomes available.

PL-5. Perimeter Fence Repair

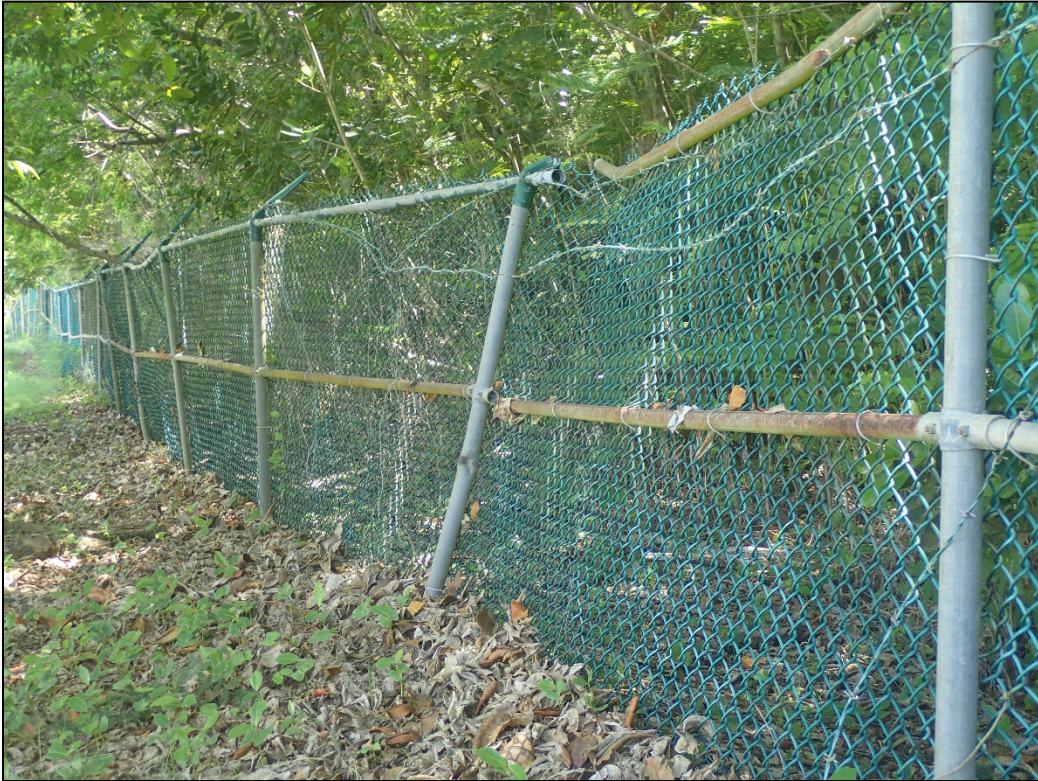
PL-6. Damaged Perimeter Fence

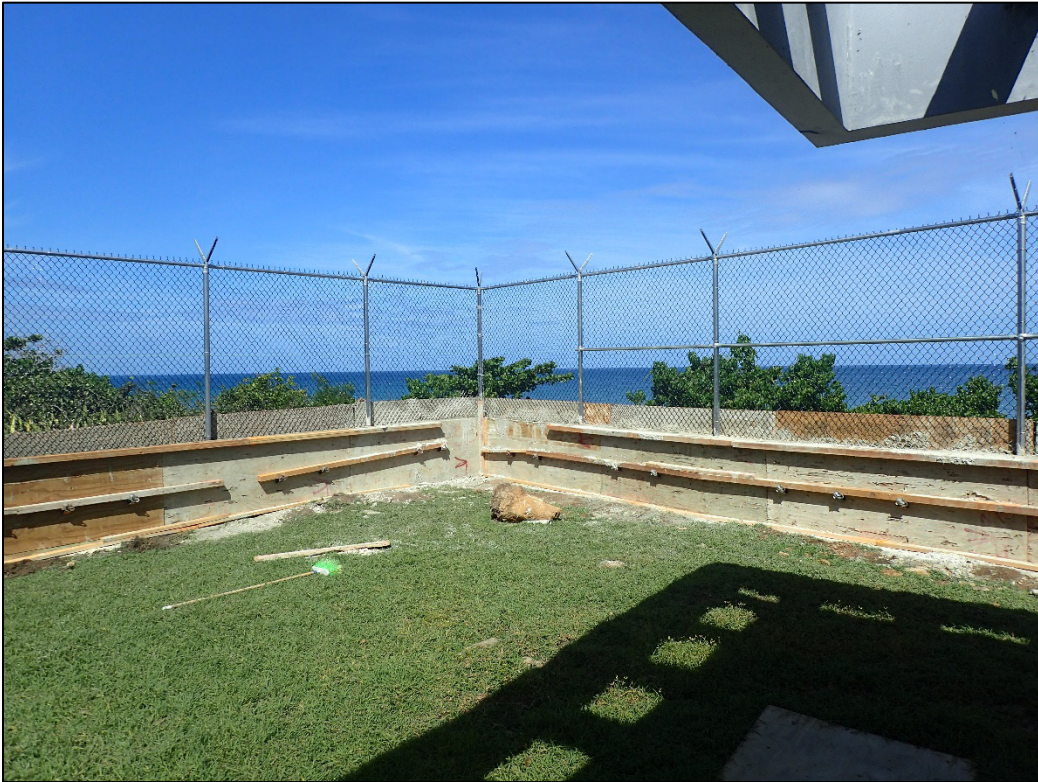
The new retaining wall with security fence atop was being installed just west of the support facilities area during the time of the inspection (PL-7 and PL-8). The new location of the wall and fence was well thought out and should serve to protect this area of the site from trespass for years to come.

PL-7. New Perimeter Wall and Fence

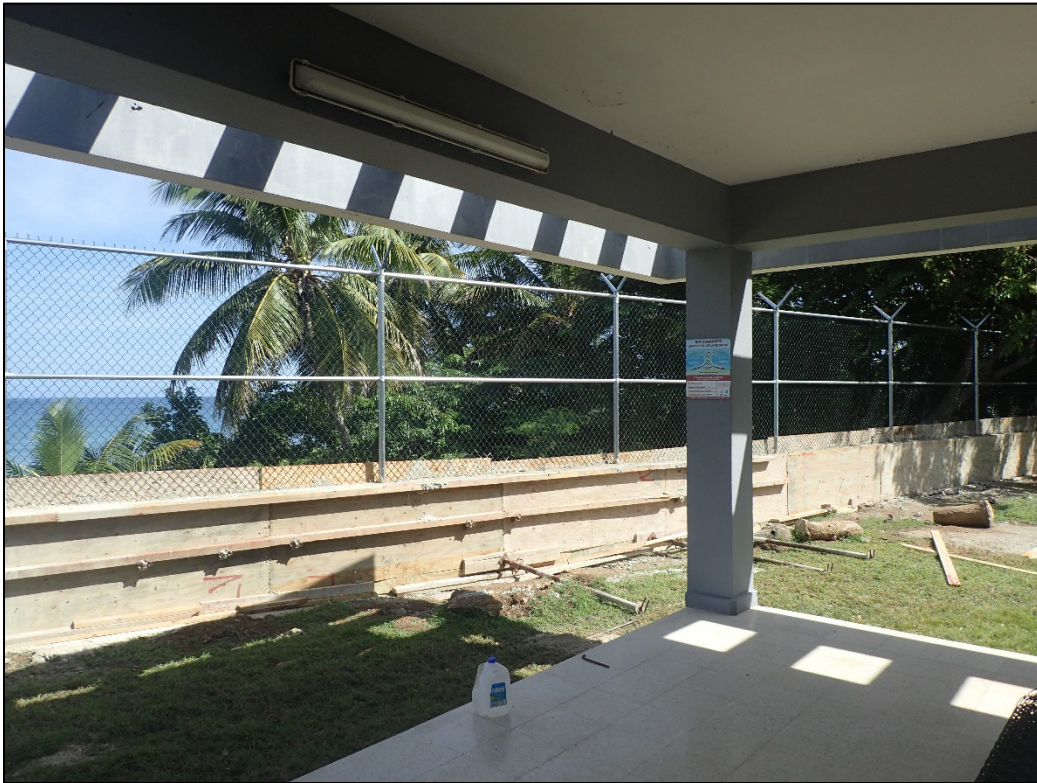
PL-8. New Perimeter Wall and Fence

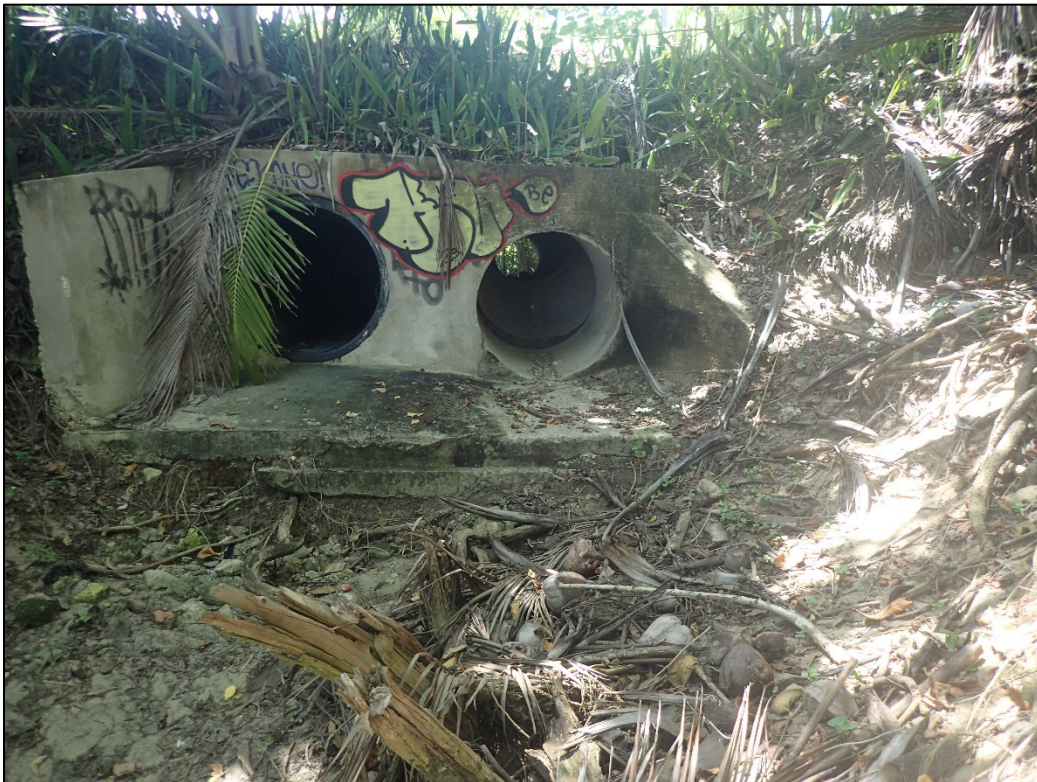
Storm drains leading from the site were found to be clear and free of debris (PL-9). The beach west of the facility is readily utilized by the public.

PL-9. Drain Culvert
