Bayo Canyon Aggregate Area, Los Alamos, New Mexico, Site Visit

August 2024

U.S. DEPARTMENT OF
ENERGY

Legacy
Management

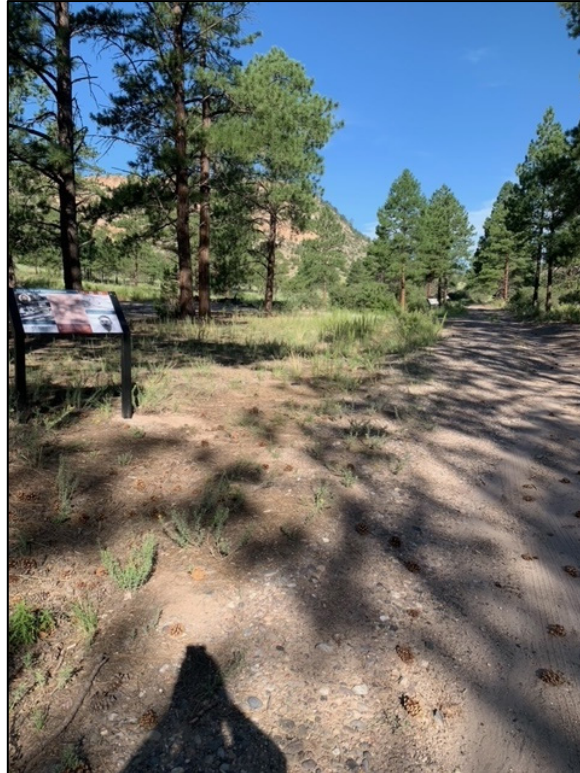
- There are numerous signs posted throughout the Bayo Canyon site, including along the road at the entrance to this dawn-to-dusk public park. Los Alamos County, as the property owner, continues to do an excellent job maintaining the hundreds of acres for public use (Photo 1).
- A new addition near the FUSRAP area were the three LM designed and fabricated interpretive signs that were installed by Los Alamos County in fall 2023. These signs, donated to Los Alamos County, convey the site history, the cleanup, and the recreation use of the Bayo Canyon site (Photo 2).

*Photo 1. View of Bayo Canyon Site
Recreation Area*

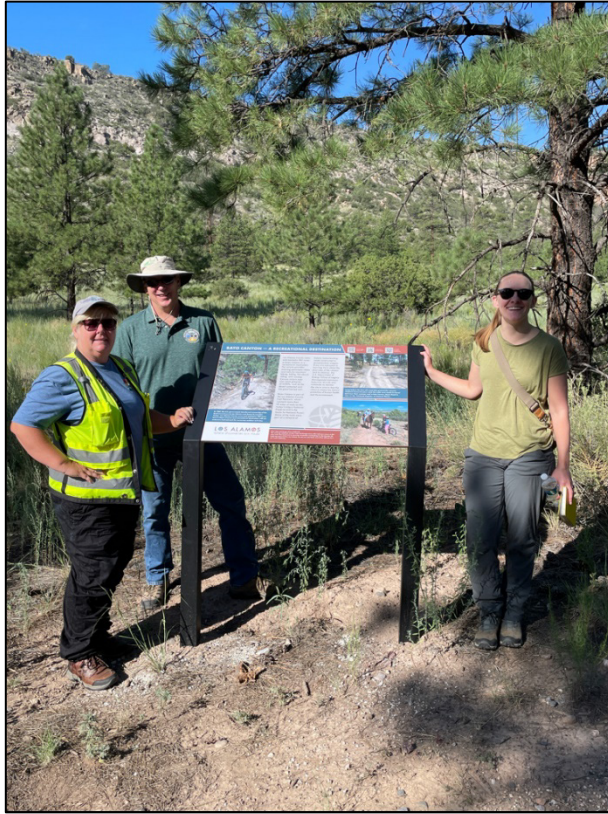
Photo 2. LM and LMS Staff Visiting the Site and Signage

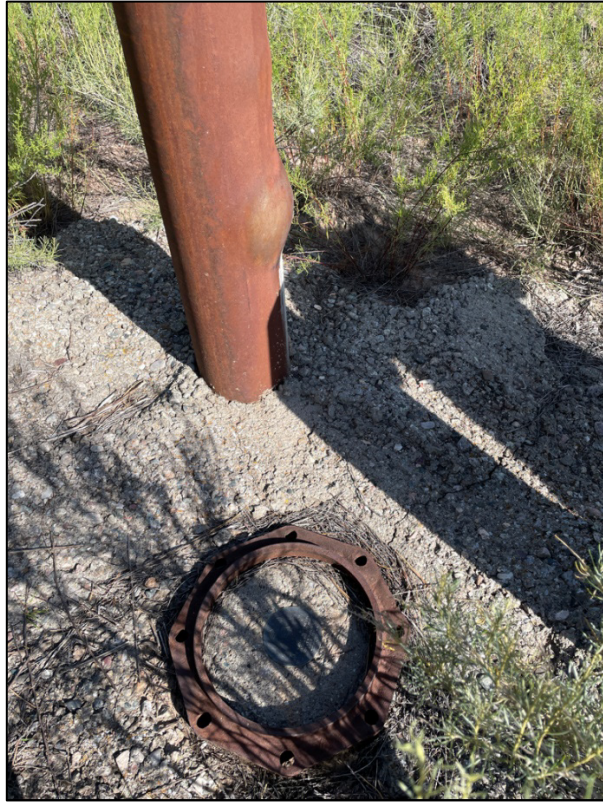
- Overall, the six sets of three bollards and six markers installed in 1982 were found to be in good condition. Two bollards were observed to have bulges on one side but remain intact and protective (Photo 3). However, site marker 1/monument A was missing by assumed theft (Photo 4 and Photo 5). LM will continue to monitor the stability of the bollards, and replacement of the missing marker will be planned as a Bayo Canyon FUSRAP site activities in fiscal year 2025. No maintenance action is required at this time.

Photo 3. Example of Bollard Bulge

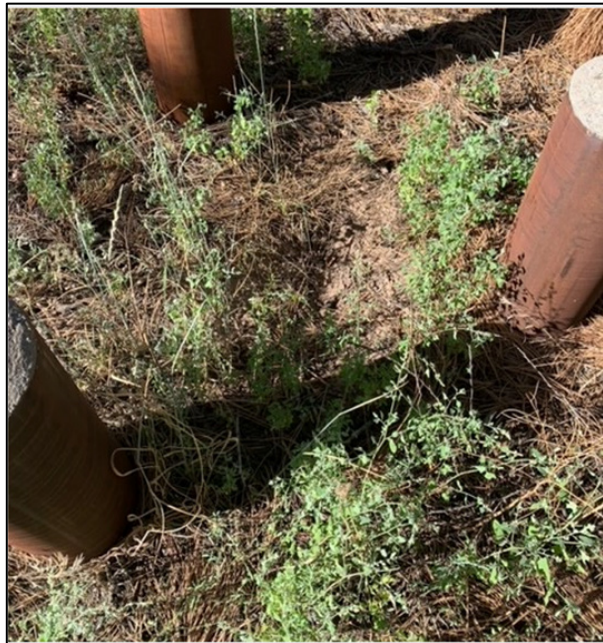
*Photo 4. Location of Missing Site Marker #1/Monument A
(Center of Bollards)*

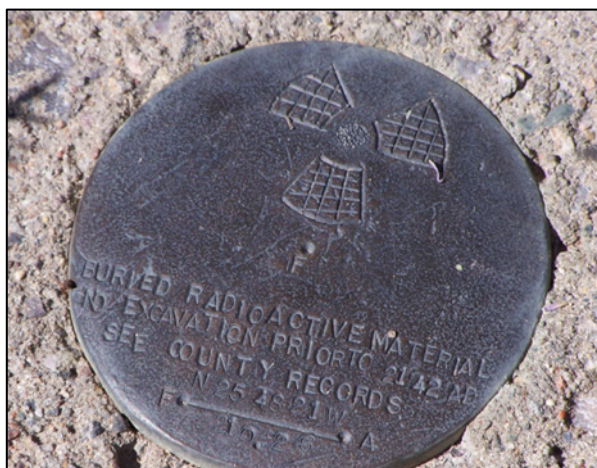
Photo 5. Example of Missing Site Marker
