SUBJECT: Transmittal of the June 2014 Fernald Site Inspection Forms

Fernald Preserve Field Walkdown Inspection Report

Fernald Preserve

Site Inspection Findings

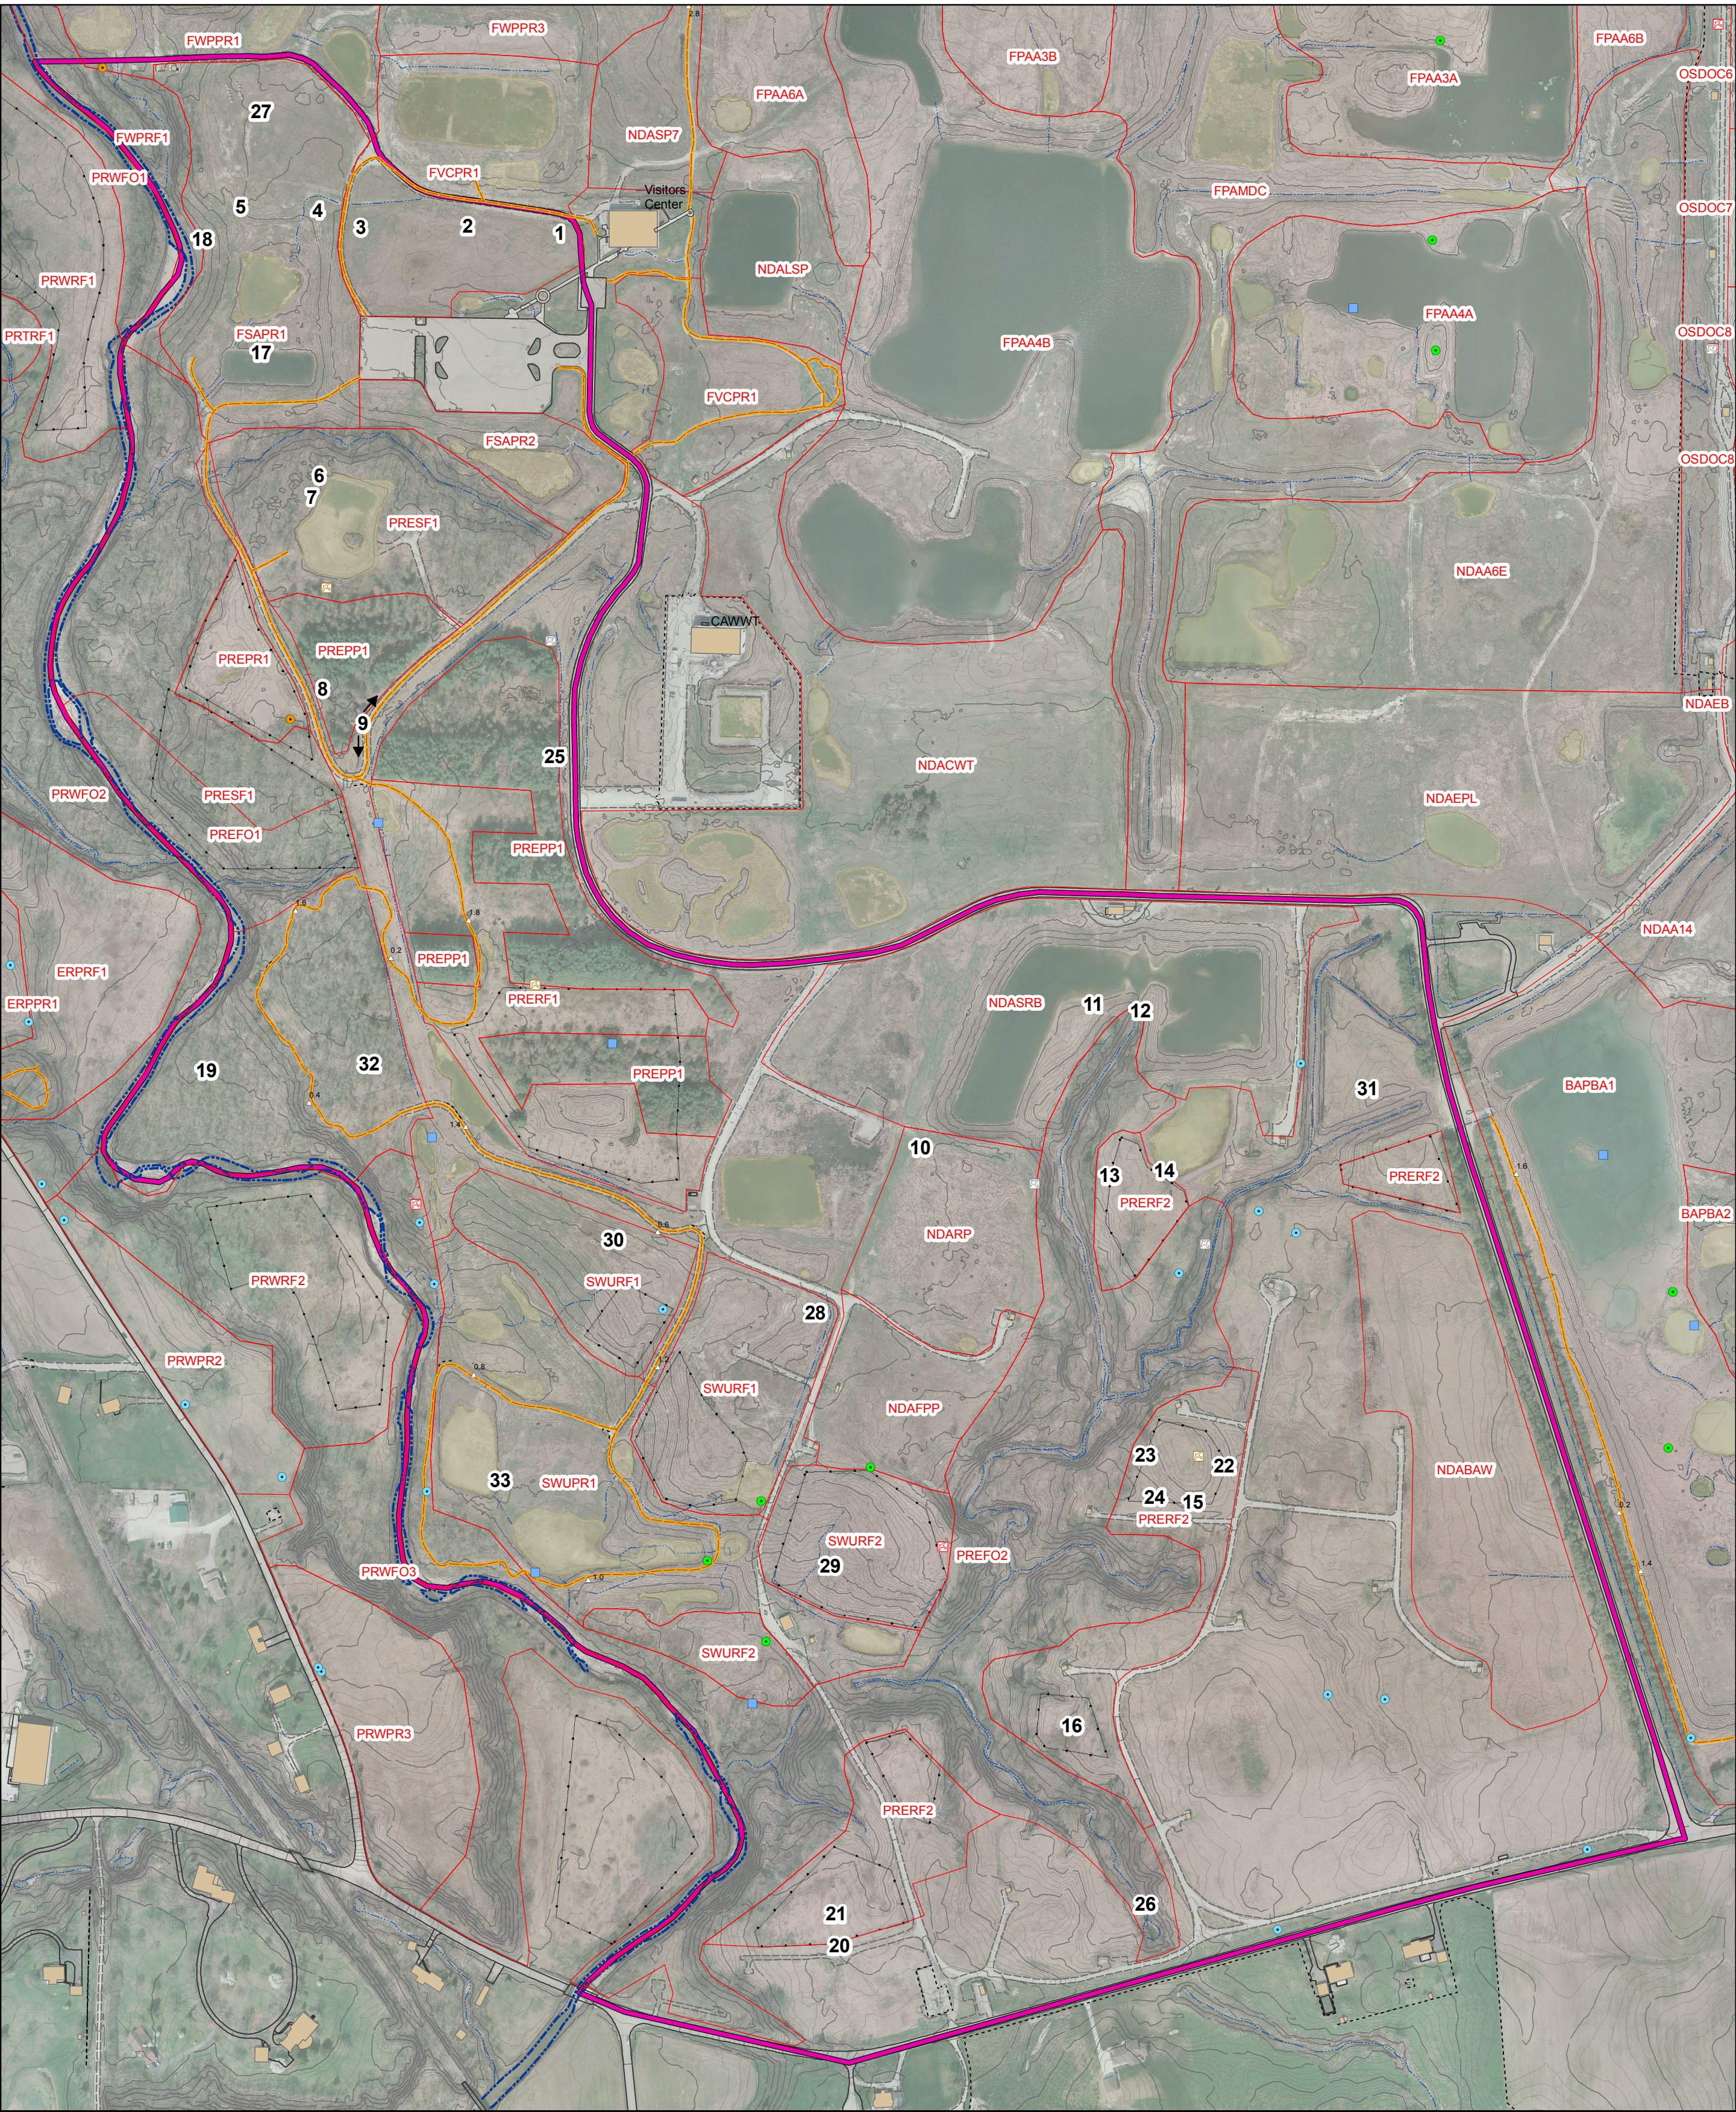
Map No.	Location	GPS?	Type of Finding	Description	Photo? (File No.)
1	Former compost area	No	Vegetation	Area needs re-seeded	
2	Southwest of bio-wetland	No	Debris	asphalt	
3	South of drainage ditch	No	Vegetation	Crown vetch	
4	Near road and along drainage	No	Vegetation	Crown vetch	
5	Ridge top	No	Vegetation	Thistle and crown vetch	
6	North of "Ant Island" basin	No	Fencing	Remove deer cages as needed	
7	NW of "Ant Island" basin	No	Vegetation	Phragmites	
8	Edge of trail	No	Vegetation	reed canary grass	
9	Edge of trail	No	Vegetation	reed canary grass	
10	SW of storm water retention basin	No	Vegetation	reed canary grass	
11	Bank of storm water retention basin	No	Vegetation	canada thistle	
12	At outlet to storm sewer outfall ditch	No	Vegetation	reed canary grass	
13	West fence	No	Fencing	Hole in deer fence (2)	
14	North fence	No	Fencing	Hole in fence

Map No.	Location	GPS?	Type of Finding	Description	Photo? (File No.)
15	SE fence	No	Fencing	Hole in fence	
16	Southern deer fence	No	Fencing	Fence needs to be removed	
17	Between ponds	No	Vegetation	Individual musk thistle	
18	North	No	Vegetation	Individual musk thistle and teasel	
19	West of Sycamore trail next to Paddys Run	No	Fencing	Old cages	
20	West deer fence	No	Fencing	Gate down	
21	Inside deer fence	No	Vegetation	Teasel	
22	Between wells	No	Fencing	Fencing sliding down poles	
23	Behind deer fence	No	Fencing	Old cages	
24	South edge	No	Fencing	Sliding down poles	
25	West of 'speed limit 15' sign	No	Vegetation	teasel	
26	Under power lines in ravine	No	Vegetation	Nodding thistle (musk thistle)	
27	West of Visitors Center, north of silo ponds	No	Vegetation	Crown vetch	
28	Deer fence north of 'dance hall'	No	Vegetation	teasel	
29	South of gravel road	No	Vegetation	teasel	
30	SWU slope	No	Vegetation	teasel

31	Field across from Comm building and Lodge Pond	No	Vegetation	teasel

Map No.	Location	GPS?	Type of Finding	Description	Photo? (File No.)
32		No	Debris	aluminum well cap	
33	East slope of basin	No	Debris	sheet metal roofing
