1.0 Ambrosia Lake, New Mexico, Disposal Site

1.1 Compliance Summary

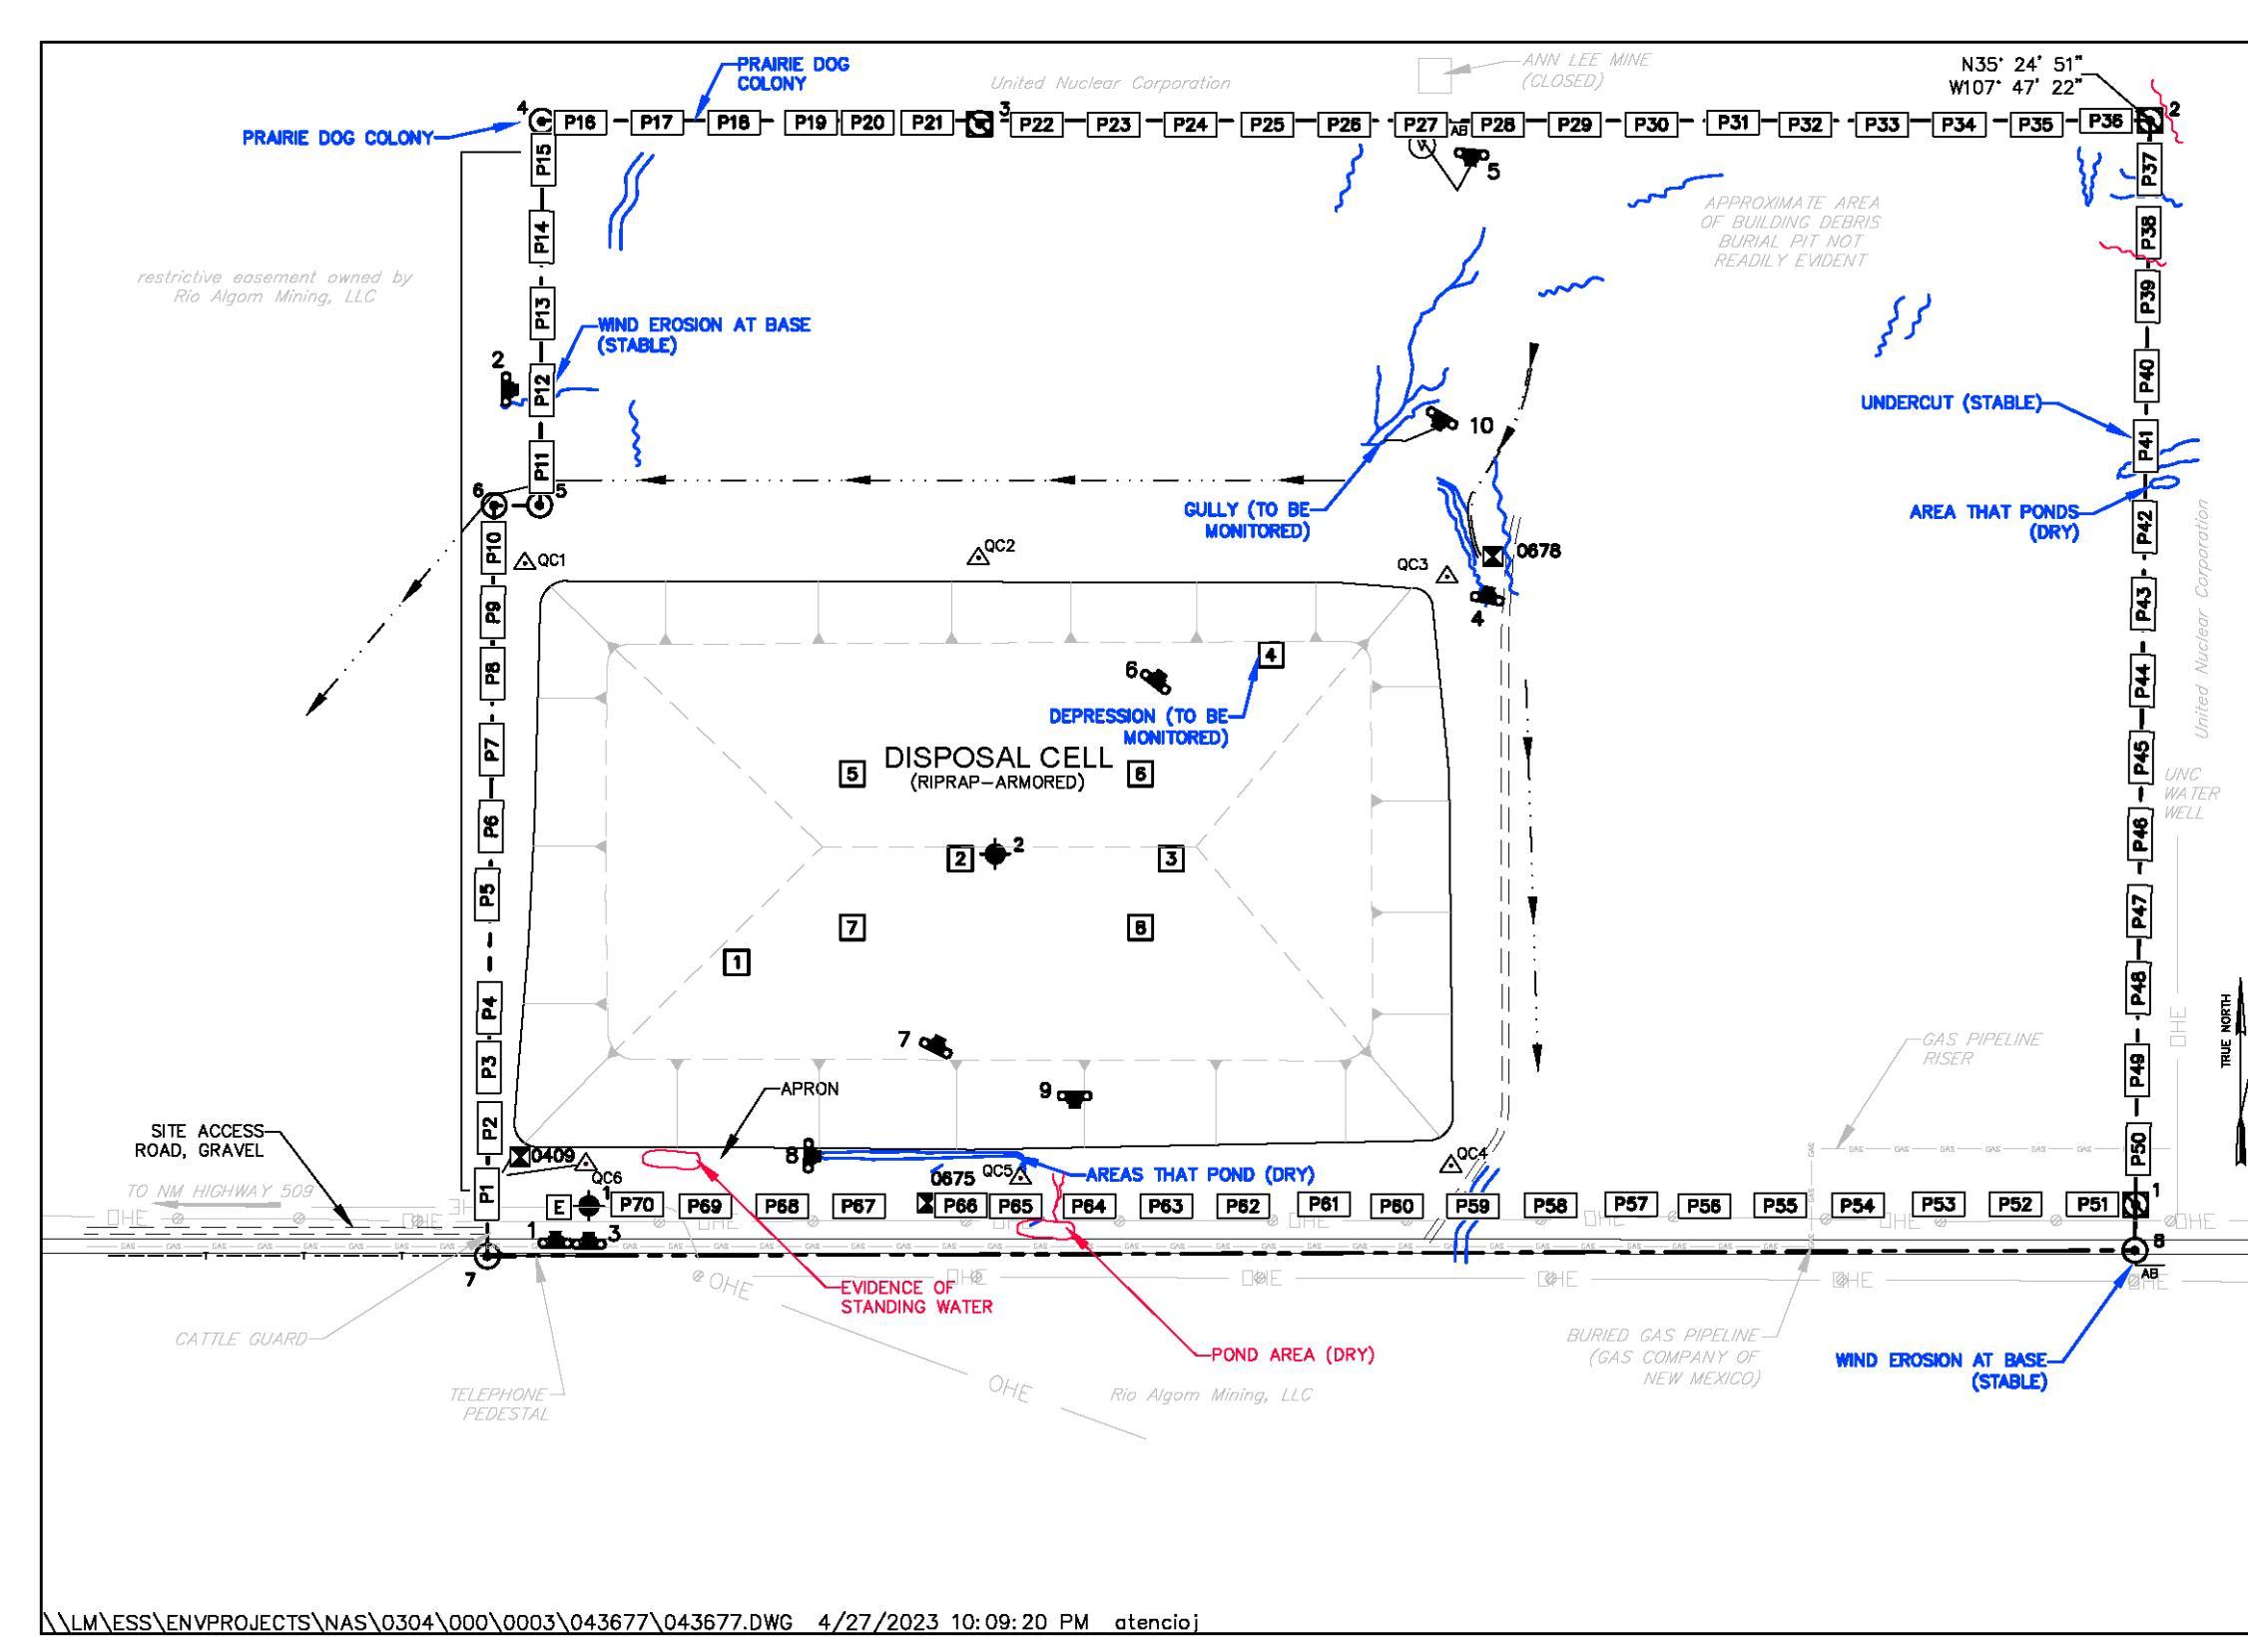
Figure 1-1. 2023 Annual Inspection Drawing for the Ambrosia Lake, New Mexico, Disposal Site

Figure 1-1 shows the locations of site features, including site surveillance features and inspection areas, in black and gray font. Some site features that are present but not required to be inspected are shown in italic font. Observations from previous inspections that are currently monitored are shown in blue, and new observations identified during the 2023 annual inspection are shown in red. Inspection results and recommended maintenance activities associated with site surveillance features are described in the following subsections. Photographs to support specific observations are noted in the text and in Figure 1-1 by photograph location (PL) numbers. The photographs and photograph log are presented in Section 1.10.

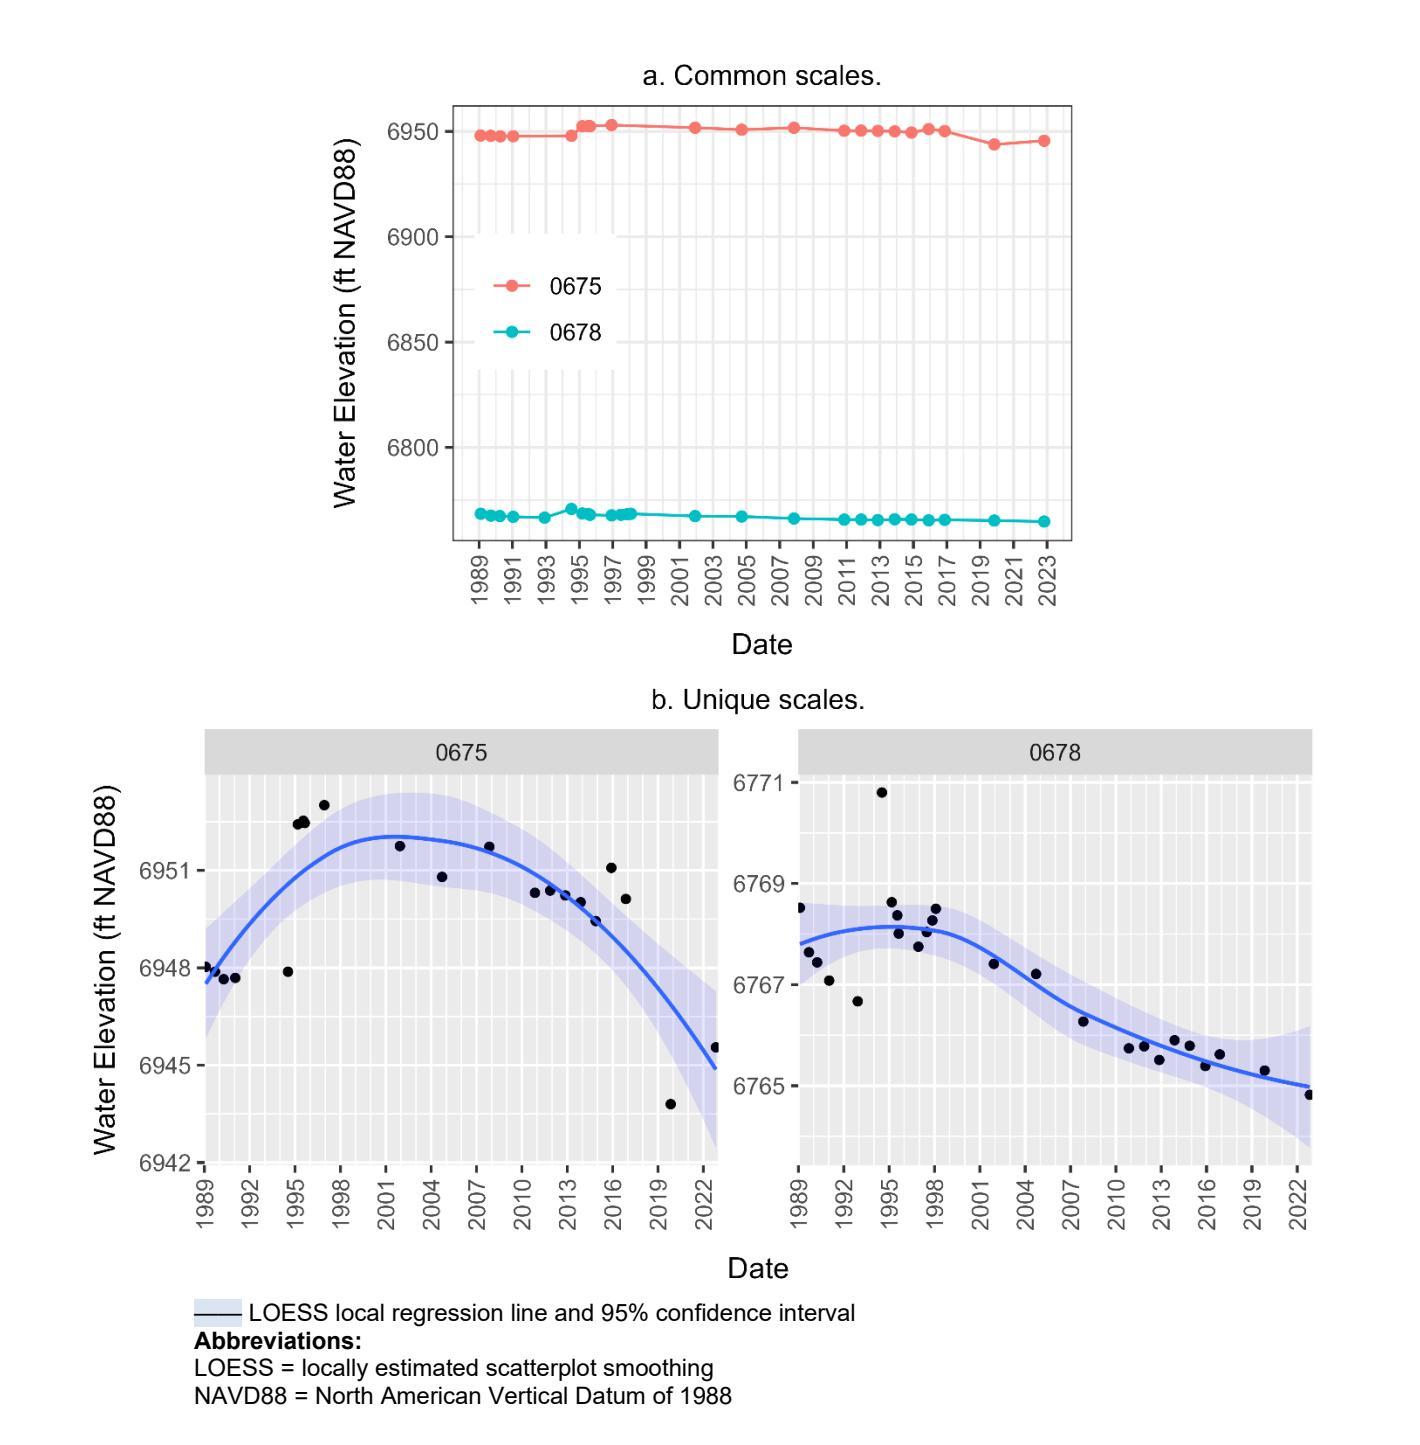
Figure 1-3. Groundwater Elevation Trends in Ambrosia Lake, New Mexico, Disposal Site Monitoring Wells

For groundwater elevations, well 0409 has been dry at the time of every sampling event since being installed in 2011. Water-level elevations in well 0675 have fluctuated between 6943.8 and 6953.0 ft since the well was installed in 1989; the lowest water elevations were measured in 2019 and 2022 (Figure 1-3). Over the same duration, water-level elevations in well 0678 have fluctuated between 6764.8 and 6770.8 ft. The vertical hydraulic gradient between the two wells is strongly downward and averages 0.86 ft/ft suggesting that unsaturated conditions potentially exist between the two well screens.

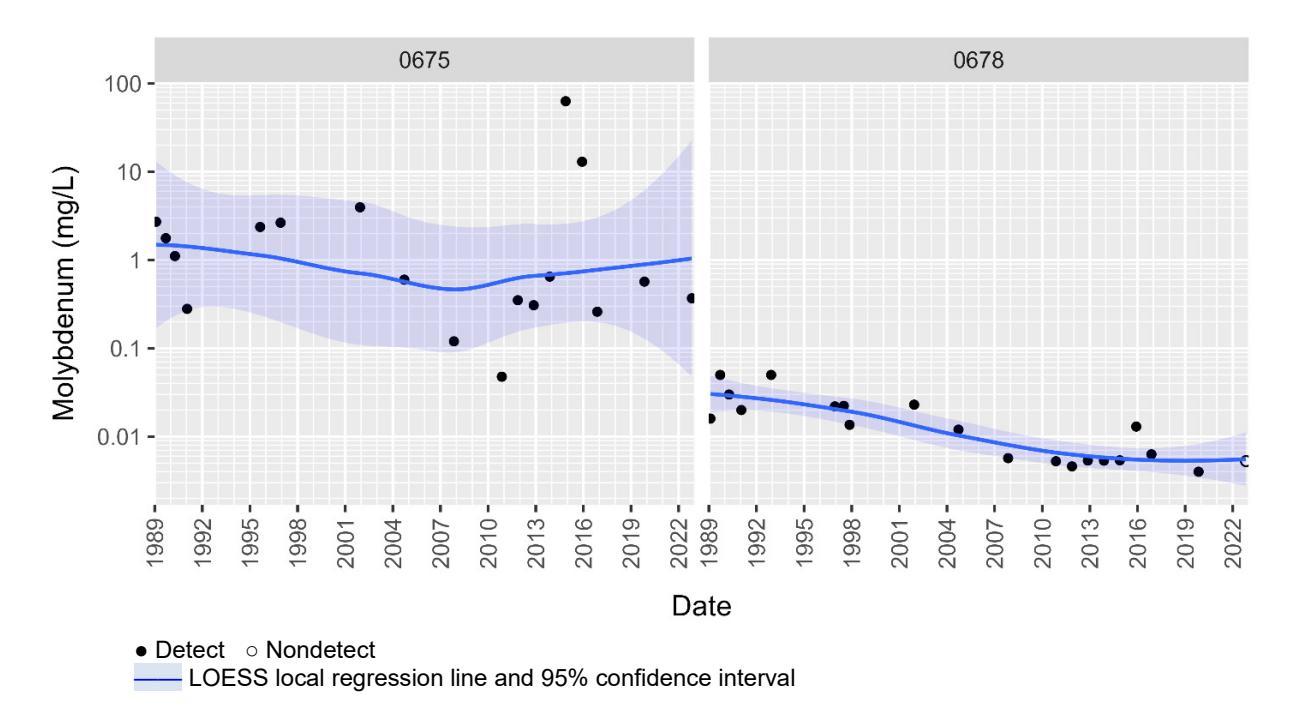
Figure 1-4. Molybdenum Concentrations in Groundwater at the Ambrosia Lake, New Mexico, Disposal Site

Molybdenum concentrations in well 0675, screened in the weathered Mancos Shale, have fluctuated widely at times, ranging from 0.004 milligram per liter (mg/L) to 63.0 mg/L from 1989 to 2023 and averaging about 5 mg/L (Figure 1-4). The highest concentrations were measured in 2014 and 2015 (63.0 and 13.0 mg/L, respectively), but levels have since declined (the most recent result was 0.37 mg/L). Well 0678, screened in the Tres Hermanos B Sandstone unit of the Mancos Shale at an elevation approximately 200 ft deeper than well 0675, historically has had molybdenum concentrations below 0.1 mg/L. The most recent result was below the detection limit (<0.0053 mg/L) (Figure 1-4).

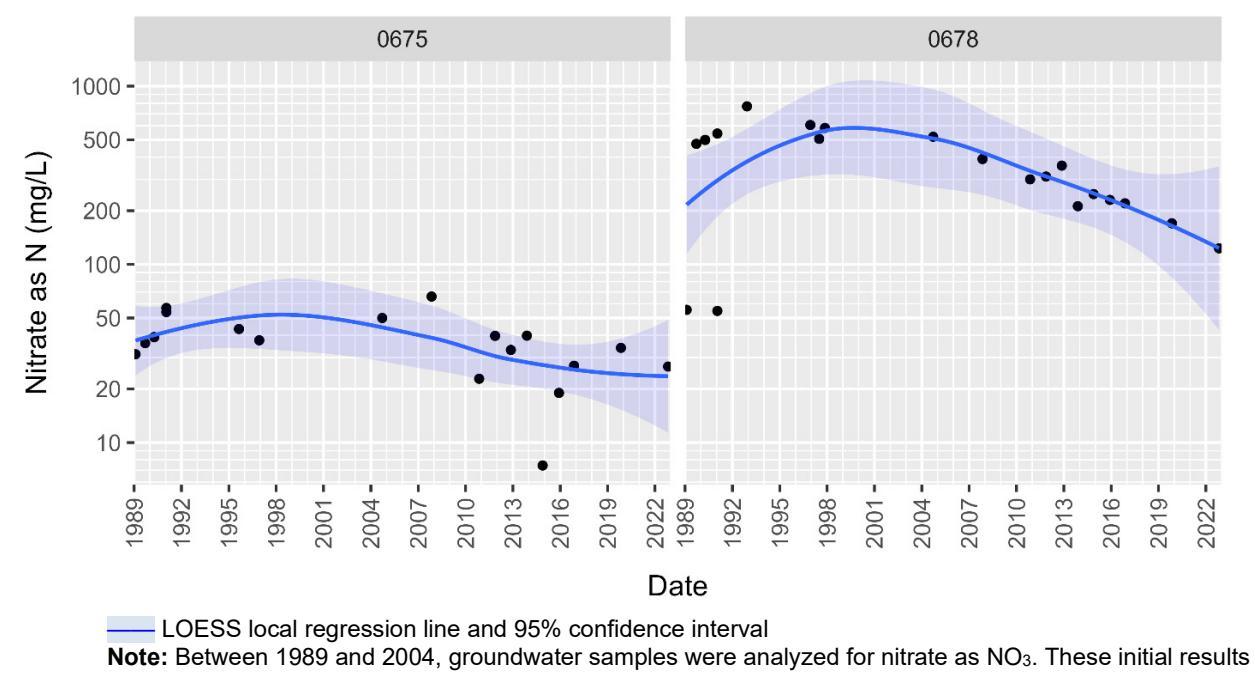
Figure 1-5. Nitrate as N Concentrations in Groundwater at the Ambrosia Lake, New Mexico, Disposal Site

Nitrate as nitrogen (N) concentrations in well 0675 have historically remained below 70 mg/L (Figure 1-5). Nitrate (as N) concentrations in the deeper well (0678) reached a maximum concentration of 770.3 mg/L in 1992 and have steadily decreased to a present-day concentration of 123.0 mg/L (Figure 1-5).

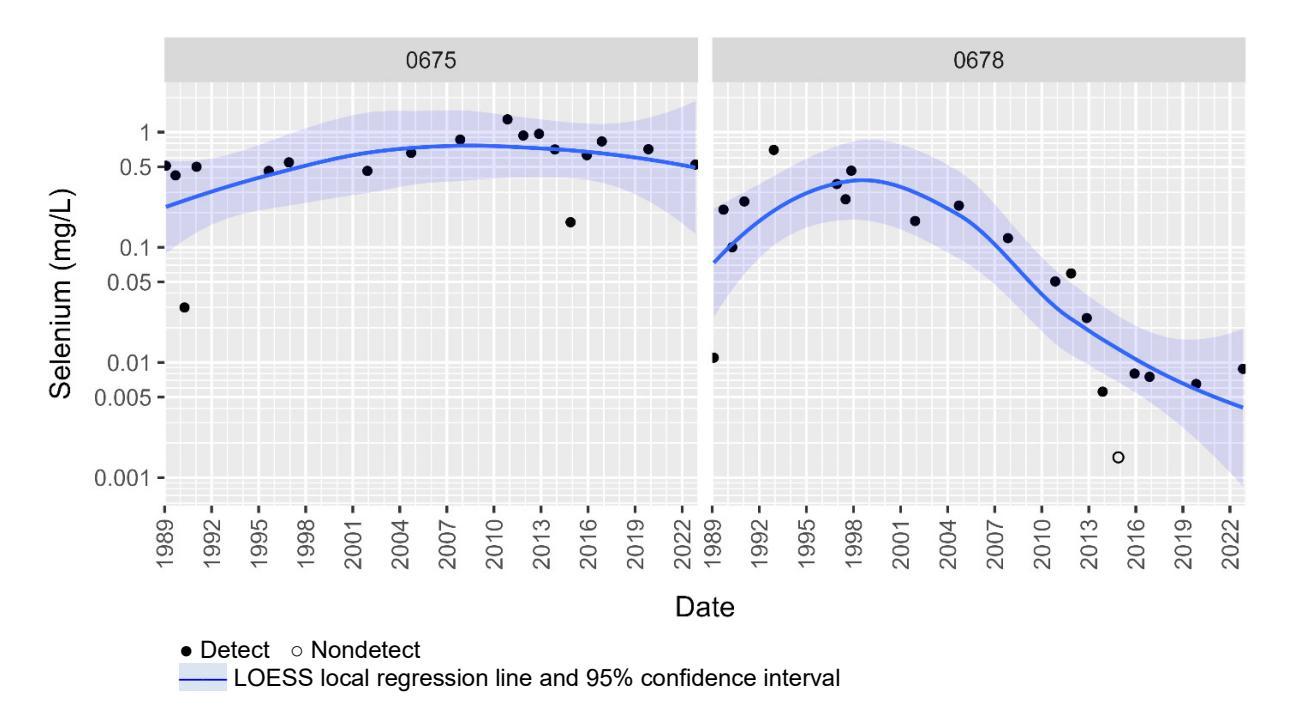
Figure 1-6. Selenium Concentrations in Groundwater at the Ambrosia Lake, New Mexico, Disposal Site

Well 0675 had an initial selenium concentration of 0.51 mg/L. Concentrations trended upwards and peaked in 2010 at 1.29 mg/L and then declined to 0.17 mg/L in 2014. The most recent result, 0.52 mg/L, is essentially equivalent to the initial (1989) concentration. Selenium concentrations in the deeper well (0678) reached a peak concentration of 0.7 mg/L in 1992 and have declined to present-day concentrations of less than 0.01 mg/L (Figure 1-6).

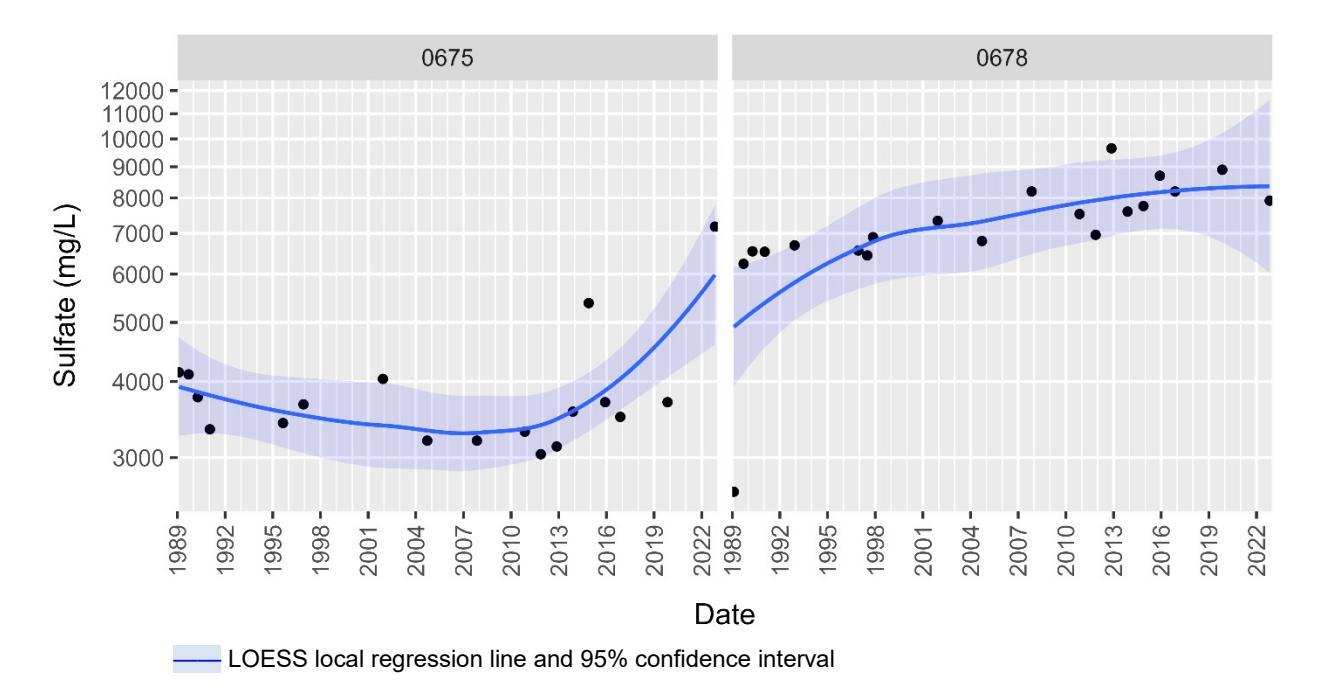
Figure 1-7. Sulfate Concentrations in Groundwater at the Ambrosia Lake, New Mexico, Disposal Site

Historically, sulfate concentrations in well 0675 have generally ranged between 3000 and at or just above 4000 mg/L (Figure 1-7). There are two exceptions: the 2014 measurement (5380 mg/L) and the most recent (2022) result of 7180 mg/L, the maximum sulfate concentration measured in that well. The deeper well (0678) had an initial sulfate concentration of 2638 mg/L; this early measurement is an outlier relative to subsequent results that have exceeded 6000 mg/L. Since September 1989 (6240 mg/L), sulfate concentrations gradually increased to levels between 7000 and 10,000 mg/L (Figure 1-7). The most recent result was 7920 mg/L.

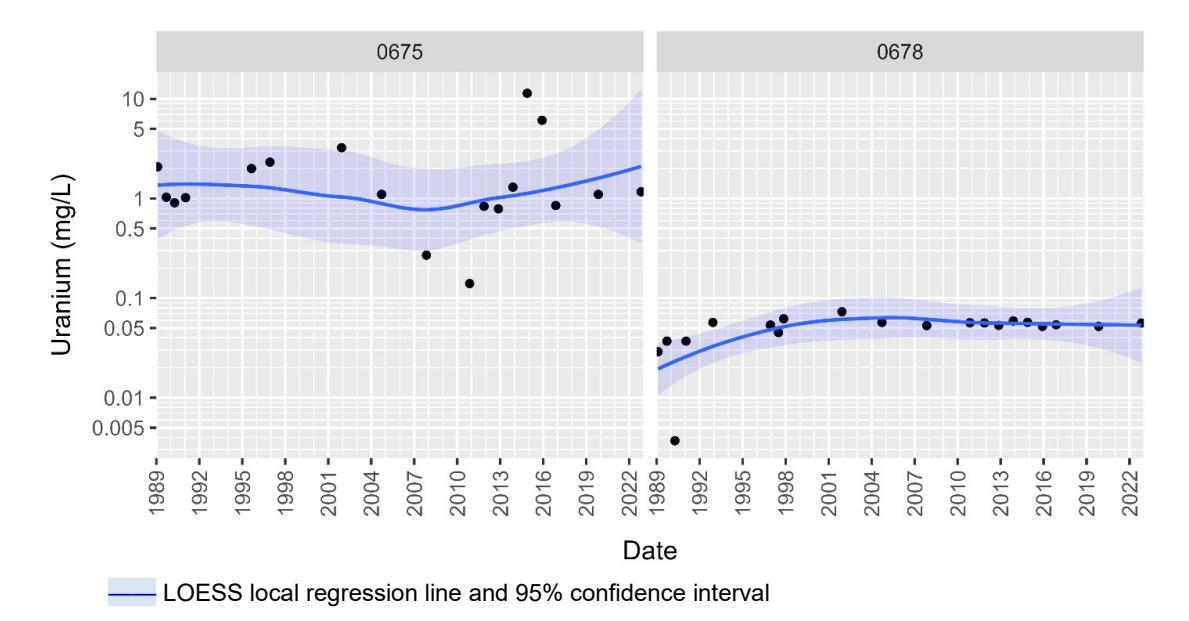
Figure 1-8. Uranium Concentrations in Groundwater at the Ambrosia Lake, New Mexico, Disposal Site

Uranium concentrations in well 0675 ranged from 0.91 to 3.24 mg/L from 1989–2001 and then declined to a low of 0.14 mg/L in 2010 (Figure 1-8). Concentrations then increased to a high of 11.4 mg/L in 2014 and have declined to a present-day concentration of 1.17 mg/L. Uranium concentrations in the deeper well (0678) have historically remained below 0.1 mg/L (Figure 1-8).

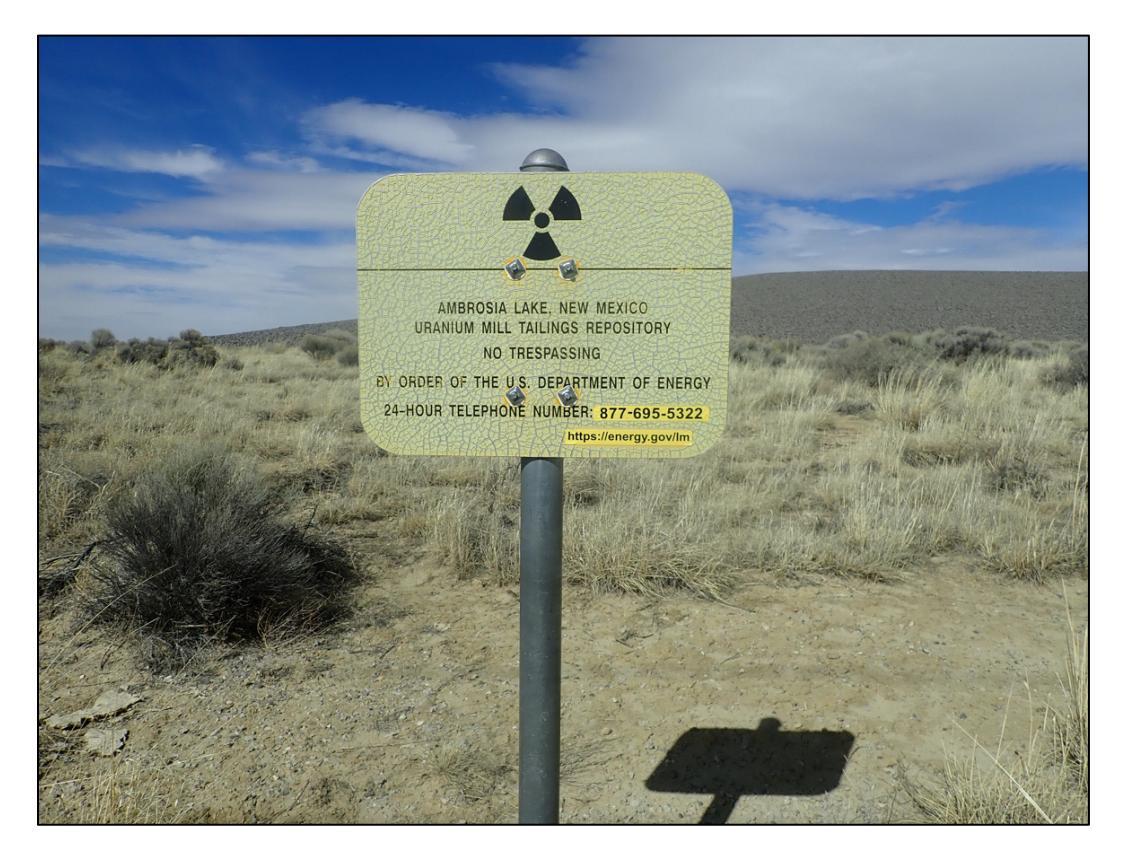
There are 70 perimeter signs, attached to steel posts set in concrete, positioned along the unfenced property boundary. Posts for perimeter signs P1 through P15 include additional warning signs about mining restrictions. Many of the perimeter signs were cracked and weathered but remain legible. Erosional gullies have formed around the base of perimeter signs P12 (PL-2), P38, and P41, but all perimeter signs are stable. Prairie dog colonies were identified near perimeter signs P17 and P18 during the 2021 inspection and observed again in 2022 and 2023. The colony does not threaten the integrity of either of the perimeter signs, therefore, no additional action is needed. No maintenance needs were identified.

The site has three monitoring wells. A gully adjacent to well 0678 appears to be stable, and the well is not affected by the erosion (PL-4). All wellhead protectors observed during the inspection were undamaged, locked, and properly labeled. No maintenance needs were identified.

The disposal cell, completed in 1994, occupies 91 acres and is armored with basalt riprap to control erosion and deter animal and human intrusion. The top slope showed no evidence of cracking, slumping, or erosion, and there was no indication of riprap degradation. A shallow depression around settlement plate SP-4, near the northeast corner of the disposal cell cover, was first noted during the 1997 inspection and continued to grow in depth and area in subsequent years. The depression was repaired in August 2005. Continual visual observations since the 2017 annual inspection indicate that minor additional settlement has occurred since the depression was repaired. During the 2023 annual inspection, the settlement was shallow enough that it was

determined not to have changed significantly (PL-6). Inspectors will continue to monitor this area during each annual inspection, document surface topography, and note any developing erosional features.

Annual weeds and perennial grasses are sporadically growing on the top of the disposal cell top (PL-7). In accordance with the LTSP, deep-rooted shrubs are to be removed from the disposal cell cover. No deep-rooted shrubs were noted during the inspection. Weed control will be conducted before the next inspection in 2024.

The basalt riprap-covered side slopes and apron showed no evidence of erosion, settling, slumping, or cracking. Standing water is occasionally observed in a portion of the south apron, but the area was dry during the inspection (PL-8). An additional ponding area, which was dry, was identified during the 2023 inspection. This location is south of the current standing water area near the apron and closer to the access road. These locations are in a topographic low spot along the base of the disposal cell, and stormwater runoff collects in these areas. During the 2022 inspection, rilling and erosion were observed on the south side slope (PL-9) near aerial survey quality control monument QC-5. During the 2023 inspection, these features seemed to be stable. Inspectors will continue to monitor this area. No maintenance needs were identified.

Onsite rills and gullies north and east of the disposal cell have been visually monitored for several years, and existing features have continued to develop, particularly to the northeast of the disposal cell. One gully, northeast of the disposal cell, has grown to a depth of 6–8 ft and a width of 8–10 ft (PL-10). Inspectors collected GPS locations and measurements of this gully in 2021. While no immediate maintenance needs were identified during the 2023 inspection, an evaluation of the need for erosion control structures around the large gully northeast of the disposal cell is ongoing. Newly forming small rills were observed around the site during the 2022 annual inspection near perimeter signs P17, P59, and P65.

PL-1. Entrance Sign

PL-2. Erosion at Base of Perimeter Sign P12

PL-3. Site Marker SMK-1

PL-4. Monitoring Well 0678 and Adjacent Gully

PL-5. Mine Vent Shaft

PL-6. Depression Area near Settlement Plate 4 (Not Discernible)

PL-7. Weeds and Grasses on Disposal Cell Top Slope

PL-8. Evidence of Ponding Water; Evaporite Forming on Riprap of Cell Apron

PL-9. Disposal Cell South Side Slope Toe Drain

PL-10. Gully Outlet Northeast of Disposal Cell
