3.0 Canonsburg, Pennsylvania, Disposal Site

Figure 3–1. 2006 Annual Compliance Drawing for the Canonsburg, Pennsylvania, Disposal Site

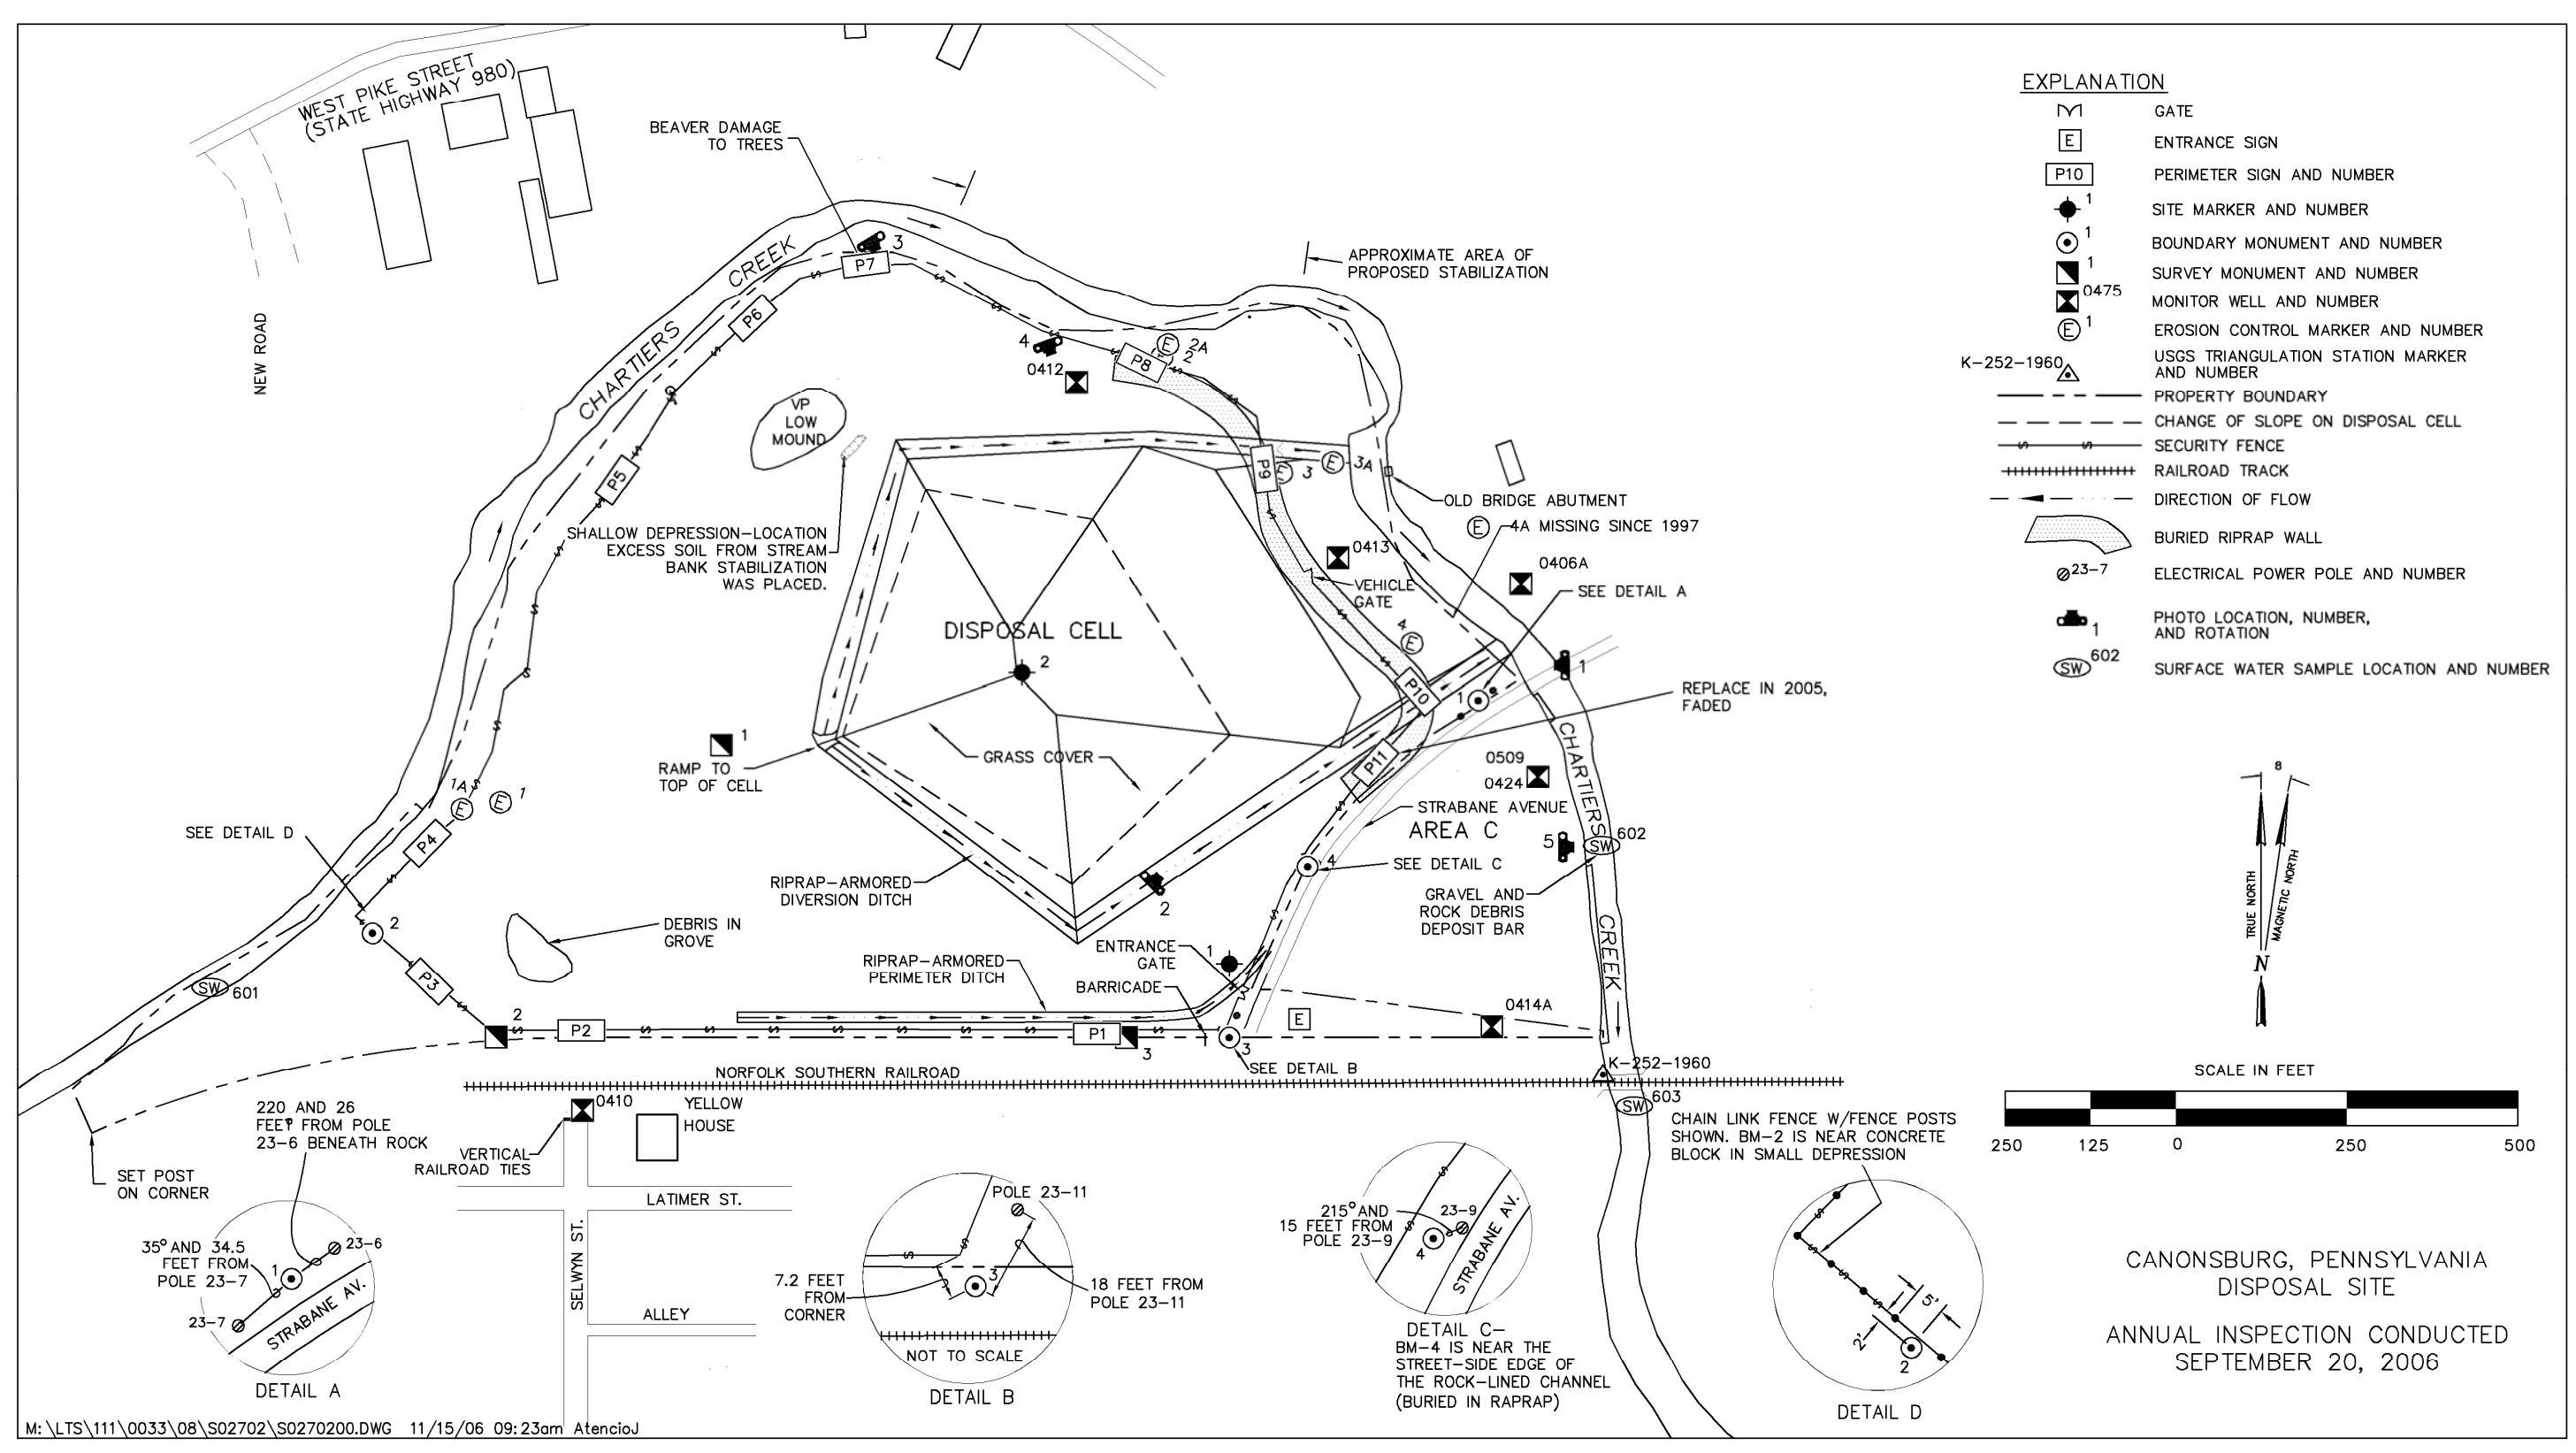
The site, located between the communities of Canonsburg and Houston, Pennsylvania, was inspected on September 20, 2006. Features and photograph locations (PLs) mentioned in this report are shown on Figure 3–1. Numbers in the left margin of this report refer to items summarized in the Executive Summary table.

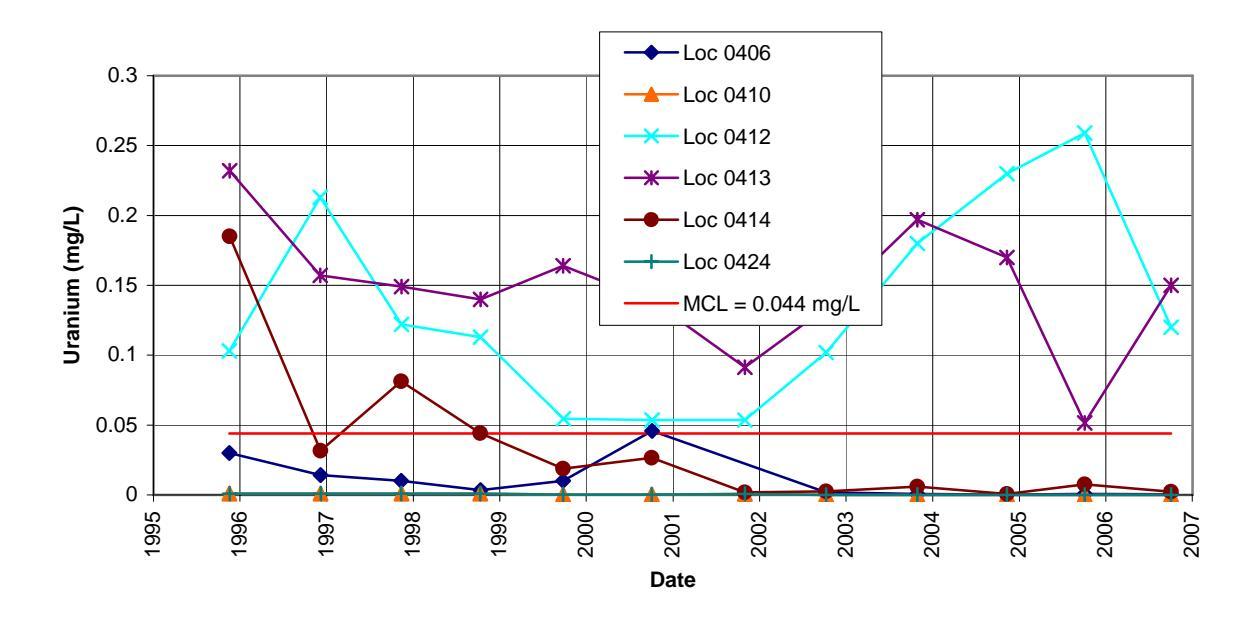
Figure 3–2. Time-Concentration Plots of Uranium in Ground Water at the Canonsburg, Pennsylvania, Disposal Site

Uranium is the analyte of primary concern at this site because of the frequency with which it has exceeded its MCL of 0.044 mg/L in two of the downgradient ground water monitoring wells (MW-0412 and MW-0413). In 2005 and 2006, uranium concentrations in these two wells continued above the MCL, but considerably below the ACL (Figure 3–2). Following a downward trend from 1996 through 1999, concentrations of uranium at well MW-0412 had increased from 2001 through 2005. In 2005, the highest uranium concentration since the LTSPrequired monitoring began in 1995 was reported at 0.259 mg/L from this well; however, still significantly below the ACL of 1.0 mg/L. In 2006, the concentration of uranium from this well decreased to 0.12 mg/L. No definitive trend has established in well MW-0412. From 1995 through 2001, uranium concentrations in well MW-0413 displayed a downward trend. Since 2002, uranium concentrations in well MW-0413 have fluctuated but remain below the initial 1995 concentration and have not exceeded the ACL. Uranium concentrations were substantially below the MCL at the rest of the ground water monitoring locations in 2005 and 2006. Uranium concentrations at all surface water sampling locations in Chartiers Creek, although reporting a sight increase in 2006, continue near the laboratory detection limit and have displayed a decreasing trend since 2001 (Figure 3–5).

DOE continues to consider the risk associated with uranium in ground water within the unconsolidated materials and shallow bedrock (defined as the uppermost aquifer for regulatory purposes) beneath the site to be negligible because neither unit is considered a viable aquifer from a water resource perspective, although the zone is capable of discharging to surface water (Appendix A to 10 CFR Part 40). Because the materials are not ideal for aquifer formation and the source of recharge to the shallow units is minimal, sustained yield to a well from these units would be limited. The shallow ground water is not used as a drinking water source in the area, although some domestic water is derived from a few private wells deeper than 100 feet. Institutional controls, in the form of government ownership of the site, prevent access to the ground water directly beneath the site. NRC concurred in deleting ground water use restrictions for Area C in 2003. Most of the residents in the area are connected to a municipal water system, which is supplied by surface water reservoirs upgradient from the site. Chartiers Creek, the discharge point for the shallow ground water beneath the site, is not a source of potable water. Additionally, uranium concentrations reported from samples collected from the creek are near the detection limit and have declined in recent years. Therefore, human health and the environment are adequately protected.

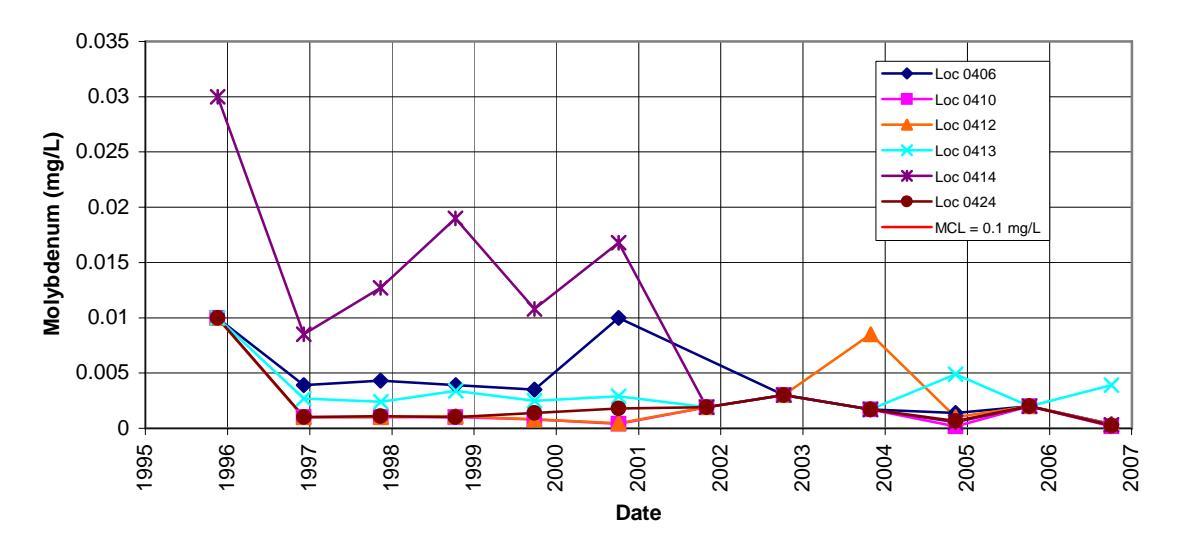
Figure 3–3. Time-Concentration Plots of Molybdenum in Ground Water at the Canonsburg, Pennsylvania, Disposal Site

In 2005 and 2006, molybdenum concentrations in ground water continued well below the MCL at all locations, with values remaining near the laboratory detection limit. Historically, the highest concentrations of molybdenum were reported from well MW–0414 during the initial years of monitoring. Concentrations in this well have decreased significantly in recent years and display an overall decreasing trend (Figure 3–3). In general, molybdenum concentrations at all other wells have remained relatively constant. The maximum concentration of molybdenum reported in 2006 was 0.0039 mg/L at well MW–0413.

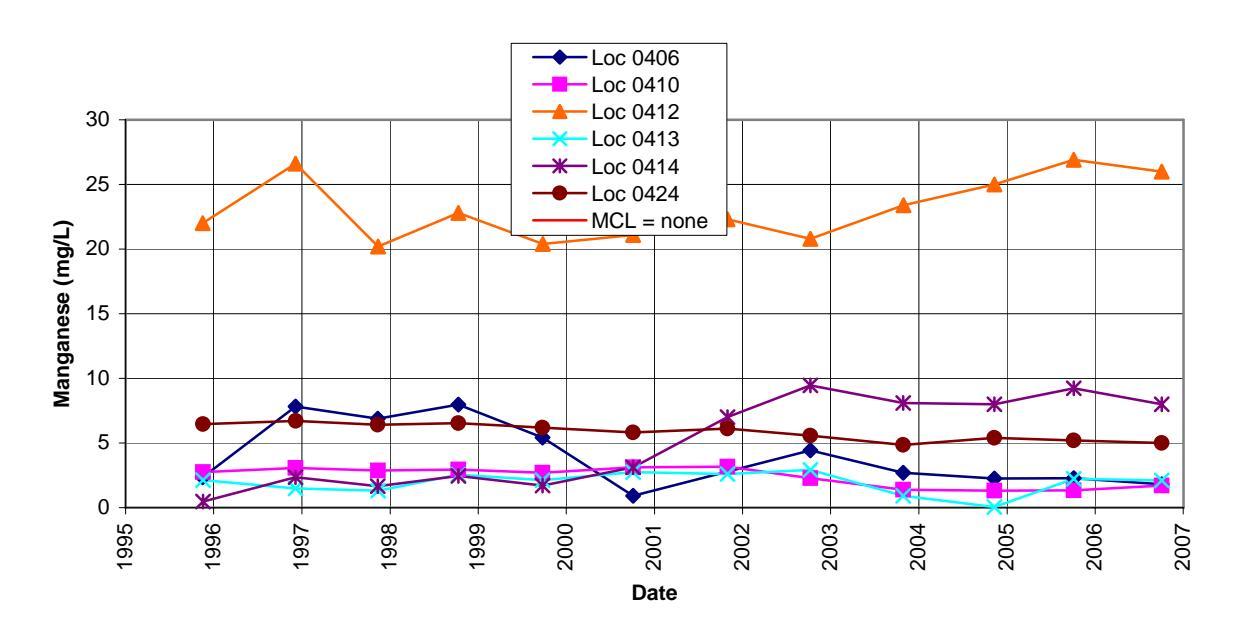
Figure 3–4. Time-Concentration Plots of Manganese in Ground Water at the Canonsburg, Pennsylvania, Disposal Site

Manganese concentrations in ground water continue to exceed the secondary drinking water standard of 0.05 mg/L at all point of compliance wells. In 2004, well MW–0413 had an apparent anomalous manganese concentration of 0.044 mg/L, just below the standard. Otherwise, results from 2005 and 2006 are generally consistent with results from previous years; no increasing or decreasing trends are observed with the exception of well MW–0414 where an overall increasing trend can be observed, which appears to have leveled off in recent years (Figure 3–4). Concentrations of manganese reported from well MW–0412 (26 mg/L in 2006) remain significantly above all other wells. The manganese concentration in the upgradient background well MW–0410 was below all other wells in 2005 and 2006; however, this well had exceeded the concentrations MW–0413 and MW–0414 from 1995 through 1999.

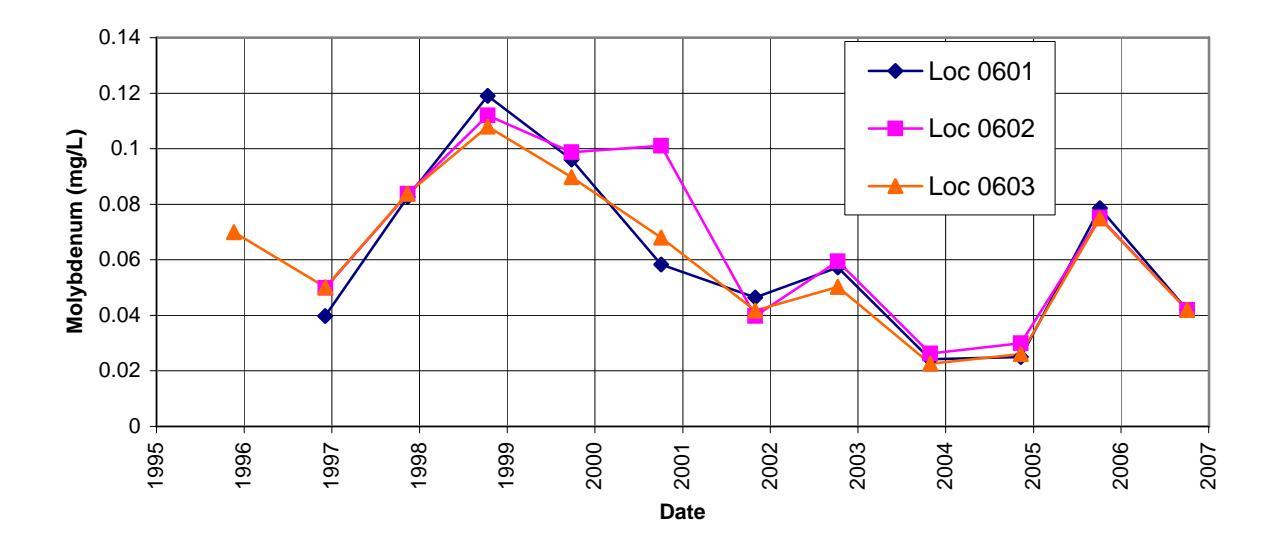
Figure 3–6. Time-Concentration Plots of Molybdenum in Surface Water at the Canonsburg, Pennsylvania, Disposal Site

The concentrations of molybdenum in the Chartiers Creek samples, as in the past, were higher than in ground water samples, though still well below the MCL of 0.1 mg/L. Concentrations at all locations exceeded the MCL in 1998 and again, although only slightly, at location SW–0602 in 2000 (Figure 3–6). Surface water concentrations both upstream and downstream of the site exceed concentrations in ground water. This indicates an ambient or upstream source of molybdenum rather than from site related activities. The surface water quality is indistinguishable between upstream and downstream locations. Molybdenum concentrations in both upstream and downstream locations display an overall decreasing trend, despite a relatively sharp increase at all locations in 2005.

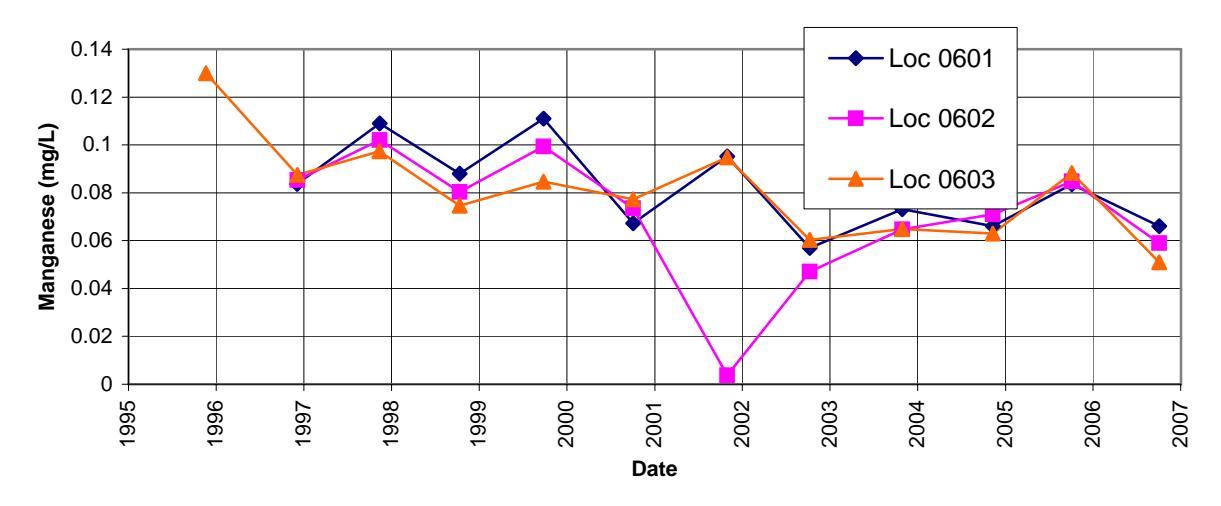
Figure 3–7. Time-Concentration Plots of Manganese in Surface Water at the Canonsburg, Pennsylvania, Disposal Site

Manganese concentrations in surface water in Chartiers Creek (the point of exposure) display an overall decreasing trend at all three locations, although location SW–0602 appeared to have an anomalously low concentration in 2001 (Figure 3–7). With the exception of location SW–0602 in 2001 and 2002, all manganese concentrations in surface water remain above the secondary drinking water standard but well below the EPA risk based guideline of 1.7 mg/L.

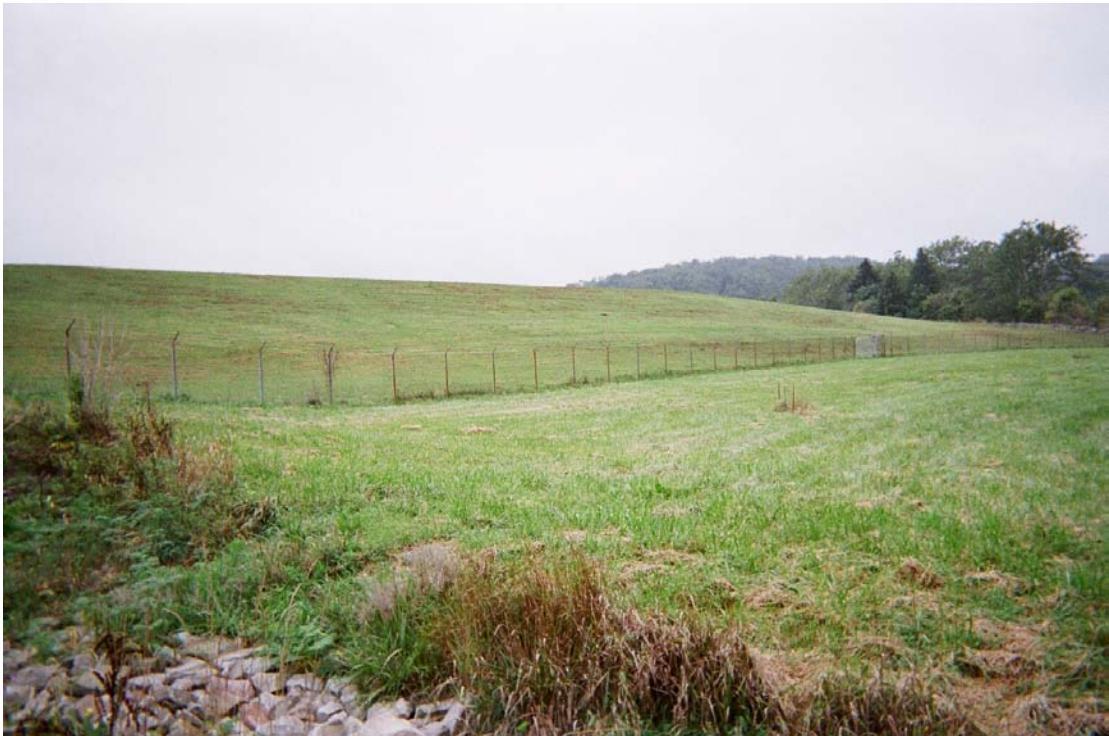
The grass turf on the northeast side slope has been monitored for several years because it had appeared less healthy than that of the remainder of the site. For the past three years, including 2006, the inspections were conducted earlier in the growing season and the turf appeared healthy (PL-1). The condition of the turf in this area will continue to be inspected to verify that the vegetation is providing adequate erosion protection.

CAN 9/2006. PL-1. Turf condition on northeast site slope.

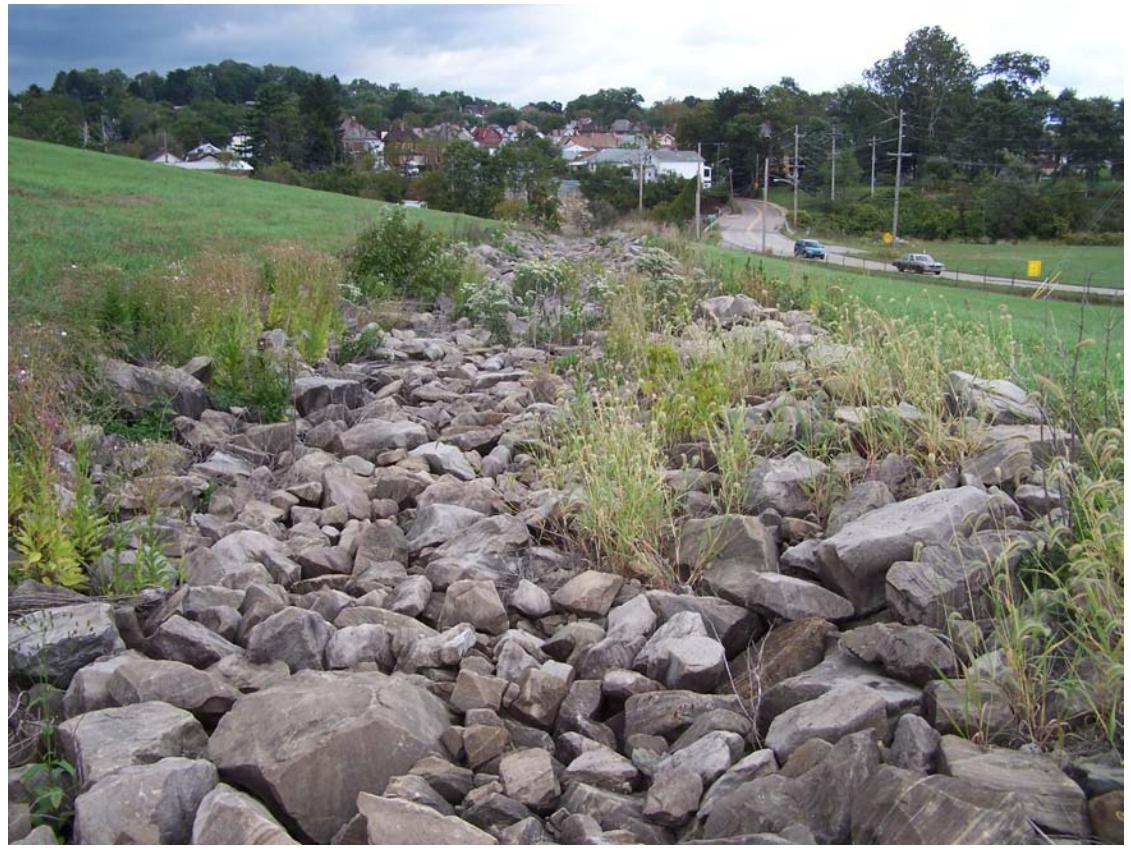
As noted during previous inspections, individual rocks have deteriorated. Although the occurrences are few and rock deterioration is not considered to be a problem at this time, DOE will continue to monitor the rock condition in the channels and ditch.

Vegetation in the diversion channels and perimeter ditch was treated with herbicide in 2005. Vegetation continues to grow in these features but does not impede function (PL–2).

CAN 9/2006. PL-2. Vegetation in diversion channel.

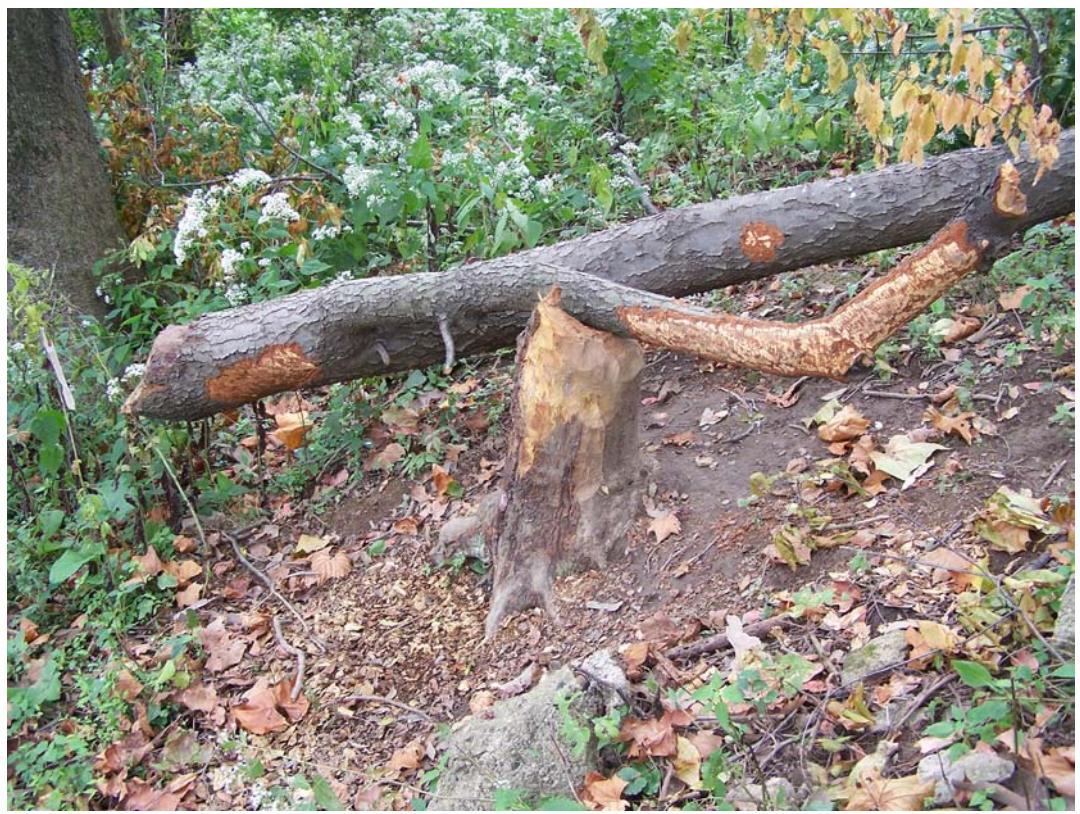
Beavers have been felling mature hardwood trees along the Chartiers Creek stream bank (PL–3). Only occasional trees are affected, and the trees are north of the site where the bank slope is flatter and the cross section of the drainage appears to be greater than further downstream.

Abundant vegetation remains on this portion of the bank. Inspectors will continue to monitor this activity for threats to stream bank stability.

CAN 9/2006. PL-3. Beaver damage along Chartiers Creek.

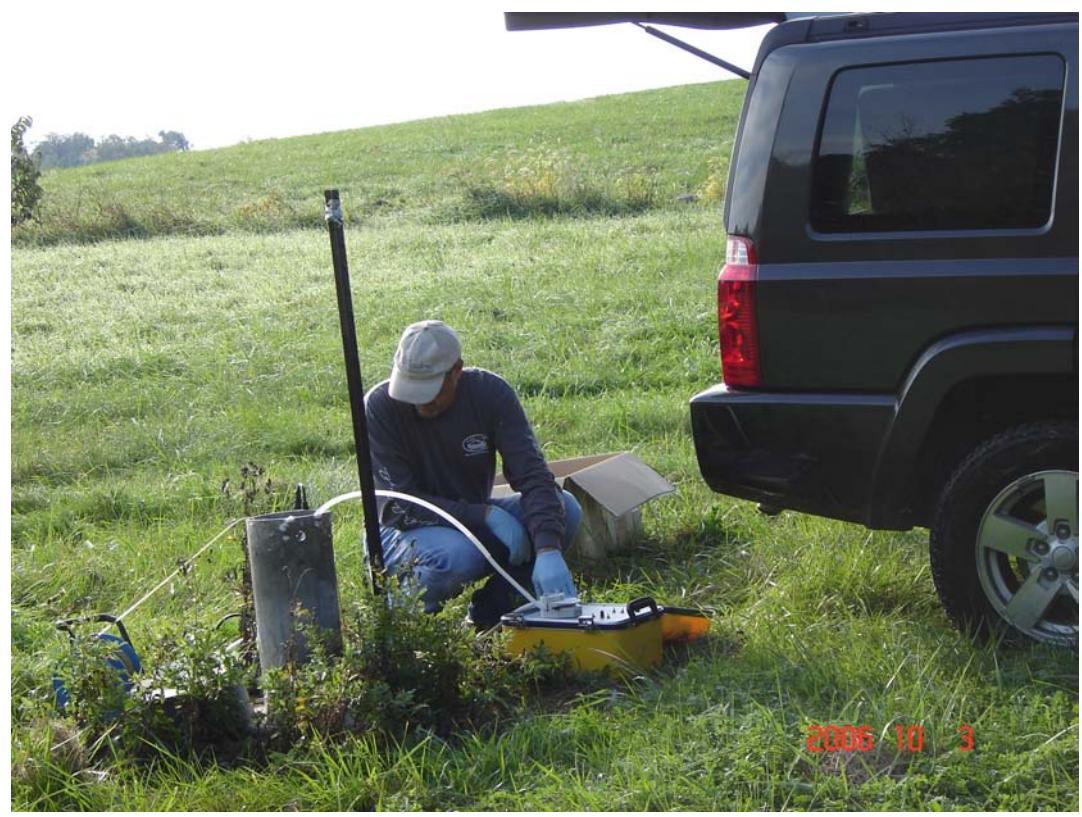
CAN 9/2006. PL-4. Ground water sampling.

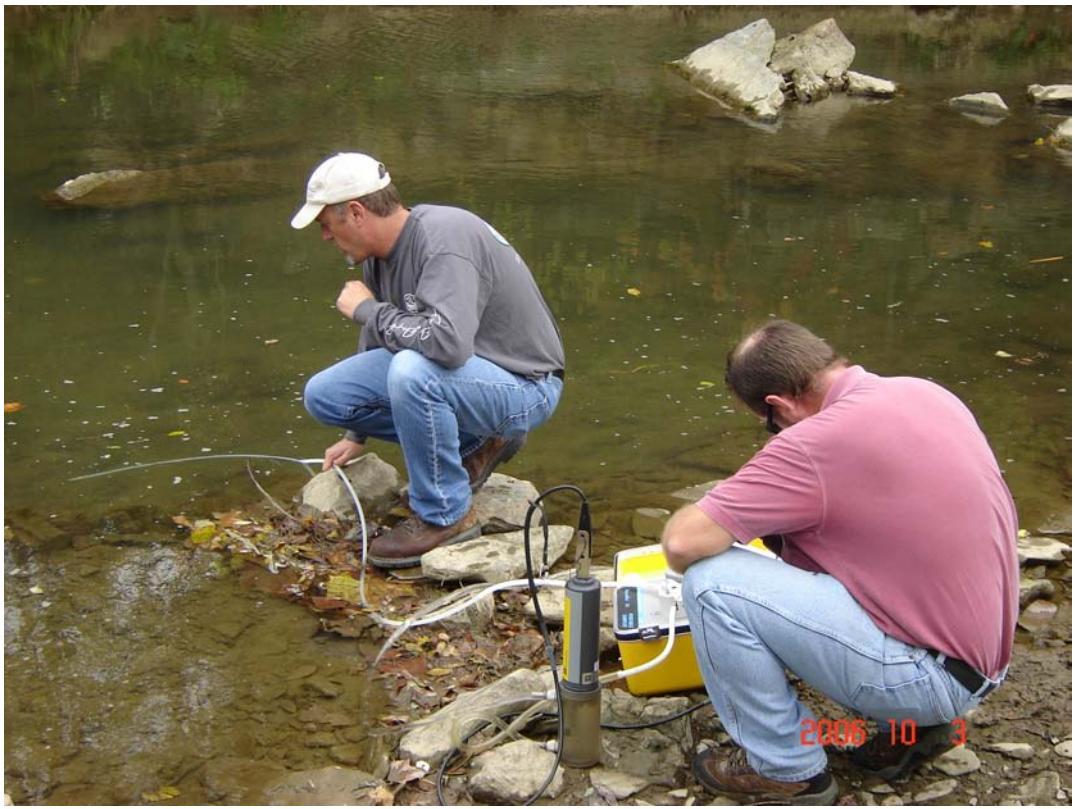
CAN 9/2006. PL-5. Surface water sampling.
