יווי 2020 Annual Land-Use Covenant **Inspection Report** for DOE Areas at the Laboratory for Energy-Related Health **Research/Old Campus Landfill Superfund Site University of California, Davis** January 2021 ENERGY Legacy Management

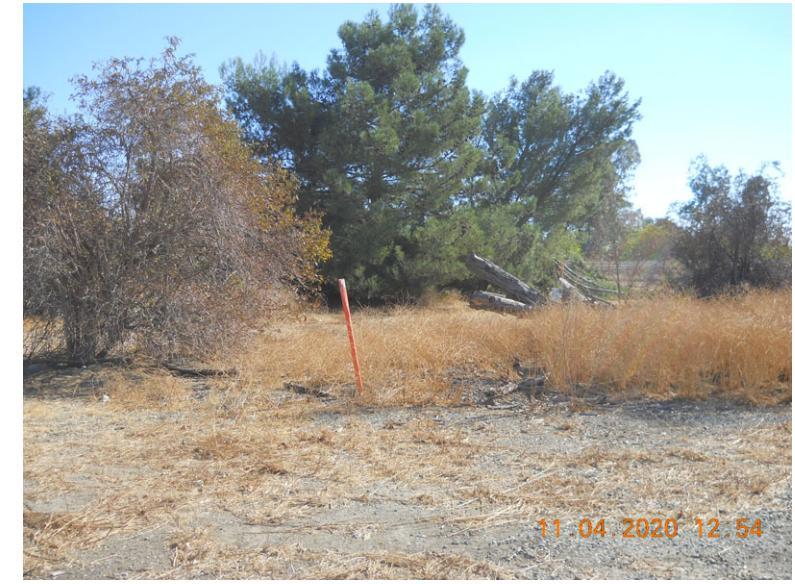
View southeast of Eastern Dog Pens Area from northwest corner showing northwest corner monument location; downed tree near center of frame was originally located outside the Eastern Dog Pens Area (Photo No. 4174).

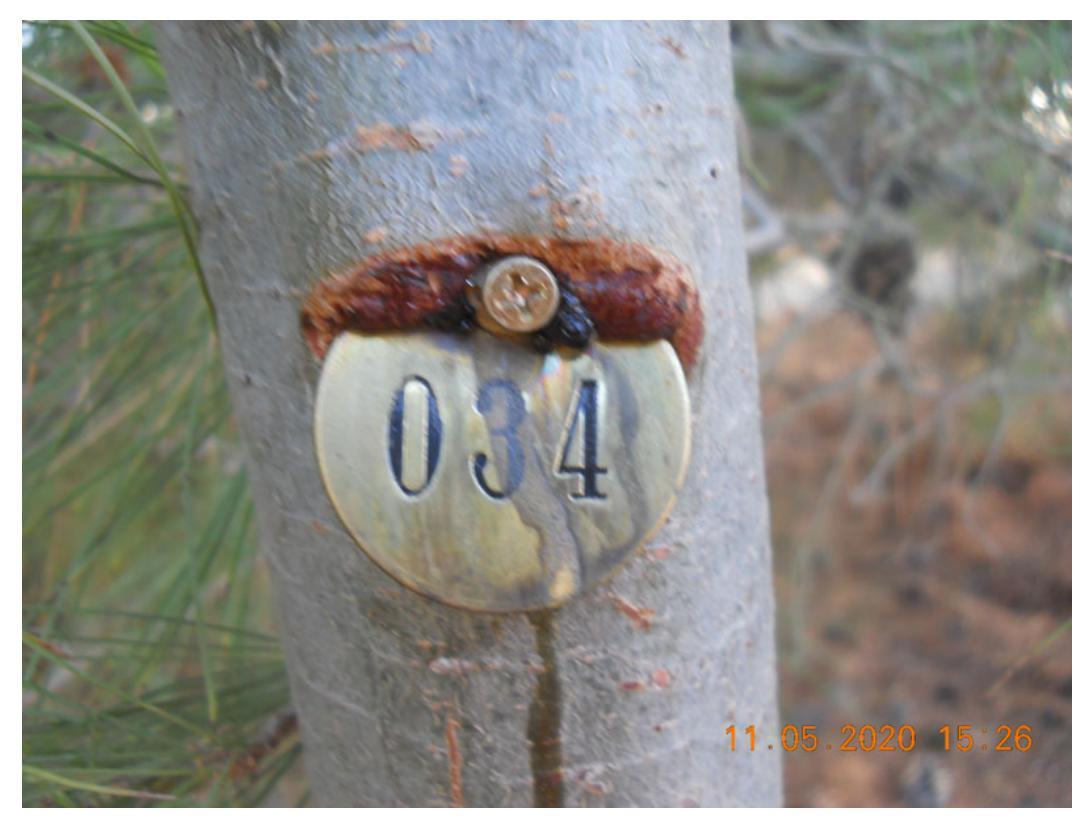
Tissue growing over tag on tree 16234 (Photo No. 4310).

Tree 16234 – Tag reattached allowing space from tree trunk (Photo No. 4323).

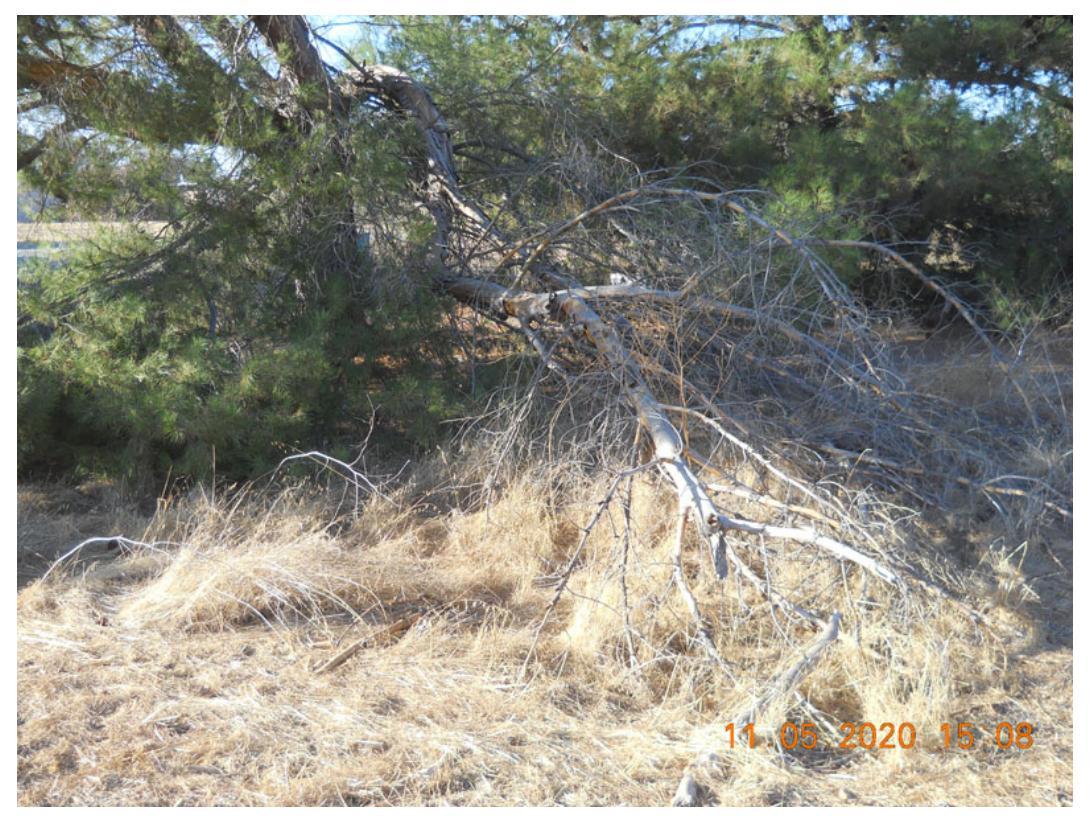
• Tree 16236 was alive at the time of the inspection, but one of its larger limbs is dead and appears partially fallen to the ground, but remains attached to the tree. Review of photographs taken in 2019 and 2020 indicates the condition of the dead limb has not changed since 2019. No action is recommended with respect to the dead limb because it does not pose an immediate safety hazard and the tree will be removed during the UC Davis landfill capping project.

Large dead limb extending from tree 16236 (Photo No. 4298).
