### 2016 Annual Inspection Report of the Parkersburg, West Virginia, Disposal Site

## 1.1 Inspection Summary

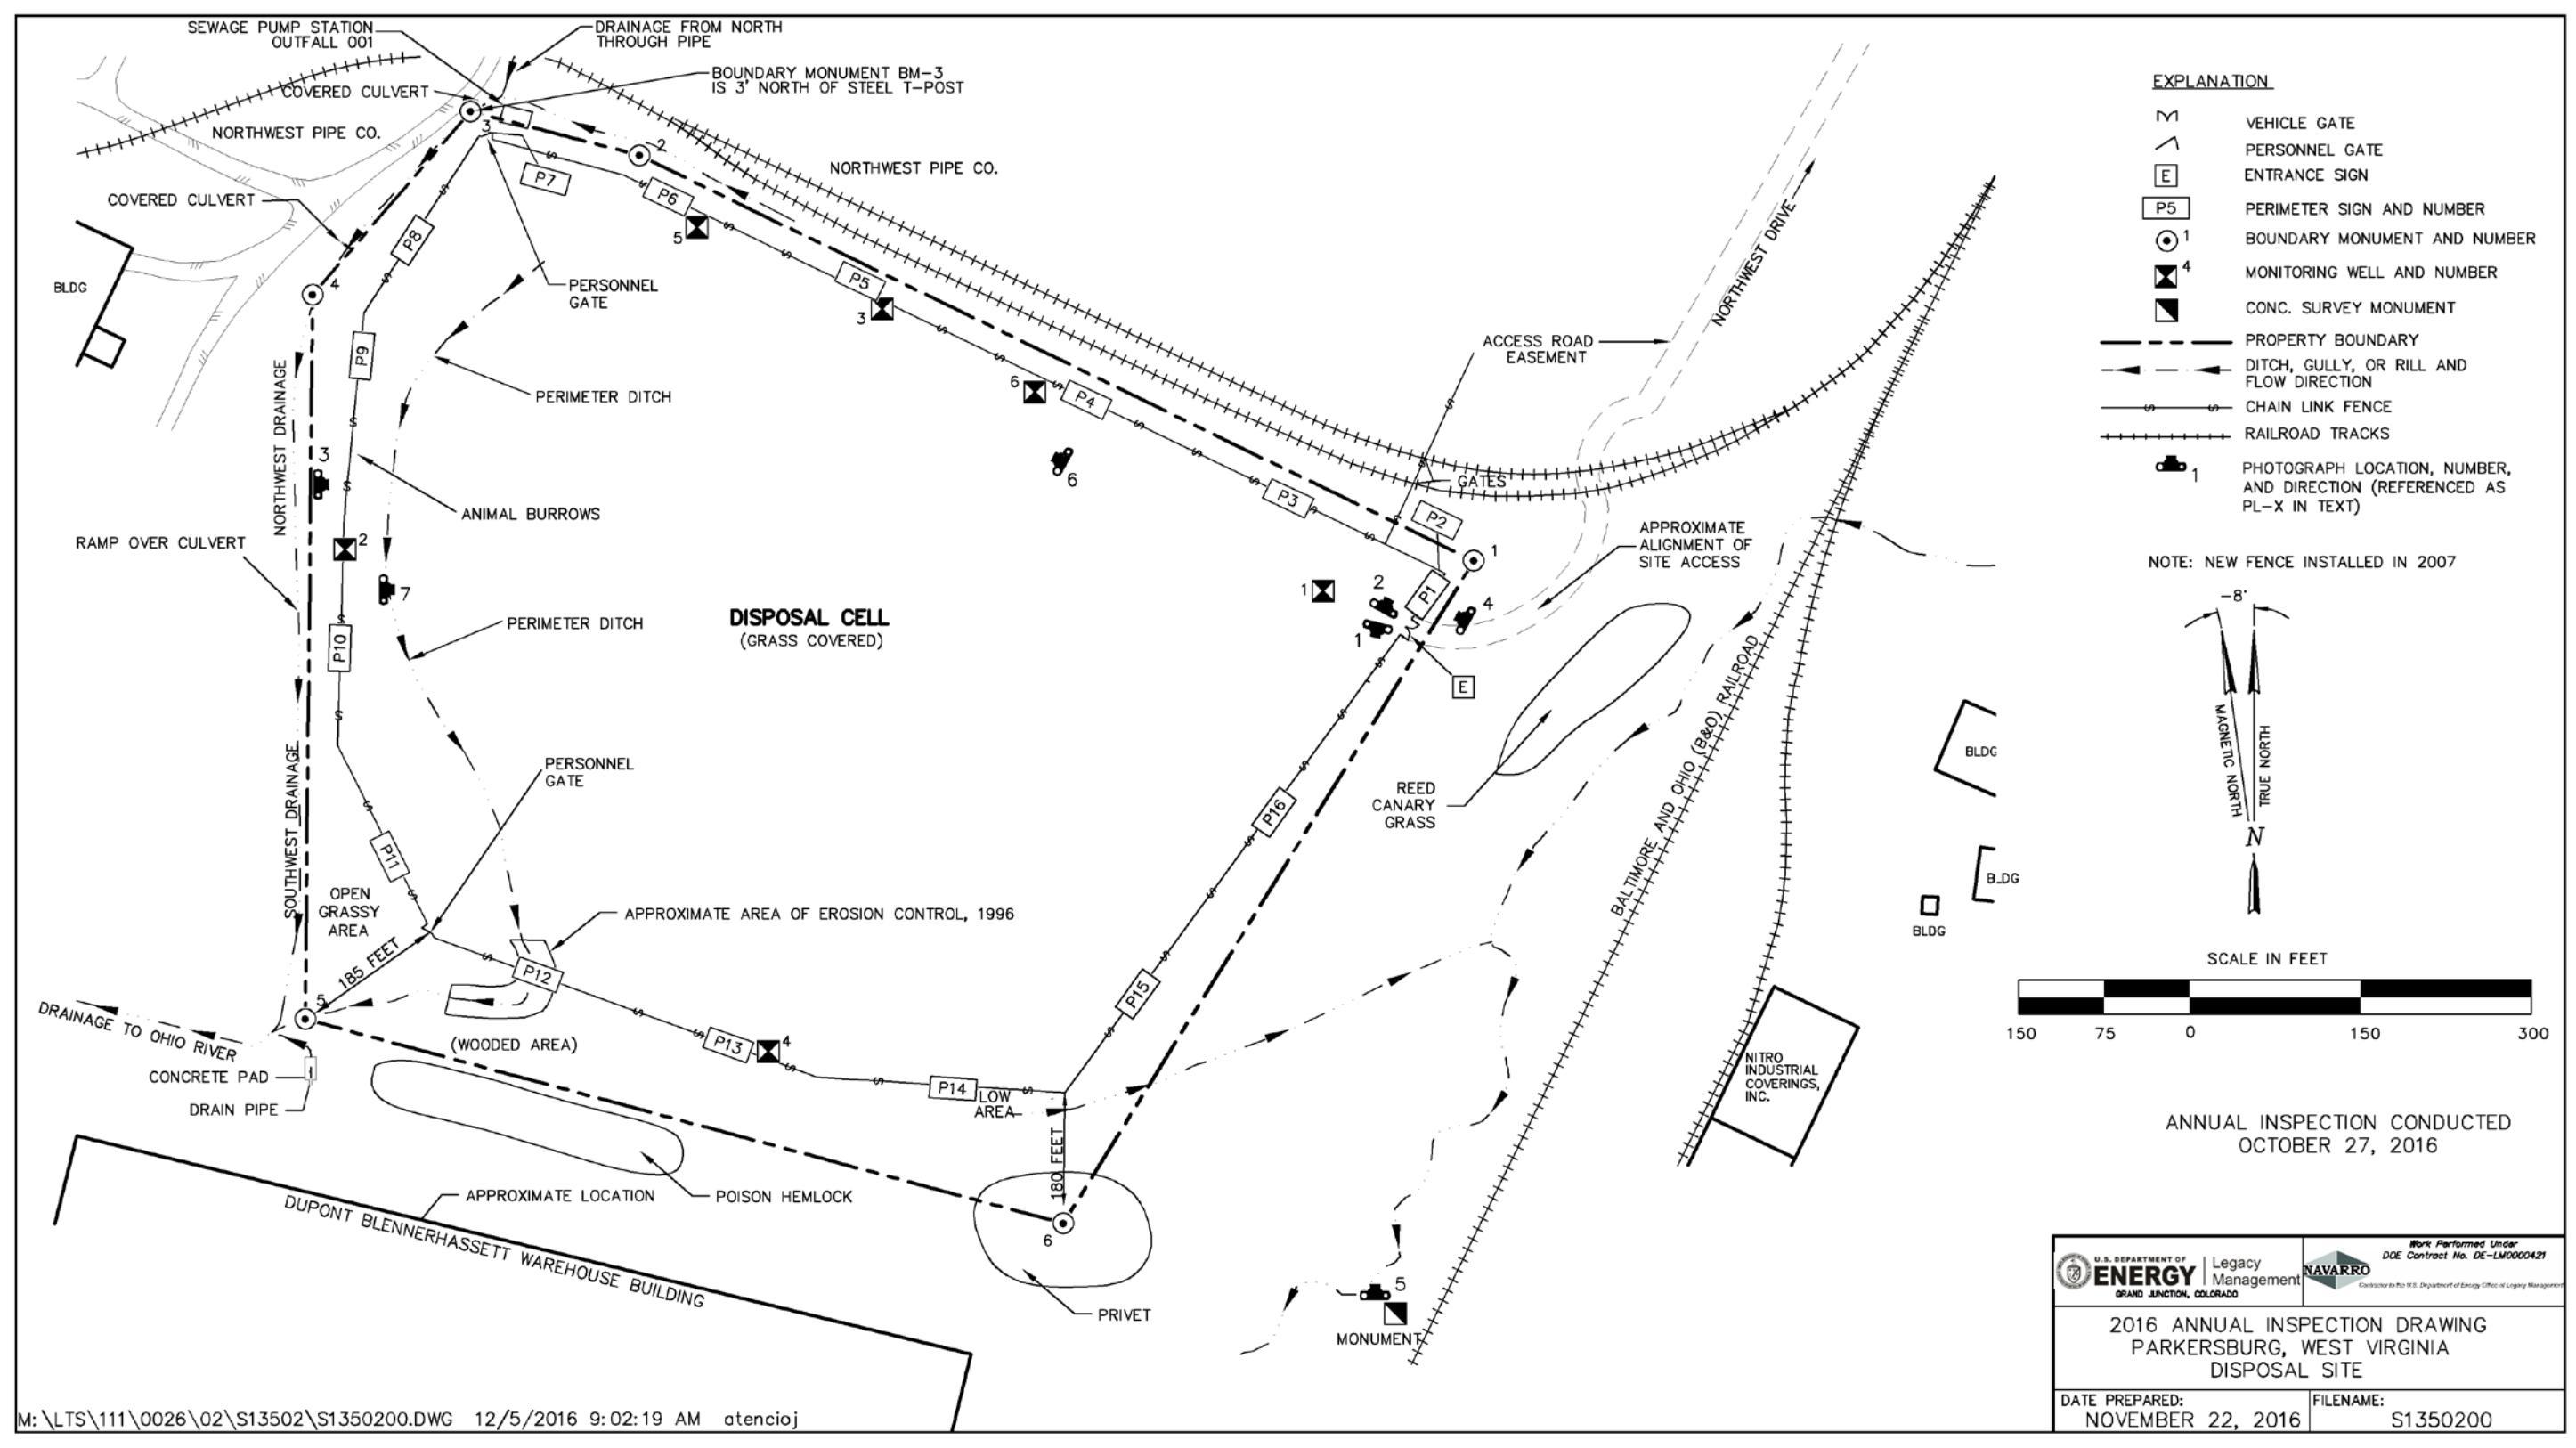
Figure 1. 2016 Annual Inspection Drawing for the Parkersburg Disposal Site

The locations of site-surveillance features are shown on Figure 1. Inspection results and recommended maintenance activities associated with site-surveillance features are described in the following subsections. Photographs to support specific observations are identified in the text and on Figure 1 by photograph location (PL) number.

Several invasive species were observed in the eastern wooded portion of the site. Reed canary grass and wintercreeper have become established at locations identified on Figure 1. Neither species is designated by the State of West Virginia as a noxious weed, but both are considered invasive due to their aggressive growth and the fact that they are non-native to the local ecosystem.
