Post-Closure Monitoring and Inspection Plan for Amchitka Island Mud Pit Release Sites, Well Abandonment, and Infantry Road Repair Amchitka, Alaska

March 2011

Legacy
Management

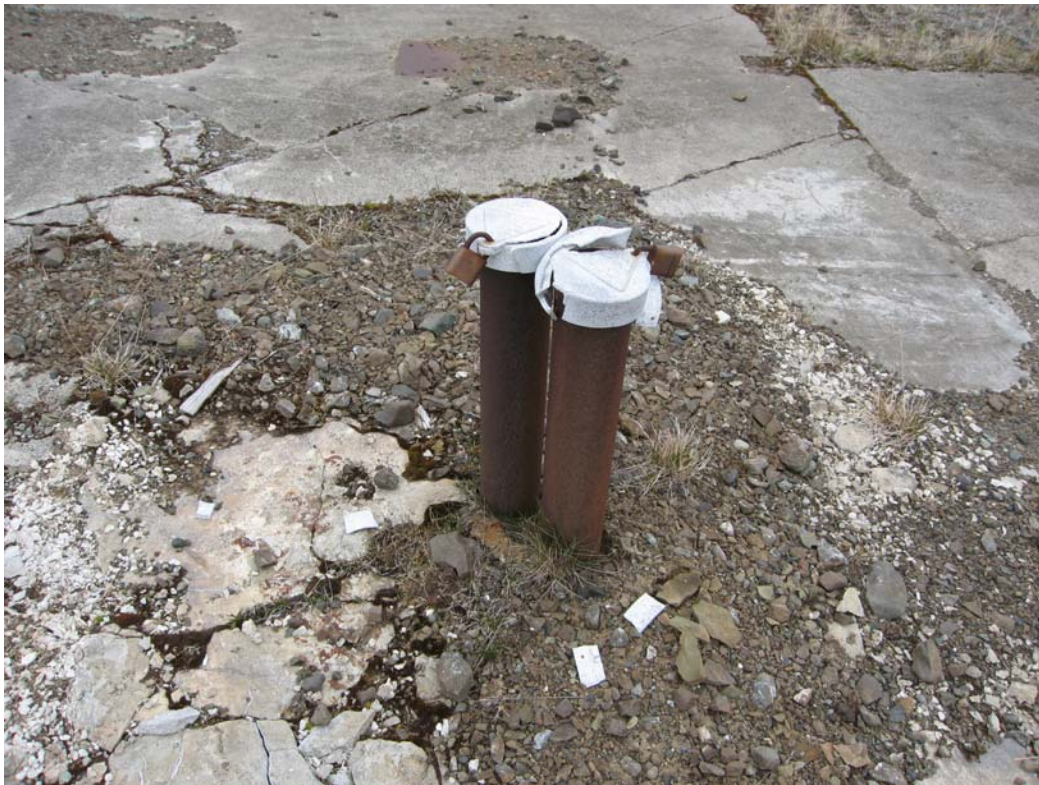
Figure 3. Long Shot Wells GZ-1 and GZ-2

Three wells will be inspected on Amchitka in 2011. Two of these wells are groundwater monitoring wells located at the Long Shot Site, and the third is a hydrologic test well located at Drill Site E. The two groundwater monitoring wells at the Long Shot Site are GZ-1 and GZ-2 and were part of the U.S. Environmental Protection Agency's Long-Term Hydrologic Monitoring Program (DOE 1982). The wells are 2 inches in diameter and are inside a 4-inch protective casing. The depths of GZ-1 and GZ-2 are 100 ft and 50 ft, respectively. Figure 3 and Figure 4 are photographs of these two wells. The Site E well is exploratory hole UAE-7c/h (also called Site E Hydro Exploratory Hole) that was drilled to 7,495 ft, plugged back to 1,040 ft, and then sidetracked for UAE-7H to a final depth of 6,273 ft (Fenix & Scission 1972). At ground level, this is an 8-5/8-inch cored hole. The surface expression of this exploratory hole is shown in Figure 5 and Figure 6.

A borehole video camera will be placed down each of the 2-inch wells to determine the competency of each of the wells. If a well is determined to be compromised (e.g., can't get the borehole camera to total depth), the well will be abandoned. The 2-inch wells will be abandoned by either pulling the protective casing out of the borehole or cutting the outside protective casing at ground level. Once the protective casing has been removed, the 2-inch well will be cut off at ground level and filled with bentonite hole plug from bottom to top. It is estimated that the 50- and 100-ft wells will take two to four 5-gallon buckets of hole plug, respectively, to fill each 2-inch well.

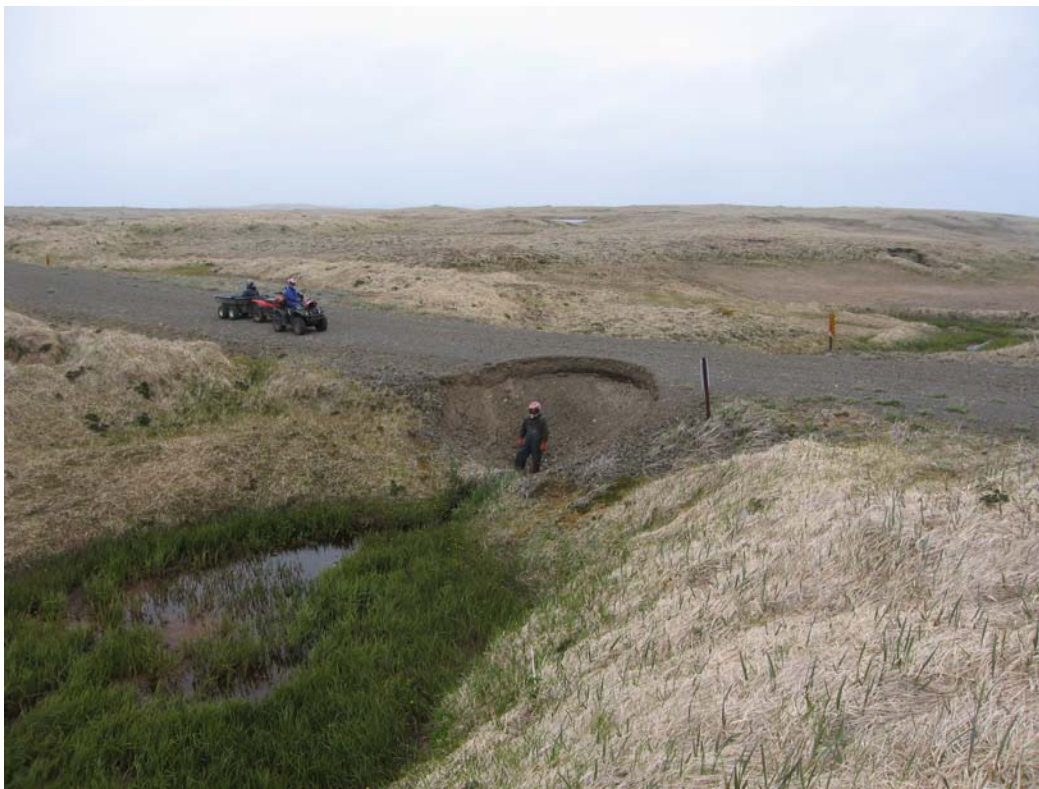
Figure 7. Infantry Road Partial Washout near MM 4

During LM's last trip to Amchitka Island in the summer of 2008, Infantry Road was impassable near Mile Marker (MM) 8 and marginally passable just south of the Long Shot Site near MM 4. At both locations, the roadbed has been, or soon will be, washed out. The washout appears to be due to inadequate culvert size to handle peak stream flow beneath the roadbed. During peak stream flows, water backs up on the upstream side of the roadbed until the surface water level begins to flow over the top of the roadbed, causing erosion on both sides, but primarily on the downstream side, of the roadbed. Figure 7 shows the partial roadbed washout near MM 4, and Figure 8 shows the roadbed washout near MM 8.

When personnel from DOE's Office of Environmental Management (EM) were on-island to perform the cap inspection in 2006, the roadbed near MM 8 was not yet completely washed out, and its condition was similar to that of the roadbed near MM 4 in 2008. For the 2011 on-island work, it is likely that the roadbed will be completely washed out near MM 4.

In 2008, the area around MM 4 was scouted briefly for a potential stream crossing. The terrain near MM 4 has many small streams that have incised the local topography and have created steep-banked stream terraces. To ensure a safe stream crossing, a skid steer loader will be available for minor excavation work within the footprint of the roadway such as cutting back the road embankment to allow the utility vehicles to cross the stream safely.

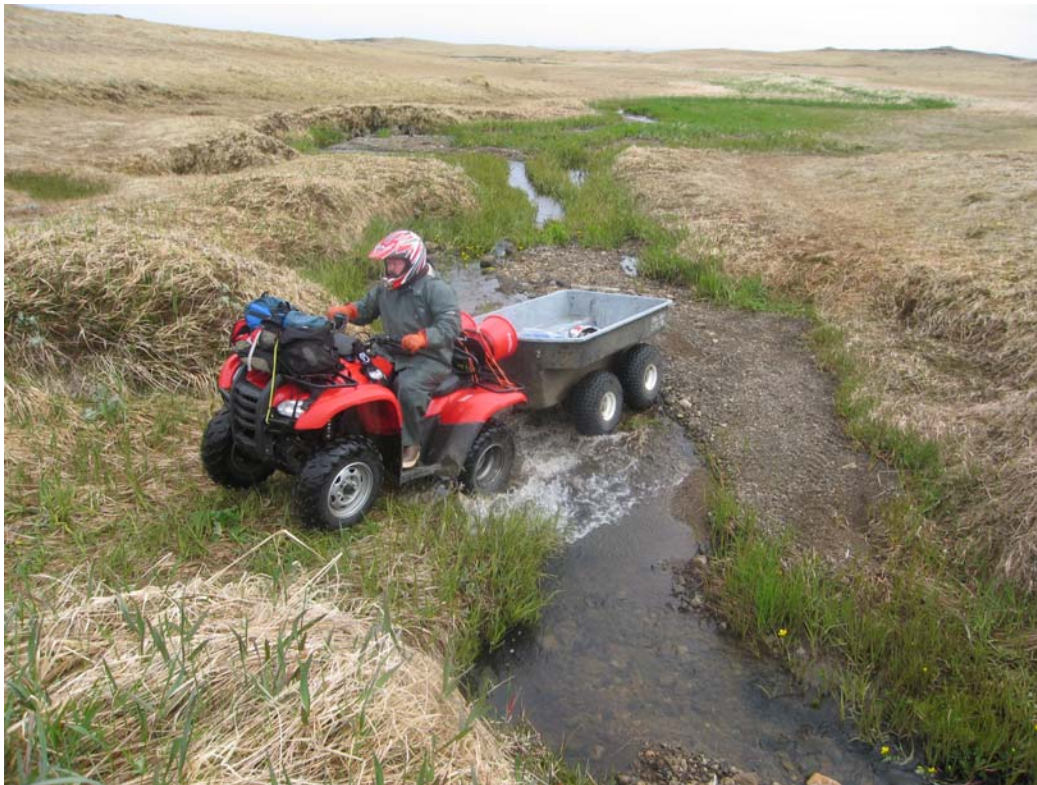
Figure 9. Stream crossing near MM 8

To get around the washout near MM 8 in 2008, the three all-terrain vehicles (ATVs) used for transportation had to detour around the washout and ford the stream at a safe location. Figure 9 shows the stream crossing just downstream of the MM 8 roadbed washout.

In 2011, four-wheel-drive utility vehicles will be used instead of ATVs, and one of the utility vehicles will be a four-passenger vehicle. This change of vehicle type will lessen the off-road maneuverability that the previous ATVs provided, and more care must be taken in choosing a safe, passable stream crossing. The utility vehicles can probably use the same stream crossing at MM 8 that the ATVs used, but the stream crossing at MM 4 may require some existing road embankment modification to facilitate a safe crossing.

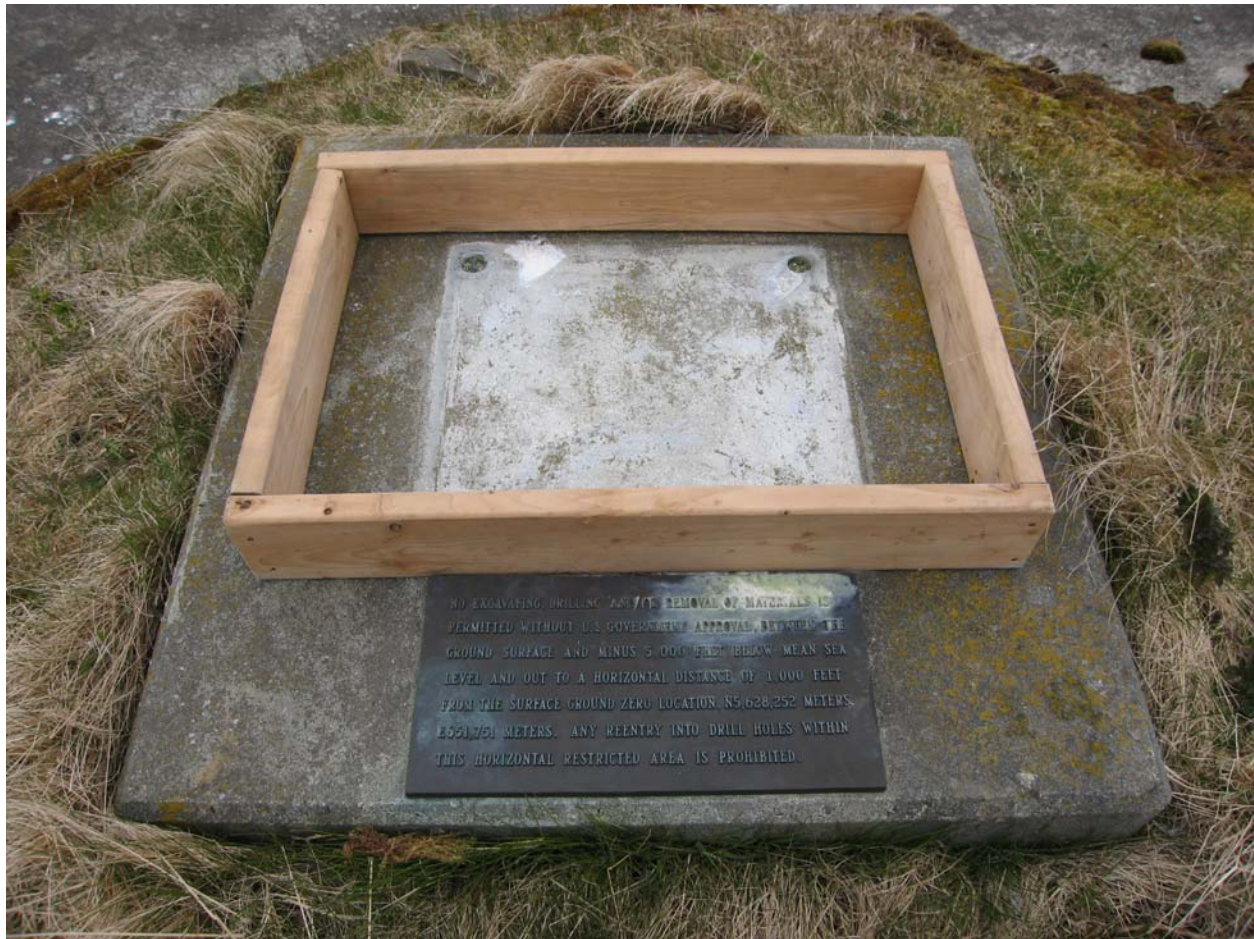
Figure 10. Setting Milrow Plaque-1

Sometime prior to EM's 2006 inspection of the sites on Amchitka, the SGZ plaque at Milrow had been removed. One of the informal recommendations of the 2006 inspection was to replace the SGZ marker as soon as possible. When LM representatives visited Amchitka in 2008 to reseed several of the earthen covers, plans were made to place a new SGZ plaque at Milrow. That task was partially completed in 2008, but the foundation of the plaque required more concrete than was brought in 2008. The concrete form and SGZ plaque were left in place, and the additional concrete is planned be added to the base of the SGZ plaque during the next site inspection. Figure 10 shows the 2 × 6 form, approximately 34 inches by 22 inches in area, that the SGZ plaque rests on. Additional concrete will be added to bring the base up into contact with the bottom of the plaque.
