6.0 Grand Junction, Colorado, Disposal Site

6.1 Compliance Summary

The site, 18 miles southeast of Grand Junction, Colorado, was inspected on December 19, 2022. The inspection was conducted by J. Lobato, P. Wetherstein, H. Petrie, R. Mumby, and J. Warkentin of the Legacy Management Support contractor. S. Woods (LM) and M. Cosby (Colorado Department of Public Health and Environment) also attended the inspection. The purposes of the inspection were to confirm the integrity of visible features at the site, identify changes in conditions that might affect conformance with the Interim LTSP, and evaluate whether maintenance or follow-up inspection and monitoring are needed.

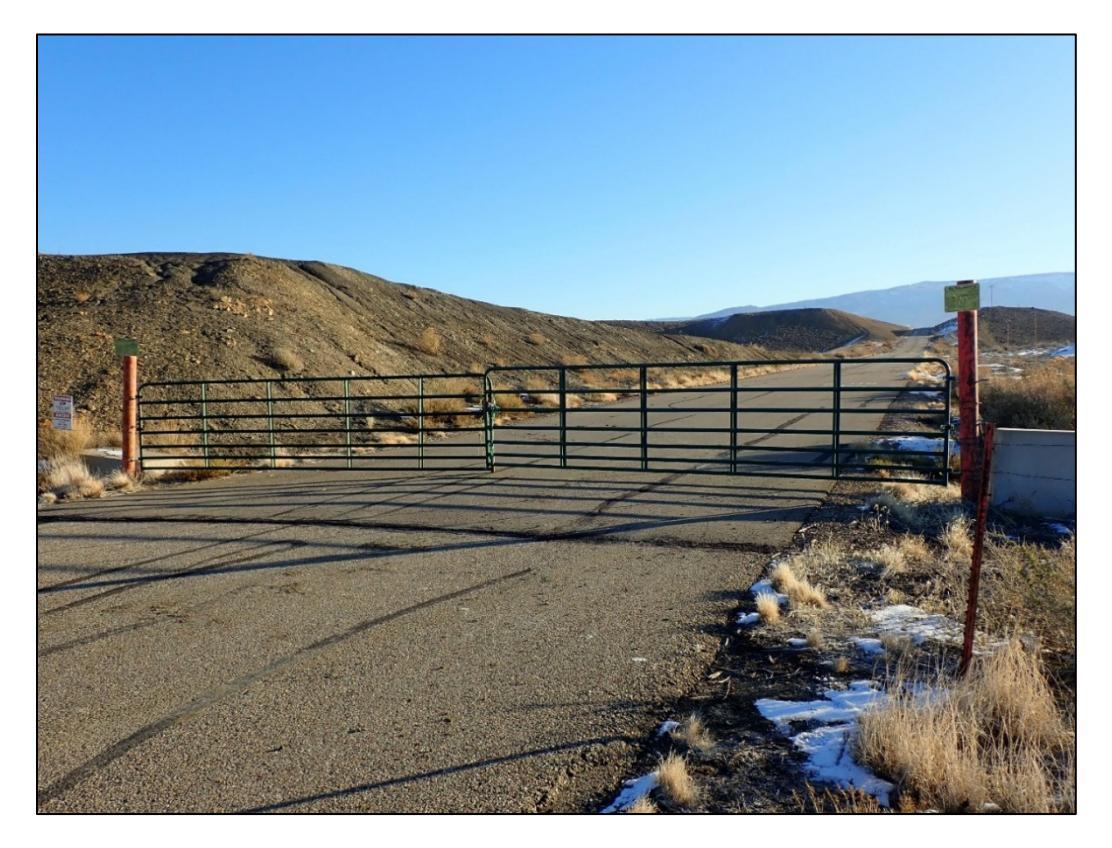
PL–1. Site Access Gate

Access to the site is from U.S. Highway 50 by a right-of-way grant on federal land that is administered by the U.S. Bureau of Land Management (BLM). A steel double-swing gate along the highway right-of-way fence provides access to the BLM-administered right-of-way that leads to the site entrance gate. The access gate was secured at the time of the inspection (PL-1), and the lock was replaced during the inspection. Site access signs next to the gate were in good condition. No maintenance needs were identified.

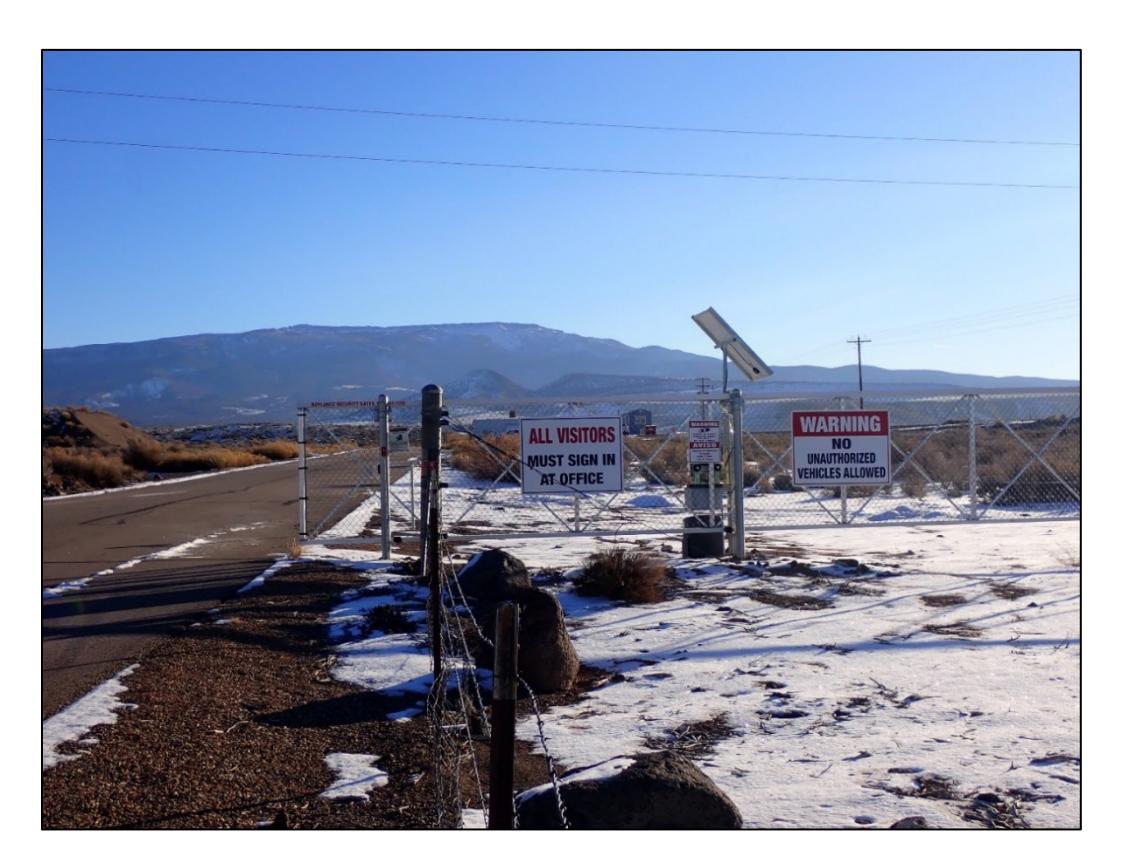
PL-2. Site Entrance Gate

The solar-powered site entrance gate is secured by an electronic locking device that requires entry of a keypad code to open the gate. The entrance gate was functional at the time of the inspection (PL-2). Site entrance signs on and next to the entrance gate were in good condition. No maintenance needs were identified.

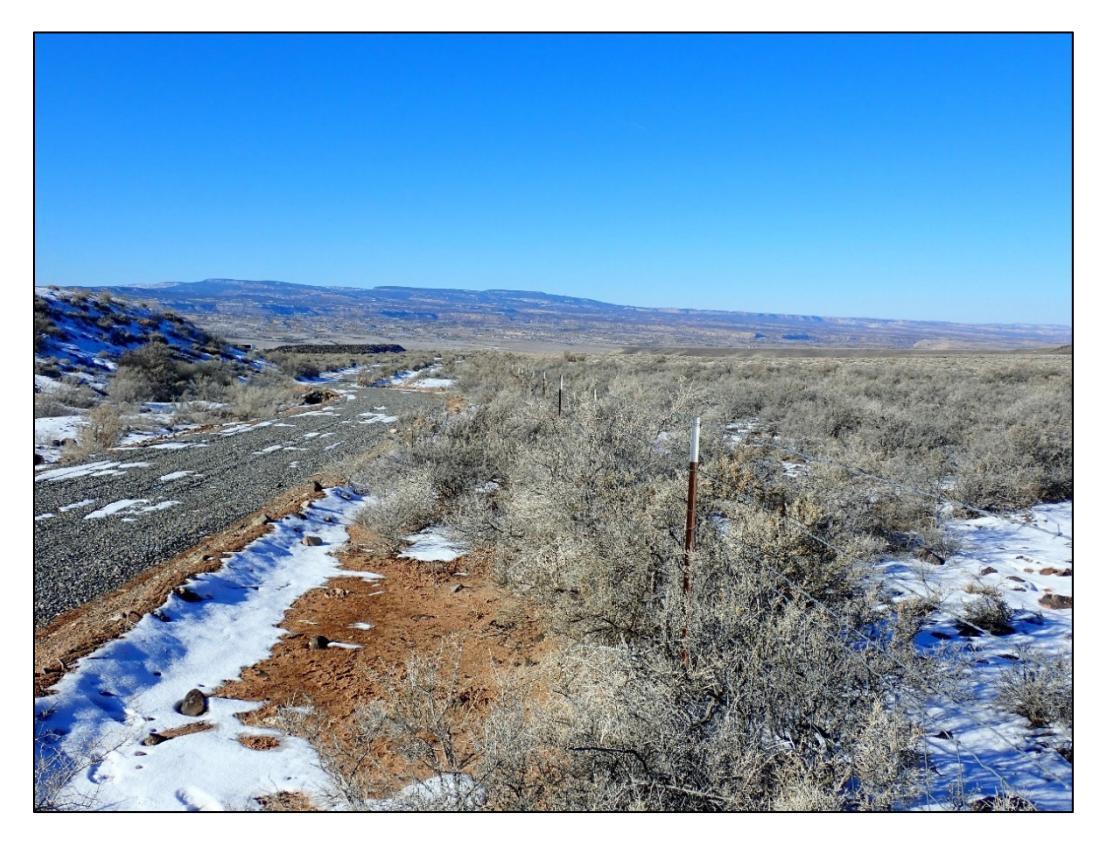
PL–3. North Perimeter Fence

A perimeter fence encloses the disposal cell features and operations areas (PL-3). It consists of a standard four-strand, barbed-wire fence in some areas and a woven wire fence topped with barbed wire in others. The perimeter fence does not match the property boundary in several areas. The perimeter fence includes warning signs ("No Trespassing" and "Controlled Area" signs) positioned at regular intervals. Multiple warning signs require repair or replacement as follows: warning signs on the north perimeter fence that are partially detached, illegible, or missing and two warning signs on the south perimeter fence that are partially detached or illegible (PL-4). Several warning signs on the southeast perimeter fence that were reported in 2021 as damaged or detached were repaired or replaced before the inspection. Affected warning signs will be repaired or replaced before the next inspection.

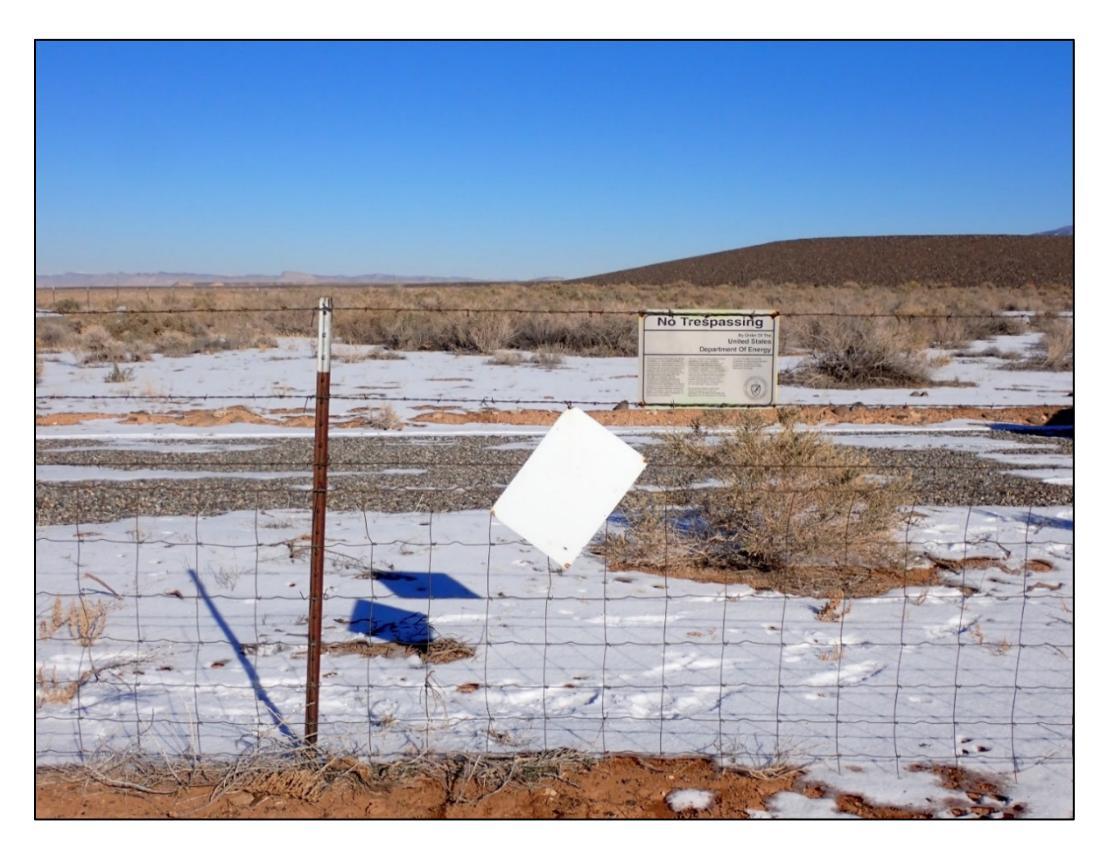
PL-4. Partially Detached Perimeter Fence Sign

- Replacement or repair of warning signs on the north and south perimeter fences
- Reset of the location stake at boundary monument BM-3
- Continued repairs on the areas adjacent to the perimeter road

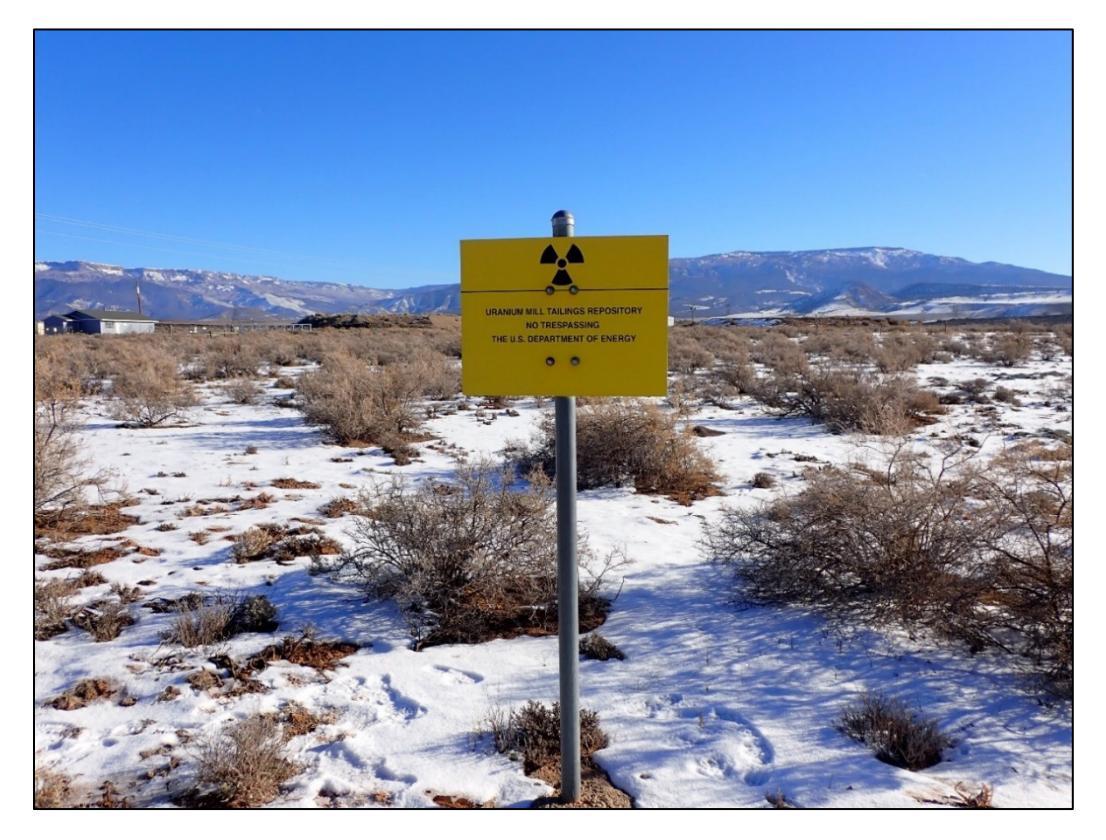
PL–5. Perimeter Sign P1

There are 29 perimeter signs attached to steel posts set in concrete positioned at regular intervals along the property boundary (PL-5). Several perimeter signs along the south property boundary are faded or peeling but remain legible. Perimeter signs P15 and P16, reported in 2021 with bullet damage, were replaced before the inspection. Perimeter sign P20, replaced in 2021 because of bullet damage, has bullet damage again but remains legible. No other maintenance needs were identified.

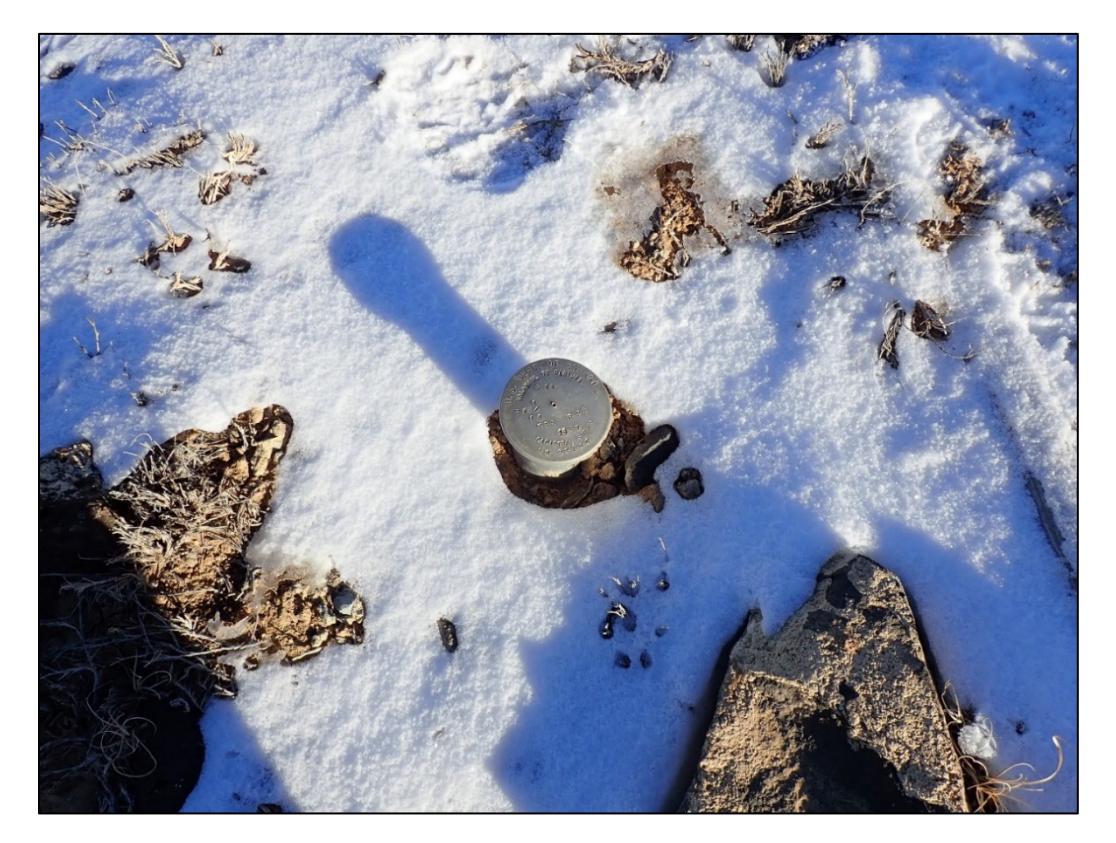
PL–6. Boundary Monument BM-1

Four boundary monuments delineate the corners of the property boundary (PL-6). All were present and in good condition. The location stake at boundary monument BM-3 needs to be reset. No other maintenance needs were identified.

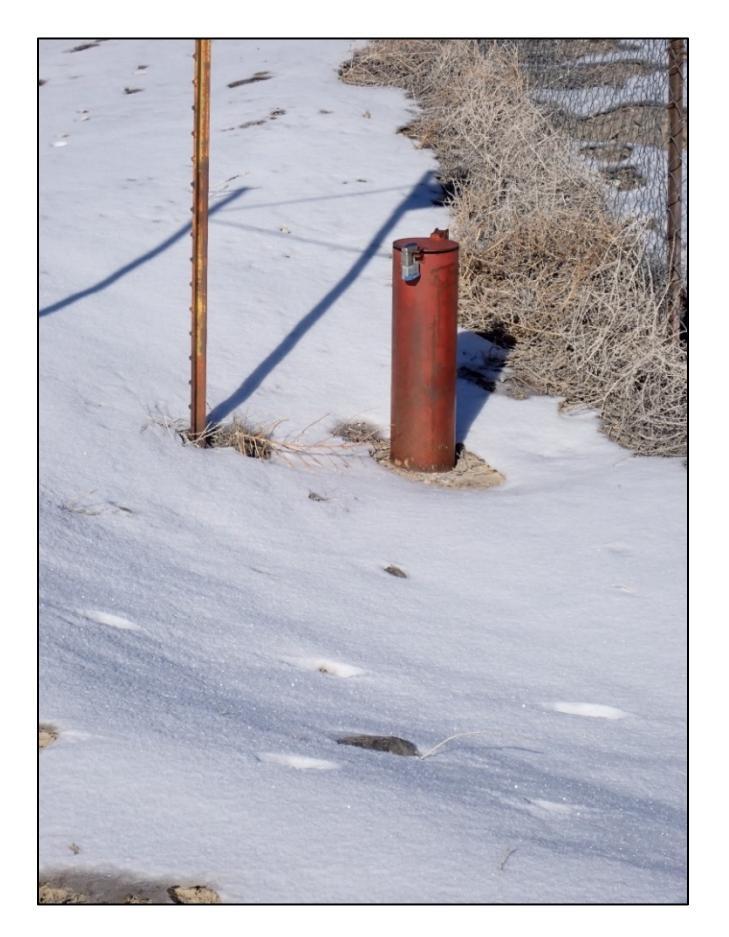
PL-7. Monitoring Well 0733

The groundwater monitoring network consists of three monitoring wells (0731, 0732, and 0733) (PL-7). All wellhead protectors were locked and undamaged. Root growth was observed in the well screens of monitoring wells 0731 and 0732 in 2021 (DOE 2022). The wells were redeveloped in 2022. Weed spraying around each wellhead was completed in spring 2022 to keep out any deep-rooted plants. No other maintenance needs were identified.

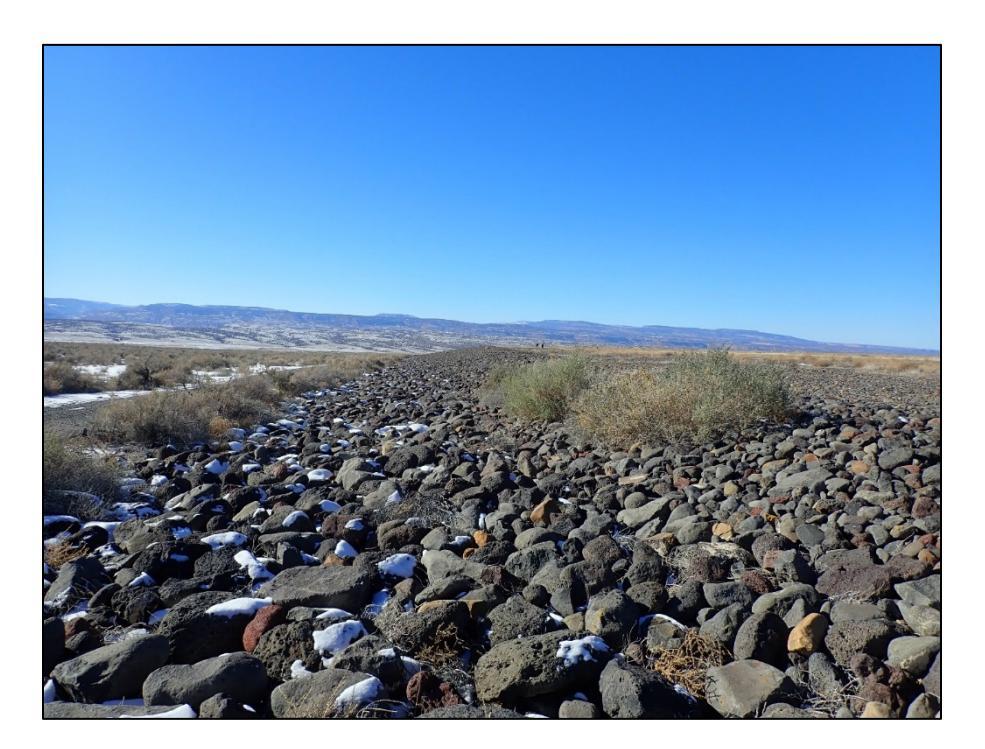
PL-8. South Side Slope of Disposal Cell

The closed portion of the disposal cell is armored with basalt riprap to control erosion (PL-8). The rock showed no significant weathering. Inspectors noticed an area, approximately 23×12 feet (ft), east of monitoring well 0733 that appears to be a low area. Inspectors will continue to monitor this area. There was no evidence of erosion, settling, slumping, rock degradation, or other modifying processes that might affect the integrity of the disposal cell (PL-9).

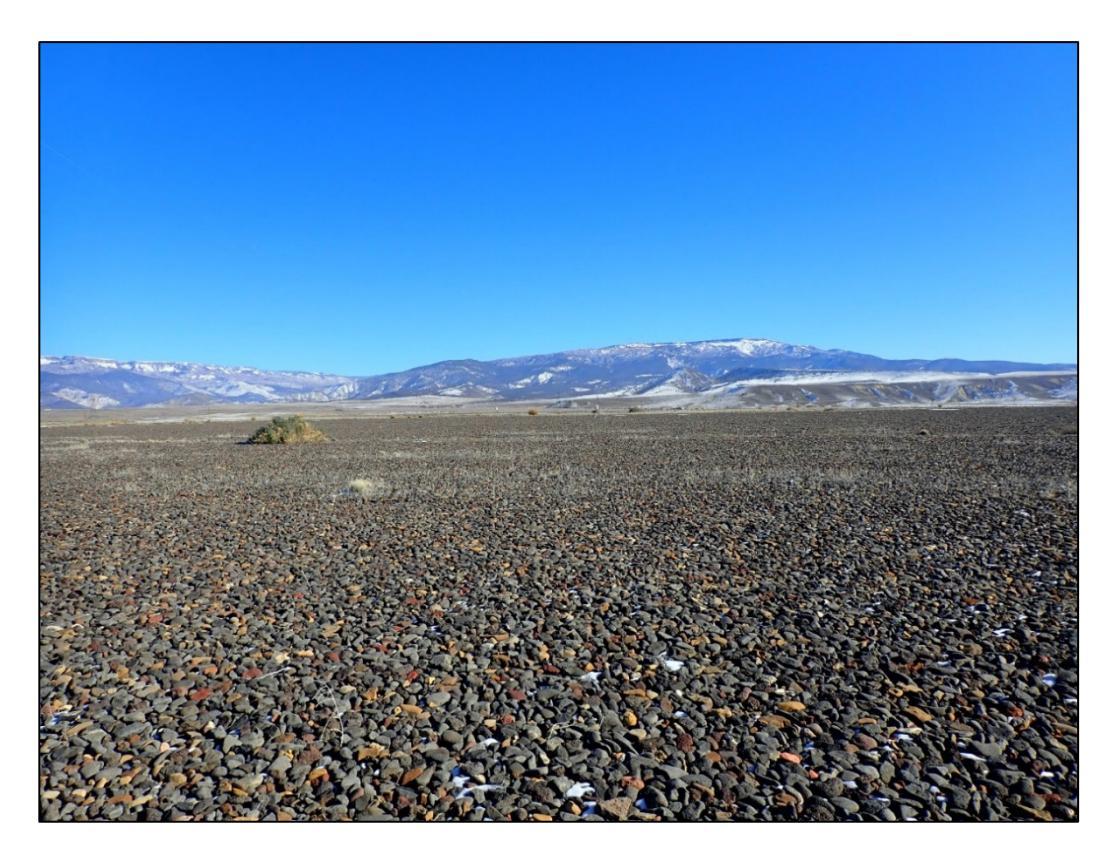
PL–10. Top of Disposal Cell

Grasses and weeds were growing on most of the disposal cell cover (PL-10). Historically, deep-rooted shrubs on top of the disposal cell have been treated with herbicide. Although treatment is not required by the Interim LTSP, LM plans to continue controlling the deep-rooted shrubs as needed. No maintenance needs were identified.

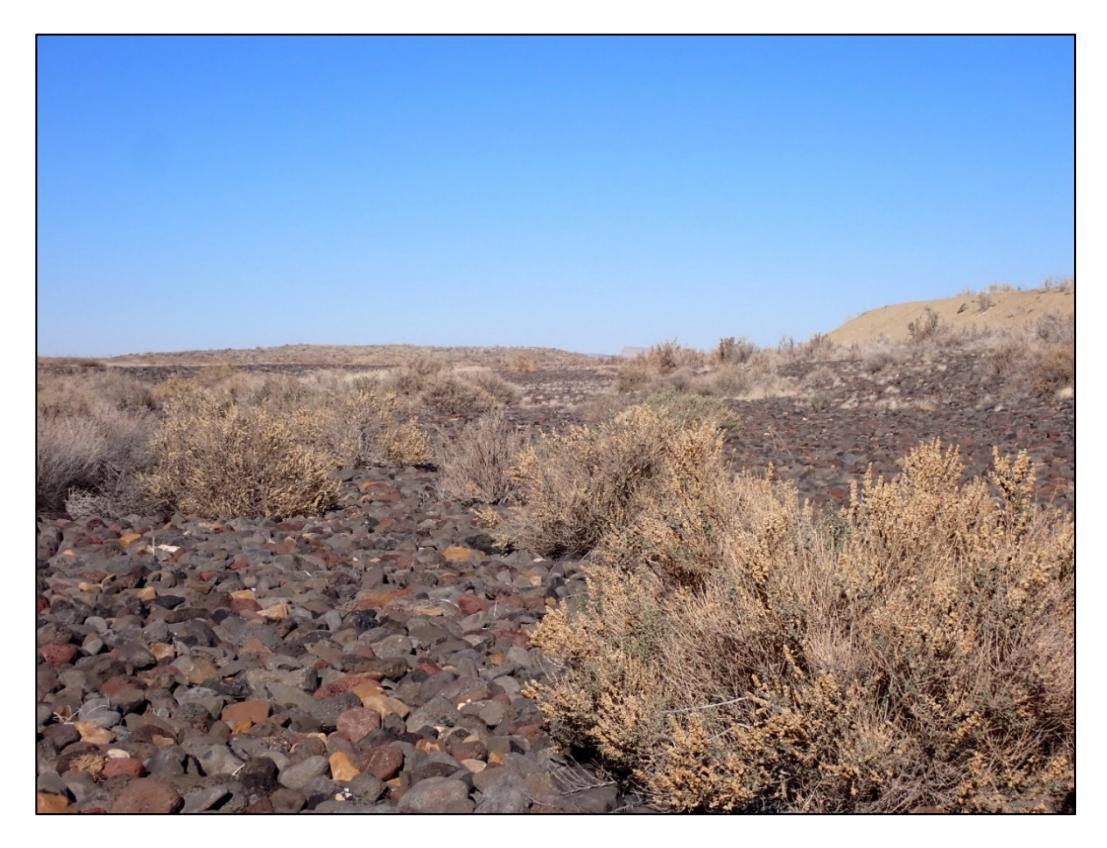
PL-11. South Diversion Channel

The south diversion channel is a large, riprap-armored structure that intercepts run-on water from offsite and onsite, as well as stormwater runoff from the disposal cell, and conveys the water into a natural drainage that flows away from the site to the southwest (PL-11). Grasses, weeds, and shrubs growing within the diversion channel are not expected to affect the channel's performance. The discharge area of the channel is armored with large-diameter basalt riprap. No maintenance needs were identified.
