ORNL/TM-2000/305

Results of the Indoor Radiological Survey of the Iowa Army Ammunition Plant, Middletown, Iowa

Draft Issued - November 2000

Prepared by the OAK RIDGE NATIONAL LABORATORY Oak Ridge, Tennessee 37831-6285 managed by UT-BATTELLE, LLC, for the U. S. DEPARTMENT OF ENERGY under contract DE-AC05-00OR22725

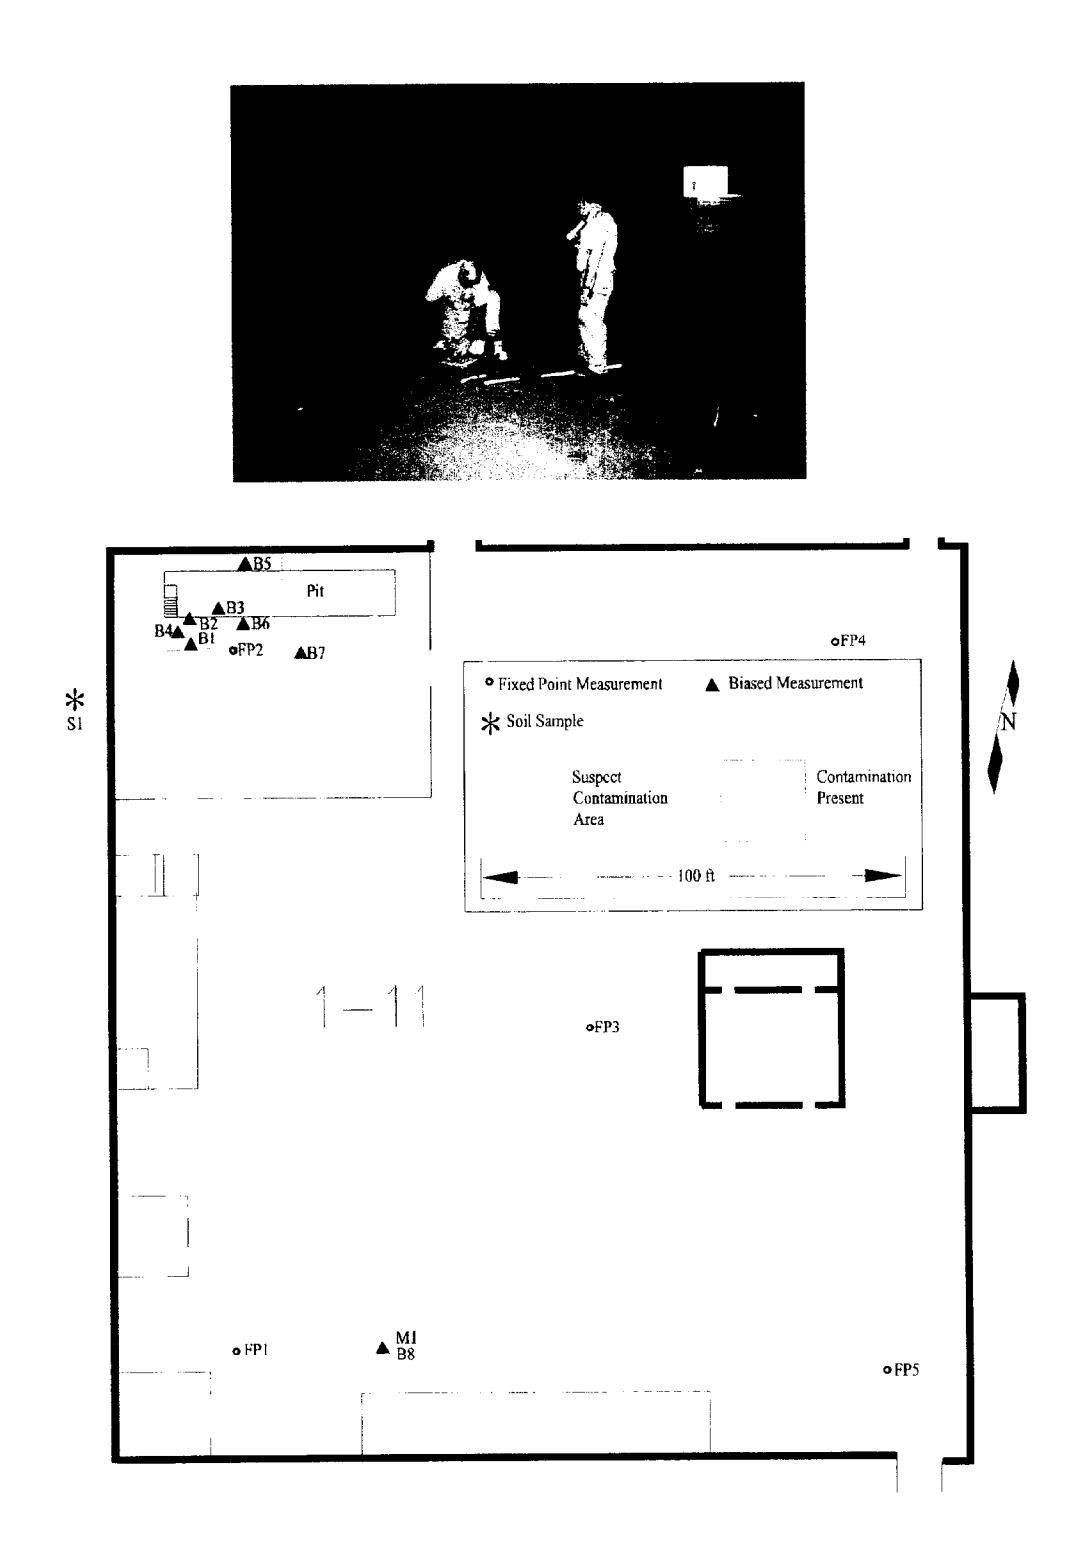
The contamination found in Building 1-11 is primarily limited to the northwest corner of the building. One small spot of contamination was found near the south loading dock. Fig. 4 illustrates areas of contamination. As expected, the highest residual contamination was found in the cracks and concrete seams. Samples M1 and M8 were analyzed by gamma spectroscopy to determine the contaminant to be DU. Smear samples T1, T2, and T3 indicated that the contamination is not transferrable under normal use. Soil sample S1 was collected outside the exit door in the northwest corner and contained only DU and a trace amount of cesium-137 consistent with fallout from aboveground weapons tests.

Also within the northwest corner of 1-11 is a pit containing about 18 inches of water and covered with a metal grate. Portions of the grate showed contamination up to 31,000 dpm/100 cm². The gamma exposure rates in the area were not distinguishable from background. Radiological survey results from the 1970s indicated radioactive materials were handled in this area.

Fig. 4. Diagram of Building 1-11 showing results of radiation survey and a view of sample collection.

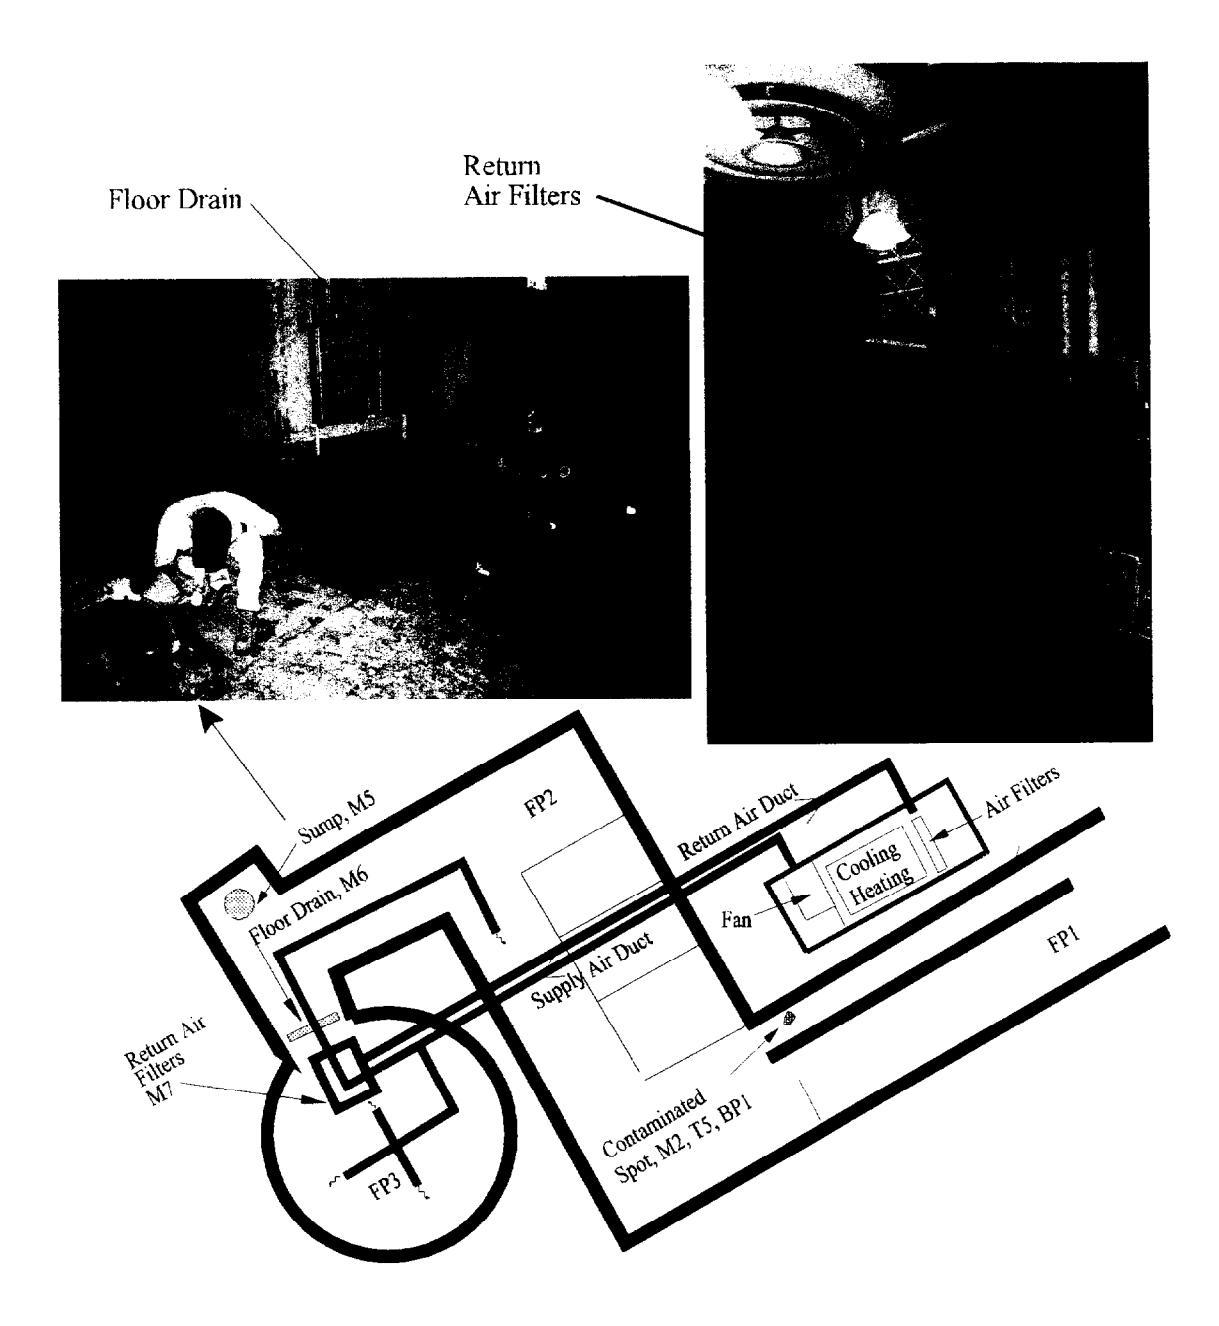
Contamination was found in four locations. It should be noted that just inside the entrance to 1-63-6 is a "Caution Radiation" sign indicating recent work with radioactive materials. Figure 5 details the layout of 1-63-6, the measurements and sample locations. All of the contamination found was identified by gamma spectroscopy as DU. A small spot ($<50 \text{ cm}^2$) of loose contamination was found near the entrance; however, smear sample T5 indicated the material was not readily picked up by conventional smear sampling. Sample M2 collected from the debris was analyzed and found to have 39,000 pCi/g DU. Direct measurements revealed 150,000 dpm/100 cm² beta, 290 dpm/100 cm² alpha, and 14 μ R/h gamma at the spot.

Samples were taken from a sump (M5) and floor drain (M6). Sample analysis showed 2.3 pCi/g and 86 pCi/g DU, respectively. The most significant contamination found was on the return air filters in the round process area of 1-63-6. Twelve 24" x 24" filters were mounted in a metal support housing. The filters were generally contaminated at levels of 20,000 to 30,000 dpm/100 cm² beta-gamma. Given the poor measurement geometry, the likely radioactivity is reasonably higher. Measurements inside the ductwork and downstream filters showed no additional contamination. A portion of one of the filters was collected as sample M7, and analysis of the sample by gamma spectroscopy showed 2600 pCi/g of DU.

Fig. 5. Diagram of Building 1-63-6 showing results of radiation survey and views of return air filters and sample collection.

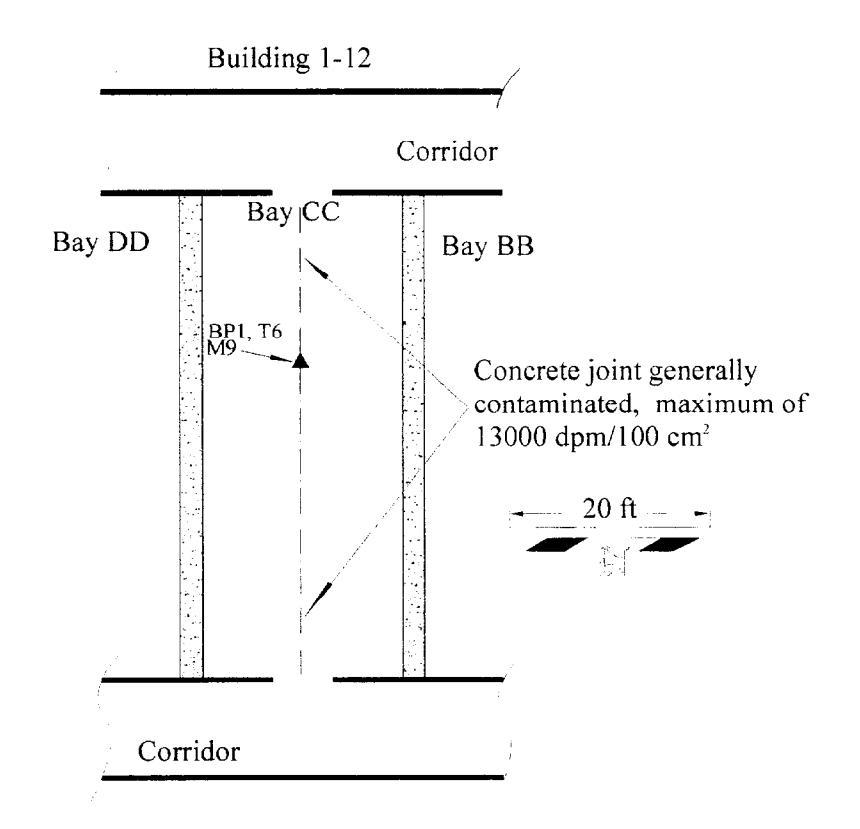
The areas surveyed in Building 1-12 were the bays designated with double letters (AA through FF). The contamination found was limited to the concrete seam in Bay CC. The maximum measurement was 13,000 dpm/100 cm² beta. Analysis of sample M9 by gamma spectroscopy indicated the contamination to be DU. Figure 6 illustrates areas of contamination.

Fig. 6. Diagram of Building 1-12 showing results of radiation survey.
