Memorandum

Date: 13 April 2011

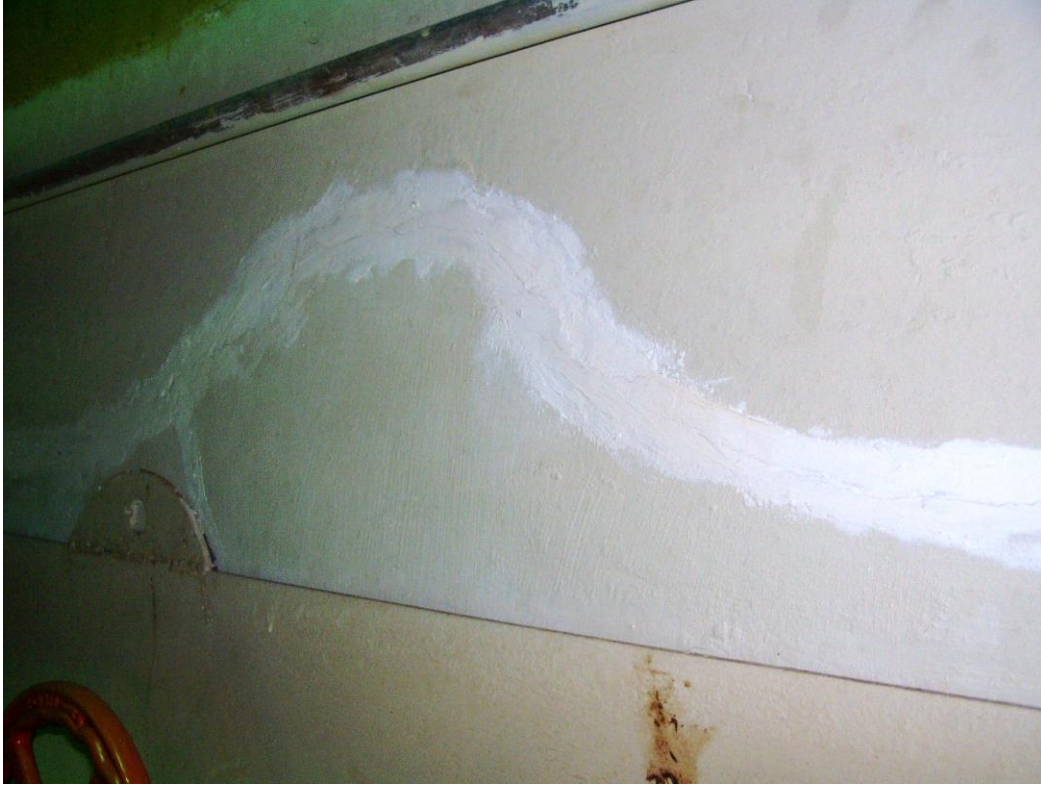
Figure 1. Entombment Top (North Side) – Surface Cracks (Typical)

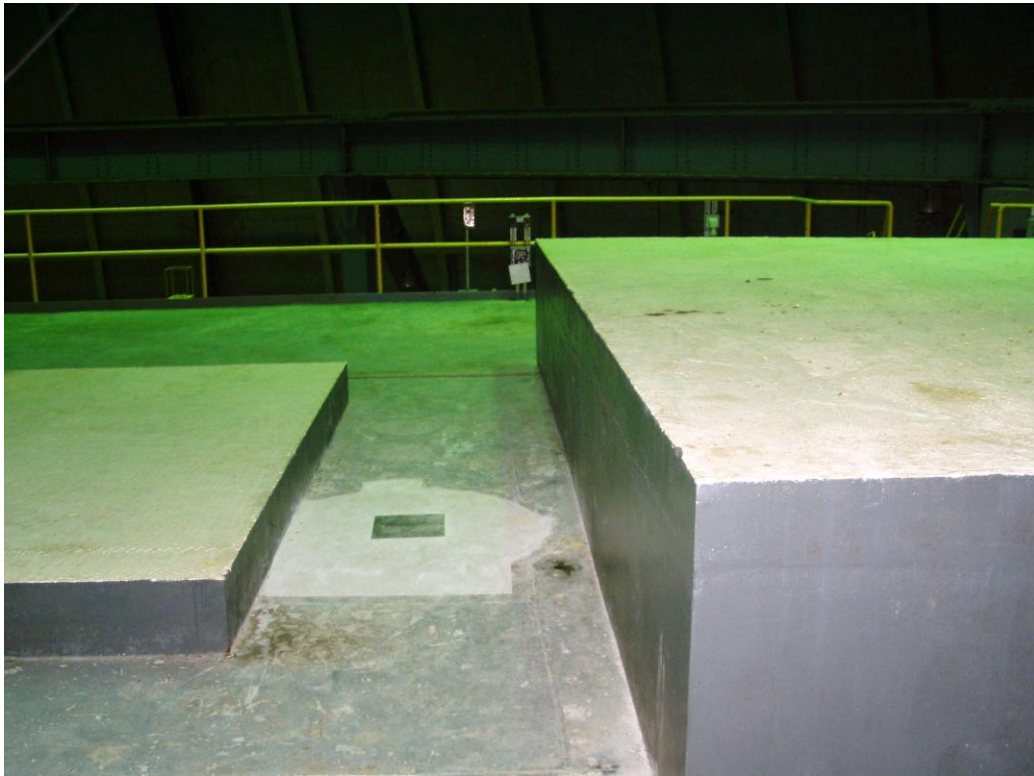
Figure 2. Entombment Top (Top Plug)

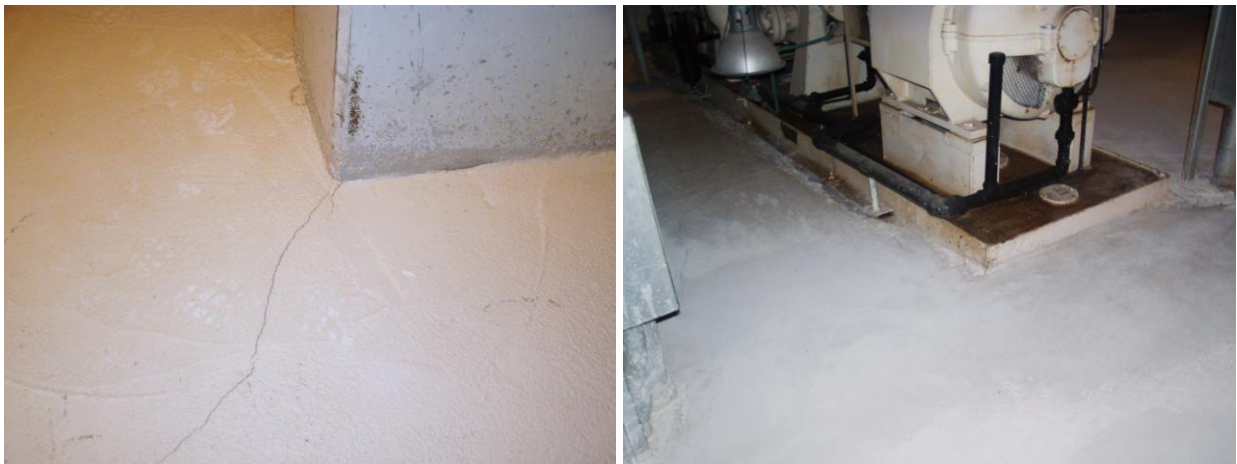
Figure 8a and 8b. Basement Level – Surface Cracks in Concrete Cover (Typical)

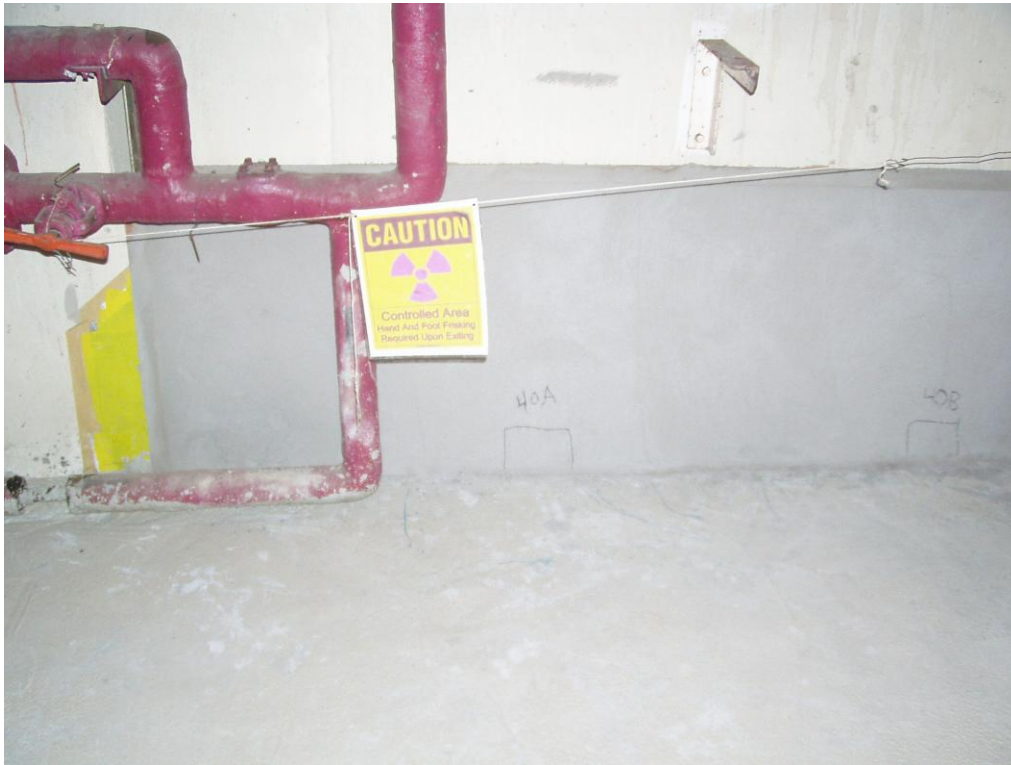
Figure 9. Basement Level – Survey Locations 40A and 40B

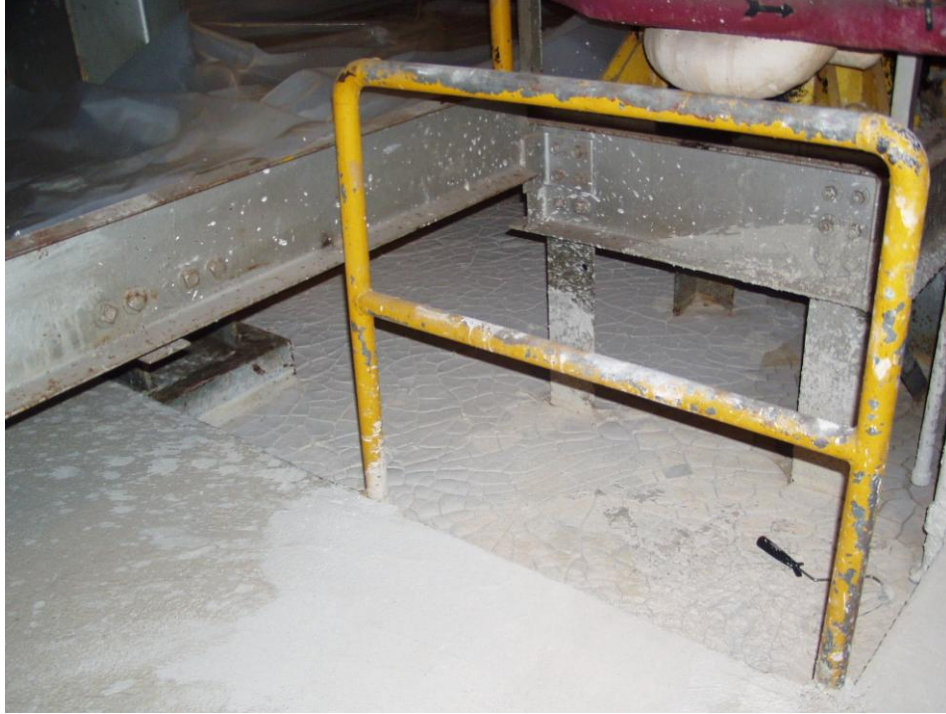
Figure 25. Basement Level – Lowest Point in Basement Shows No Recent Signs of Flooding (Dry, Cracked Silt/Mud is Visible)

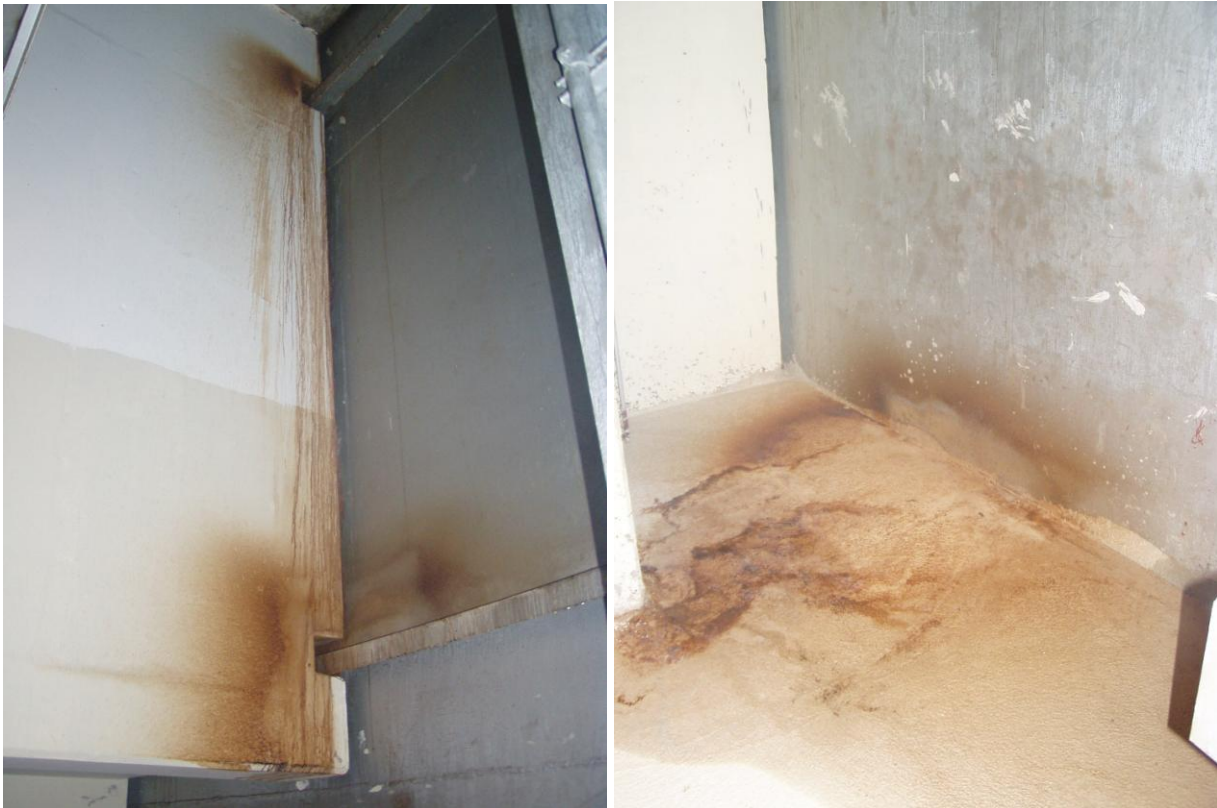
Figure 26a and 26b. Basement Level – Staining Due to Water Infiltration beneath Northern Entrance

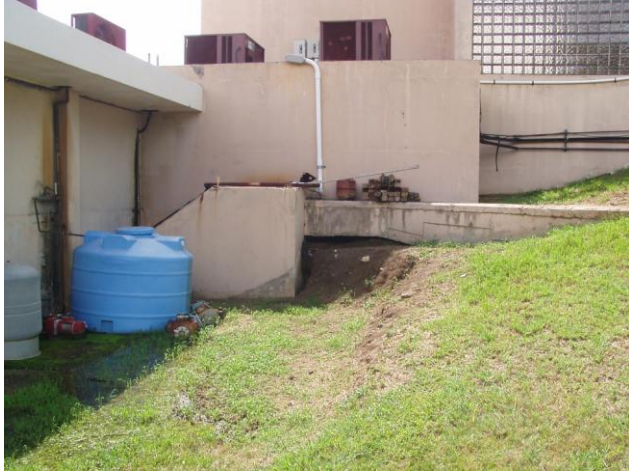
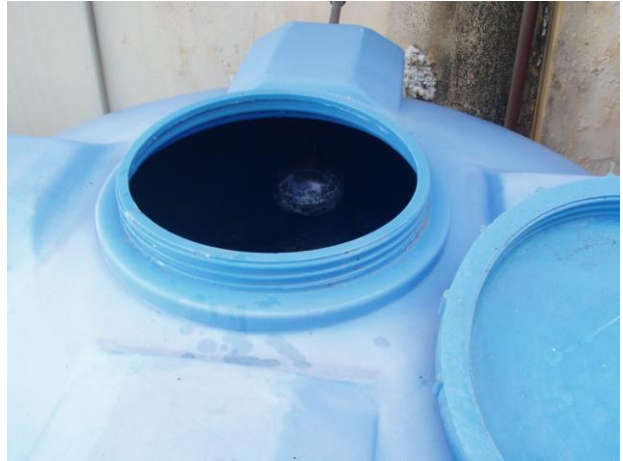
Figure 32a and 32b. Water Storage Tank with Malfunctioning Float Switch (32b) – Resulting in Overflow and Pooling Water on Ground (32a)
