**DR. MODESTO IRIARTE TECHNOLOGICAL
MUSEUM (FORMER BONUS FACILITY)**

2012 ANNUAL RADIOLOGICAL SURVEY REPORT

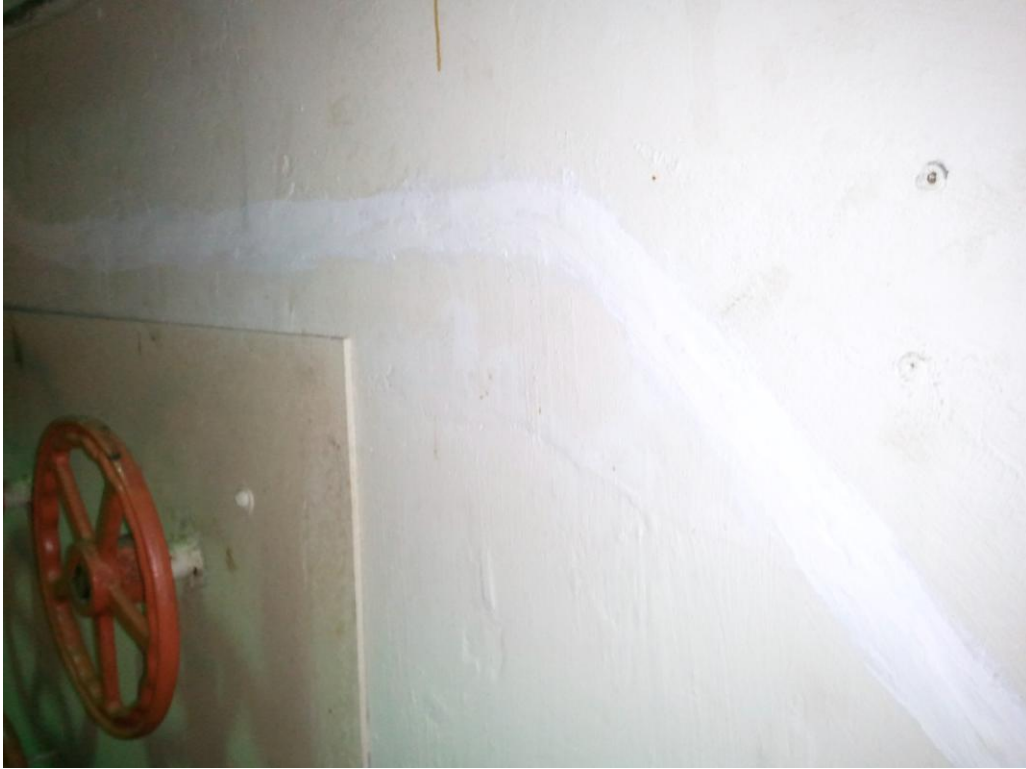
Figure 1. Entombment Top (North Side) – Surface Cracks (Typical)

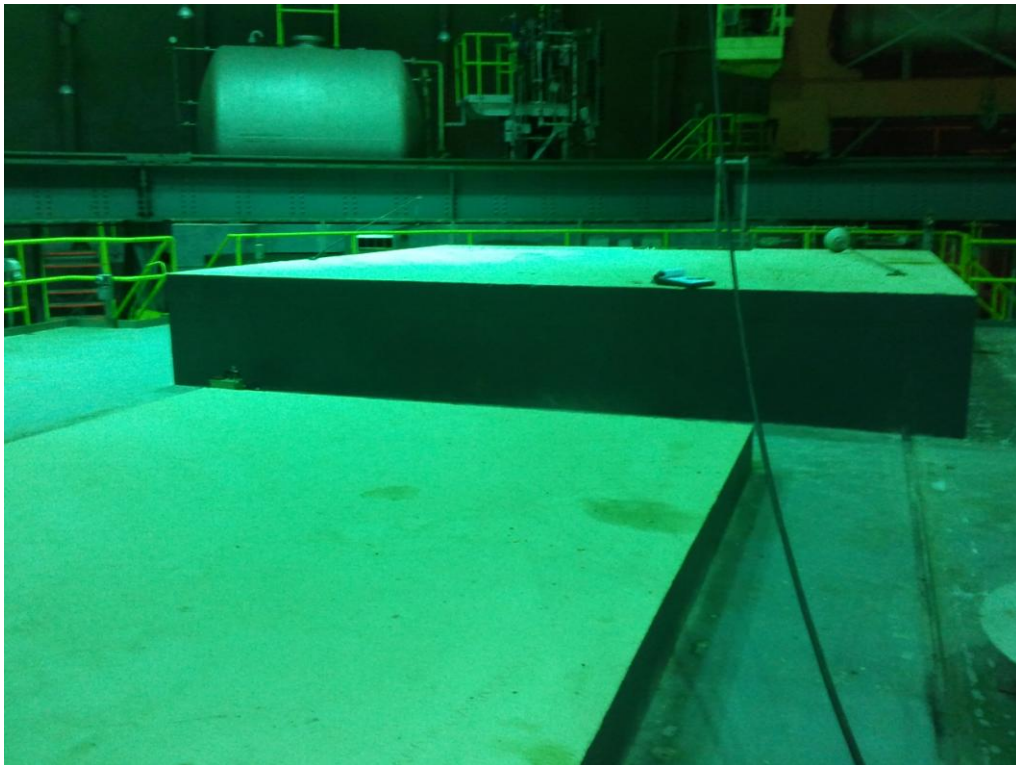
Figure 2. Entombment Top (Top Plug)

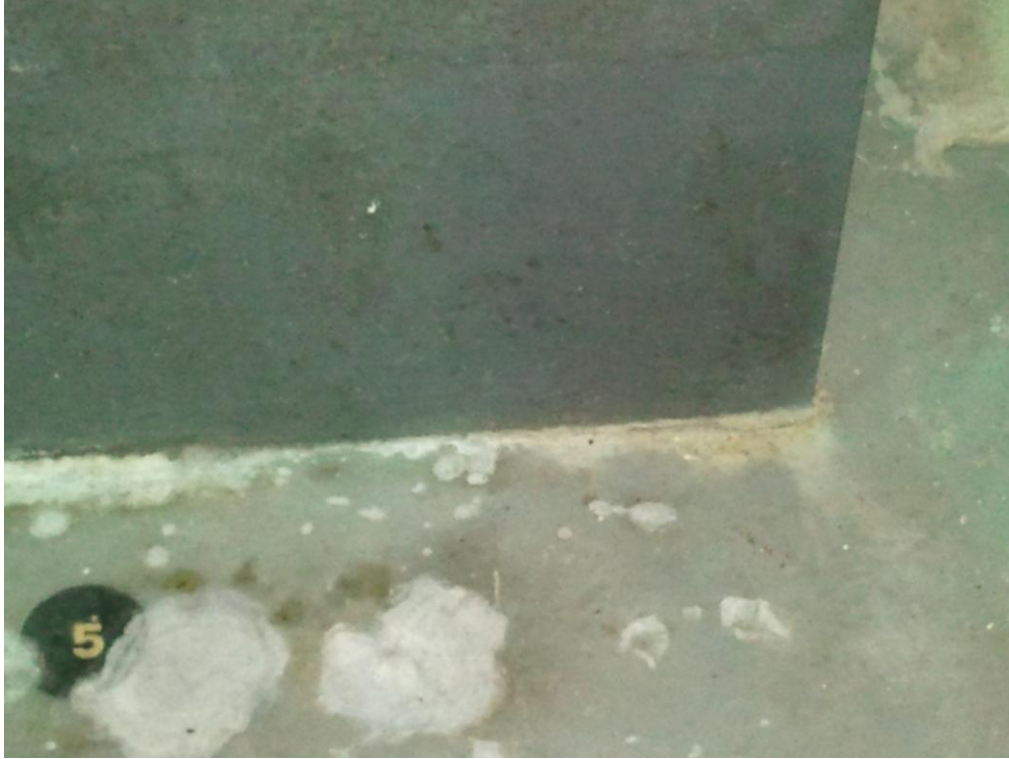
Figure 3. Entombment Top (Top Plug) – Surface Cracks (Typical)

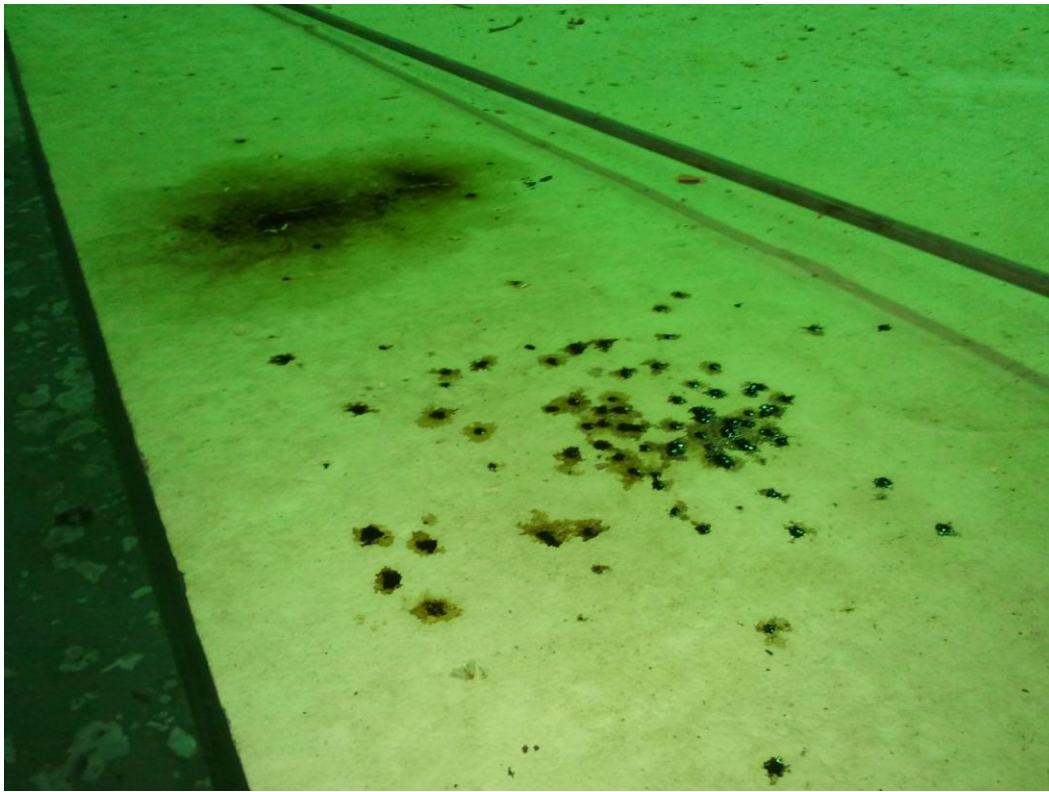
Figure 4. Entombment Top (Top Plug) – Oil Drip/Stains from Overhead Crane

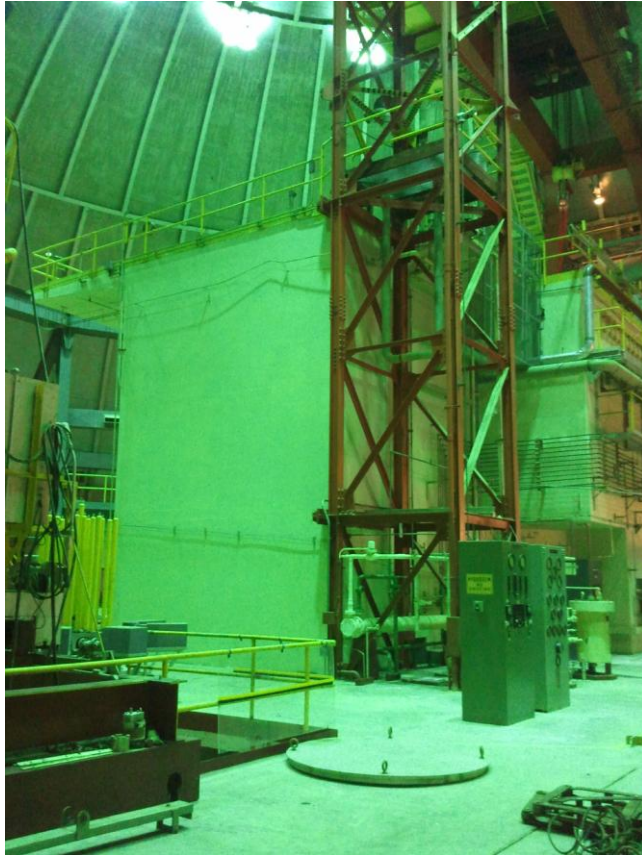
Figure 5. Entombment (Northeast Side)

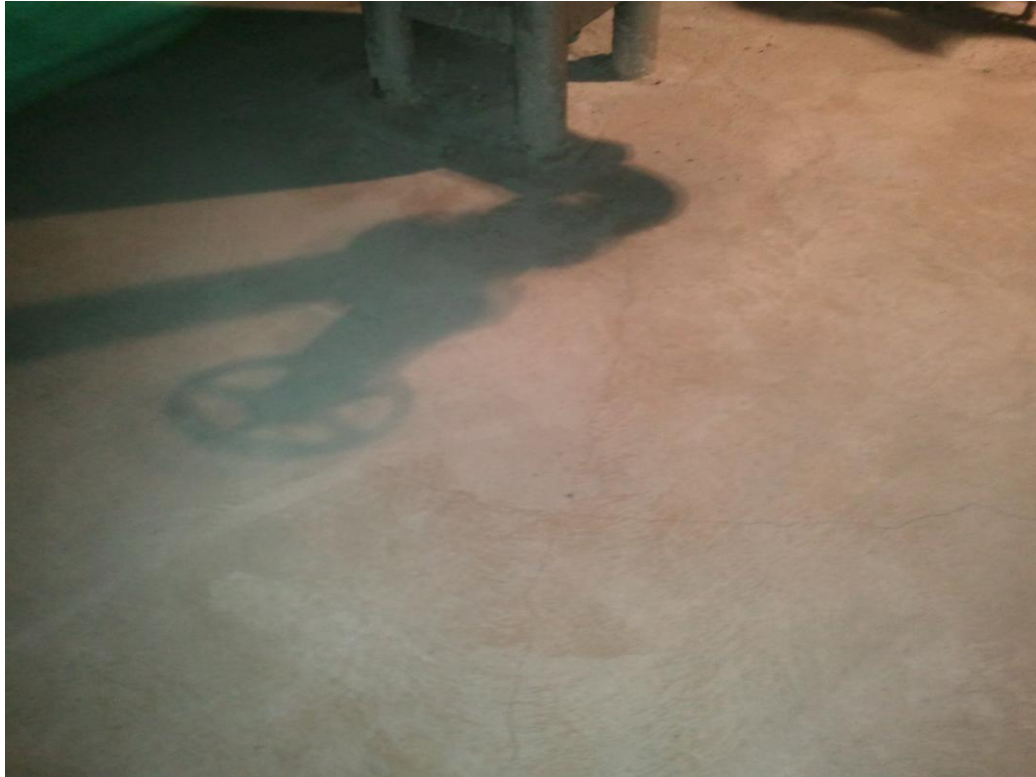
Figure 17. Basement Level – Cracks in Concrete Floor (Typical)

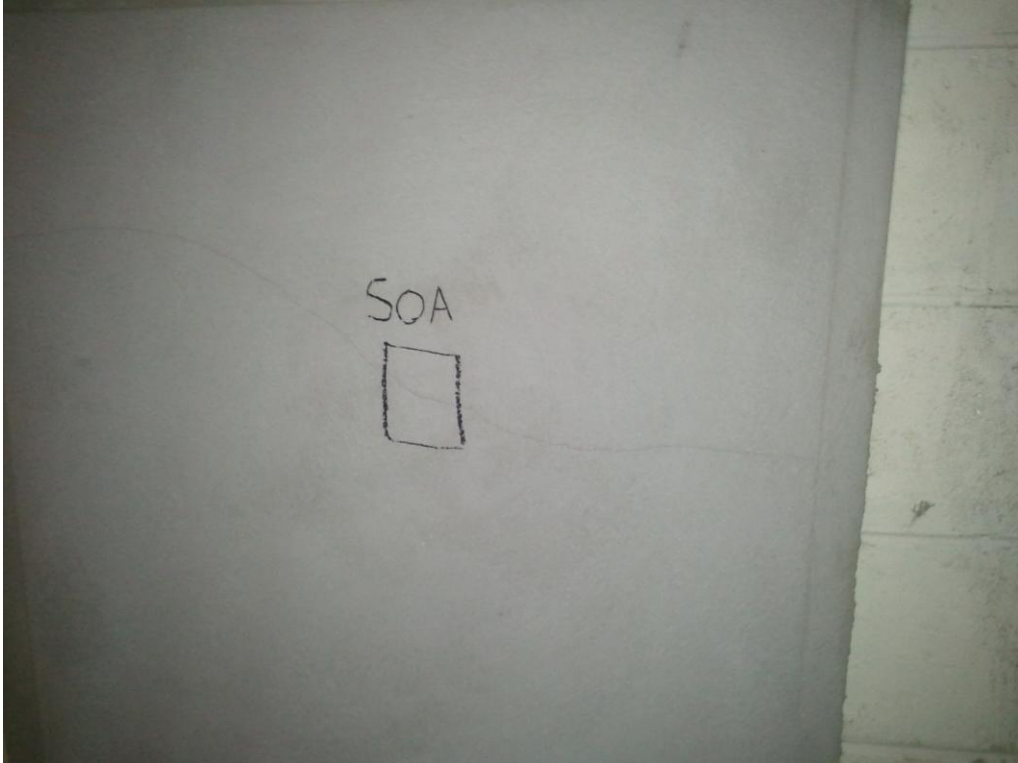
Figure 18. Basement Level – Sample Location 50A (Small Crack in Concrete Shielding)

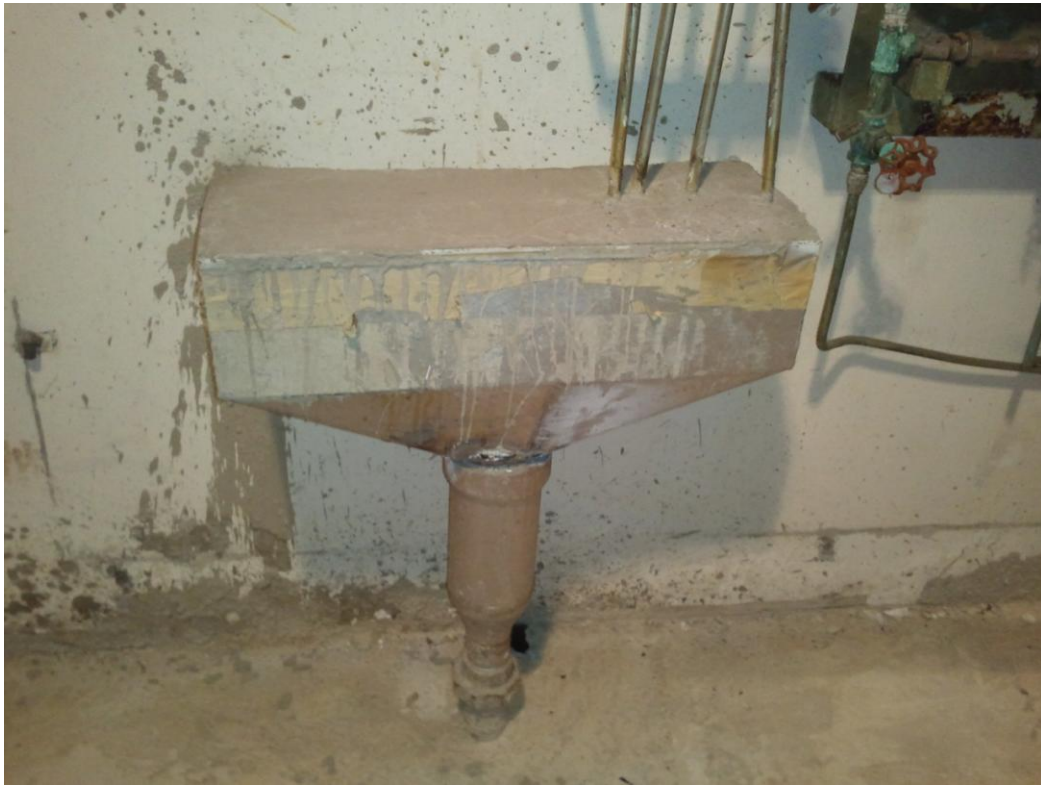
Figure 19. Basement Level – Concrete Filled Sink

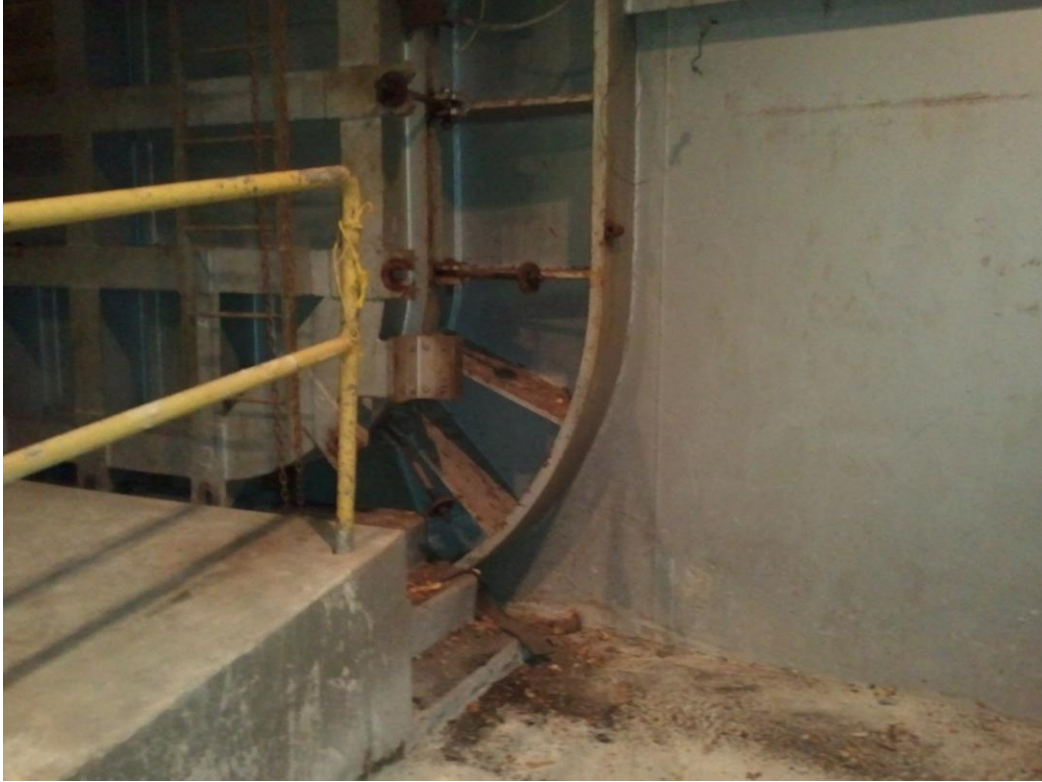
Figure 22. Basement Level – Loading Access Door (No Signs of Leak through Door)

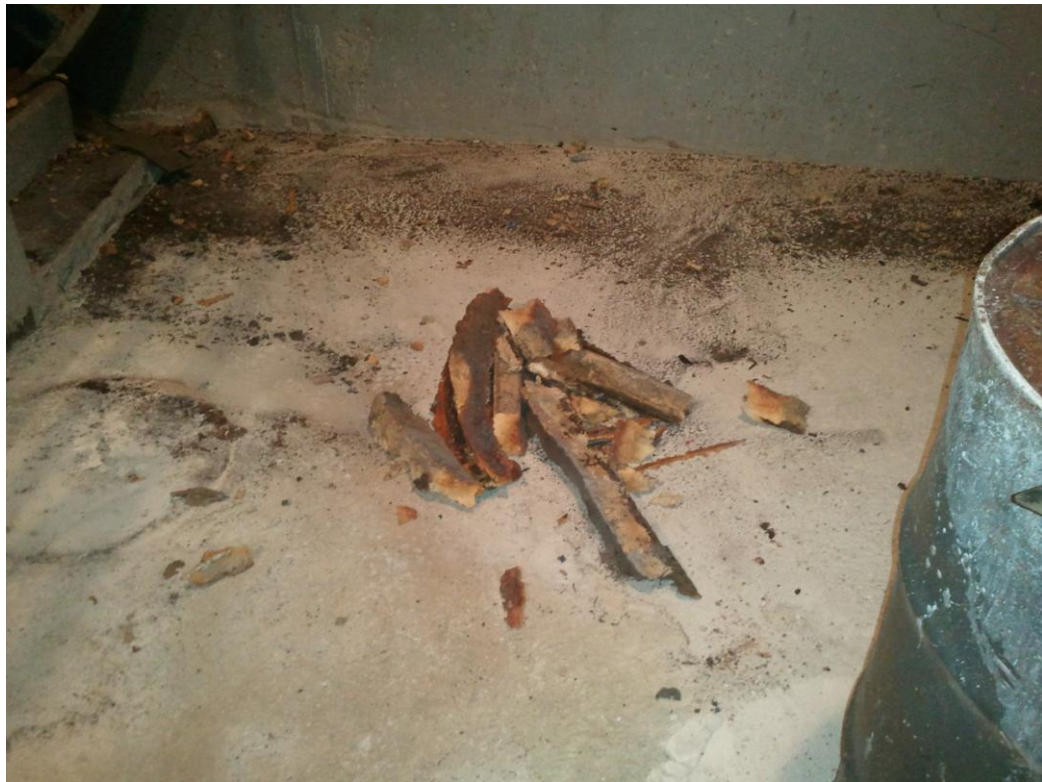
Figure 23. Basement Level – Loading Access Door (Debris from Old Seal Material)

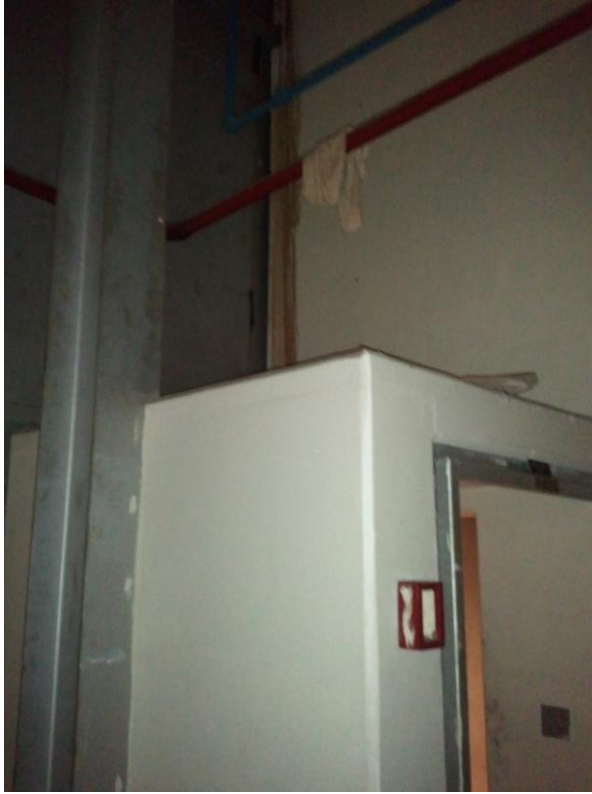
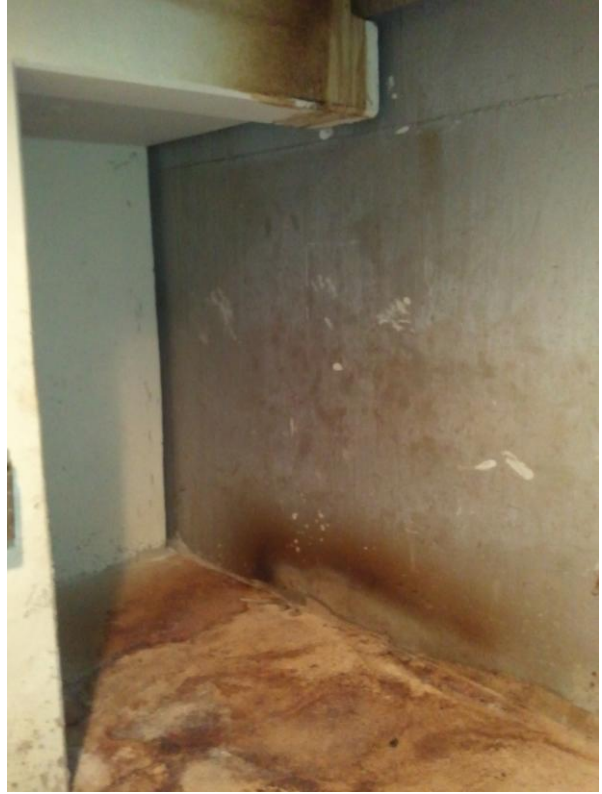
Figures 26A and 26B. Basement Level – Beneath North Entrance (No Signs of Recent Water Leak into Basement Level)

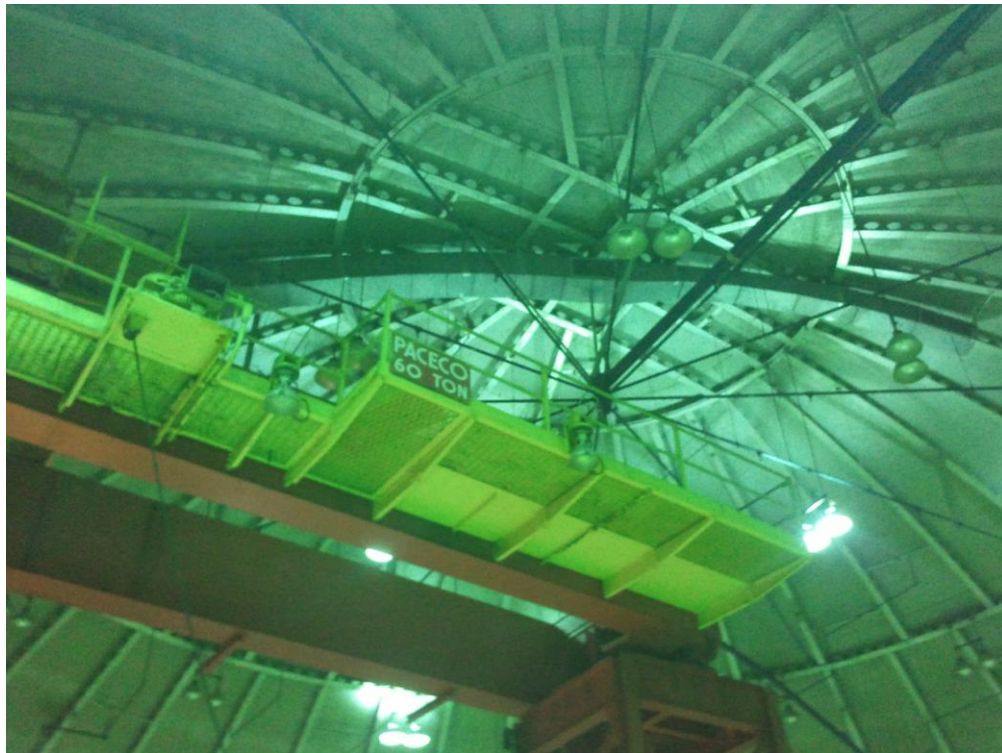
Figure 27. Dome Structure – Interior with Fire Suppression Piping

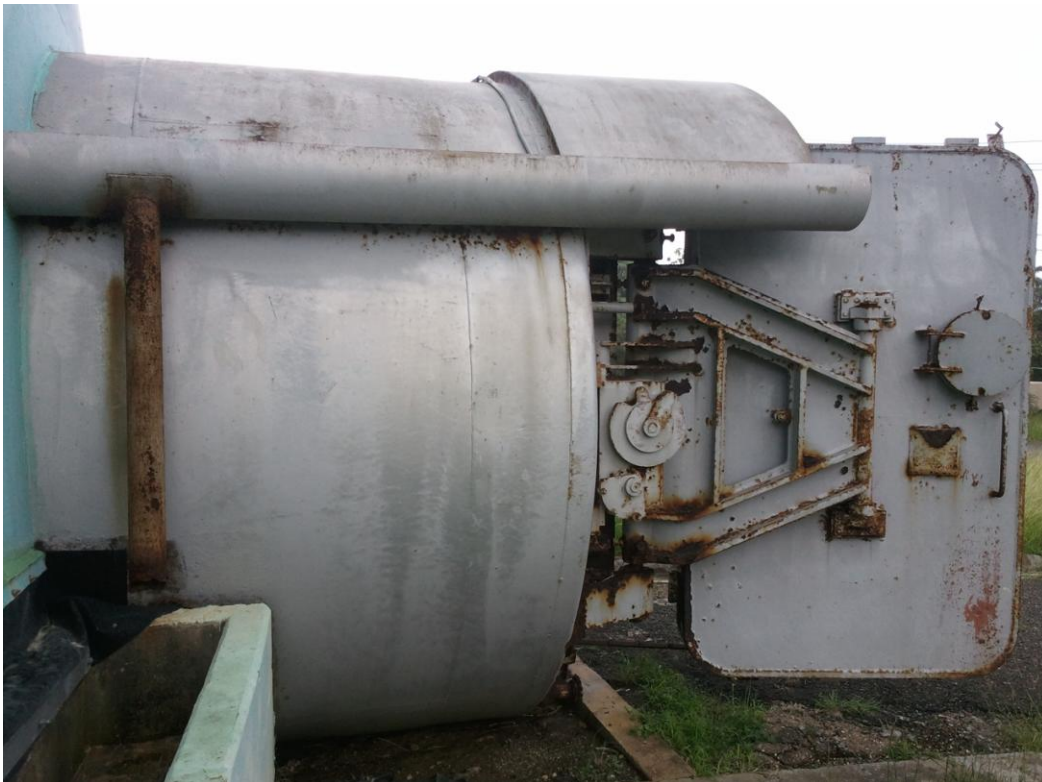
Figure 29. Dome Structure – North Entrance (Exterior with Significant Corrosion)

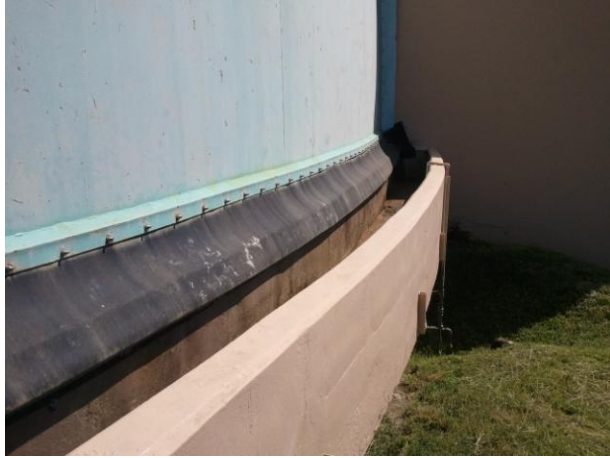
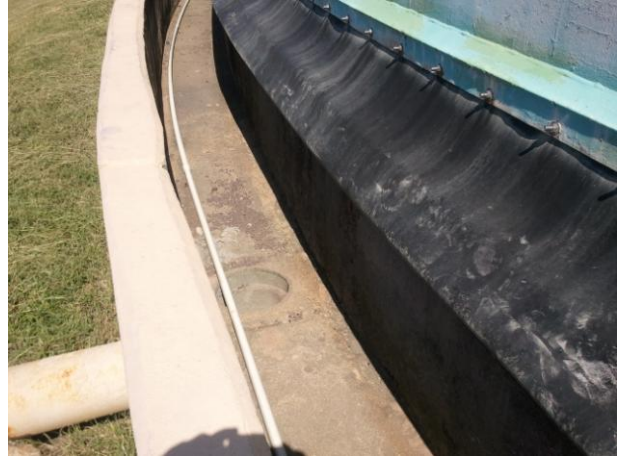
Figures 30A and 30B. Dome Structure – Flexible Gasket/Seal
