4.0 Durango, Colorado, Disposal Site

The U.S. Department of Energy (DOE) Office of Legacy Management (LM) conducted the Durango, Colorado, Uranium Mill Tailings Radiation Control Act (UMTRCA) Title I Disposal Site (site) annual inspection on June 16, 2020, and the annual groundwater monitoring event in June 2020. No cause for a follow-up inspection was identified.

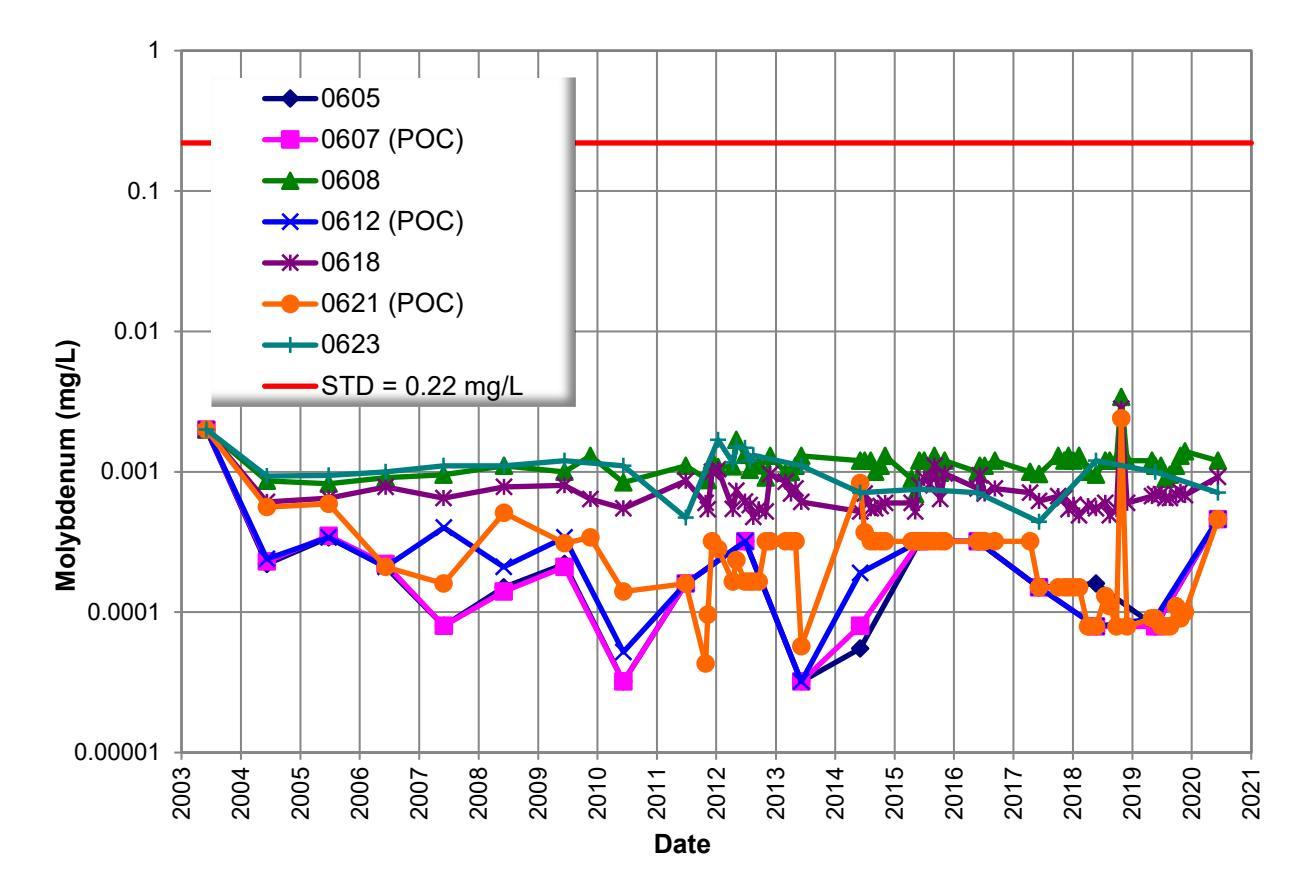
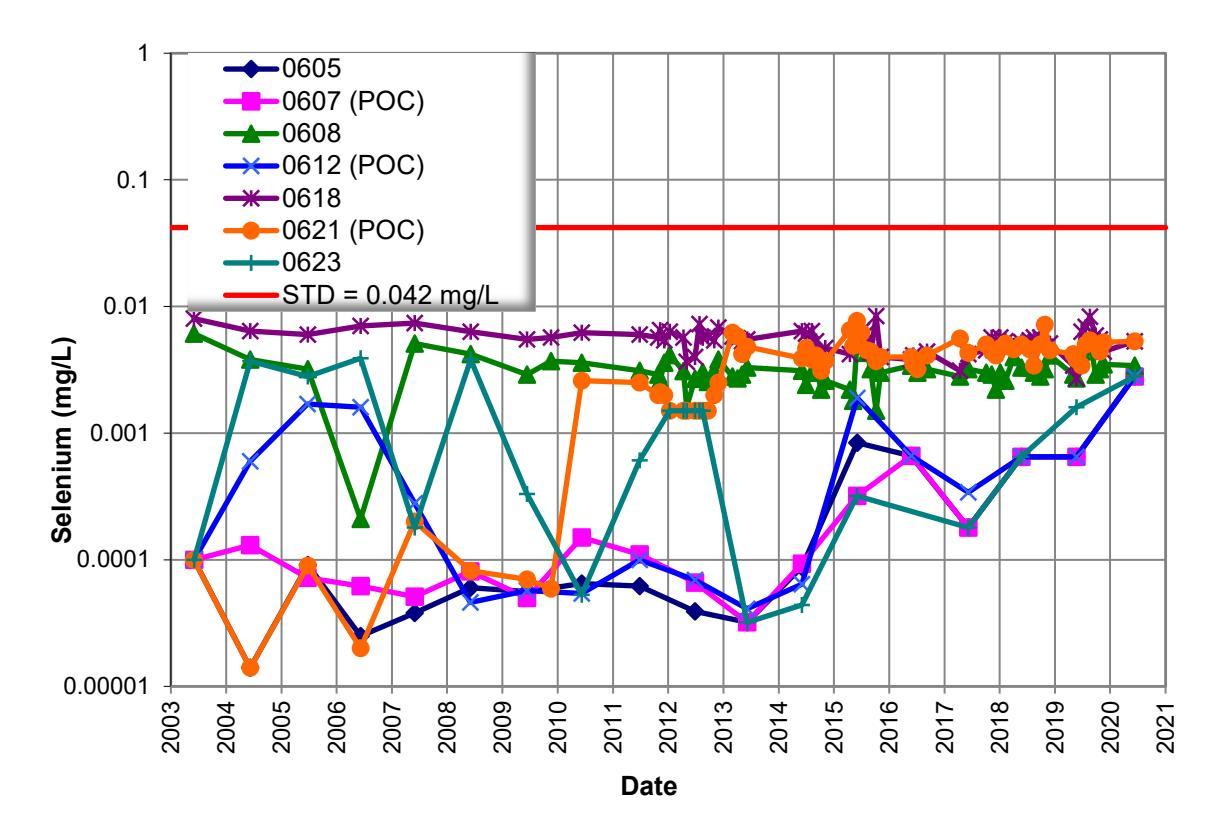
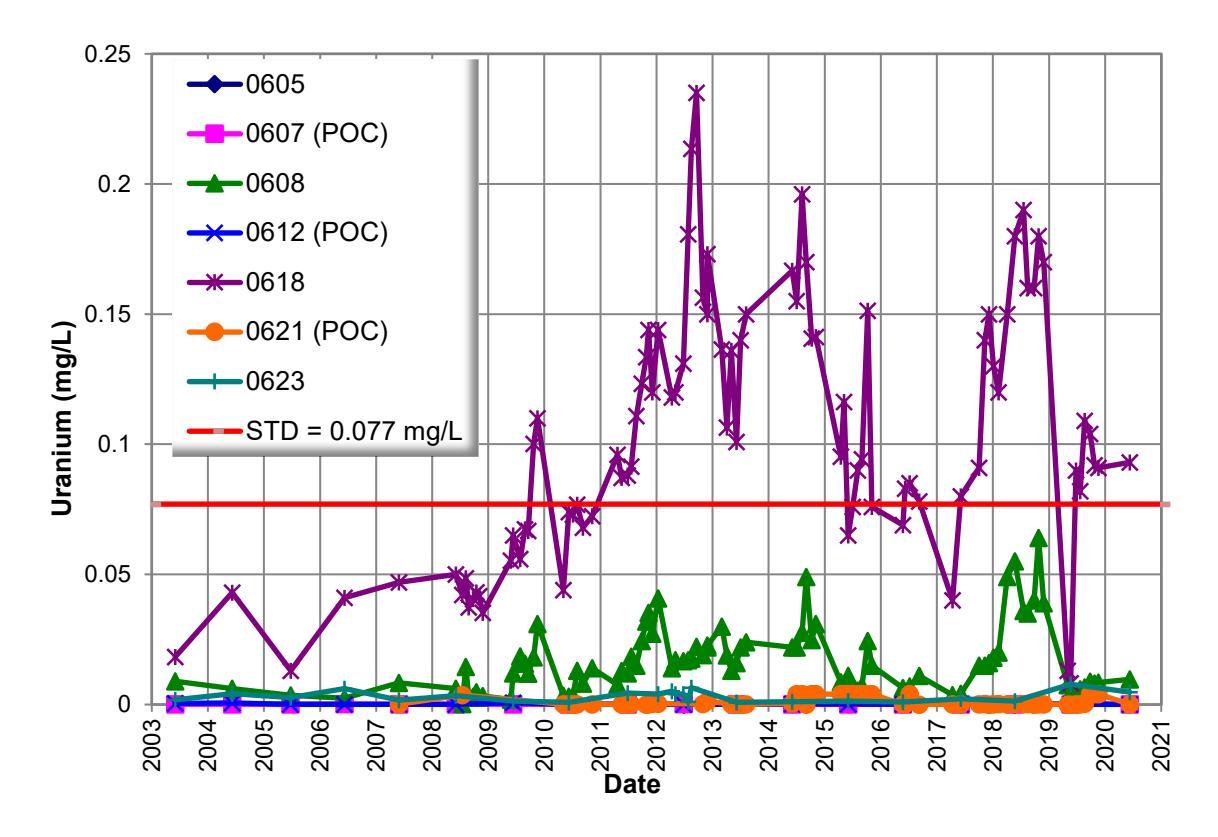
Figure 4-3. Molybdenum in Groundwater at the Durango, Colorado, Disposal Site

Figure 4-4. Selenium in Groundwater at the Durango, Colorado, Disposal Site

Figure 4-5. Uranium in Groundwater at the Durango, Colorado, Disposal Site

Molybdenum, selenium, and uranium concentrations in POC wells (0607, 0612, and 0621) in the uppermost aquifer are below their respective standards.

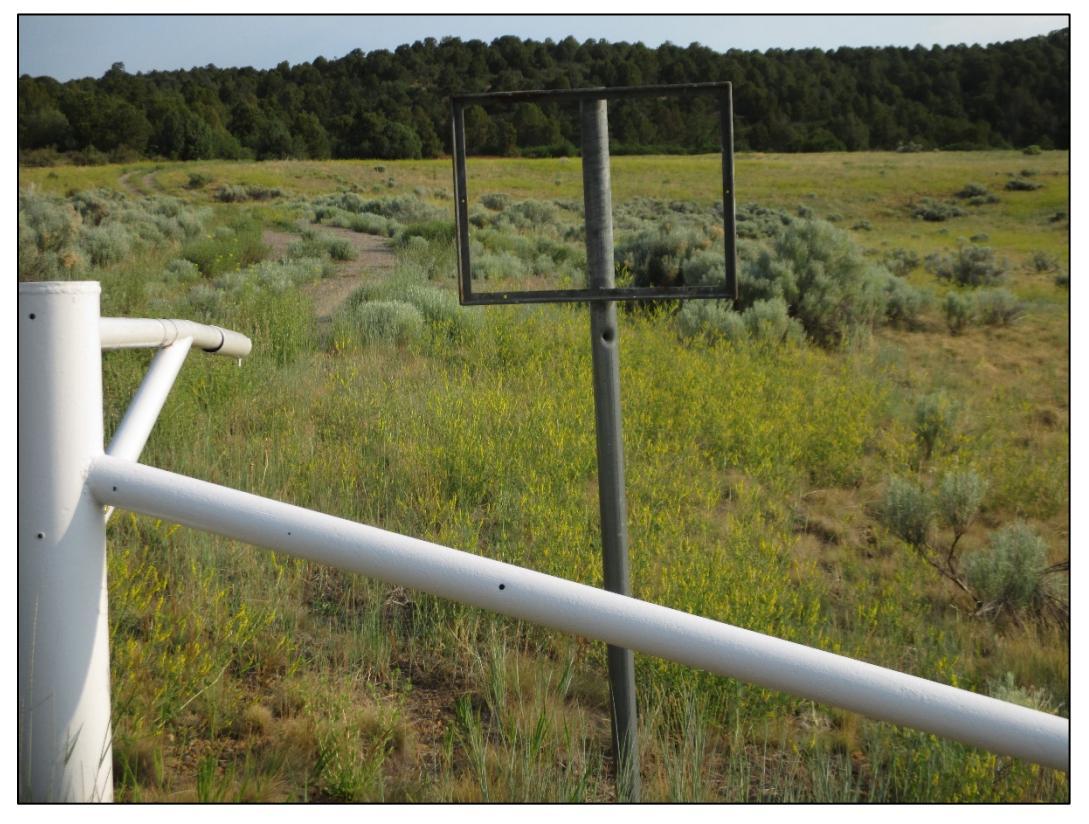
The entrance sign is at the older entrance gate within the property boundary. Though the post for the sign was present, the sign was missing (PL-1). The sign was replaced following the inspection.

PL-1. Entrance Sign Missing

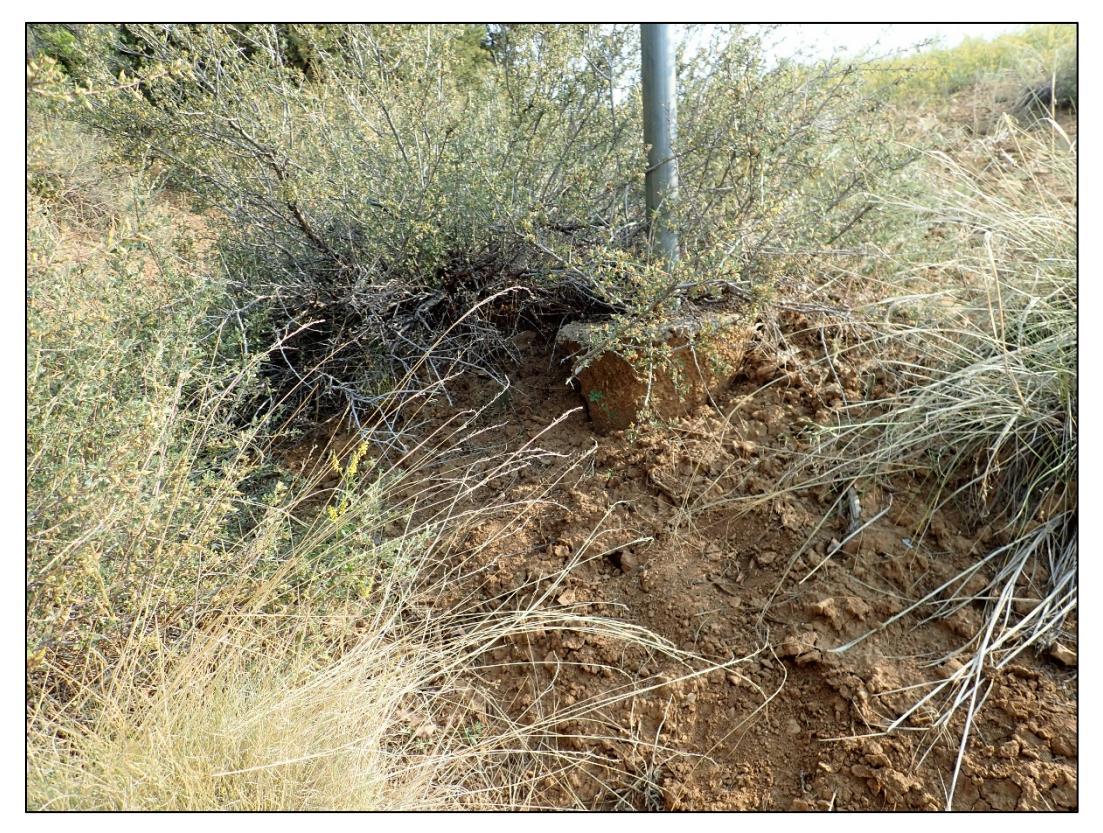
The concrete bases of several perimeter signs have been and continue to be undercut, but the positions of the signs remain uncompromised. Inspectors noted several maintenance issues associated with the signs (1) the base of perimeter sign P79 was actively eroding and needs to be stabilized (PL-2) and (2) vegetation needs to be cleared from around perimeter signs P4 and P60 (PL-3 and PL-4, respectively) and (3) perimeter sign P1 was missing. These issues were addressed following the inspection.

PL-2. Perimeter Sign P79 Undercut by Erosion

- Replacing the missing entrance sign and perimeter sign P1
- Removing vegetation from around perimeter signs P4 and P60 and boundary monument BM-5
- Reinforcing the eroding base of perimeter sign P79
- Installing T-posts (with reflectors) at the five quality control survey monuments
- Treating woody species on the side and top slopes of the disposal cell
- Picking up trash in the southwest corner of the site by the entrance gate

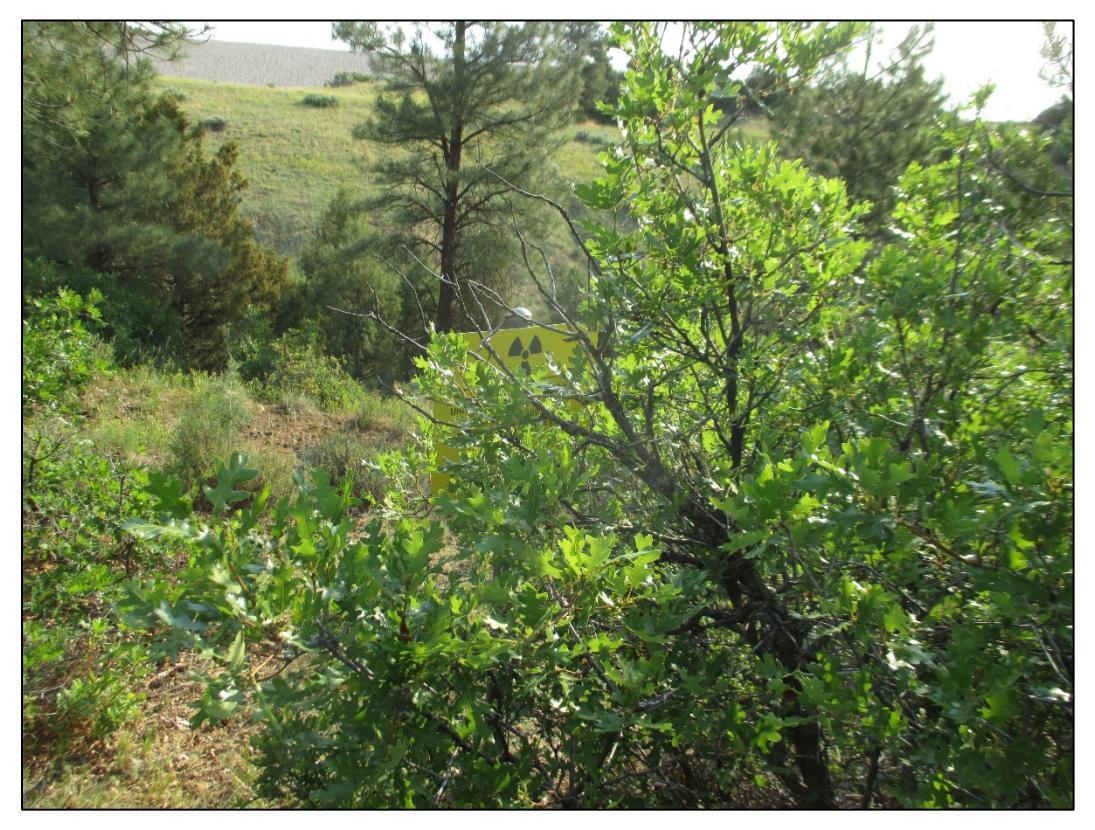
PL-3. Vegetation Surrounding Perimeter Sign P4

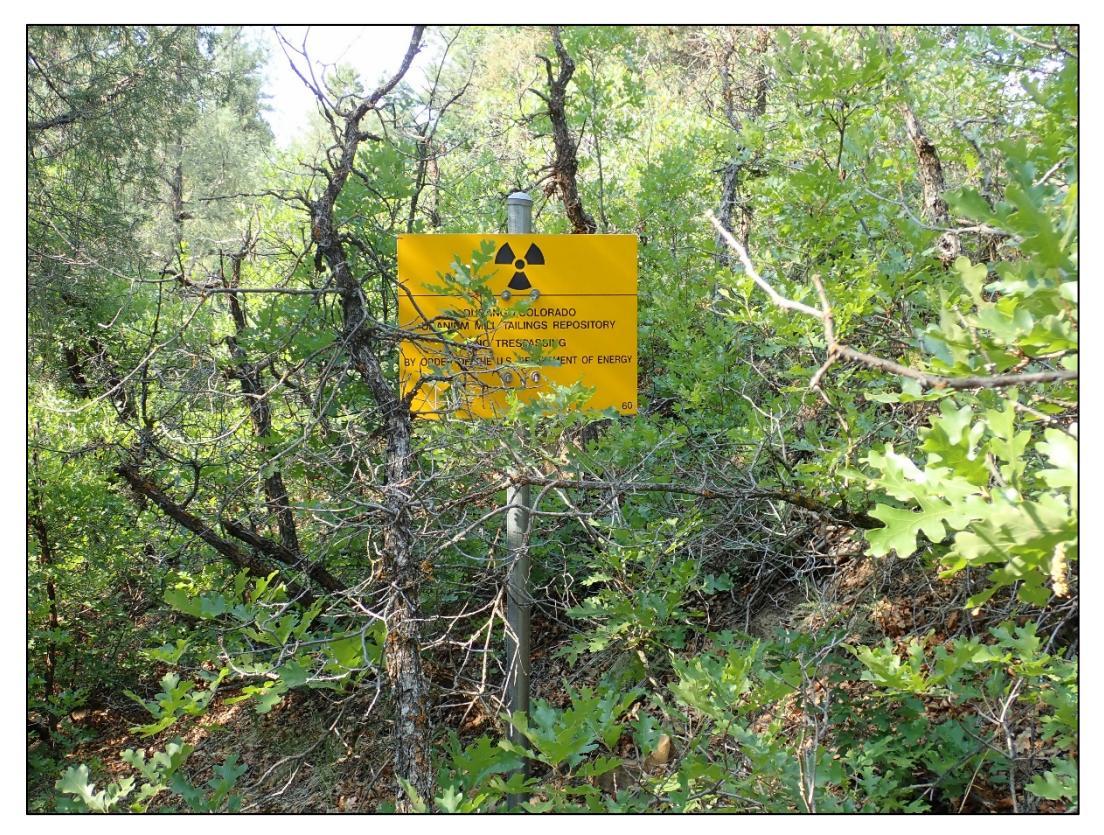
PL-4. Vegetation Around Perimeter Sign P60

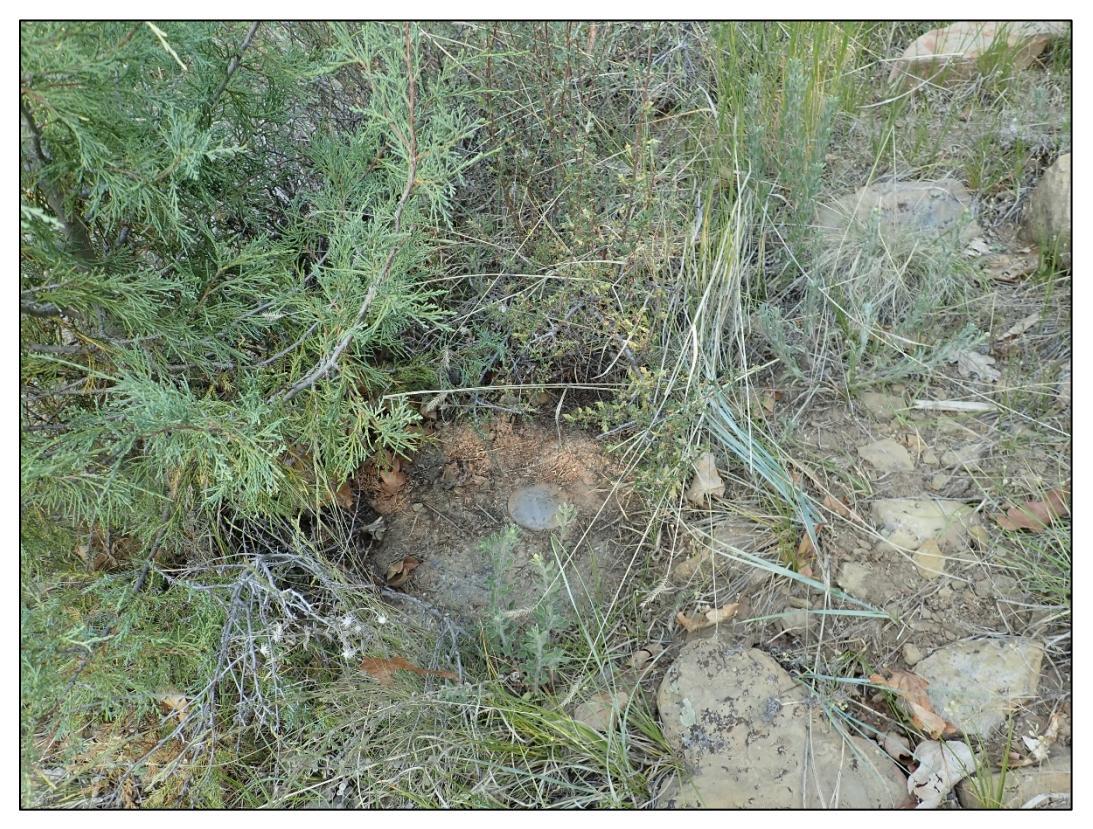
Four survey monuments and six boundary monuments (each with two witness corners) delineate the property boundary. All monuments were inspected. Boundary monument BM-6 has been missing since the adjacent U.S. Bureau of Reclamation (USBR) pipeline was installed, bringing the current number of boundary monuments to five. However, both witness corners to boundary monument BM-6 were present. Replacement of boundary monument BM-6 is not warranted at this time. Boundary monument BM-5 (PL-5) and one of its witness corners was covered with vegetation, which was removed following the inspection. No other maintenance needs were identified.

PL-5. Boundary Monument BM-5 with Surrounding Vegetation

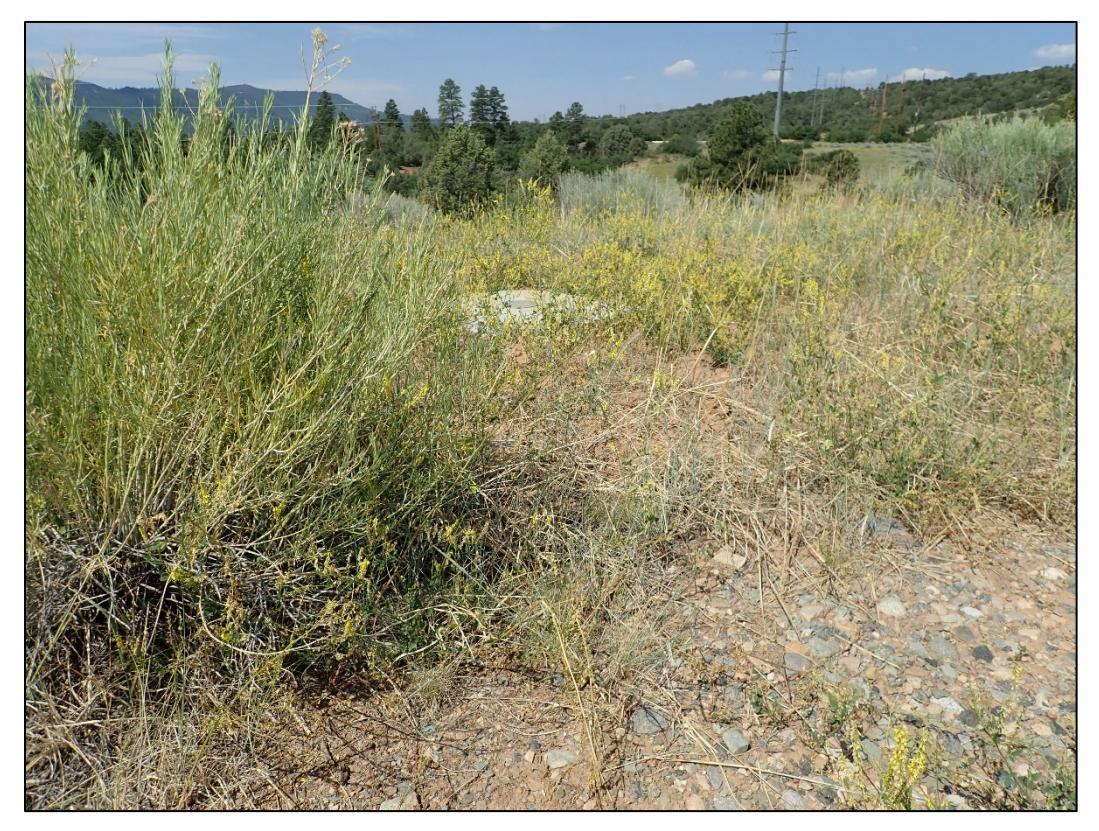
Five aerial survey quality control monuments installed in 2018 were inspected during the 2020 annual inspection. Inspectors noted that they are flush with the ground and will be difficult to find once vegetation matures around them (PL-6). Inspectors recommended the quality control monuments be marked with a T-post and reflector. Maintenance was completed following the inspection.

PL-6. Quality Control Monument QC1

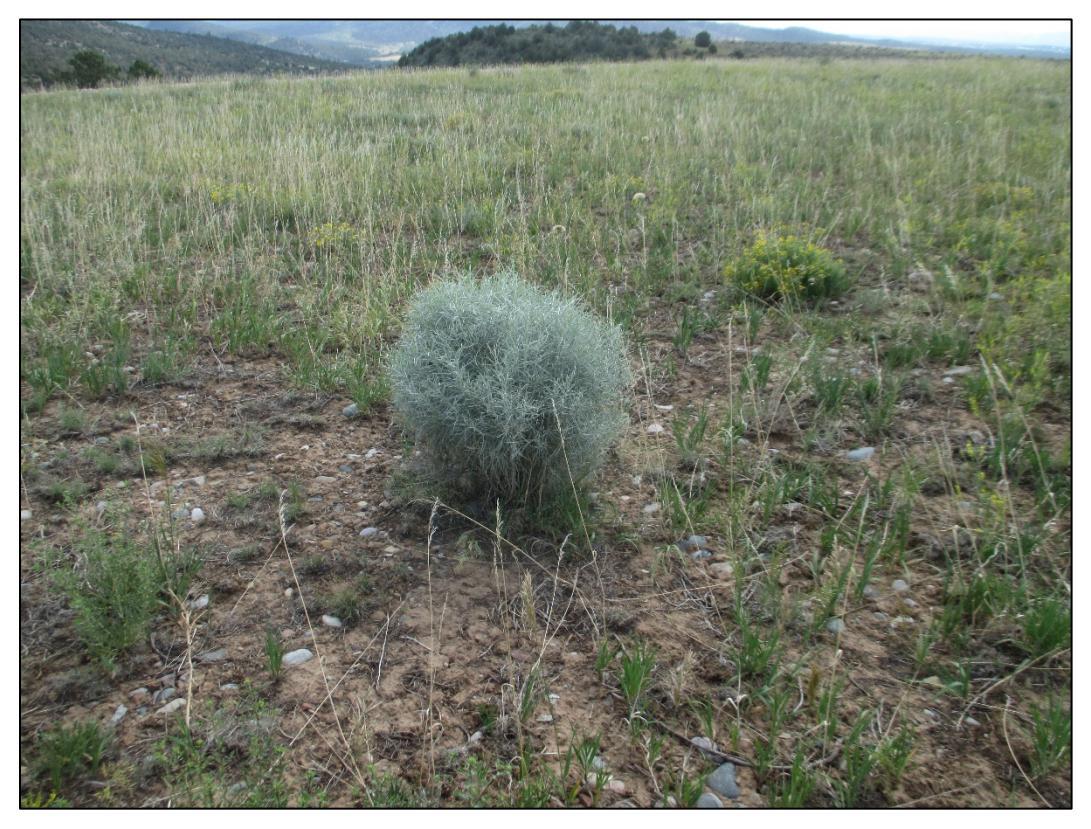
The disposal cell, completed in 1990, occupies 60 acres. It has a vegetated cover consisting primarily of perennial grasses and broadleaf plants. There was no evidence of erosion, settling, slumping, or other modifying processes on top of the disposal cell. In the past, inspectors have observed small animal burrows in several areas throughout the top; however, none were observed in 2020. A single volunteer rabbitbrush shoot (a woody species) (PL-7) was observed growing on the disposal cell top and was treated with herbicide later in the year. No other maintenance needs were identified.

PL-7. Rabbitbrush on Cell Top Slope

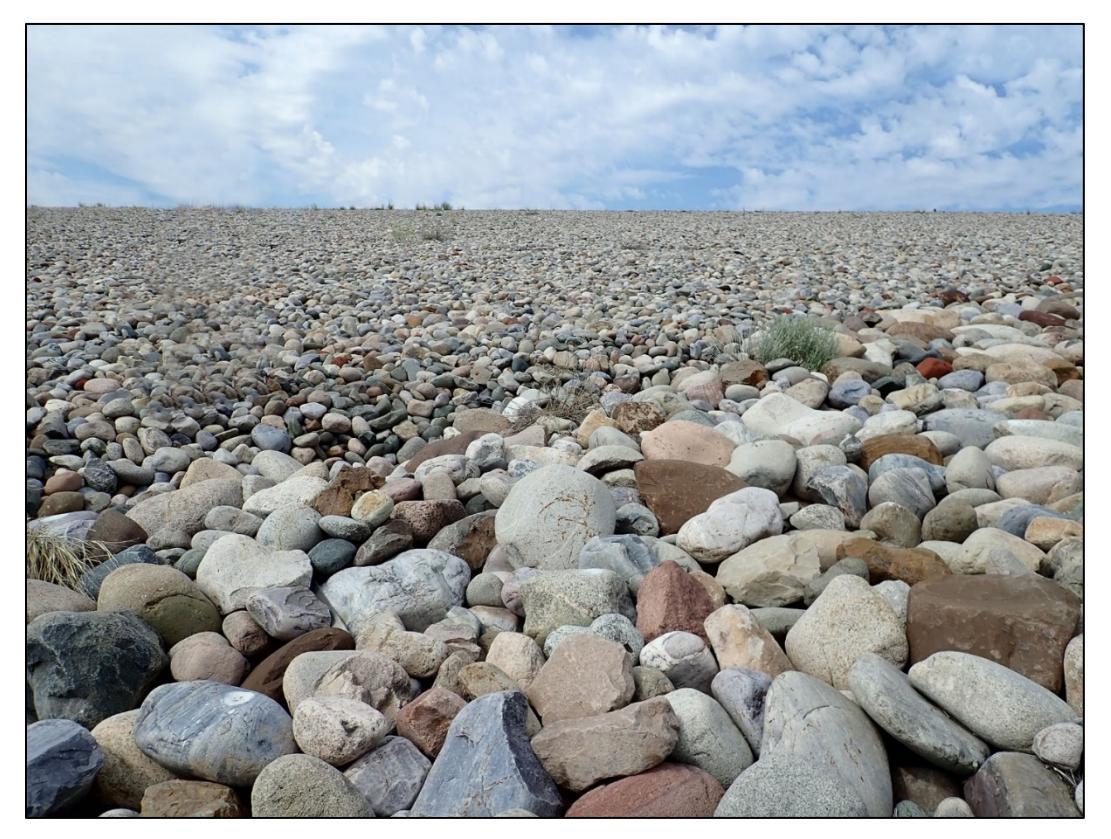
The side slopes of the disposal cell are armored with rock riprap. Along the north toe of the disposal cell, rock has moved, resulting in a linear depression approximately 18 feet (ft) long (PL-8) that first was observed in 2015. Inspectors did not observe significant changes to the depression. Inspectors will continue to monitor this area.

PL-8. Linear Depression in Cell Toe Slope

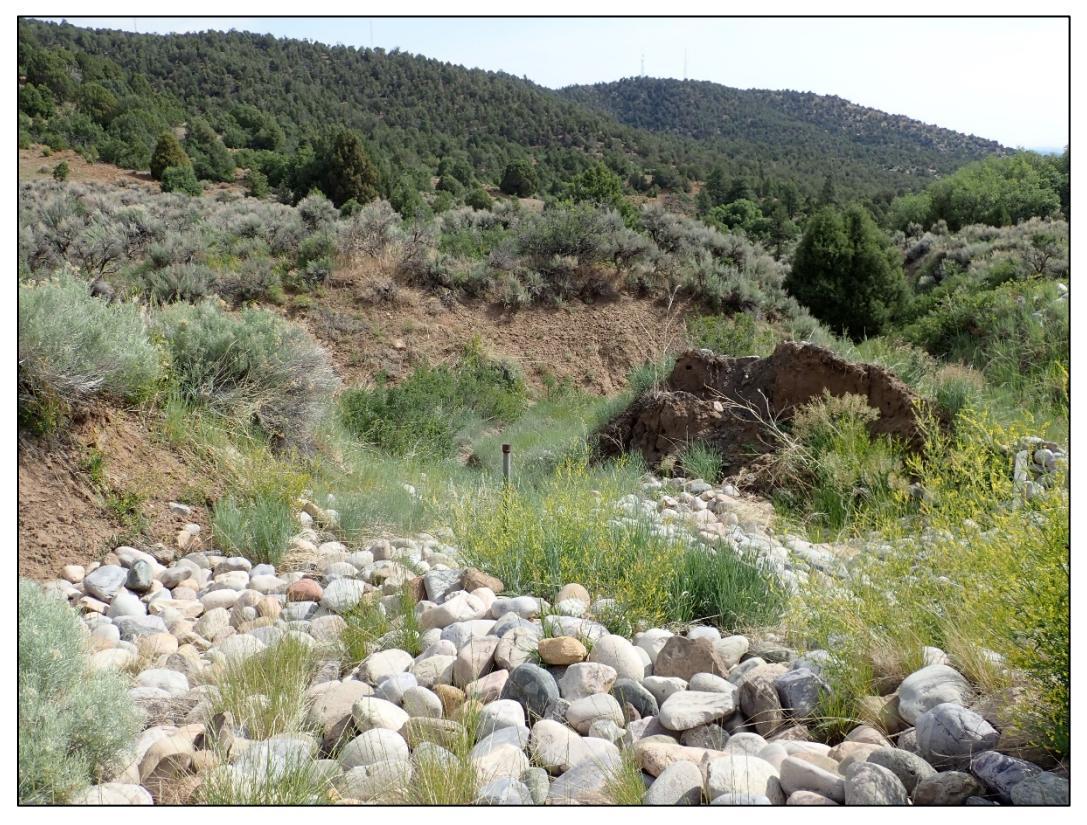
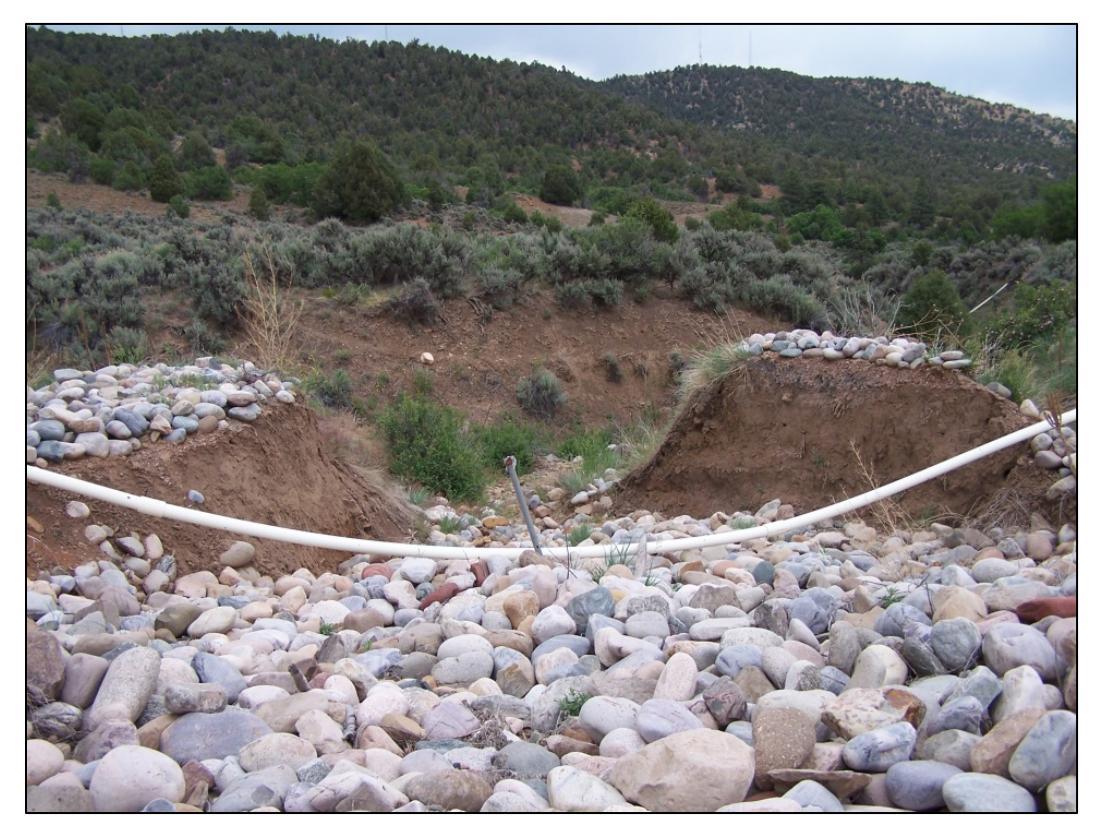
The riprap-covered outflows of the drainage ditches were designed to self-armor over time. The outflows and drainage channels below them are monitored annually. A larger boxelder tree is growing along the edge of the south outflow channel but does not affect the stability or effectiveness of the channel. The uplands above the northeast outflow are steadily eroding (PL-9a and PL-9b), but this process does not affect the stability or effectiveness of the outflow area. No maintenance needs were identified.

PL-9a. Northeast Outflow in 2020

PL-9b. Northeast Outflow in 2006

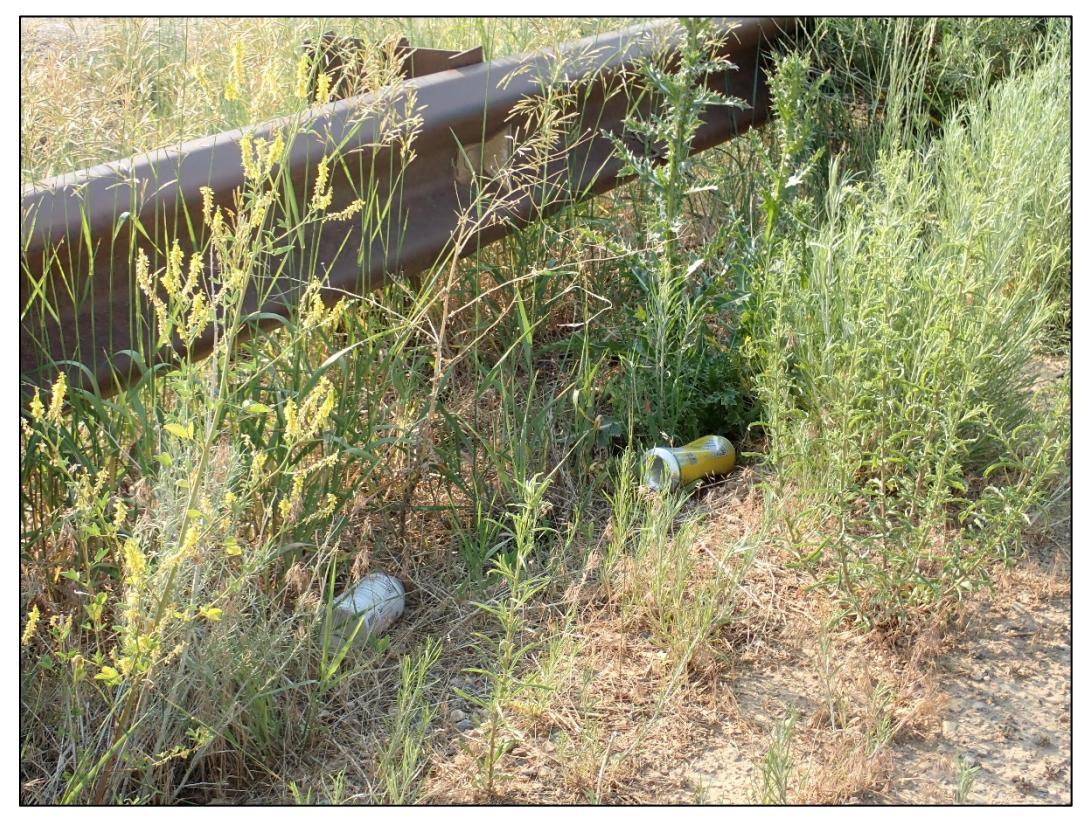
PL-12. Trash Dumped Near Site Entrance
