Remedial Action of Adjacent Properties FUSRAP Linde Site Remediation, Tonawanda, NY

U.S. Army Corps of Engineers, Buffalo District Shaw Environmental & Infrastructure, Inc. DACW41-98-D-9006, Task Order No. 0013 (Kansas City TERC)

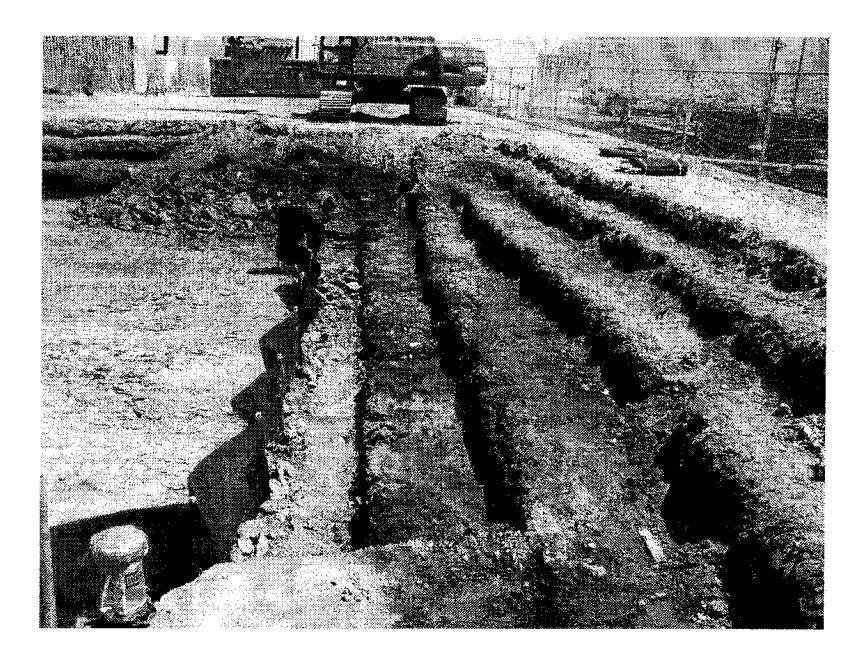
Fig. 2 - Dark lens of material in the excavation

By evaluating gamma count rates relative to background in the area of the dark lens, field scanning data could contribute to identifying area requiring remediation. Elevated count rates and the visual observations of the black lens provided sufficient evidence to support the presence of MED material in excess of subsurface ROD criteria. This effort resulted in time and cost savings because the excavation of the area could proceed as guided by the Health Physics Technician, while confirmatory alpha spectrometry analytical results were being processed. To support documentation of this effort, daily photographs of the dark lens material were taken. Additionally, GPS coordinates of its location, thickness, count rate, and the count rate of overlying material were also recorded. This methodology proved to be extremely successful during the remediation of this area.

Based on the information acquired during previous remedial action and characterization events, a method was developed to segregate the soils that exceeded subsurface Record of Decision (ROD) criteria (black lens material) from soils that did not exceed surface ROD criteria (overburden). This allowed for the segregated overburden soils to be utilized as post-excavation backfill while ensuring that this material met the New York State Department of Environmental Conservation (NYSDEC) beneficial use standard (6 NYCRR 360-1.15[b][8]). The method was developed through the combined efforts of USACE-Buffalo District, NYSDEC, and the remedial action contractor.
