## 19.0 Tuba City, Arizona, Disposal Site

### 19.1 Compliance Summary

The Tuba City, Arizona, Uranium Mill Tailings Radiation Control Act (UMTRCA) Title I Disposal Site was inspected on May 7, 2024. No significant changes were observed on the disposal cell or in the associated drainage features. Inspectors identified maintenance needs but found no cause for a follow-up inspection.

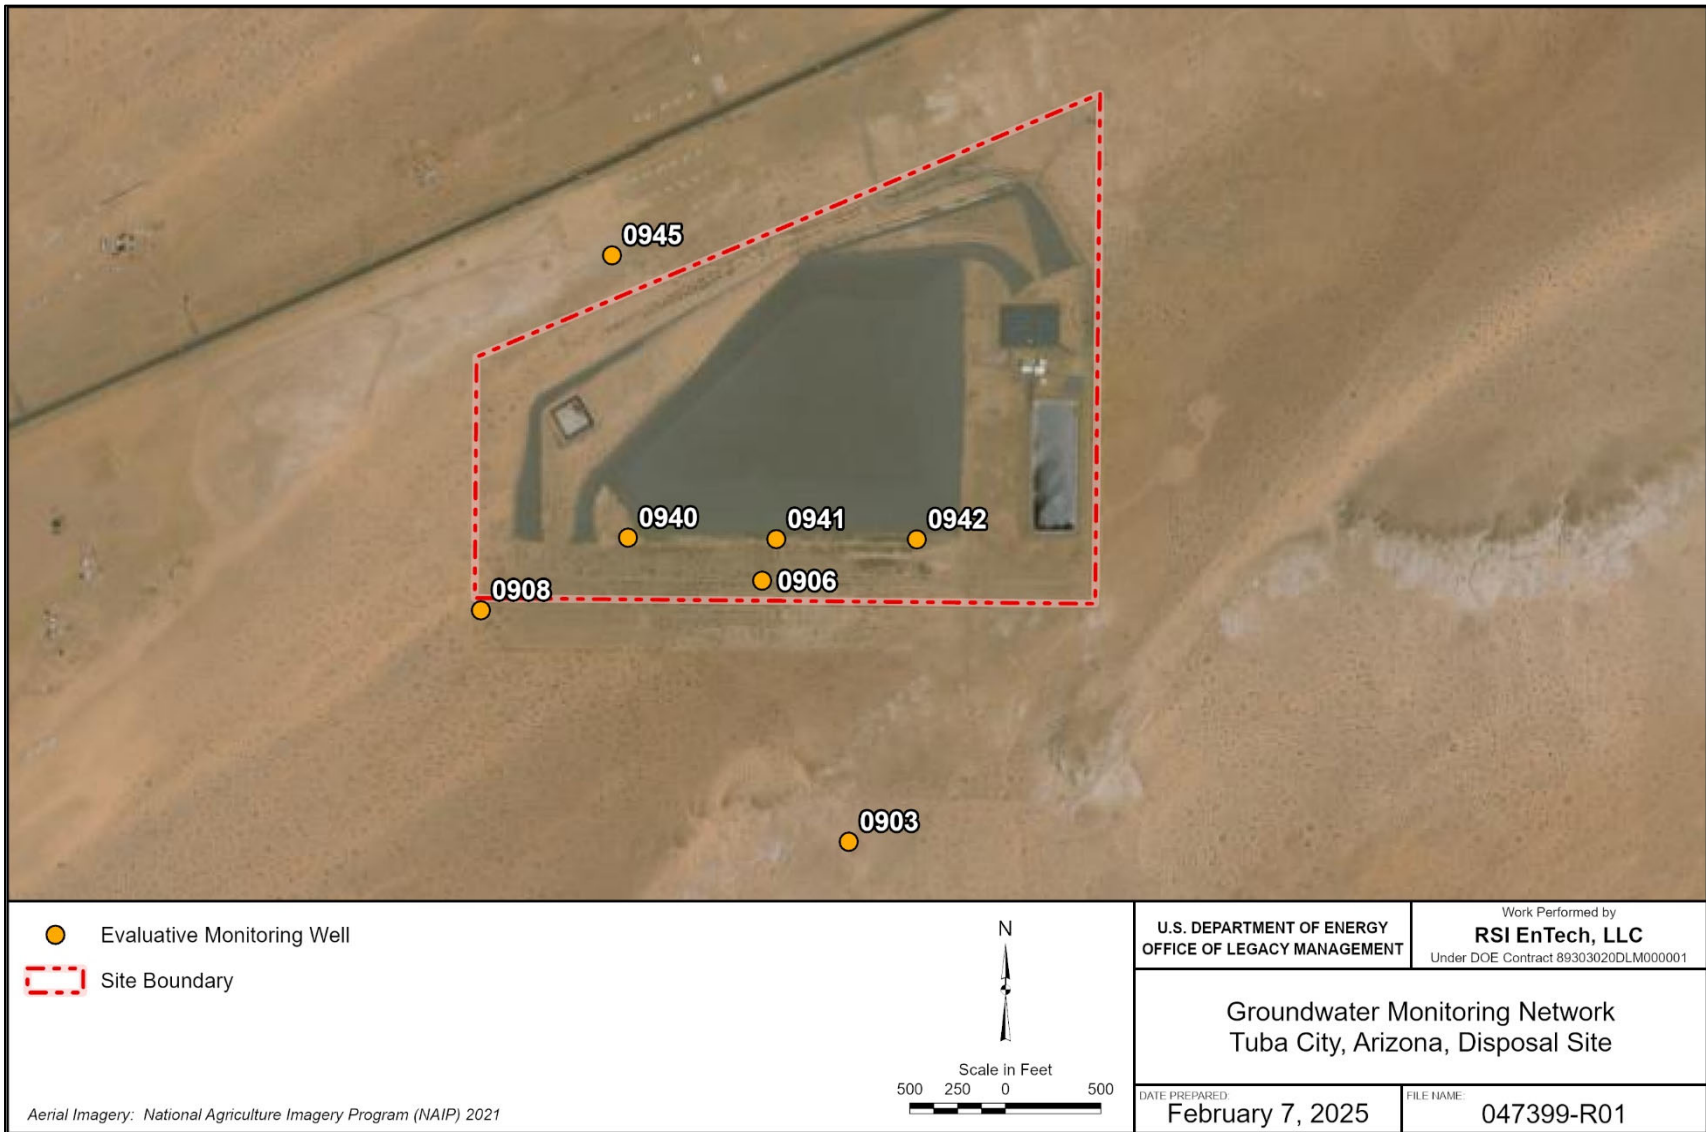
*Figure 19-2. Evaluative Groundwater Monitoring Network at the Tuba City, Arizona, Disposal Site*

**Note:** Well 0942 was converted from a monitoring well to an extraction well in 2015.

Seven wells (Figure 19-2 and Table 19-2) identified in the LTSP are monitored for four hazardous constituents: molybdenum, nitrate, selenium, and uranium (DOE 1996). As a baseline for cell performance evaluation, provisional upper baseline limits (UBLs) for the four constituents were calculated in accordance with the U.S. Environmental Protection Agency’s *Statistical Analysis of Ground-Water Monitoring Data at RCRA Facilities, Interim Final Guidance* (EPA 1989) and documented in the LTSP (DOE 1996). The UBLs are listed in Table 19-3.

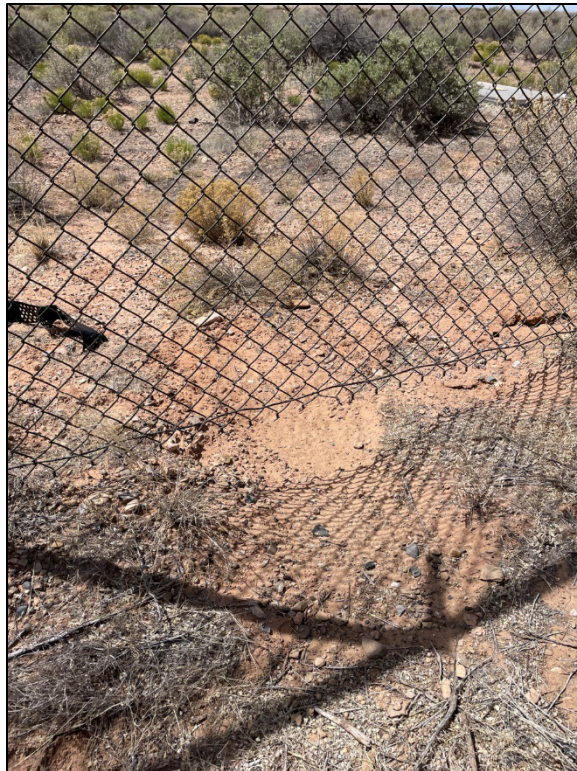
under the fence (PL-1). There are also many gaps under the fence from animal access (PL-2). These areas will be repaired before the next inspection. The sediment deposition gauge installed in 2023 between perimeter signs P9 and P10 will be read every year to quantify sand deposition as part of the annual inspection. At the time of the inspection, sand accumulated to a height of approximately 1.6 feet (PL-3). Similar to previous years, trash and debris have accumulated outside the fence near perimeter sign P9 (PL-4).

*PL-2. Gap Created by Animals Under Fence Between Perimeter Signs P12 and P13*

- Remove the trash and debris along the perimeter fence line
- Repair the animal access areas and gaps along the perimeter fence
- Control deep-rooted vegetation on the disposal cell
- Perform annual brush removal
- Address active bird nest on power pole southwest of disposal cell

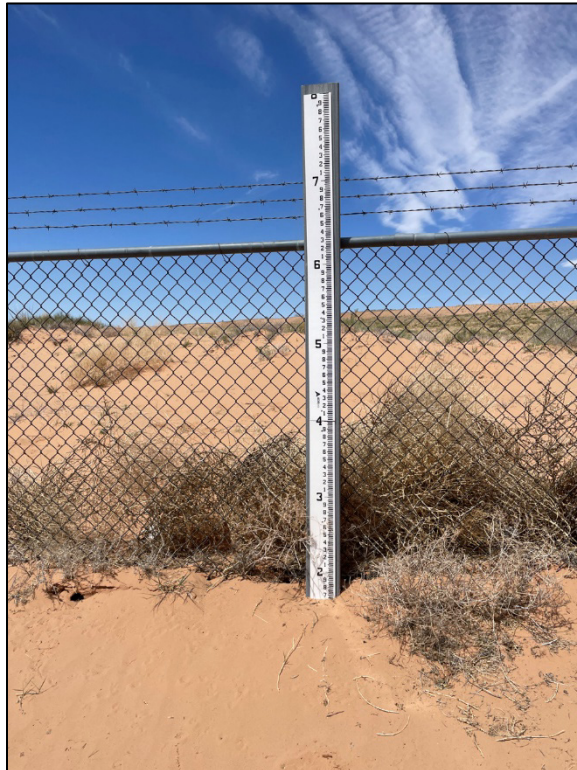
*PL-3. Sediment Deposition Gauge Between Perimeter Signs P9 and P10*

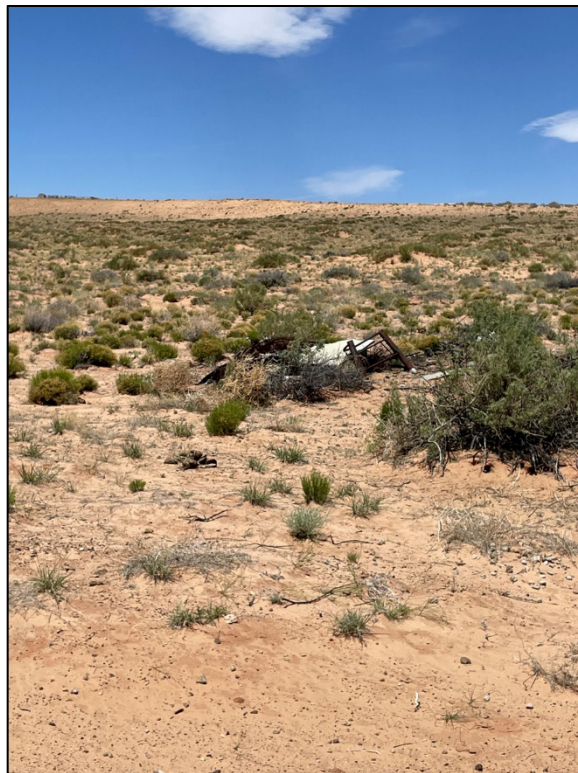
*PL-4. Debris near Perimeter Sign P9*

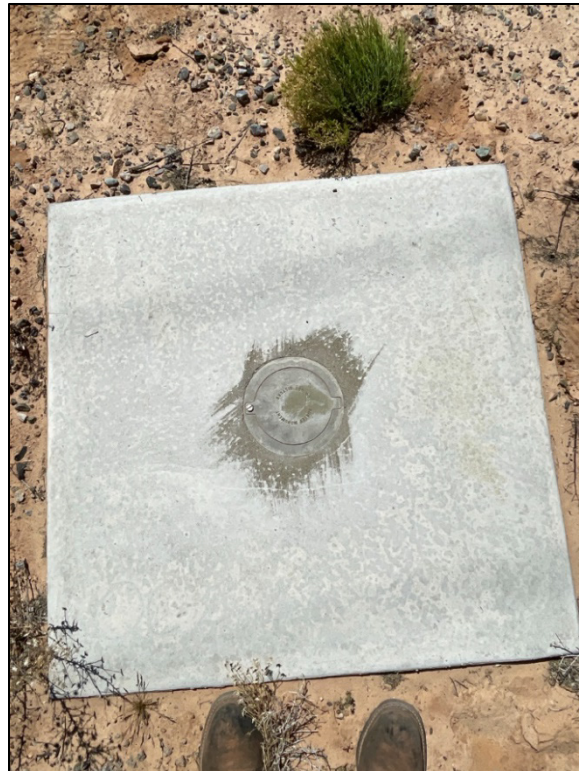
Five aerial survey quality control monuments were located and in good condition (PL-6).

*PL-6. Quality Control Monument QC-2*

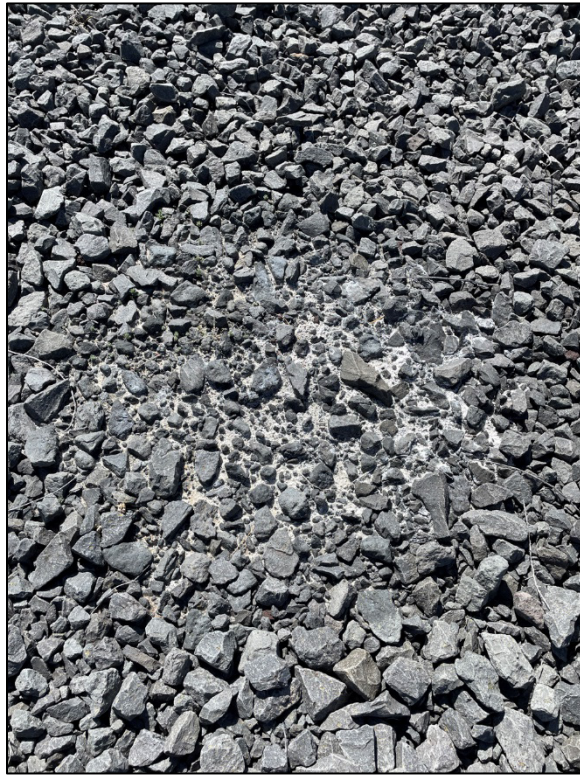
The disposal cell, completed in 1989, occupies 50 acres. The disposal cell is armored with riprap to control erosion and deter animal and human intrusion. Inspectors confirmed parallel tracks on the top slope of the disposal cell that were reported in previous annual reports. An evaporative mineral, caused by water pooling and subsequent evaporation, on top of windblown deposited sediment within riprap matrixes was noted on the top of the disposal cell (PL-7). Some exposed bedding layer was also noted on the top of the disposal cell. Potential tire tracks were observed on the southeast corner of the disposal cell (PL-8). These areas will continue to be monitored. There was no evidence of erosion, settling, slumping, or other modifying processes on the disposal cell.

*PL-7. Evaporative Materials on Top Slope of Disposal Cell*

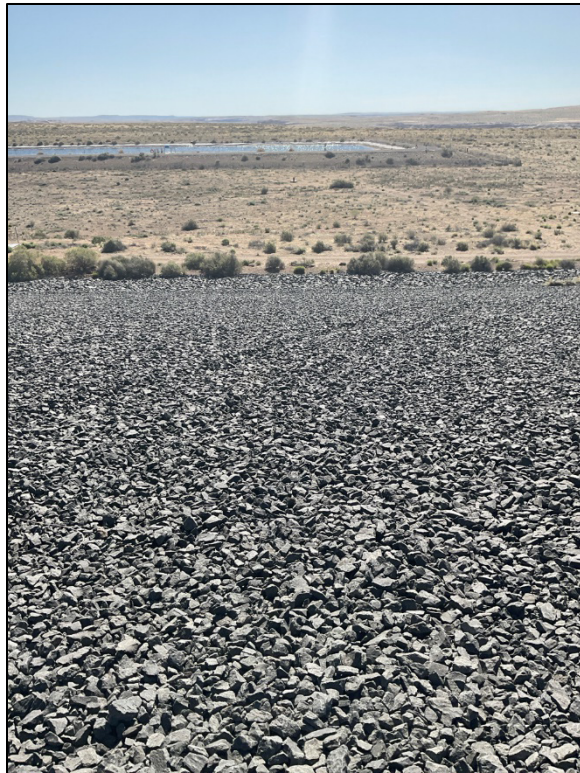
*PL-8. Potential Tire Tracks on the Southeast Corner of the Disposal Cell*

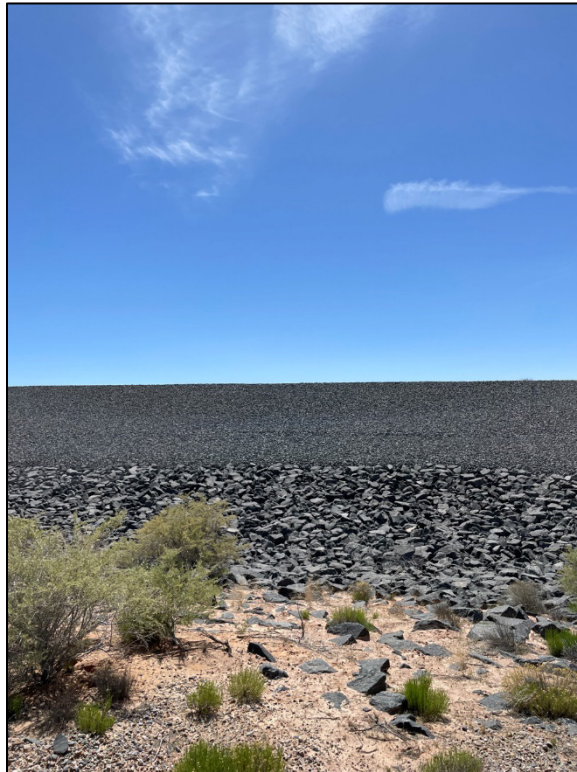
The riprap-covered side slopes were in good condition. There were visible horizontal channels along the southwest slopes (PL-9). The channels are most likely formed from surface flow from melting snow cover or precipitation, or both. Sediment deposition (PL-10) and debris (PL-11) were noted on the south slope of the disposal cell. Two 3-inch divots with sediment deposition were noted in the riprap of the east slope of the disposal cell. These features do not currently pose a threat to the integrity of the disposal cell; however, continued monitoring is recommended to ensure that erosion features do not create any problems that could undermine the soil and rock interface or the rock side slope below.

*PL-9. Horizontal Lines on West Slope of Disposal Cell*

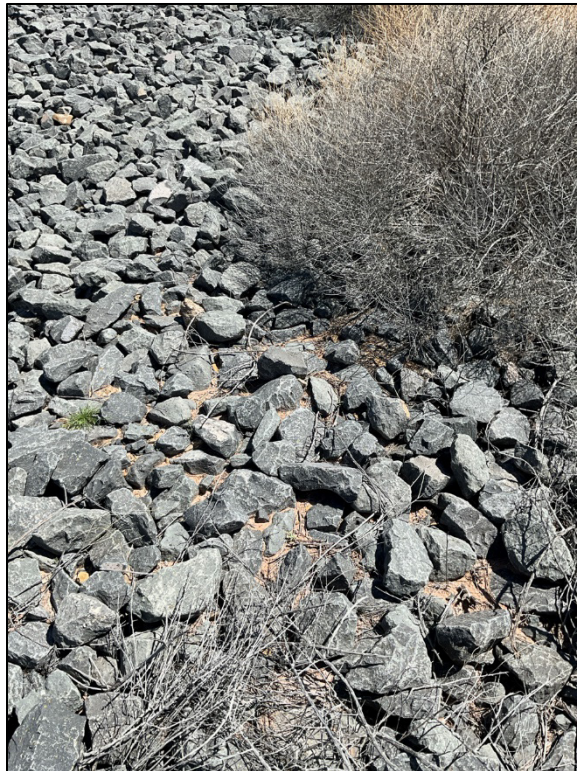
*PL-10. Sediment Deposition on the South Slope of the Disposal Cell*

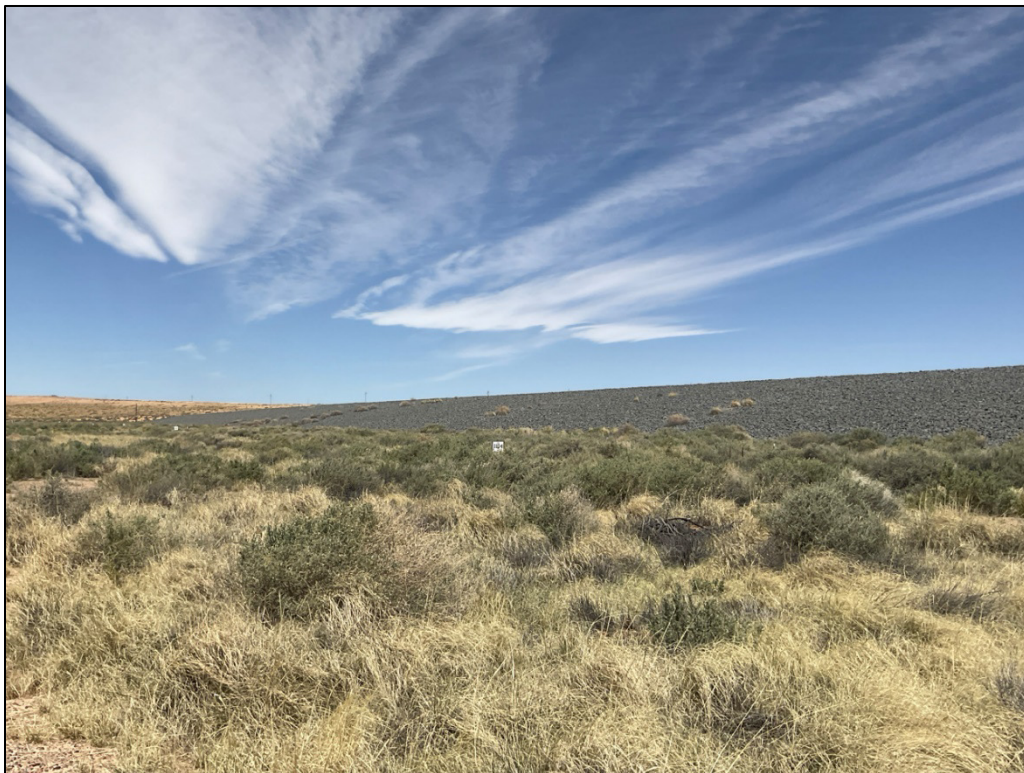
In accordance with the LTSP, deep-rooted vegetation is controlled to prevent potential penetration of the radon barrier. Windblown sediments continue to accumulate on the rock-covered surfaces, providing a favorable environment for plant growth. Periodic spot application of herbicide has been effective in controlling deep-rooted vegetation growth on the disposal cell cover. No deep-rooted shrubs were observed on top of the disposal cell, but some shrubs have become established on the side slopes (PL-12), as noted in previous inspections. This will be treated with herbicide before the next inspection.

*PL-12. Vegetation on South Slope of the Disposal Cell*

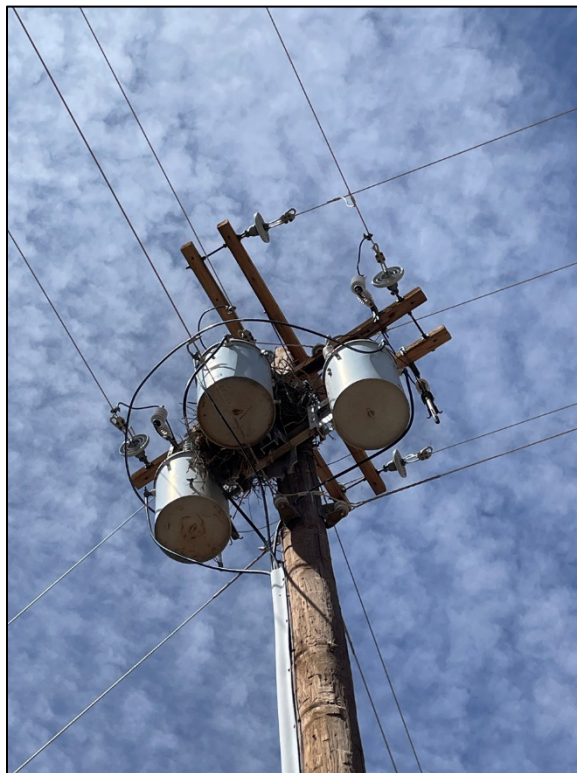
An active bird nest was identified on a power pole southwest of the disposal cell (PL-14). Environmental Compliance personnel have been notified and measures to identify the type of bird nest are underway. The nest will be addressed to mitigate fire hazards, as well as to prevent electrical issues. This task will be completed before the 2025 inspection.

*PL-14. Active Bird Nest on Power Pole Southwest of Disposal Cell*
