## SW027 Hillside and South Interceptor Ditch (SID) Vegetation/Erosion Controls Evaluation

### SW027 Hillside Evaluation Vegetation

### **SID Evaluation**

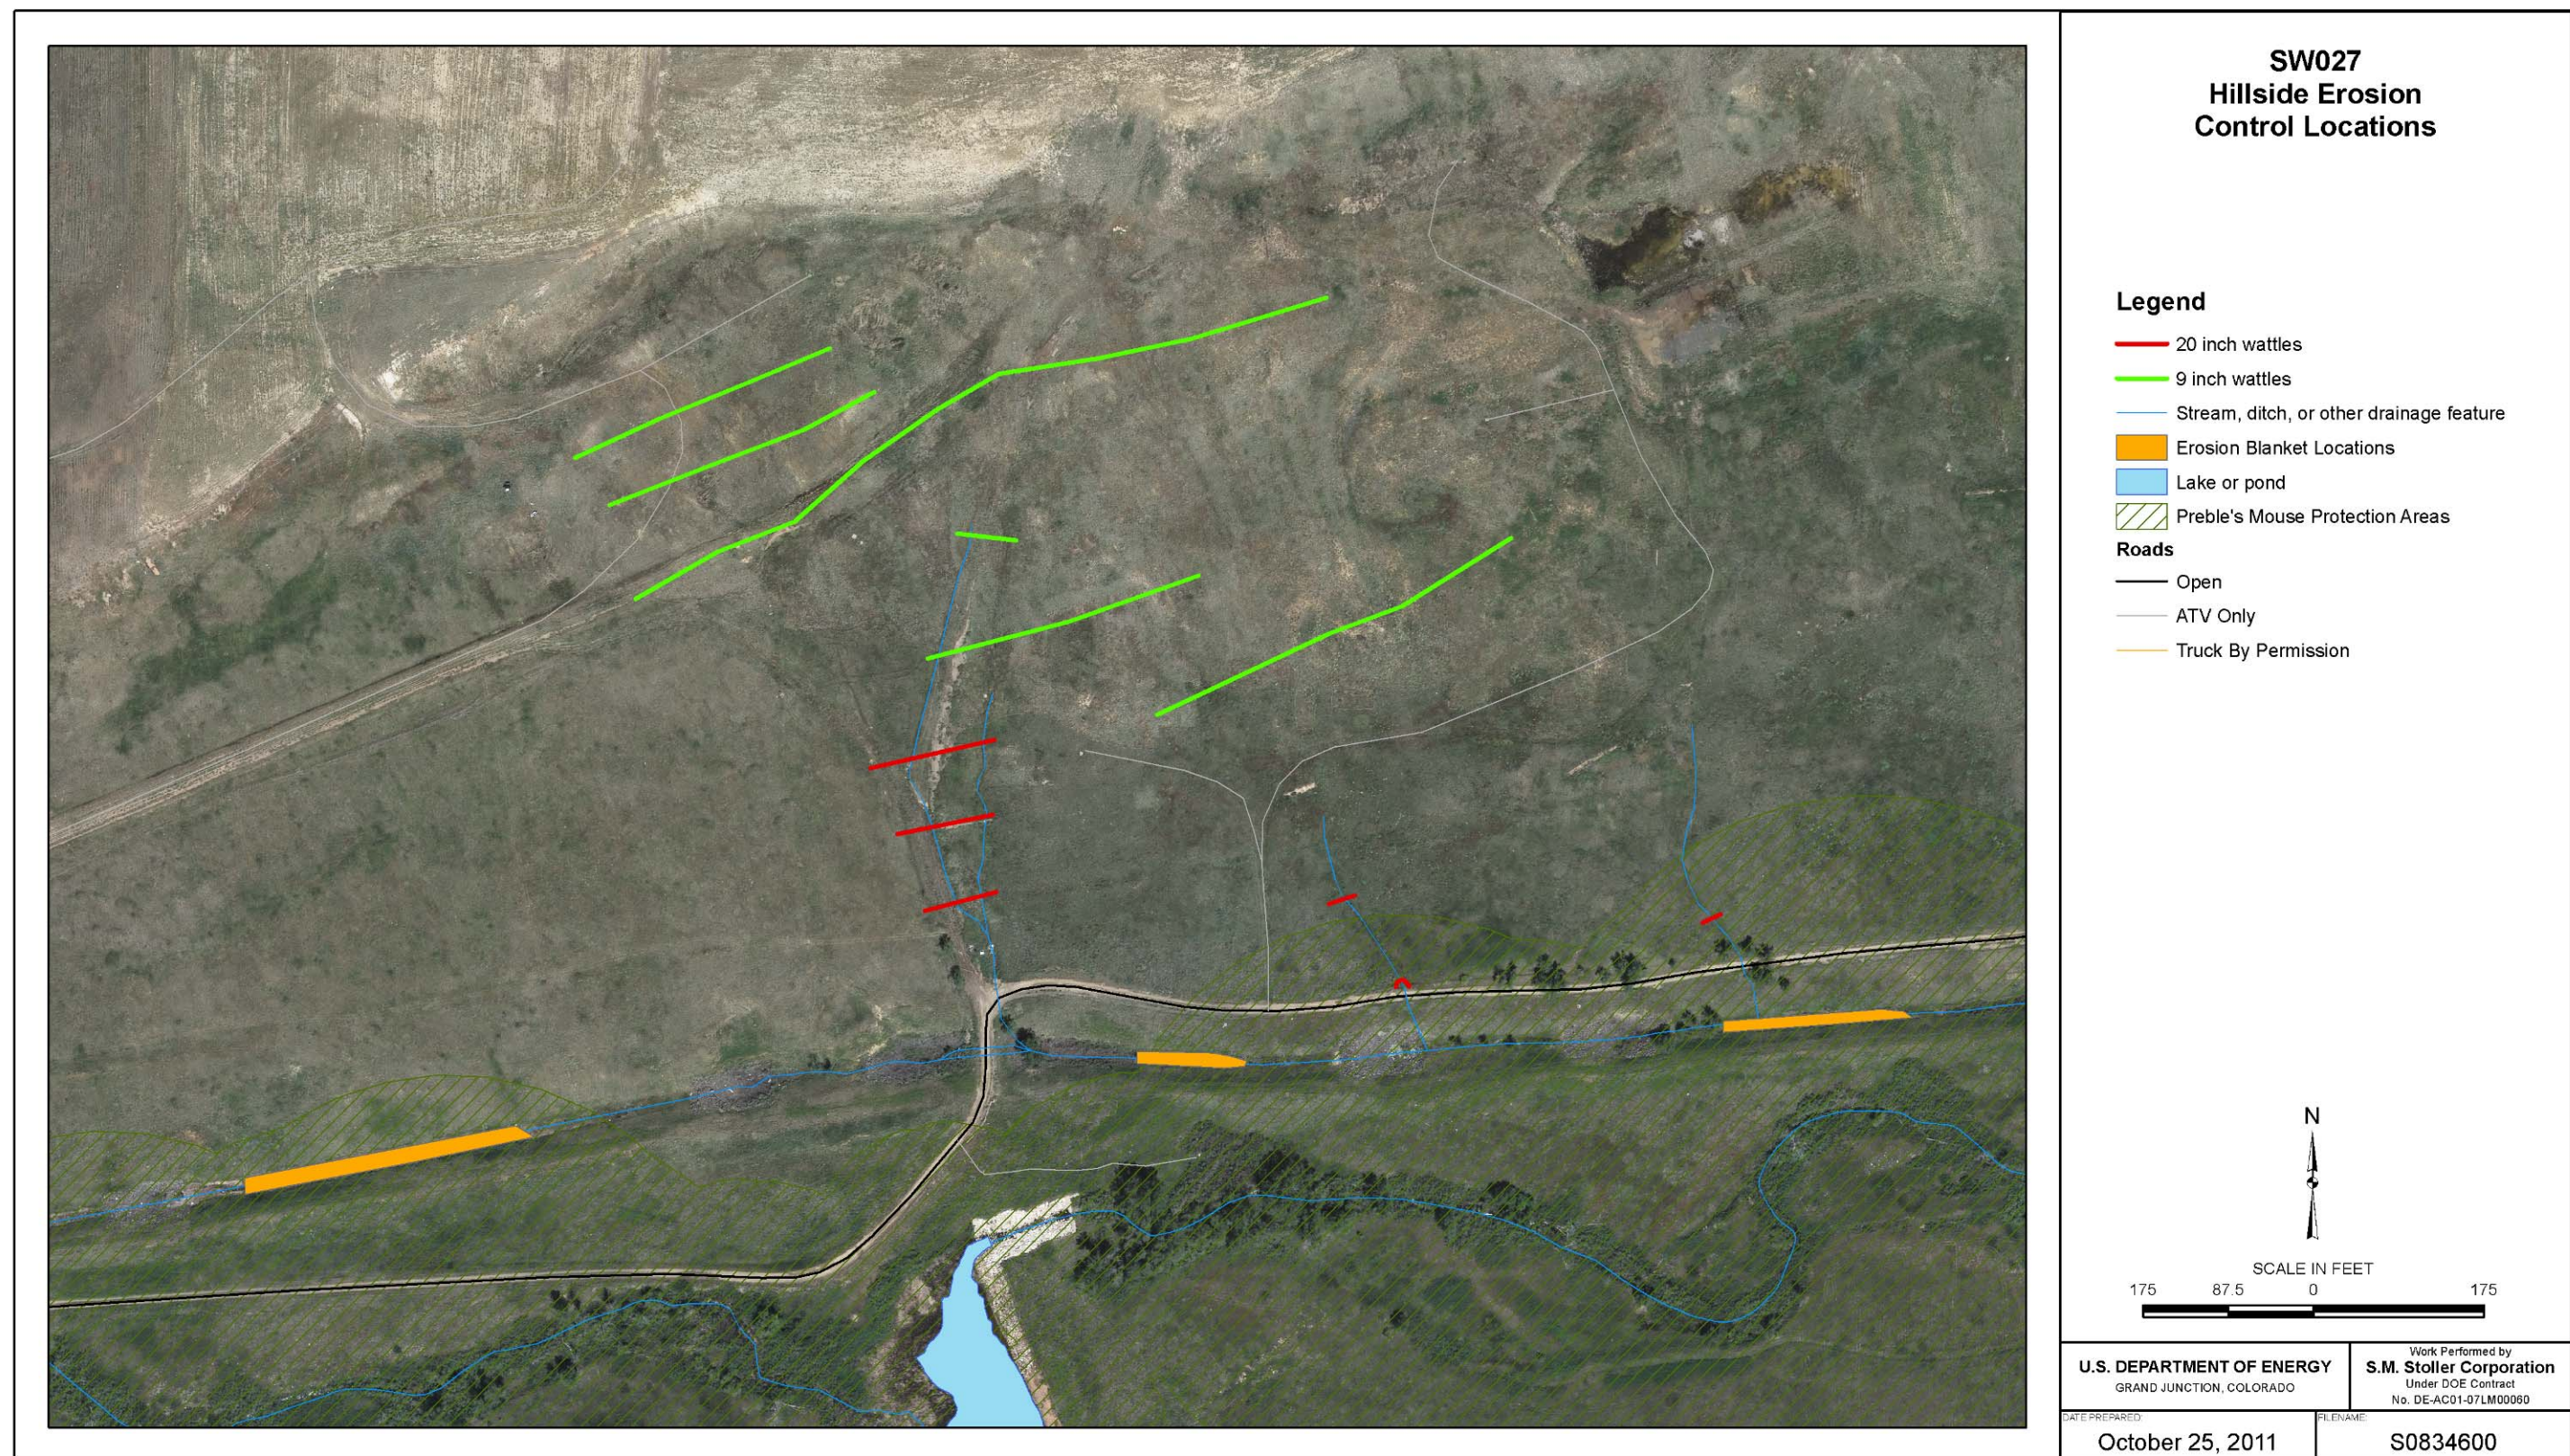
Figure 1. SW027 Hillside Erosion Control Locations

On June 23, 2010, several areas on the SW027 hillside (the 903 lip area) were interseeded to increase the vegetation cover. In December 2010, several rows of Filtrexx wattles, which were filled with compost, woodchips, and seed, were installed across the hillside (Figure 1) to reduce the potential for sediment movement from the hillside. Per the requirements of the *Adaptive Management Plan*, the vegetation and erosion controls were evaluated after one full growing season. The end of the growing season was defined as the point at which most species of plants on the prairie had stopped growing, had gone to seed, and were beginning to senesce for the year. In 2011, the end of the growing season was near the end of September.

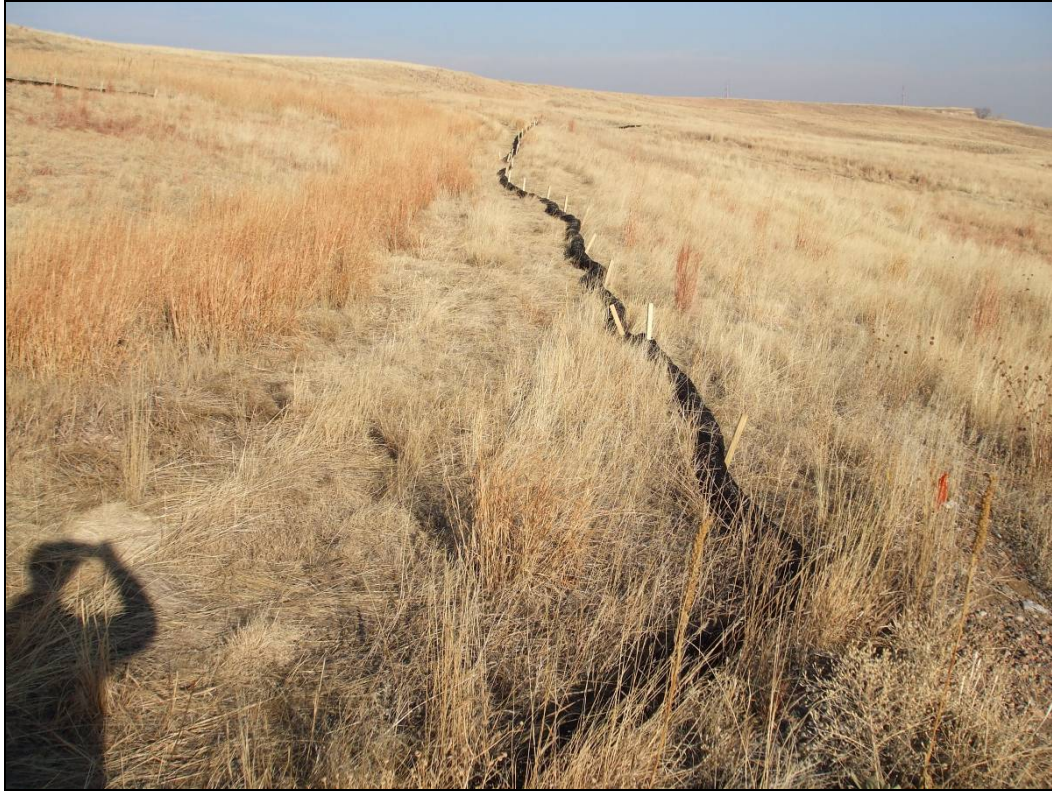
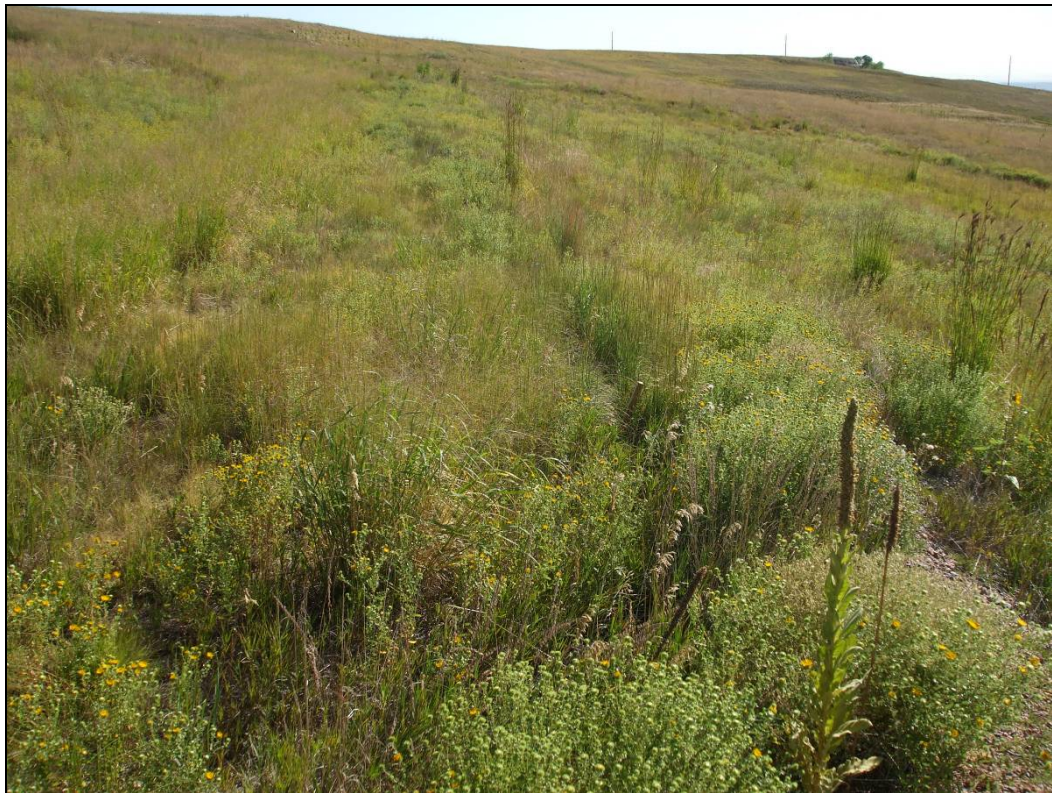
A visual evaluation of the Filtrex wattles on the SW027 hillside was made on October 11, 2011. The wattles were all still staked in place and holding up well. A few sprouts of new grass were observed to be growing out of the tops of some of the wattles. Additionally, the vegetation around the wattles had grown so well on the uphill and downhill sides of the wattles that many of the wattles were hidden by the grass when viewed down the length of the wattles (Figure 2). The wattles continue to do their job of slowing and filtering sheet flow that may occur on the hillside. The abundant growth of the vegetation on the uphill and downhill sides of the wattles should increase the effectiveness of the wattles by providing additional slowing and filtering of sheet flows on the hillside.

*Figure 2. Top photo shows Filtrex wattle after installation on hillside in 2010. Bottom photo shows the same wattle with vegetation growth around it in 2011.*

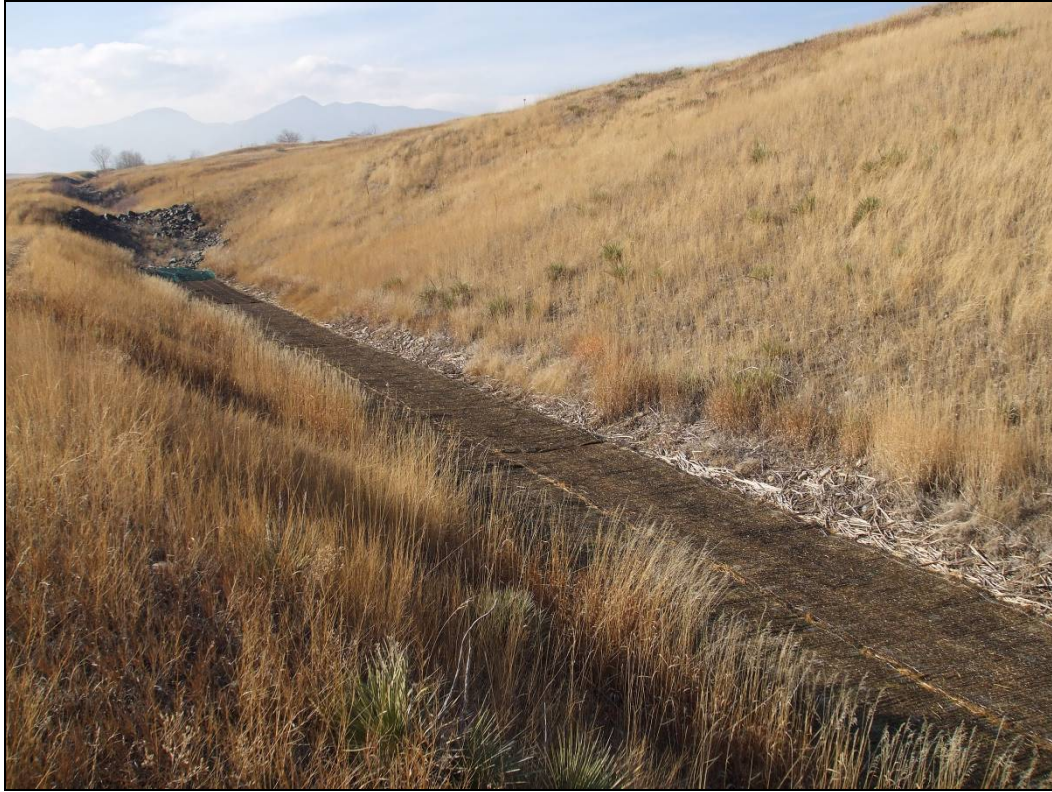
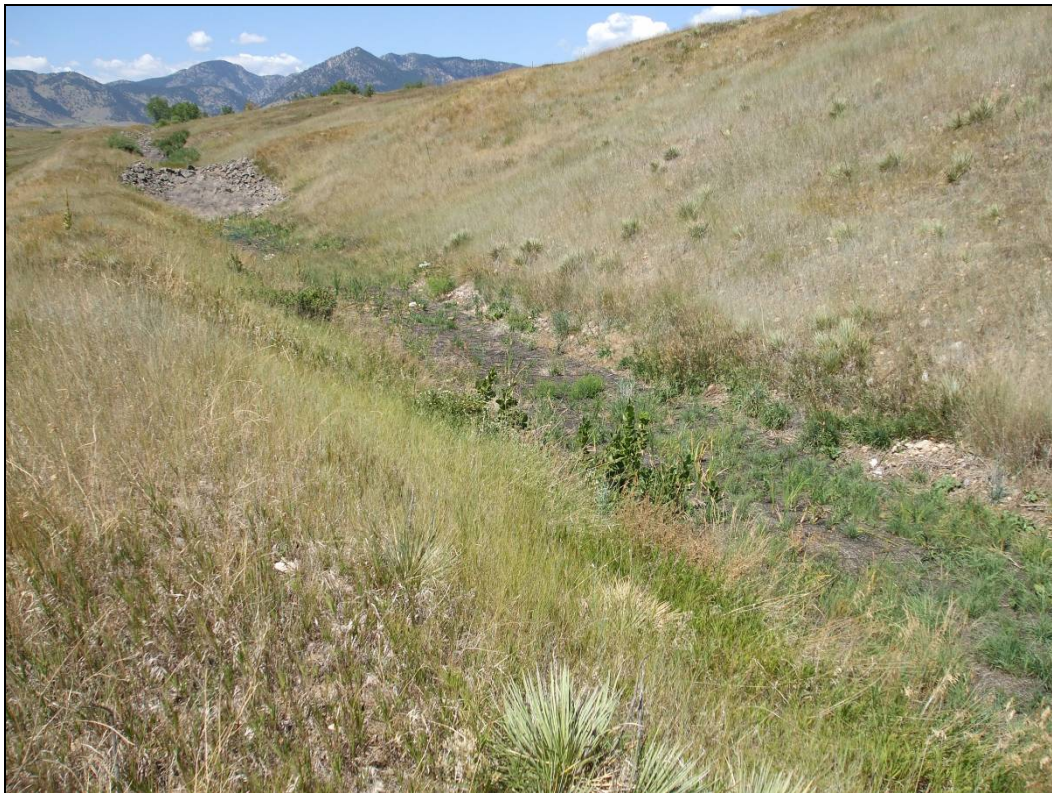
The vegetation is establishing very well at the locations that were seeded and matted (Figure 3). Total foliar cover is estimated between 50 and 70 percent on average across the areas.

The erosion matting continues to be staked and in place in the SID. The establishing vegetation, in addition to the pins that were initially installed, is now holding the mat in place (Figure 3).

*Figure 3. Top photo shows location in SID in 2010 after seeding and placement of erosion matting. Bottom photo shows location in 2011.*
