## 7.0 Split Rock, Wyoming, Disposal Site

### 7.1 Compliance Summary

The Split Rock, Wyoming, Uranium Mill Tailings Radiation Control Act (UMTRCA) Title II Disposal Site was inspected on August 20–21, 2024. This was the first annual inspection for this site. Inspectors identified minor fence maintenance needs but found no cause for a follow-up inspection.

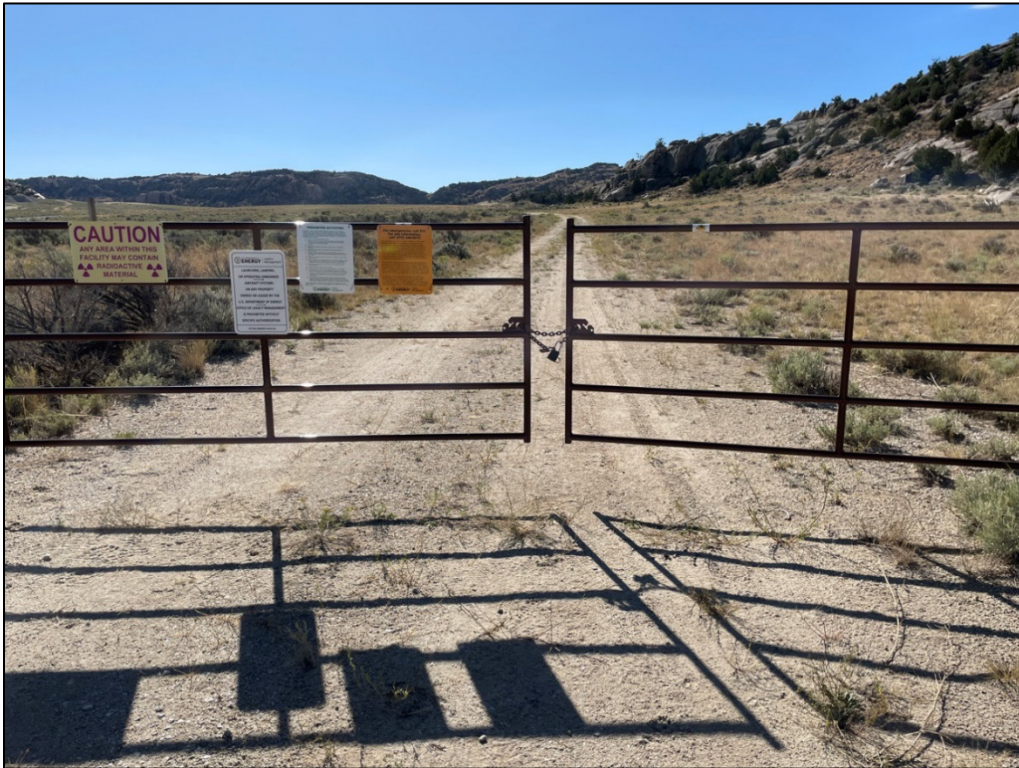
Access to the site is directly from Fremont County Ore Road. The main entrance gate is a tubular steel double swing gate in the disposal cell fence that provides access to the northern portion of the disposal cell. This gate, in the west portion of the disposal cell area fence, was secured by a lock and chain (PL-1). An access point south of the site entrance on Ore Road along the perimeter fence, previously secured by a locked cable, was replaced with two 10-foot tubular steel double swing gates in August 2024. No other maintenance needs were identified.

*PL-1. Entrance Gate Secured by Lock and Chain*

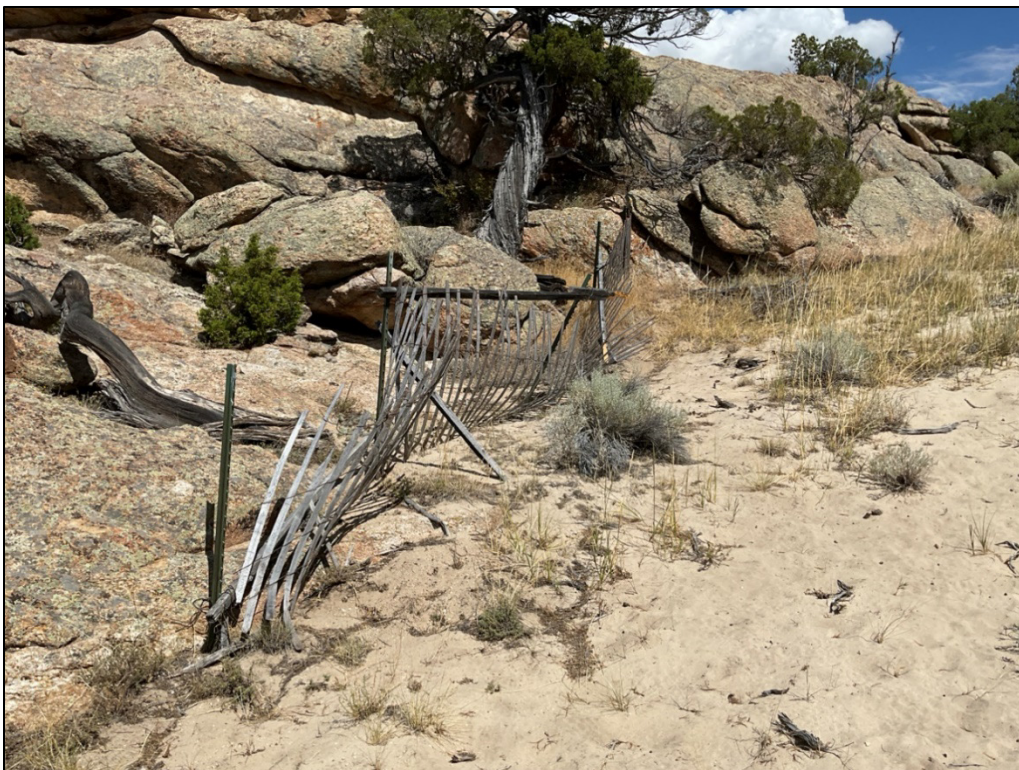
A barbed-wire stock fence and granite outcrops enclose the site disposal cell and reclaimed evaporation pond and restrict access from livestock. The grazing licenses granted by LM to local ranchers allow livestock grazing outside of the disposal cell area in exchange for perimeter and stock fence maintenance. Fences around the disposal cell area were inspected to ensure that they were intact. During the inspection, it was noted that there were several small segments of fencing interior to the disposal cell fence that may have been used in the past to restrict livestock access to the disposal cell via the granite outcrops on the stock fence line on the south side of the disposal area. These are noted in Figure 7-1 as “small segments of fence” (PL-2). However, no evidence of cattle grazing on the disposal cell area was observed. Before transition of the site, there were plans to repair 10% of the fence every year starting in 2024. The fence along Ore Road was identified as an immediate need for repair to keep livestock off the disposal cell and the reclaimed evaporation pond, and would satisfy the 10% fence repair requirement in 2024. The repair was completed in August 2024 (PL-3). Additionally, LM will work with the grazing licensees to ensure that the stock fence is maintained according to the grazing agreement. No other maintenance needs were identified.

*PL-2. Site Fence Between Granite Outcrop to Keep Livestock off Engineered Structures*

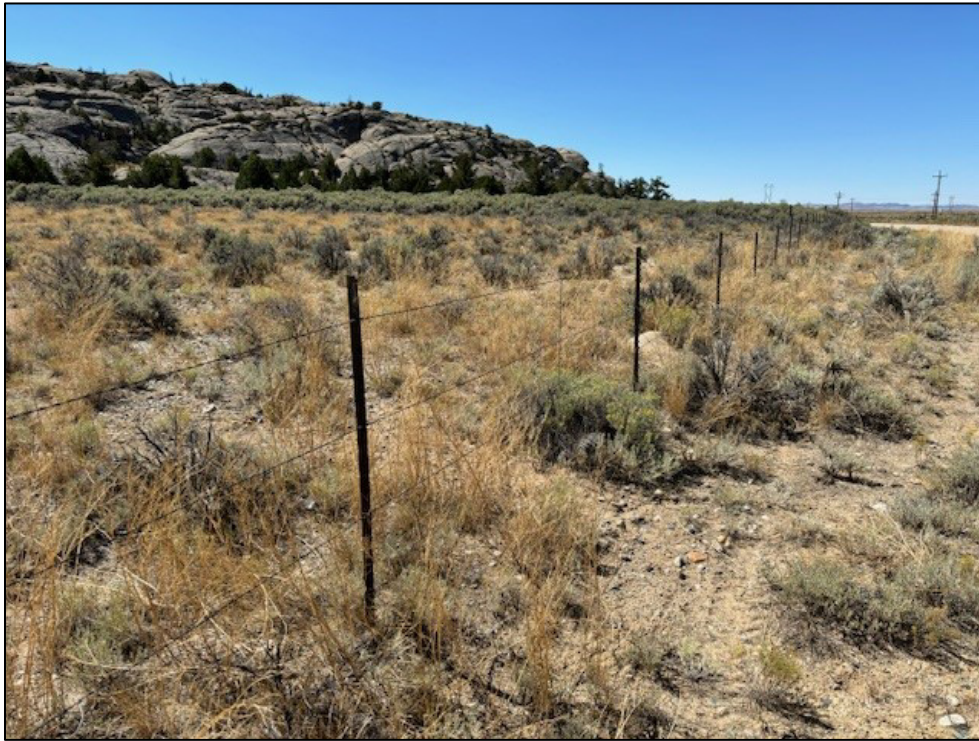
*PL-3. Repaired Fence Along Ore Road*

In accordance with the LTSP (DOE 2023), routine site maintenance will be performed by LM as needed. Maintenance to the tailings impoundment fence is anticipated to occur annually. In 2024, the section of the disposal cell area fence along Ore Road was repaired and a gate was replaced. No other maintenance needs are identified.

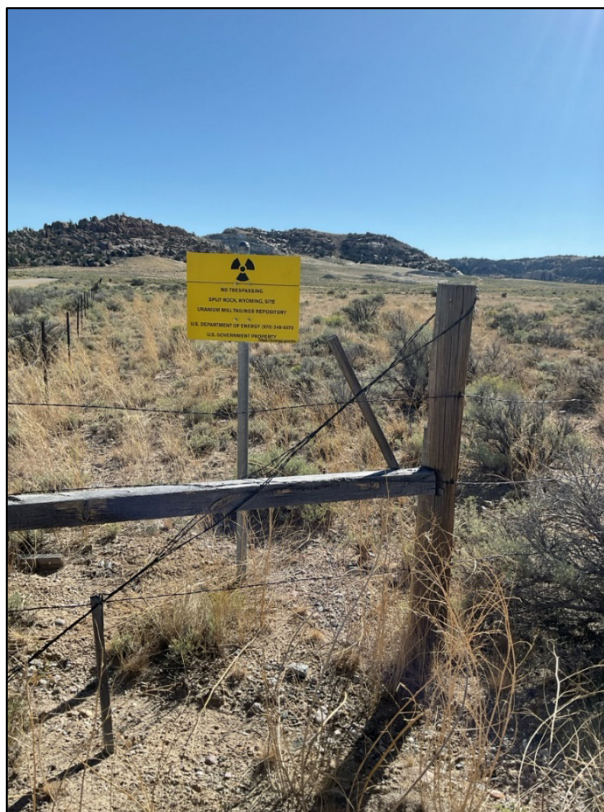
The entrance sign, identified in Figure 7-1, is on the main site access road near the site marker (PL-4). Before transition, 40 additional steel signposts were placed around the perimeter of the site and the tailings impoundment at locations where access to the site is most likely to occur. Before the inspection, no signs had been installed on the posts. Signs were installed during the inspection at the most likely access points, including along Ore Road and adjacent to Highway 287, and one was added to the disposal cell area fence (PL-5).

*PL-4. Entrance Sign*

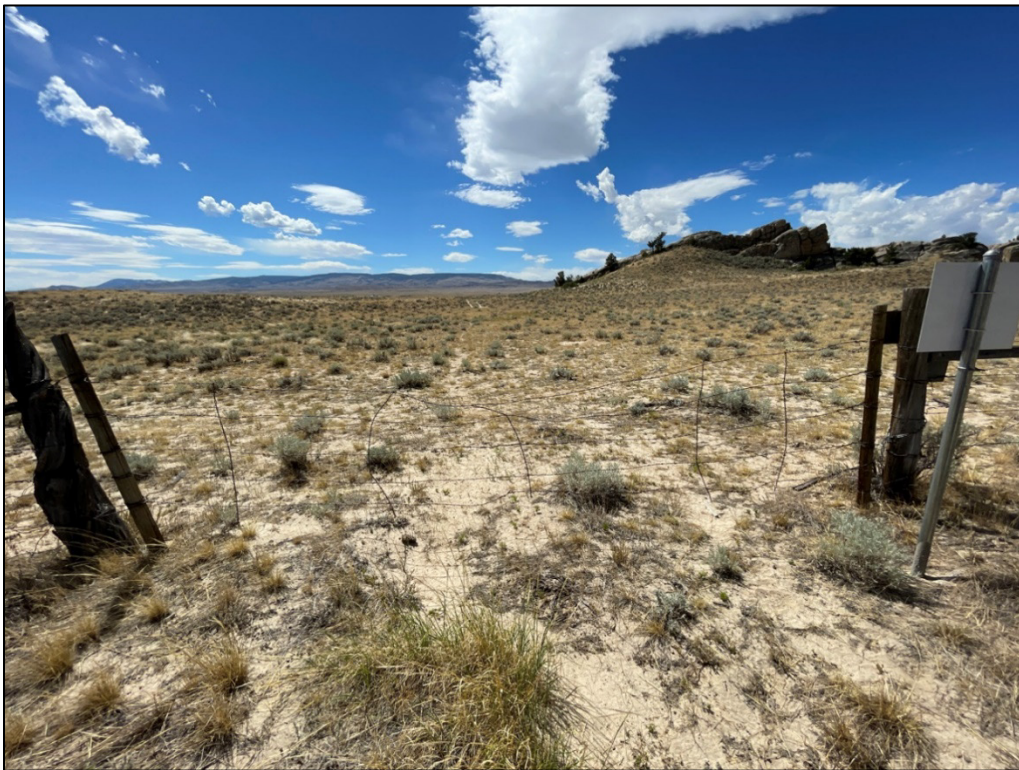
*PL-5. Perimeter Sign on the North Side of the Stock Fence*

Perimeter warning sign installation will continue during the next annual site inspection. Several of the sign locations may eventually be abandoned or relocated due to practicality, such as along the riverbank where vegetation is taller than the signposts and access would be difficult. No other maintenance needs were identified.

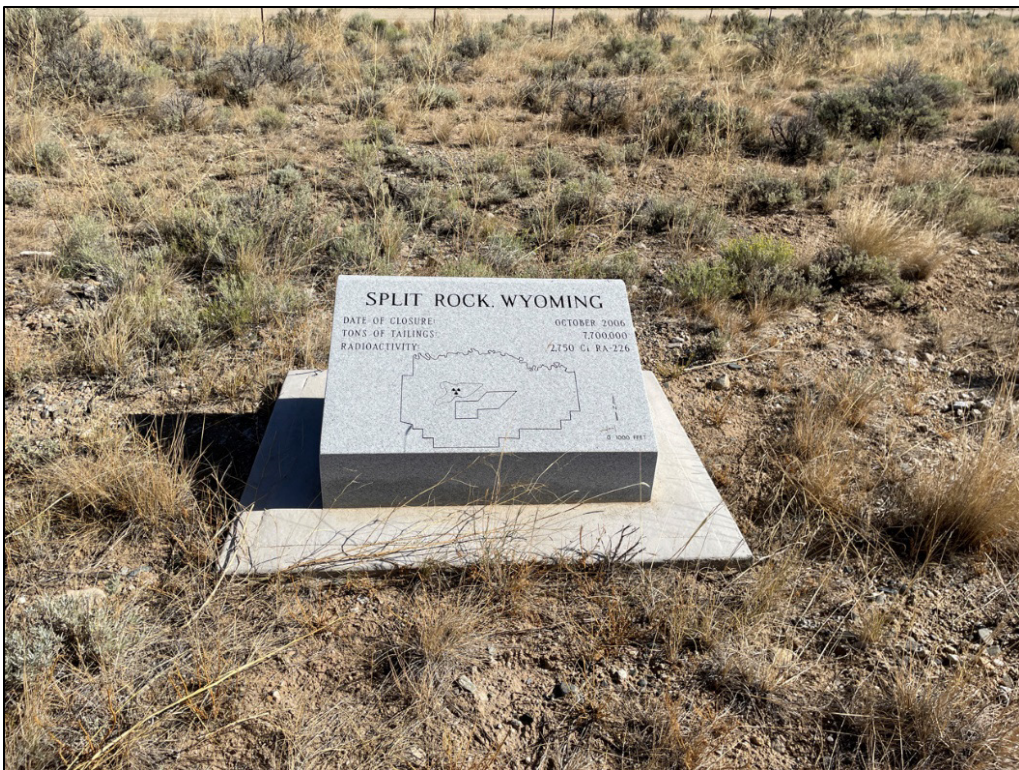
The site has one granite site marker near the main entrance gate (PL-6). No maintenance needs were identified.

*PL-6. Site Marker near Entrance Gate*

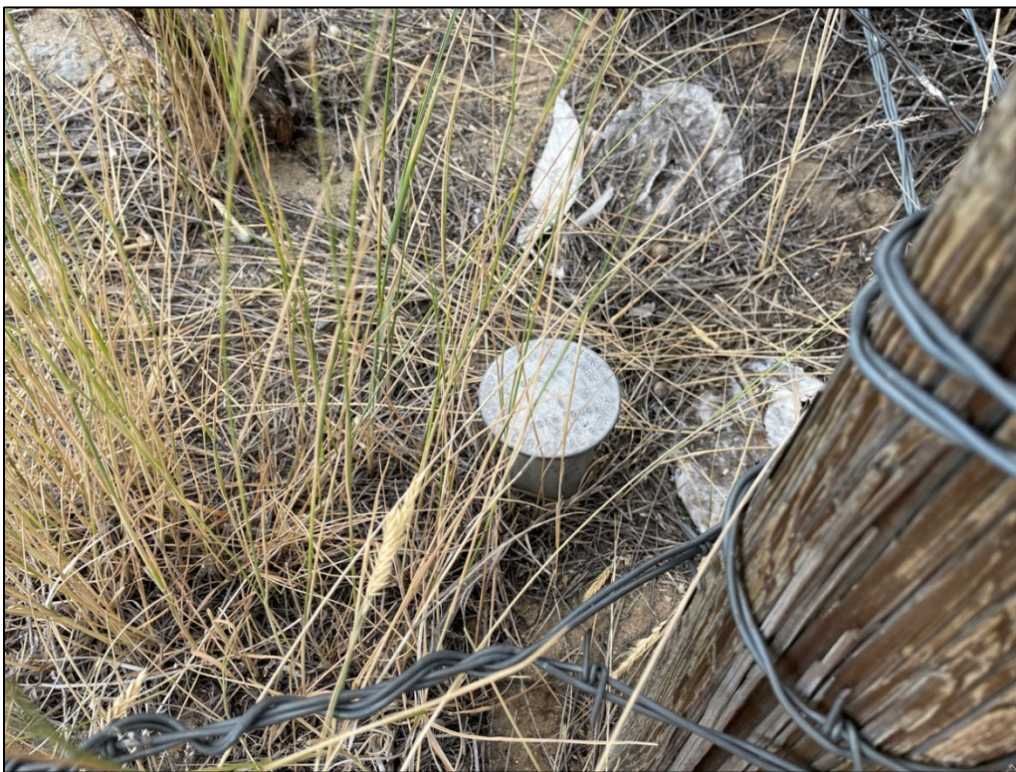
There are 37 boundary monuments delineating the site boundary (PL-7). No maintenance needs were identified.

*PL-7. Boundary Monument BM-17*

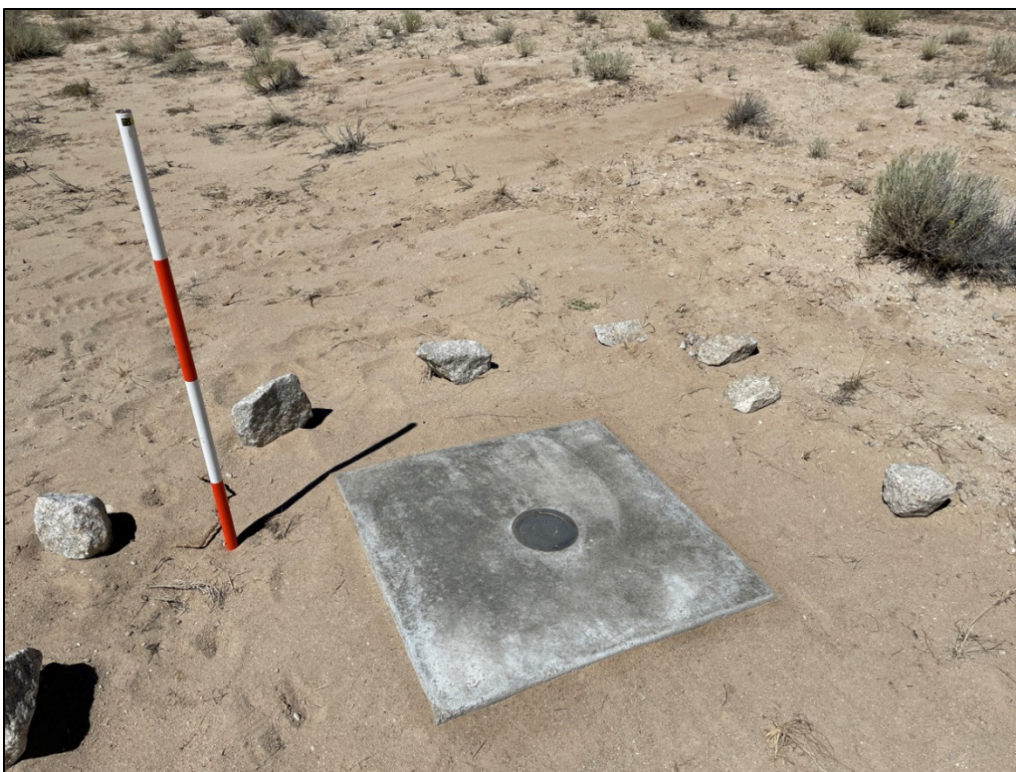
In August 2024, eight permanent quality control monuments were installed at the site in preparation for a September 2024 baseline aerial survey of the disposal cell (PL-8). The quality control monument locations are shown in Figure 7-1. No maintenance needs were identified.

*PL-8. Quality Control Monument QC-3*

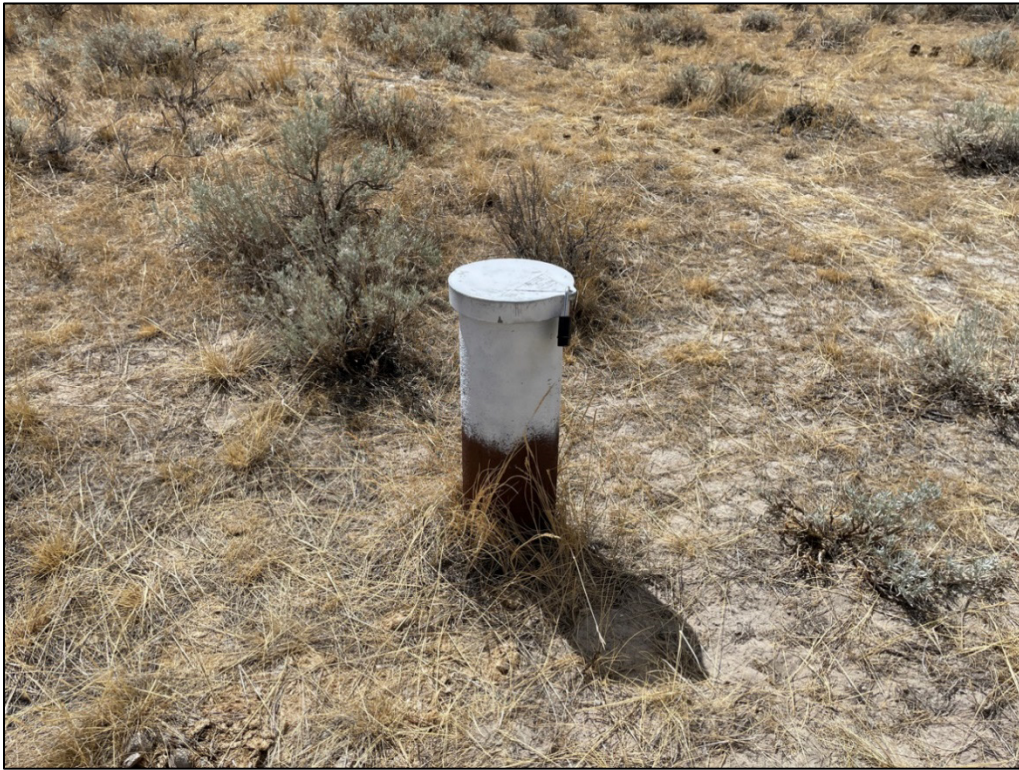
The site's groundwater monitoring network consists of 12 monitoring wells (Figure 7-1; DOE 2023) and one livestock well (WN-24) that were previously used in Western Nuclear Inc.'s (WNI) licensed monitoring program. Stock watering well, well-22, is within the property boundary but is not being used for monitoring. The groundwater use restriction for stock watering well, well-22, allows for livestock use only. Stock watering well, well-22, was not being used at the time of inspection. The monitoring well network wellhead protectors were undamaged and locked (PL-9). No maintenance needs were identified.

*PL-9. Monitoring Well SWAB-29*

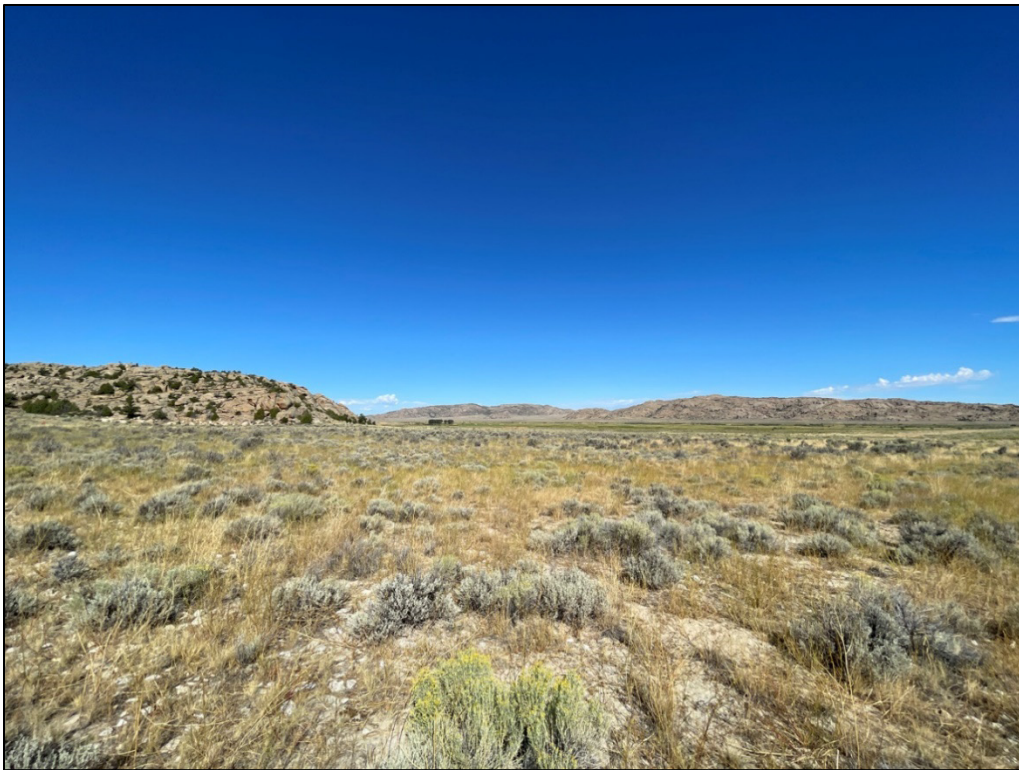
The tailings impoundment, completed in 1996, occupies 265 acres and protrudes between granite outcrops. The outcrops split the tailings impoundment into two lobes in the northwest valley (NWV) (PL-10) and the southwest valley (SWV) (PL-11). The cover in the NWV consists of a rock layer overlain by a revegetated soil and rock mulch matrix, whereas the remaining cover consists of only a rock layer for erosion protection. There were no signs of erosion, settlement, or other modifying processes on the tailings impoundment cover that might affect its integrity.

*PL-10. Northwest Valley Lobe of Disposal Cell*

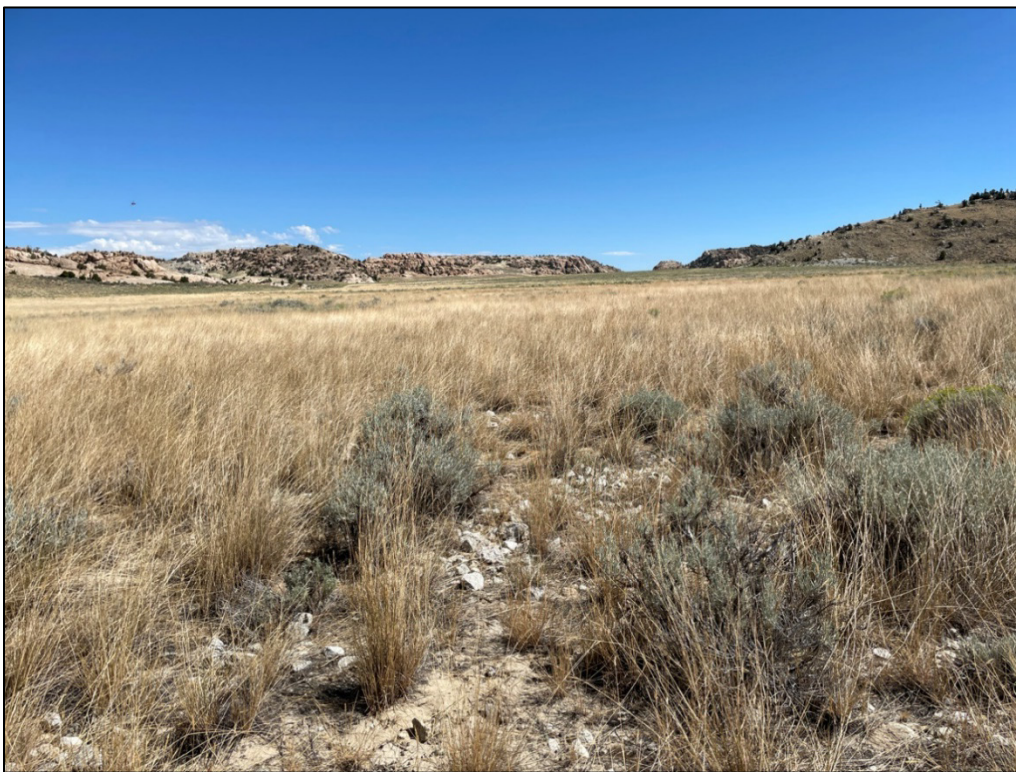
*PL-11. Southwest Valley Lobe of Disposal Cell*

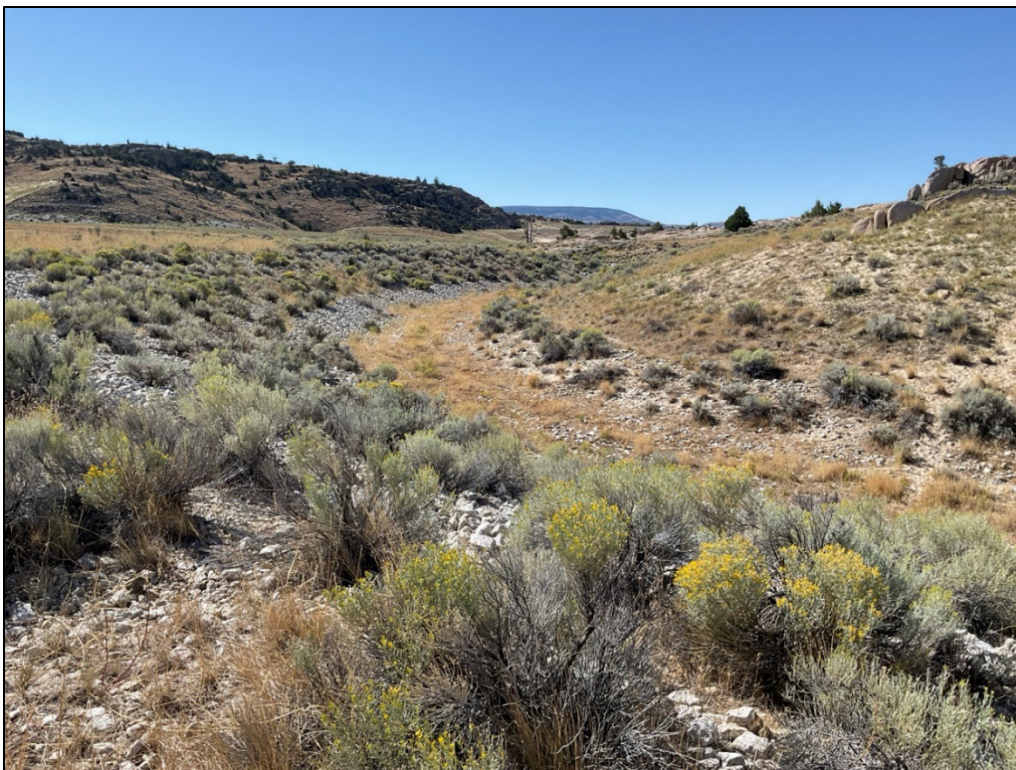
Since construction of the final reclamation cover and before the site transitioned to LM, shrubs and grasses had established on the tailings impoundment and side slopes (PL-12) (DOE 2010). No negative performance impacts of established vegetation on the disposal cell have been identified (DOE 2023). No maintenance needs were identified.

*PL-12. Vegetation on Side Slope of Disposal Cell*

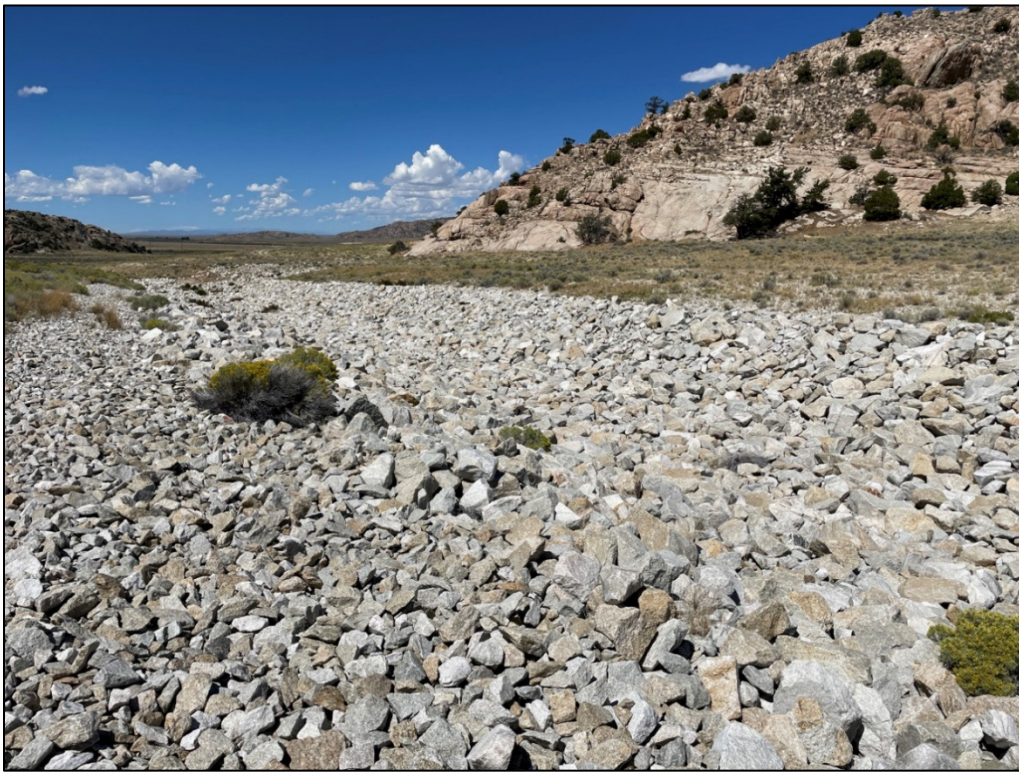
The site stormwater diversion system was designed to control surface water flows from impacting the disposal area by conveying surface water away from the reclaimed tailings impoundment. The site stormwater diversion system consists of four diversion ditches: the North Diversion Channel (PL-13), South Diversion Channel (PL-14), North Central Diversion Channel (PL-15), and South Central Diversion Channel (PL-16). In addition, three riprap-lined swales are constructed on top of the reclaimed tailings impoundment to direct flood flows into the North Diversion Channel (PL-17). Riprapped erosion aprons and scour trenches were constructed at the outlets of all the diversion ditches to prevent headcutting and long-term erosion.

*PL-13. North Diversion Channel*

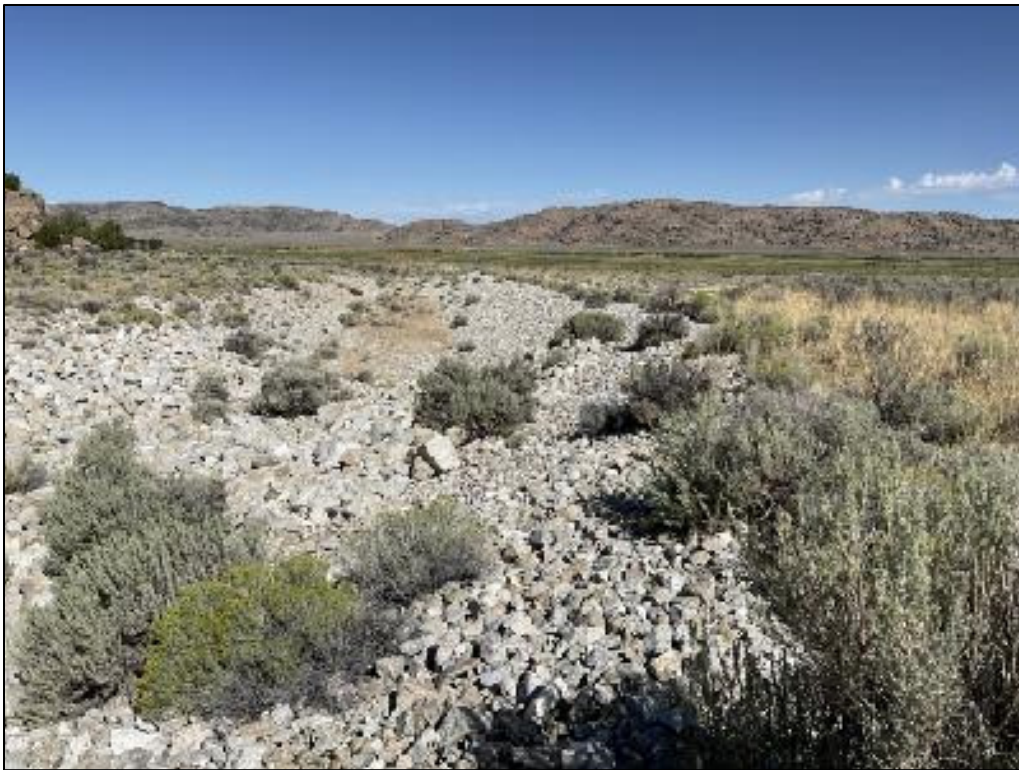
*PL-14. South Diversion Channel*

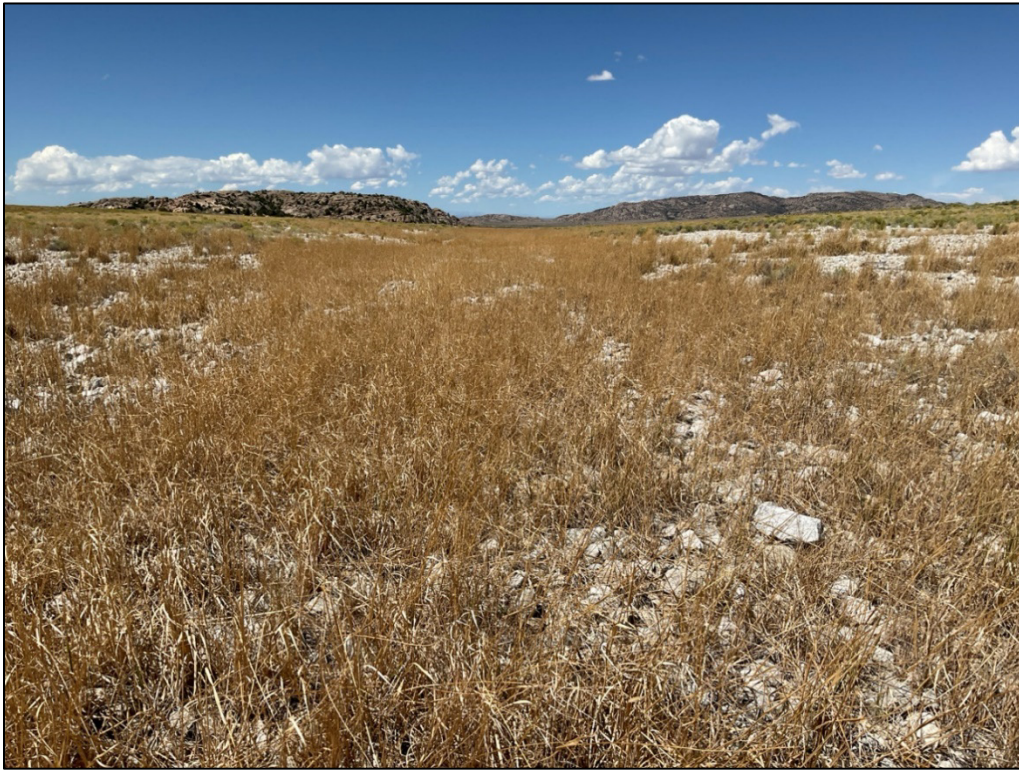
*PL-15. North Central Diversion Channel*

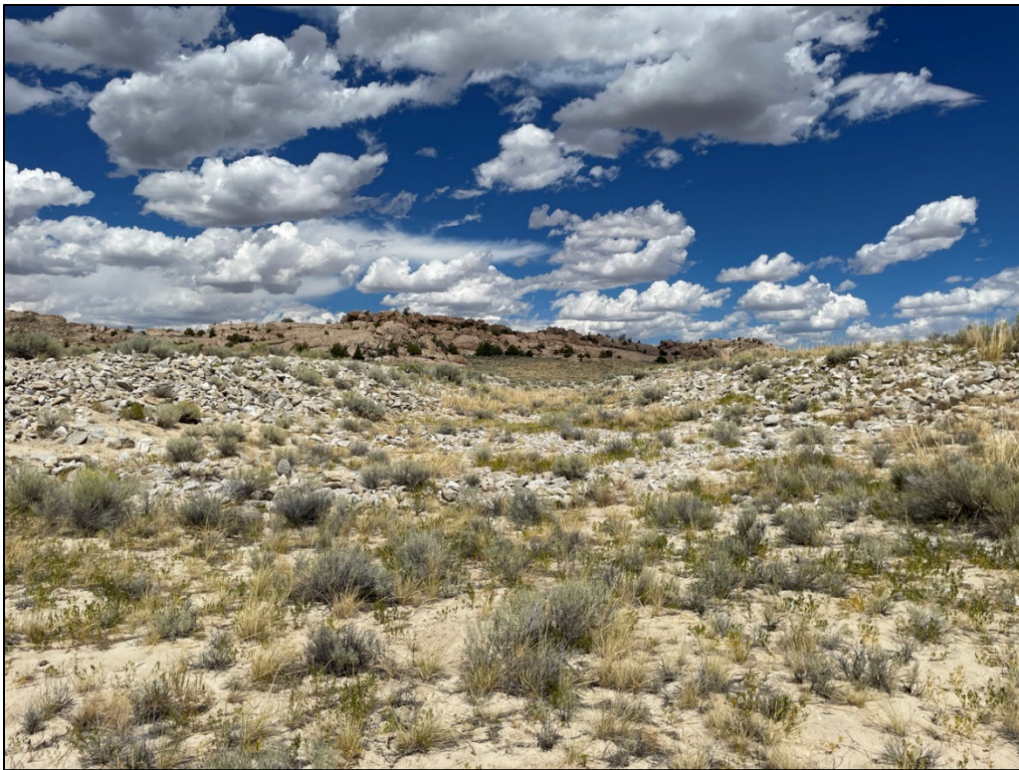
*PL-16. South Central Diversion Channel*

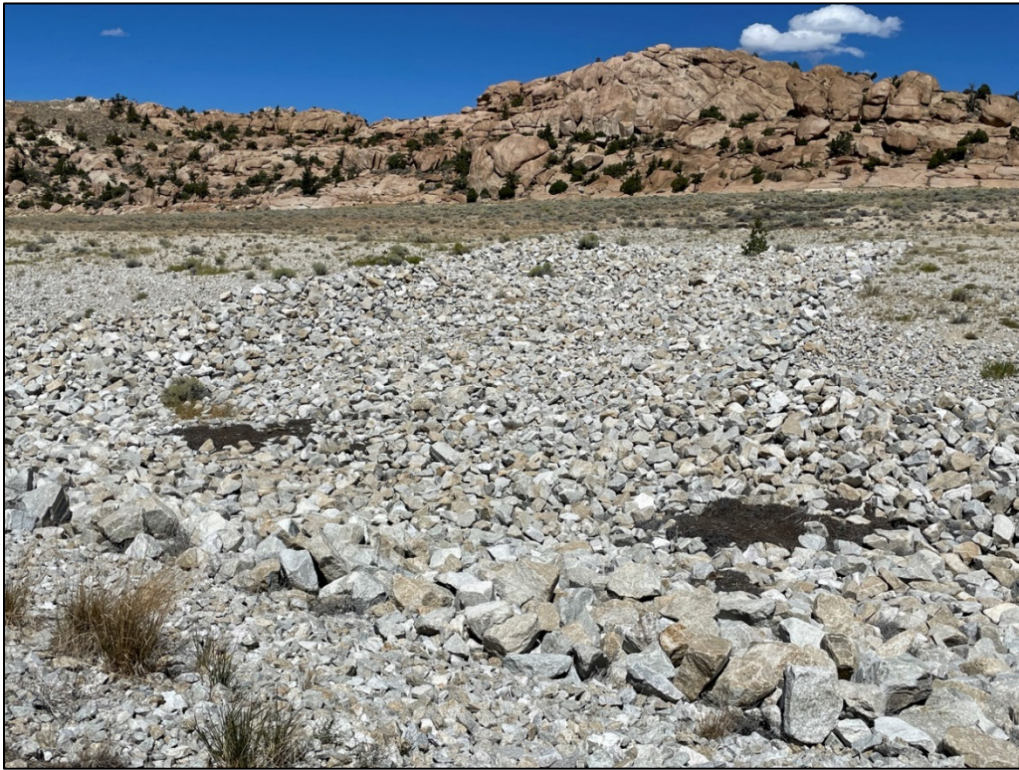
*PL-17. Swale Inlet Channel on Disposal Cell*

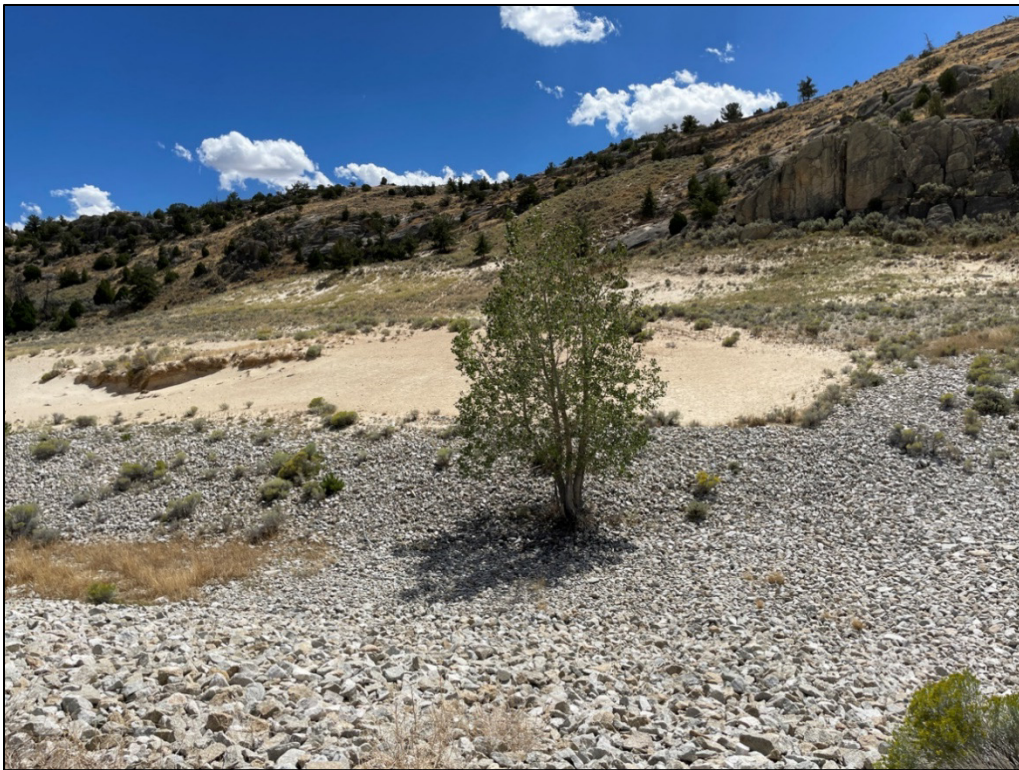
Since construction and before the site transitioned to LM, deep-rooted vegetation has established in the stormwater diversion system (DOE 2023). Inspectors noted volunteer growth of deep-rooted species within the stormwater diversion system; however, no negative performance impacts have been identified from their presence (PL-18). No maintenance needs were identified.

*PL-18. Deciduous Tree in South Diversion Channel*

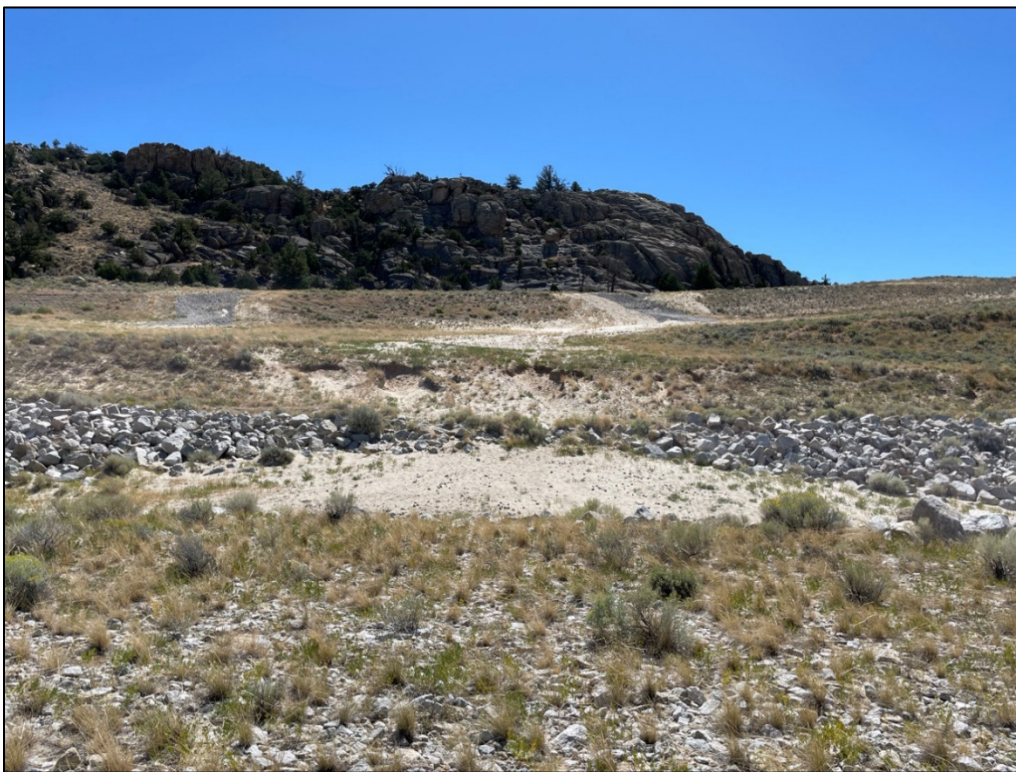
Before site transition to LM, erosion was repaired on the south side slope of the granite outcrop that has deposited sediment in the South Diversion Channel (PL-19). Further repair of the erosion is not anticipated because potential erosion in that portion of the site is not expected to significantly impact the function of the channel. No maintenance needs were identified.

*PL-19. Erosion Repair Area Completed by WNI*

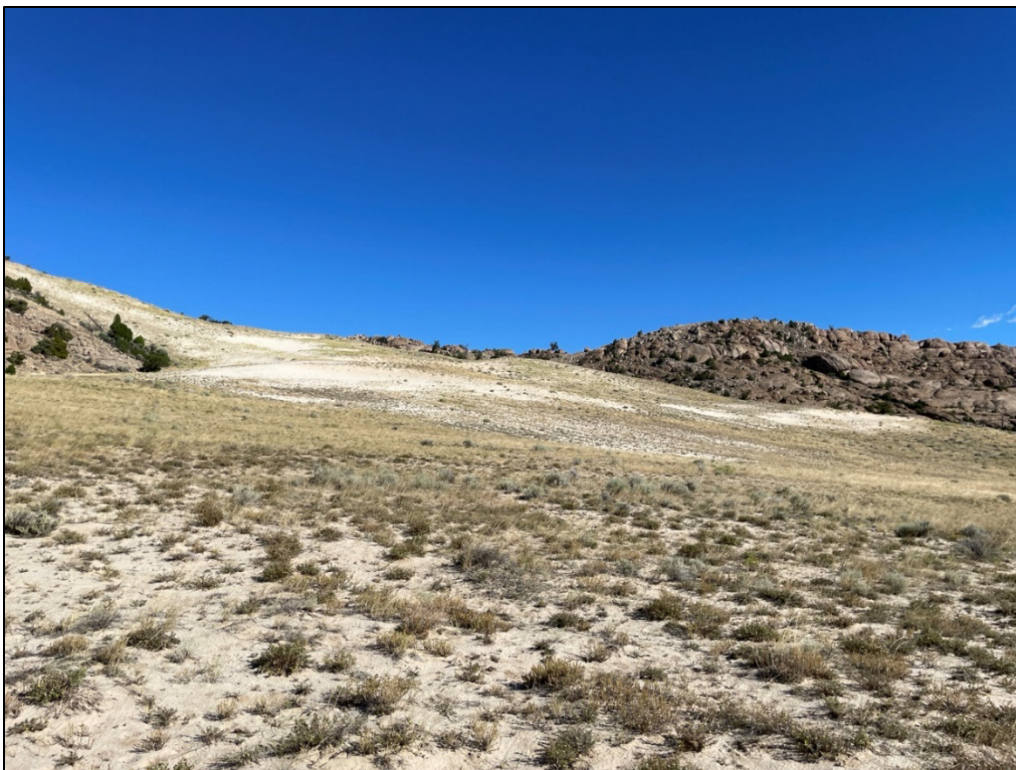
Private land surrounds and is present within the site boundary. The balance of the site includes granite outcrops, riparian areas along the Sweetwater River, a former borrow area, revegetated slopes and flats, and native rangelands. Inspectors looked for changes in development in the surrounding areas, which could be development or expansion of human habitation, erosion, road building, oil and gas development, or other changes in land use. No signs of intrusion or other activities were identified on these properties during the 2024 inspection that may affect site protectiveness. Vegetation is well-established with few exceptions. There is a sand blowout area (PL-20) in reclaimed areas between rock outcrops in the interior of the Split Rock site. In these areas, pretransition grass reseeding efforts have failed, and plant cover is very sparse. However, no adverse effects of vegetation establishment were identified. No maintenance needs were identified.

*PL-20. Sand Blowout in Reclamation Area*

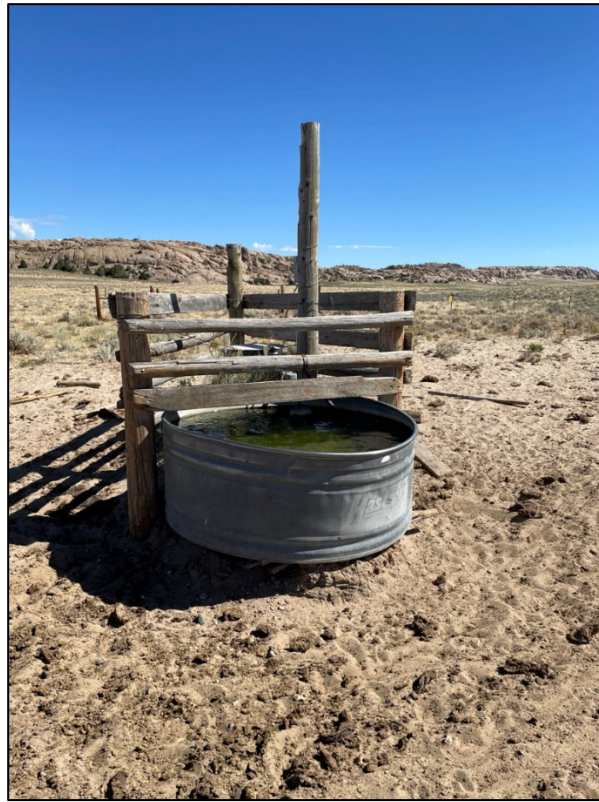
Use of livestock well WN-24 was established between WNI, the former site licensee, and the same rancher who is currently utilizing the site for grazing under an LM grazing license. There was no evidence before transition that the well had been affected by processing-related groundwater contamination. The grazing license allows the rancher to pump water for livestock watering purposes and to utilize the watering facility (PL-21). No maintenance needs were identified.

*PL-21. Livestock Well WN-24*
