## 3.0 Canonsburg, Pennsylvania, Disposal Site

### 3.1 Compliance Summary

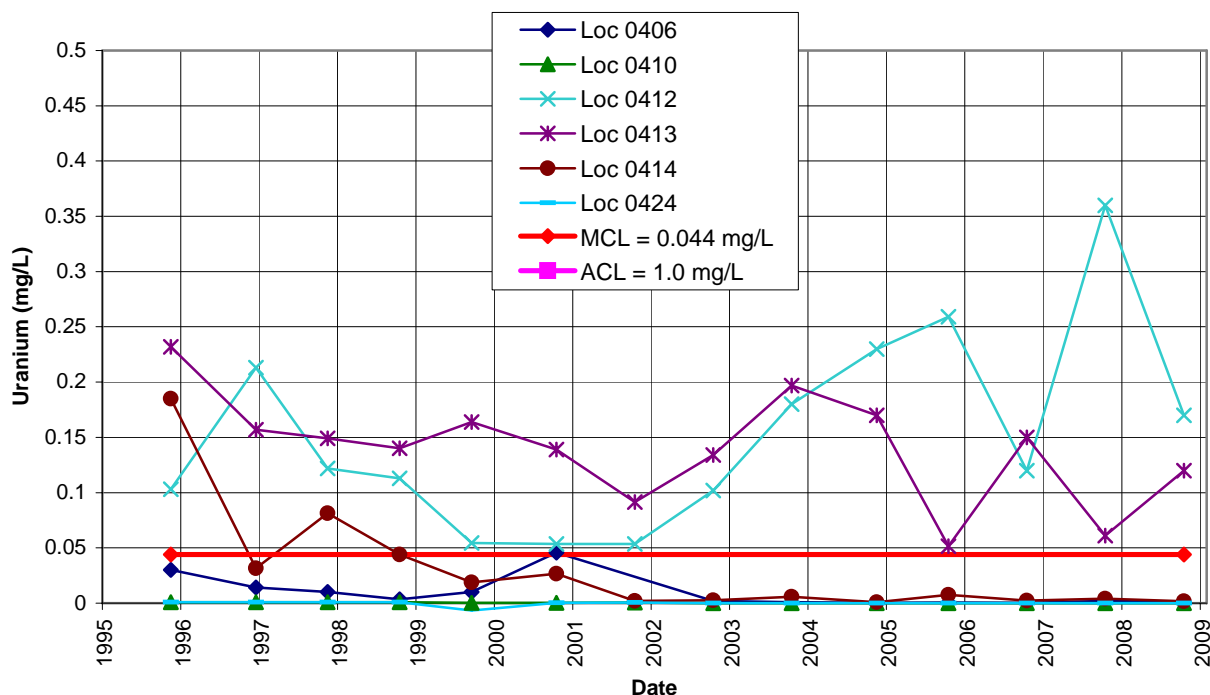
Figure 3-2. Time-Concentration Plots of Uranium in Groundwater at the Canonsburg Disposal Site

**Groundwater**—In 2007 and 2008, uranium concentrations in wells MW-0412 and MW-0413 remained above the MCL but considerably below the established ACL (Figure 3-2). Following a downward trend from 1996 through 1999, concentrations of uranium at well MW-0412 had increased from 2001 through 2005, with a decrease reported in 2006. In 2007, the uranium concentration rose to 0.36 mg/L, the highest value recorded for this well. In 2008, the uranium concentration dropped to 0.17 mg/L. Even though there continues to be fluctuation in this well, all uranium concentrations remain well below the ACL. No definitive trend can be established in well MW-0412. From 1995 through 2001, uranium concentrations in well MW-0413 displayed a downward trend. Since 2002, uranium concentrations in well MW-0413 have fluctuated but remain below the initial 1995 concentration and have not exceeded the ACL. Uranium concentrations remain below the MCL at the other groundwater monitoring locations in 2007 and 2008.

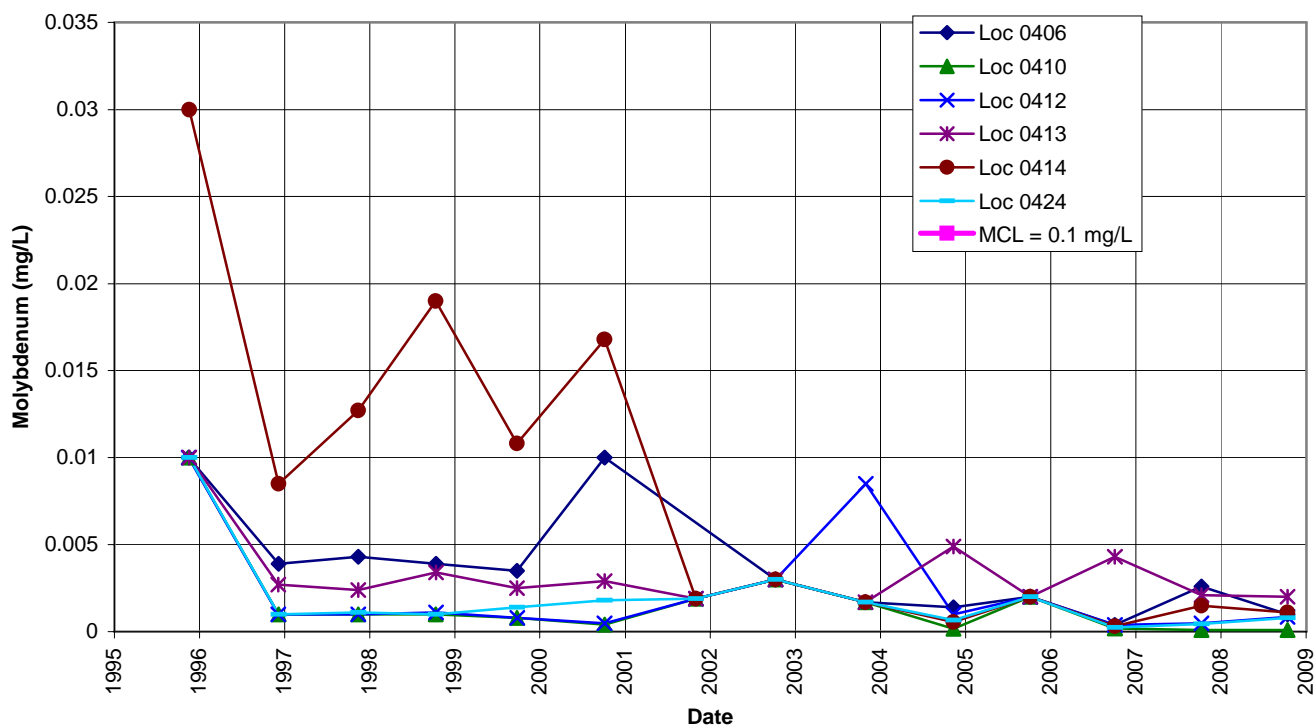
Figure 3–3. Time-Concentration Plots of Molybdenum in Groundwater at the Canonsburg Disposal Site

In 2007 and 2008, molybdenum concentrations in groundwater continued well below the MCL at all locations, with values remaining near the laboratory detection limit. Historically, the highest concentrations of molybdenum were reported from well MW-0414 during the initial years of monitoring. Concentrations in this well have decreased significantly in recent years and indicate an overall decreasing trend (Figure 3-3). In general, molybdenum concentrations at all other wells have remained relatively constant.

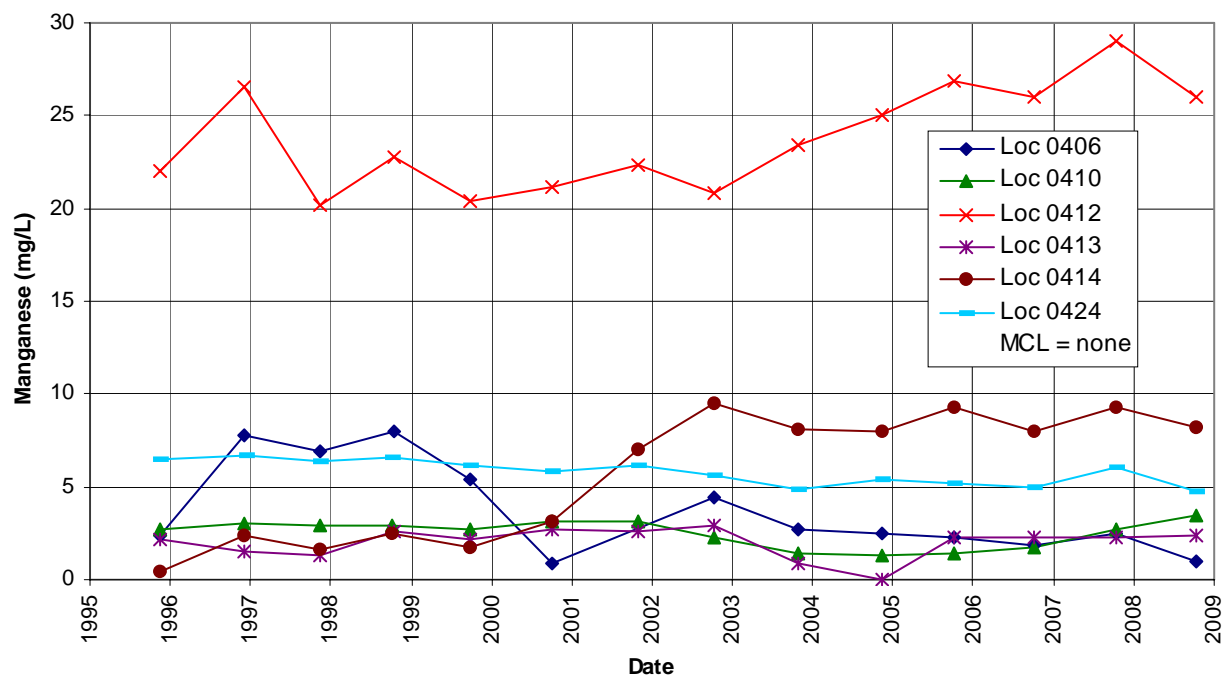
Figure 3-4. Time-Concentration Plots of Manganese in Groundwater at the Canonsburg Disposal Site

Manganese concentrations in groundwater continue to exceed the secondary drinking water standard of 0.05 mg/L at all POC wells. Results from 2007 and 2008 are consistent with results from previous years (Figure 3–4). Concentrations of manganese reported from well MW–0412 remain significantly higher than all other wells.

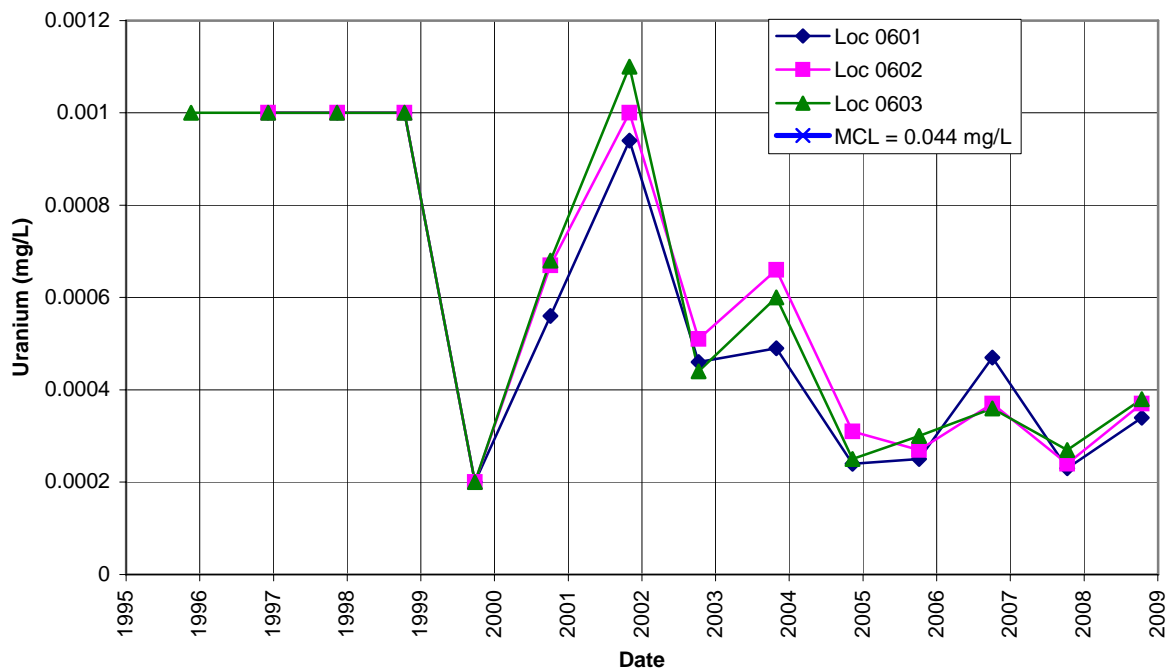
Figure 3-5. Time-Concentration Plots of Uranium in Surface Water at the Canonsburg Disposal Site

**Surface Water**—Uranium concentrations at all surface water sampling locations in Chartiers Creek remain well below the target concentration of 0.01 mg/L and continue to display a decreasing trend that began in 2001 (Figure 3–5).

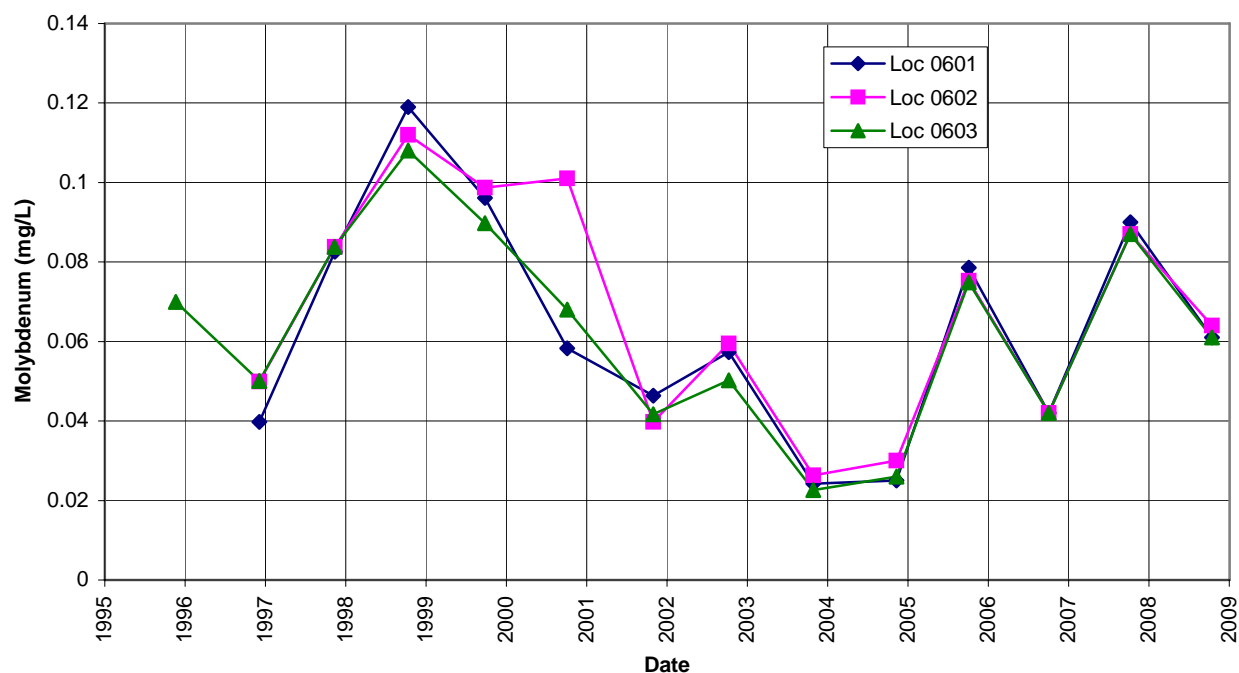
Figure 3–6. Time-Concentration Plots of Molybdenum in Surface Water at the Canonsburg Disposal Site

The concentrations of molybdenum in the Chartiers Creek samples, as in the past, were higher than in groundwater samples, though still below the MCL of 0.1 mg/L. Historically, concentrations have only exceeded the MCL in 1998 (at all locations) and again, although only slightly, at location SW–0602 in 2000 (Figure 3–6). Surface water concentrations both upstream and downstream of the site exceed concentrations in groundwater. This indicates an ambient or upstream source of molybdenum rather than site-related activities. The surface water quality in upstream and downstream locations is indistinguishable. Molybdenum concentrations at all locations continue to display an overall decreasing trend that began in 1998.

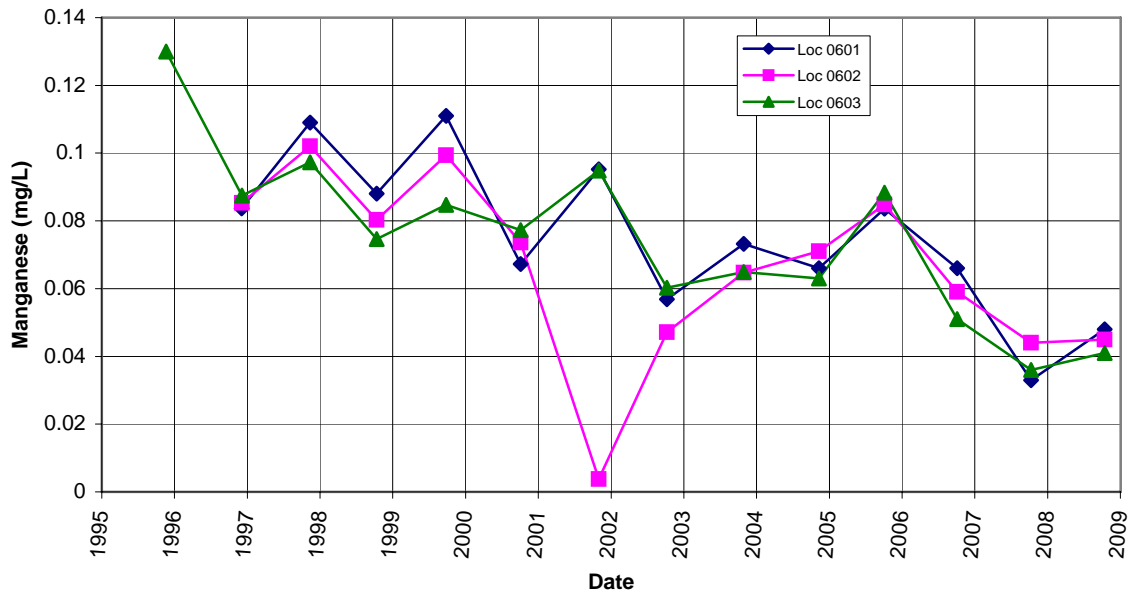
Figure 3-7. Time-Concentration Plots of Manganese in Surface Water at the Canonsburg Disposal Site

Manganese concentrations in surface water in Chartiers Creek continue to display an overall decreasing trend at all three locations, although location SW–0602 appeared to have an anomalously low concentration in 2001 (Figure 3–7). With the exception of location SW–0602 in 2001 and 2002, all manganese concentrations in surface water remain above the secondary drinking water standard of 0.05 mg/L but well below the EPA risk-based guideline of 1.7 mg/L. However, manganese concentrations do not appear to be site-related as upstream and downstream concentrations are the same.

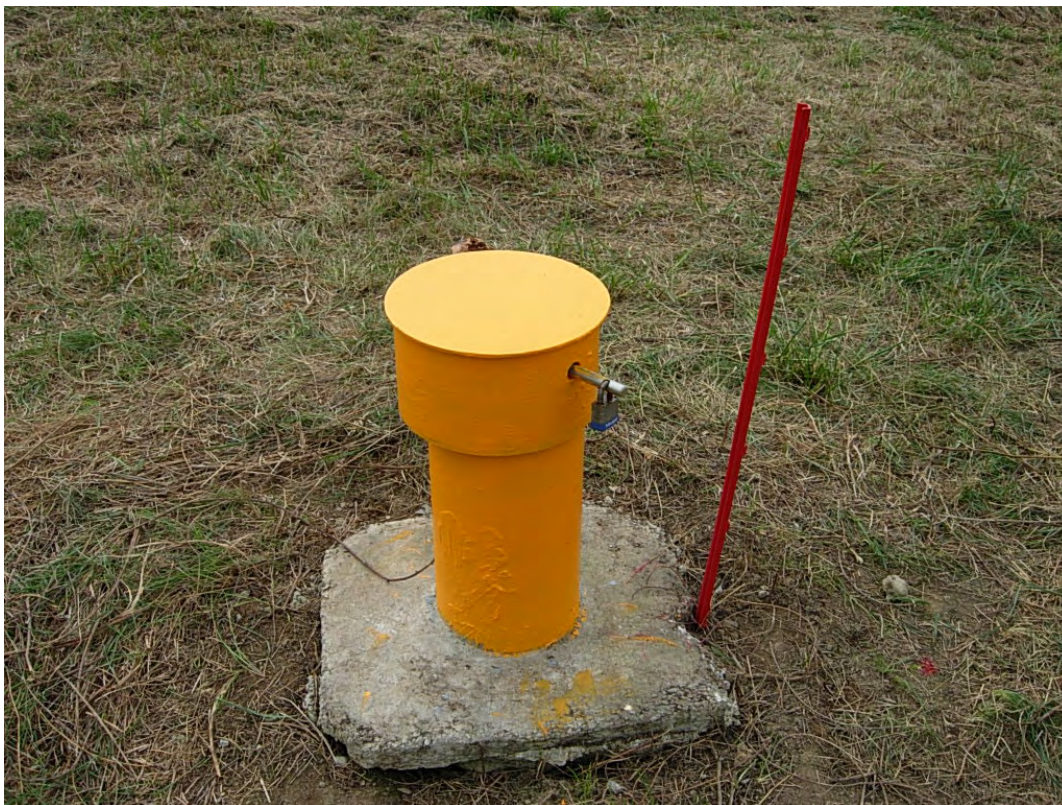
**Monitor Wells**—The groundwater monitoring network for the site consists of six monitor wells (MW–0406A, MW–0410, MW–0412, MW–0413, MW–0414B, and MW–0424). All were in excellent condition. The protective casings and bollards for all monitor wells were painted in 2008 (PL–1).

*CAN 10/2008. PL-1. Monitor Well 0412 (recently painted).*

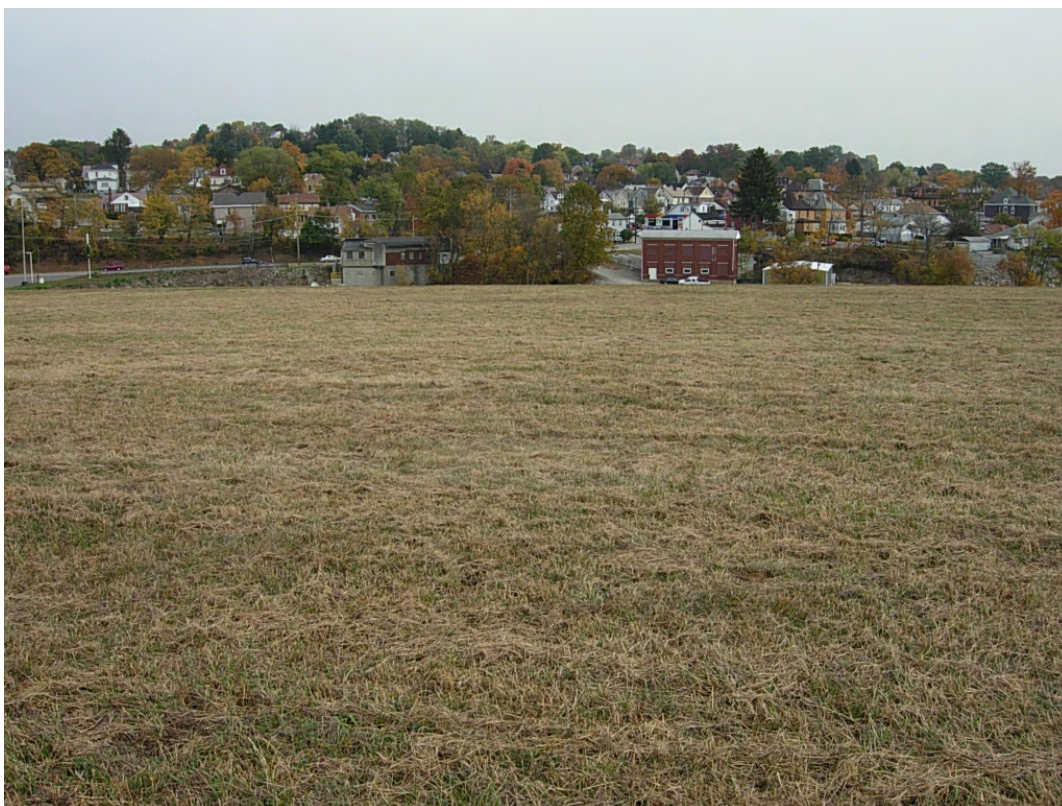
**3B Disposal Cell**—The grass-covered disposal cell surface was in excellent condition (PL-2); there was no evidence of slumping, settling, erosion, or other modifying processes. The grass is mowed and mulched at least annually in accordance with the LTSP. DOE continued to control Canada thistle and poison hemlock through a combination of spot spraying with herbicide and mulching, which has greatly reduced the extent of these listed noxious and invasive weeds.

*CAN 10/2008. PL-2. Grass-covered disposal cell.*

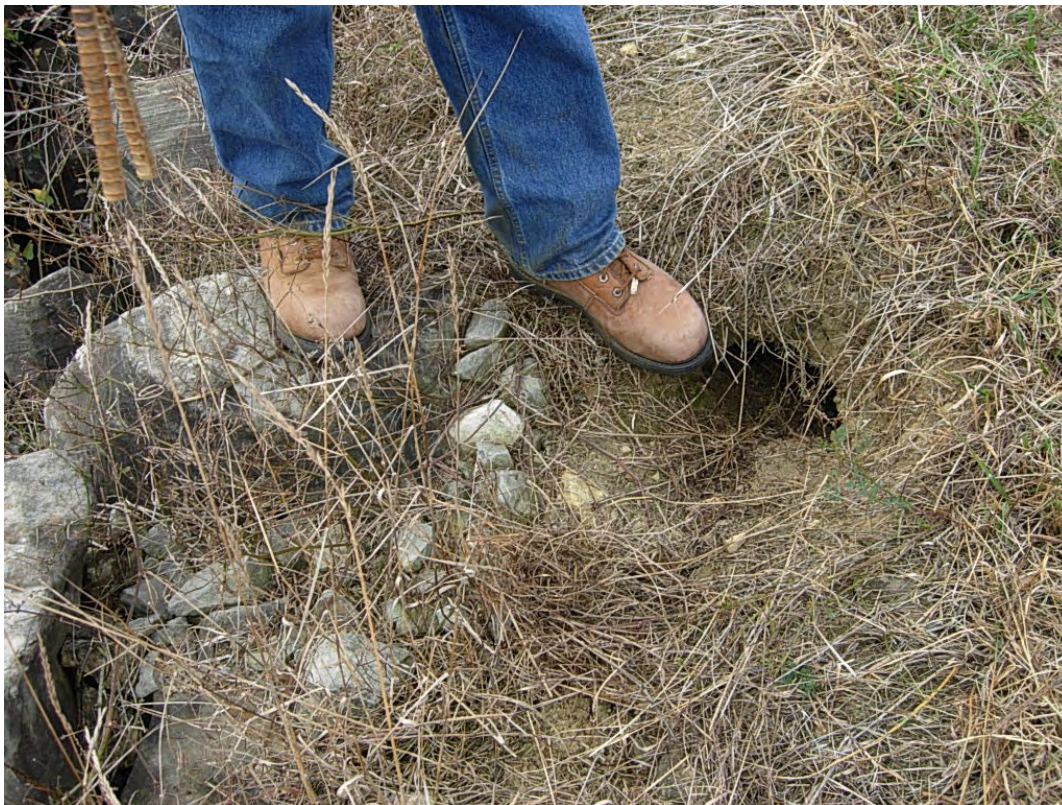
**3C** Animal burrows continue to be observed on the cell cover, but only the upper topsoil material appears to have been displaced. Because the buried tailings at this site are overlain by a 36-inch-thick clay layer (radon barrier), an 18-inch-thick rock layer, and a 12-inch-thick topsoil layer, biointrusion into the tailings is unlikely, and such burrows should not pose a risk to disposal cell integrity or public health. The location and significance of burrows will continue to be monitored. In 2008, three animal burrows were noted on the east side of the cell cap just above the diversion ditch (PL-3). No new activity was noted at any of the existing burrows, and no new burrows were detected.

*CAN 10/2008. PL-3. Animal burrow along edge of the disposal cell and diversion channel.*

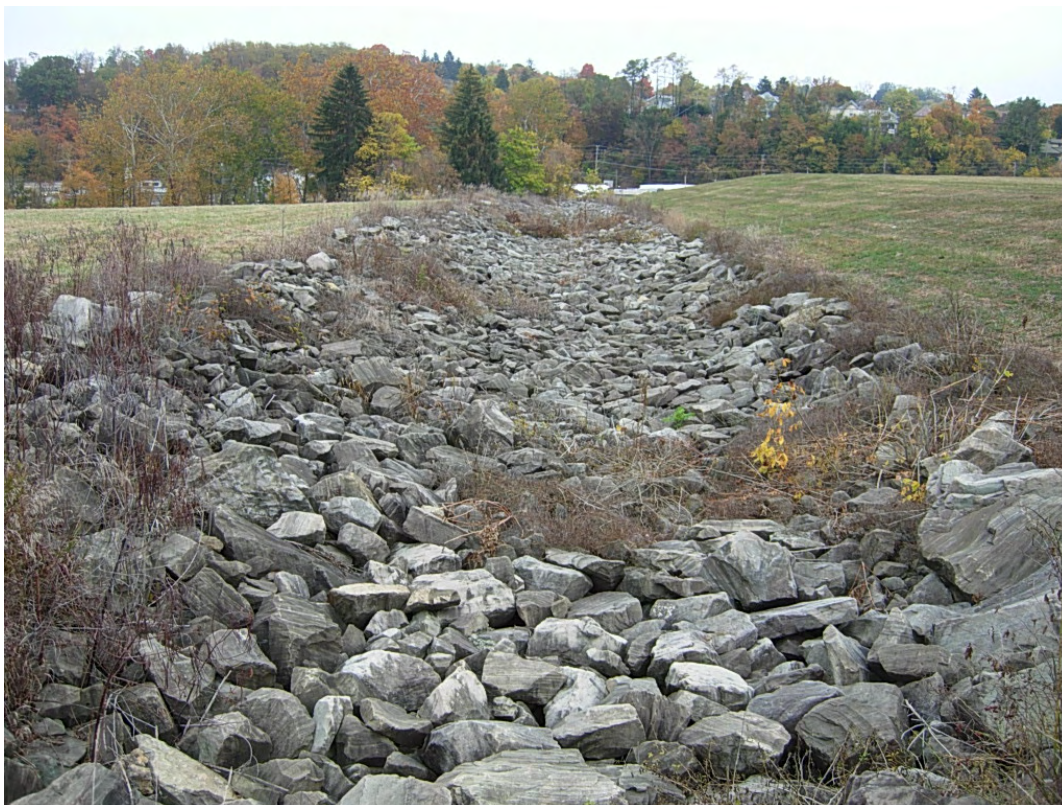
**3D Diversion Channels and Perimeter Ditch**—Diversion channels around the disposal cell and the perimeter ditch along the south side of the site are armored with riprap and were in good condition. No indications of diminished rock durability were noted. Woody vegetation establishing in the diversion ditches continues to be controlled by cutting and spraying (PL-4). Riprap in the outlet to the diversion ditch northeast of the cell cap was restored after a temporary access road for the stream bank stabilization work was removed (PL-5).

*CAN 10/2008. PL-4. Riprap-armored diversion ditch northwest of the disposal cell.*

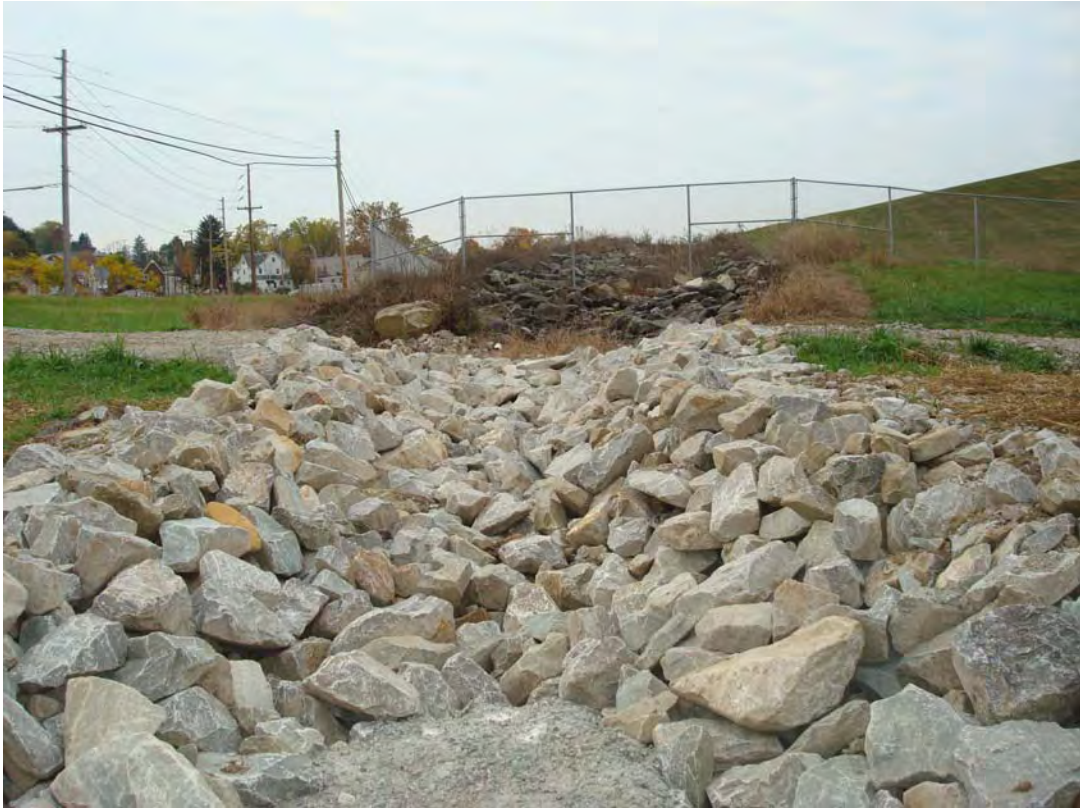
*CAN 10/2008. PL-5. Riprap restoration at outlet to the east diversion channel.*

In 2008, DOE restored riprap placement at the outlet to the east diversion channel, controlled woody growth within the diversion channels, painted the monitor well protective casings and bollards, mowed grass on and adjacent to the disposal cell, cleared vegetation from the perimeter fence, and sprayed noxious and invasive weeds.

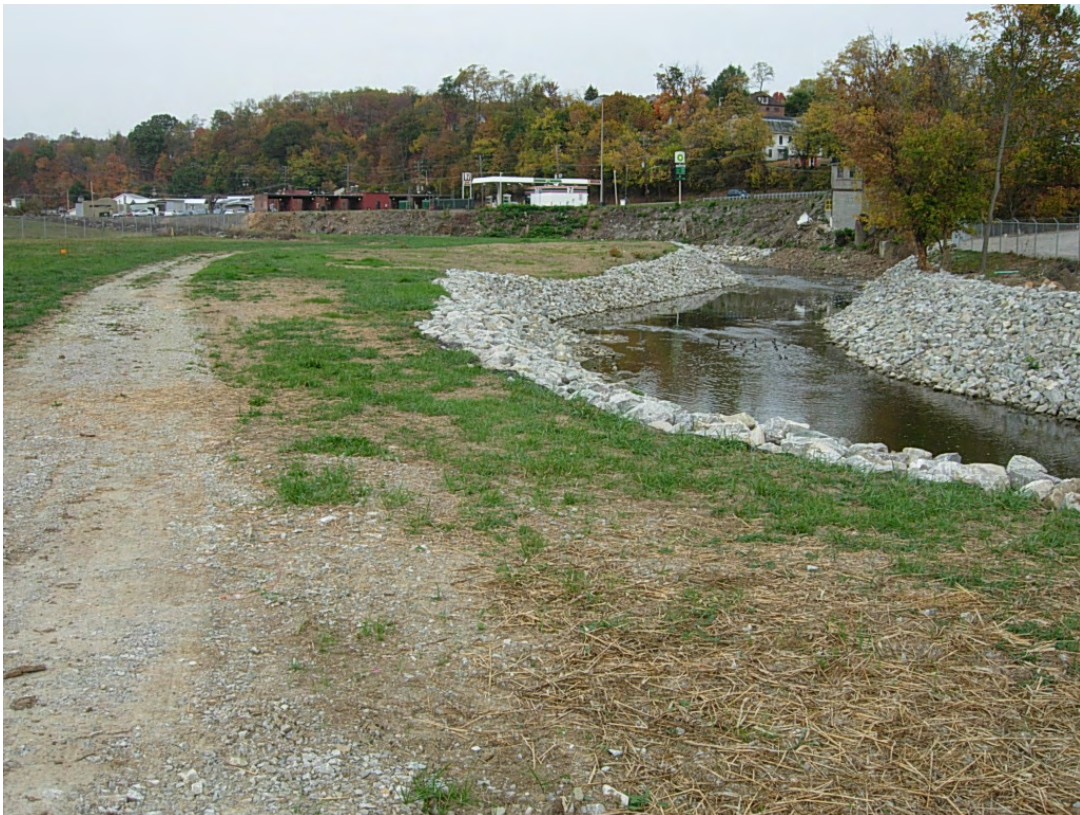
- 3E The completion of the Chartiers Creek stream bank stabilization work was verified during the 2008 inspection (PL-6). Stream bank stability will continue to be monitored.

*CAN 10/2008. PL-6. Completed stream bank stabilization work west of Strabane Avenue Bridge.*

2006, the area between perimeter signs P7 and P8 was stabilized. And, in 2008, the area between perimeter sign P8 and Strabane Avenue Bridge was stabilized. The stabilization work consisted of cutting back the slope of the creek bank and armoring the toe with riprap keyed into bedrock. The riprap was underlain by a geotextile fabric. Above the riprap, the slope was protected by stabilization matting and the planting of live fascines.
