3.0 Canonsburg, Pennsylvania, Disposal Site

3.1 Compliance Summary

The Canonsburg, Pennsylvania, Disposal Site, inspected on September 20, 2007, was in excellent condition. Modifications to the groundwater and surface water-monitoring program were proposed in a final draft of the revised Long-Term Surveillance Plan (LTSP); concurrence from NRC is pending. Vegetation control for noxious weeds is ongoing. DOE replaced the chain link security fence and gating. Approximately 0.5 acre of former Tract 117 is pending sale. No other maintenance needs or cause for a follow-up inspection or contingency were identified.

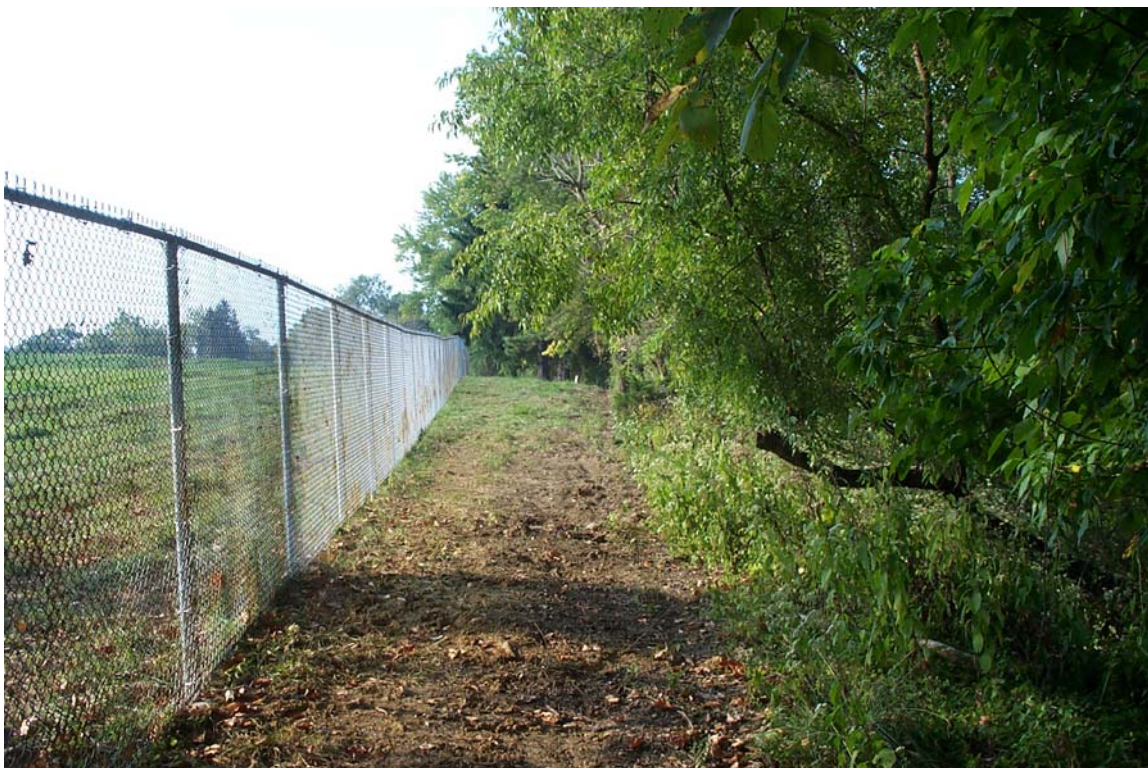
3A Access, Gates, Fence, and Signs—Access to the site is directly from Strabane Avenue, a public right-of-way within the borough of Canonsburg in Washington County, Pennsylvania. The security fence and the entrance gate were replaced just prior to the inspection and are in excellent condition. In addition three new gates have been installed and are shown on Figure 3–1. Because unauthorized entry has not been an issue at this site, and to reduce maintenance requirements, angle brackets and barbed wire were not installed on the new fence. The new fence was repositioned away from Chartiers Creek bank on the northwest side of the site to create an access corridor along the outside of the west fence line (PL–1). In the past, trees, woody brush, and vines encroached upon portions of the west fence line because it was too close to the steep drop off down to Chartiers Creek to provide maintenance access.

The perimeter security fence has 11 perimeter signs and one entrance sign attached to it that are in good condition.

CAN 9/2007. PL-1. View down outside of the security fence from perimeter sign P5.

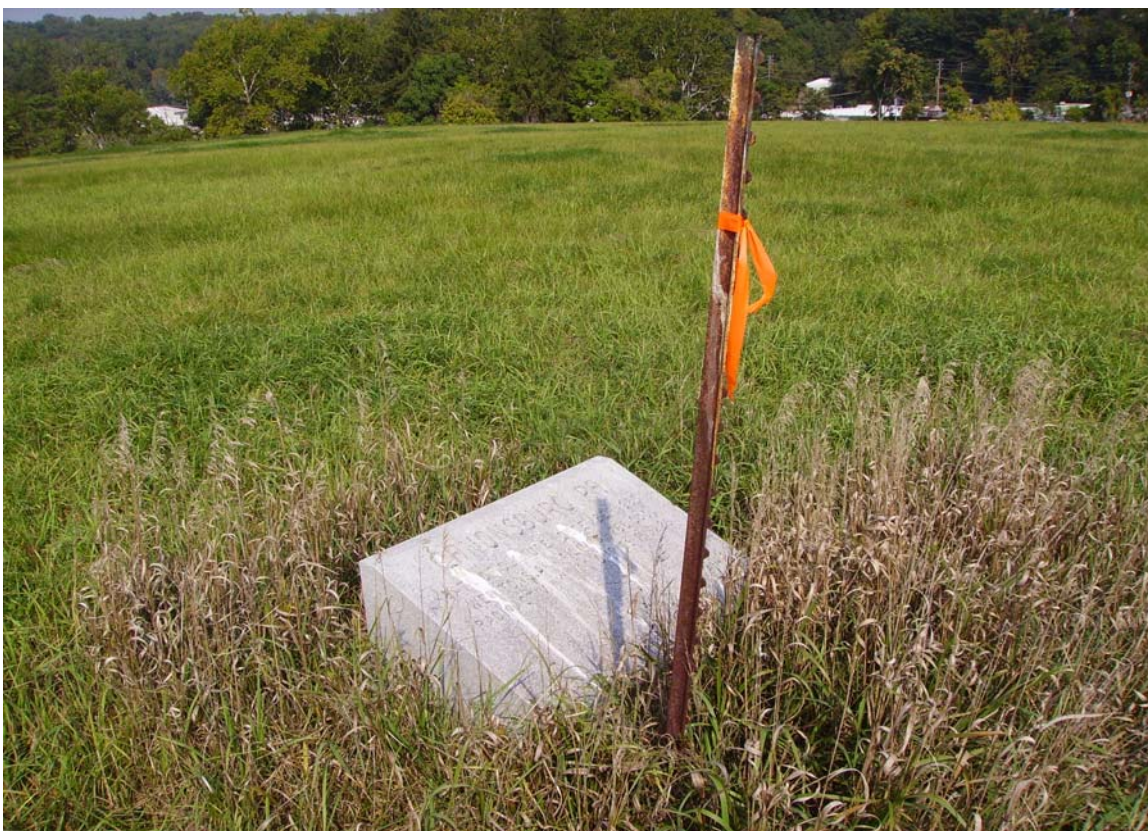
Site Markers and Monuments—The site contains two site markers (PL–2), three survey monuments, and four boundary monuments. Both site markers and all three survey monuments were located and are in excellent condition. All four boundary markers are also in excellent condition. Boundary monument BM–1 is buried beneath approximately 1 foot of riprap.

CAN 9/2007. PL-2. Site marker SMK-1.

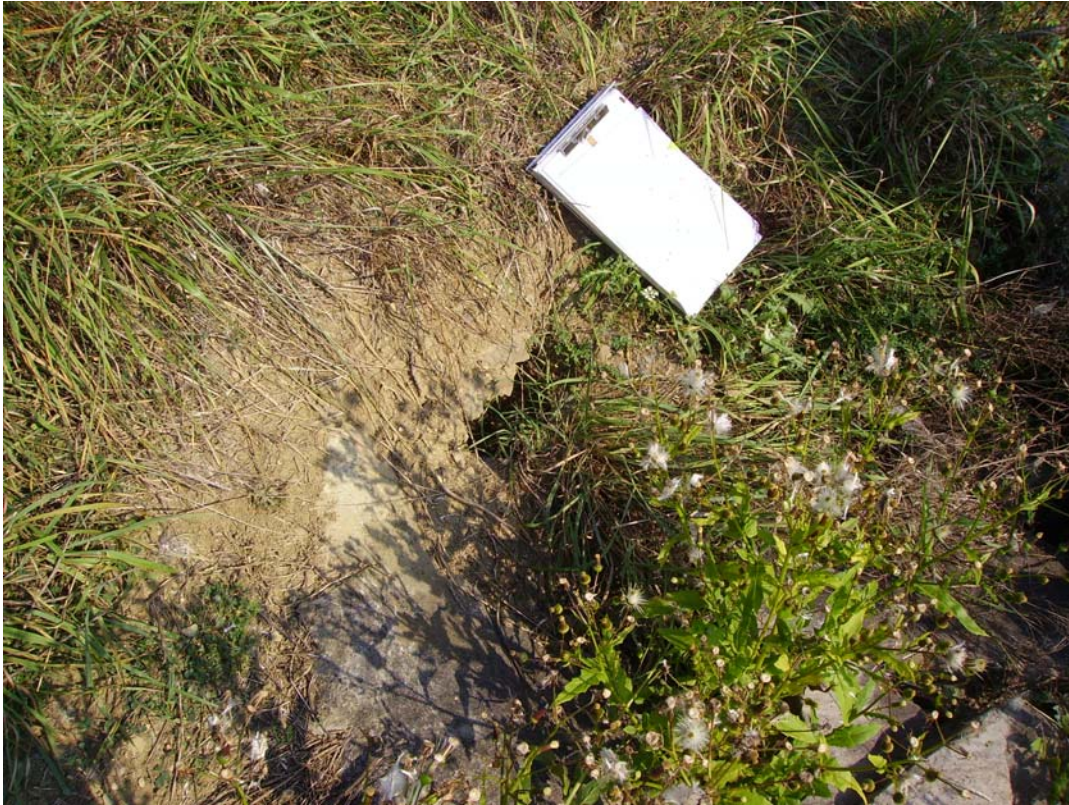
3C In the past, occasional animal burrows have been found on the cell cover, but only topsoil material has been displaced. Because the buried tailings at this site are overlain by a 36-inch-thick clay layer (radon barrier), an 18-inch-thick rock layer, and a 12-inch-thick topsoil layer, biointrusion into the contaminated layer is unlikely and such burrows should not pose a risk to cell integrity or public health. The location and significance of burrows will continue to be monitored by inspectors each year. This year, four animal burrows were discovered on the east side of the cell just above the diversion ditch (PL-3). Based on the size of the holes, the burrows were probably dug by woodchucks. The burrowing animals will be trapped and relocated off site. The burrows will be filled in and monitoring will continue.

CAN 9/2007. PL-3. Animal burrow.

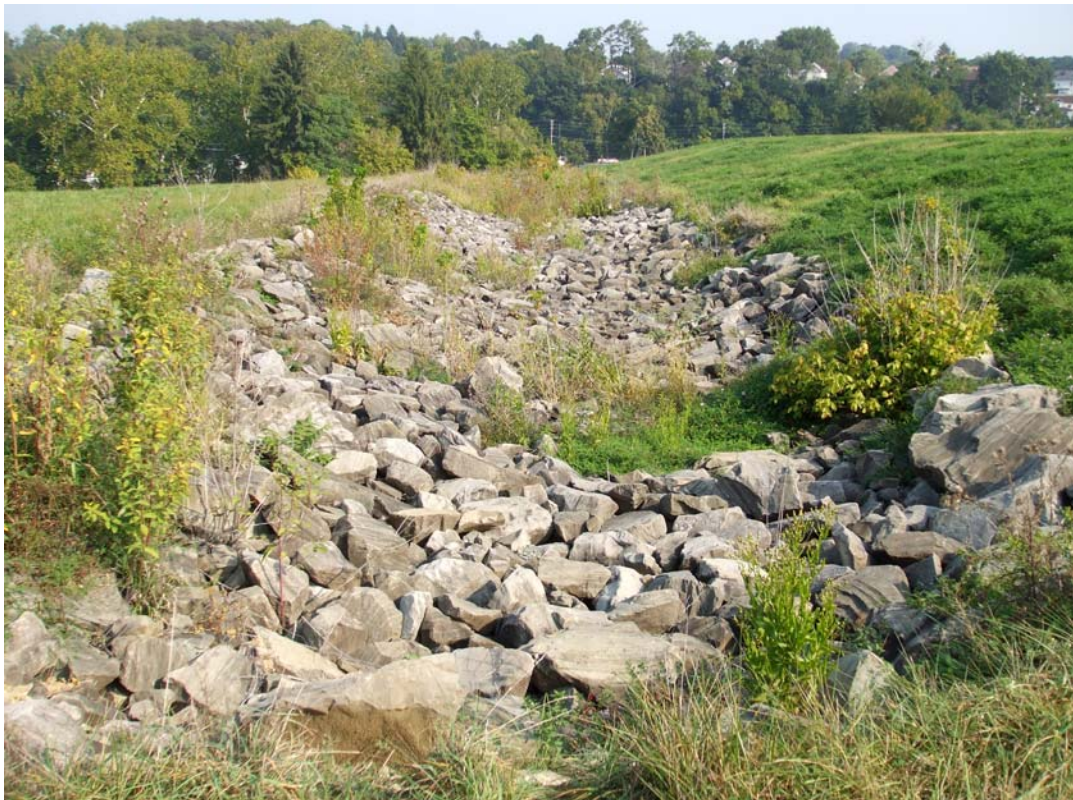
Woody vegetation has become established in most of the diversion ditches surrounding the disposal cell, but currently does not impede function. This vegetation (PL-4) has been removed approximately every 3 years since this site was licensed. This woody vegetation will be removed in 2008.

CAN 9/2007. PL-4. Vegetation growing in west diversion channel.

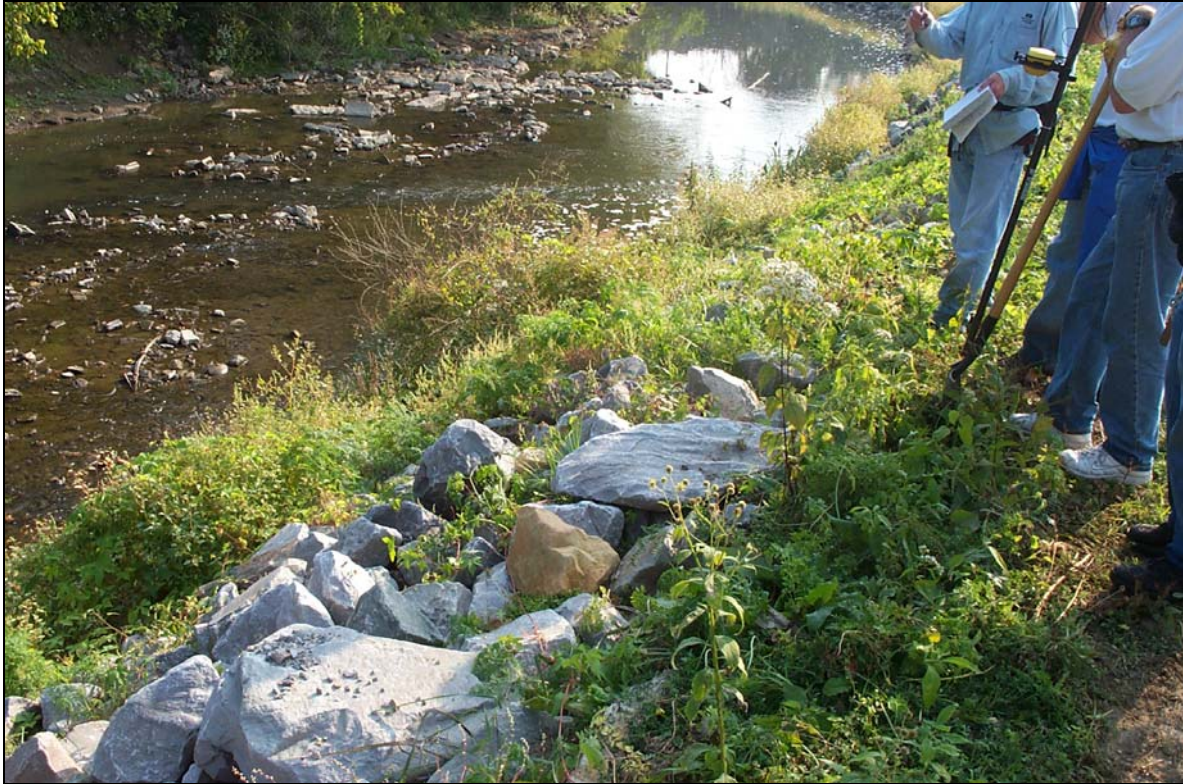
Site Perimeter—Chartiers Creek is an active, meandering waterway that is only partially restrained on the east end of the disposal site. The creek is slowly cutting into the bank and the flooding in 2004 upset the equilibrium. In order to enhance the bank stability, local and state officials have arranged grant monies to stabilize the stream bank near perimeter sign P8. DOE and NRC representatives evaluated the proposed plan and agreed that the proposed work would not affect the integrity of the disposal cell, and would provide protection from further bank erosion. The work, performed in November 2006, consisted of cutting back the slope of the bank and armoring the toe above the 1000-year flood levels with riprap keyed into bedrock. Above the riprap, the slope was protected by stabilization matting and planting of live fascines. In 2007, the stream bank stabilization work was observed to be functioning as designed. However, based on the seed mix used, revegetation is not establishing as expected and will be reseeded (PL-5).

CAN 9/2007. PL-5. Vegetation encroaching on newly installed riprap along Chartiers Creek between perimeter signs P7 and P8.

3D In 2008 a DOE-funded and Borough-sponsored stabilization of the creek bank between Strabane Avenue and the eastern edge of the 2006-stream bank control project will be undertaken. DOE will work with stabilization project personnel to ensure that the preferred bioengineering approach will provide the best possible stabilization of the bank.
