**SUMMARY REPORT
CENTRAL NEVADA TEST AREA
DEMOBILIZATION
AND
RESTORATION ACTIVITIES**

**UNITED STATES ATOMIC ENERGY COMMISSION
NEVADA OPERATIONS OFFICE
Las Vegas, Nevada**

HOLMES & NARVER, INC.
ON-CONTINENT TEST DIVISION
Las Vegas, Nevada

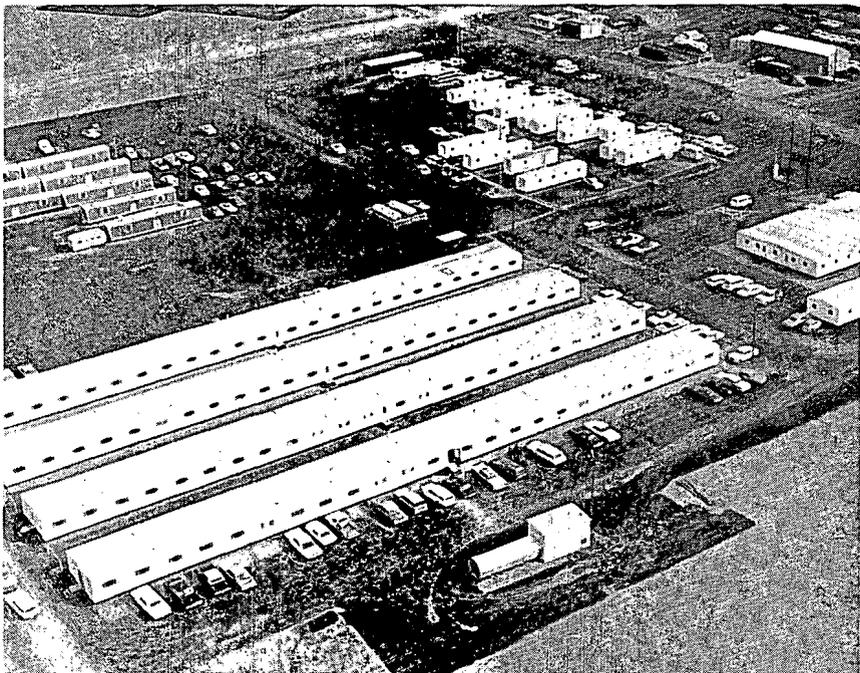
Figure 2 Base Camp for the Faultless Event

The Base Camp and Control Point (CP) areas (the CP is shown in Figure 1) were developed in two stages. Originally, the Base Camp was a Holmes & Narver (H&N) subcontractor's temporary camp (refer to Figure 2), built to support the Faultless event. During CY 1968 and 1969, after Faultless and prior to the planned Adagio event, these areas were improved for reuse. Selected facilities were purchased from the H&N subcontractor; several new buildings were constructed and others were replaced with portable, trailer-type structures from the NTS (refer to

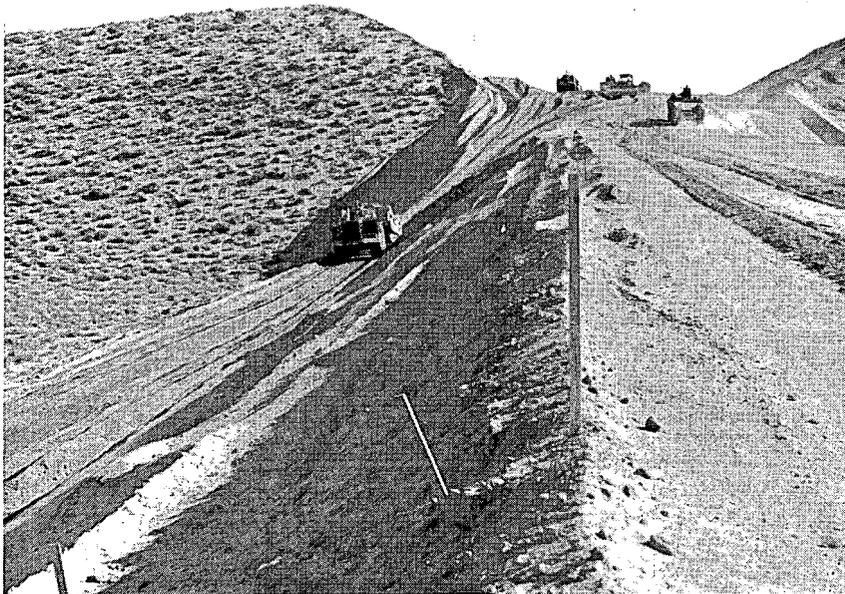
Figure 6 Road Construction - Central Pipe Yard Area

Figures 3 and 4). For the planned, but subsequently canceled, Adagio event, a new control point, airstrip, access road system, recording trailer park, cableway, and ground zero area were constructed, complete with technical structures (refer to Figures 5, 6, and 7).

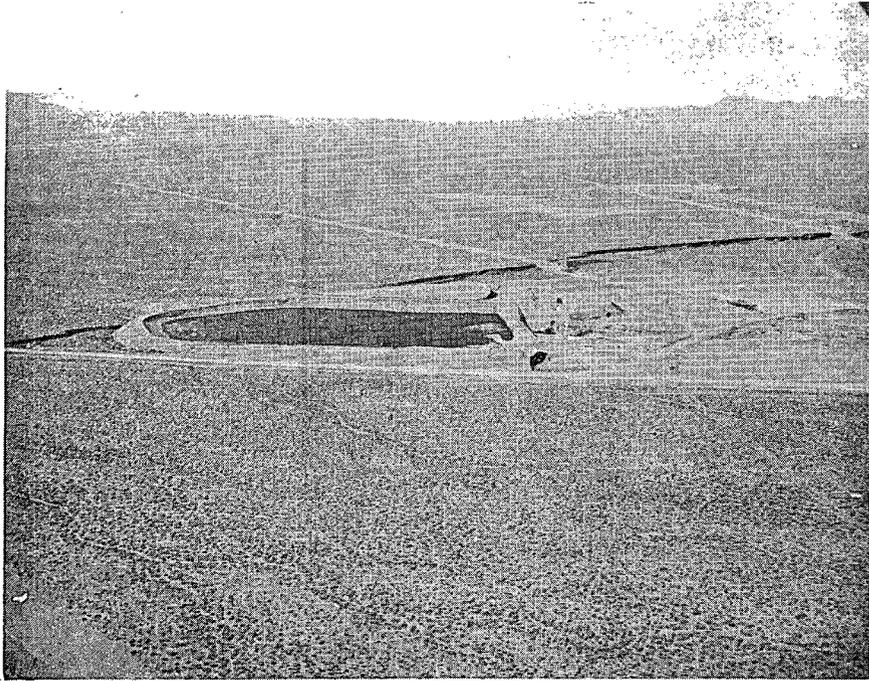
Figure 9 Faultless Subsidence Area - Central Mud Pit

Project Faultless has been the only nuclear test conducted at the CNTA. It was executed to determine the behavior of seismic waves generated by a nuclear device detonation in Hot Creek Valley and to evaluate the potential usefulness of the site for higher-yield experiments. The event was conducted on January 19, 1968. The device, with a yield of less than one megaton, was detonated at a depth of 3200 feet in drill hole UC-1, at Nevada State coordinates (central zone) N 1,414,340 feet, E 629,000 feet, Nye County, Nevada. (Refer to Figure 8 for the Faultless ground zero area.) The event produced an unusual collapse crater. Instead of the typical cone-shaped depression, a large area subsided as an irregular block bounded by local faults (refer to Figure 9).

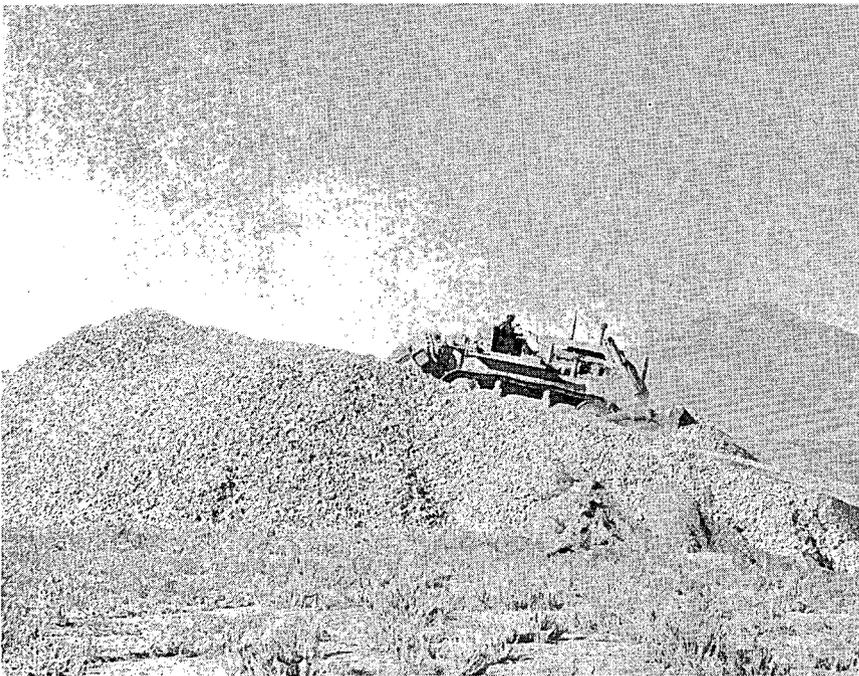
Figure 10 Aggregate Site A - Waste (Oversize) Gravel

Debris was removed, waste piles were rounded off, steep slopes were improved, and exploratory sampling pits were backfilled (see Figure 10).

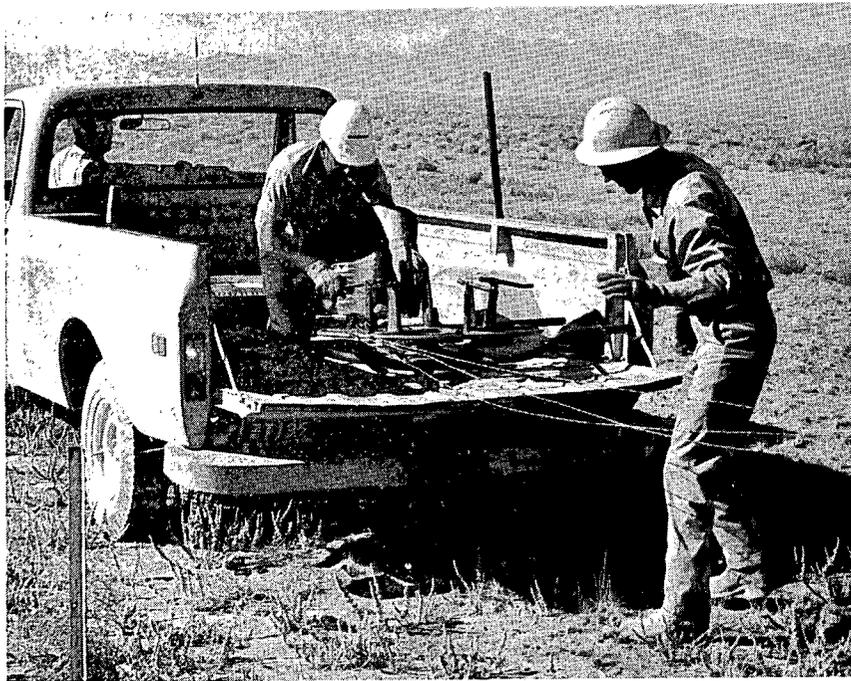
Figure 11 Removing Fence Wire - UC-3 Cableway

Fencing was removed and a parallel drainage ditch was backfilled (refer to Figure 11).

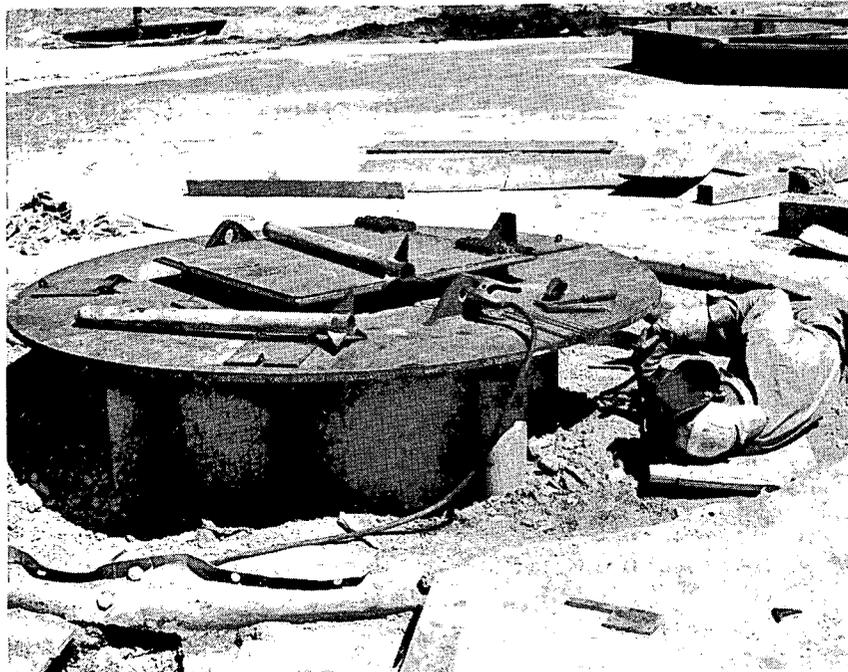
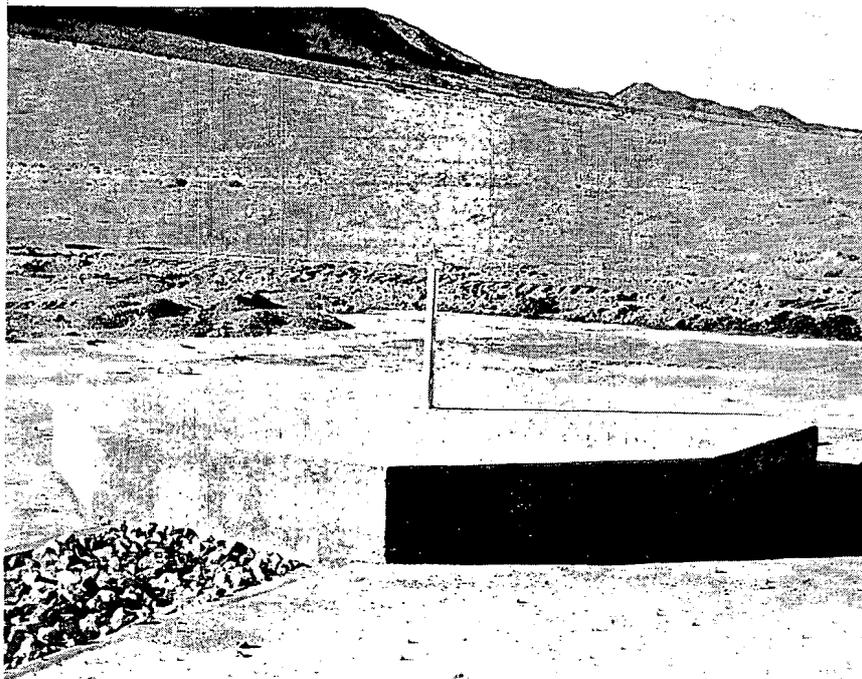
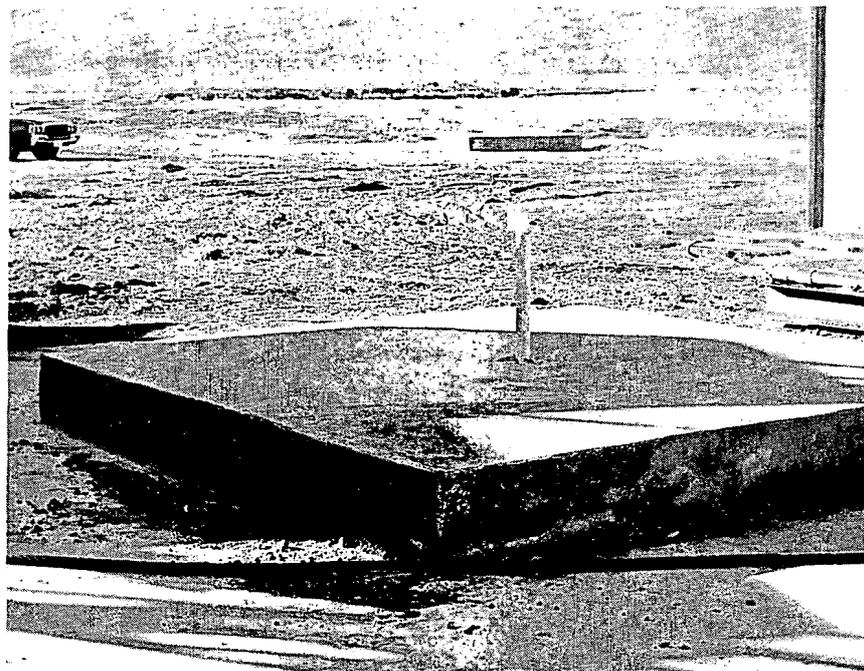
b. Capping of the large diameter UC-3 emplacement and canister holes with heavy concrete slabs over existing steel plates. (See Figures 12, 13, and 14.)

Figure 12 Welding Cover Plate to Casing - Sta. UC-3

Figure 13 Concrete Cover Slab - Sta. UC-3

Figure 14 Concrete Cover Slab - UC-3 Cannister Hole

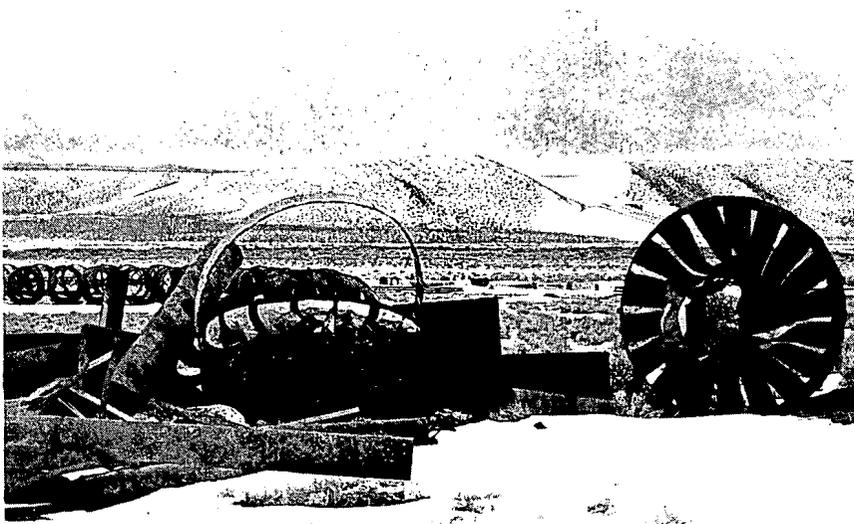
Figure 15 Scrap Metal - Central Pipe Yard

Scrap metal was disposed of through a public sale of ferrous iron. The hillside to the west was cleaned up (refer to Figure 15). Salvable equipment from other areas was moved inside the fence. Drill casing stored outside the fence was moved inside (see Figure 16). A completion report was prepared and signed off except for the fenced area which NV is retaining as a storage yard. During June and July of 1974, a large amount of drilling equipment was moved to the NTS.

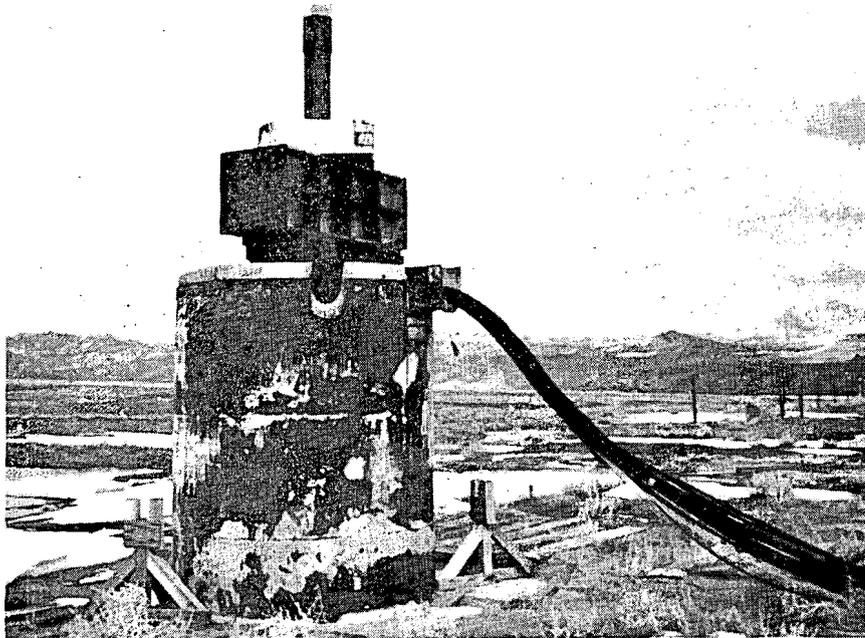
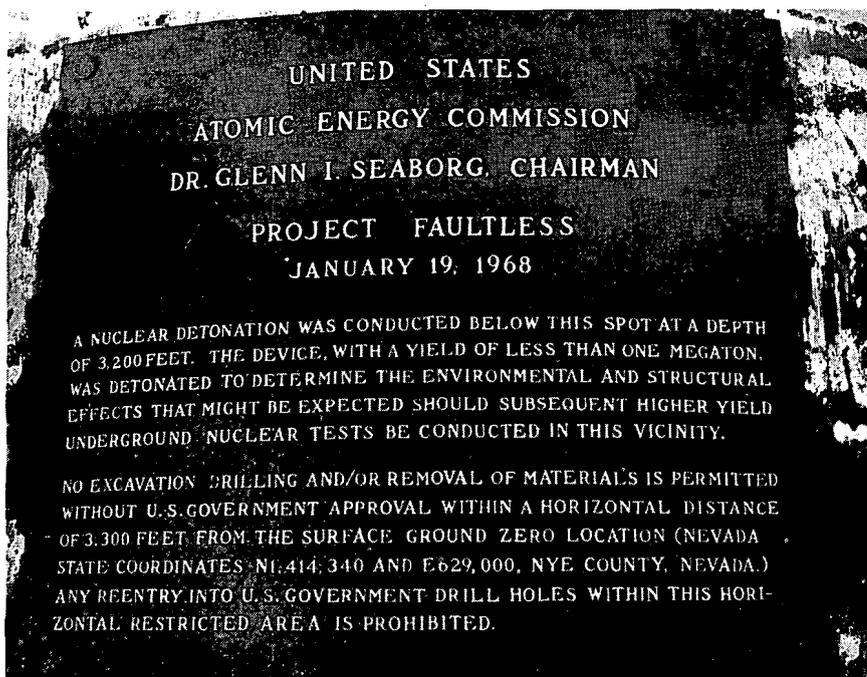
With BLM's concurrence, a plan to erect a concrete monument was canceled in favor of installing a bronze tablet directly on the 88-inch diameter surface pipe used originally for the drill rig's cellar. This pipe, along with inner casing strings, is approximately nine feet higher than the land surface. Prior to the event, the top of the pipe was flush with the ground surface. This change in relative elevations resulted from differential subsidence after the event. The surface pipe serves as an interesting monument that was directly involved with Project Faultless (see Figures 17 and 18).

Figure 17 Projecting Surface Pipe - Sta. UC-1
prior to Cleanup and Restoration

Figure 18 Project Faultless Plaque - Sta. UC-1

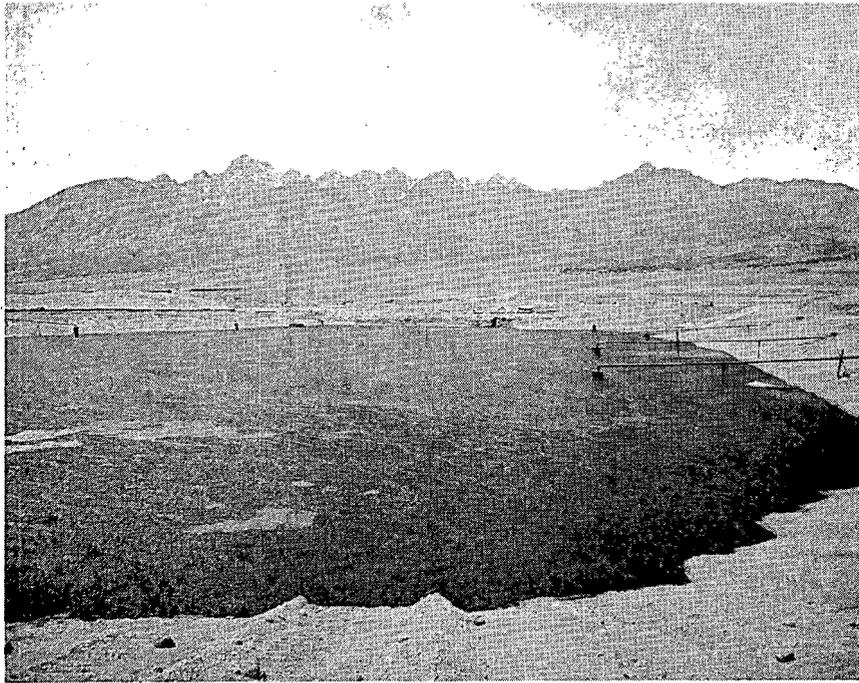
Figure 19 Central Mud Pit

A mud pump and other salvable equipment was moved to the Central Pipe Yard. A large equipment pit was backfilled. The berm surrounding partially dry mud was opened to prevent future accumulations of water. This will further dry the drilling mud to allow backfilling at a future date. The fence was retained (refer to Figures 19 and 20). The pit is within the UC-1 land withdrawal which NV is retaining.

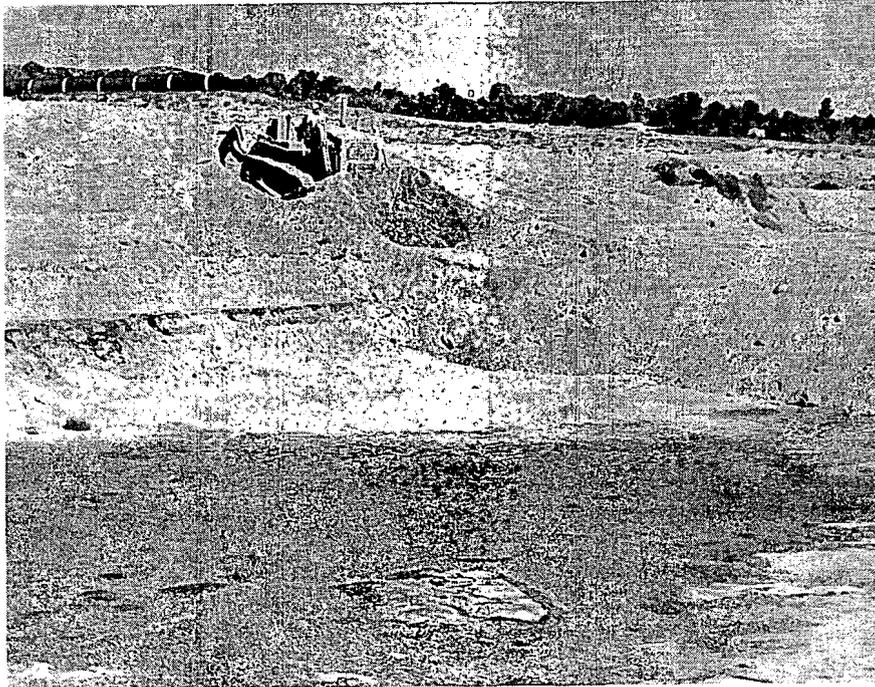
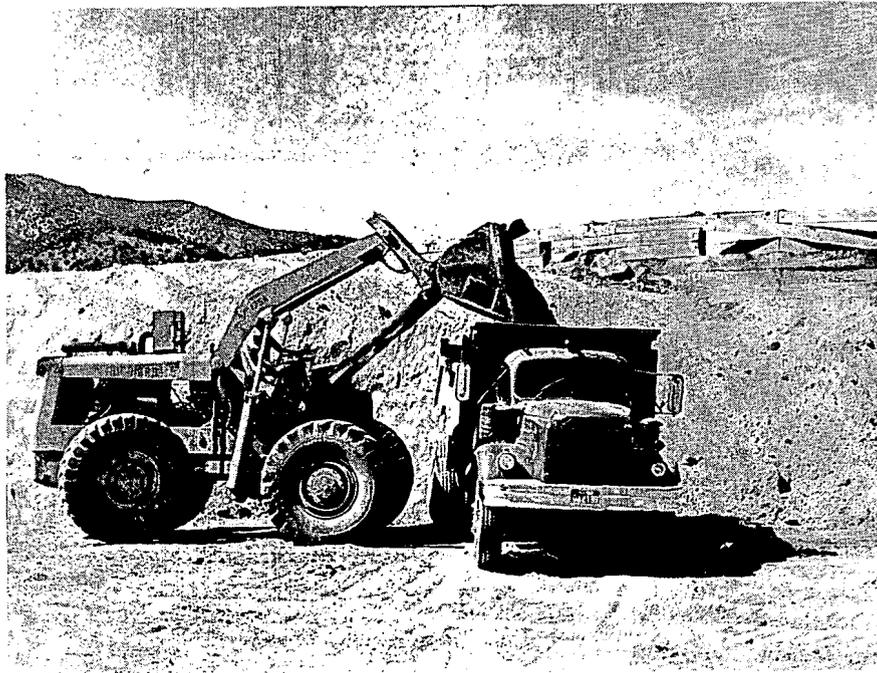
The shaker plant's bulkhead was removed. All mud pits except one were backfilled (refer to Figures 21 and 22). The emplacement hole had previously been capped by welding a two-inch thick steel plate to the surface conductor pipe (see Figure 23). Additionally, a heavy concrete slab was poured over the plate (see Figure 24). The area was cleaned up. Perimeter fencing, 41 each 60-foot long joints of 54-inch diameter hole casing remain at UC-4. Although NV will retain this area, the BLM has accepted all work accomplished to date by signing a completion report. The berm surrounding the remaining mud pit was cut to prevent water accumulation and expedite drying. Refer to Figures 25 and 26 for drilling operations and Figure 27 for the demobilized site.

Figure 21 Backfilling Mud Pits at Station UC-4

Figure 22 Loading Fill Material at Station UC-4

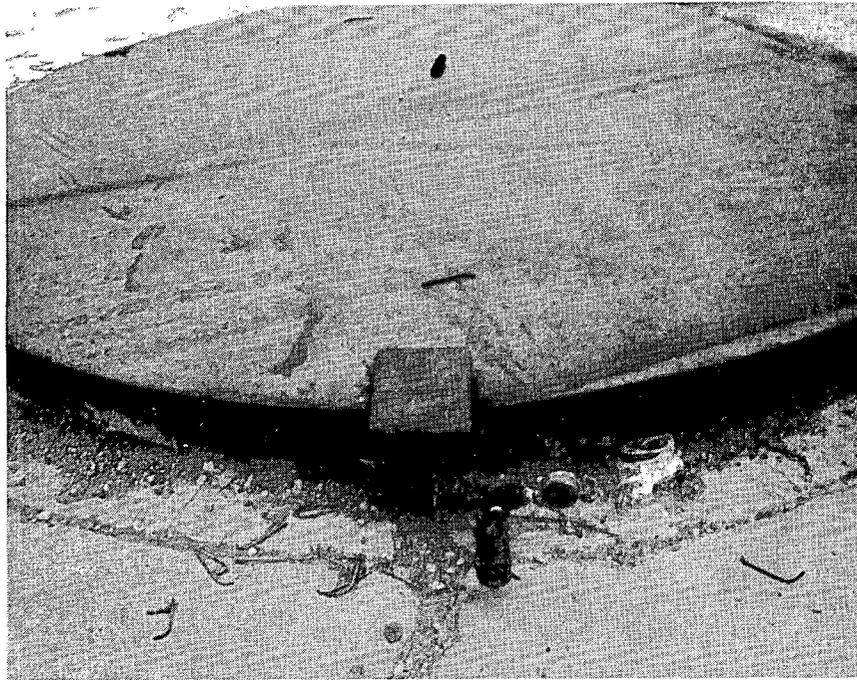
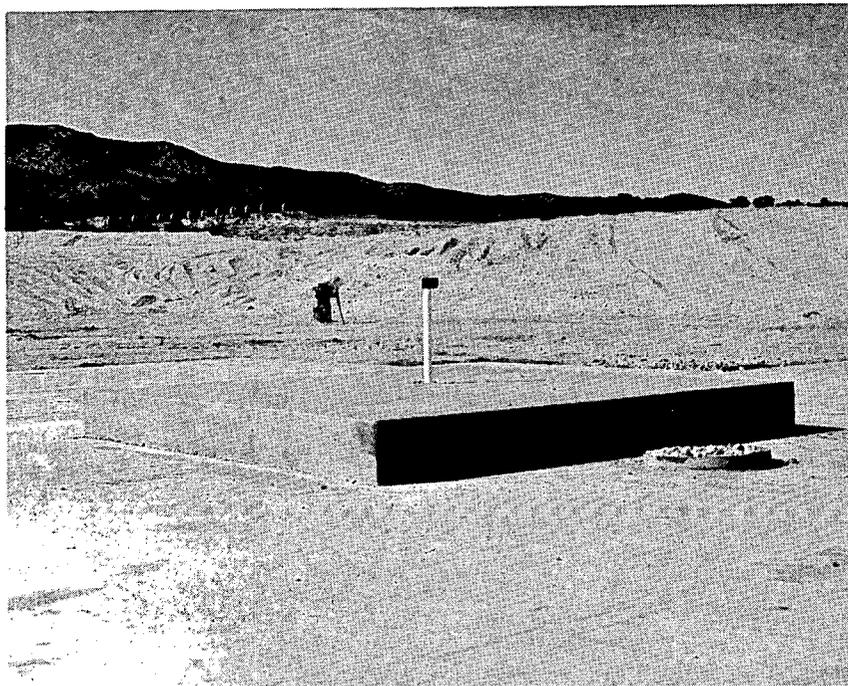
Figure 23 Steel Cover Plate - UC-4 Emplacement Hole

Figure 24 Concrete Slab Cover - Station UC-4

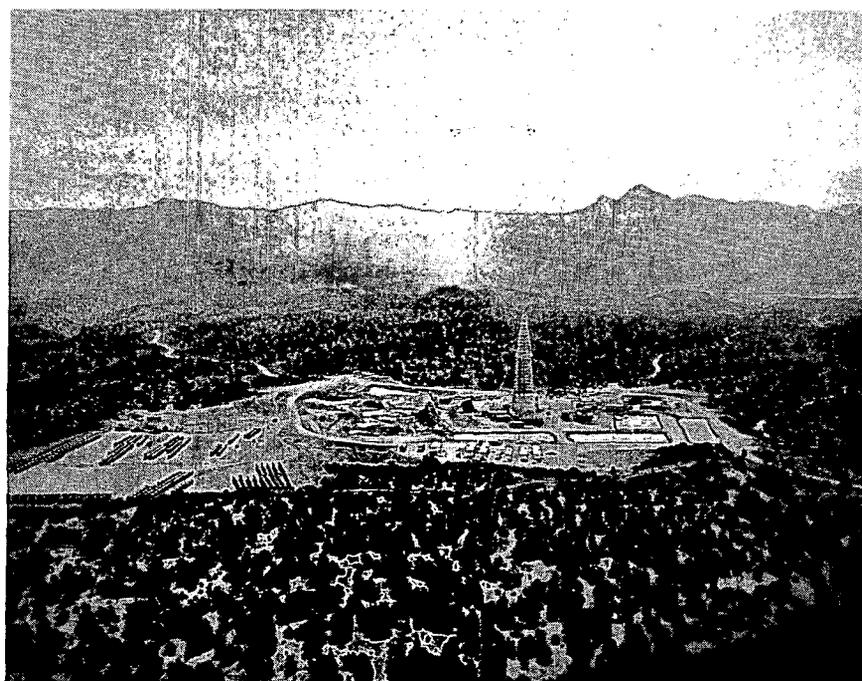
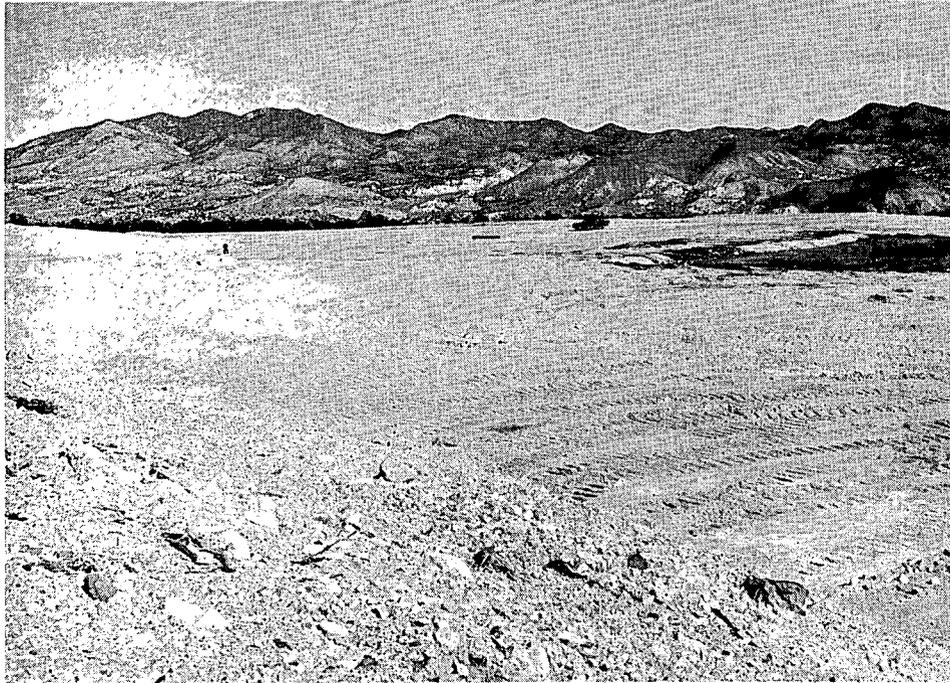
Figure 26 UC-4 Area during Drilling Operations

Figure 27 UC-4 Area after Demoblization and Restoration Activities

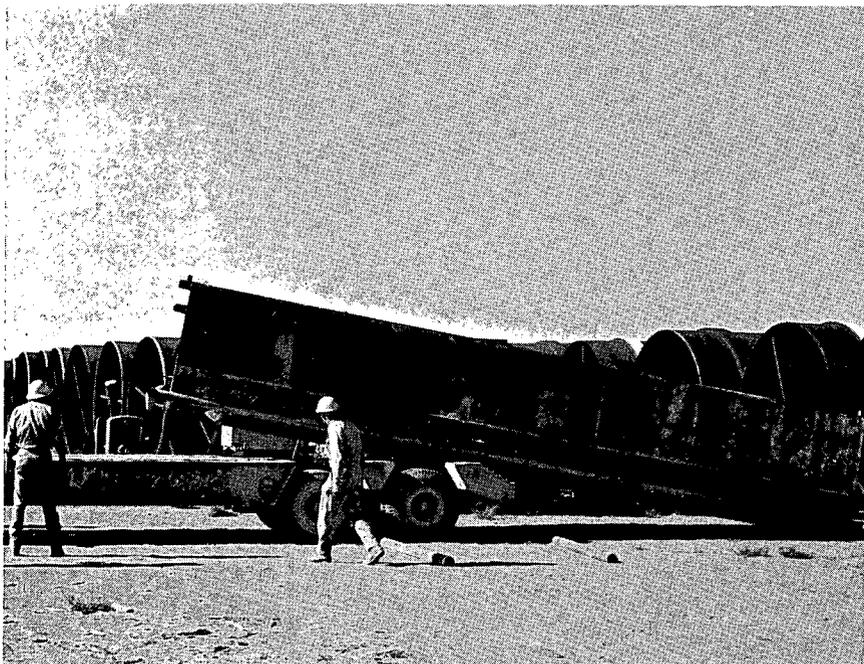
Figure 28 Offloading a UCE-18 Mud Tank at the Pipe Yard

See paragraph C-1 for methods used to test and plug this hole. Other work included: removal of fencing, hauling salvable equipment and material to the Central Pipe Yard (see Figures 28 and 29), backfilling the water sump, disposal of nonsalvable lean-to shelters, transfer of a 10,000-gallon diesel tank to the AFSC, and cleanup of the area.

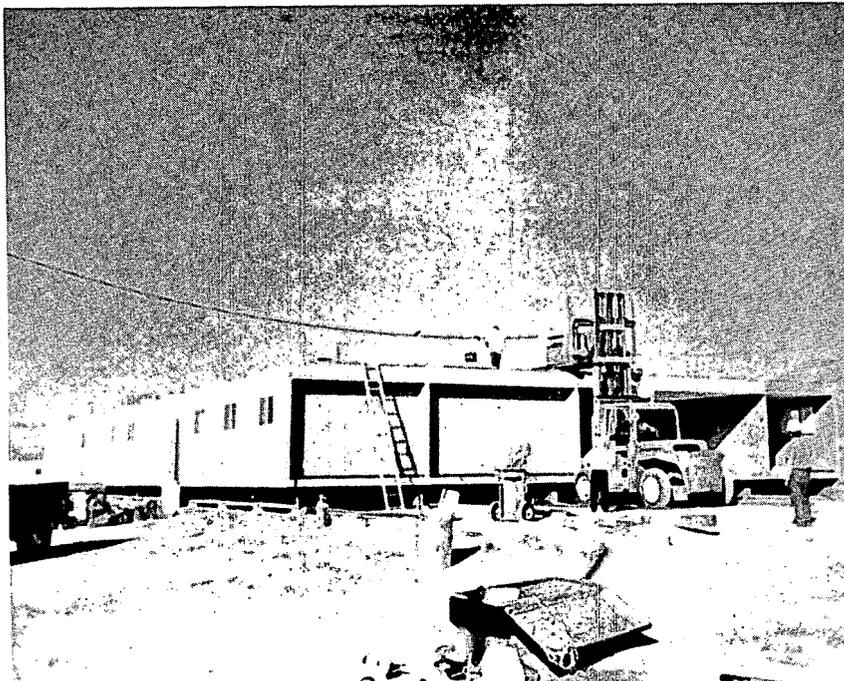
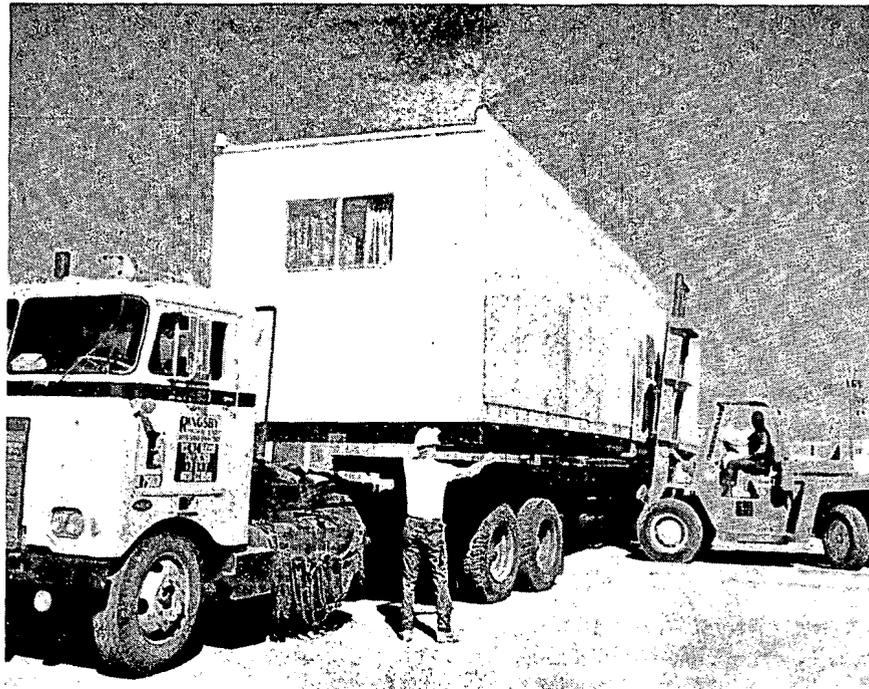
Figure 30 Dissassembling the Base Camp Office Building

By the Lawrence Livermore Laboratory to Livermore, California. Office structure (16 each trailer modules, see Figures 30 and 31), dining hall (8 each trailer modules), dispensary (2 each trailer modules), and several smaller office trailers.

Figure 31 Loading an Office Building Module

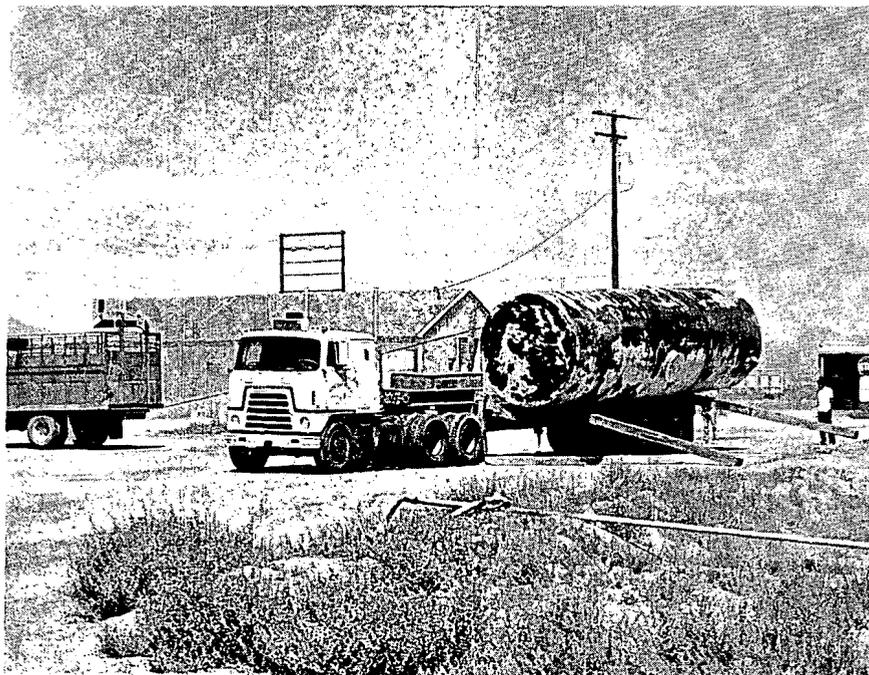
Figure 32 Loading a 10,000 gallon Fuel Tank

By the Intertribal Council, Duckwater, Nevada--3 each 10,000-gallon tanks (see Figure 32).
