# 2018 Postclosure Groundwater Monitoring and Inspection Report, Central Nevada Test Area, Nevada, Subsurface Corrective Action Unit 443

July 2019

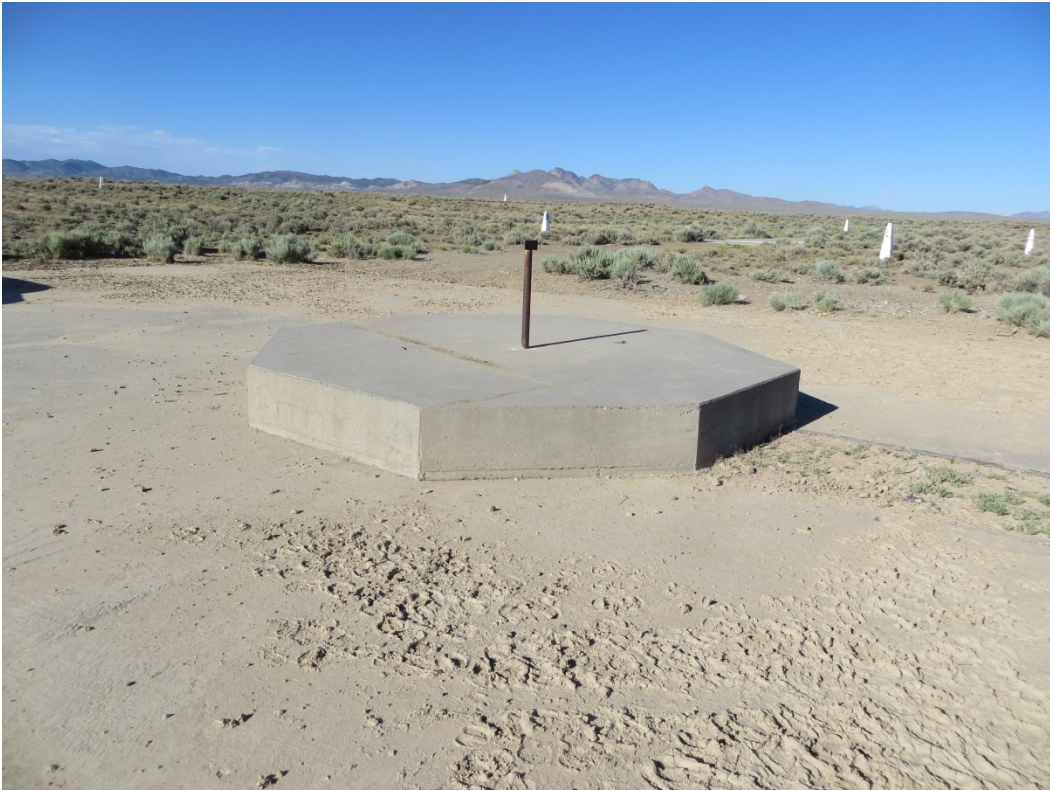
*Figure A-1. Concrete Cap that Covers the UC-3 Emplacement Borehole*

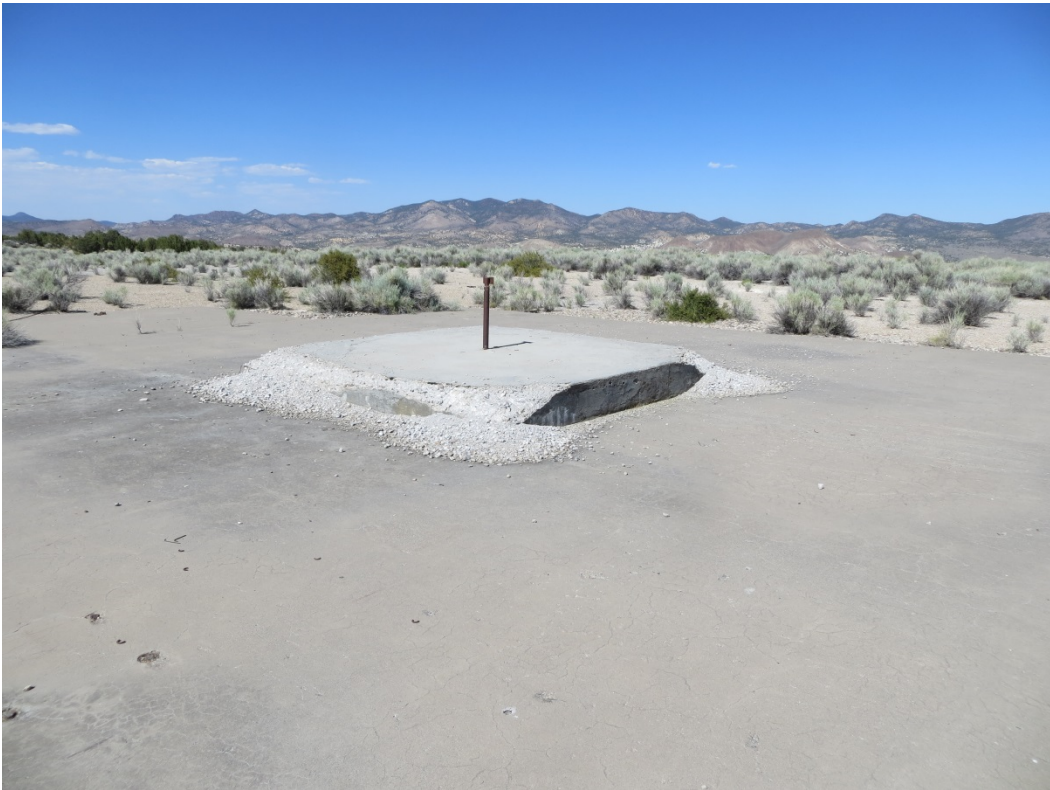
*Figure A-2. Concrete Cap that Covers the UC-4 Emplacement Borehole*

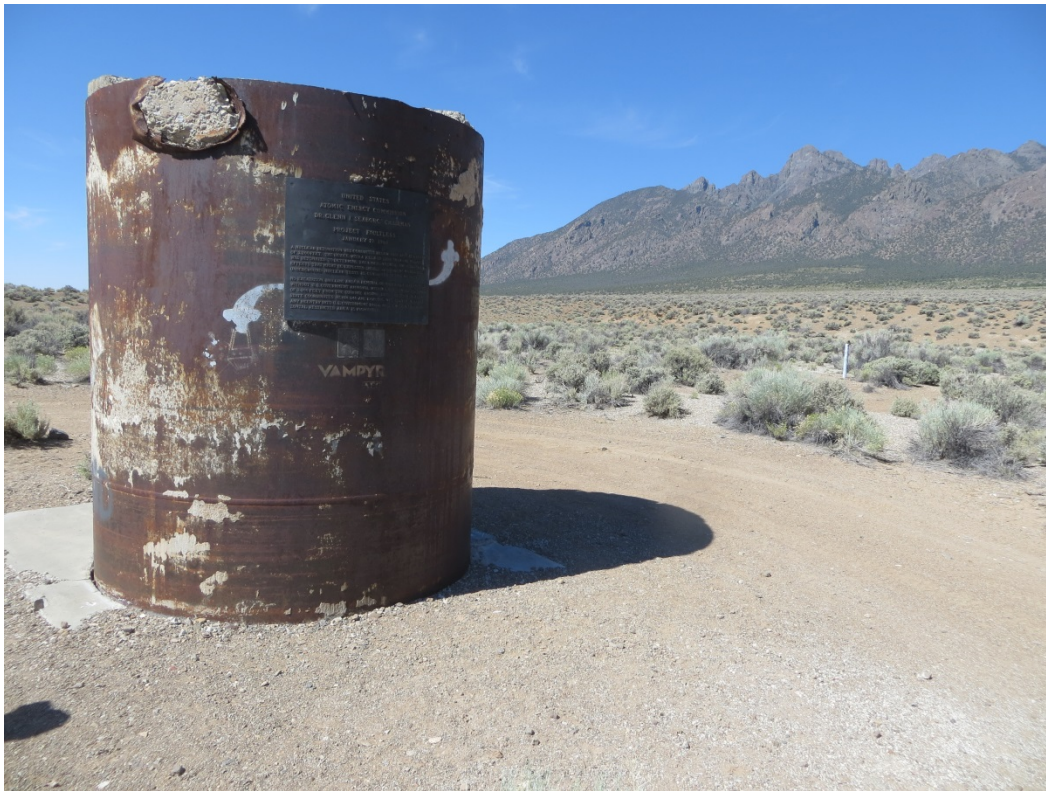
*Figure A-3. UC-1 Monument Plaque on the Emplacement Borehole Casing*

*Figure A-4. UC-1 Monument Plaque on the Emplacement Borehole Casing*
