**Post-Closure Inspection,  
Sampling, and Maintenance  
Report for the  
Salmon, Mississippi, Site

Calender Year 2008**

**U.S. DEPARTMENT OF  
ENERGY**

Office of  
Legacy Management

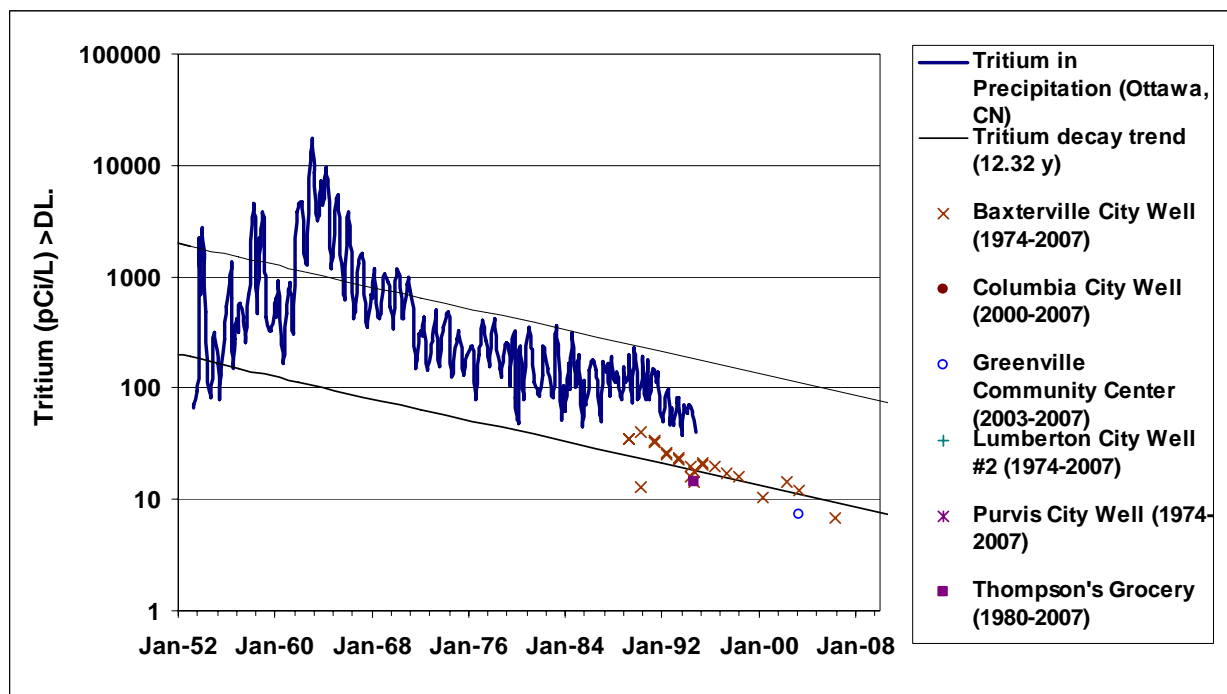
Figure 6. Tritium Decay Trend and Off-Site Sample Concentrations Above the Detection Limit

Figure 6 shows tritium concentrations in off-site municipal well water. Results for off-site surface locations are shown in Figure 7. These graphs are semilog plots of data collected by EPA (Las Vegas) from locations near the Salmon Site since 1972. Beginning in 2008, the samples were collected by DOE. The MCL for tritium is 20,000 picocuries per liter (pCi/L). All 2008 results were below the detection limit. For comparison of decay trends, the graph also shows tritium in precipitation (Brown 1995). The large increase in the 1950s and 1960s is due to atmospheric testing of nuclear weapons. The upper decay trend line represents a starting concentration of 2,000 pCi/L tritium; the lower line represents a starting concentration of 200 pCi/L tritium.

The tritium results for the Baxterville well are not believed to be due to contamination from the site. If the contamination had originated at the site, the decay curve for that well would show both the normal tritium decay curve and the effects of dilution in the groundwater. This would result in a curve steeper than the tritium decay trend line. Tritium in the samples collected in Baxterville in April 2007 and 2008 was below the detection limit.

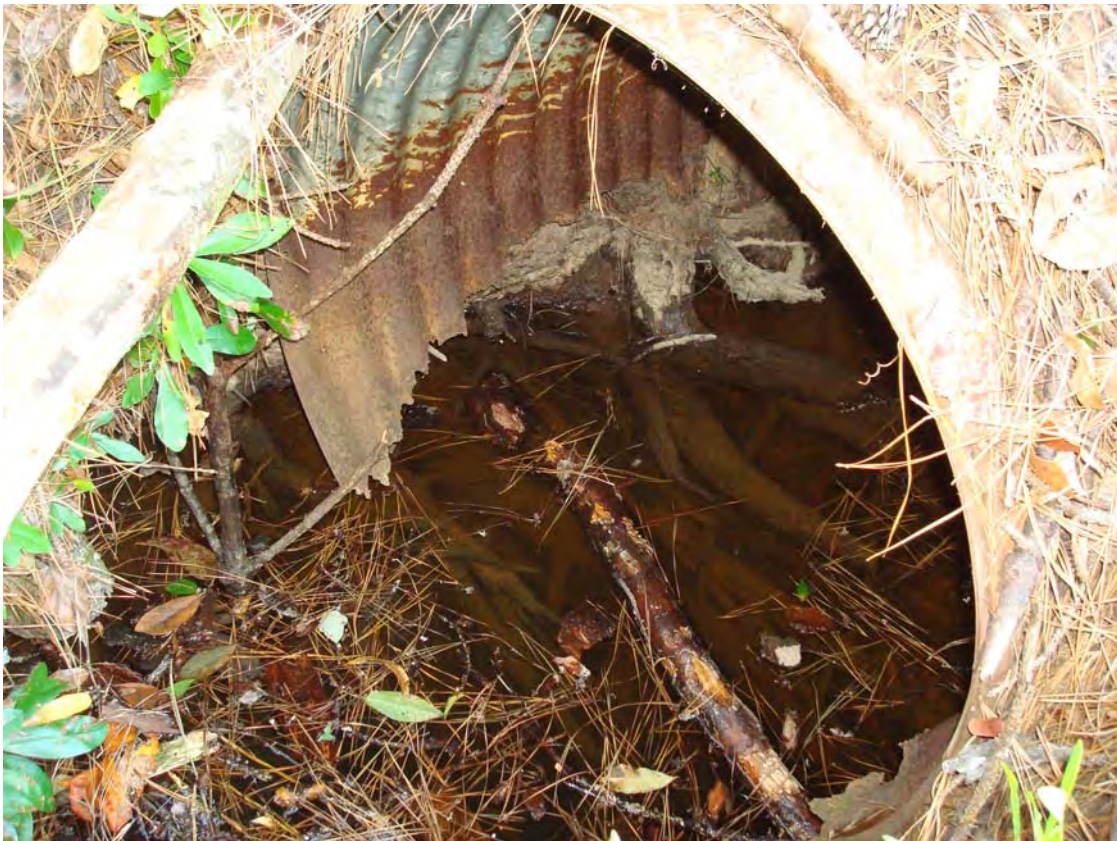
Several roads at the site were damaged by erosion where water had flowed across the road. Some of the damaged areas were due to culvert collapse (Photo A-1). To repair the damage, six new culverts were installed.

*Photo A-1 Culvert with Corrosion of the Base*

- Two culverts, each 30 ft long and 24 inches in diameter, were replaced where Hickory Hollow Creek runs beneath the road that leads to the southwest corner.
- A culvert, 40 ft long and 24 inches in diameter, was replaced under the road to Hickory Hollow Creek. The original culvert failed due to the weight of truck traffic during the installation of the two culverts carrying Hickory Hollow Creek (Photo A-2).
- A culvert that was 20 ft long and 24 inches in diameter was installed near well HM-L2, and another culvert, with the same dimensions, was replaced on the road to well HM-L2.
- A culvert connecting the south and north ponds was replaced with one that was 50 ft long and 36 inches in diameter (Photo A-3).

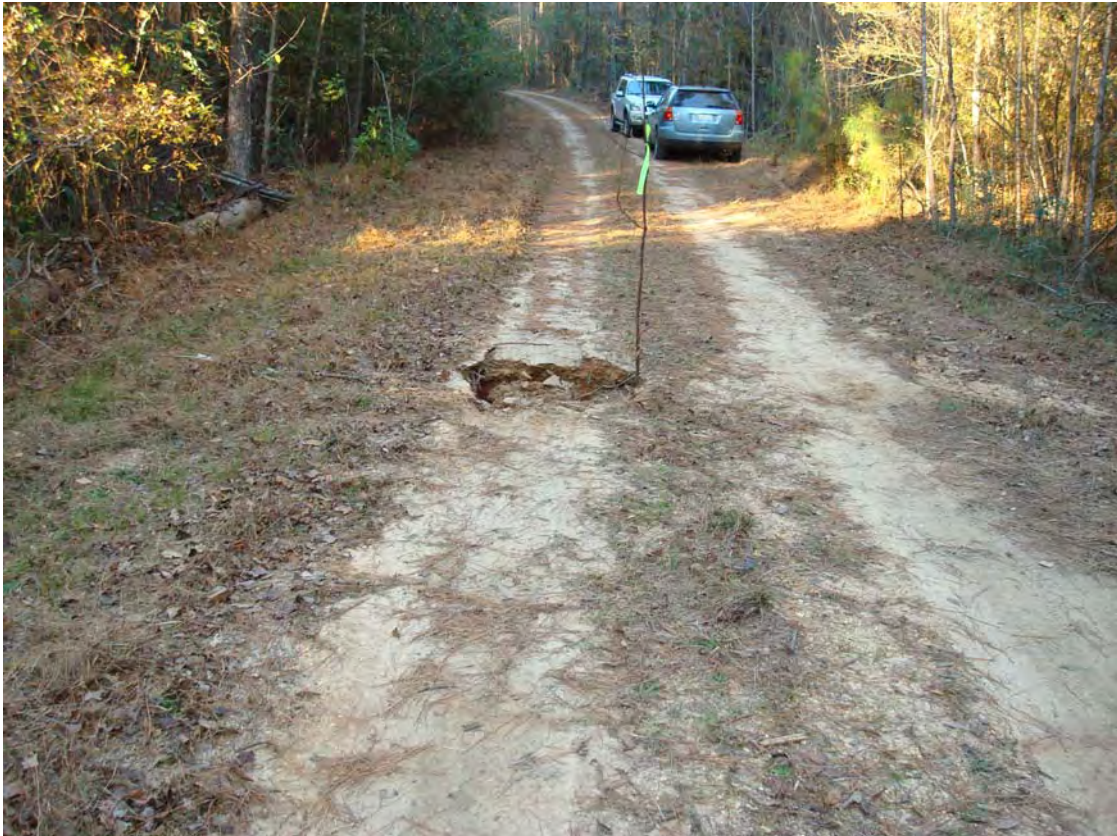
*Photo A-2. Sinkhole in Road Caused by Culvert Failure*

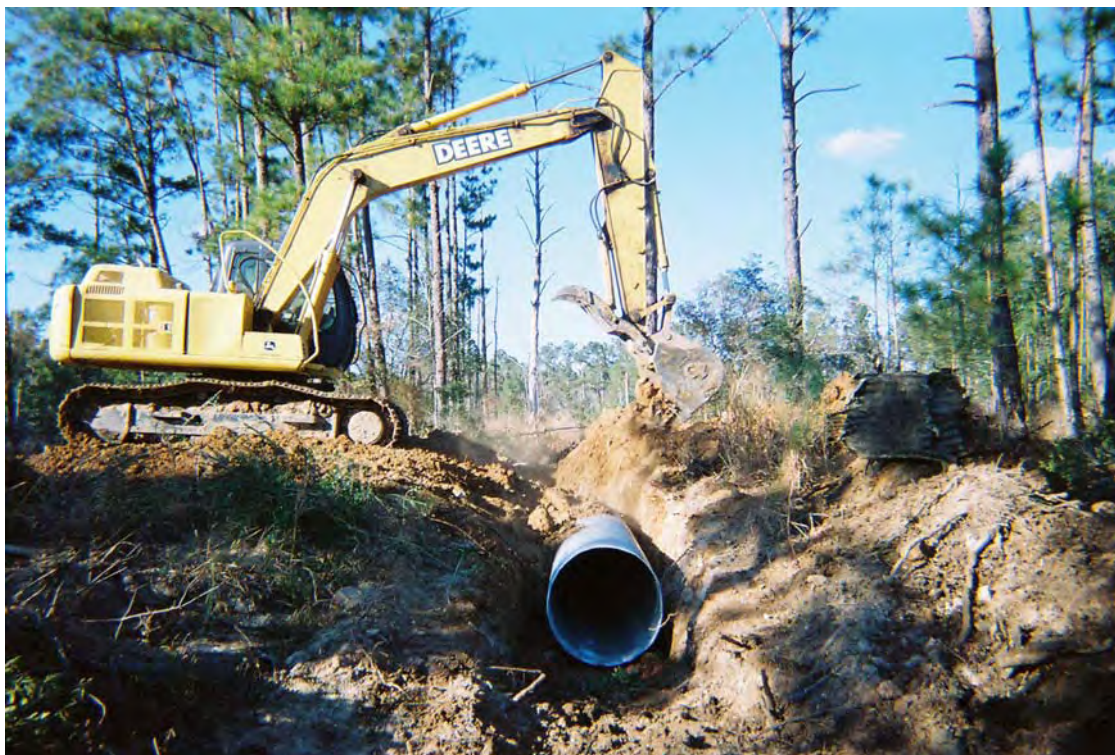
*Photo A-3. Installation of Culvert Between North and South Ponds*

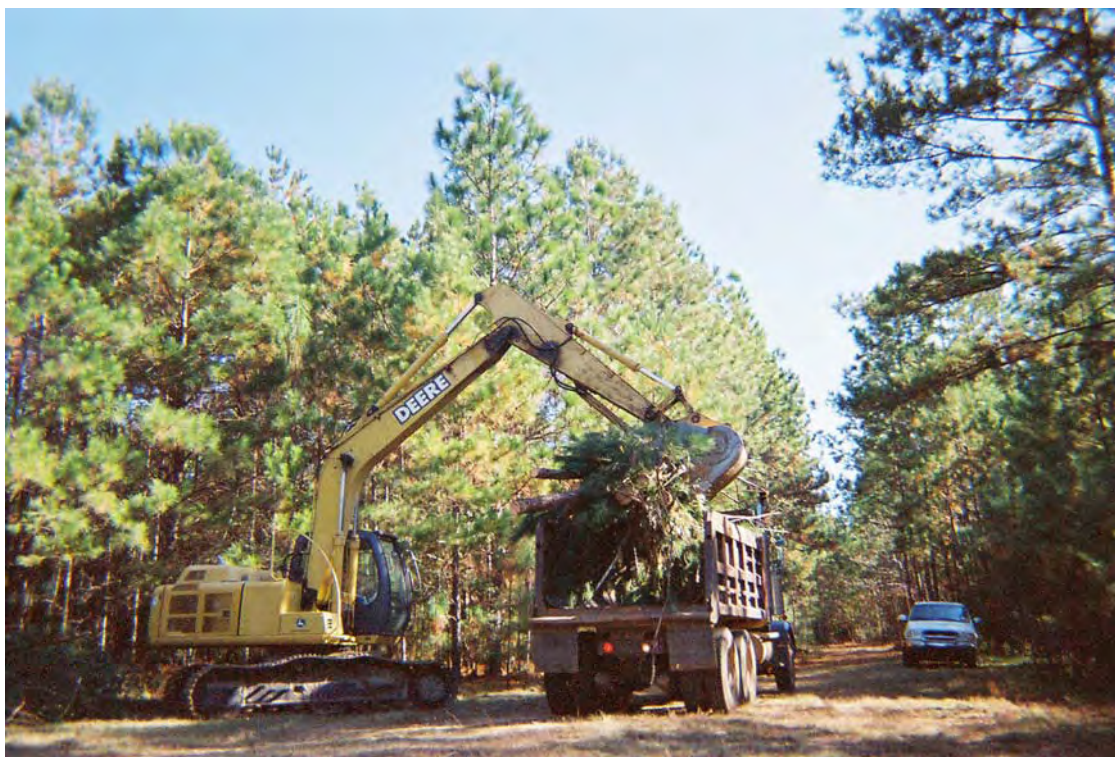
Fallen trees blocking the roads were removed. Trees that were dead, were leaning, and appeared likely to fall and block the roads were also removed. The removed material (approximately 90 cubic yards) was taken to a local recycling facility (Photo A-4).

*Photo A-4. Loading Trees for Transport to a Recycling Facility*

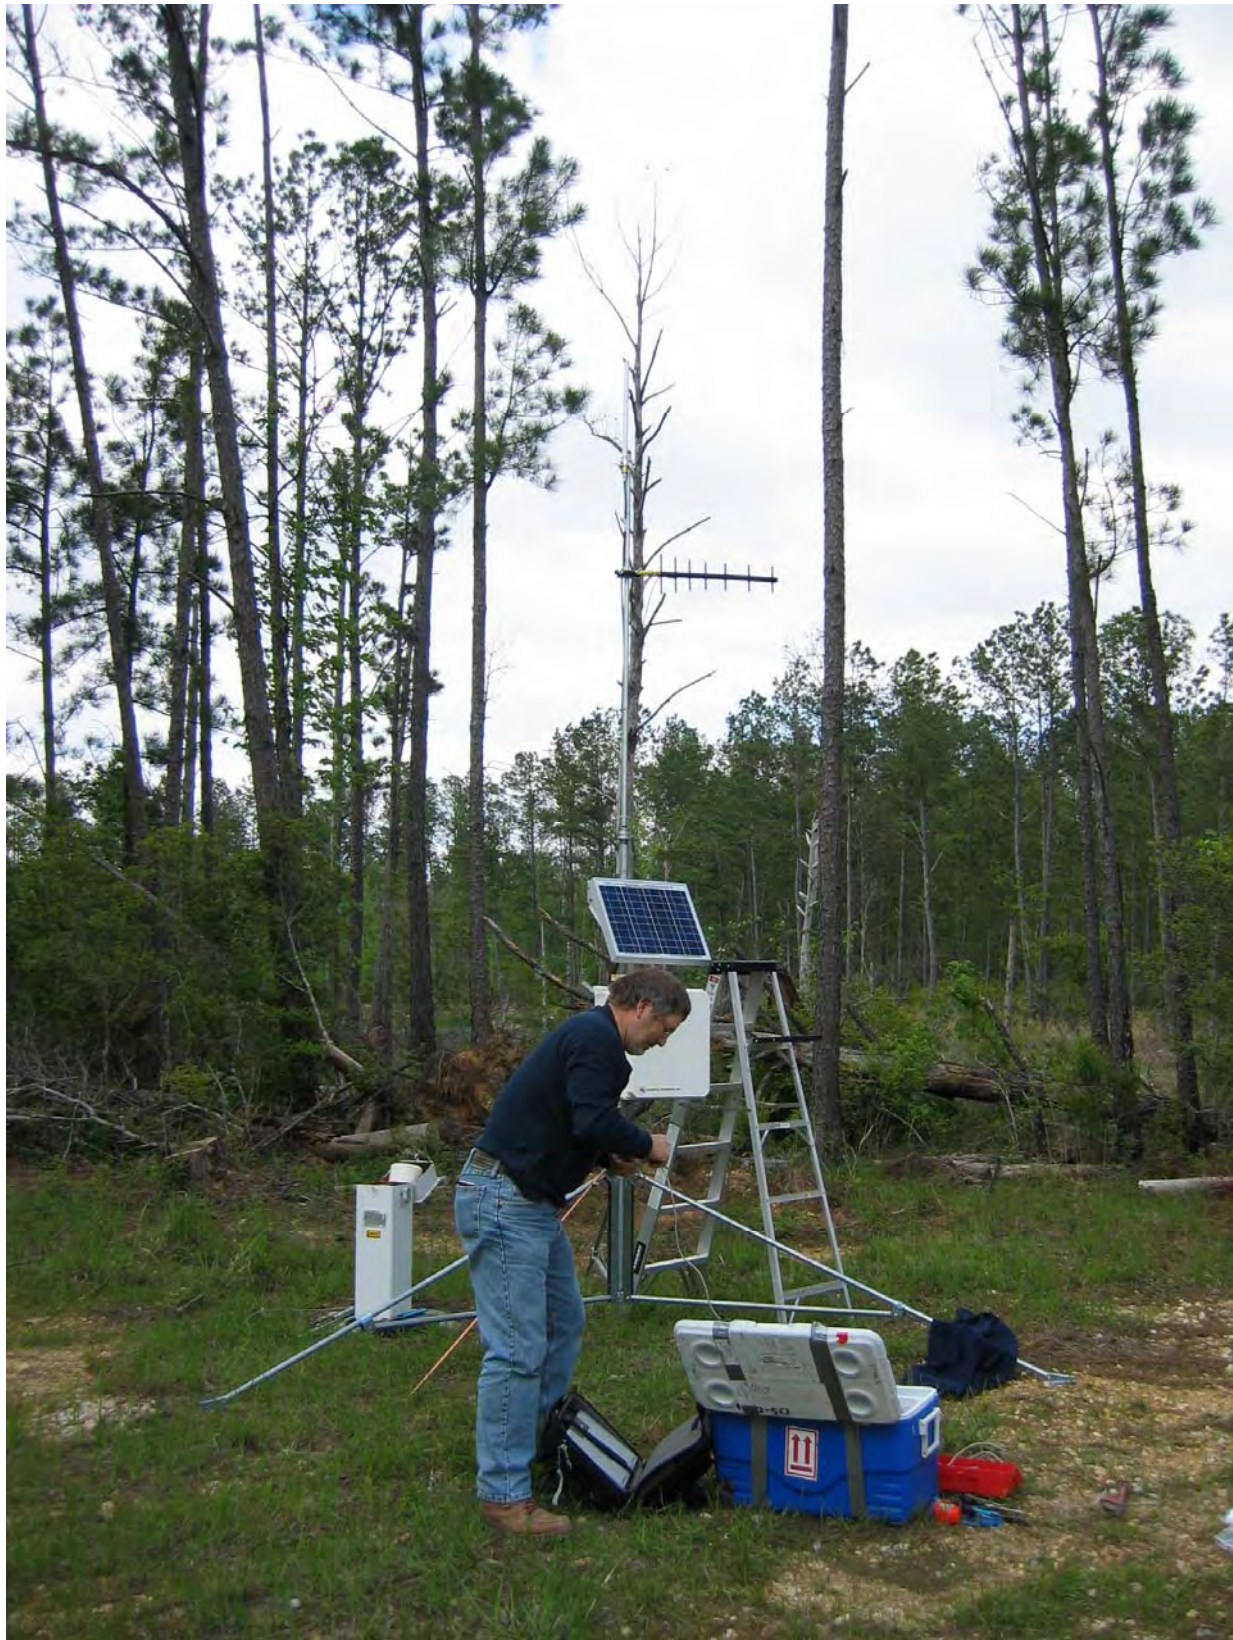
Two water-level telemetry units were installed and calibrated (Photo A-5). The telemetry system transmits water level data, which is monitored remotely using LM's System Operation and Analysis at Remote Sites system.

*Photo A-5. Installation of Telemetry Base Station at Well SA1-7-H*

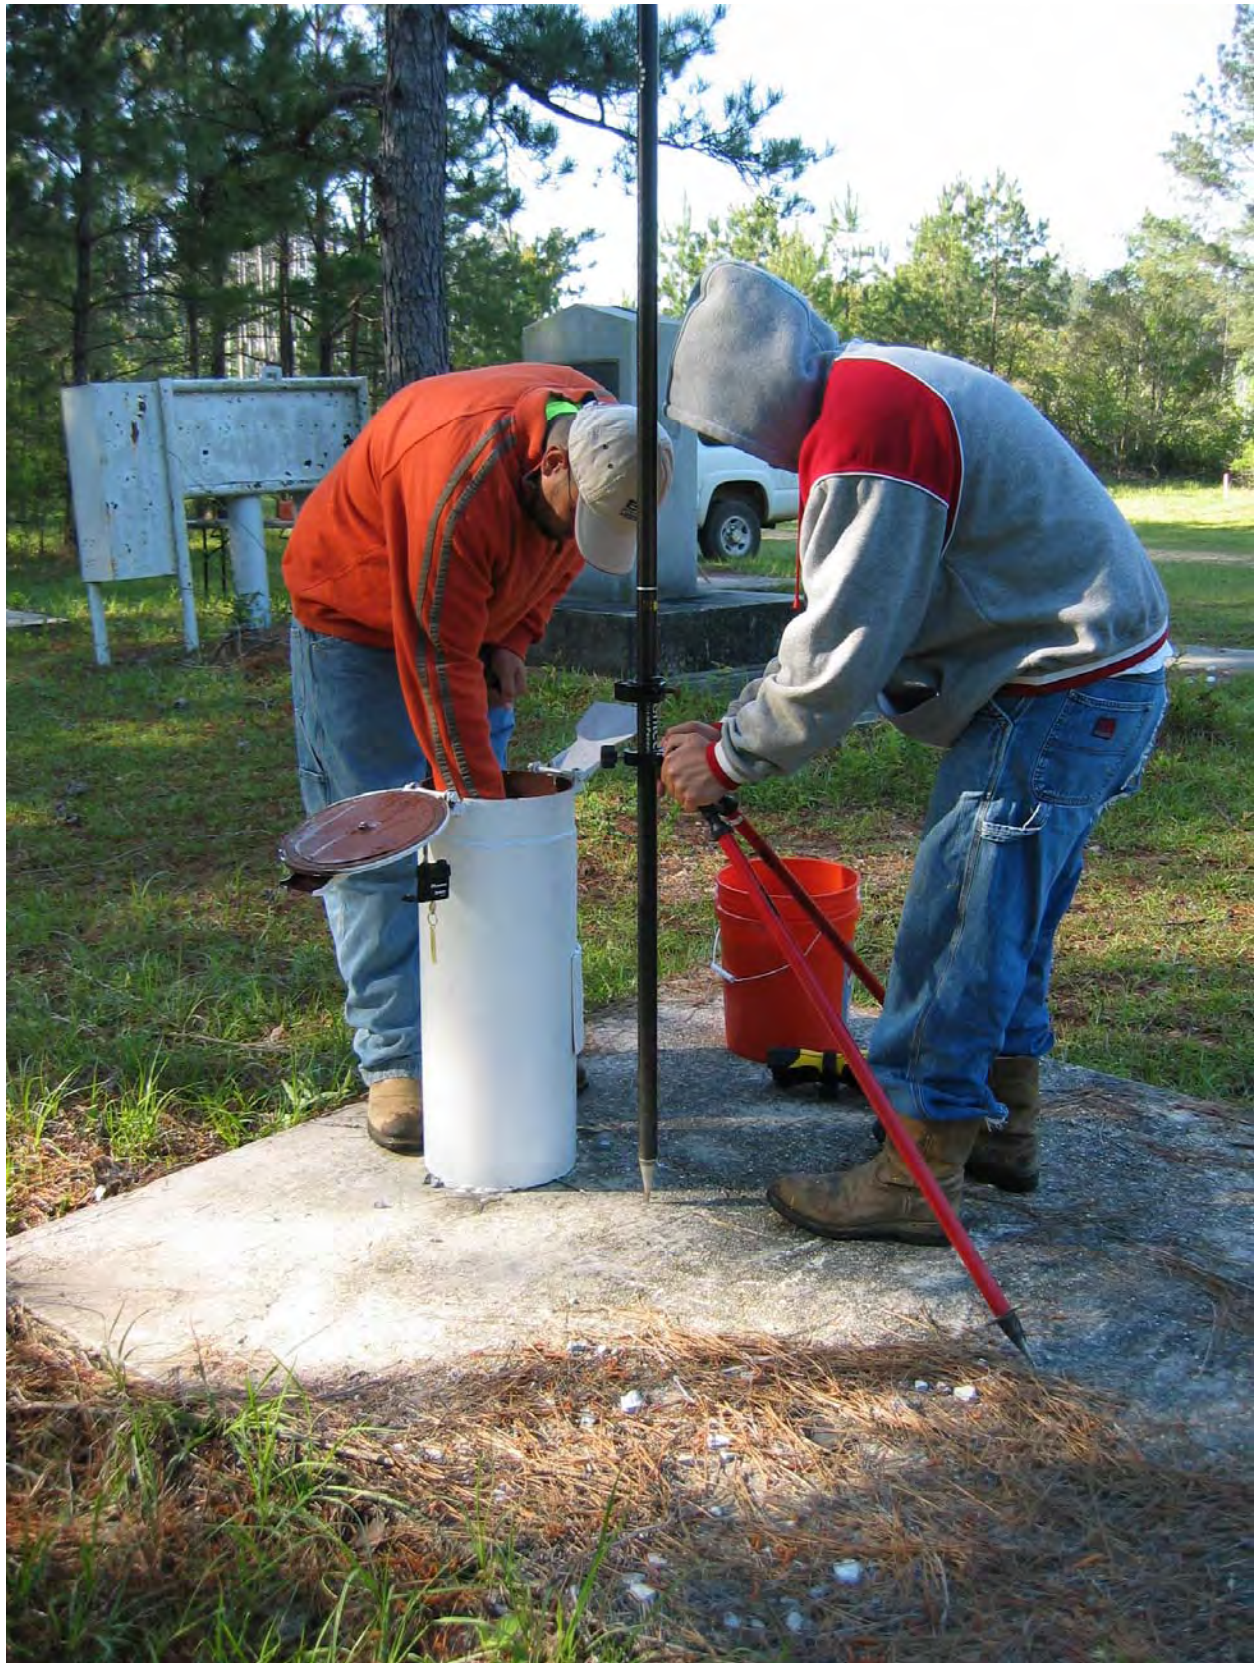
New well-casing elevations were surveyed during April and June 2008 (Photo A-6). The removal of the electric pumps in September 2007 and the installation of the bladder pumps in 26 of 28 wells modified the well configurations for which elevations were previously determined.

*Photo A-6. Surveyors Preparing to Measure Well Elevation*

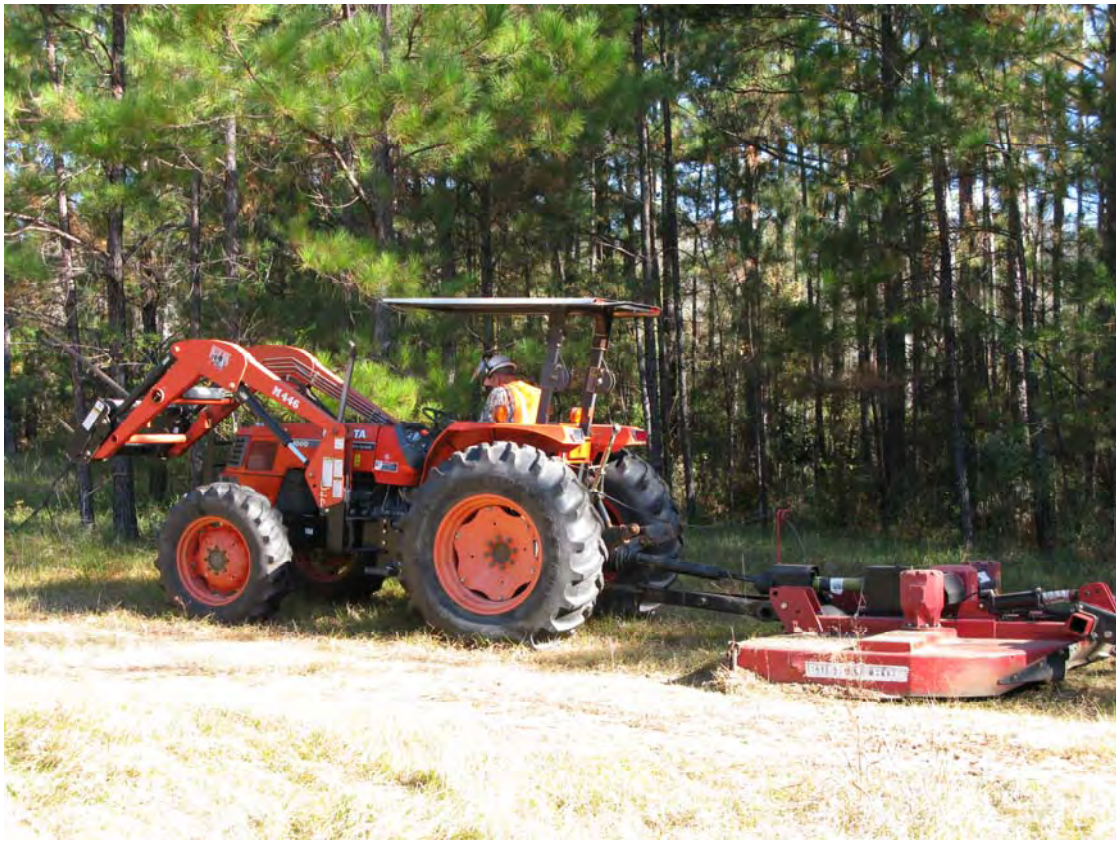
Vegetation was removed from around each of the 28 site wells (Photo A-7).

*Photo A-7 Mowing Vegetation Near Ground Zero*

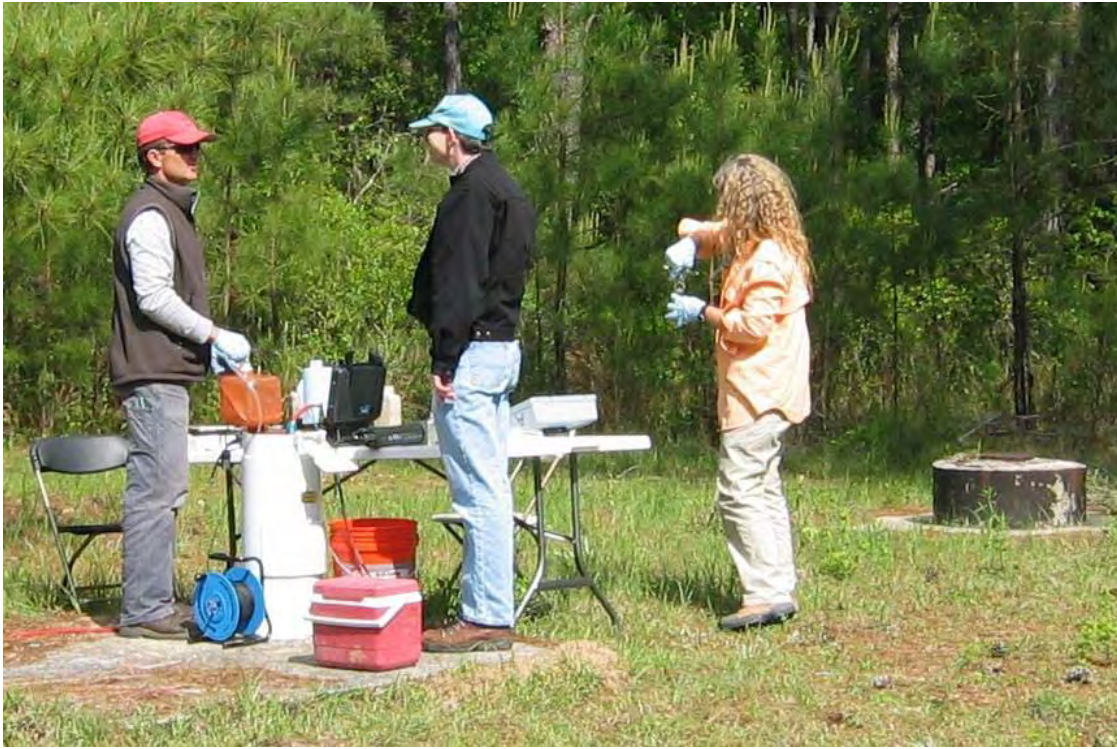
In 2008, DOE sampled 48 locations. On site, 28 monitoring wells and 8 surface locations were sampled (Photo A–9). Off site, seven surface water and five municipal water supplies were sampled. Temperature, pH, turbidity, and conductivity were measured before each well was sampled. VOC and metal analytical results above the laboratory detection limits are shown in Appendix B, Table B–1. Tritium levels above the laboratory detection limits are shown in Table B–2. No gamma-emitting elements were detected.

*Photo A-9 Water Sampling*
