Post-Closure Inspection and Monitoring Report for the Salmon, Mississippi, Site

Calendar Year 2007

May 2008

Office of Legacy Management

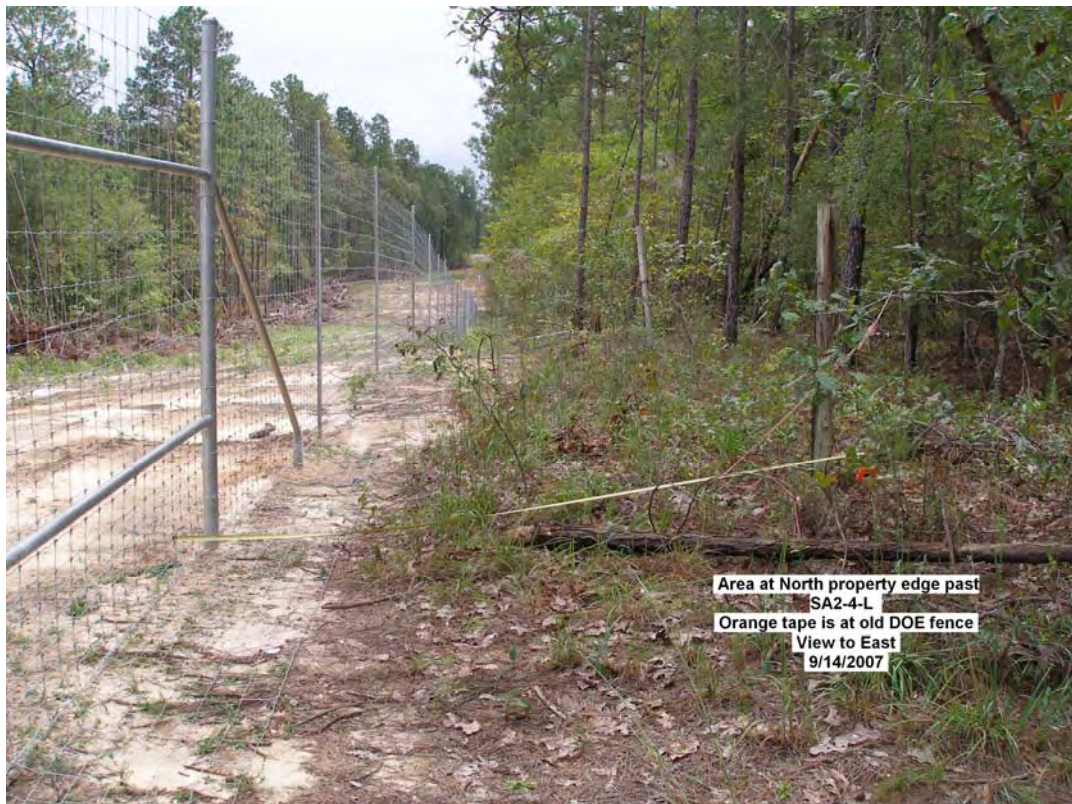
Photo A-1. New Fence Along North Site Boundary

Along the northern perimeter, the owner of the adjacent property has cleared a 100-ft-wide strip of property adjacent to the site boundary and installed a new fence (see Photo A-1).

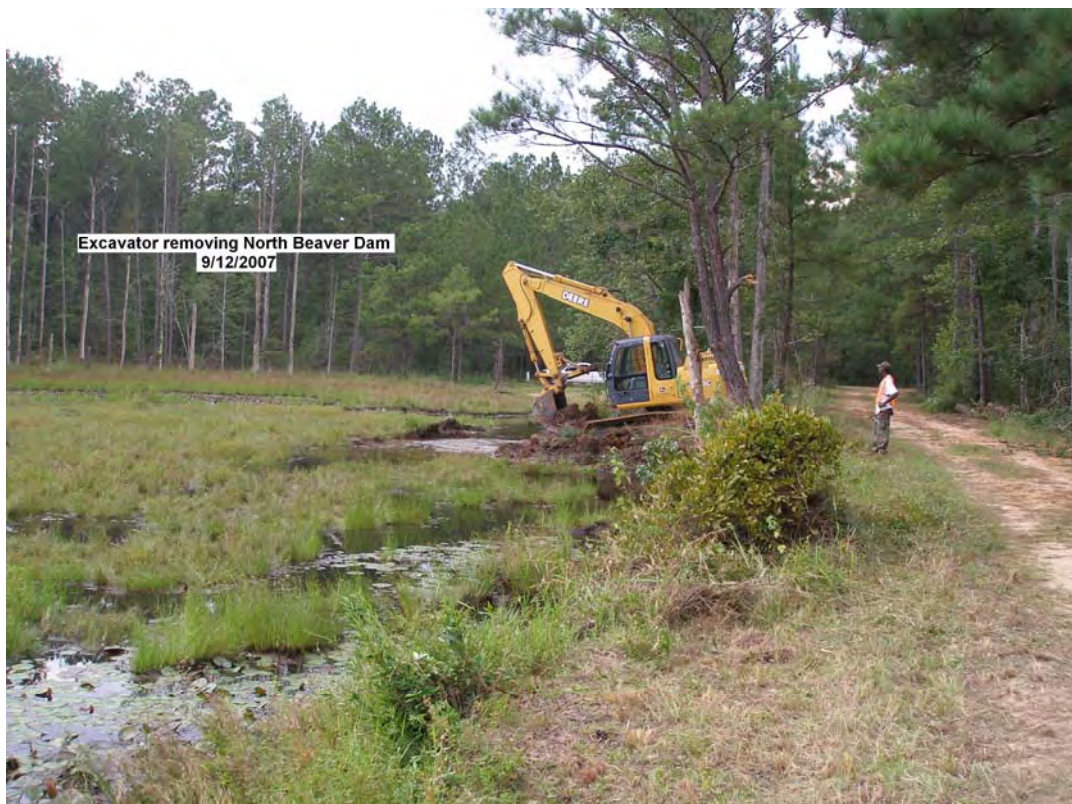
Photo A-2. Beaver Dam Removal

The roads at the site were in poor condition. Some were impassible because of fallen trees. Beavers had undermined the levee road and built dams, which resulted in flooding of the pond and extensive erosion of the levee road. In April 2007 a subcontractor used an excavator to breach the beaver dams and lower the pond levels. Several roads were cleaned and graded. In September 2007 a subcontractor used an excavator (Photo A-2) to remove the main beaver dam, some smaller dams, and a beaver lodge. This restored the pond to its preexisting level. A contract to control the beavers will be necessary to prevent future damage from beavers. DOE has

initiated an interagency agreement with the U.S. Department of Agriculture for beaver control beginning in March 2008.

- Implement an interagency agreement for beaver control to prevent future road damage along the pond.
- Contract for mowing of the road right-of-way.
- Discontinue off-site tritium sampling in 2009 with concurrence of the State of Mississippi.

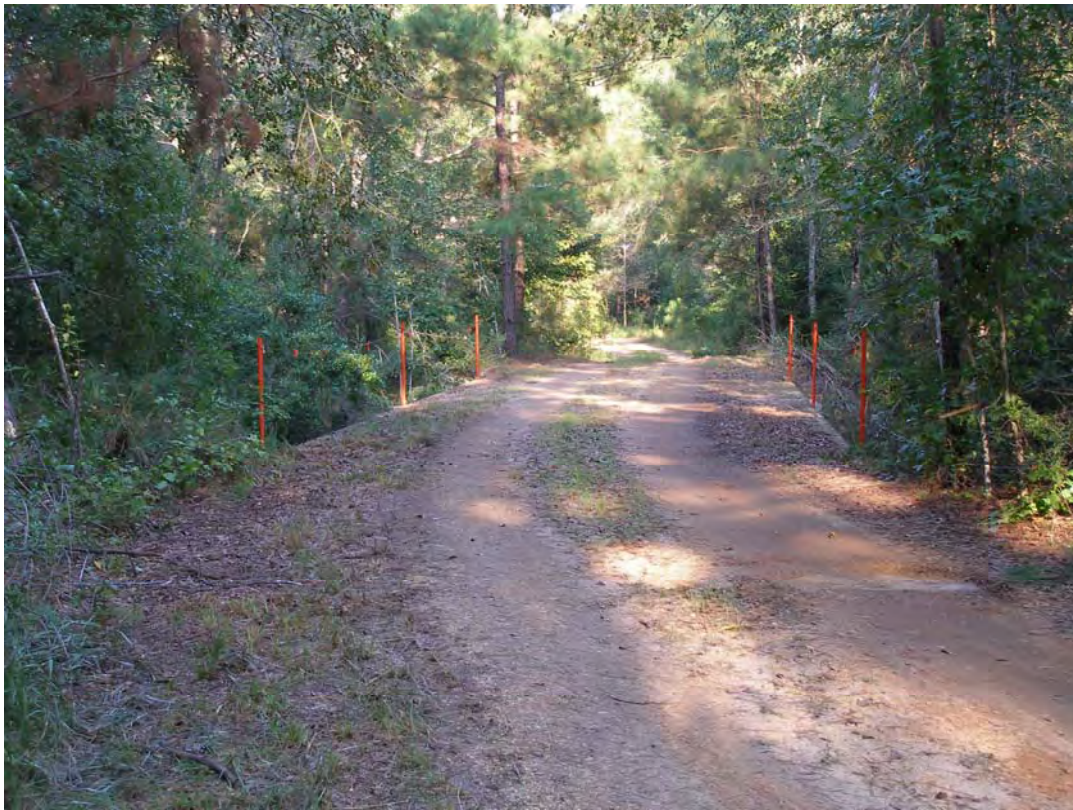
Photo A-3. Half Moon Creek Bridge

In order to improve visibility of the bridge, steel pipes were welded to the sides of the Half Moon Creek bridge (Photo A–3.) The pipes were painted orange, steel cable was strung between them, and reflective tape was hung from the cables.

The archaeologist inspected an abandoned bridge over Half Moon Creek and recommended that DOE determine the actual date of construction. If the bridge is over 50 years old, it may qualify for protection as a historic structure under the National Historic Preservation Act.

- Determine if the old bridge is considered a historical structure.
- Dispose of old pumps and well casing.
- Load historical analytical data into the SEEPro database for posting on GEMS.

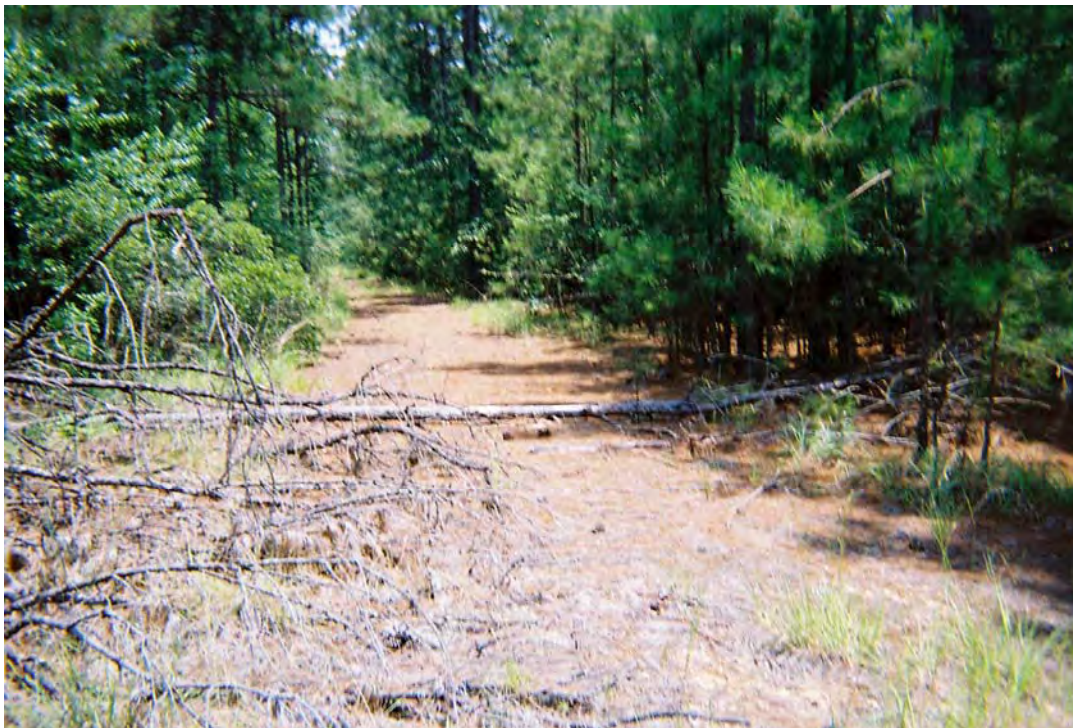
Photo A-4. Road Blocked by Fallen Tree

All site roads were cleared of fallen trees and reopened (Photo A–4). The sides of the roads were scraped to clear the vegetation. Areas around the monitoring wells and the former cable storage area were also cleared. A contract will be put in place to mow these areas regularly to prevent growth of vegetation.

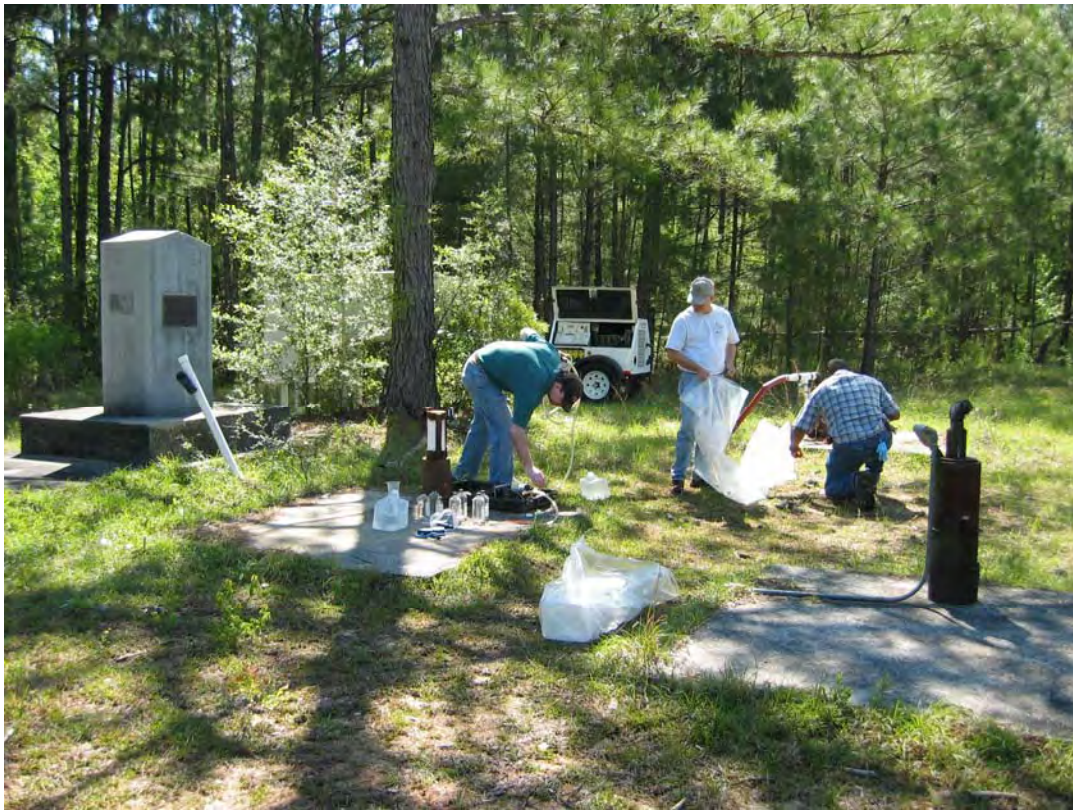
Photo A-5. Monitor Well Sampling by EPA Sampling Team

In 2007 DOE sampled 21 monitoring wells and 6 surface locations for metals. Fourteen wells were sampled for VOCs. Temperature, pH, turbidity, and conductivity were measured prior to sampling each well. Analytical results above the laboratory detection limits are shown in Appendix B, Table B-1. The EPA and the State of Mississippi collected samples both on and off site for radionuclide analysis during the April inspection and monitoring event (Photo A-5).
