Post-Closure Inspection, Sampling, and Maintenance Report for the Salmon, Mississippi, Site Calendar Year 2009

October 2010

**U.S. DEPARTMENT OF
ENERGY**

Legacy
Management

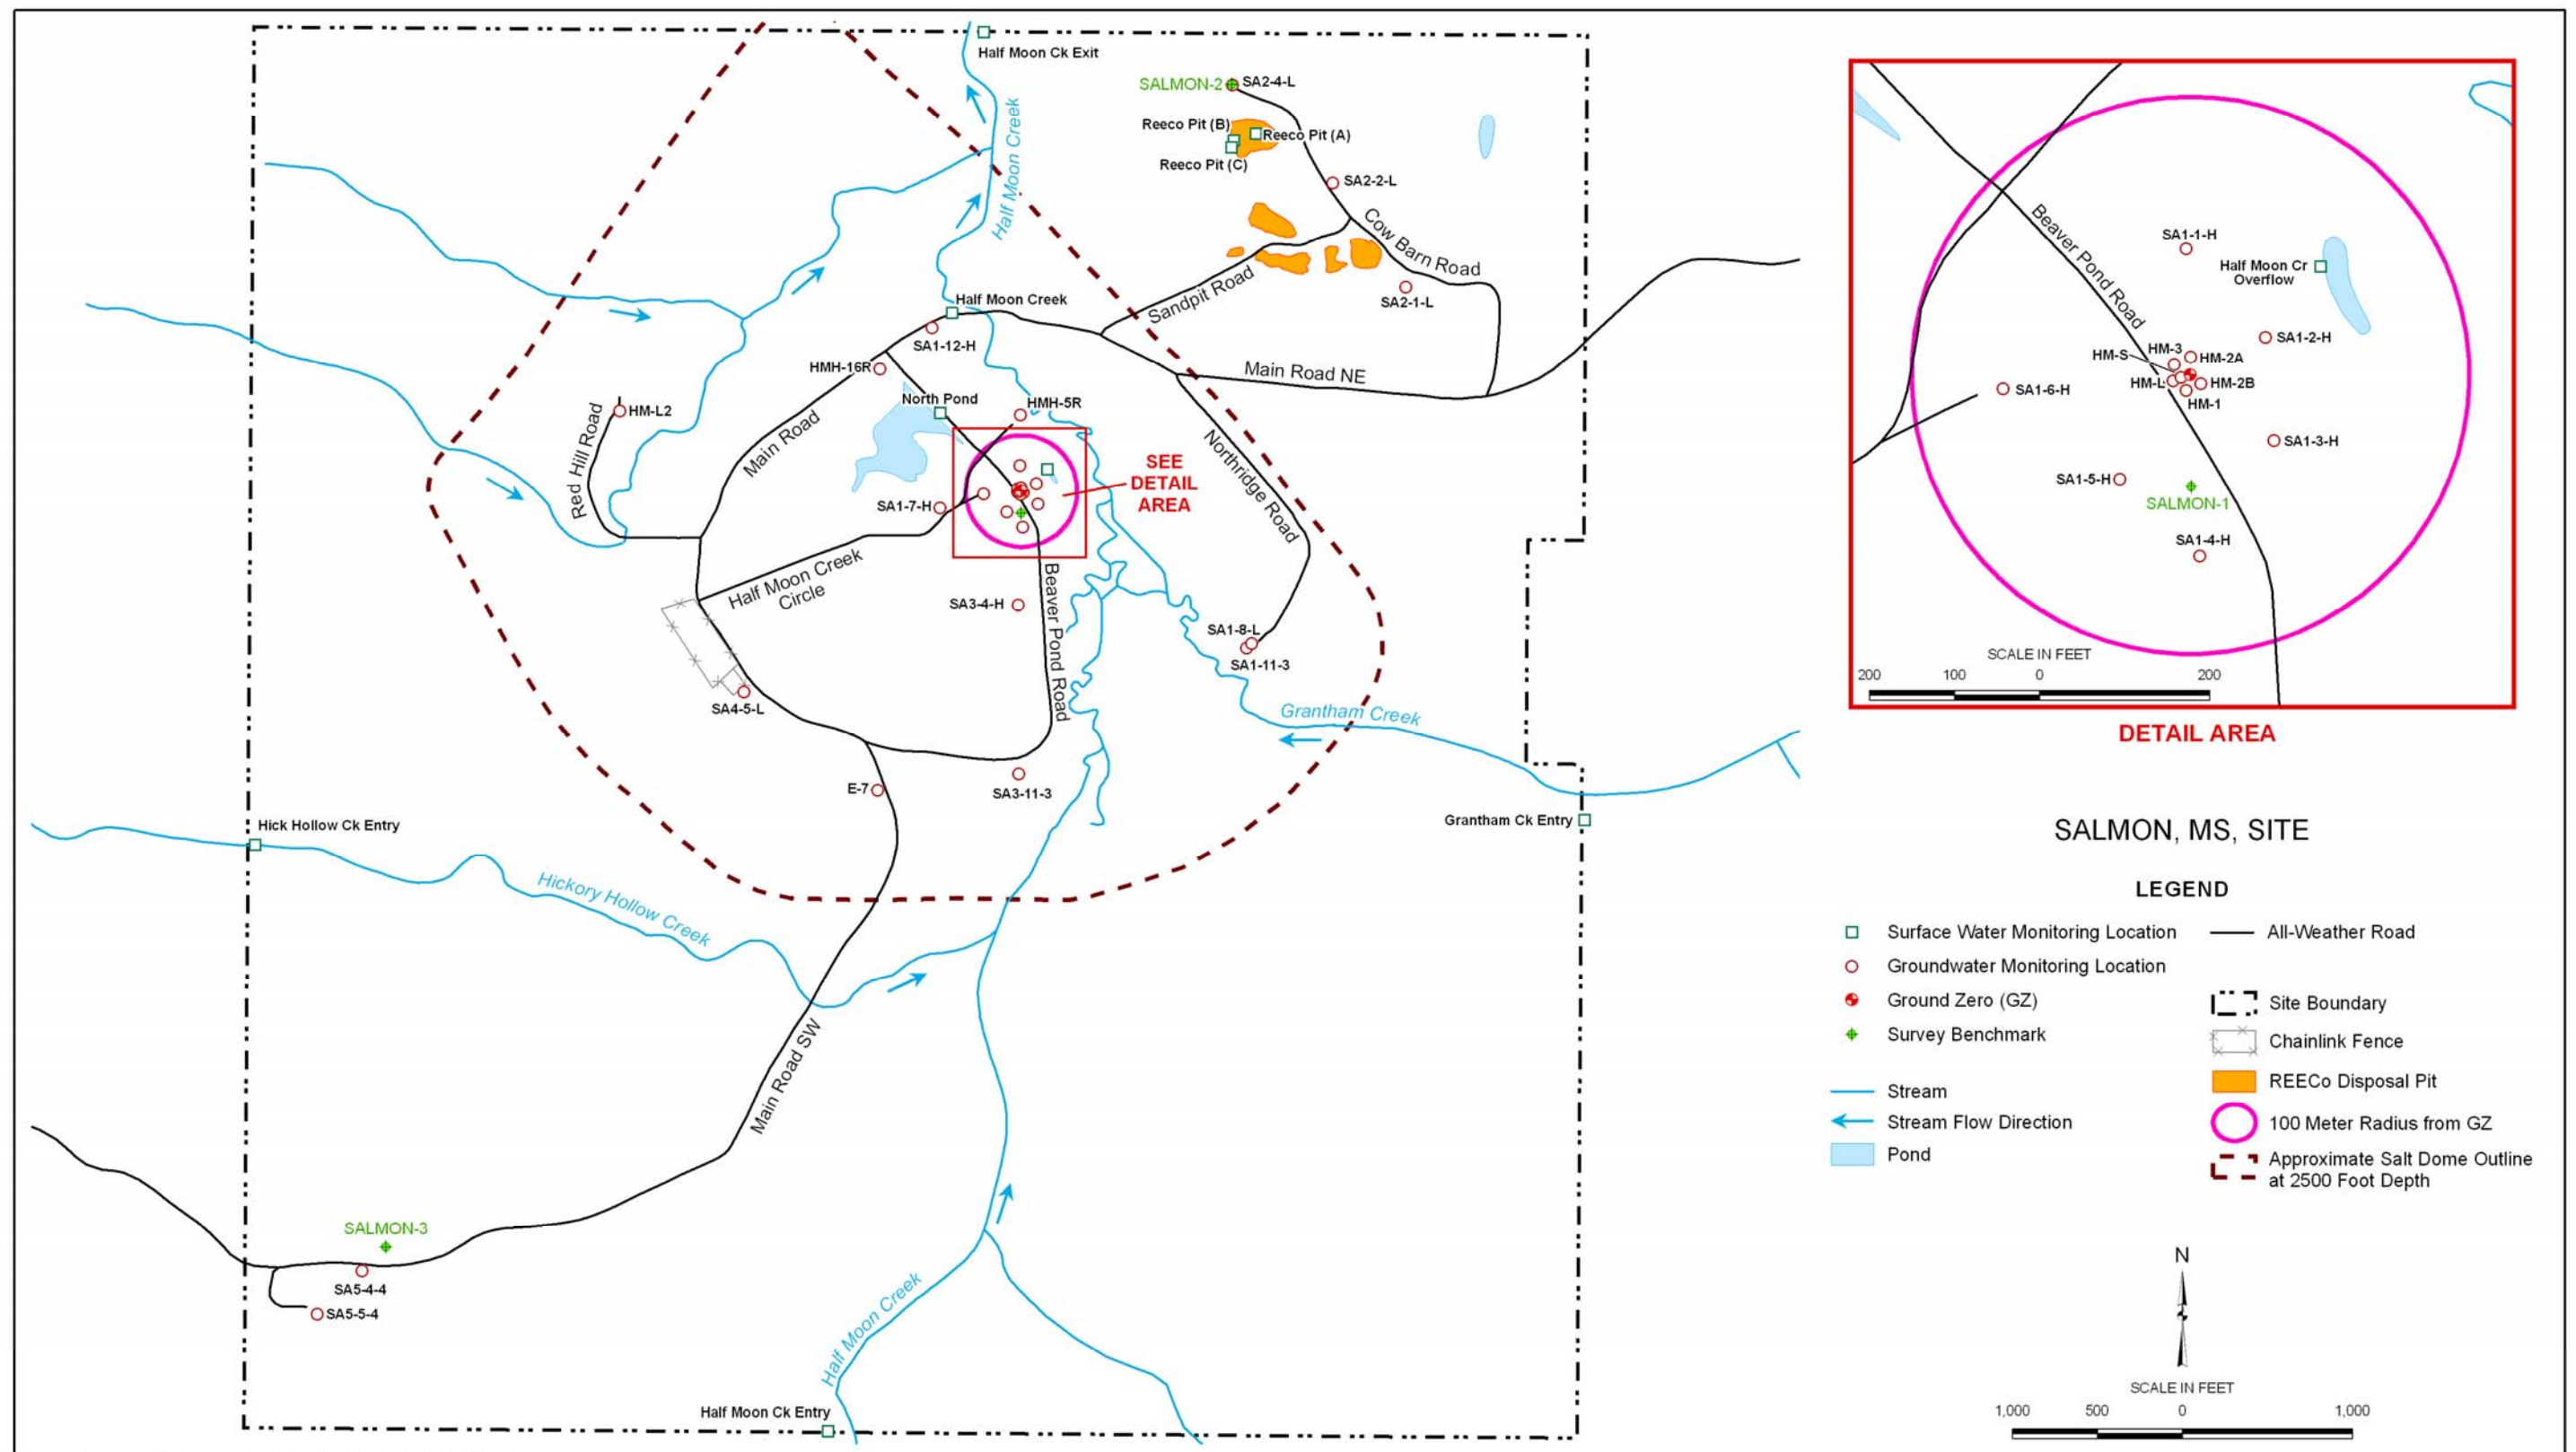
Figure 1–2. Sampling Locations at the Salmon, Mississippi, Site

Laboratory analyses of tritium by EPA of surface water and groundwater samples collected annually since 1972 show that this shallow contamination is attenuating naturally as expected. Current surface water sample points and monitoring well locations are shown in Figure 1–2.

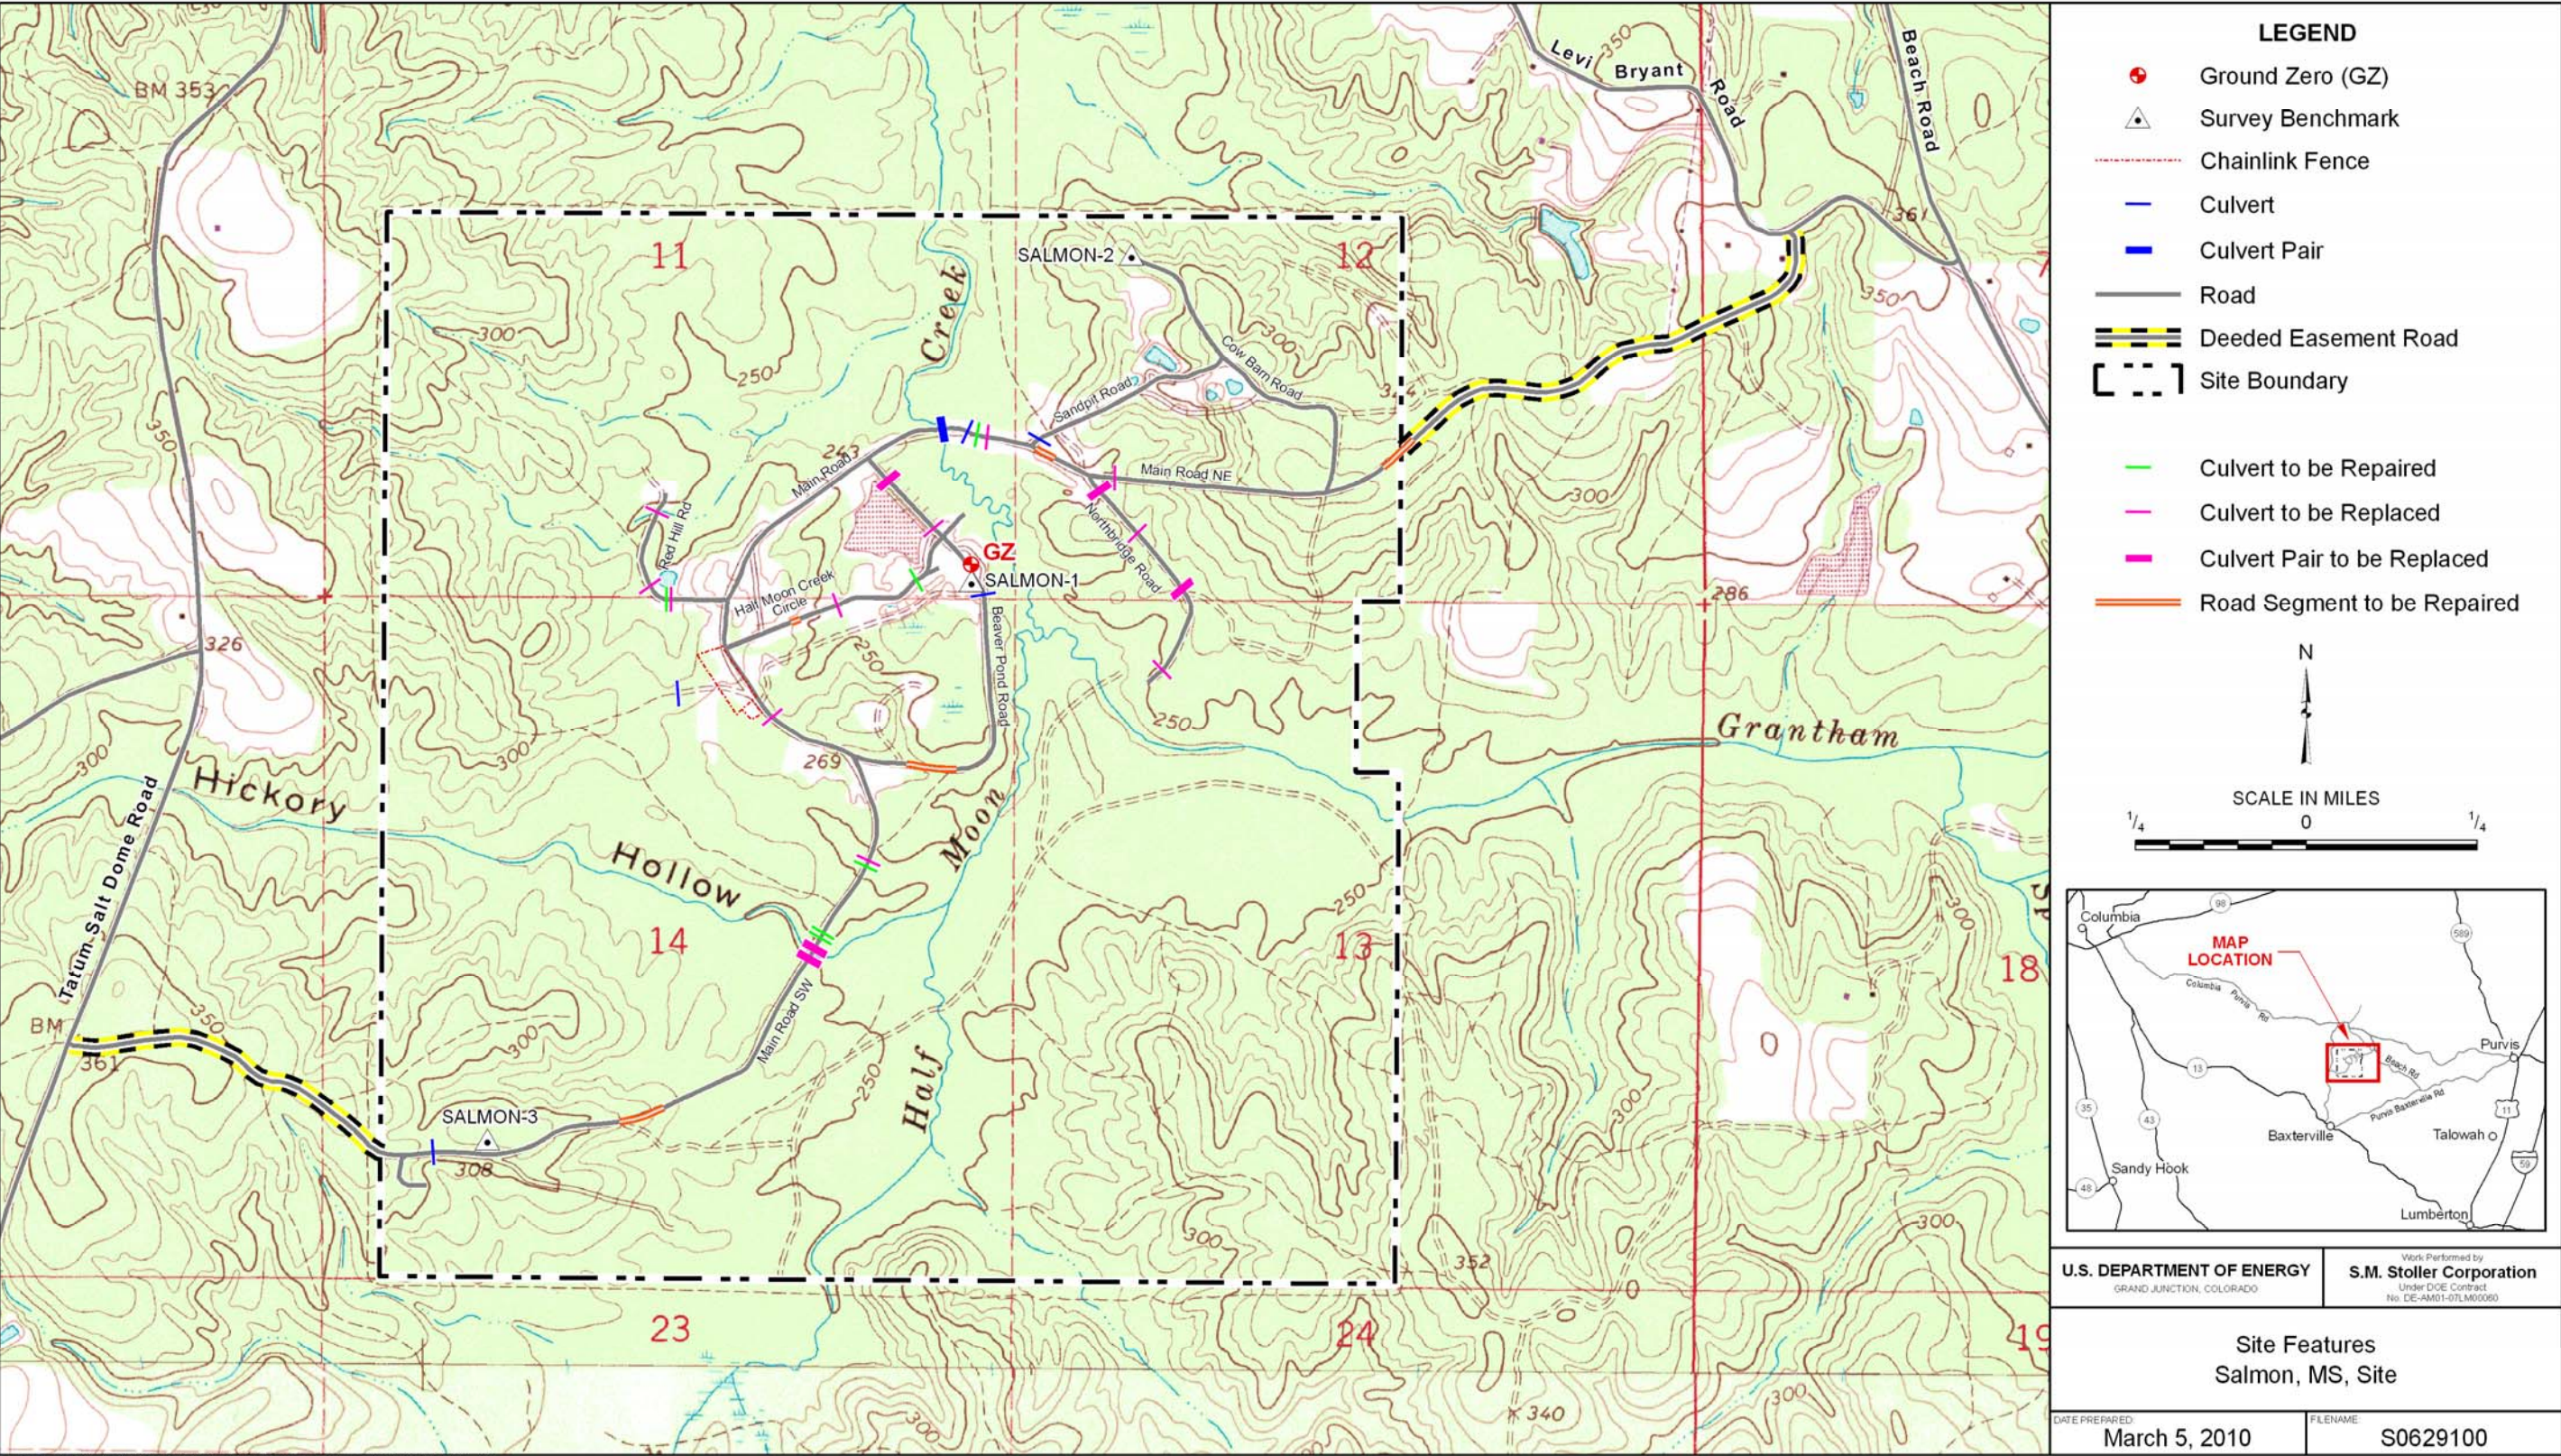
Figure 2-1. Topographic Map Showing Culverts and Road Repairs Scheduled for Winter 2010

Five road segments were damaged by erosion from unusually heavy spring rains. The total damage is about a quarter mile of roadway. Repair is scheduled for 2010. The damaged road segments are shown in Figure 2-1.

Figure 2-1 shows the location of all culverts, including the 20 culverts planned for replacement and the 6 culverts to be repaired. The culvert work is planned for the spring of 2010.

Twenty culverts are to be replaced and six culverts repaired. The plan includes adding riprap at nine inlet or outlet pools.

The general replacement design plan is to replace the old culvert with the same length and diameter culvert, add flared ends where appropriate, and protect culvert inlets and outlets at the road shoulder with riprap. At all inlets and outlets, a 20-ft by 20-ft area of brush smaller than 6 inches in diameter will be removed with the restriction that this surface is not to be permanently disturbed by vehicles on tires or tracks or by grubbing; stumps must remain.

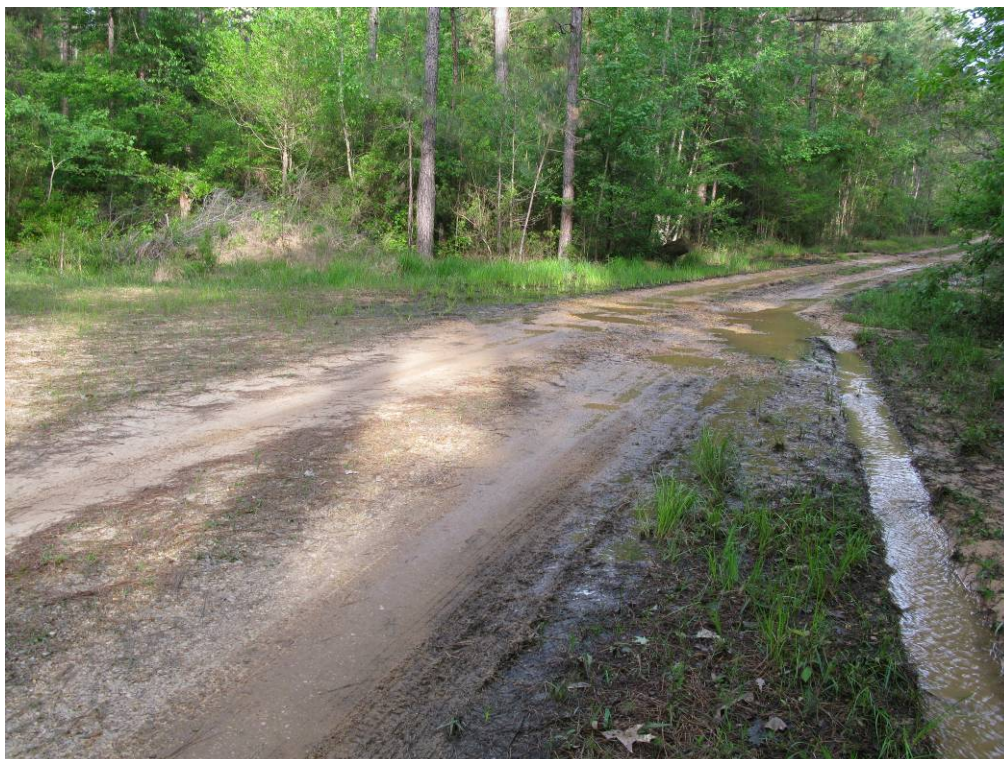
Photo A-1. Water Damage of Main Road NE Caused by a Blocked Culvert Located on the Main Road NE at the Intersection with Northridge Road

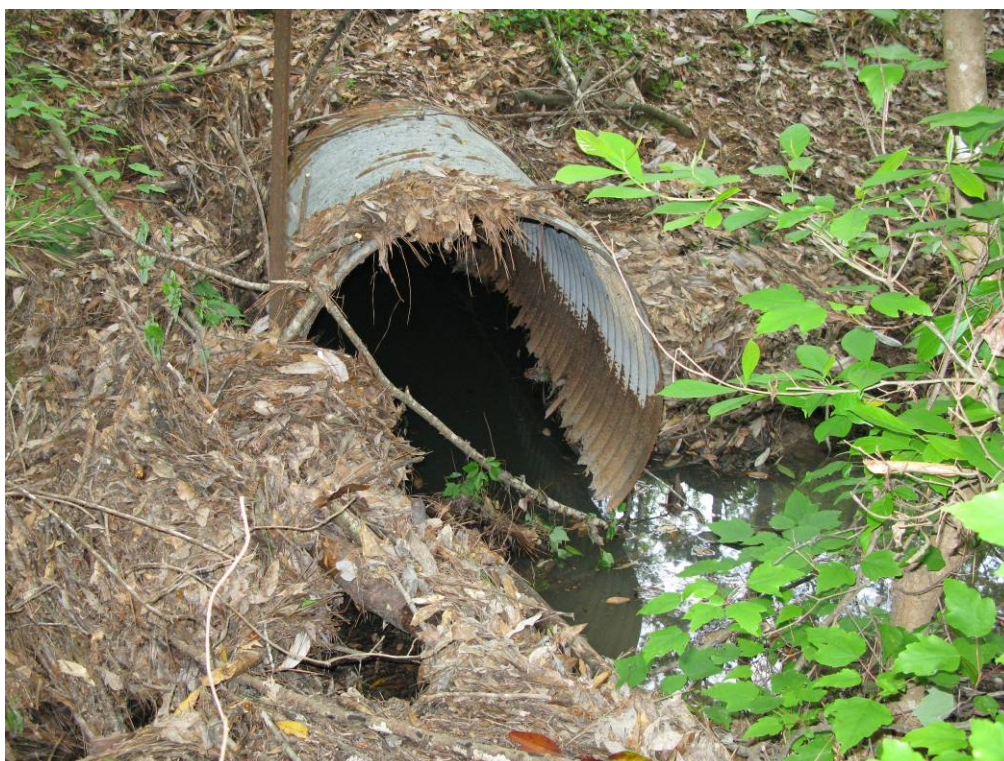
An inventory and assessment of on-site culverts was conducted in April 2009. Thirty-one culverts were identified at that time. The culvert invert (or bottom half) was observed to have eroded completely from most of the culverts (see Photo A-2). The failure is caused by water that

undermined the base of the culverts and accelerated rusting. In two locations, the road has slumped and formed hazardous sink holes due to the culvert failure (see Photo A-3). Culvert locations are shown in Figure 2-1.

Photo A-2. Typical Culvert Invert Failure

- Repair or replace culverts that are failing.
- Inspect the railroad flatcar bridge over Half Moon Creek.
- Use businesses from nearby communities for 2010 maintenance whenever possible.
- Continue the interagency agreement for beaver control.
- Continue the current on-site water sampling plan that includes sampling of:
 - Resource Conservation and Recovery Act metals plus antimony, barium, beryllium, chromium, mercury, nickel, and zinc.
 - VOCs.
 - Tritium and appropriate gamma-emitting radionuclides.

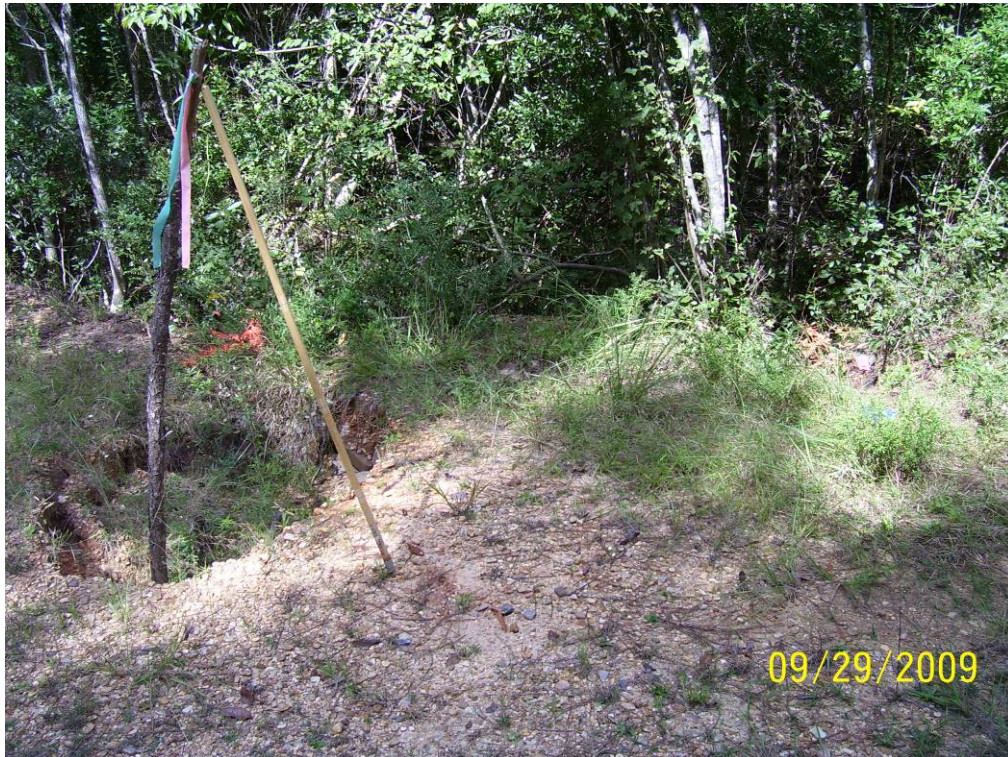
Photo A-3. Sink Hole in Main Road SW Due to Culvert Invert Failure at Location C031

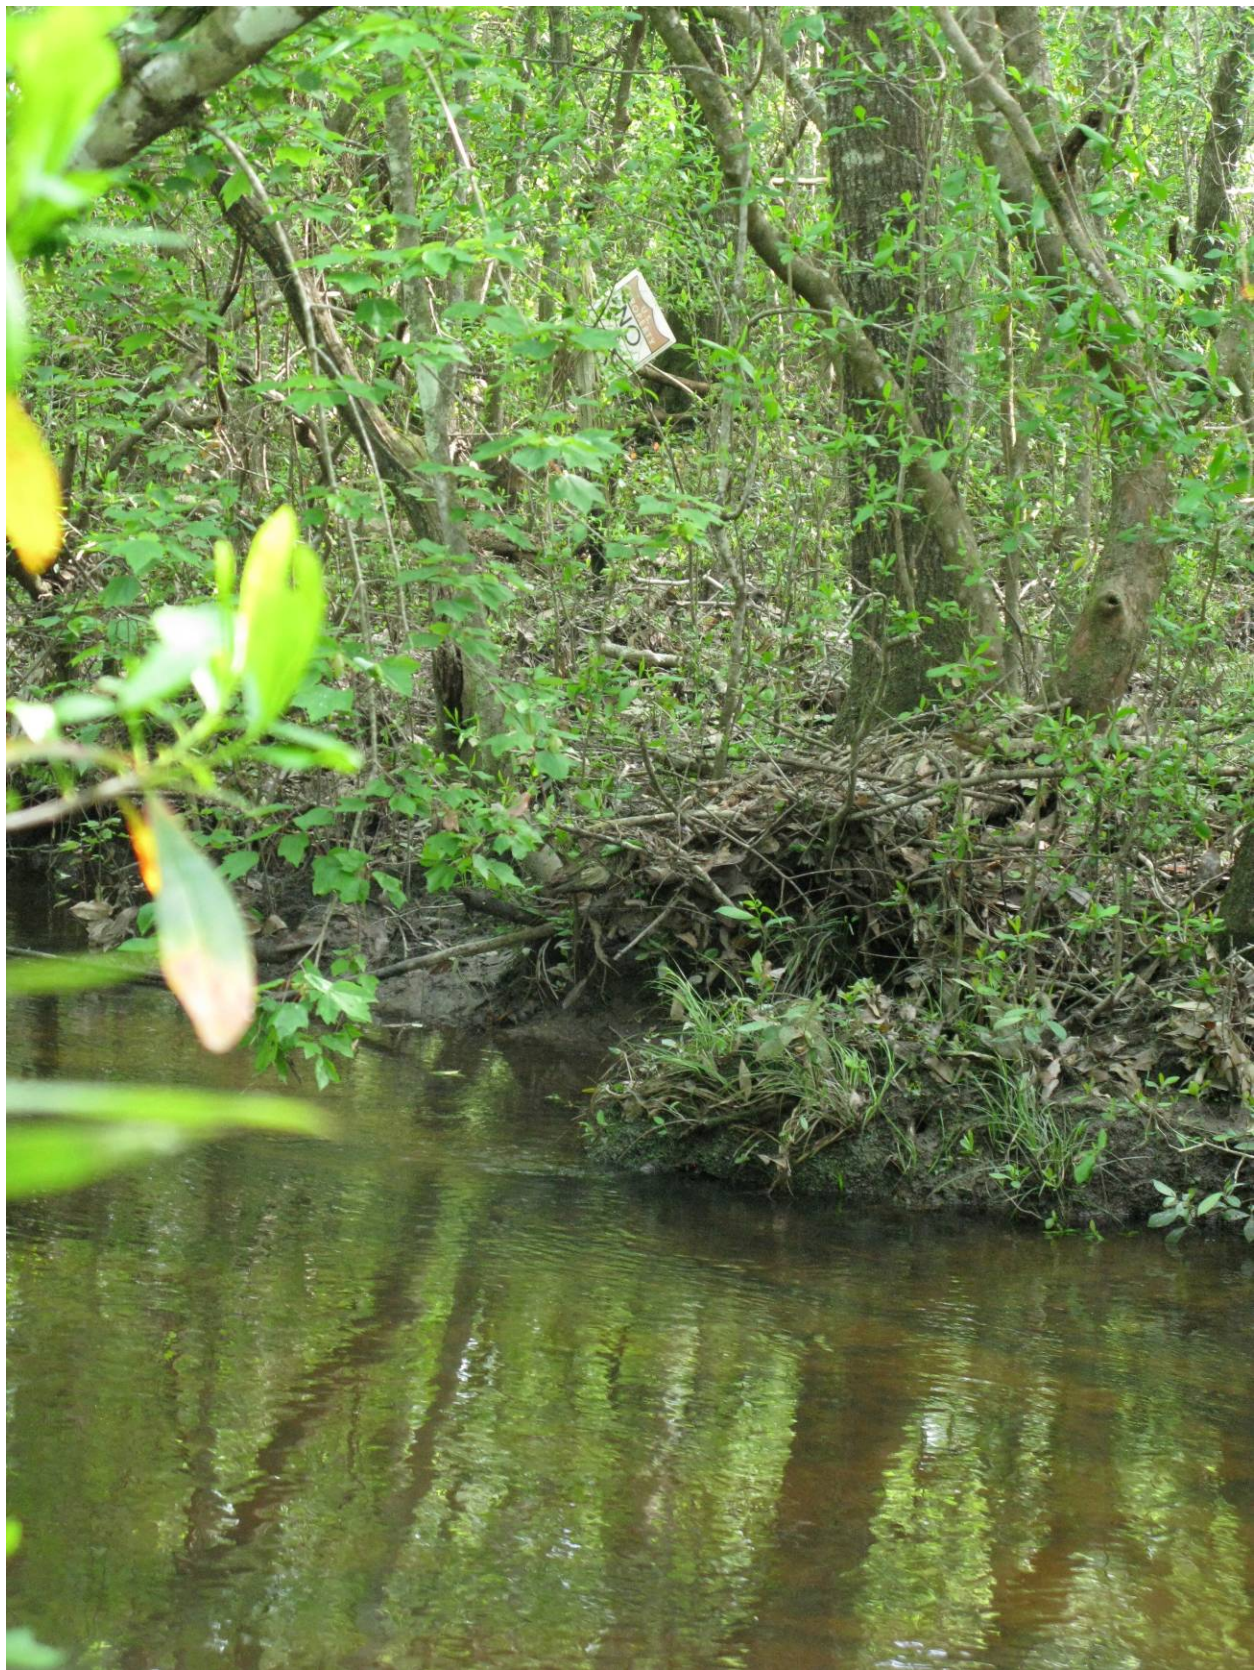
All posted signs at the gate and the northwest corner are in good condition. A federal "No Trespassing" sign was observed on the south boundary where Half Moon Creek enters the site (see Photo A-7).

Photo A-7. No Trespassing Sign Posted at the Half Moon Creek Entry

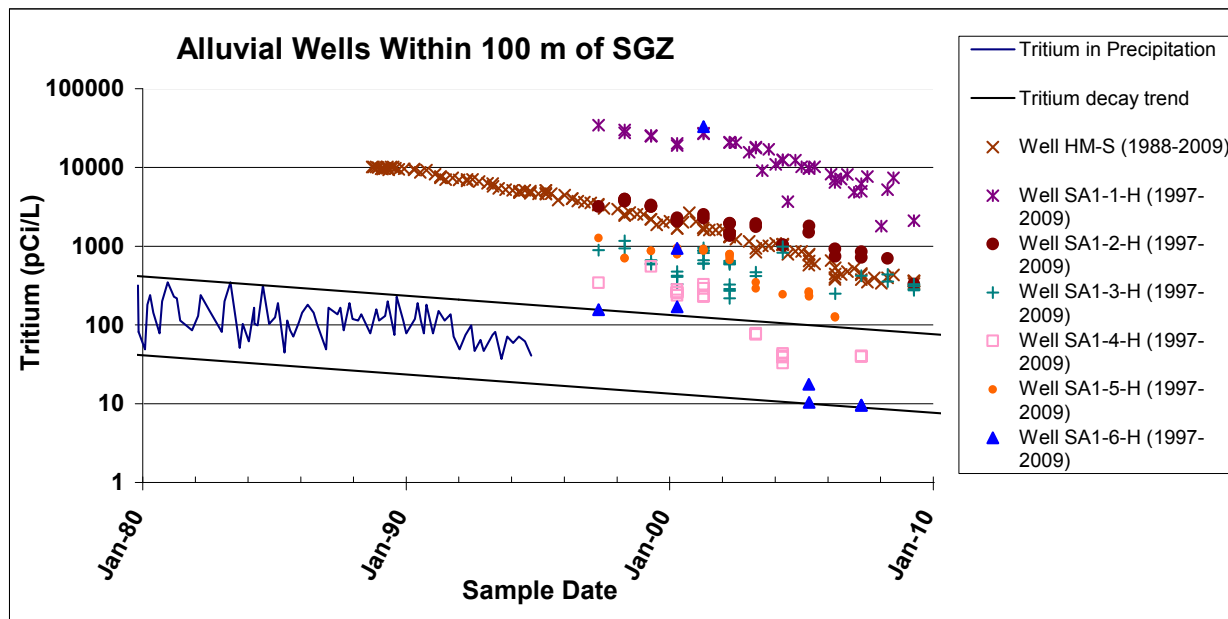
Historical results through 2009 are plotted in Appendix B, Figures B–1 through B–4, for tritium in groundwater and grouped by location or aquifer for comparison of the trends. Tritium in precipitation is also plotted (Lehr and Lehr 2000) along with a pair of tritium decay trend lines. The half-life of tritium is 12.32 years and is described by an exponential decay curve. When exponential decay is plotted on a logarithmic scale, the concentration trend is a straight line.

Figure B-1. Concentration Trend of Tritium Detected in Groundwater Samples versus Time. The samples were collected from Alluvial Aquifer monitoring wells located within 100 meters of ground zero. Only results above the MDC are plotted. Measured tritium in rainfall is shown for 1980 through 1995. Tritium decays with a half-life of 12.32 years. The tritium decay trend is a straight line when plotted on a logarithmic scale (vertical axis) versus time (horizontal axis).

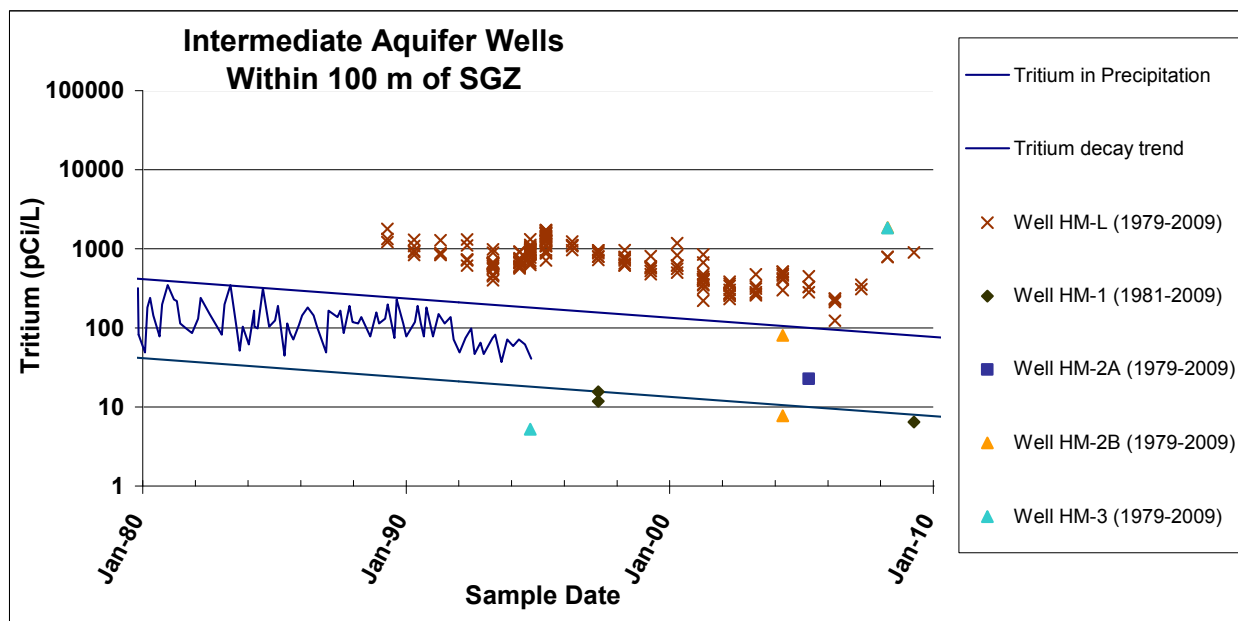
Figure B-2. Concentration Trend of Tritium Detected in Groundwater Samples versus Time. The samples were collected from wells that monitor aquifers spaced above the salt dome. The detonation point is 2,710 feet below the surface in the salt. Only results above the MDC are plotted. Measured tritium in rainfall is shown for 1980 through 1995. Tritium decays with a half-life of 12.32 years. The tritium decay trend is a straight line when plotted on a logarithmic scale (vertical axis) versus time (horizontal axis).

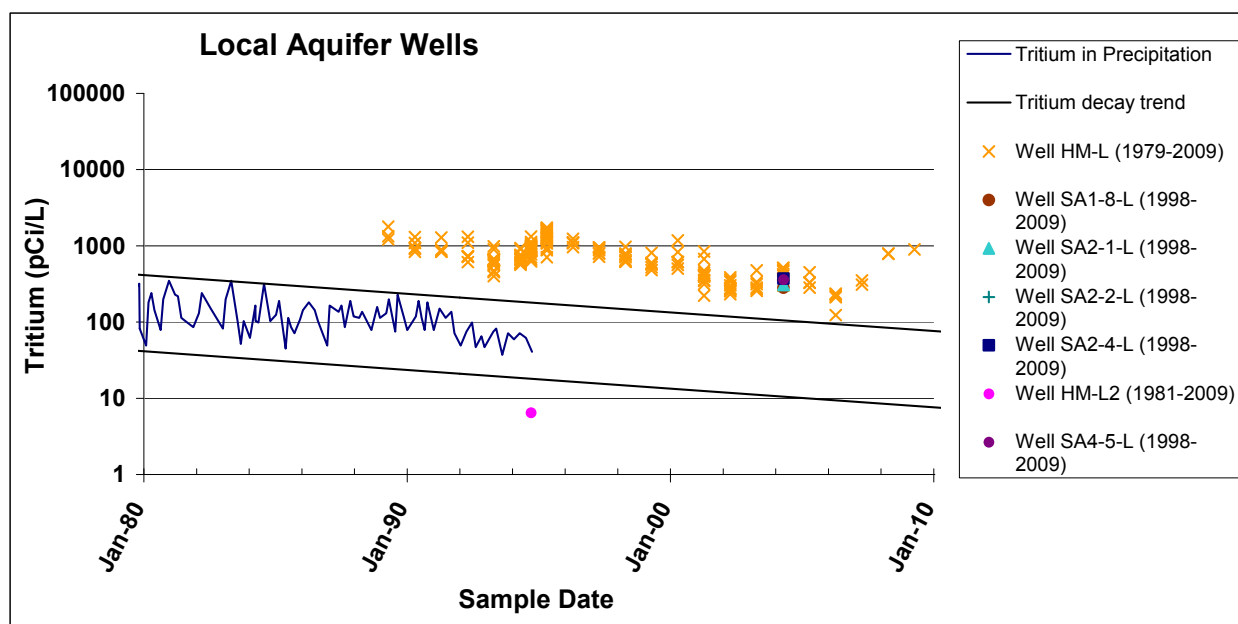
All trends, except for tritium in well HM-L and barium in well SA4-5-L, appear to be decreasing with time, as expected. Tritium in well HM-L and barium in well SA4-5-L have increased over the last 3 years. Barium is a component of drilling mud, but the reason for its appearance only in well SA4-5-L is not known.

Figure B-3. Concentration Trend of Tritium Detected in Groundwater Samples versus Time. The samples were collected from monitoring wells within the Local Aquifer. Only results above the MDC are plotted. Measured tritium in rainfall is shown for 1980 through 1995. Tritium decays with a half-life of 12.32 years. The tritium decay trend is a straight line when plotted on a logarithmic scale (vertical axis) versus time (horizontal axis).

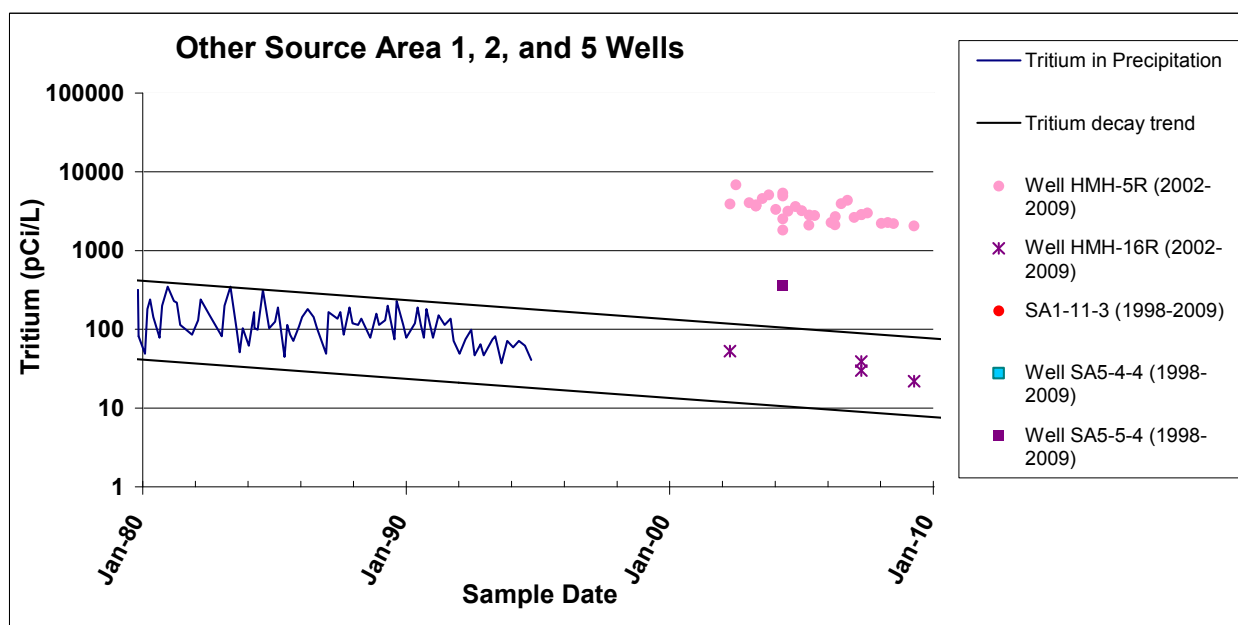
Figure B-4. Concentration Trend of Tritium Detected in Groundwater Samples versus Time. The samples were collected from various monitoring wells. The SA5 wells monitor Aquifer 5, which was injected with radioactive liquids during the testing. The other three wells listed in the legend monitor the Alluvial Aquifer. Only results above the MDC are plotted. Measured tritium in rainfall is shown for 1980 through 1995. Tritium decays with a half-life of 12.32 years. The tritium decay trend is a straight line when plotted on a logarithmic scale (vertical axis) versus time (horizontal axis).

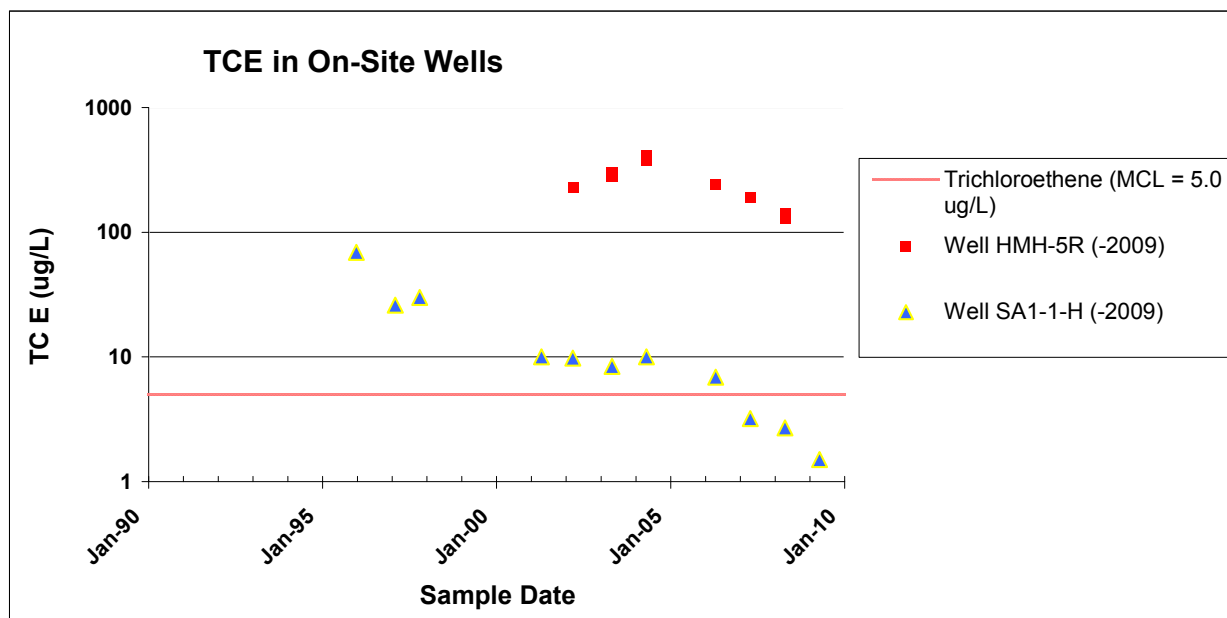
Historical VOC data for TCE and *cis*-1,2-dichloroethene detected in the Alluvial Aquifer are plotted in Appendix B, Figures B–5 and B–6.

Figure B-5. Concentration Trend of Trichloroethene (TCE) Detected in Groundwater Samples versus Time. The samples were collected from monitoring wells in the Alluvial Aquifer. Only results above the detection limit are plotted. The TCE is from a drilling mud additive used as a lubricant during drilling for the test detonations. The MCL for TCE is plotted in red. The vertical axis is the logarithm of TCE concentration. The horizontal time axis is linear.

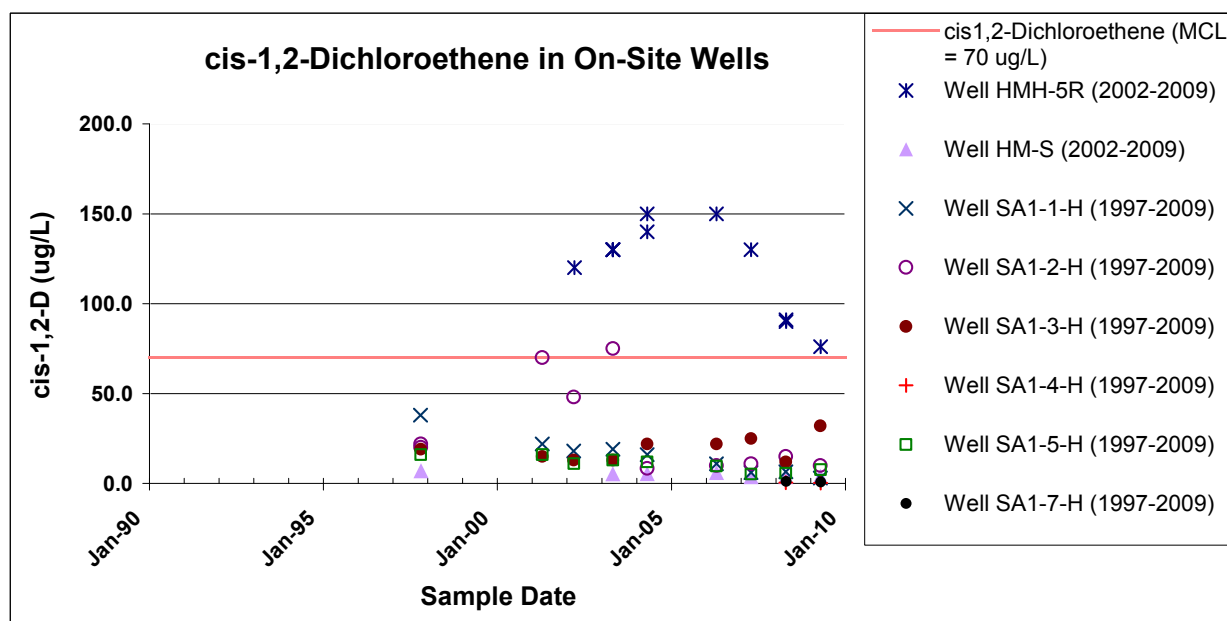
Figure B-6. Concentration Trend of cis-1,2-Dichloroethene Detected in Groundwater Samples versus Time. The samples were collected from monitoring wells in the Alluvial Aquifer. Only results above the detection limit are plotted. This contaminant is from a drilling mud additive used as a lubricant during drilling for the test detonations. The MCL is plotted in red. The vertical axis is the logarithm of cis-1,2-dichloroethene concentration. The horizontal time axis is linear.

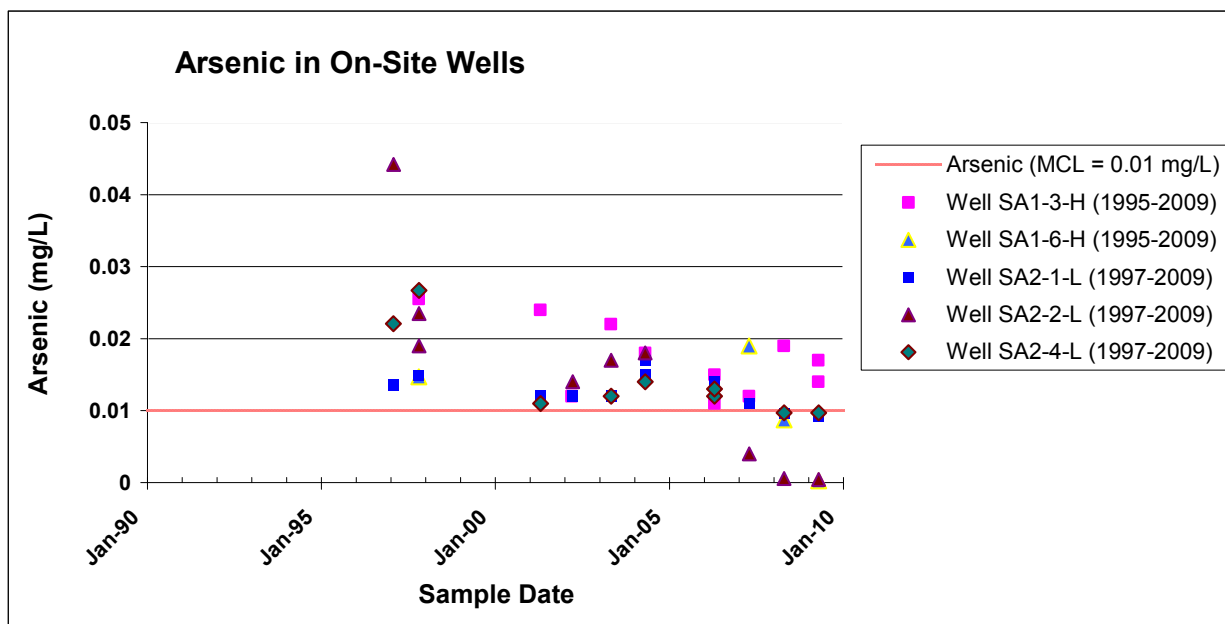
Historical metals data detected in groundwater are plotted in Appendix B, Figures B–7 through B–10, for arsenic, barium, chromium, and lead. Lead was not detected above its MCL in 2009.

Figure B–7. Concentration Trend of Arsenic Detected in Groundwater Samples versus Time. The samples were collected from monitoring wells in the Alluvial and Local Aquifers. Only results above the detection limit are plotted. The source of the arsenic has never been established. The arsenic MCL is plotted in red. The vertical axis is the logarithm of arsenic concentration. The horizontal time axis is linear.

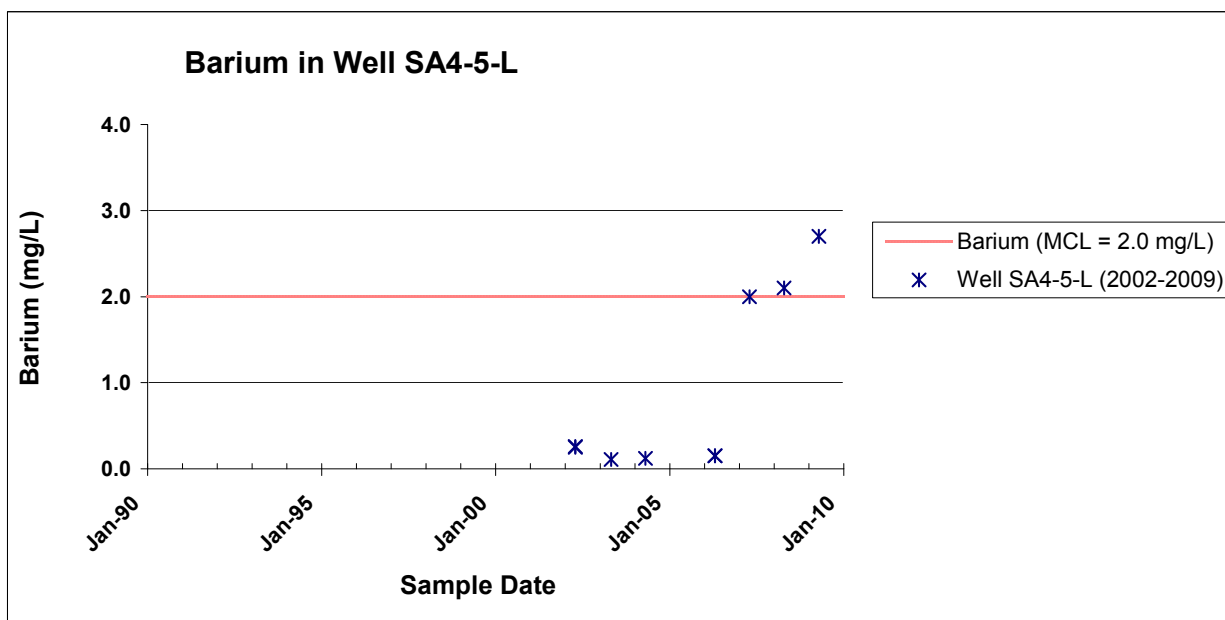
Figure B–8. Concentration Trend of Barium Detected in Groundwater Samples versus Time. The samples were collected from monitoring wells in the Local Aquifer. Only results above the detection limit are plotted. Barium is a major component of drilling mud. The barium MCL is plotted in red. The vertical axis is the logarithm of barium concentration. The horizontal time axis is linear.

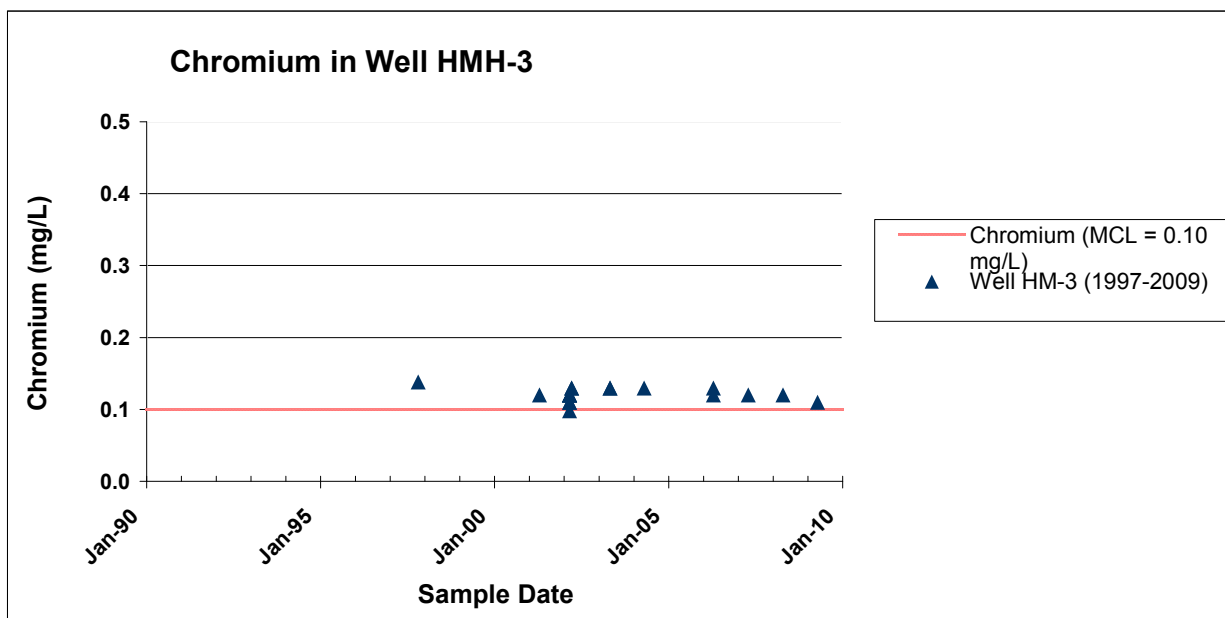
Figure B–9. Concentration Trend of Chromium Detected in Groundwater Samples versus Time. The samples were collected from Aquifer 3. Only results above the detection limit are plotted. The chromium may be from a drilling mud additive. The chromium MCL is plotted in red. The vertical axis is the logarithm of chromium concentration. The horizontal time axis is linear.

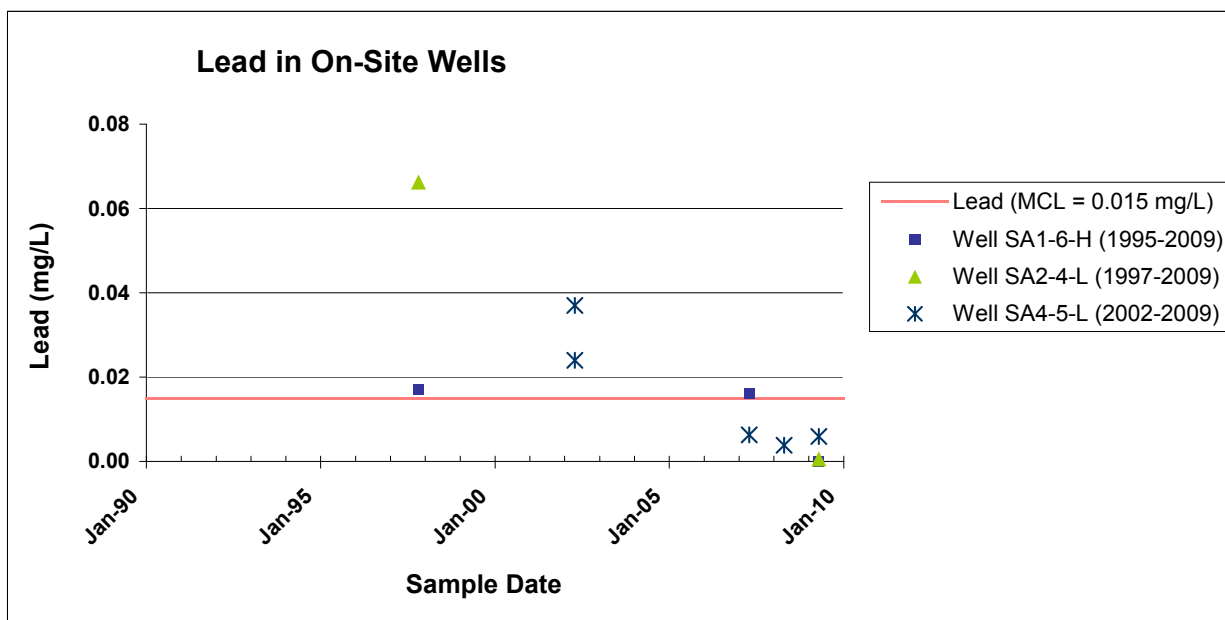
Figure B–10. Concentration Trend of Lead Detected in Groundwater Samples versus Time. The samples were collected in three wells. Only results above the detection limit are plotted. Lead was not detected in 2009. The lead MCL is plotted in red. The vertical axis is the logarithm of lead concentration. The horizontal time axis is linear.
