# **Post-Closure Inspection, Sampling, and Maintenance Report for the Salmon, Mississippi, Site**

## **Calendar Year 2010**

**March 2011**

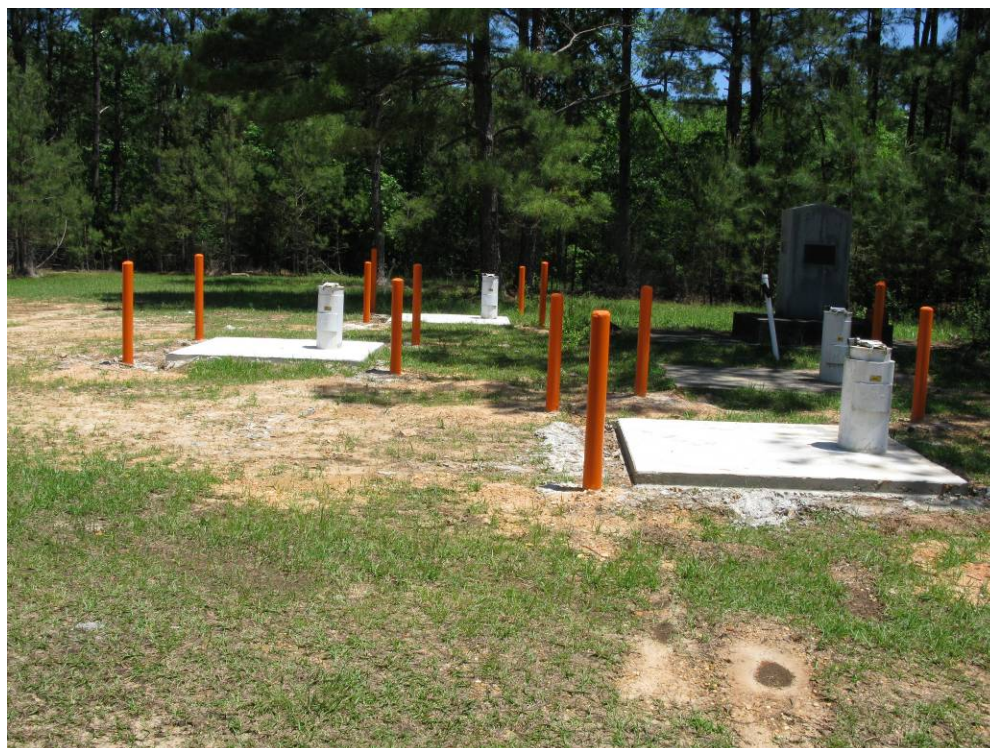
A typical monitoring well installation has a white, locked, metal protective cover surrounded at the base by a rectangular concrete pad with a 4 ft high bollard at each corner. A bollard is a concrete-filled pipe set into a concrete-filled hole. The well cover is painted white and the bollards bright “safety orange.” A three-bollard set surrounds each of the three surveyor benchmarks.

*Image A-2. Four ground zero wells, orange bollards, and new concrete well pads are shown. The wells reside inside the white protective casing. The monument (ground zero) is in the background, to the right.*

Existing bollard sets were repaired or new bollard sets installed. Twenty-two new sets of bollards were installed, three sets were replaced, and two sets were repaired. Three concrete well pads were replaced. Bollards and new well pads are shown in Appendix A, Image A–2.

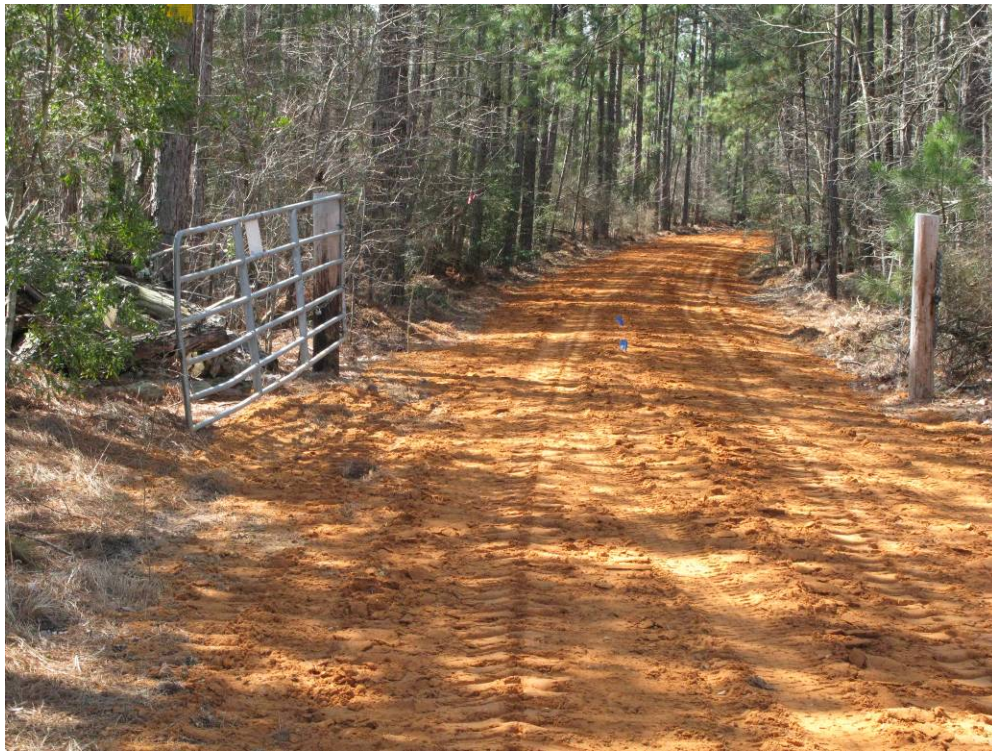
During the pre-bid subcontractor site-maintenance tour, a surveyor's stake was found about 15 ft inside the main gate in the middle of the Main Road NE (Appendix A, Image A–3). If the surveyor's stake is true, the posted main gate is 15 feet beyond the site boundary on private property.

*Image A-3. Main gate. The blue flags in the center of the repaired road, mark the location of a surveyor's stake, about 15 feet inside the gate.*

The two site gates and locks are in good condition. The main gate is shown in Appendix A, Image A-3.

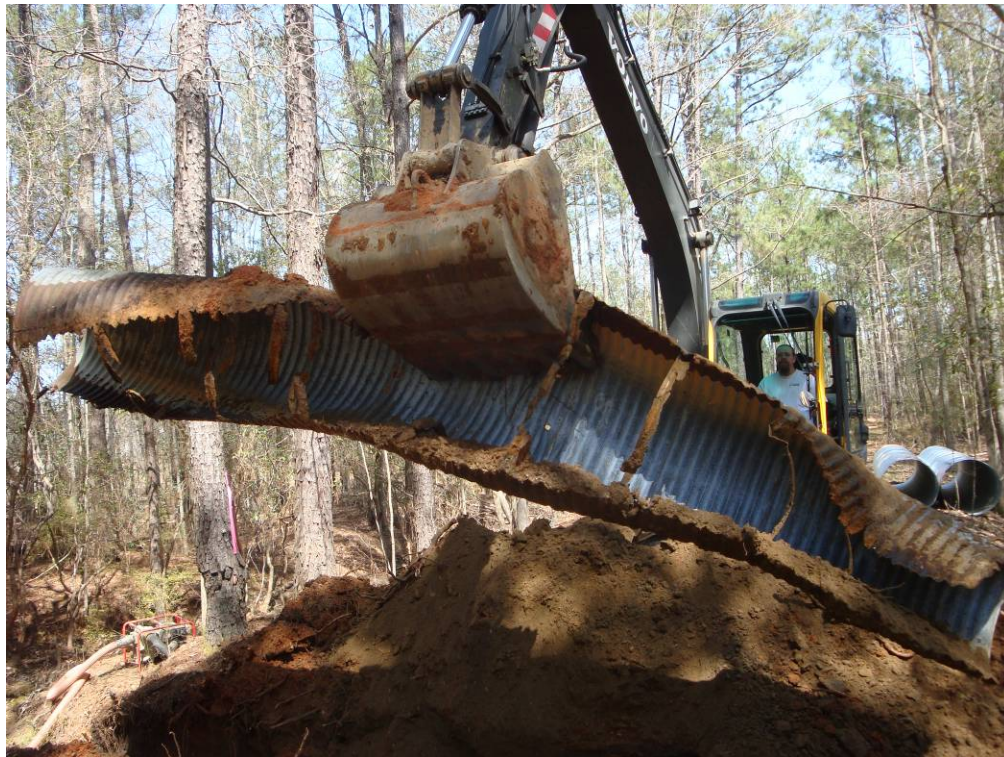
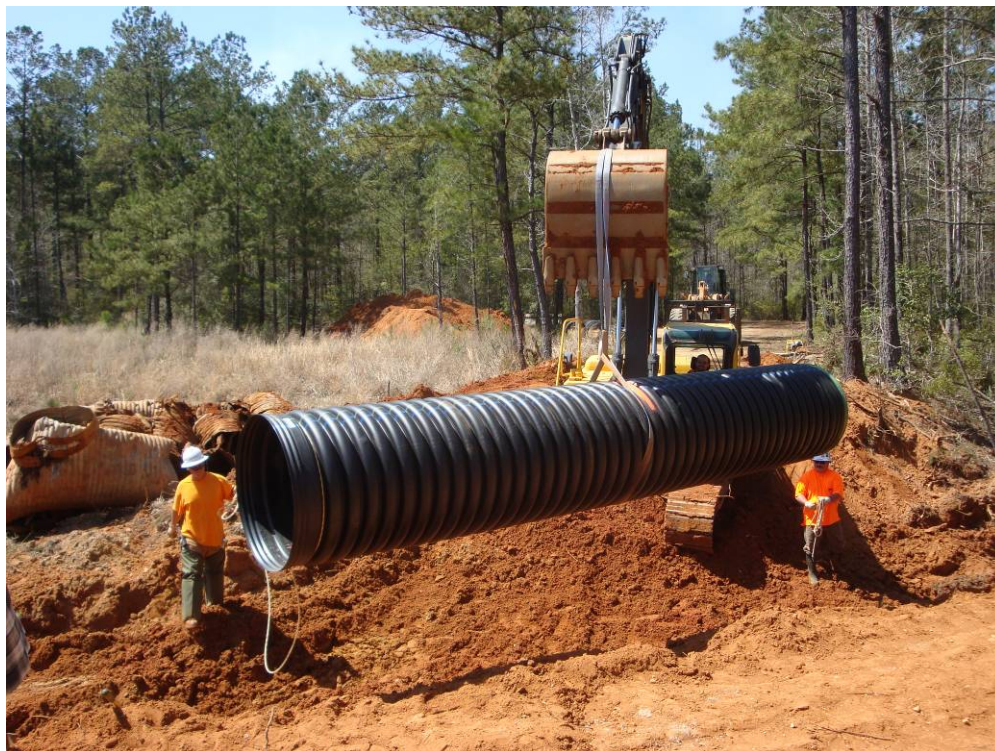
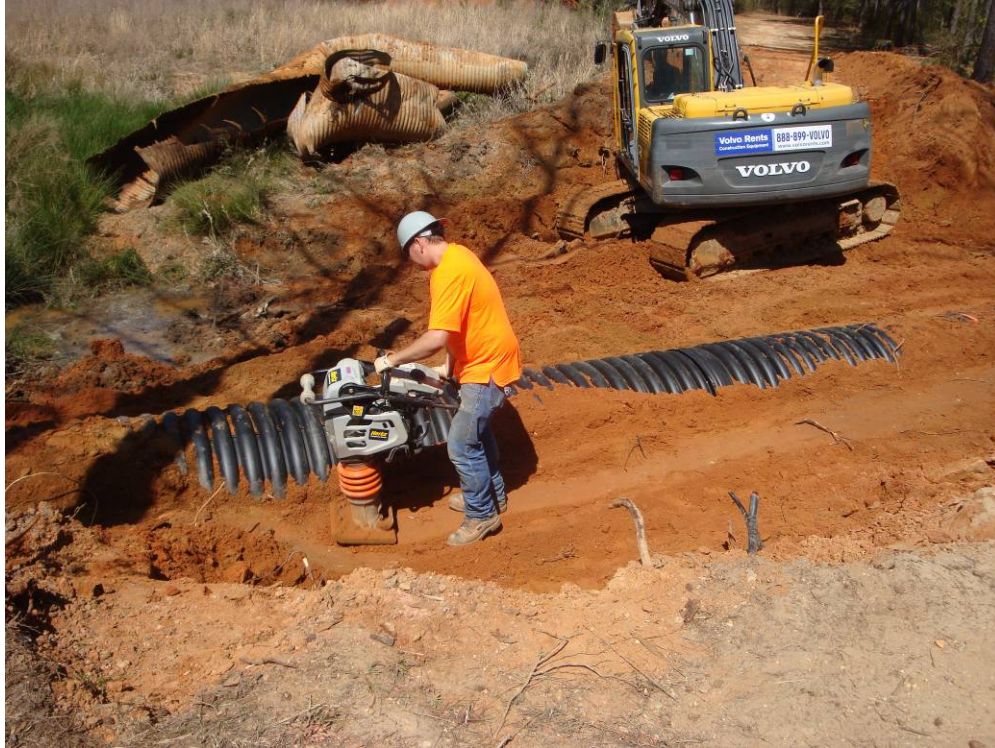
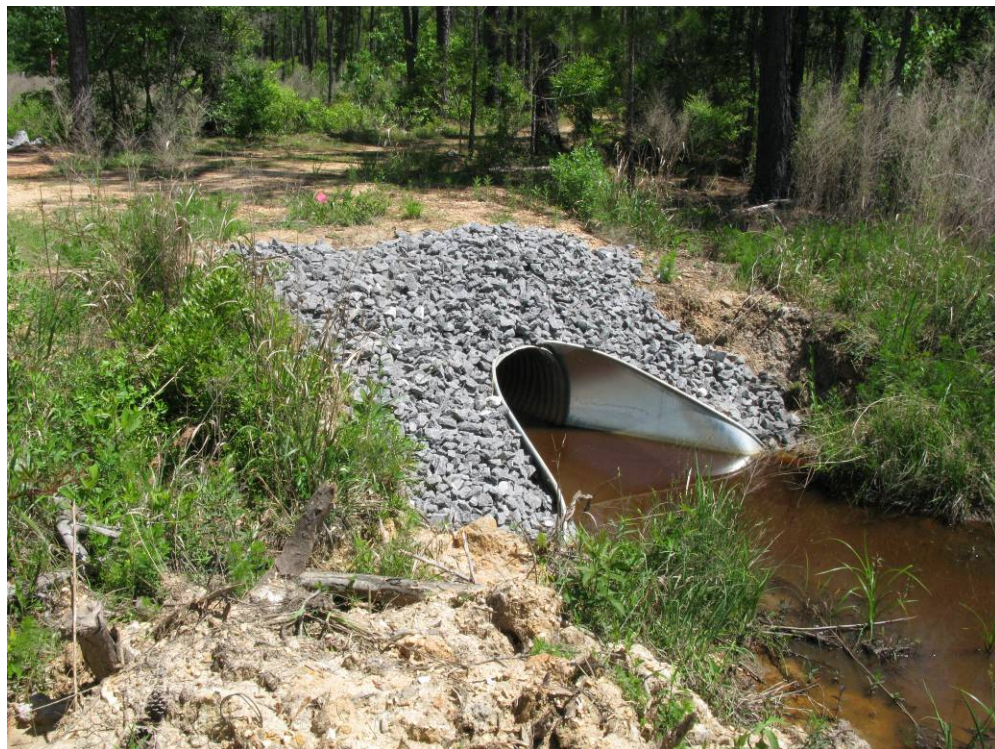
*Image A-5. Removal of an old culvert.*

*Image A-6. Installation of a new plastic culvert on Beaver Pond Road. Most new culverts that were installed are galvanized steel.*

*Image A-7. Compacting backfill.*

*Image A-8. Finished end of a new culvert.*

Twenty-six buried culverts were repaired or replaced. Seventeen culverts were replaced and six culverts were repaired. The replaced culvert lengths were the same as the old culvert lengths. Three of the culverts were replaced by two swales. The MSFC suggested the use of a swale (or broad-based dip) instead of a culvert at certain locations. Except for the plastic culverts under Beaver Pond Road, all culverts were galvanized steel. Most culverts were fitted with flared ends at inlet and outlet and after staged compaction. The culverts were completed with riprap on the road shoulders and on the road edge at the inlet and outlet. Known culvert locations are shown in Figure 3. Images taken during the repair are in Appendix A, Images A–5 through A–8.

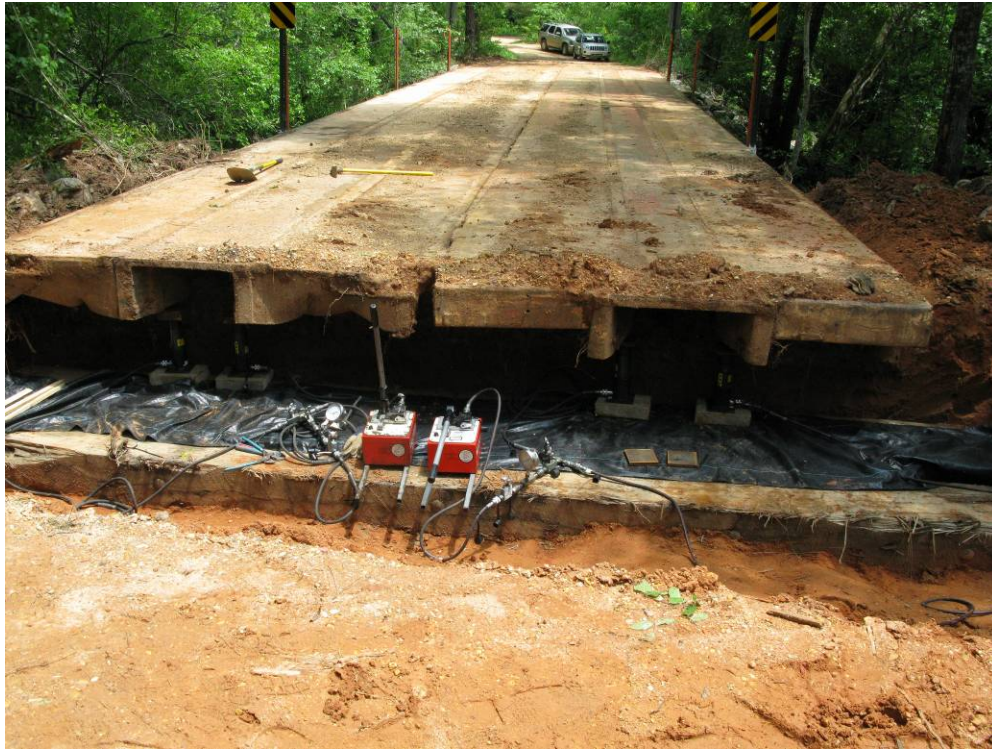
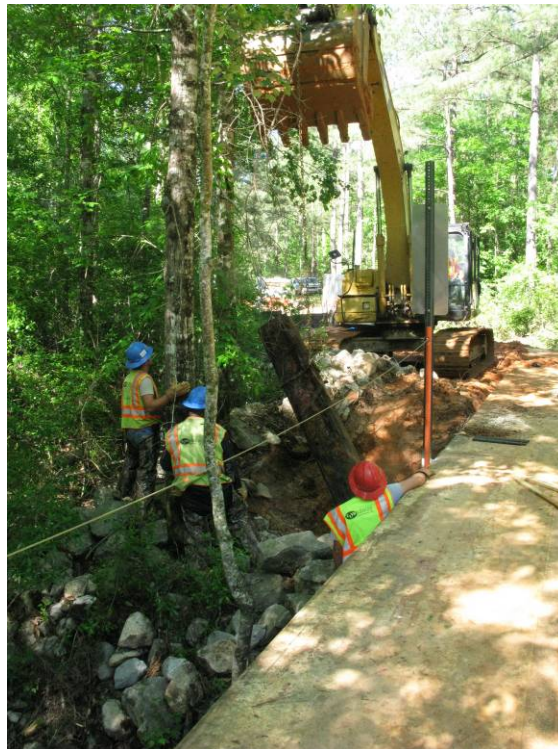
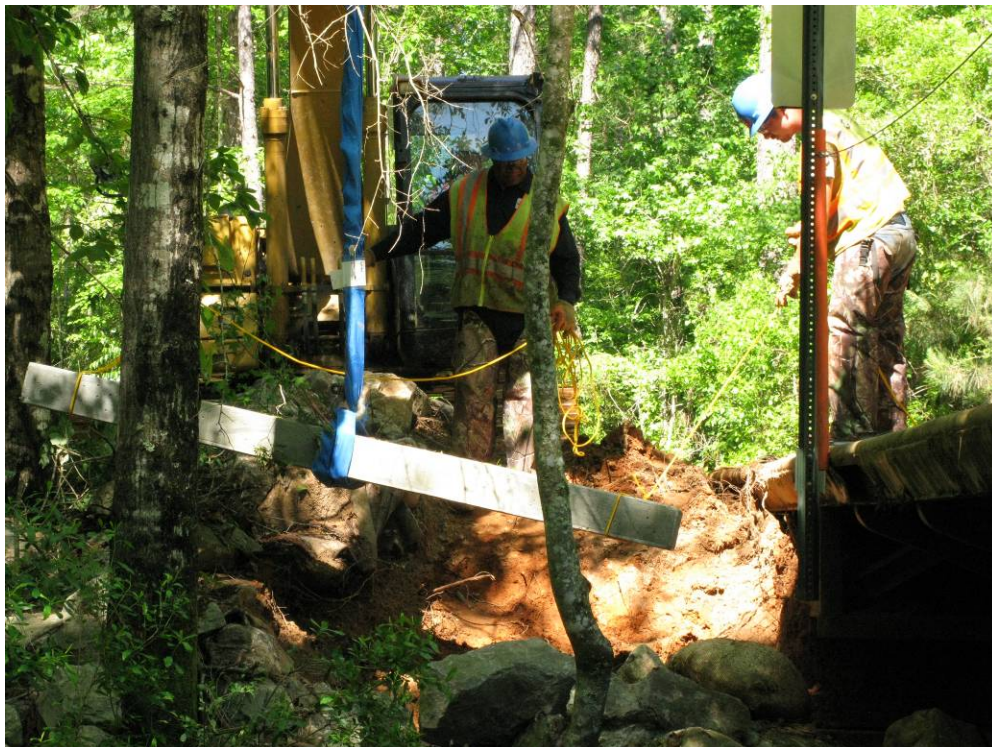
The bridge was inspected by a qualified<sup>1</sup> bridge inspector on 12 January 2010 to comply with a DOE requirement<sup>2</sup>. The inspector observed deterioration of the wood head caps<sup>3</sup> due to localized bulging and some wood rot. The head caps are sandwiched between the top of each 24-inch-wide bridge bent—an inverted T-shaped pier—and the underside of the flatcars, at the approximate location where the trucks were formerly attached.

*Image A-9. West end of flatcar bridge raised on hydraulic jacks that sit on cribbing.*

*Image A-10. Removing wood head cap from west end of the flatcar bridge.*

*Image A-11. Installation of a new concrete head cap under the west end of the flatcar bridge.*

In May, the head caps were replaced with concrete head caps. The subcontractor raised each end of the bridge, removed the wood head caps, installed concrete head caps on the bents, and topped each head cap by an isomeric (neoprene) pad or pads onto which the bridge was lowered. The concrete head caps were cast according to the structural engineer's design specifications: concrete compressive strength of 3,000 pounds-force per square inch and compressive yield strength of 750 pounds-force per square inch. When each end of the bridge was elevated on blocking for head cap replacement, the structural engineer inspected the bridge substructure and found both ends to be in good condition. Images of the bridge repair are in Appendix A, Images A-9 through A-11.

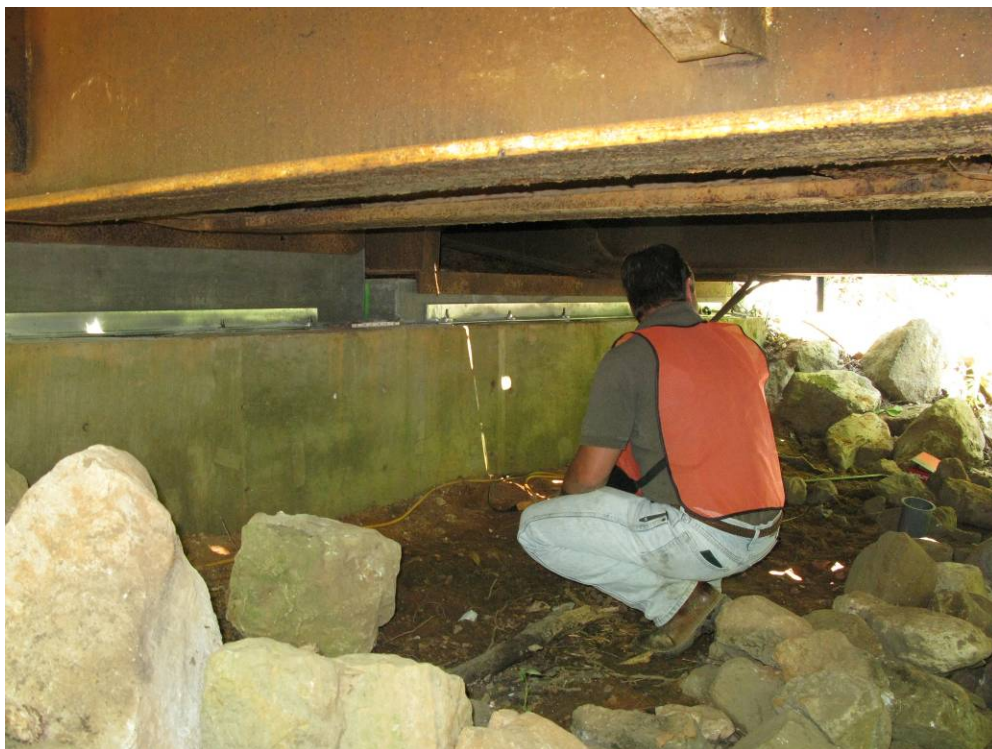
*Image A-12. Re-inspection of flatcar bridge after the new concrete head caps are in place and secured by stainless steel angles.*

The bridge passed the subsequent re-inspection (Appendix A, Image A-12). A copy of the inspector's report and a completed Mississippi Department of Transportation Bridge Inspection form was sent to the MSFC.

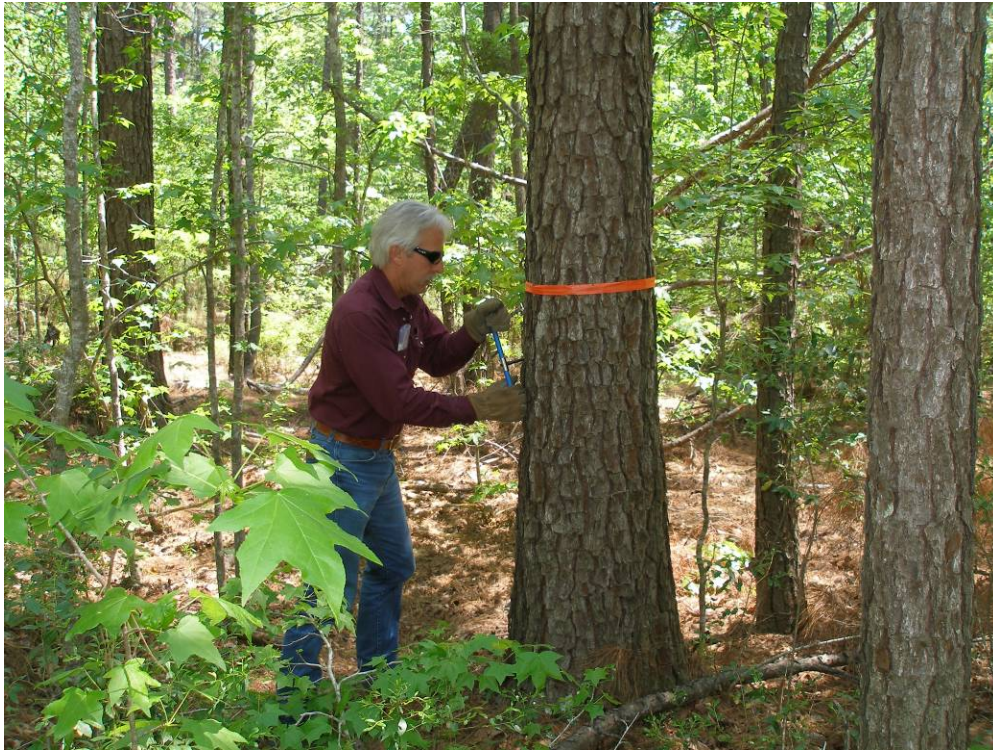
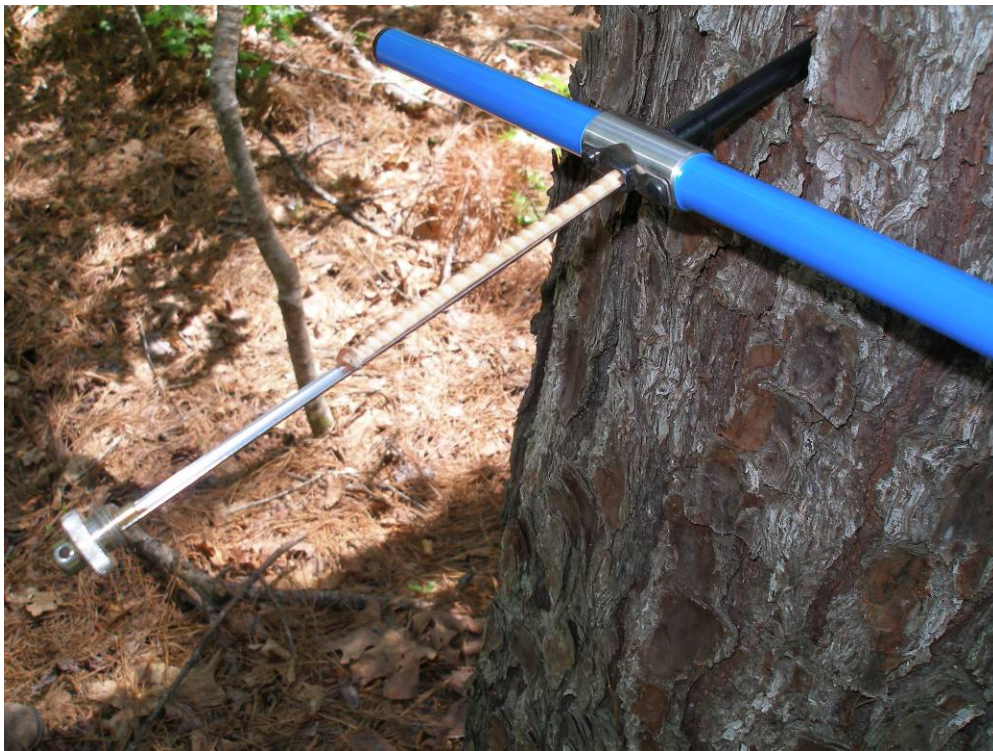
As part of due diligence, the MSFC collected tree-wood samples to analyze for tritium, since trees logged from the site would be sold commercially. LM independently sampled one-tenth of the same trees sampled by MSFC. Details and summary results are in Section 3.4. Images of LM’s tree-wood collection activity are in Appendix A, Images A–13 and A–14.

*Image A–13. Collection of a tree core sample. The orange tape indicates the tree had previously been sampled by the State.*

*Image A–14. The core sample withdrawn from the incremental borer. The tree rings are visible.*

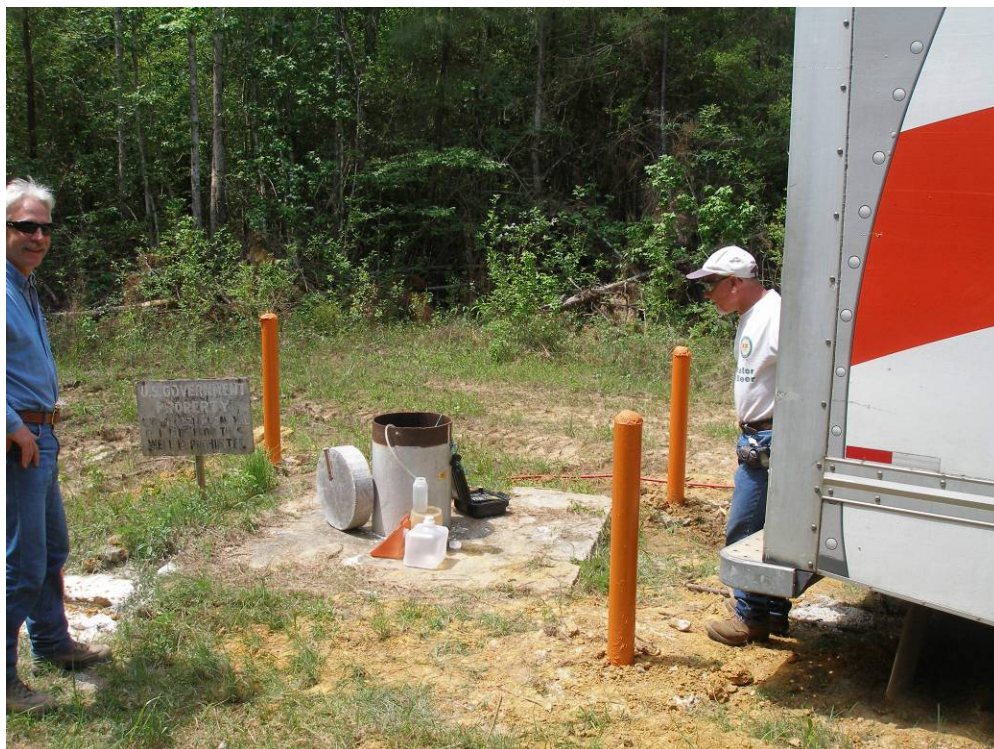
*Image A-15. Collection of a groundwater sample at well E-7 by LM.*

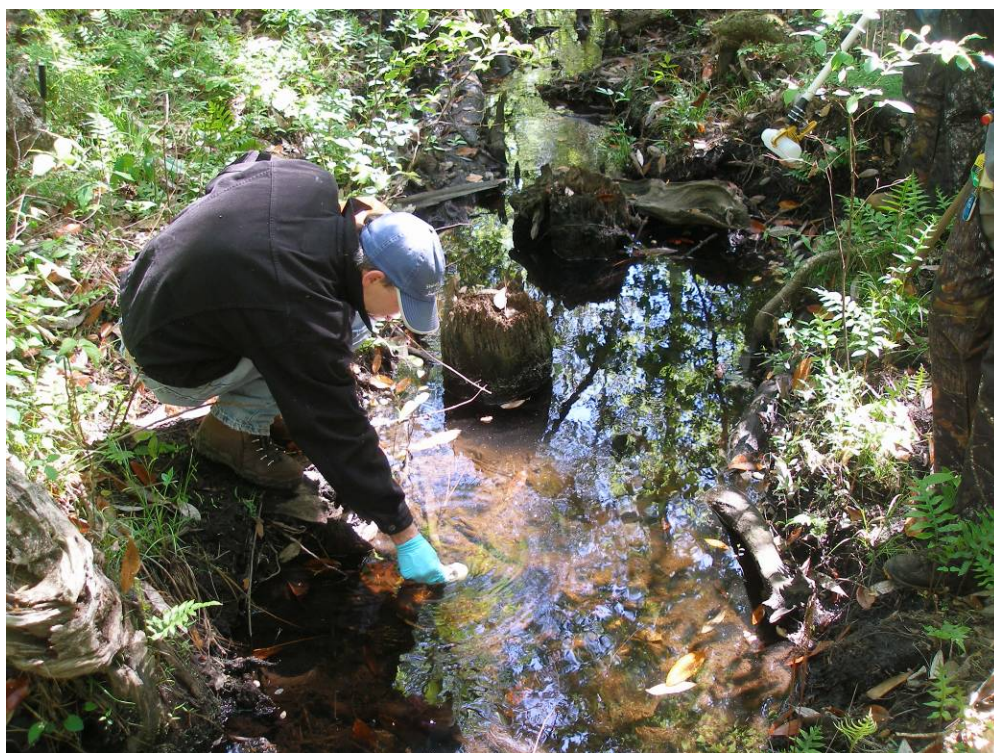
*Image A-16. Collection of a surface water sample by the State.*

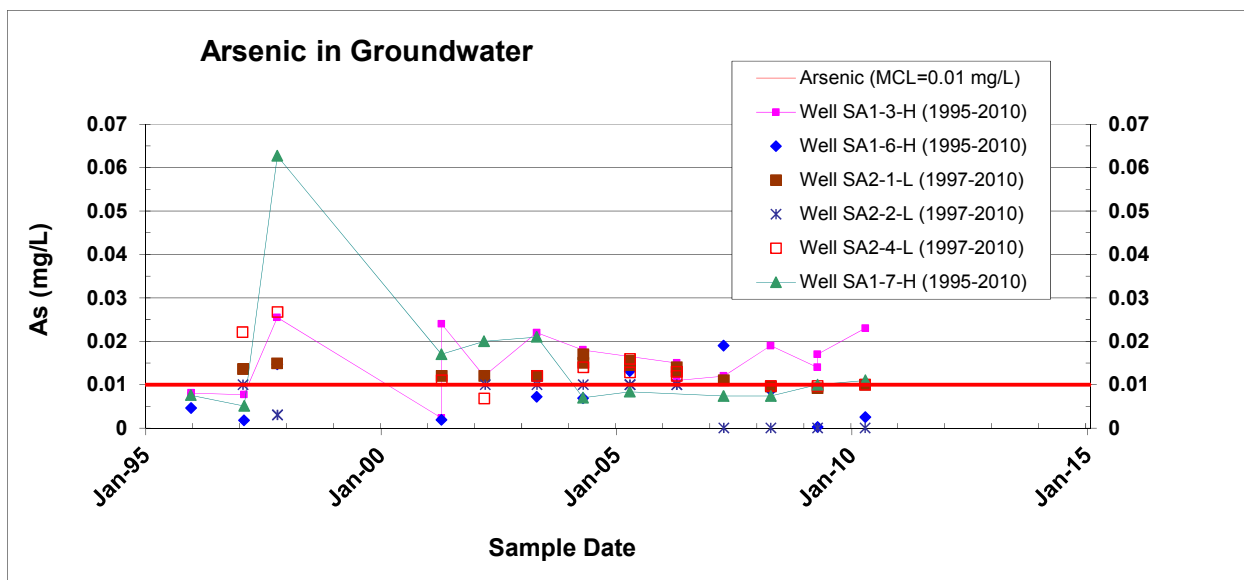
Figure C–7. Arsenic detected in groundwater collected from on-site wells that historically have exceeded the MCL. A line is drawn through the data per well if the arsenic concentration exceeded the MCL in 2010.

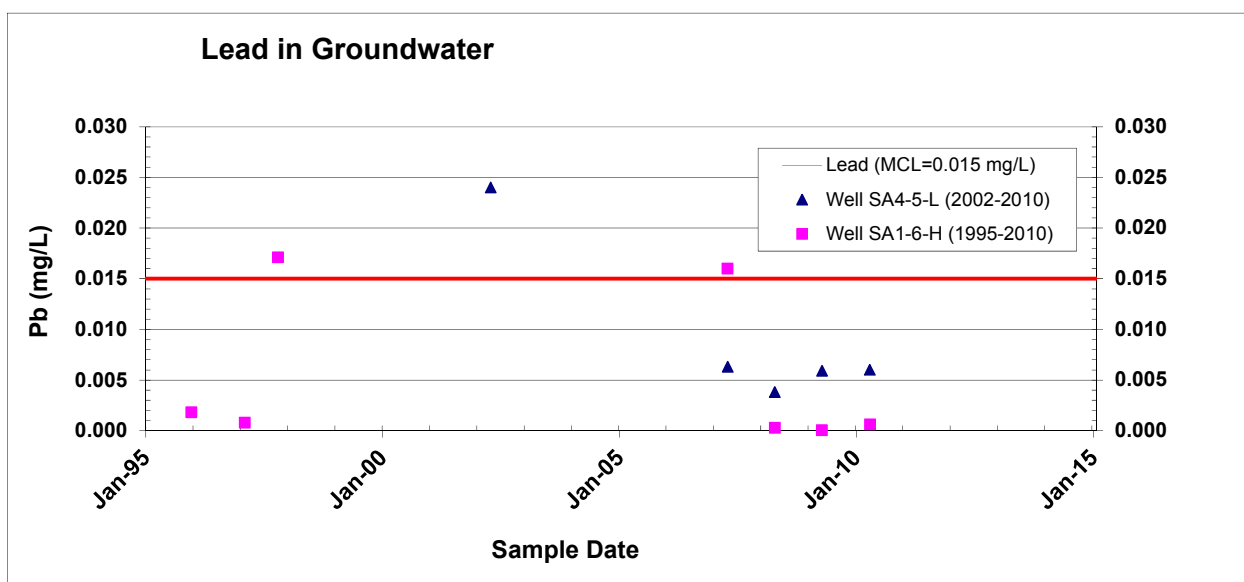
Figure C-10. Lead concentration detected in groundwater collected from on-site wells that historically have exceeded the MCL. Lead was not detected above the MCL in 2010.

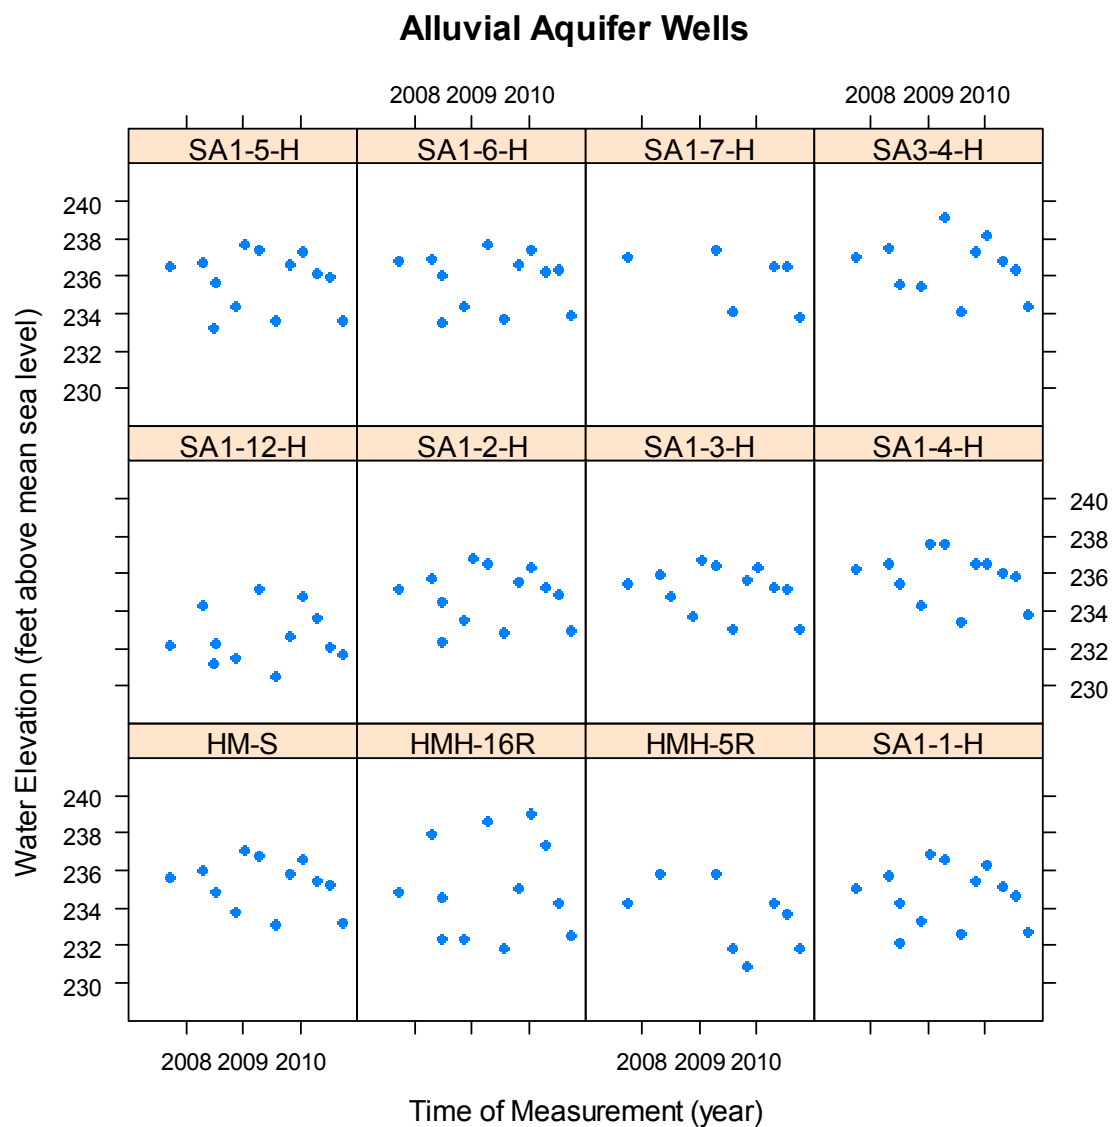
Figure C-14. Measured water levels in the 12 Alluvial Aquifer wells are plotted by measurement date between September 2007 and October 2010.

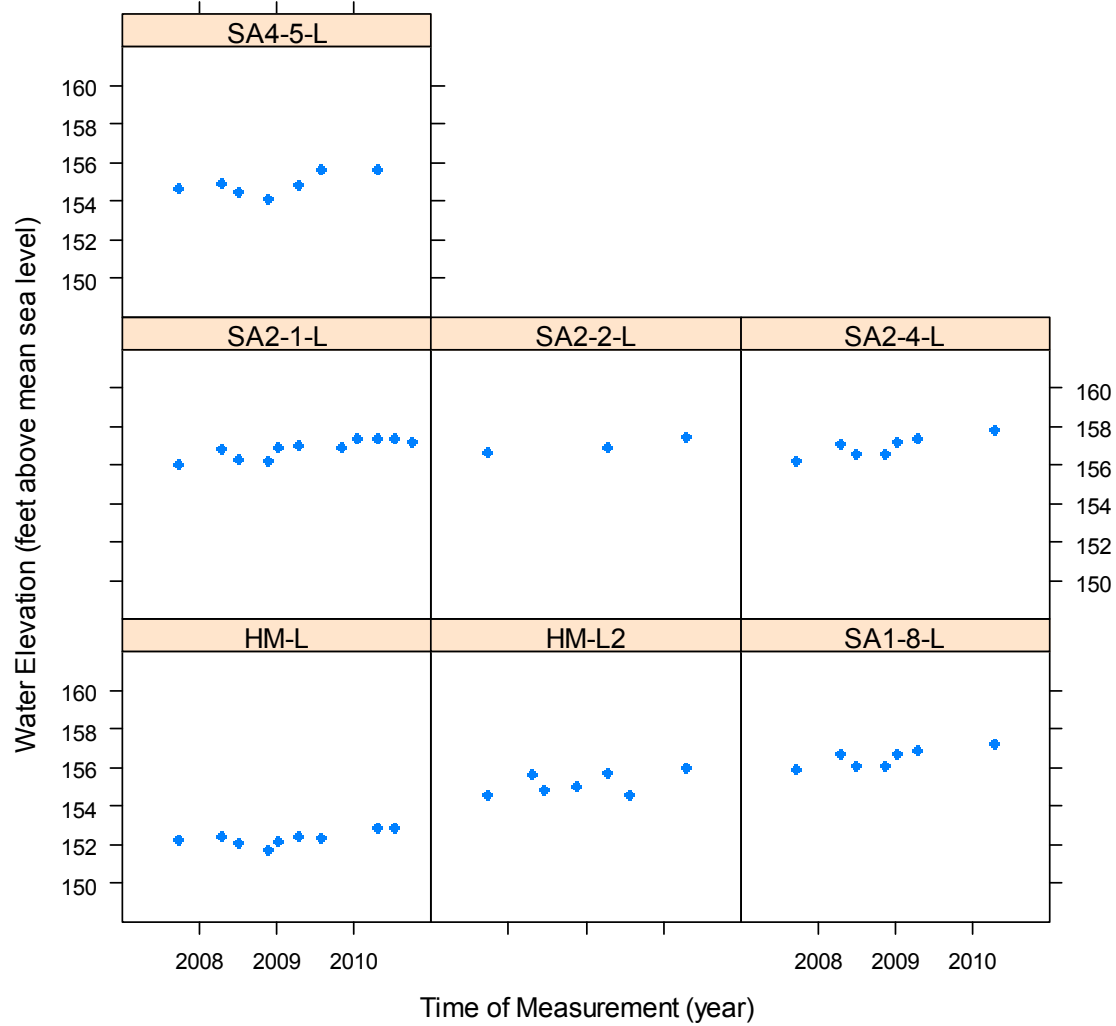
Figure C–15. Measured water levels in the 7 Local Aquifer wells are plotted by measurement date between September 2007 and October 2010.
